**Flood Control Project Maintenance
Levee Inspections
LMA District Cover Sheet
Spring 2009 Levee Inspection Results**

Brannan Andrus Levee Maintenance District

Levee Inspection Report By Mile - Spring 2009

Waterway	Bank	Unit Miles	Inspection Start/End	Inspector
Unit No. 02 Sacramento River	Left	13.30	04/15/2009 04/15/2009	Richard Willoughby

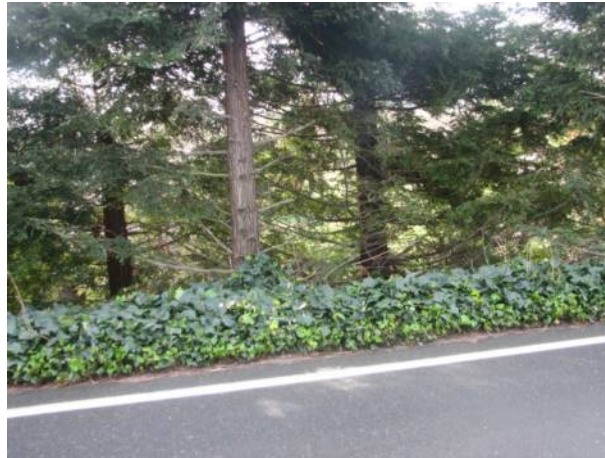
Levee Mile Report Line	4
Start Levee Mile	0.81
End Levee Mile	0.83
Location	Land Side
Category	Earthen Levee
Item	Encroachments
Landscaping on landside slope blocking view of slope from LM .81 to 0.83

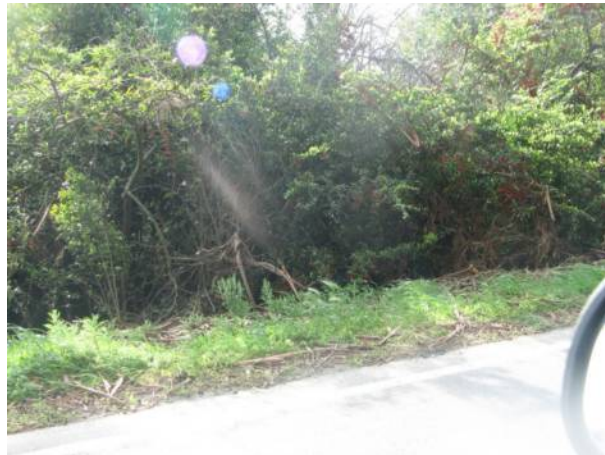
6	1.91	1.95	Earthen Levee	Encroachments	LS	CO	Landscaping	38.173120 ° -121.591505 °	38.172598 ° -121.591853 °	Y	12
7	2.14	2.22	Earthen Levee	Trim / Thin Trees	LS	C	Trim and thin trees to allow visibility of the ground and room to flood fight.	38.170115 ° -121.593708 °	38.169200 ° -121.594270 °		13
8	2.27	2.27	Earthen Levee	Trim / Thin Trees	LS	C	Trim trees to at least five feet above ground level.	38.168537 ° -121.594740 °	38.168537 ° -121.594740 °		14
9	2.68	2.68	Earthen Levee	Vegetation	LS	U	Remove the wild growth other than native grasses from the levee slopes.	38.165160 ° -121.600592 °	38.165160 ° -121.600592 °		941
10	2.77	2.77	Earthen Levee	Encroachments	LS	M	Tree or limb	38.164408 ° -121.601908 °	38.164408 ° -121.601908 °	Y	17
11	3.14	3.16	Earthen Levee	Vegetation	WS	C	Remove the wild growth other than native grasses from the levee slopes.	38.162703 ° -121.608408 °	38.162715 ° -121.608622 °		50

Levee Mile Report Line	6
Start Levee Mile	1.91
End Levee Mile	1.95
Location	Land Side
Category	Earthen Levee
Item	Encroachments
Landscaping on landside slope blocking view of slope from LM 1.91 to 1.95

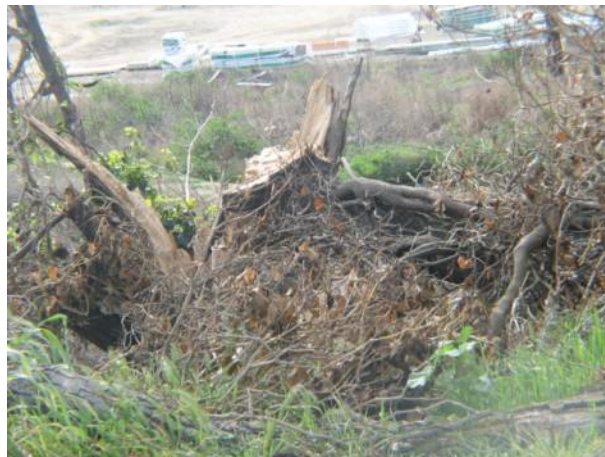
Levee Mile Report Line	10
Start Levee Mile	2.77
End Levee Mile	2.77
Location	Land Side
Category	Earthen Levee
Item	Encroachments
Tree limbs at landside slope at LM 2.77

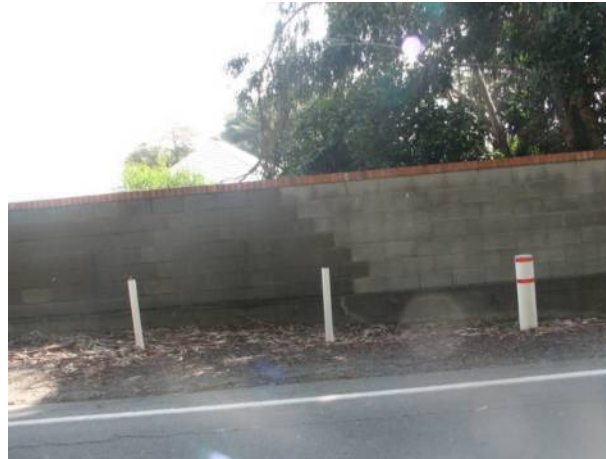
Levee Mile Report Line	27
Start Levee Mile	6.82
End Levee Mile	6.82
Location	Land Side
Category	Earthen Levee
Item	Encroachments

Brick wall on landside shoulder at LM 6.82
