**Flood Control Project Maintenance
Levee Inspections
LMA District Cover Sheet
Spring 2010 Levee Inspection Results**

Brannan Andrus Levee Maintenance District

Levee Inspection Report By Mile - Spring 2010

Waterway				Bank	Unit Miles
Unit No. 02 Sacramento River				Left	13.30
	Spring (March - May)	Summer (June - August)	(September - November) Fall	Winter (December - February)	
Unit Maintenance Rating (Fall Only)					
Date of Inspection	4/28/2010 - 4/28/2010				
DWR Inspector	Richard Willoughby				
Accompanied By	Andy Ginnianni BALMD				
	Gil Labrie DCC Engineering

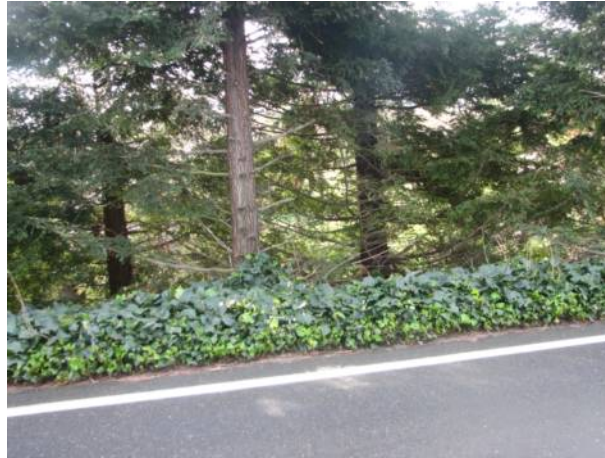
Levee Mile Report Line	3
Start Levee Mile	0.81
End Levee Mile	0.83
Location	Land Side
Category	Earthen Levee
Item	Encroachments

Landscaping on landside slope blocking view of slope from LM .81 to 0.83

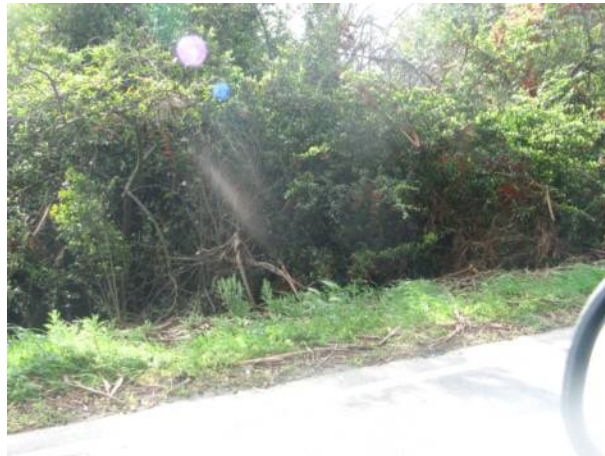
Levee Mile Report Line	6
Start Levee Mile	1.91
End Levee Mile	1.95
Location	Land Side
Category	Earthen Levee
Item	Encroachments

Landscaping on landside slope blocking view of slope from LM 1.91 to 1.95

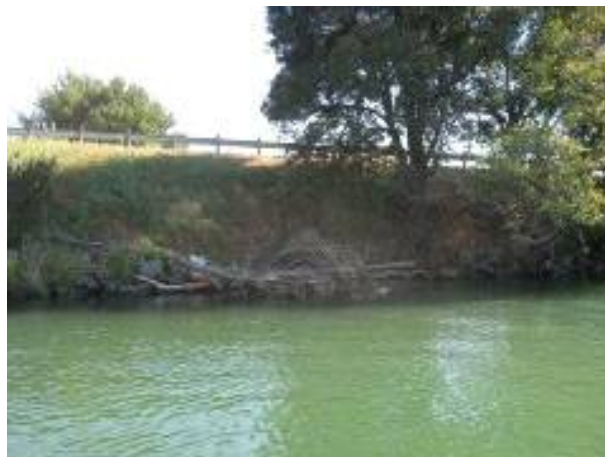
Levee Mile Report Line	7
Start Levee Mile	2.66
End Levee Mile	2.74
Location	Water Side
Category	Supplemental
Item	USACE Erosion Survey

2009: no berm, 1:1 slope, tree hazards, clays and silts, 3.81 ft/s [2009 SiteID:SAC_18-0_L]

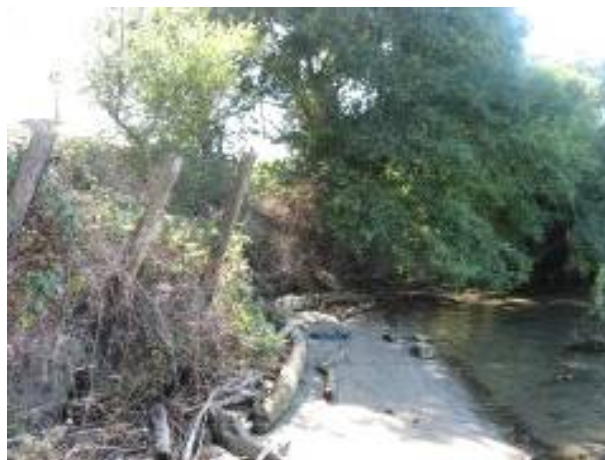
Levee Mile Report Line	11
Start Levee Mile	3.38
End Levee Mile	3.57
Location	Water Side
Category	Supplemental
Item	USACE Erosion Survey

2009: no berm, vertical slope, tension cracks, tree hazards, holes and slumping, silts, 3.43 ft/s [2009 SiteID:SAC_17-2_L]

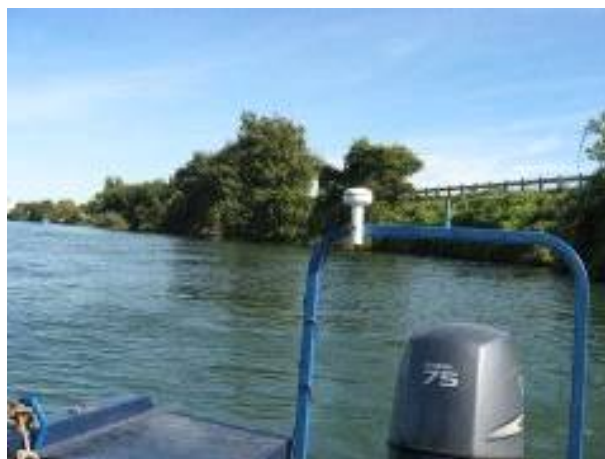
Levee Mile Report Line	13
Start Levee Mile	3.63
End Levee Mile	3.74
Location	Water Side
Category	Supplemental
Item	USACE Erosion Survey

2009: no berm, vertical slope, tension cracks, tree hazards, holes and slumping, silts, 3.22 ft/s [2009 SiteID:SAC_16-8_L]

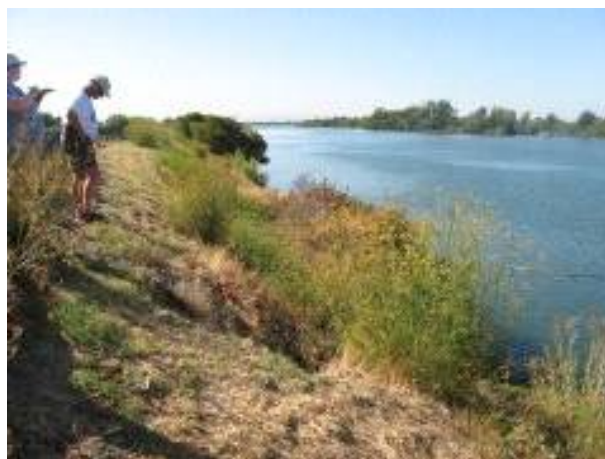
Levee Mile Report Line	19
Start Levee Mile	5.70
End Levee Mile	5.72
Location	Water Side
Category	Supplemental
Item	USACE Erosion Survey

2009: no berm, 1:1 slope, tension cracks and slumping, sands and cobbles, 2.82 ft/s [2009 SiteID:SAC_15-0_L]

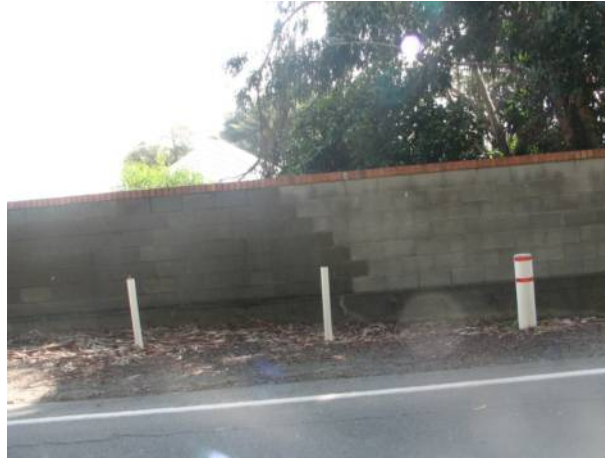
Levee Mile Report Line	24
Start Levee Mile	6.82
End Levee Mile	6.82
Location	Land Side
Category	Earthen Levee
Item	Encroachments
Brick wall on landside shoulder at LM 6.82	
richard_s_20100505_003.jpg

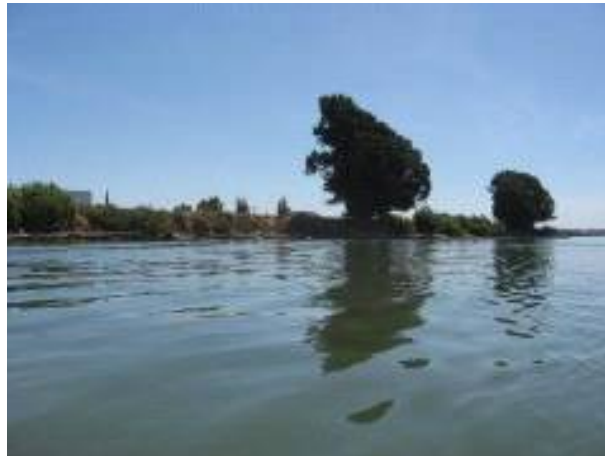
Levee Mile Report Line	26
Start Levee Mile	8.99
End Levee Mile	9.21
Location	Water Side
Category	Supplemental
Item	USACE Erosion Survey
2009: no berm, 1:1 slope, tree hazards, holes, and slumping, clays and silts, 6.8 ft/s [2009 SiteID:SAC_11-2_L]	
USACE2009_SAC_11-2_L_2009_09_18-D4P33_small.JPG

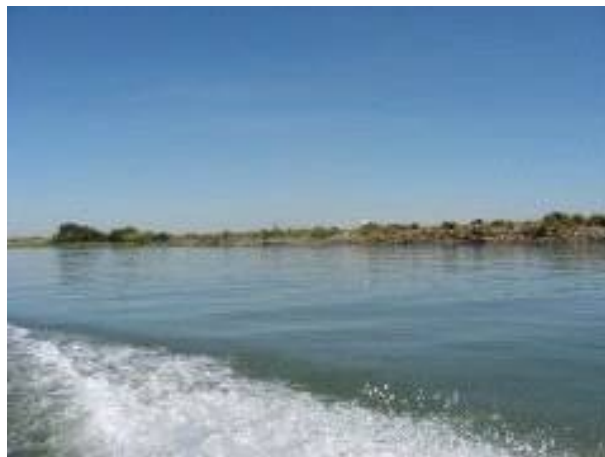
Levee Mile Report Line	29
Start Levee Mile	9.70
End Levee Mile	9.97
Location	Water Side
Category	Supplemental
Item	USACE Erosion Survey
2009: no berm, 1:1 slope, no stability issues, clays and silts, 7.05 ft/s [2009 SiteID:SAC_10-8_L]	
USACE2009_SAC_10-8_L_2009_09_18-D4P35_small.JPG
