**Flood Control Project Maintenance
Levee Inspections**
LMA District Cover Sheet
Spring 2012 Levee Inspection Results

Brannan Andrus Levee Maintenance District

Levee Inspection Report By Mile - Spring 2012

Waterway				Bank	Unit Miles	Inspection Start/End	Inspector
Unit No. 01 Georgiana Slough				Right	6.02	03/07/2012 03/07/2012	Richard Willoughby

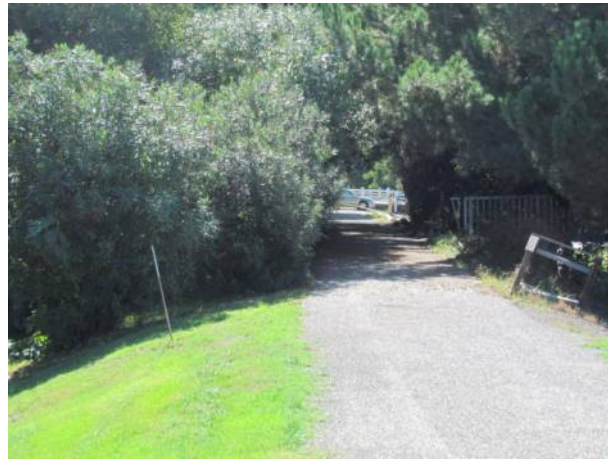
Levee Mile Report Line	9
Start Levee Mile	2.29
End Levee Mile	2.34
Location	Land Side
Category	Earthen Levee
Item	Vegetation
Looking south at dense landscape on waterside and landside of levee.	
richard_s_20120306_009.jpg

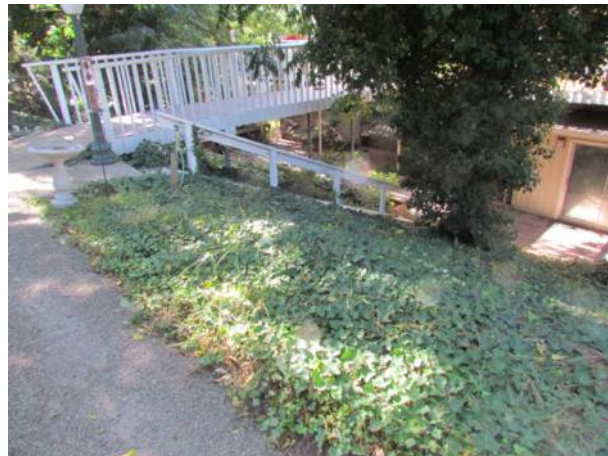
Levee Mile Report Line	9
Start Levee Mile	2.29
End Levee Mile	2.34
Location	Land Side
Category	Earthen Levee
Item	Vegetation
Looking west at ground cover on landside slope.	
richard_s_20120306_010.jpg

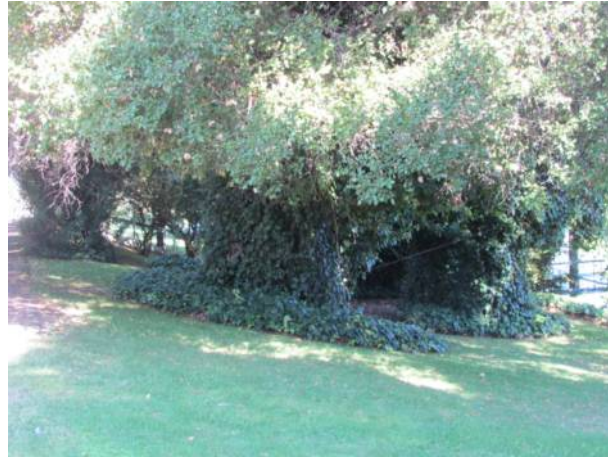
Levee Mile Report Line	9
Start Levee Mile	2.29
End Levee Mile	2.34
Location	Land Side
Category	Earthen Levee
Item	Vegetation

Looking north at dense vegetation on waterside slope.

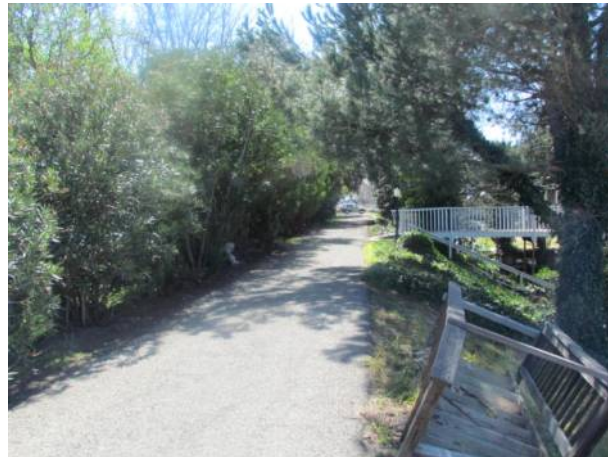
Levee Mile Report Line	9
Start Levee Mile	2.29
End Levee Mile	2.34
Location	Land Side
Category	Earthen Levee
Item	Vegetation

Looking south at dense oleander on waterside shoulder spring 2012

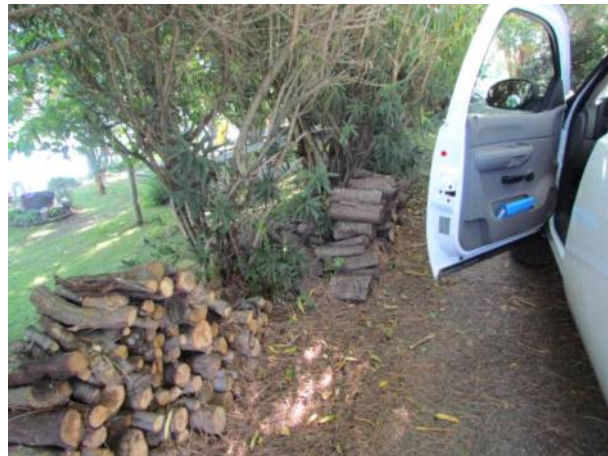
Levee Mile Report Line	10
Start Levee Mile	2.30
End Levee Mile	2.30
Location	Water Side
Category	Earthen Levee
Item	Encroachments

Looking east at firewood on waterside shoulder.

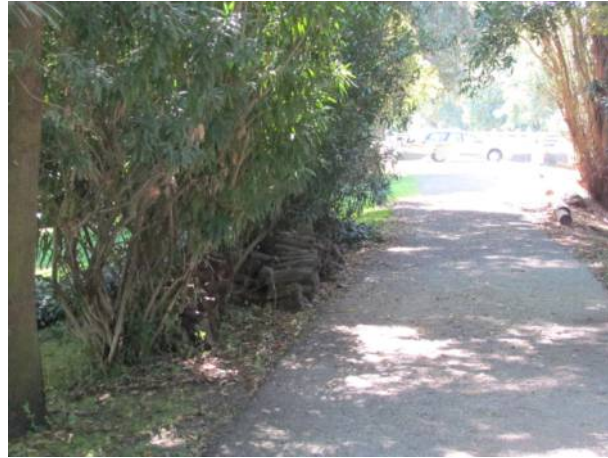
Levee Mile Report Line	10
Start Levee Mile	2.30
End Levee Mile	2.30
Location	Water Side
Category	Earthen Levee
Item	Encroachments

Looking south at firewood on waterside shoulder.

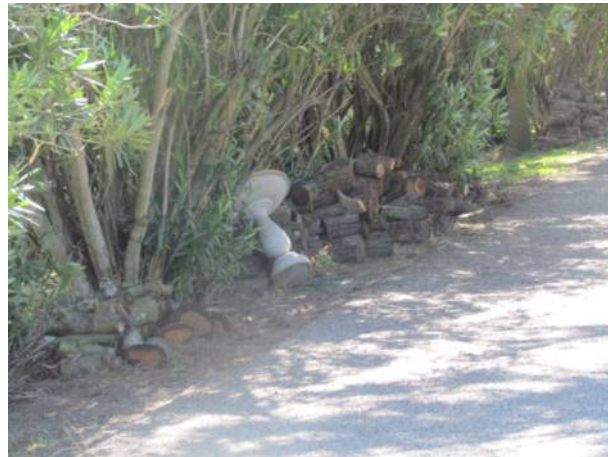
Levee Mile Report Line	10
Start Levee Mile	2.30
End Levee Mile	2.30
Location	Water Side
Category	Earthen Levee
Item	Encroachments

Looking southeast at firewood on waterside shoulder.

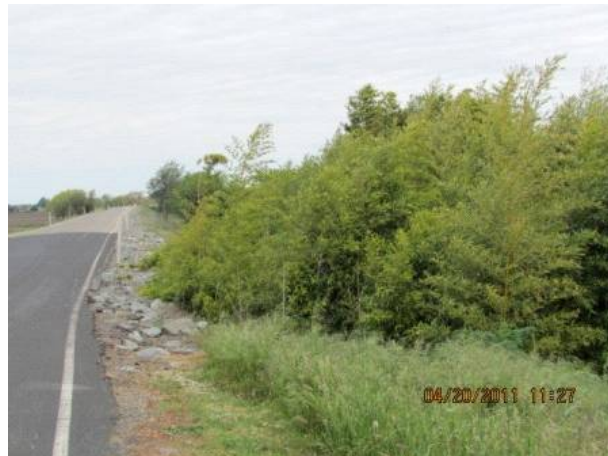
Levee Mile Report Line	15
Start Levee Mile	3.93
End Levee Mile	3.93
Location	Water Side
Category	Earthen Levee
Item	Vegetation

Looking west at dense vegetation on waterside slope.

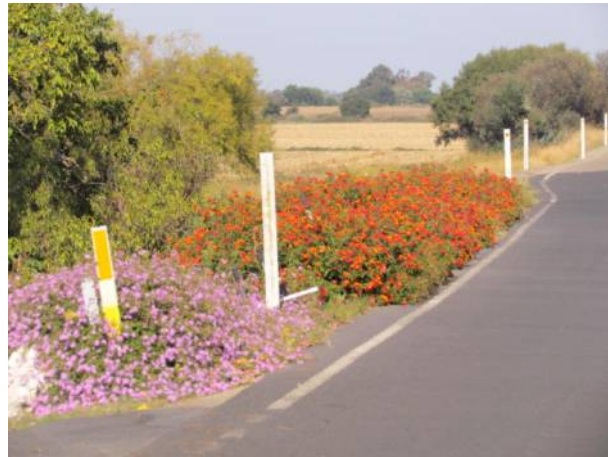
Levee Mile Report Line	16
Start Levee Mile	3.93
End Levee Mile	3.97
Location	Land Side
Category	Earthen Levee
Item	Vegetation

Looking northeast at landscape on landside slope.

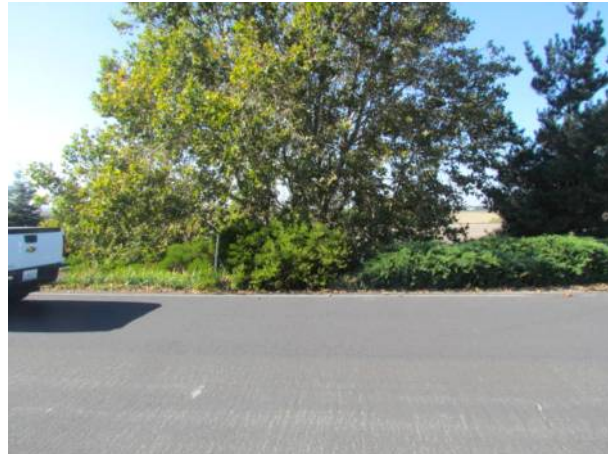
Levee Mile Report Line	16
Start Levee Mile	3.93
End Levee Mile	3.97
Location	Land Side
Category	Earthen Levee
Item	Vegetation

Looking west at dense landscape on landside slope.

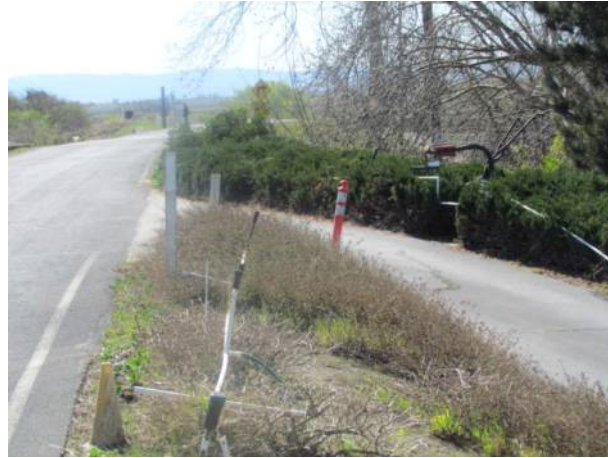
Levee Mile Report Line	16
Start Levee Mile	3.93
End Levee Mile	3.97
Location	Land Side
Category	Earthen Levee
Item	Vegetation

Looking south at brushes on landside shoulder and slope.

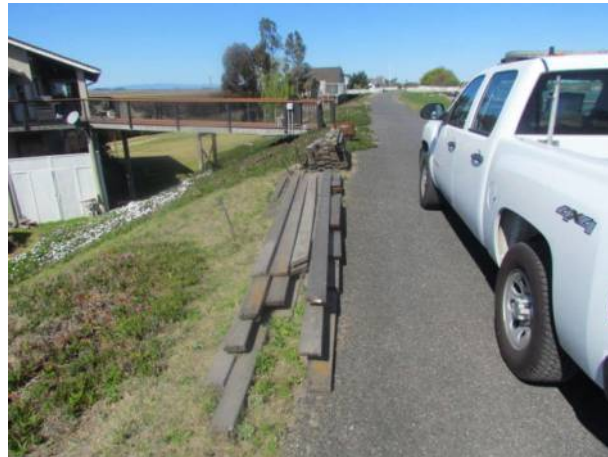
Levee Mile Report Line	20
Start Levee Mile	4.78
End Levee Mile	4.78
Location	Land Side
Category	Earthen Levee
Item	Encroachments

Looking northwest at wooden boards on landside shoulder.

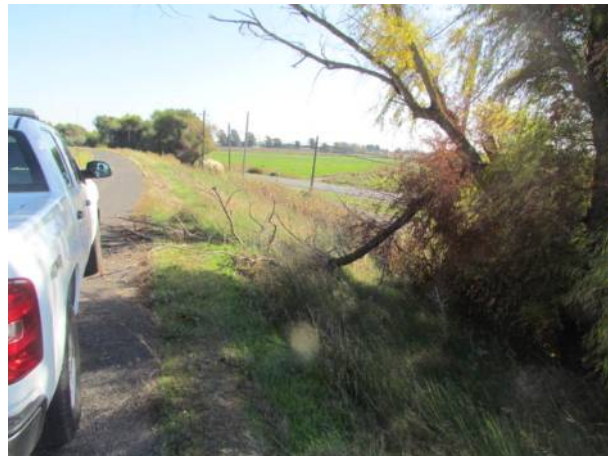
Levee Mile Report Line	25
Start Levee Mile	5.42
End Levee Mile	5.42
Location	Land Side
Category	Earthen Levee
Item	Encroachments

Looking southwest downed tree limb on landside slope.

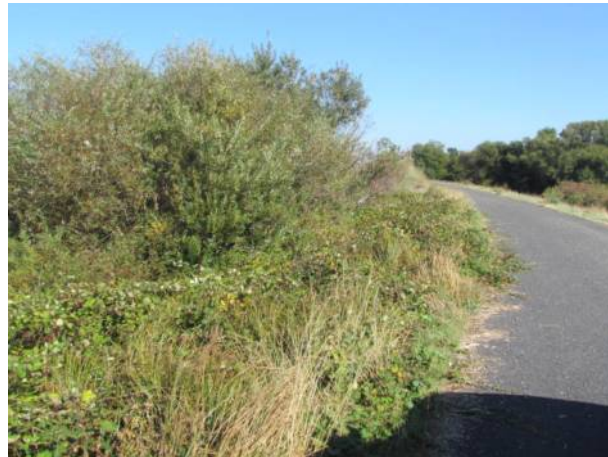
Levee Mile Report Line	27
Start Levee Mile	5.63
End Levee Mile	5.67
Location	Water Side
Category	Earthen Levee
Item	Vegetation

Looking south at dense vegetation on waterside slope.

27	5.63	5.67	Earthen Levee	Vegetation	WS M Ma	V2 : Remove the wild growth other than native grasses from the levee slopes. Inspector Comments: Wild roses or berryvines on waterside slope.	38.129240 ° -121.585328 °	38.129252 ° -121.584723 °	18 Y	
DWR ID: DWR_NA0002_01_s_2012_18										
28	5.69	5.69	Earthen Levee	Vegetation	WS M Ma	V2 : Remove the wild growth other than native grasses from the levee slopes. Inspector Comments: Willows on waterside slope	38.129307 ° -121.584253 °	38.129307 ° -121.584253 °	19	
DWR ID: DWR_NA0002_01_s_2012_19

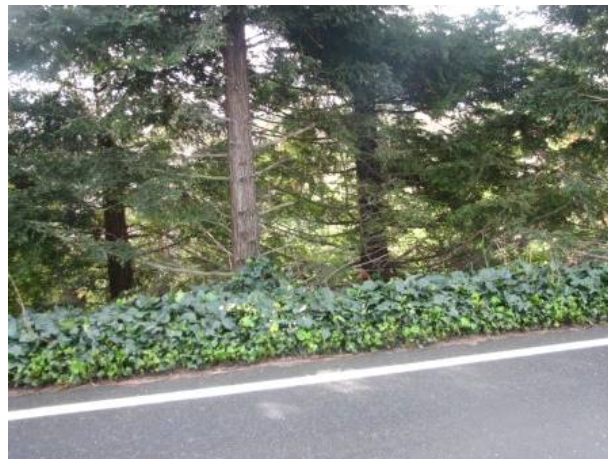
Levee Mile Report Line	6
Start Levee Mile	0.81
End Levee Mile	0.83
Location	Land Side
Category	Earthen Levee
Item	Vegetation

Landscaping on landside slope blocking view of slope from LM .81 to 0.83.

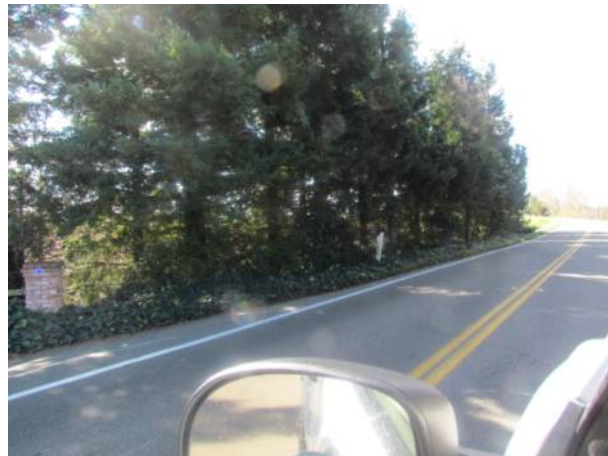
Levee Mile Report Line	6
Start Levee Mile	0.81
End Levee Mile	0.83
Location	Land Side
Category	Earthen Levee
Item	Vegetation

Looking southeast at dense landscaping on landside slope.

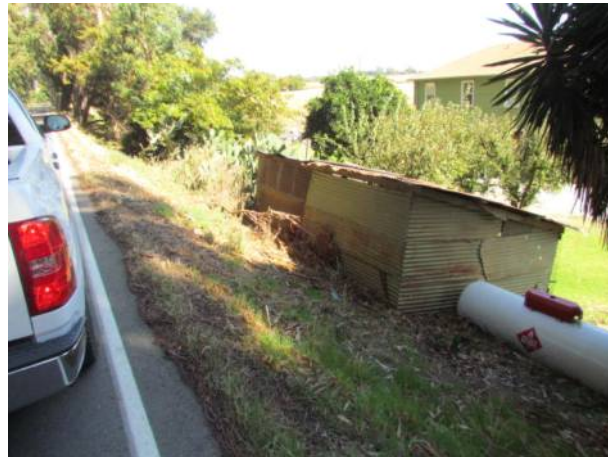
Levee Mile Report Line	12
Start Levee Mile	1.83
End Levee Mile	1.83
Location	Land Side
Category	Earthen Levee
Item	Encroachments

Looking northeast pump shed on landside toe.

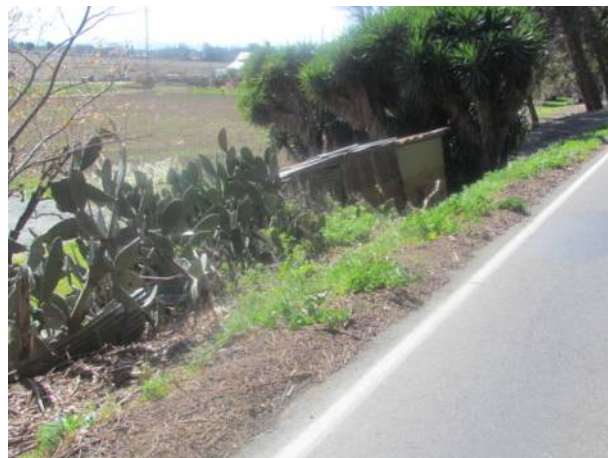
Levee Mile Report Line	12
Start Levee Mile	1.83
End Levee Mile	1.83
Location	Land Side
Category	Earthen Levee
Item	Encroachments

Looking southeast at pump shed and landscaping on landside slope and toe.

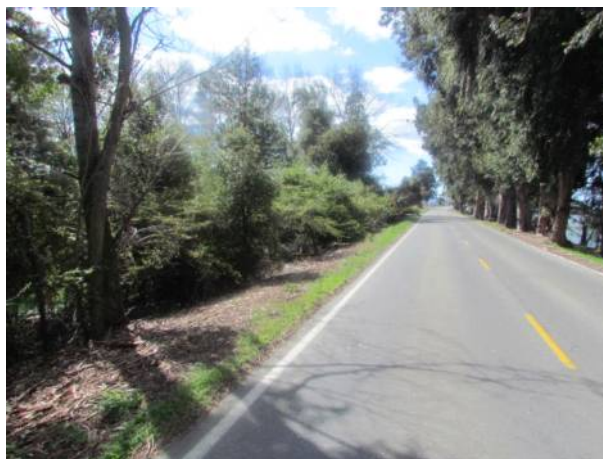
Levee Mile Report Line	14
Start Levee Mile	1.91
End Levee Mile	1.95
Location	Land Side
Category	Earthen Levee
Item	Vegetation

Looking south at dense landscaping on landside slope and toe.

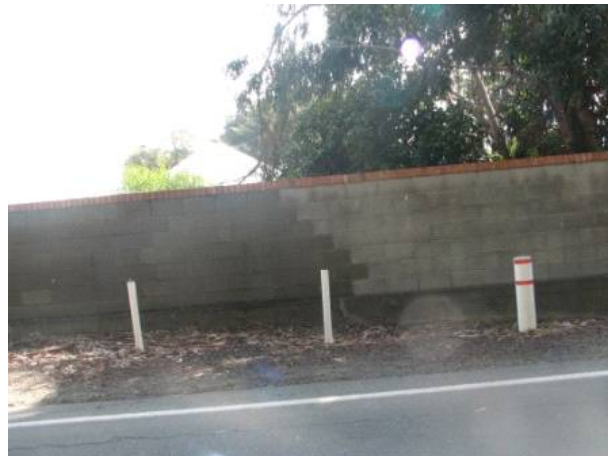
Levee Mile Report Line	36
Start Levee Mile	6.82
End Levee Mile	6.82
Location	Land Side
Category	Earthen Levee
Item	Encroachments

Brick wall on landside shoulder at LM 6.82.
