**Flood Control Project Maintenance
Levee Inspections****LMA District Cover Sheet****Spring 2013 Levee Inspection Results****Brannan Andrus Levee Maintenance District**

Spring 2013 Levee Inspection Results

Brannan Andrus Levee Maintenance District

Levee Inspection Report By Mile - Spring 2013

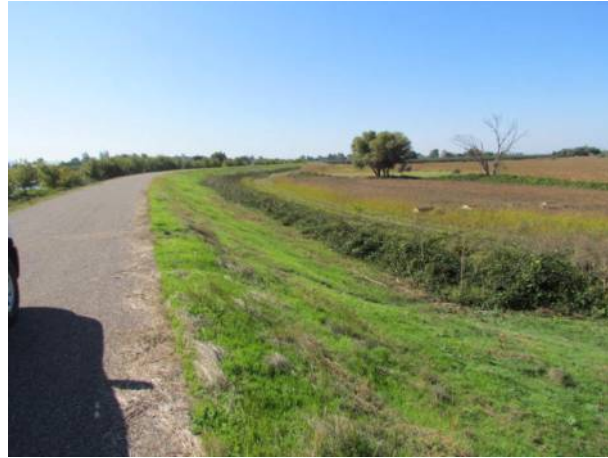
Levee Mile Report Line	6
Start Levee Mile	0.50
End Levee Mile	0.75
Location	Land Side
Category	
Item	Vegetation
Looking southwest at wild roses or berry vines on landside toe.	
richard_s_20130304_001.jpg

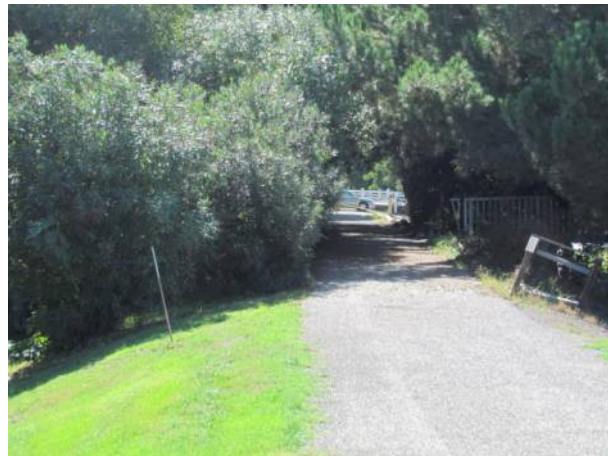
Levee Mile Report Line	10
Start Levee Mile	2.29
End Levee Mile	2.34
Location	Land Side
Category	
Item	Vegetation
Looking south at dense landscape on waterside and landside of levee.	
richard_s_20130304_014.jpg

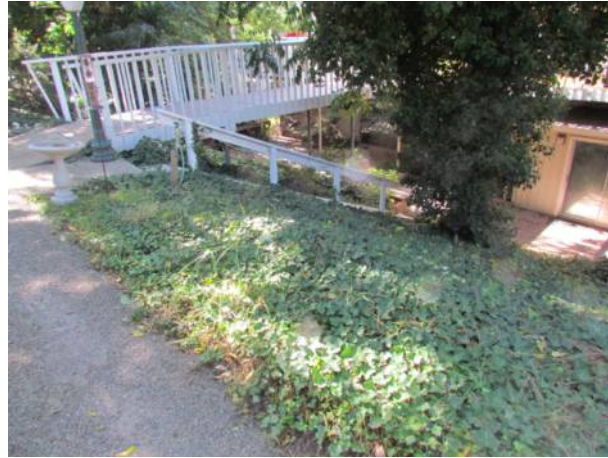
Levee Mile Report Line	10
Start Levee Mile	2.29
End Levee Mile	2.34
Location	Land Side
Category	
Item	Vegetation

Looking west at ground cover on landside slope.

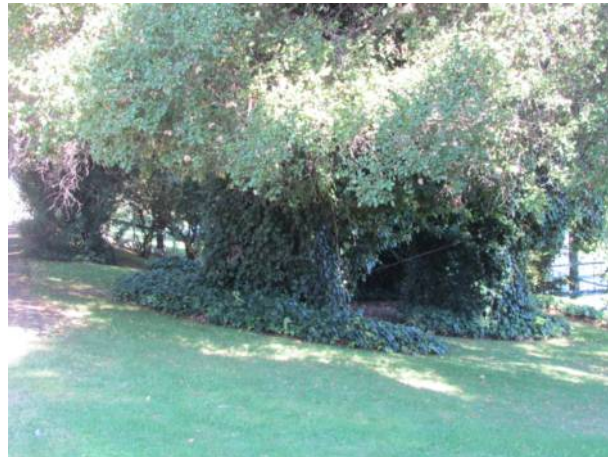
Levee Mile Report Line	10
Start Levee Mile	2.29
End Levee Mile	2.34
Location	Land Side
Category	
Item	Vegetation

Looking north at dense vegetation on waterside slope.

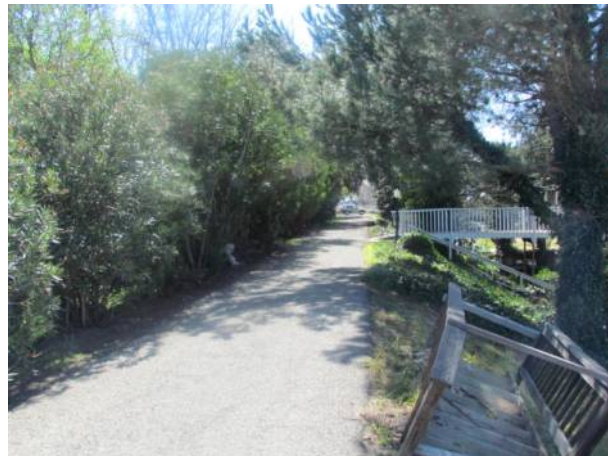
Levee Mile Report Line	10
Start Levee Mile	2.29
End Levee Mile	2.34
Location	Land Side
Category	
Item	Vegetation

Looking south at dense oleander on waterside shoulder spring 2012

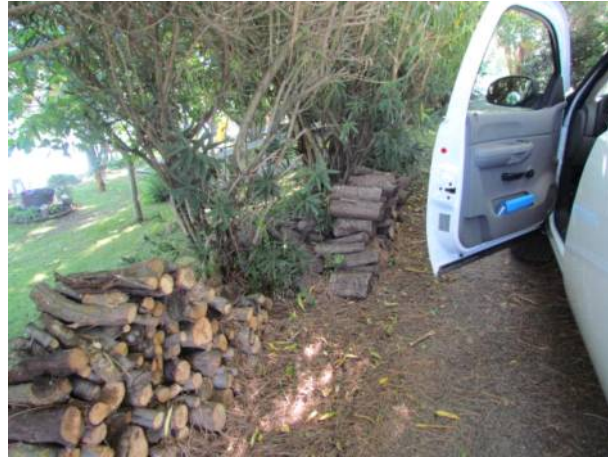
Levee Mile Report Line	11
Start Levee Mile	2.30
End Levee Mile	2.30
Location	Water Side
Category	
Item	Encroachments
Looking east at firewood on waterside shoulder.	
richard_s_20130304_002.jpg

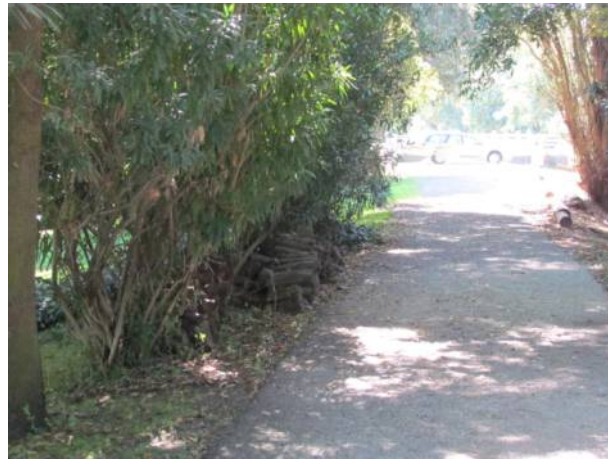
Levee Mile Report Line	11
Start Levee Mile	2.30
End Levee Mile	2.30
Location	Water Side
Category	
Item	Encroachments
Looking south at firewood on waterside shoulder.	
richard_s_20130304_003.jpg

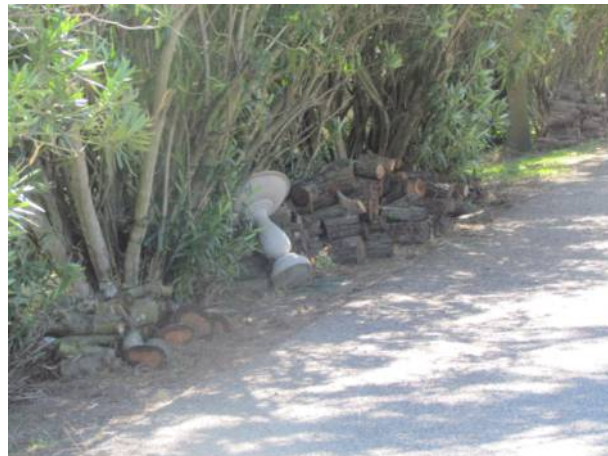
Levee Mile Report Line	11
Start Levee Mile	2.30
End Levee Mile	2.30
Location	Water Side
Category	
Item	Encroachments
Looking southeast at firewood on waterside shoulder.	
richard_s_20130304_004.jpg

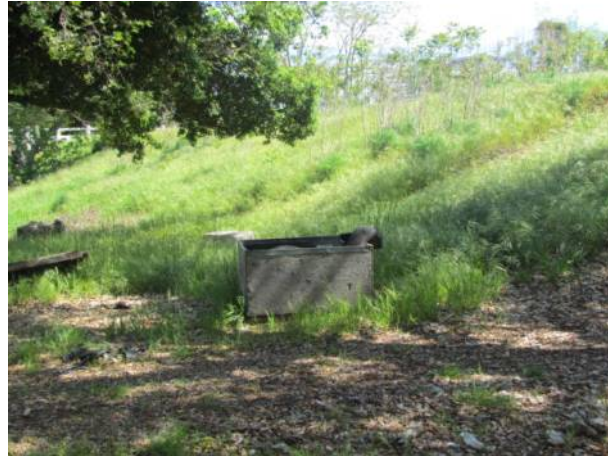
Levee Mile Report Line	13
Start Levee Mile	2.39
End Levee Mile	2.39
Location	Land Side
Category	
Item	Encroachments
Looking northeast at garbage at landward toe.	
richard_s_20130404_057.JPG

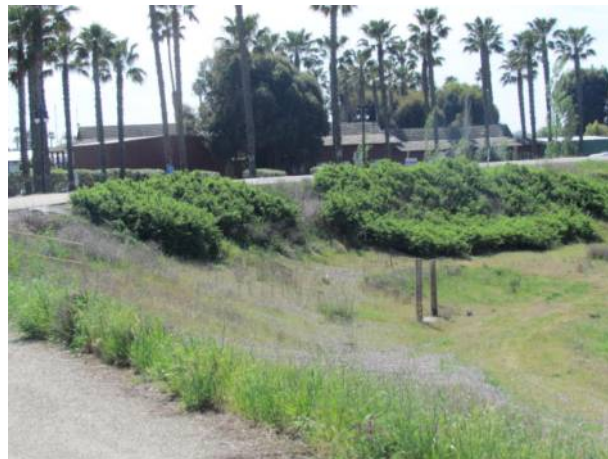
Levee Mile Report Line	15
Start Levee Mile	3.32
End Levee Mile	3.35
Location	Land Side
Category	
Item	Vegetation
Looking south at wild roses on landward slope and toe.	
richard_s_20130404_058.JPG

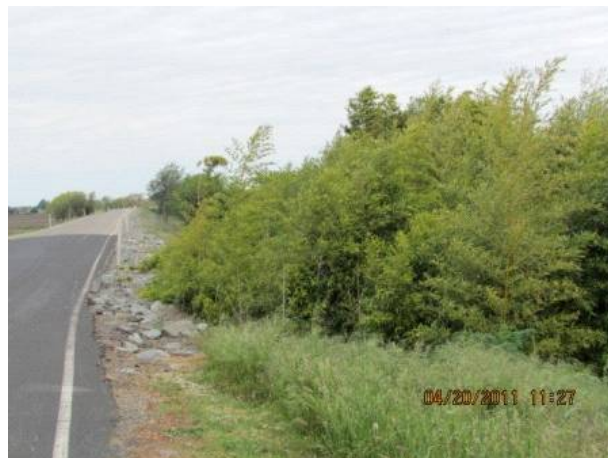
Levee Mile Report Line	19
Start Levee Mile	3.93
End Levee Mile	3.93
Location	Water Side
Category	
Item	Vegetation
Looking west at dense vegetation on waterside slope.	
richard_s_20130304_006.jpg

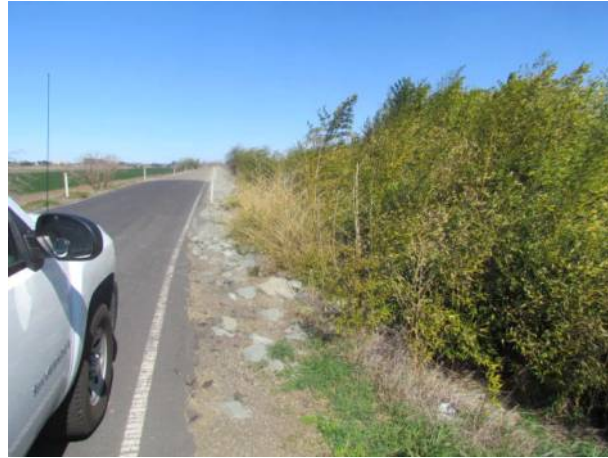
Levee Mile Report Line	19
Start Levee Mile	3.93
End Levee Mile	3.93
Location	Water Side
Category	
Item	Vegetation

Looking west at dense vegetation on waterside slope spring 2012.

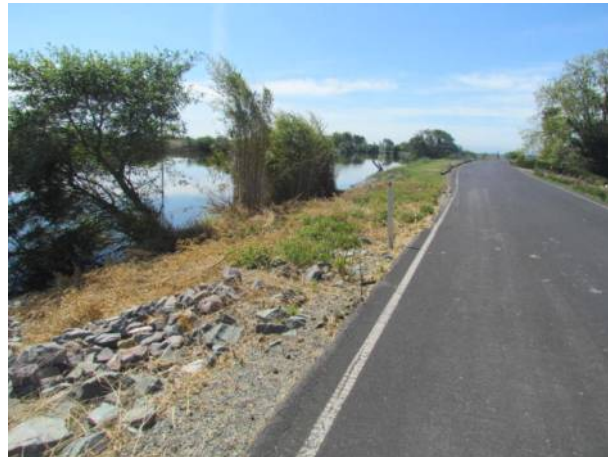
Levee Mile Report Line	19
Start Levee Mile	3.93
End Levee Mile	3.93
Location	Water Side
Category	
Item	Vegetation

Looking south at dead willows on waterward slope. (Spring 2013)

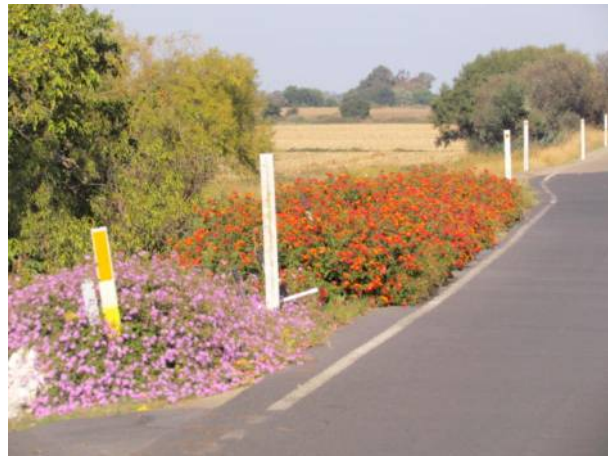
Levee Mile Report Line	20
Start Levee Mile	3.93
End Levee Mile	3.97
Location	Land Side
Category	
Item	Vegetation

Looking northeast at landscape on landside slope.

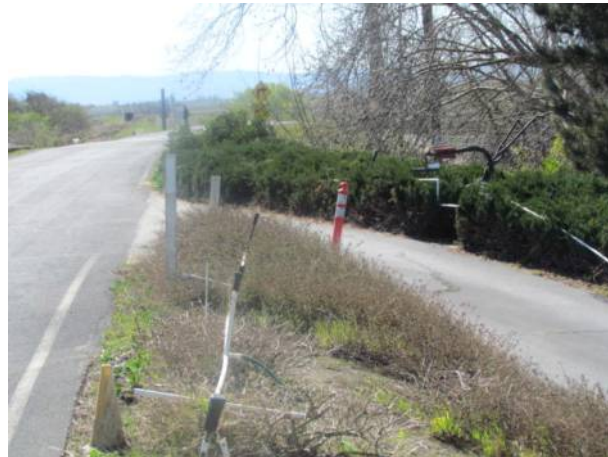
Levee Mile Report Line	20
Start Levee Mile	3.93
End Levee Mile	3.97
Location	Land Side
Category	
Item	Vegetation
Looking south at brushes on landside shoulder and slope.	
richard_s_20130304_010.jpg

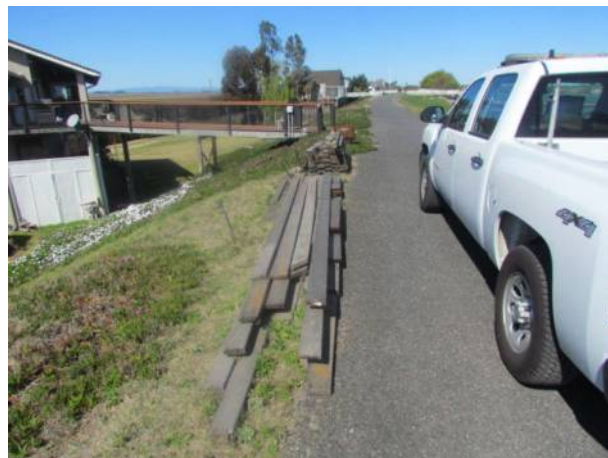
Levee Mile Report Line	24
Start Levee Mile	4.78
End Levee Mile	4.78
Location	Land Side
Category	
Item	Encroachments
Looking northwest at wooden boards on landside shoulder.	
richard_s_20130304_013.jpg

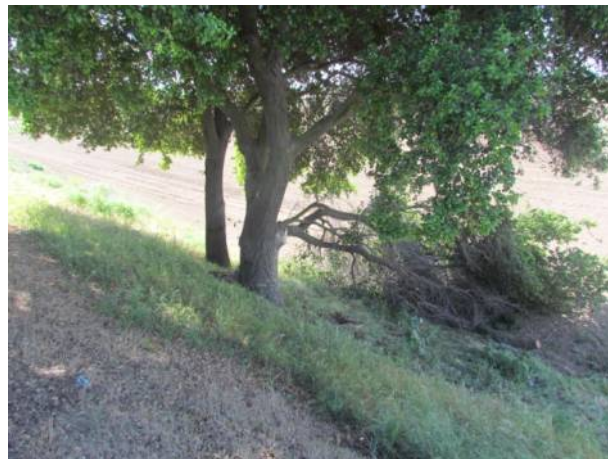
Levee Mile Report Line	29
Start Levee Mile	4.59
End Levee Mile	4.59
Location	Land Side
Category	
Item	Encroachments

Looking northeast at broken tree limb on landward slope and toe.

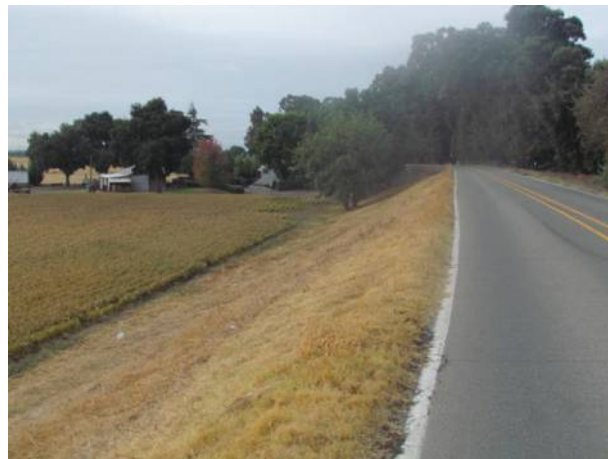
Levee Mile Report Line	37
Start Levee Mile	5.82
End Levee Mile	6.15
Location	Land Side
Category	
Item	Vegetation
Looking southeast at vegetation complies on landside slope.	
richard_s_20130304_026.JPG

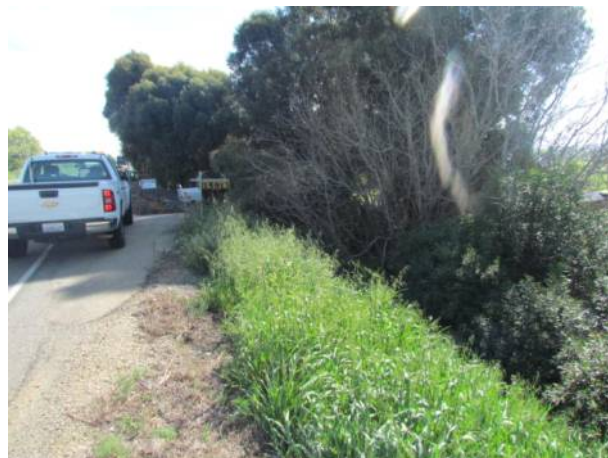
Levee Mile Report Line	38
Start Levee Mile	6.29
End Levee Mile	6.29
Location	Land Side
Category	
Item	Vegetation
Looking north at dense landscaping on landward slope.	
richard_s_20130404_048.JPG

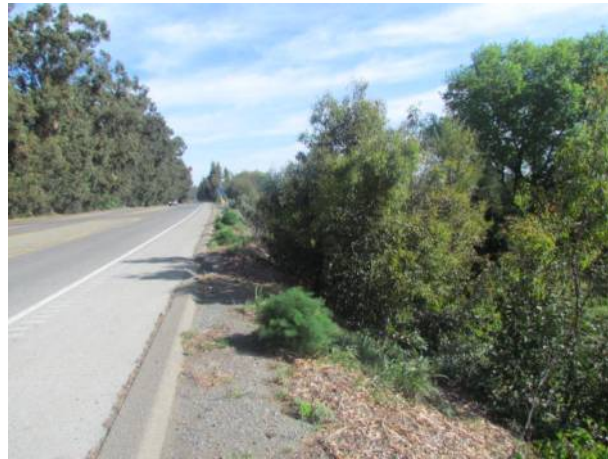
Levee Mile Report Line	47
Start Levee Mile	8.68
End Levee Mile	8.89
Location	Land Side
Category	
Item	Trim / Thin Trees
Looking north at dense trees on landward slope and toe.	
richard_s_20130404_046.JPG

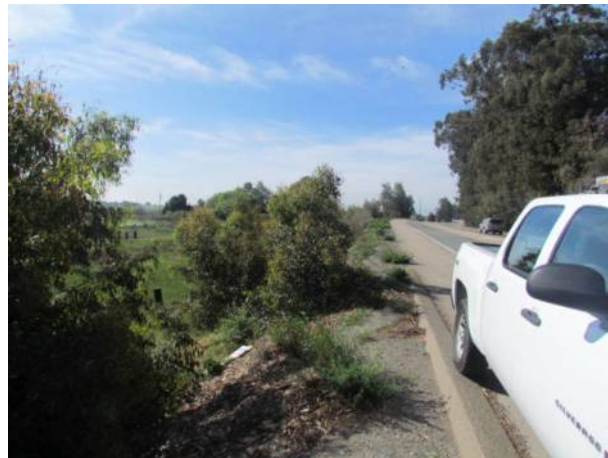
Levee Mile Report Line	47
Start Levee Mile	8.68
End Levee Mile	8.89
Location	Land Side
Category	
Item	Trim / Thin Trees
Looking south at trees on landward slope.	
richard_s_20130404_047.JPG
