**Flood Control Project Maintenance
Levee Inspections**
LMA District Cover Sheet
Spring 2014 Levee Inspection Results

Brannan Andrus Levee Maintenance District

Spring 2014 Levee Inspection Results

Waterway		Bank	Unit Miles
Unit No. 01 Georgiana Slough		Right	6.02

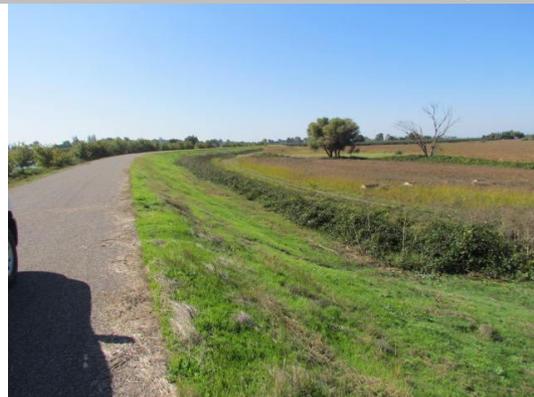
Photo 1 of 1 : richard_s_20140318_469.jpg

Looking southwest at wild roses or berry vines on landside toe.

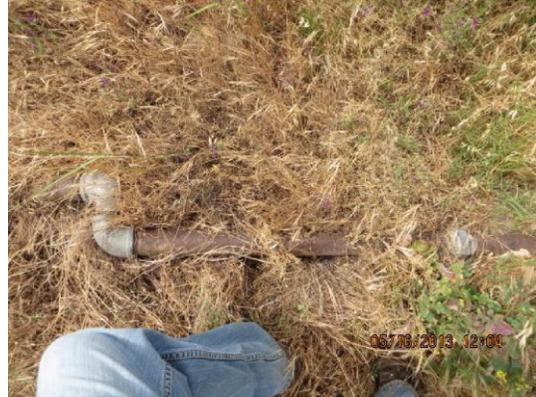
Photo 1 of 1 : UCIP_893.jpg

LM Start	0.61	Rating **	M	Issue No.	35
LM End	0.61	Issue Type +	En	Location *	LS
Category	Supplemental			GPS Latitude/Longitude	
				Start	End
Item	DWR UCIP Field Study			38.182213 °	38.182213 °
				-121.572356 °	-121.572356 °
DWR ID	DWR_NA0002_01_s_2014_35				
Action/Comments					
Inspector Comments: FS_ID:13560 EP_NO: 2015 Repair Type: Crossing Status: UCIP Comments: This pipe appears abandoned and should be removed. FIELD_STRUCT_DESC: 2-inch galvanized pipe through levee 2.0 feet below crown. Gas well drain (Permit No. 2015, 1959). FS Date: 5/16/2013

Pipe on LS slope.

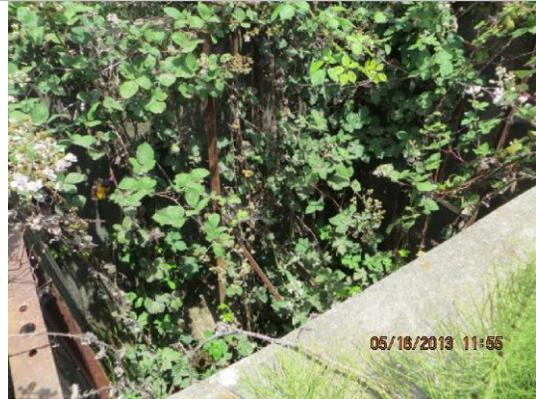
Photo 1 of 1 : UCIP_1399.jpg

LM Start	0.75	Rating **	M	Issue No.	37
LM End	0.75	Issue Type +	En	Location *	LS
Category	Supplemental			GPS Latitude/Longitude	
				Start	End
Item	DWR UCIP Field Study			38.182212 °	38.182212 °
				-121.574987 °	-121.574987 °
DWR ID	DWR_NA0002_01_s_2014_37				
Action/Comments					
Inspector Comments: FS_ID:15984 EP_NO: 11232 Repair Type: Crossing Status: UCIP Comments: Unable to locate any appurtances other than distro box. Need to verify proper abandonment. FIELD_STRUCT_DESC: 12-inch pipe through levee 3.2 feet below crown. Siphon breaker on landward slope. Concrete distribution box located landward of the toe (ABO No. 11232, 1975). 2" primer valve. Originally included in the 1954 O&M manual. FS Date: 5/16/2013

Concrete distribution box on LS toe.

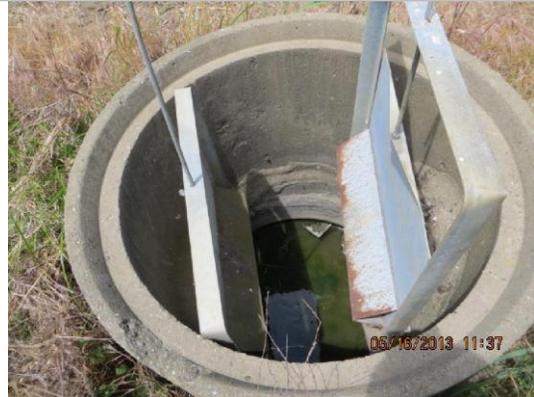
Photo 1 of 1 : UCIP_890.jpg

LM Start	1.22	Rating **	M	Issue No.	38
LM End	1.22	Issue Type +	En	Location *	LS
Category	Supplemental		GPS Latitude/Longitude		
			Start	End	
Item	DWR UCIP Field Study		38.177669 °	38.177669 °	
			-121.580222 °	-121.580222 °	
DWR ID	DWR_NA0002_01_s_2014_38				
Action/Comments					
Inspector Comments: FS_ID:13558 EP_NO: 11234 Repair Type: Crossing Status: UCIP Comments: Appears abandoned and should be done so properly. FIELD_STRUCT_DESC: 1 of 2: 8-inch steel pipe through levee 4.3 feet below crown. Pump in pump house on waterward berm. 60-inch diameter concrete standpipe on LS toe (ABO No. 11234, 1975). Originally included in the 1954 O&M manual. FS Date: 5/16/2013

Concrete standpipe on LS toe.

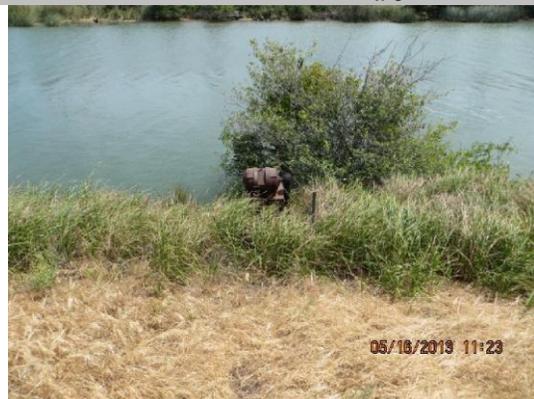
Photo 1 of 1 : UCIP_888.jpg

LM Start	1.54	Rating **	M	Issue No.	39
LM End	1.54	Issue Type +	En	Location *	LS
Category	Supplemental		GPS Latitude/Longitude		
			Start	End	
Item	DWR UCIP Field Study		38.173254 °	38.173254 °	
			-121.580718 °	-121.580718 °	
DWR ID	DWR_NA0002_01_s_2014_39				
Action/Comments					
Inspector Comments: FS_ID:13554 EP_NO: 11252 Repair Type: Crossing Status: UCIP Comments: Pipe heavily rusted at distribution box. Good candidate for video inspection. FIELD_STRUCT_DESC: 1 of 3: 8-inch steel pipe through levee 4.6 feet below crown. Pump and valve on waterward slope. Siphon breaker in 24-inch CMP riser on LS shoulder. 7'X10'-concrete distribution box at LS toe (ABO No. 11252, 1976). Originally included in the 1954 O&M manual. FS Date: 5/16/2013

Pump and pipe at WS toe.

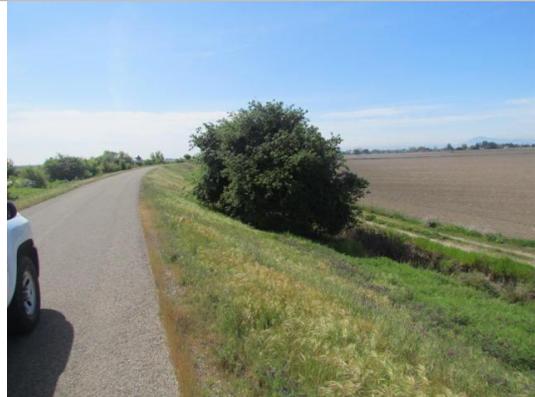
Photo 1 of 1 : richard_s_20140318_488.jpg

Looking southwest at untrimmed tree on landward slope and toe.

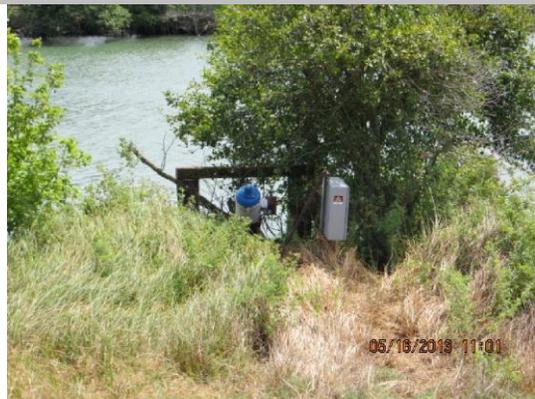
Photo 1 of 1 : UCIP_881.jpg

LM Start	2.18	Rating **	M	Issue No.	40
LM End	2.18	Issue Type +	En	Location *	LS
Category	Supplemental			GPS Latitude/Longitude	
				Start	End
Item	DWR UCIP Field Study			38.164491 °	38.164491 °
				-121.583943 °	-121.583943 °
DWR ID	DWR_NA0002_01_s_2014_40				
Action/Comments					
Inspector Comments: FS_ID:13549 EP_NO: 11252 Repair Type: Crossing Status: UCIP Comments: Pipe rusted through at inlet to box. Good candidate for video inspection. FIELD_STRUCT_DESC: 3 of 3: 12-inch steel pipe through the levee 4.0 feet below the crown. Slant pump on bank. Switch box on berm, conduit through levee. Siphon breaker in 24-inch CMP riser on landward slope. Power pole and electrical panel at landward toe (ABO No. 11252, 1975). 7'X10' concrete distribution box on LS toe. Originally included in the 1954 O&M manual. FS Date: 5/16/2013

Slant pump on WS toe.

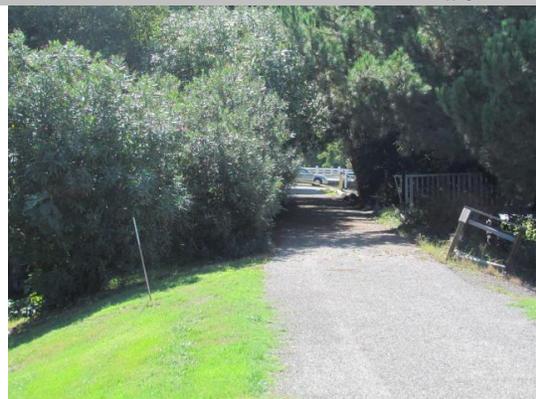
Photo 1 of 4 : richard_s_20140318_490.jpg

Looking south at dense landscape on waterside and landside of levee.

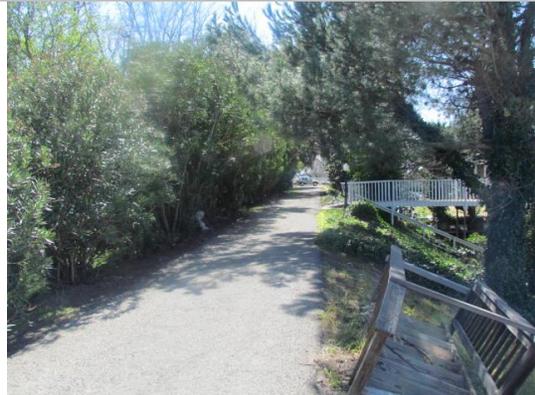
Photo 4 of 4 : richard_s_20140318_493.jpg

Looking south at dense oleander on waterside shoulder spring 2012

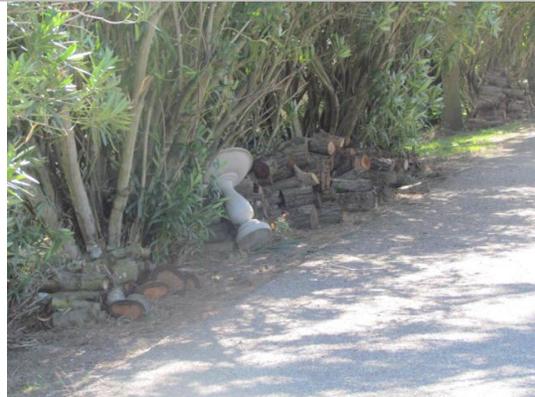
Photo 3 of 3 : richard_s_20140318_472.jpg

Looking southeast at firewood on waterside shoulder.

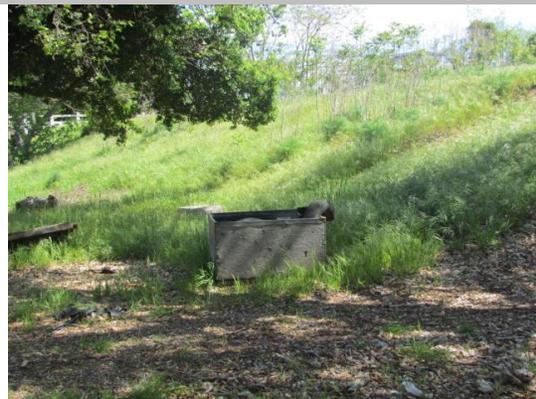
Photo 1 of 1 : richard_s_20140318_475.jpg

Looking northeast at garbage at landward toe.

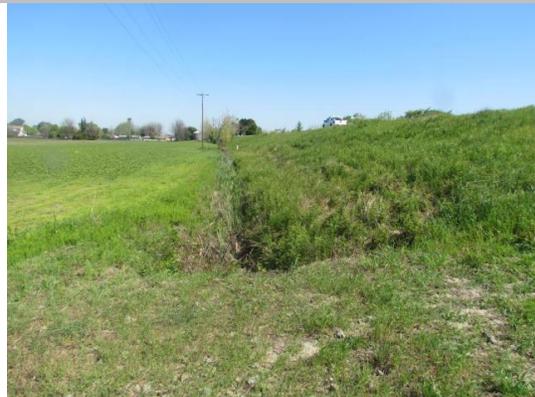
Photo 3 of 3 : richard_s_20140328_489.jpg

Looking north at south end of ditch within fifteen feet of landward toe.

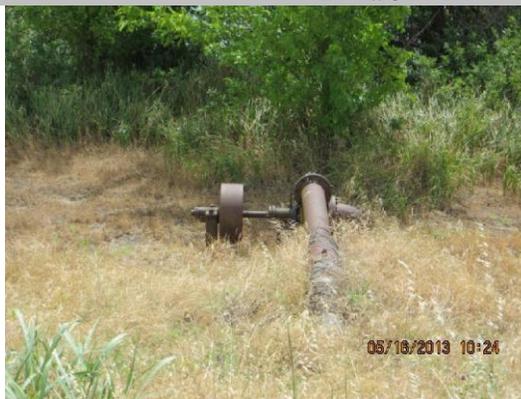
Photo 1 of 1 : UCIP_878.jpg

LM Start	2.50	Rating **	M	Issue No.	42
LM End	2.50	Issue Type +	En	Location *	LS
Category	Supplemental			GPS Latitude/Longitude	
				Start	End
Item	DWR UCIP Field Study			38.160147 °	38.160147 °
				-121.586087 °	-121.586087 °
DWR ID	DWR_NA0002_01_s_2014_42				
Action/Comments					
Inspector Comments: FS_ID:13545 EP_NO: N/A Repair Type: Crossing Status: UCIP Comments: Pipe appears abandoned and should be done so properly. standpipe on LS is covered in brush. FIELD_STRUCT_DESC: 8-inch steel pipe through the levee 3.4 feet below the crown. 6" pump on waterward side. 36-inch concrete standpipe on LS toe. Originally included in the 1954 O&M manual. FS Date: 5/16/2013

Pipe and pump on WS slope.

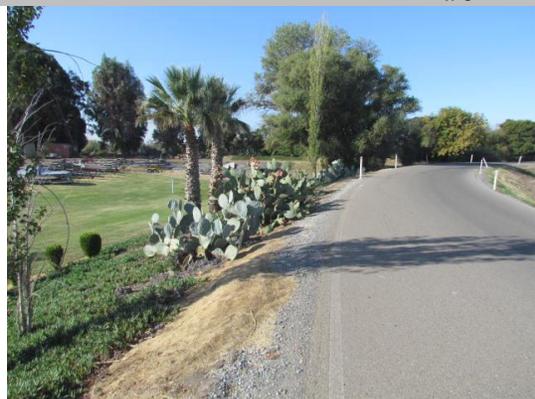
Photo 1 of 1 : richard_s_20140318_474.jpg

Looking south at cacti on waterward slope near Oxbow Harbor.

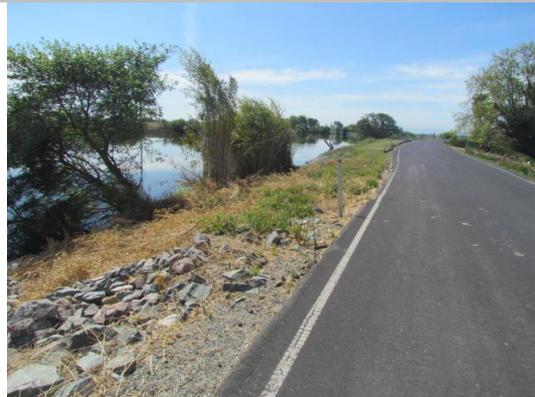
Photo 3 of 3 : richard_s_20140318_478.jpg

Looking south at dead willows on waterward slope. (Spring 2013)

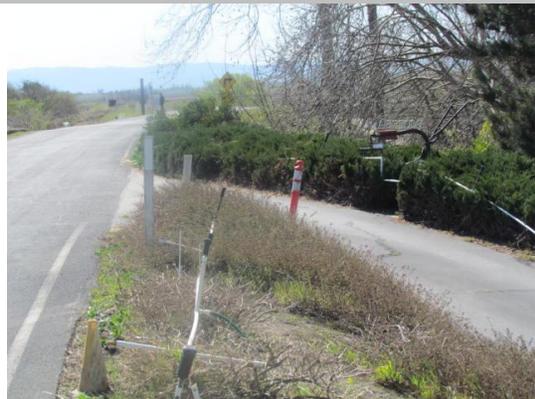
Photo 3 of 3 : richard_s_20140318_481.jpg

Looking south at brushes on landside shoulder and slope.

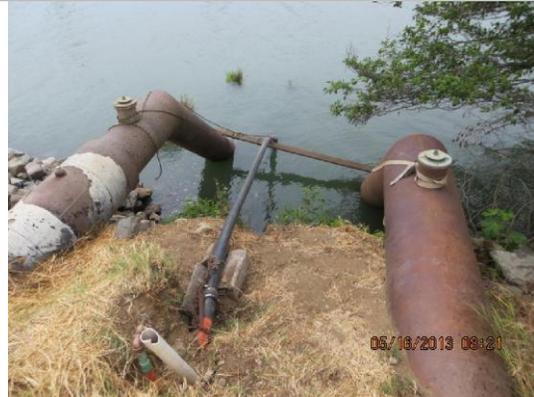
Photo 1 of 1 : UCIP_860.jpg

Pipe visible between two large storm drain pipes on WS.

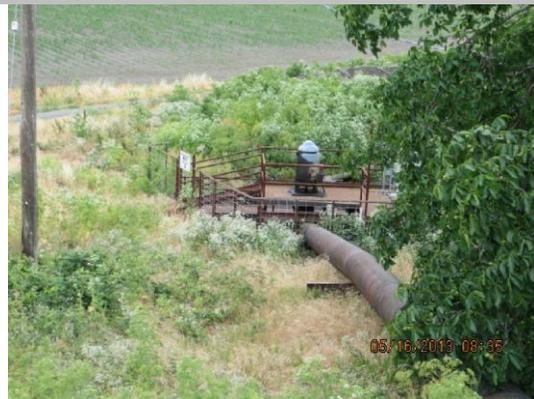
Photo 1 of 1 : UCIP_862.jpg

LM Start	3.99	Rating **	M	Issue No.	46
LM End	3.99	Issue Type +	En	Location *	LS
Category	Supplemental			GPS Latitude/Longitude	
				Start	End
Item	DWR UCIP Field Study			38.147656 °	38.147656 °
				-121.600521 °	-121.600521 °
DWR ID	DWR_NA0002_01_s_2014_46				
Action/Comments					
Inspector Comments: FS_ID:13503 EP_NO: 5534 Repair Type: Crossing Status: UCIP Comments: Pot holes over pipe may indicate internal failure. Good candidate for video inspection. FIELD_STRUCT_DESC: 22-inch steel discharge pipe through levee 3.0 feet below crown. Siphon breaker on WS shoulder. Pump in channel on landward side (Permit No. 5534, 1966). Replaced a 24-inch pipe at same location. FS Date: 5/16/2013

Pipe and pumping plant on LS slope.

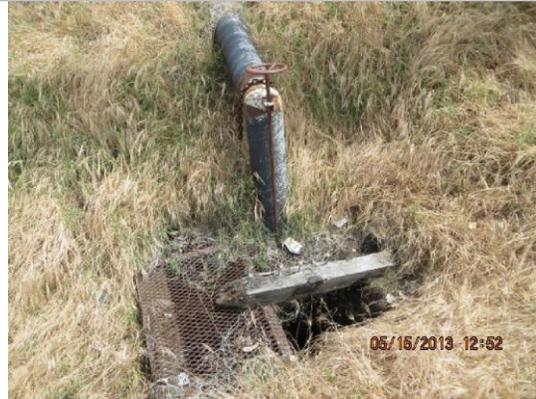
Photo 1 of 1 : UCIP_853.jpg

LM Start	4.04	Rating **	M	Issue No.	47
LM End	4.04	Issue Type +	En	Location *	LS
Category	Supplemental			GPS Latitude/Longitude	
				Start	End
Item	DWR UCIP Field Study			38.146985 °	38.146985 °
				-121.601019 °	-121.601019 °
DWR ID	DWR_NA0002_01_s_2014_47				
Action/Comments					
Inspector Comments: FS_ID:13483 EP_NO: 11238 Repair Type: Crossing Status: UCIP Comments: Missing cover on concrete sump is an immediate hazard and should be repaired. FIELD_STRUCT_DESC: 5 of 5: 8-inch steel pipe through levee 3.7 feet below crown. 5X5-foot concrete spillbox on LS slope (ABO No. 11238, 1975). Originally included in the 1954 O&M manual. FS Date: 5/8/2013

Pipe at entrance to concrete sump on LS.

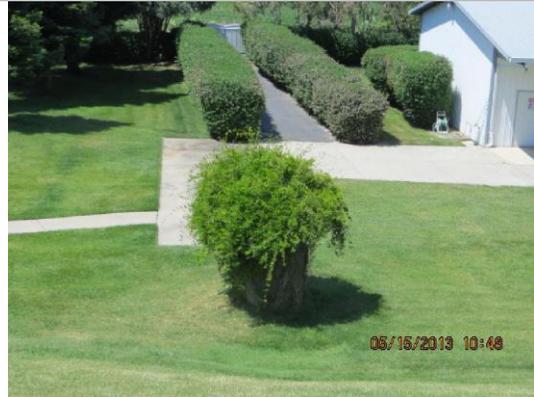
Photo 1 of 1 : UCIP_848.jpg

LM Start	4.63	Rating **	M	Issue No.	48
LM End	4.63	Issue Type +	En	Location *	WS
Category	Supplemental			GPS Latitude/Longitude	
				Start	End
Item	DWR UCIP Field Study			38.139400 °	38.139400 °
				-121.597678 °	-121.597678 °
DWR ID	DWR_NA0002_01_s_2014_48				
Action/Comments					
Inspector Comments: FS_ID:13442 EP_NO: 11237 Repair Type: Crossing Status: UCIP Comments: Appears abandoned. Good candidate for video inspection. FIELD_STRUCT_DESC: 3 of 3: 6-inch steel pipe through levee 3.6 feet below crown. 42-inch concrete standpipe on LS toe.. (ABO No. 11237, 1975). Originally included in the 1954 O&M manual. FS Date: 5/15/2013

42-inch concrete riser on LS toe.

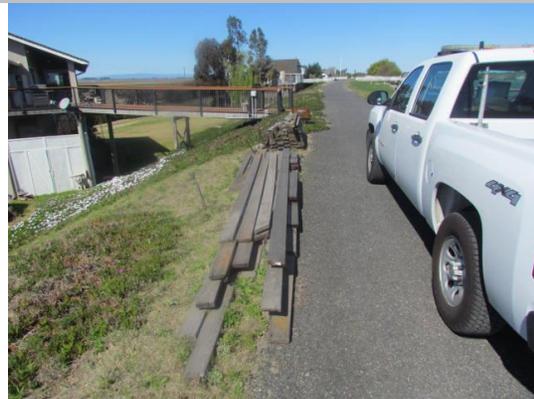
Photo 1 of 1 : richard_s_20140318_487.jpg

Looking northwest at wooden boards on landside shoulder.

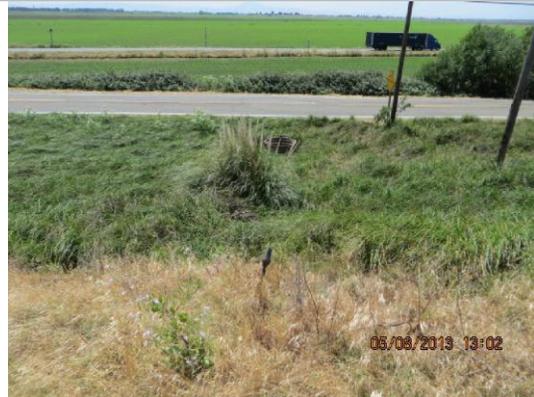
Photo 1 of 1 : UCIP_799.jpg

LM Start	5.36	Rating **	M	Issue No.	49
LM End	5.36	Issue Type +	En	Location *	WS
Category	Supplemental		GPS Latitude/Longitude		
			Start	End	
Item	DWR UCIP Field Study		38.131048 °	38.131048 °	
			-121.589655 °	-121.589655 °	
DWR ID	DWR_NA0002_01_s_2014_49				
Action/Comments					
Inspector Comments: FS_ID:13090 EP_NO: 11245 Repair Type: Crossing Status: UCIP Comments: Appears abandoned. Pipe at slide gate in riser on LS toe is rusted through. FIELD_STRUCT_DESC: 1 of 2: 14-inch steel pipe through levee 3.8 feet below crown (ABO 11245, 1975). 2" primer valve and 48-inch concrete standpipe on LS. Originally included in the 1954 O&M manual. FS Date: 5/8/2013

Filler pipe and standpipe on LS.

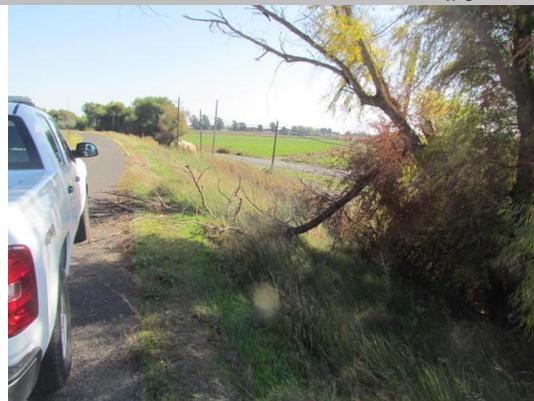
Photo 1 of 1 : richard_s_20140318_473.jpg

Looking southwest at a downed tree limb on landside slope.

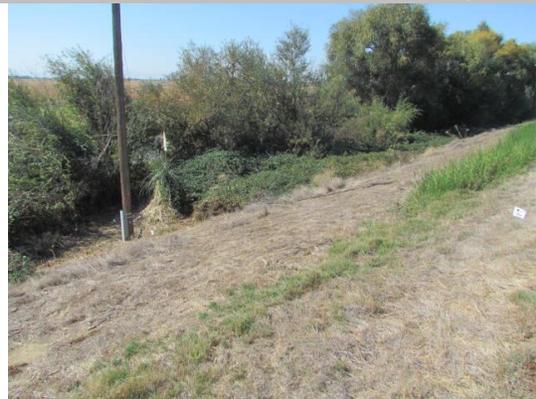
Photo 2 of 3 : richard_s_20140318_485.jpg

Looking south at dense berry vines and trees on the landward slope and toe.

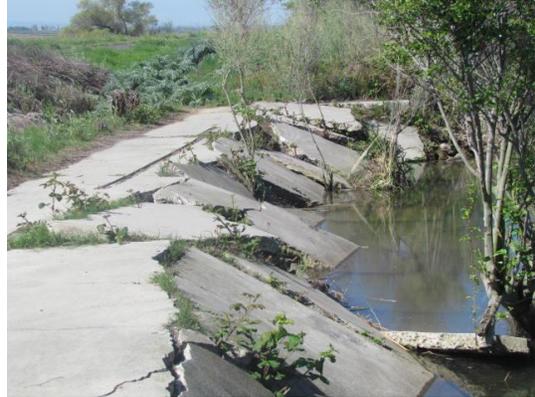
Photo 1 of 4 : richard_s_20140328_492.jpg

LM Start	5.72	Rating **	M	Issue No.	53
LM End	5.72	Issue Type +	Ma	Location *	WS
Category	Earthen Levee		GPS Latitude/Longitude		
			Start	End	
Item	Encroachments			o	o
				o	o
DWR ID	DWR_NA0002_01_s_2014_53				
Action/Comments					
Material					
Inspector Comments: Concrete slabs on water ward berm area. Possible undermining slab should be removed or broken up in place to meet Title 23 standard for Rip Rap.

Looking north at collapse concrete slab on waterward berm.

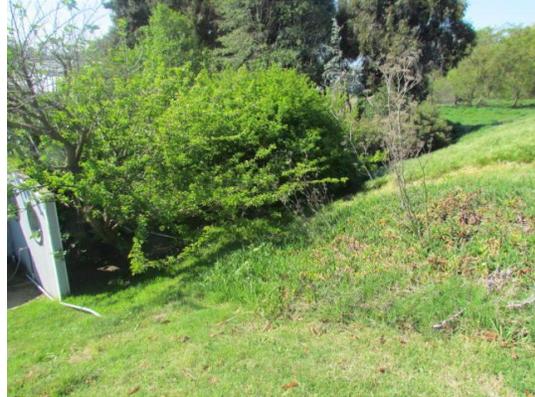
Photo 1 of 1 : richard_s_20140328_496.jpg

Looking north at dense vegetation at landward toe.

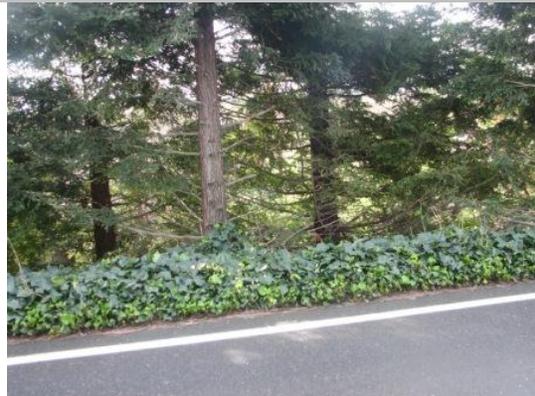
Photo 1 of 2 : richard_s_20140318_510.jpg

Landscaping on landside slope blocking view of slope from LM .81 to 0.83.

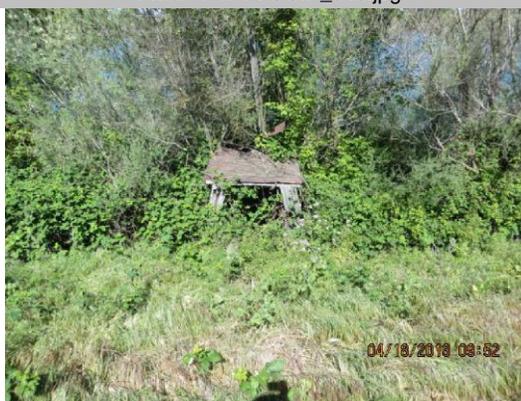
Photo 1 of 1 : UCIP_543.jpg

Pipe and pumphouse on WS berm.

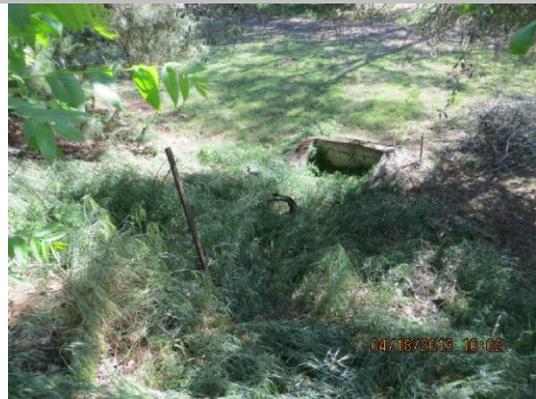
Photo 1 of 1 : UCIP_548.jpg

Concrete distribution box on LS toe.

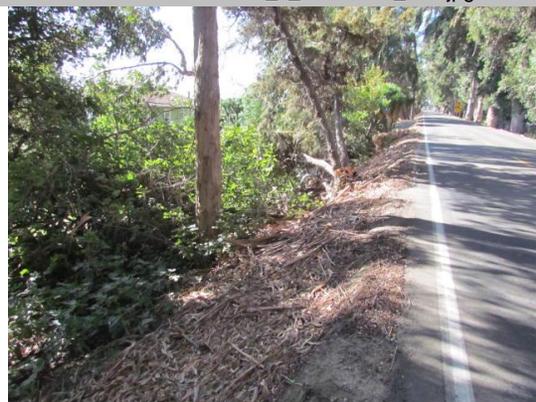
Photo 2 of 2 : richard_s_20140318_554.jpg

Looking southeast at dense vegetation on landward slope.

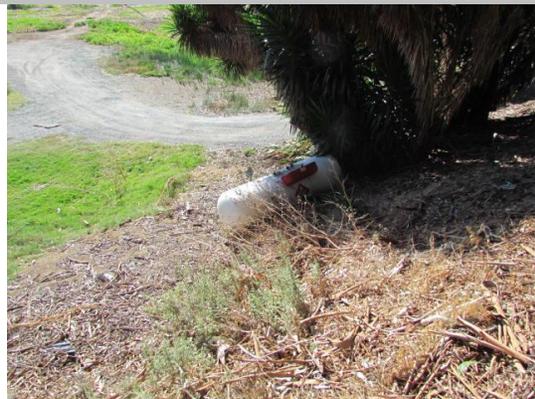
Photo 1 of 1 : richard_s_20140318_562.jpg

Looking southeast at propane tank on landward slope and toe.

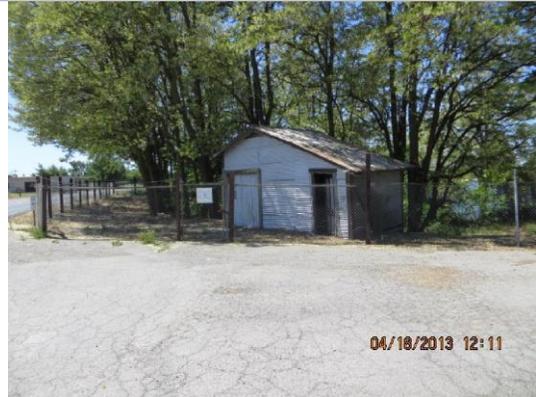
Photo 1 of 1 : UCIP_556.jpg

Possible pumphouse on WS shoulder.

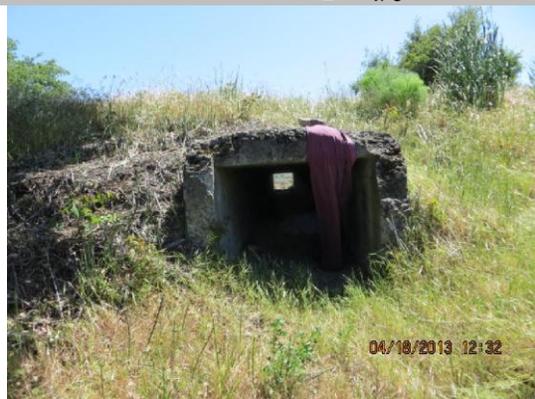
Photo 1 of 1 : UCIP_559.jpg

Concrete tunnel open on both ends.

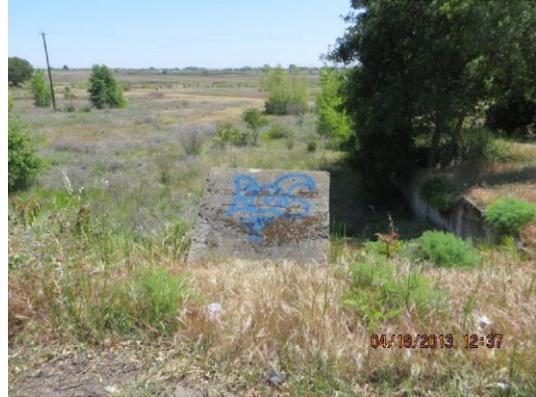
Photo 1 of 1 : UCIP_561.jpg

Concrete tunnel on LS shoulder.

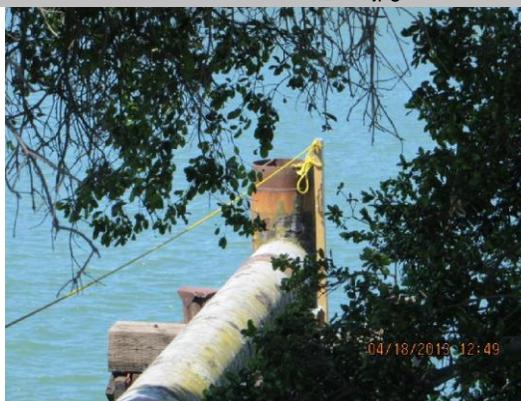
Photo 1 of 1 : UCIP_563.jpg

Pipe on pier at WS.

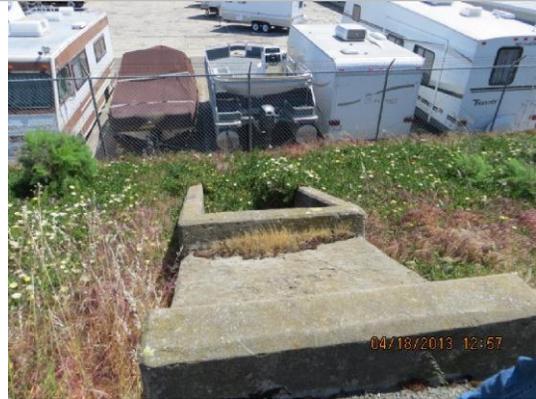
Photo 1 of 1 : UCIP_568.jpg

Entrance to tunnel on LS slope.

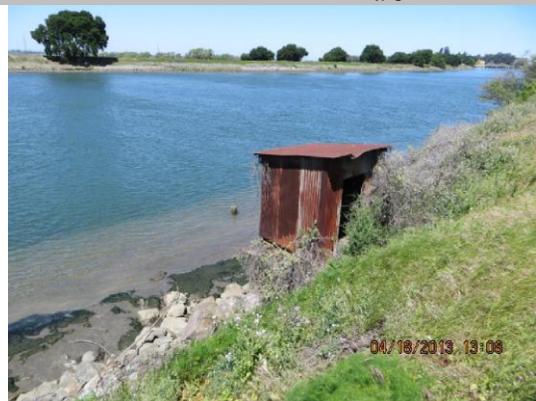
Photo 1 of 1 : UCIP_571.jpg

Pumphouse on WS slope.

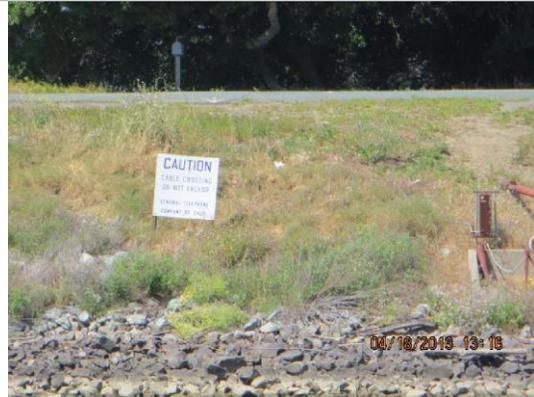
Photo 1 of 1 : UCIP_1400.jpg

Sign on opposite side of river provides indication of pipe location.

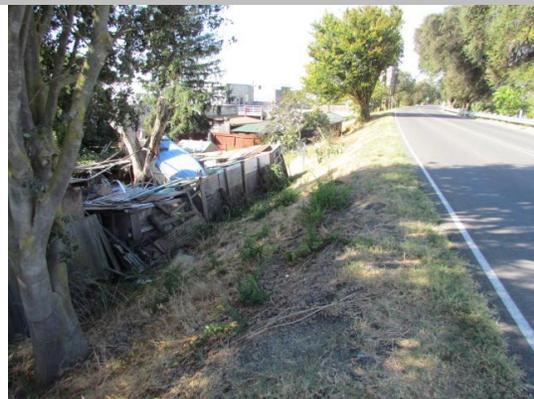
Photo 1 of 2 : richard_s_20140318_542.jpg

Looking south at urban encroachments on landward slope.

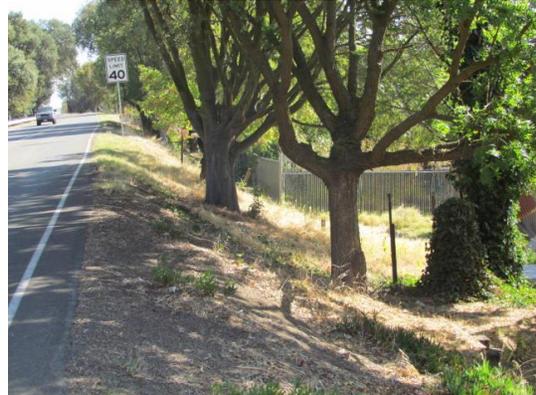
Photo 2 of 2 : richard_s_20140318_543.jpg

Looking north at urban encroachments on landward slope and toe.

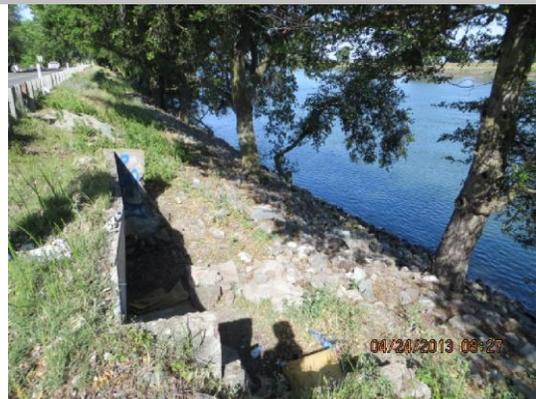
Photo 1 of 1 : UCIP_706.jpg

Foundation on WS shoulder.

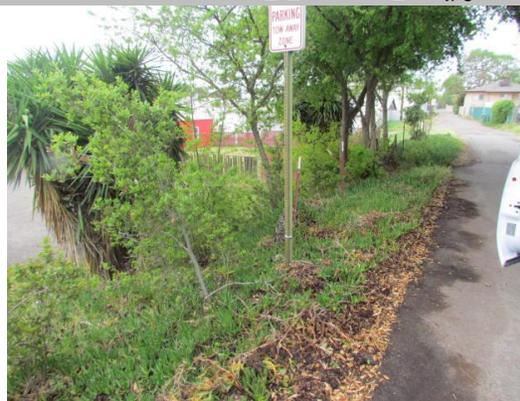
Photo 1 of 1 : richard_s_20140328_501.jpg

Looking south at overgrown landscaping on landward slope.

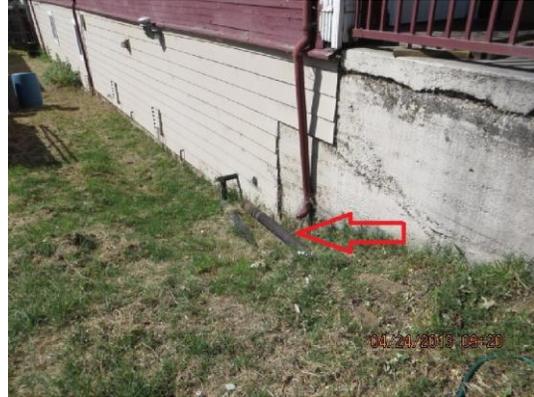
Photo 1 of 1 : UCIP_1398.jpg

Pipe visible next to foundation on LS slope.

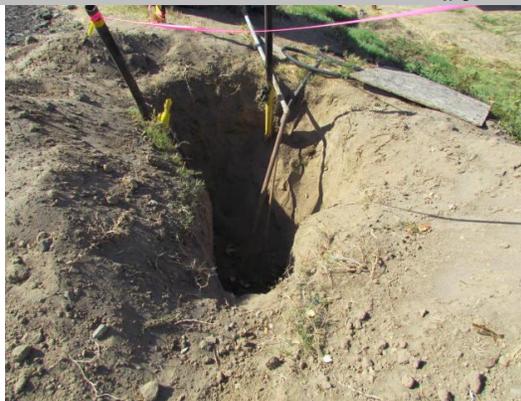
Photo 1 of 3 : richard_s_20140318_563.jpg

Looking east at excavation on landward slope.

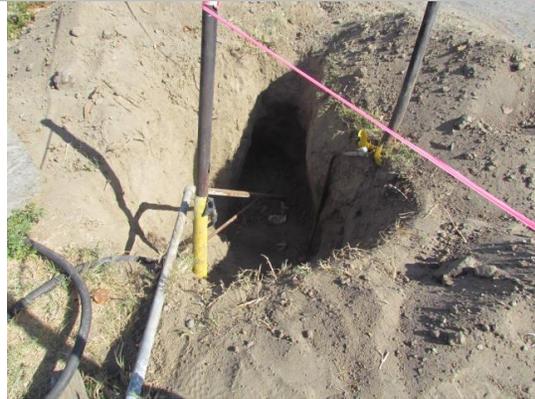
Photo 2 of 3 : richard_s_20140318_564.jpg

Looking southeast at excavation on landward slope next to ramp.

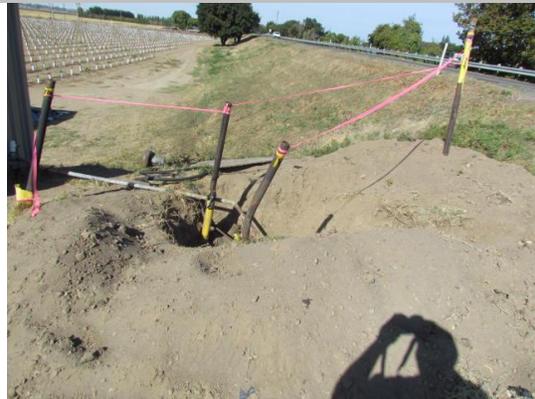
Photo 3 of 3 : richard_s_20140318_565.jpg

Looking south at excavation on landward slope.

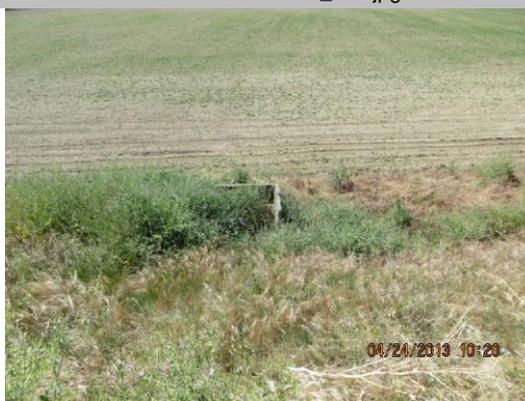
Photo 1 of 1 : UCIP_718.jpg

Concrete distribution box on LS toe.

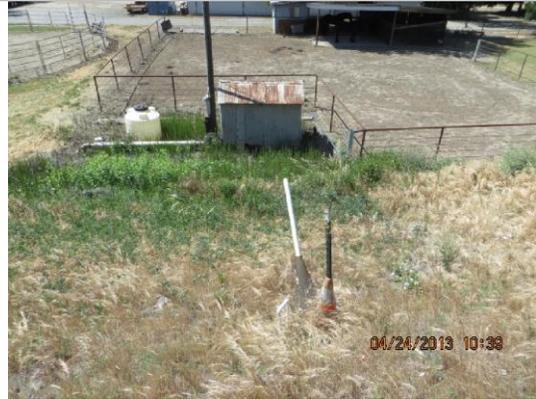
Photo 1 of 1 : UCIP_721.jpg

Pipe and pumphouse on LS.

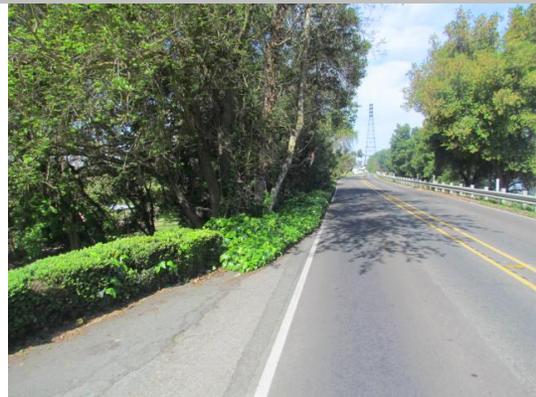
Photo 1 of 1 : richard_s_20140318_569.jpg

Looking south at dense landscaping on landward slope.

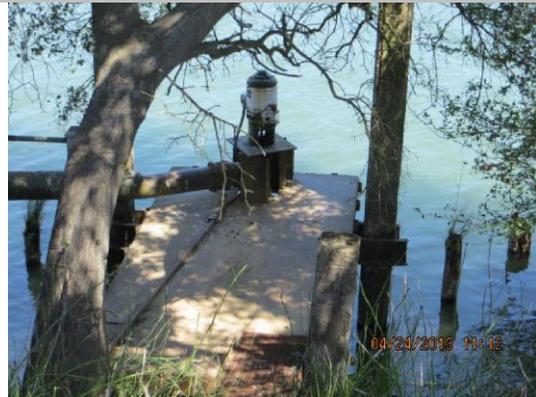
Photo 1 of 1 : UCIP_725.jpg

Pump on concrete pier on WS toe.

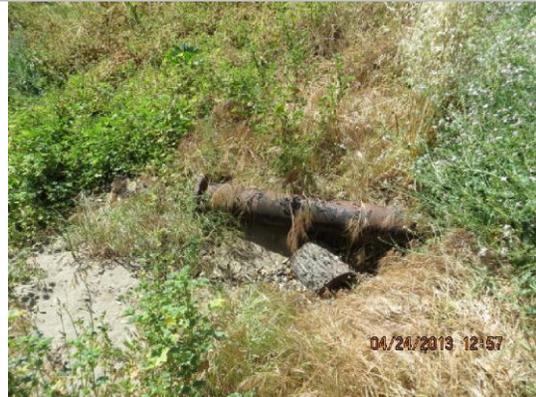
Photo 1 of 1 : UCIP_1403.jpg

Abandoned pipe on LS slope.

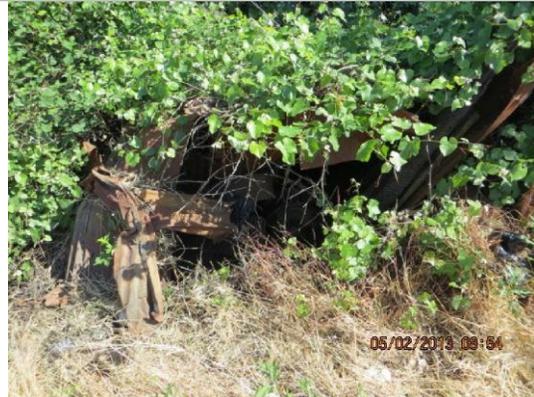
Photo 1 of 1 : UCIP_733.jpg

Broken down pumphouse on WS slope.

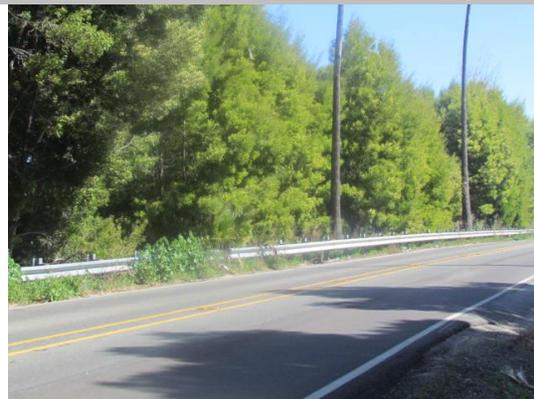
Photo 1 of 3 : richard_s_20140318_512.jpg

Looking southeast at dense trees on landside slope and toe.

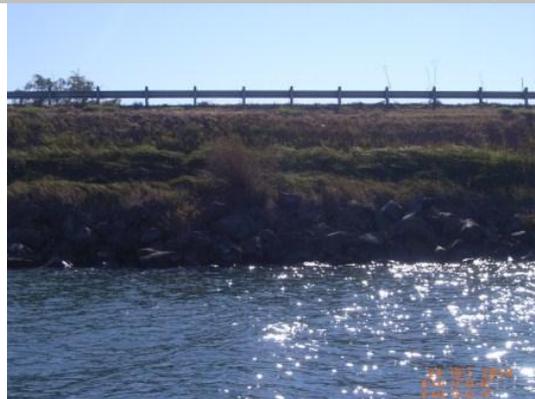
Photo 1 of 1 : USACE2013A_SAC_15-0_L_5.jpg

LM Start	5.68	Rating **	M	Issue No.	21
LM End	5.73	Issue Type +	Ma	Location *	WS
Category	Supplemental		GPS Latitude/Longitude		
			Start	End	
Item	USACE Erosion Survey		38.172580 °	38.172733 °	
			-121.651821 °	-121.652499 °	
DWR ID					
Action/Comments					
Inspector Comments: 2009 - Tension cracks on road on top of levee. Erosion into the levee slope with large mass failure scallop. 2010 - Site extended further upstream to account for additional erosion. Very steep slope with slumping. 2013: No observed changes. [2013 Site ID: SAC_15-0_L]

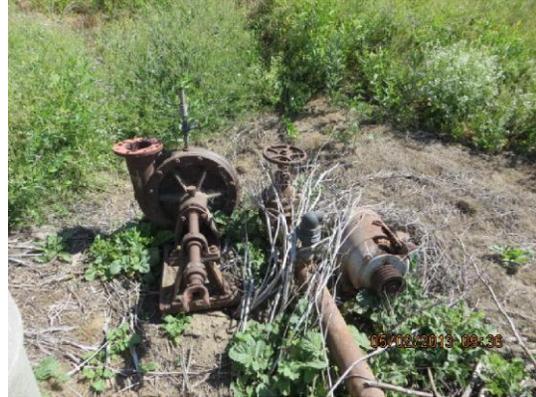
Photo 1 of 1 : UCIP_743.jpg

Pump on LS toe.

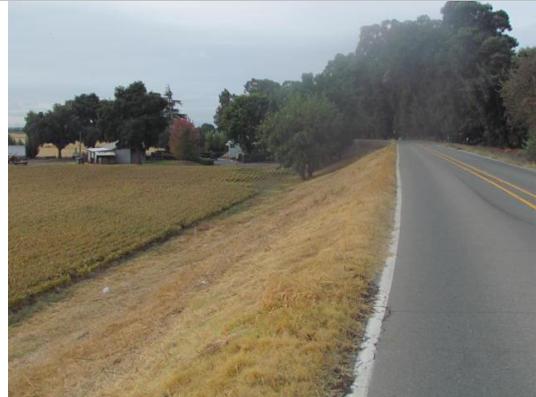
Photo 1 of 1 : richard_s_20140318_518.jpg

Looking southeast at compliant vegetation on landside slope.

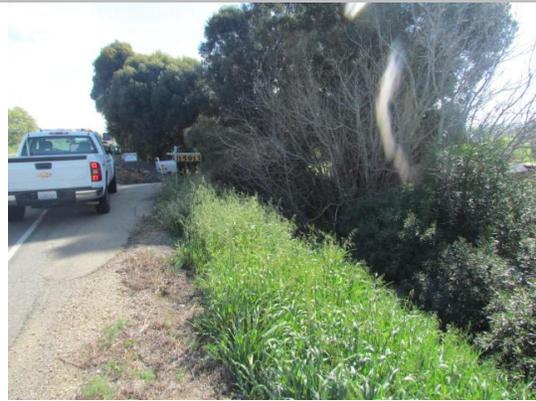
Photo 1 of 2 : richard_s_20140318_558.jpg

Looking north at dense landscaping on landward slope.

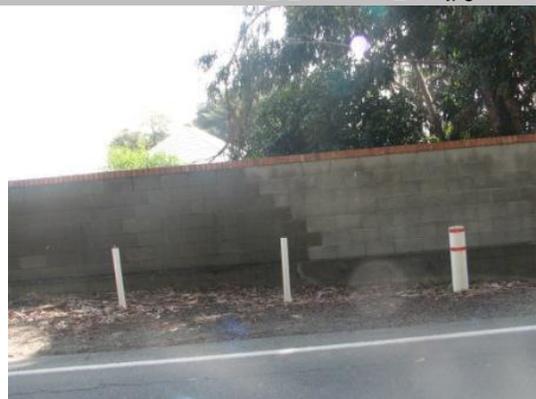
Photo 1 of 1 : richard_s_20140318_551.jpg

Brick wall on landside shoulder at LM 6.82.

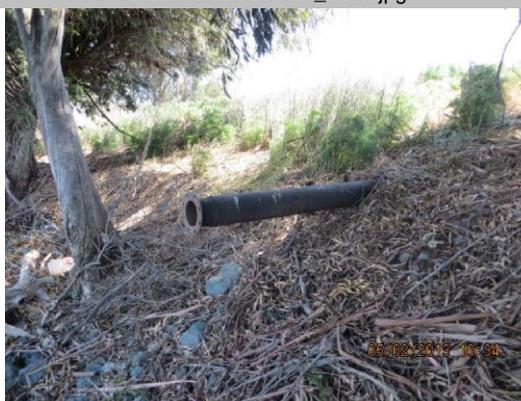
Photo 1 of 1 : UCIP_1405.jpg

Pipe open on WS slope.

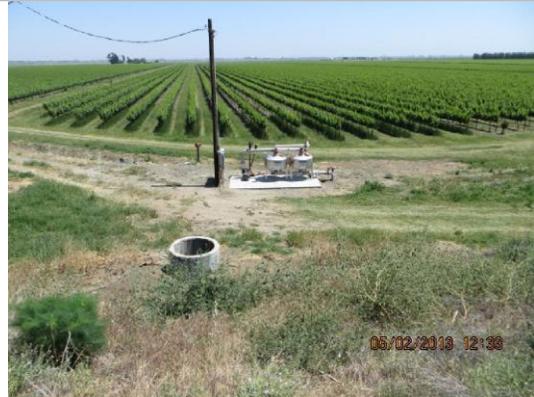
Photo 1 of 1 : UCIP_785.jpg

Concrete standpipe on LS toe.

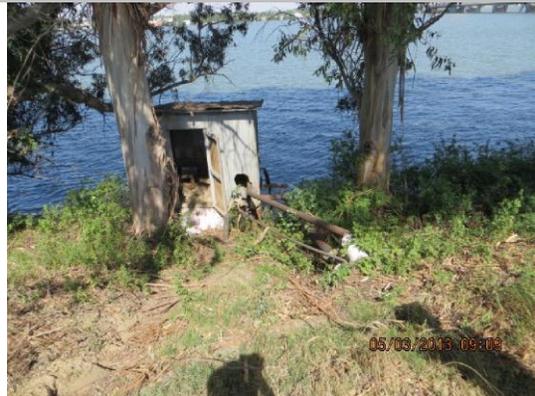
Photo 1 of 1 : UCIP_787.jpg

Pumphouse and pipe on WS slope.

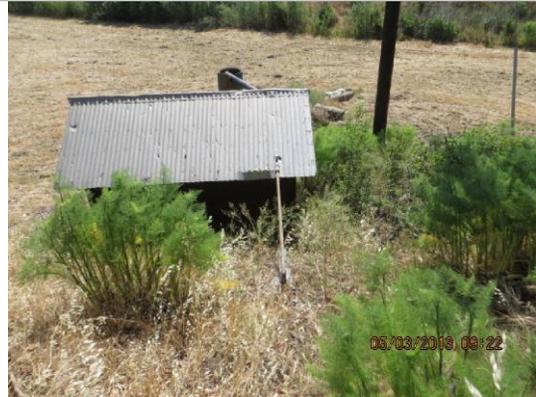
Photo 1 of 1 : UCIP_1413.jpg

Pumphouse with concrete standpipe in background on LS toe.

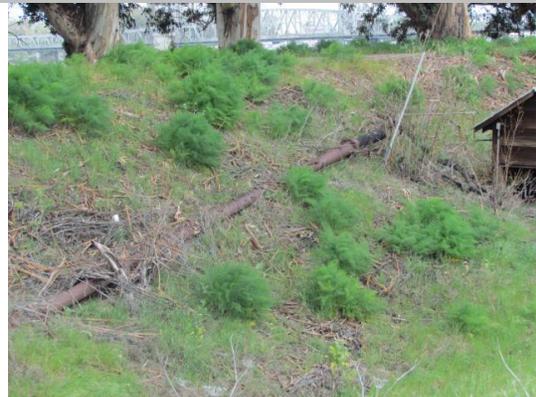
Photo 1 of 1 : richard_s_20140328_503.jpg

Looking southwest at disgarded irrigation pipe on landward slope.

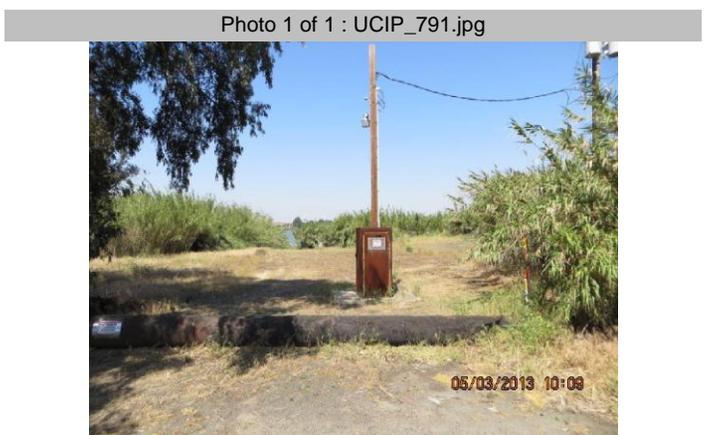
LM Start	8.58	Rating **	M	Issue No.	92
LM End	8.58	Issue Type +	En	Location *	WS
Category	Supplemental		GPS Latitude/Longitude		
			Start	End	
Item	DWR UCIP Field Study		38.146784 °	38.146784 °	
			-121.682780 °	-121.682780 °	
DWR ID	DWR_NA0002_02_s_2014_92				
Action/Comments					
Inspector Comments: FS_ID:12886 EP_NO: 842 Repair Type: Crossing Status: UCIP Comments: Need to determine disposition of pipe. FIELD_STRUCT_DESC: 12-inch gas pipe through levee 3-feet below the crown Gasline marker/vent on WS shoulder. (Permit No. 842, 1940). FS Date: 5/3/2013

Gasline marker and vent to right of JP.

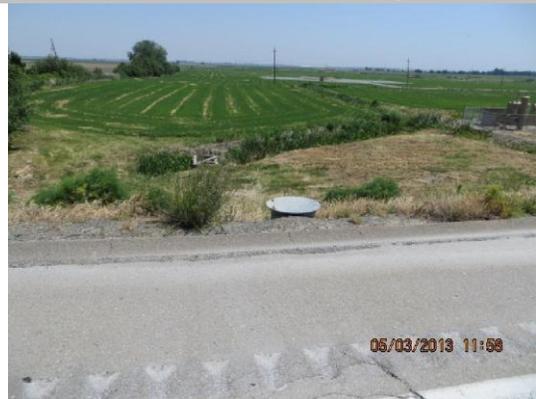
Photo 1 of 1 : UCIP_792.jpg

Standpipe and concrete box at LS.

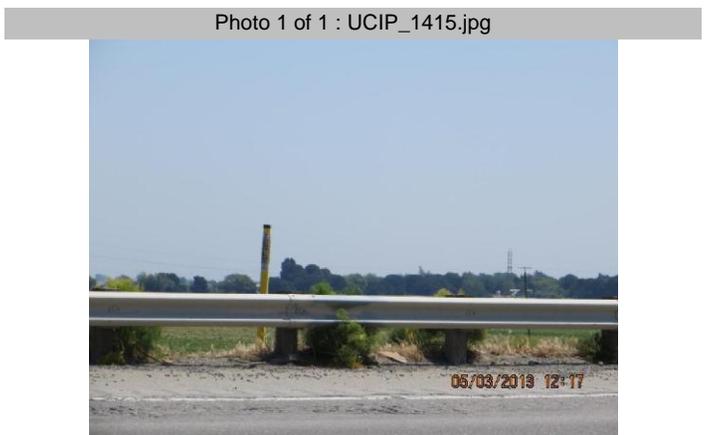
LM Start	9.53	Rating **	M	Issue No.	96
LM End	9.53	Issue Type +	En	Location *	WS
Category	Supplemental		GPS Latitude/Longitude		
			Start	End	
Item	DWR UCIP Field Study		38.133512 °	38.133512 °	
			-121.685948 °	-121.685948 °	
DWR ID	DWR_NA0002_02_s_2014_96				
Action/Comments					
Inspector Comments: FS_ID:16146 EP_NO: N/A Repair Type: Crossing Status: UCIP Comments: Need to determine Permit No. for this crossing. FIELD_STRUCT_DESC: Gasline markers on LS toe and WS shoulder. FS Date: 5/3/2013

Gasline Marker on LS shoulder
