**Flood Control Project Maintenance
Levee Inspections****LMA District Cover Sheet****Spring 2015 Levee Inspection Results****Brannan Andrus Levee Maintenance District**

Spring 2015 Levee Inspection Results

Brannan Andrus Levee Maintenance District

Waterway			Bank	Unit Miles
Unit No. 01 Georgiana Slough			Right	6.01
	Spring (March - May)	Summer (June - August)	(September - November) Fall	Winter (December - February)
Unit Maintenance Rating (Fall Only)				
Date of Inspection	03/11/2015 - 03/11/2015			
DWR Inspector	Richard Willoughby			
Accompanied By	Gilbert Labrie DCC Engineering Co, Inc

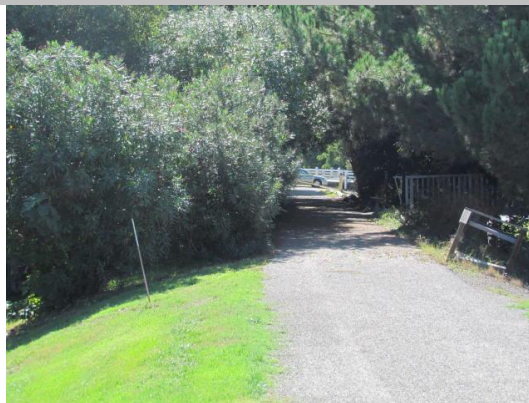
Photo 1 of 4 : SP_2015_NA0002_62_36_20150309_00023.jpg

Looking south at dense landscaping on the waterside and landside of levee.

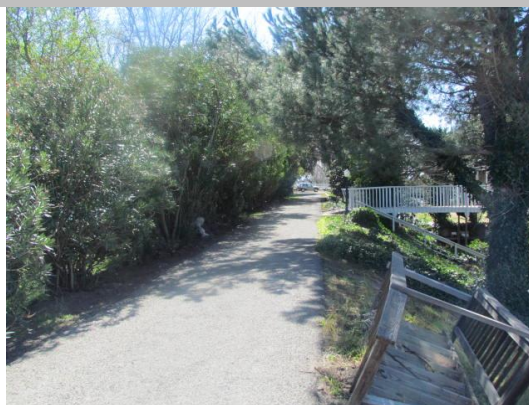
Photo 2 of 4 : SP_2015_NA0002_62_36_20150309_00024.jpg

Looking south at dense oleander on waterside shoulder, spring 2012.

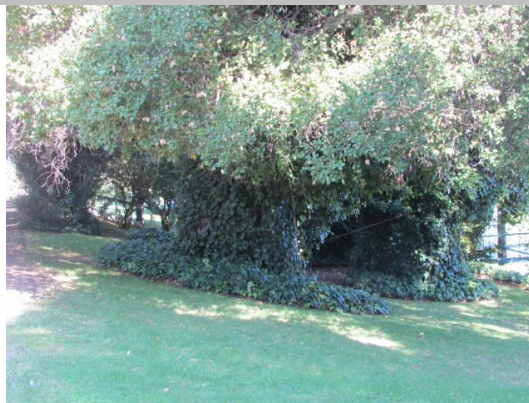
Photo 3 of 4 : SP_2015_NA0002_62_36_20150309_00025.jpg

Looking north at dense vegetation on waterside slope.

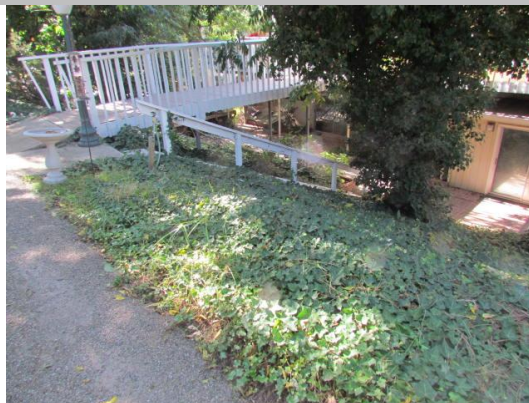
Photo 4 of 4 : SP_2015_NA0002_62_36_20150309_00026.jpg

Looking west at ground cover on landside slope.

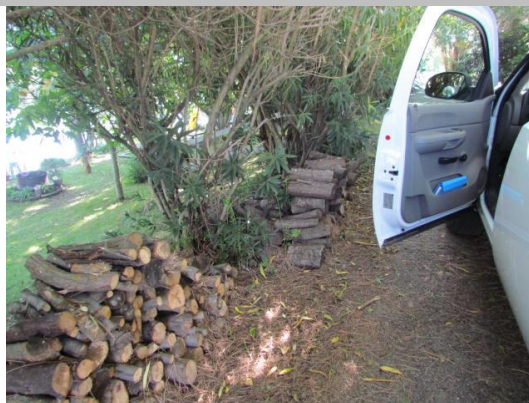
Photo 1 of 3 : SP_2015_NA0002_62_3_20150309_00002.jpg

LM Start	2.30	Rating **	M	Issue No.	3
LM End	2.30	Issue Type +	Ma	Location *	WS
Category	Earthen Levee			GPS Latitude/Longitude	
				Start	End
Item	Encroachments			38.162773 °	38.162773 °
				-121.584767 °	-121.584767 °
DWR ID	DWR_NA0002_01_s_2012_3				
Action/Comments					
Firewood

Looking east at firewood on waterside shoulder.

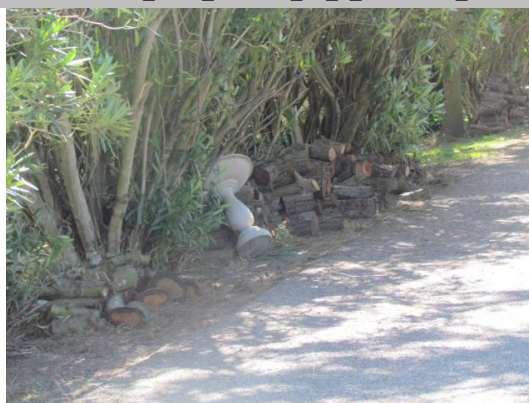
Photo 2 of 3 : SP_2015_NA0002_62_3_20150309_00003.jpg

Looking southeast at firewood on waterside shoulder.

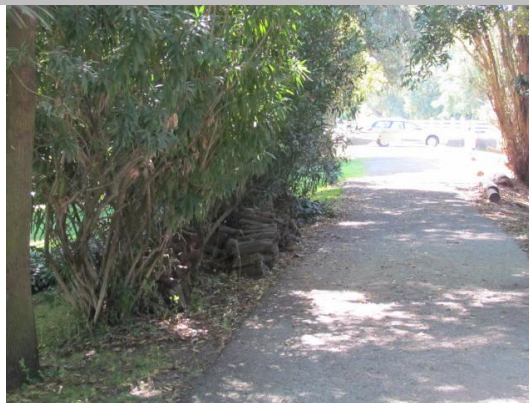
Photo 3 of 3 : SP_2015_NA0002_62_3_20150309_00004.jpg

Looking south at firewood on waterside shoulder.

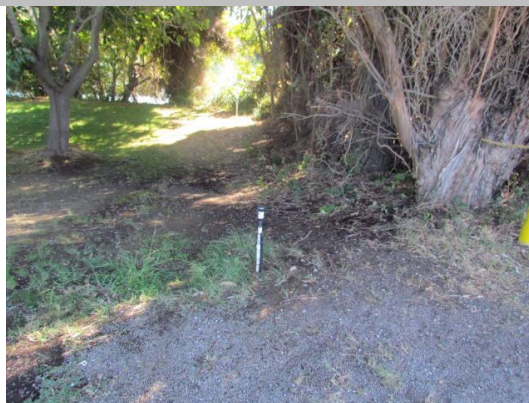
Photo 1 of 1 : SP_2015_NA0002_62_50_20150309_00029.jpg

LM Start	2.33	Rating **	M	Issue No.	50
LM End	2.33	Issue Type +	En	Location *	WS
Category	Earthen Levee			GPS Latitude/Longitude	
				Start	End
Item	Encroachments			38.162343 °	38.162343 °
				-121.585020 °	-121.585020 °
DWR ID	DWR_NA0002_01_f_2014_50				
Action/Comments					
Landscape Irrigation					
Inspector Comments: Landowner installed sprinklers along waterward slope without permit.

Looking east at sprinklers on waterward slope.

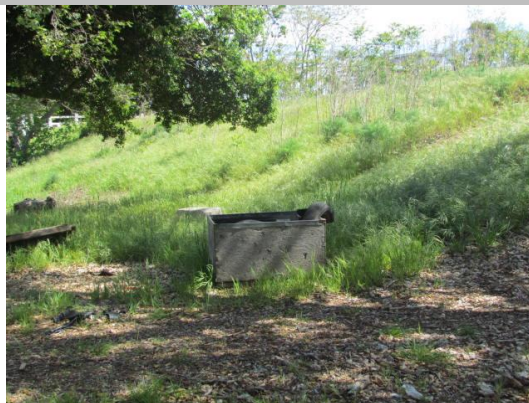
Photo 1 of 1 : SP_2015_NA0002_62_8_20150309_00007.jpg

Looking northeast at garbage at landward toe.

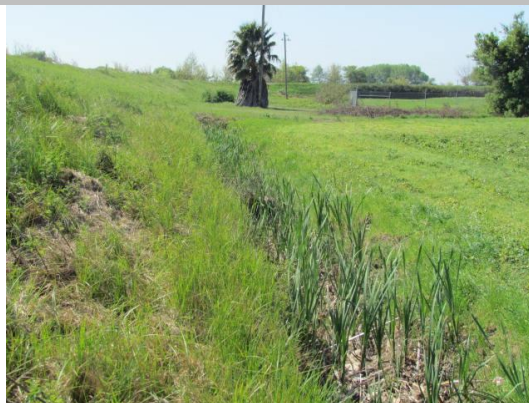
Photo 1 of 3 : SP_2015_NA0002_62_56_20150309_00036.jpg

LM Start	2.43	Rating **	M	Issue No.	56		
LM End	2.58	Issue Type +	En	Location *	LS		
Category	Earthen Levee			GPS Latitude/Longitude			
				Start		End	
Item	Encroachments				o		o
					o		o
DWR ID	DWR_NA0002_01_s _ 2014_56						
Action/Comments							
Ditch							
Inspector Comments: Ditch has been in place for several years. Ditch should be removed from within fifteen feet of landward toe.

Looking south at ditch within fifteen feet of landward toe.

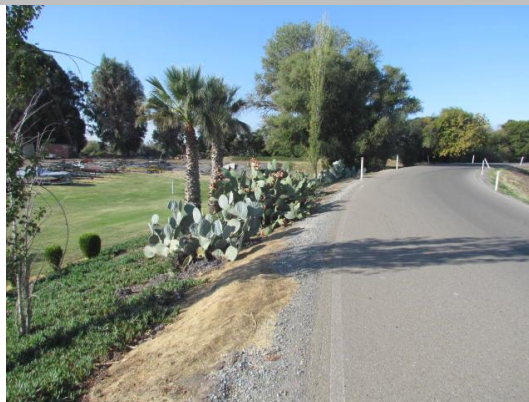
Photo 1 of 1 : SP_2015_NA0002_62_5_20150309_00006.jpg

Looking south at cacti on waterward slope near Oxbow Habor.

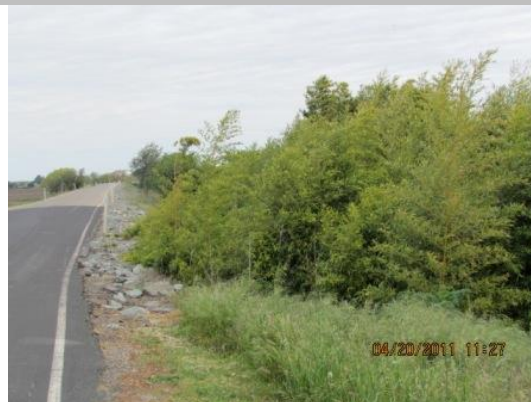
Photo 1 of 3 : SP_2015_NA0002_62_10_20150309_00008.jpg

Looking west at dense vegetation on waterside slope.

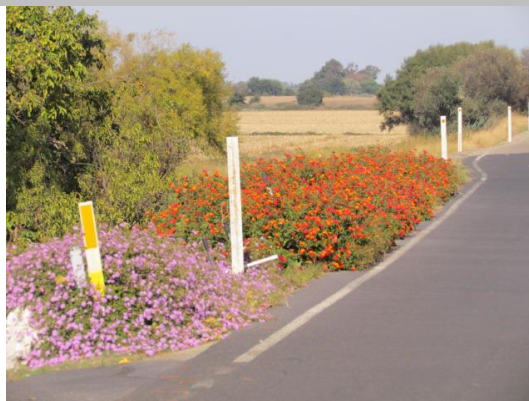
Photo 1 of 3 : SP_2015_NA0002_62_11_20150309_00011.jpg

Looking northeast at landscaping on landside slope.

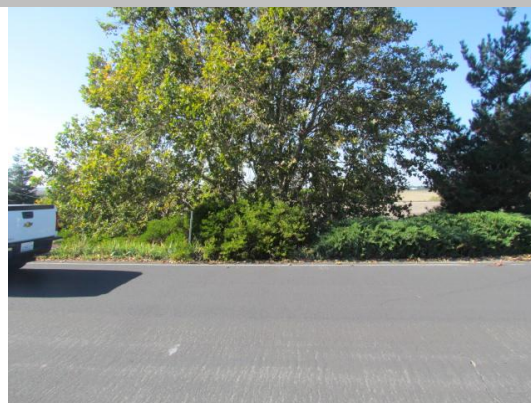
Photo 3 of 3 : SP_2015_NA0002_62_11_20150309_00013.jpg

Looking west at dense landscaping on landside slope.

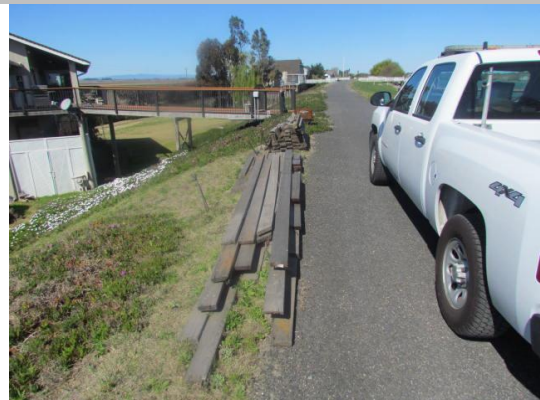
Photo 1 of 1 : SP_2015_NA0002_62_24_20150309_00019.jpg

Looking northwest at wooden boards on landside shoulder.

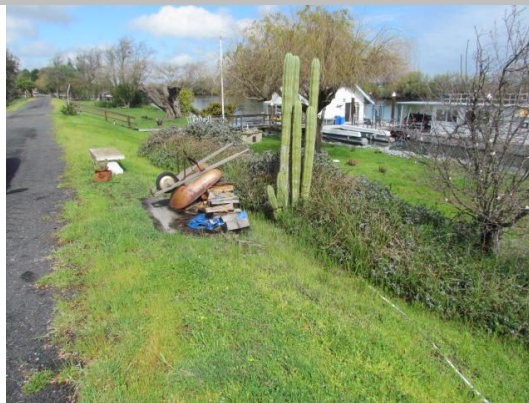
Photo 1 of 2 : SP_2015_NA0002_62_61_20150313_00061.jpg

Looking northeast at overgrowth landscaping on waterward slope.
(Spring 2015)

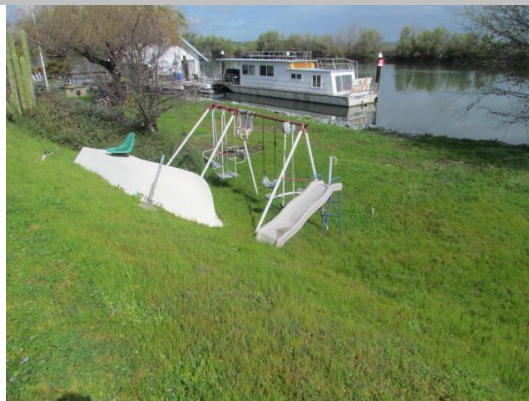
Photo 1 of 1 : SP_2015_NA0002_62_60_20150313_00063.jpg

Looking northeast at abandoned childs swing set at waterward toe.

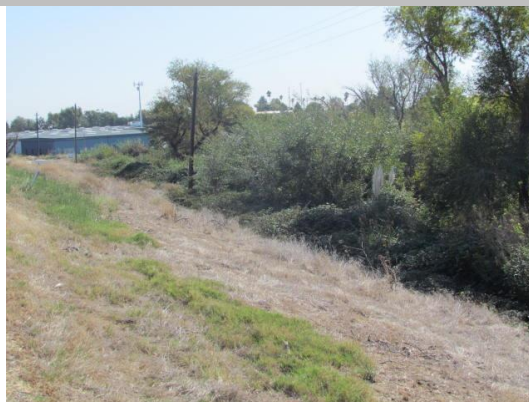
Photo 2 of 3 : SP_2015_NA0002_62_23_20150309_00017.jpg

Looking east at dense vegetation on landward toe.

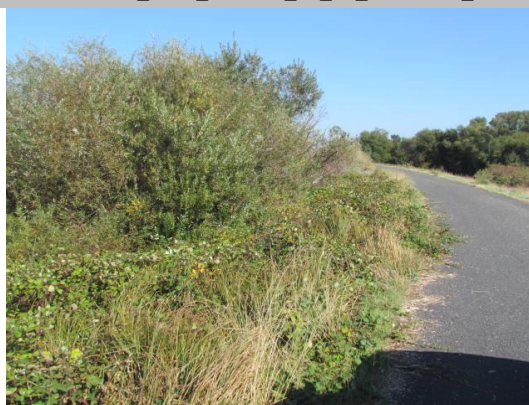
Photo 1 of 1 : SP_2015_NA0002_62_18_20150309_00014.jpg

Looking south at dense vegetation on waterside slope.

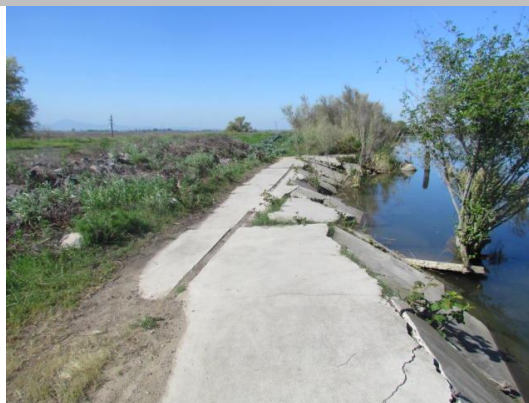
Photo 3 of 4 : SP_2015_NA0002_62_53_20150309_00033.jpg

Looking north at a collapsed concrete slab on waterward berm.

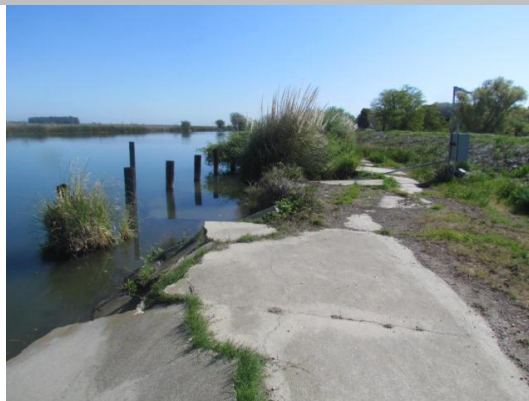
Photo 4 of 4 : SP_2015_NA0002_62_53_20150309_00034.jpg

Looking south at a collapsed concrete slab on waterward berm.

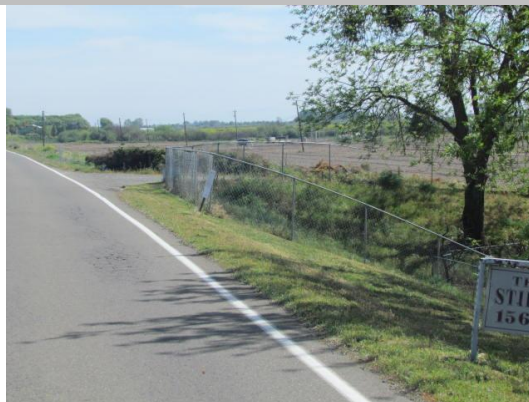
Photo 1 of 1 : SP_2015_NA0002_63_26_20150309_00024.jpg

Looking northeast at fence on landward shoulder and slope.

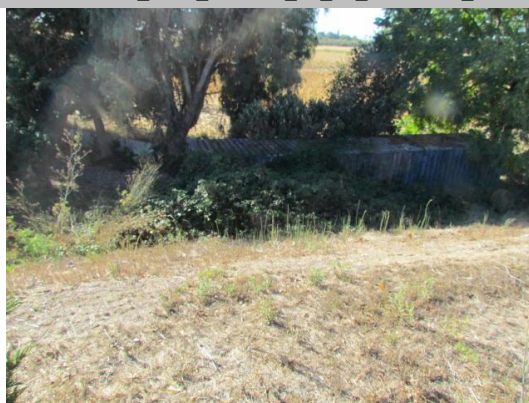
Photo 2 of 3 : SP_2015_NA0002_63_40_20150309_00038.jpg

Looking east at berryvines at landward toe.

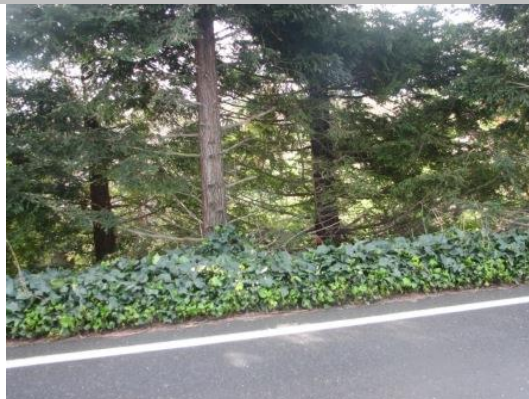
Photo 2 of 2 : SP_2015_NA0002_63_8_20150309_00007.jpg

Landscaping on landside slope blocking view of slope from LM .81 to 0.83.

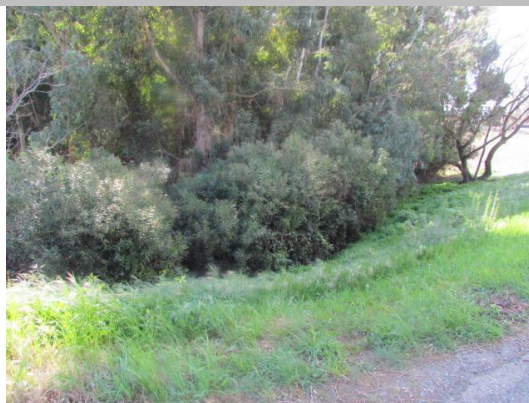
Photo 2 of 2 : SP_2015_NA0002_63_27_20150309_00026.jpg

Looking southeast at dense trees on landside toe.

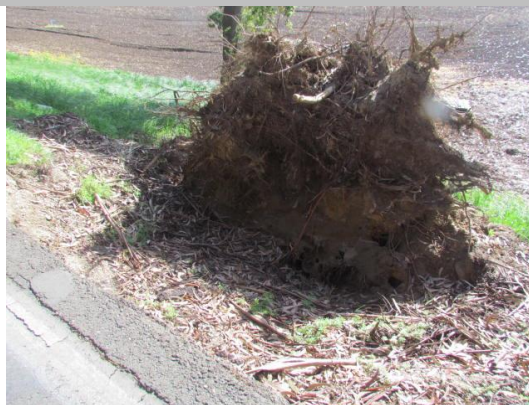
Photo 2 of 4 : SP_2015_NA0002_63_109_20150313_00099.jpg

Looking east at tree stump on landward slope. (Spring 2015).

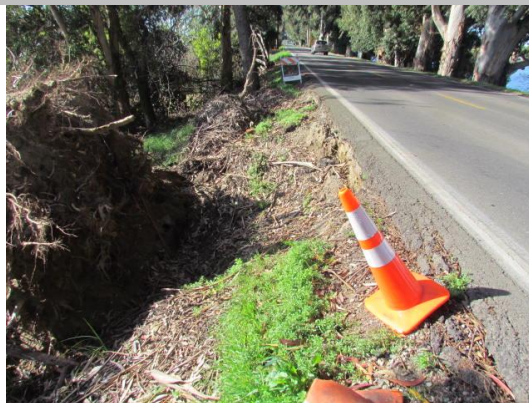
Photo 3 of 4 : SP_2015_NA0002_63_109_20150313_00100.jpg

Looking south at hole at landward shoulder. (Spring 2015)

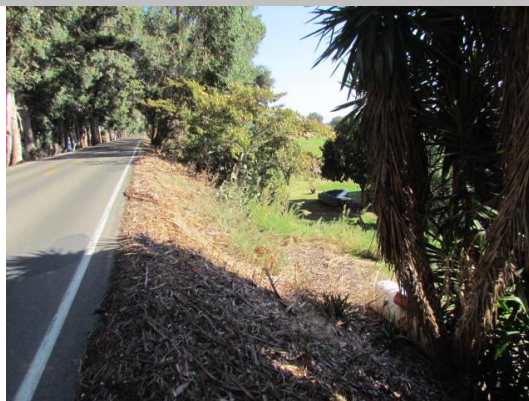
Photo 2 of 2 : SP_2015_NA0002_63_45_20150309_00044.jpg

Looking north at dense vegetation on landward slope and toe.

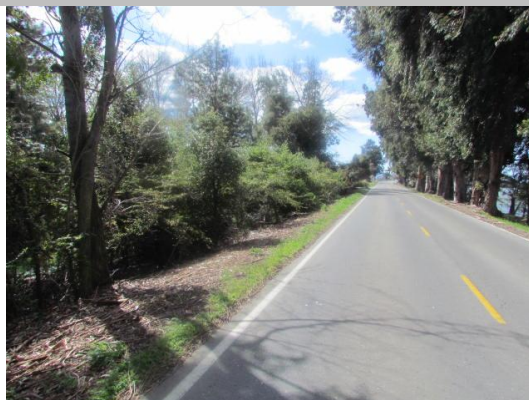
Photo 1 of 2 : SP_2015_NA0002_63_12_20150309_00012.jpg

Looking south at dense landscaping on landside slope and toe.

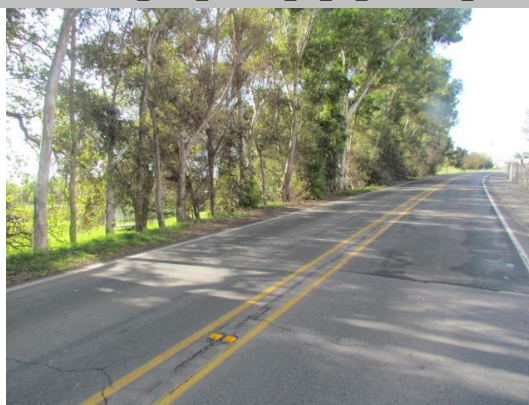
Photo 1 of 1 : SP_2015_NA0002_63_25_20150313_00102.jpg

Looking southeast at trees at landward shoulder. (Spring 2015)

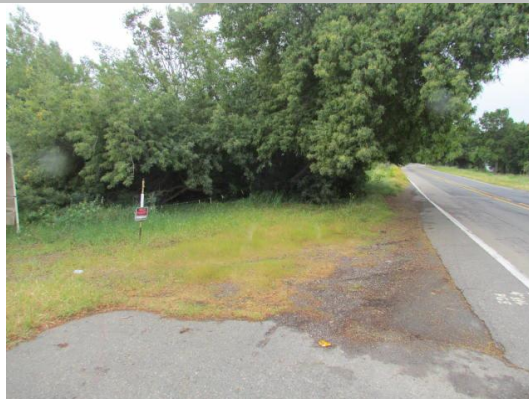
Photo 2 of 2 : SP_2015_NA0002_63_29_20150309_00029.jpg

Looking south at dense vegetation on landward slope.

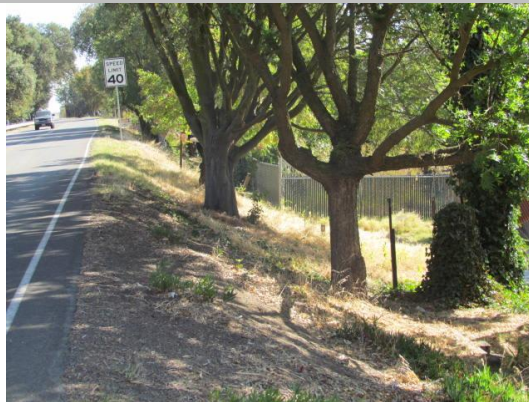
Photo 1 of 2 : SP_2015_NA0002_63_30_20150309_00030.jpg

Looking north at urban encroachments on landward slope and toe.

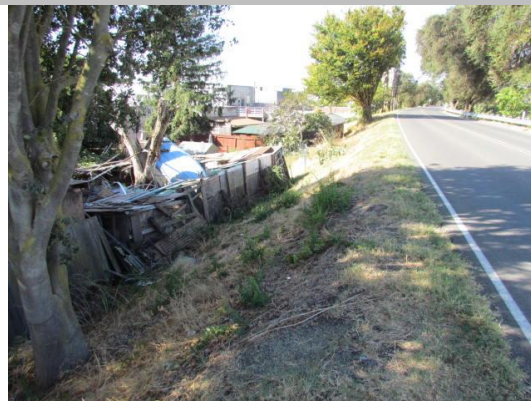
Photo 2 of 2 : SP_2015_NA0002_63_30_20150309_00031.jpg

Looking south at urban encroachments on landward slope.

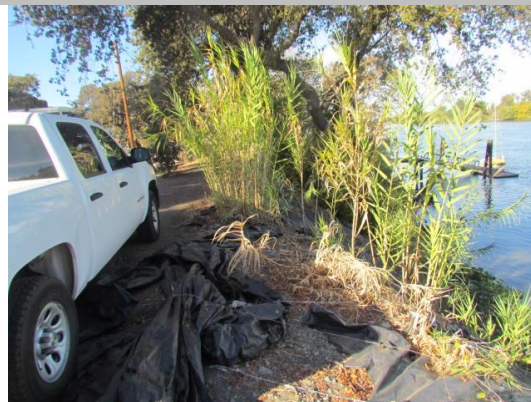
Photo 1 of 1 : SP_2015_NA0002_63_104_20150309_00061.jpg

Looking southwest at bamboo on waterward slope.

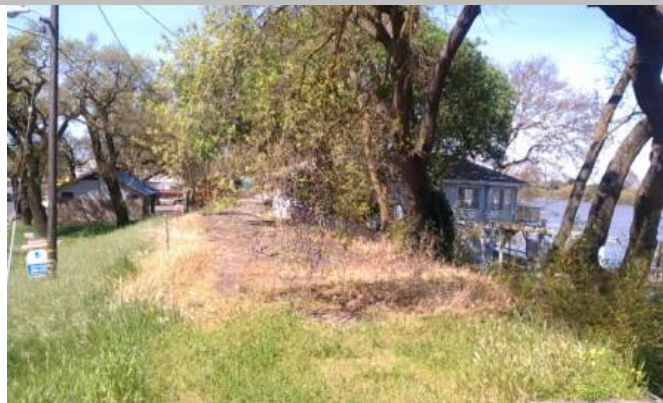
Photo 2 of 2 : SP_2015_NA0002_63_5_20150309_00004.jpg

Looking south at overhanging tree on waterside shoulder.

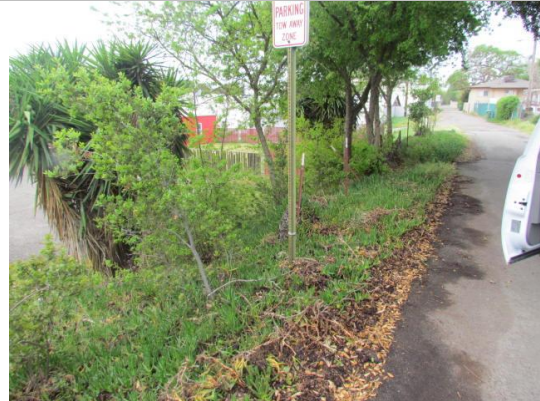
Photo 1 of 1 : SP_2015_NA0002_63_7_20150309_00005.jpg

Looking south at overgrown landscaping on landward slope.

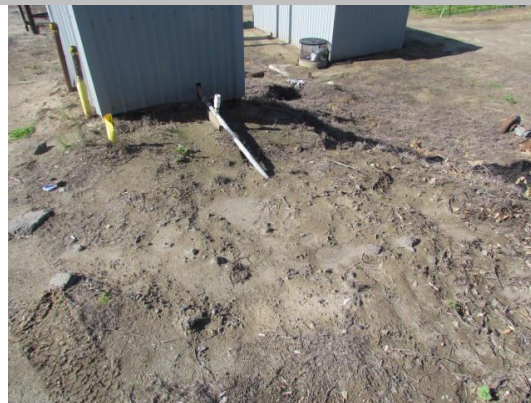
Photo 1 of 5 : SP_2015_NA0002_63_55_20150313_00103.jpg

Looking southeast at backfilled trench next to ramp on landward slope. (Spring 2015).

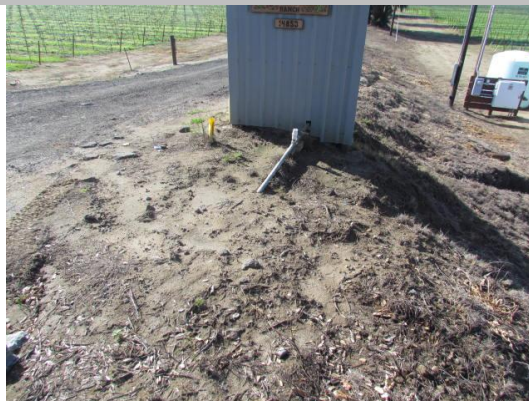
Photo 2 of 5 : SP_2015_NA0002_63_55_20150313_00104.jpg

Looking east at backfilled trench next to ramp on landward slope.
(Spring 2015).

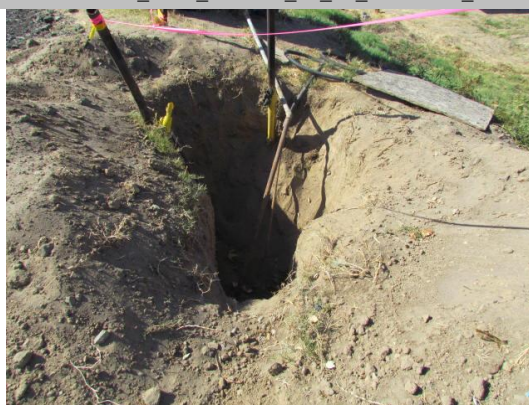
Photo 3 of 5 : SP_2015_NA0002_63_55_20150309_00052.jpg

Looking east at excavation on landward slope. (Spring 2014)

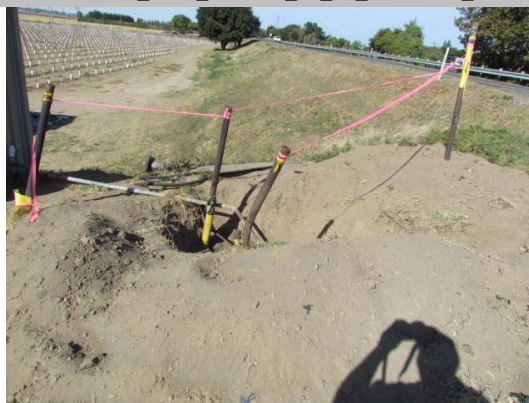
Photo 4 of 5 : SP_2015_NA0002_63_55_20150309_00053.jpg

Looking south at excavation on landward slope. (Spring 2014)

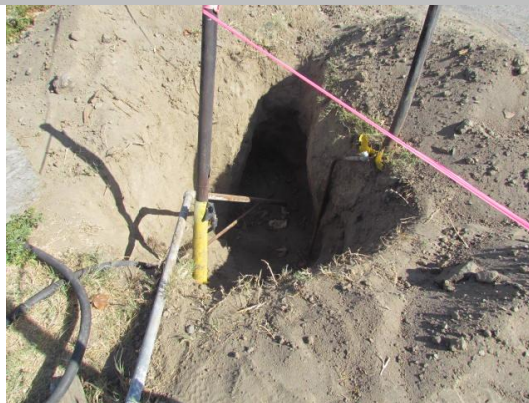
Photo 5 of 5 : SP_2015_NA0002_63_55_20150309_00054.jpg

Looking southeast at excavation on landward slope next to ramp.
(Spring 2014)

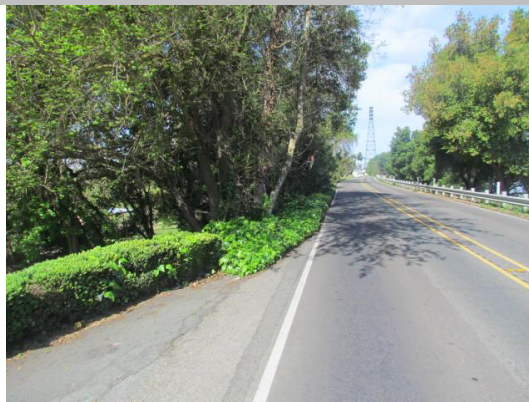
Photo 1 of 1 : SP_2015_NA0002_63_59_20150309_00055.jpg

Looking south at dense landscaping on landward slope.

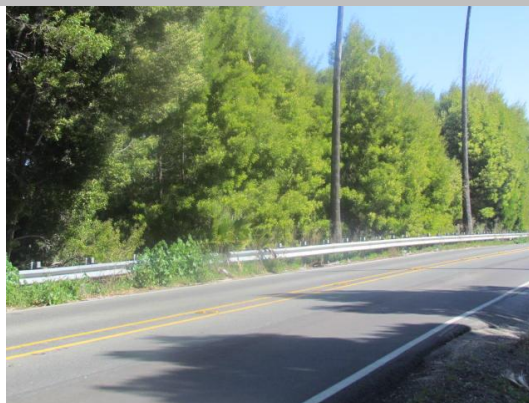
Photo 1 of 3 : SP_2015_NA0002_63_9_20150309_00008.jpg

Looking southeast at dense trees on landside slope and toe.

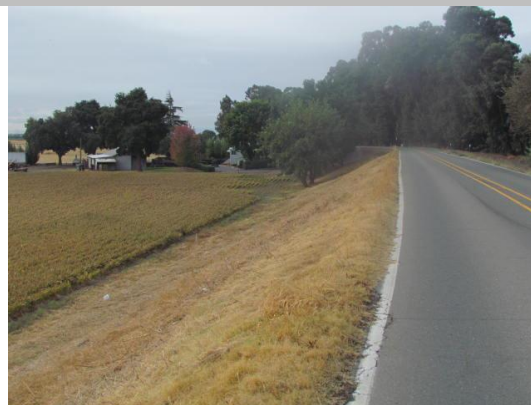
Photo 1 of 1 : SP_2015_NA0002_63_13_20150309_00014.jpg

Looking southeast at compliant vegetation on landside slope.

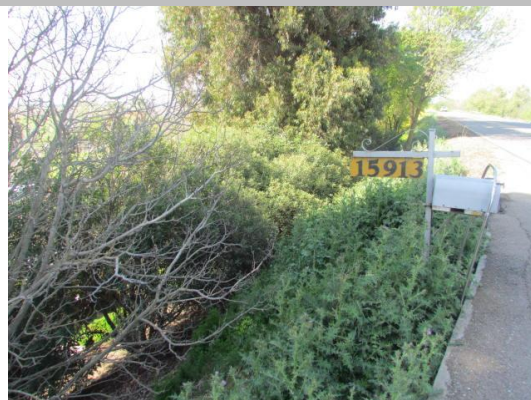
Photo 1 of 2 : SP_2015_NA0002_63_50_20150309_00048.jpg

Looking south at dense landscaping on landward slope.

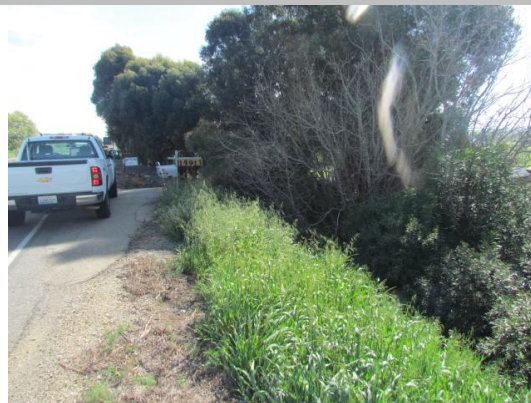
Photo 2 of 2 : SP_2015_NA0002_63_50_20150309_00049.jpg

Looking north at dense landscaping on landward slope.

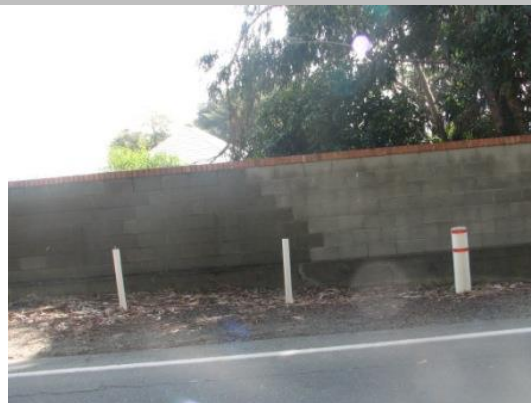
Photo 1 of 1 : SP_2015_NA0002_63_42_20150309_00041.jpg

Brick wall on landside shoulder at LM 6.82.

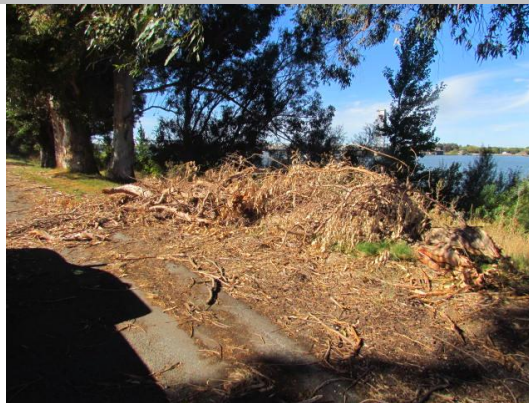
Photo 1 of 1 : SP_2015_NA0002_63_105_20150309_00062.jpg

Looking southwest at tree limbs on waterward shoulder.

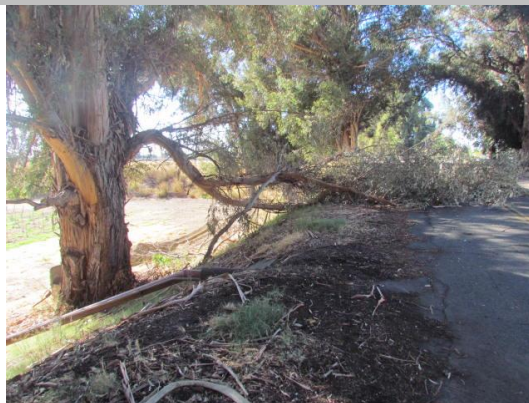
Photo 1 of 1 : SP_2015_NA0002_63_106_20150309_00063.jpg

Looking southeast at broken tree limb on landward shoulder.

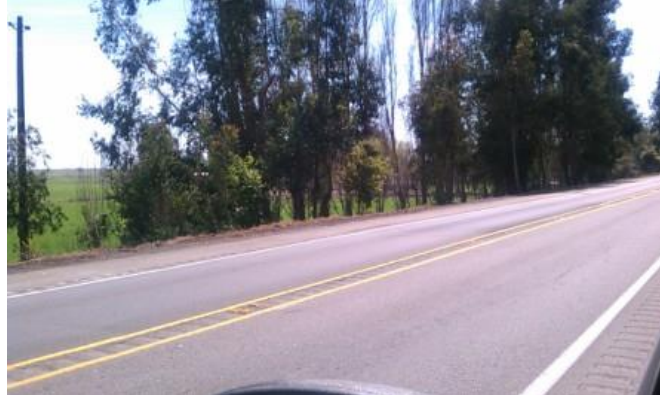
Photo 1 of 1 : SP_2015_NA0002_63_44_20150309_00042.jpg

Looking southeast at trees on landside shoulder and slope.

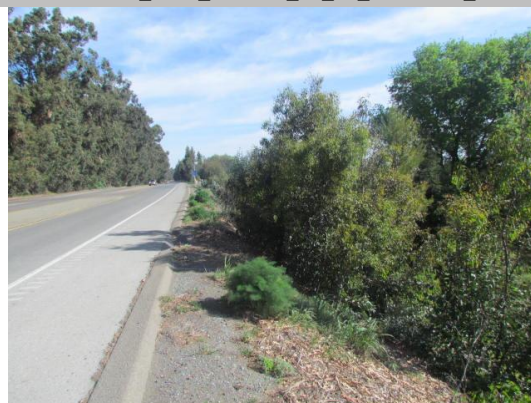
Photo 2 of 2 : SP_2015_NA0002_63_48_20150309_00047.jpg

Looking north at dense trees on landward slope and toe.

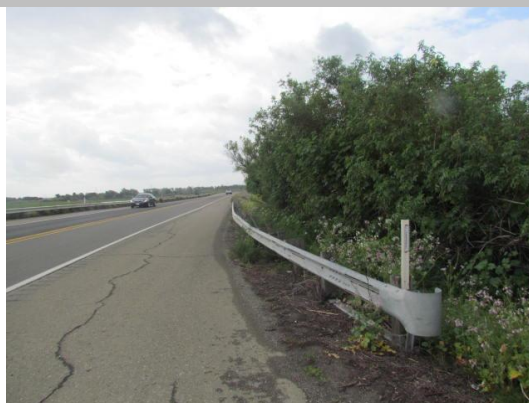
Photo 1 of 2 : SP_2015_NA0002_63_16_20150309_00015.jpg

Looking south at dense vegetation on waterward shoulder and slope.

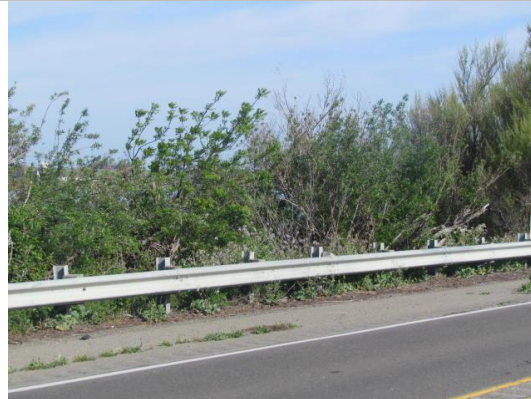
Photo 2 of 2 : SP_2015_NA0002_63_16_20150309_00016.jpg

Looking west at dense vegetation on waterward shoulder and slope.
