**Flood Control Project Maintenance
Levee Inspections****LMA District Cover Sheet****Spring 2016 Levee Inspection Results****Brannan Andrus Levee Maintenance District**

Spring 2016 Levee Inspection Results

Brannan Andrus Levee Maintenance District

Waterway			Bank	Unit Miles
Unit No. 01 Georgiana Slough			Right	6.01
	Spring (March - May)	Summer (June - August)	(September - November) Fall	Winter (December - February)
Unit Maintenance Rating (Fall Only)				
Date of Inspection	3/22/2016 - 3/22/2016			
DWR Inspector	Richard Willoughby			
Accompanied By	Gilbert Labrie DCC Engineering Co, Inc

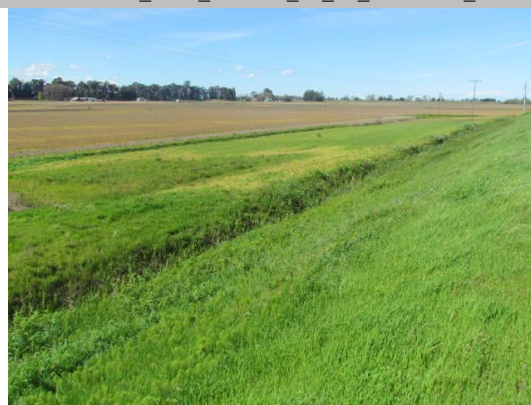
Photo 1 of 4 : SP_2016_NA0002_62_67_20160323_00099.jpg

Looking southwest at drainage ditch at landward toe.

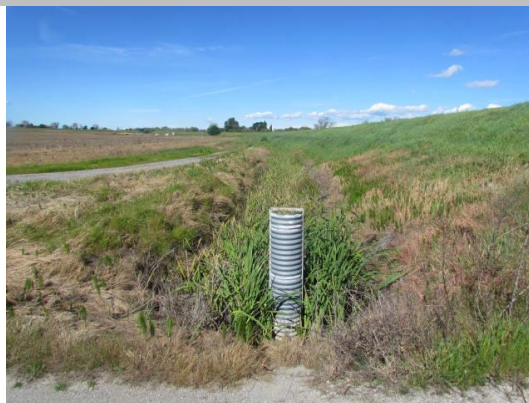
Photo 4 of 4 : SP_2016_NA0002_62_67_20160323_00101.jpg

Looking north at drainage ditch along landward toe.

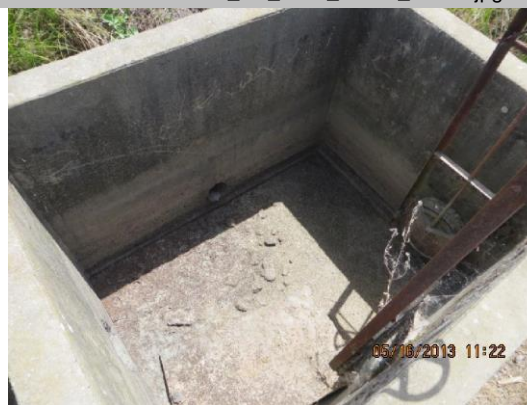
Photo 1 of 2 : UCIP_SP_2016_13554_22164.jpg

LM Start	1.54	Rating **	M	Issue No.	70
LM End	1.54	Issue Type +	En	Location *	LS
Category	Supplemental			GPS Latitude/Longitude	
				Start	End
Item	DWR UCIP Field Study			38.173254 °	38.173254 °
				-121.580718 °	-121.580718 °
DWR ID					
Comment Code					
Inspector Comment					
FS_ID:13554 DS_ID:21755 EP_NO: 11252 Repair Type: Non-Urgent Crossing Status: Found UCIP Comments: Pipe heavily rusted at distribution box. Good candidate for video inspection. FIELD_STRUCT_DESC: 1 of 3: 8-inch steel pipe through levee 4.6 feet below crown. Pump and valve on waterward slope. Siphon breaker in 24-inch CMP riser on LS shoulder. 7'X10'-concrete distribution box at LS toe (ABO No. 11252, 1976). Originally included in the 1954 O&M manual. FS Date: 5/16/2013

7X10-foot concrete distribution box on LS toe.

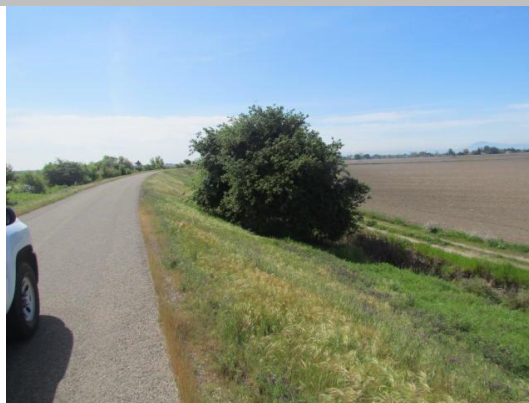
Photo 3 of 3 : SP_2016_NA0002_62_25_20160308_00026.jpg

Looking southwest at an untrimmed tree on landward slope and toe. (Spring 2014)

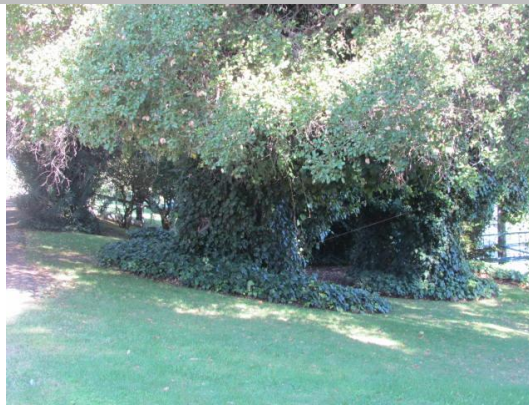
Photo 3 of 4 : SP_2016_NA0002_62_36_20160308_00035.jpg

Looking north at dense vegetation on waterside slope.

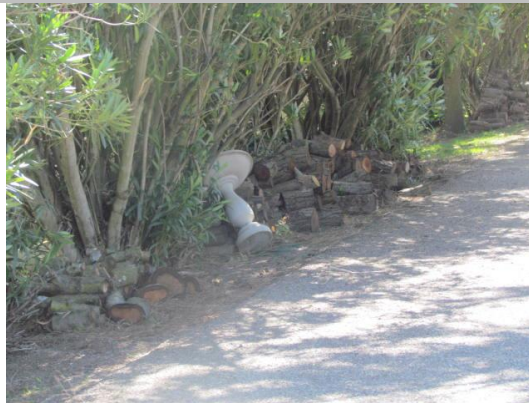
Photo 2 of 3 : SP_2016_NA0002_62_3_20160308_00004.jpg

Looking southeast at firewood on waterside shoulder.

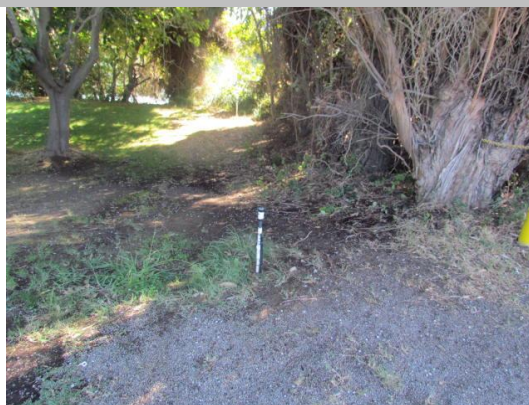
Photo 1 of 1 : SP_2016_NA0002_62_50_20160308_00040.jpg

Looking east at sprinklers on waterward slope.

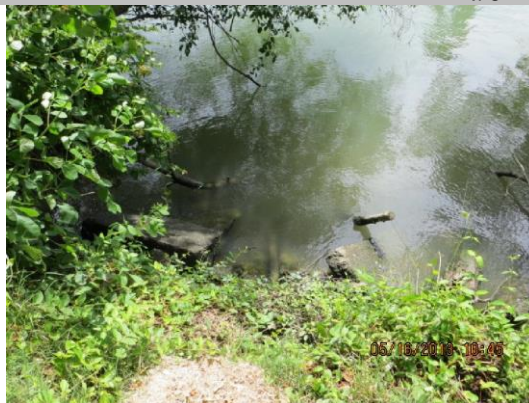
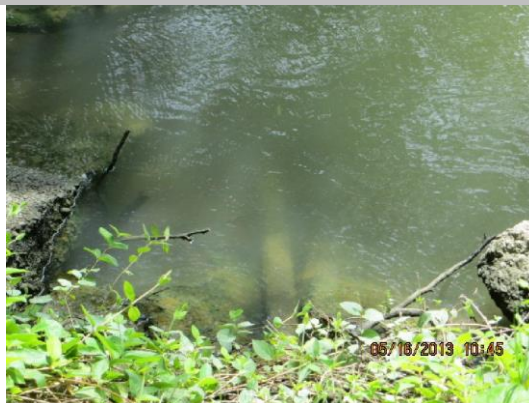
Photo 1 of 2 : UCIP_SP_2016_16123_27221.jpg

LM Start	2.34	Rating **	M	Issue No.	79
LM End	2.34	Issue Type +	En	Location *	WS
Category	Supplemental			GPS Latitude/Longitude	
				Start	End
Item	DWR UCIP Field Study			38.162332 °	38.162332 °
				-121.585032 °	-121.585032 °
DWR ID					
Comment Code					
Inspector Comment					
FS_ID:16123					
DS_ID:21819					
EP_NO: N/A					
Repair Type: Non-Urgent					
Crossing Status: Found					
UCIP Comments: Pipe appears abandoned and should be done so properly.					
FIELD_STRUCT_DESC: 2-inch steel pipe through levee 3.0 feet below crown. Originally included in the 1954 O&M manual.					
FS Date: 5/16/2013

Pipe visible in water at WS toe.

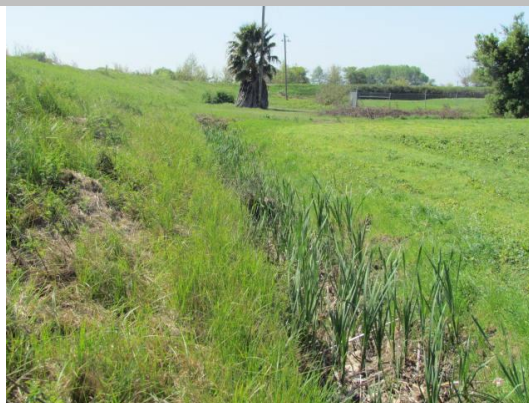
Photo 1 of 3 : SP_2016_NA0002_62_56_20160308_00052.jpg

Looking south at ditch within fifteen feet of landward toe.

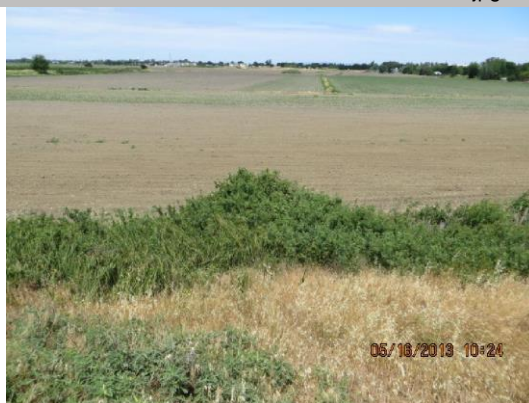
Photo 2 of 2 : UCIP_SP_2016_13545_22144.jpg

FS_ID:13545
DS_ID:21762
EP_NO: N/A
Repair Type: Non-Urgent
Crossing Status: Found
UCIP Comments: Pipe appears abandoned and should be done so properly. standpipe on LS is covered in brush.
FIELD_STRUCT_DESC: 8-inch steel pipe through the levee 3.4 feet below the crown. 6" pump on waterward side. 36-inch concrete standpipe on LS toe. Originally included in the 1954 O&M manual.
FS Date: 5/16/2013

Standpipe covered in brush on LS toe.

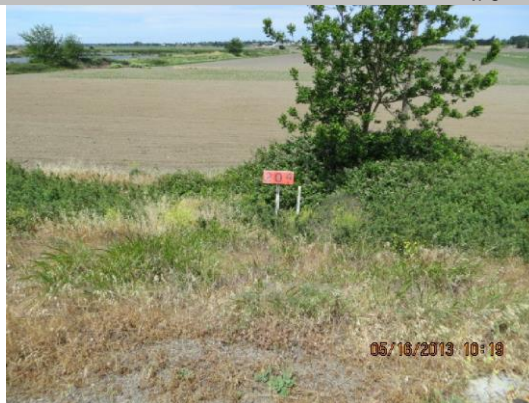
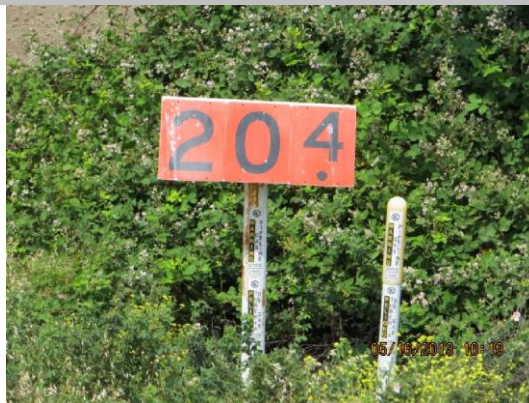
Photo 1 of 2 : UCIP_SP_2016_13525_22128.jpg

LM Start	2.54	Rating **	M	Issue No.	76
LM End	2.54	Issue Type +	En	Location *	LS
Category	Supplemental			GPS Latitude/Longitude	
				Start	End
Item	DWR UCIP Field Study			38.159569 °	38.159569 °
				-121.586340 °	-121.586340 °
DWR ID					
Comment Code					
Inspector Comment					
FS_ID:13525 DS_ID:21764 EP_NO: 17250 Repair Type: Non-Urgent Crossing Status: Indicator Found UCIP Comments: Needs better location markers. FIELD_STRUCT_DESC: 24-inch steel natural-gas pipeline through the levee 117-feet below the crown (Permit No. 17250, 2001). Possible sign on LS toe. FS Date: 5/16/2013

Gasline marker on LS toe.

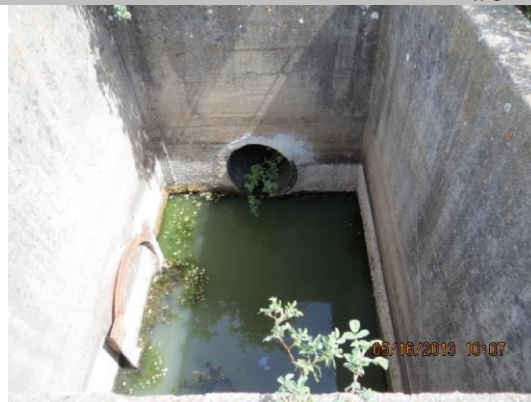
Photo 2 of 2 : UCIP_SP_2016_42846_22123.jpg

Comment Code					
Inspector Comment					
FS_ID:42846 DS_ID:21765 EP_NO: 11238 Repair Type: Urgent Crossing Status: Found UCIP Comments: Erosion along pipe at WS toe goes into levee prism. Animal activity appears to be the cause of some pretty heavy erosion damage. Some settlement along the pipe alignment on crown may indicate other problems with this pipe. FIELD_STRUCT_DESC: 1 of 5: 12-inch steel pipe through levee 4.0 feet below crown. Siphon breaker on landward shoulder. 7X9-foot concrete distribution box on LS toe (ABO No. 11238, 1975). Originally included in the 1954 O&M manual. (pipe replaced under Permit No. 18549 7/11/2009). FS Date: 5/16/2013

Concrete distribution box on LS toe.

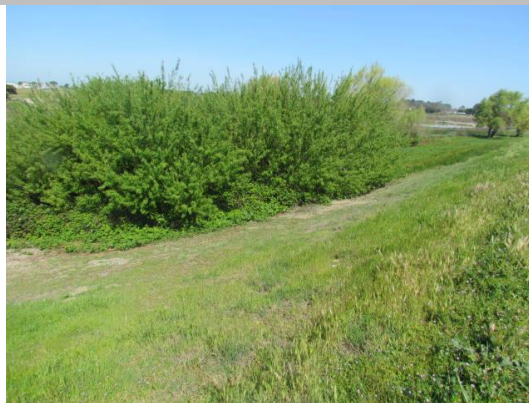
Photo 4 of 4 : SP_2016_NA0002_62_55_20160308_00051.jpg

Looking north at dense vegetation within fifteen feet of landward toe.

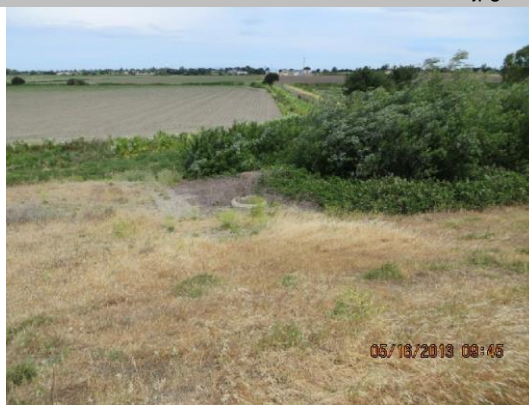
Photo 1 of 2 : UCIP_SP_2016_41561_27229.jpg

LM Start	3.01	Rating **	M	Issue No.	80
LM End	3.01	Issue Type +	En	Location *	LS
Category	Supplemental			GPS Latitude/Longitude	
				Start	End
Item	DWR UCIP Field Study			38.156379 °	38.156379 °
				-121.592527 °	-121.592527 °
DWR ID					
Comment Code					
Inspector Comment					
FS_ID:41561 DS_ID:21766 EP_NO: N/A Repair Type: Non-Urgent Crossing Status: Indicator Found UCIP Comments: Appears abandoned FIELD_STRUCT_DESC: 12-inch pipeline through levee, 5-foot diameter concrete riser on LS toe. FS Date: 5/16/2013

5-foot diameter concrete riser on LS toe, but no pipe visible.

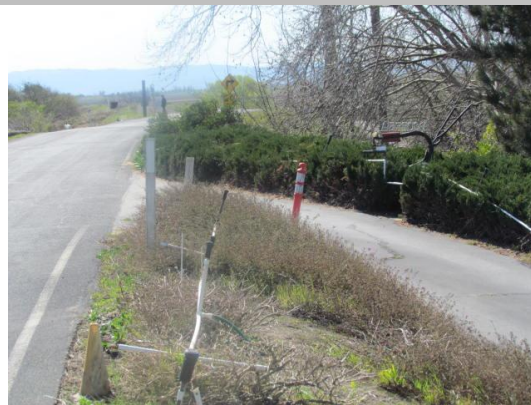
Photo 2 of 3 : SP_2016_NA0002_62_11_20160308_00012.jpg

Looking south at bushes on landside shoulder and slope.

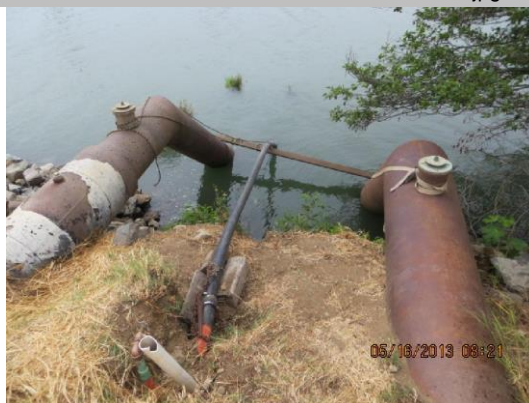
Photo 1 of 2 : UCIP_SP_2016_13487_22053.jpg

LM Start	3.99	Rating **	M	Issue No.	75
LM End	3.99	Issue Type +	En	Location *	LS
Category	Supplemental			GPS Latitude/Longitude	
				Start	End
Item	DWR UCIP Field Study			38.147653 °	38.147653 °
				-121.600491 °	-121.600491 °
DWR ID					
Comment Code					
Inspector Comment					
FS_ID:13487 DS_ID:21825 EP_NO: 11248 Repair Type: Non-Urgent Crossing Status: Found UCIP Comments: Leakage of pipe at WS toe creating erosion. Possible cavity collapse along pipe alignment on WS berm. FIELD_STRUCT_DESC: 2 of 2: 4-inch pipe through levee 4.0 feet below crown. Siphon breaker on waterward slope. Pump on landward side (ABO No. 11248, 1975). FS Date: 5/16/2013

Pipe visible between two large storm drain pipes on WS.

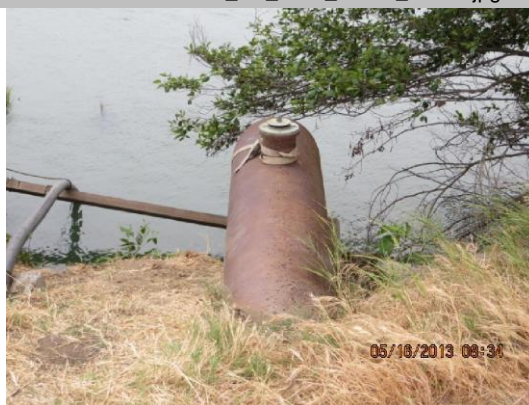
Photo 1 of 2 : UCIP_SP_2016_42847_22078.jpg

LM Start	3.99	Rating **	U	Issue No.	83
LM End	3.99	Issue Type +	En	Location *	LS
Category	Supplemental			GPS Latitude/Longitude	
				Start	End
Item	DWR UCIP Field Study			38.147657 °	38.147657 °
				-121.600521 °	-121.600521 °
DWR ID					
Comment Code					
Inspector Comment					
FS_ID:42847					
DS_ID:21773					
EP_NO: 5534					
Repair Type: Urgent					
Crossing Status: Found					
UCIP Comments: Pot holes over pipe may indicate internal failure.					
Good candidate for video inspection.					
FIELD_STRUCT_DESC: 22-inch steel discharge pipe through levee 3.0 feet below crown. Siphon breaker on WS shoulder. Pump in channel on landward side (Permit No. 5534, 1966). Replaced a 24-inch pipe at same location.					
FS Date: 5/16/2013

Pipe and siphon breaker on WS shoulder.

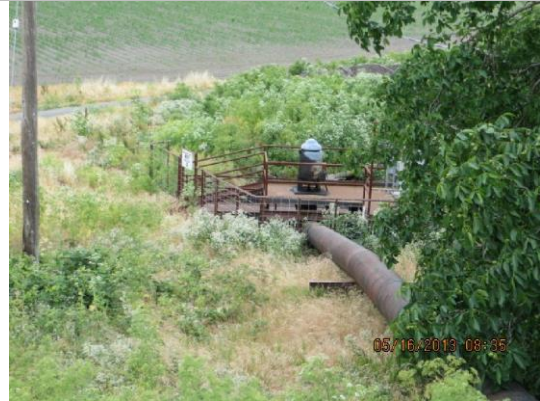
Photo 2 of 2 : UCIP_SP_2016_42847_22077.jpg

Pipe and pumping plant on LS slope.

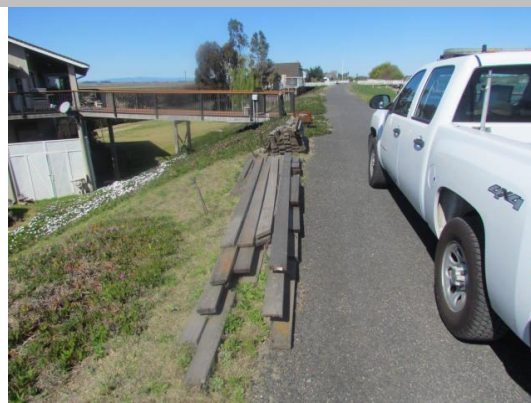
Photo 1 of 1 : SP_2016_NA0002_62_24_20160308_00023.jpg

Looking northwest at wooden boards on landside shoulder.

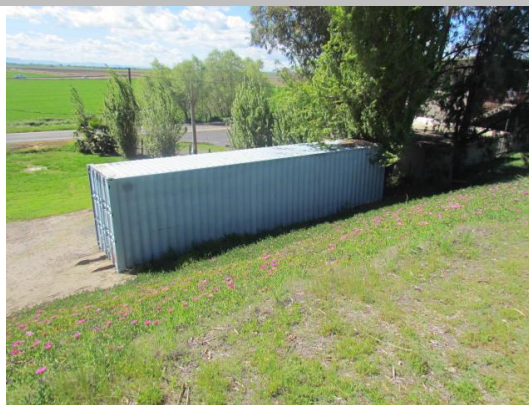
Photo 1 of 1 : SP_2016_NA0002_62_66_20160323_00104.jpg

Looking west at storage container at landward toe.

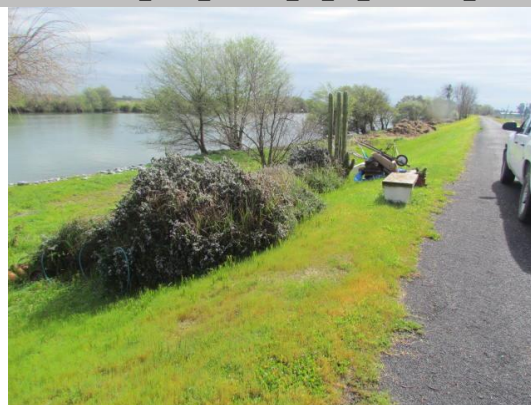
Photo 2 of 2 : SP_2016_NA0002_62_61_20160308_00057.jpg

Looking southeast at overgrowth landscaping on waterward slope.
(Spring 2015)

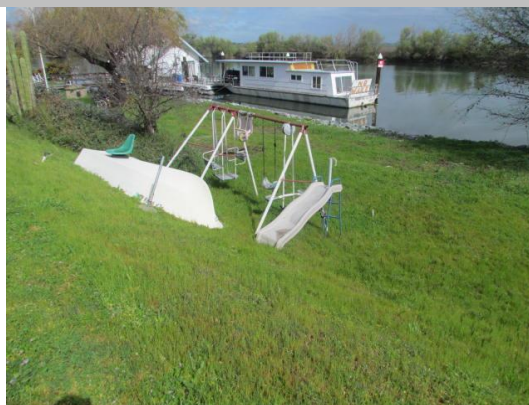
Photo 1 of 1 : SP_2016_NA0002_62_60_20160308_00055.jpg

Looking northeast at abandoned child's swing set at waterward toe.

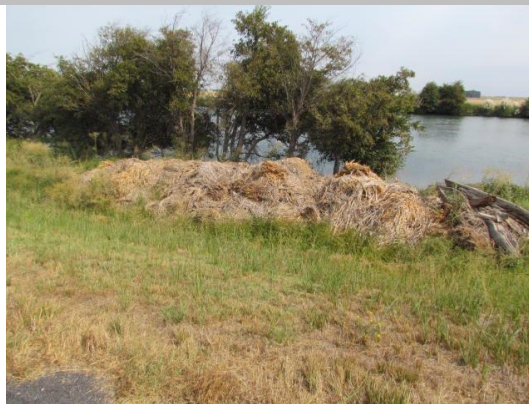
Photo 1 of 1 : SP_2016_NA0002_62_47_20160308_00037.jpg

Looking at pruning piles on waterward berm.

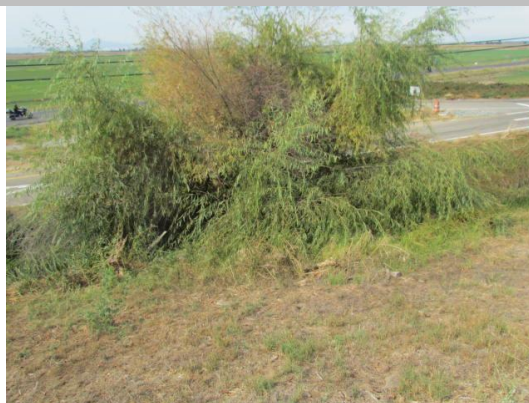
Photo 1 of 1 : SP_2016_NA0002_62_54_20160308_00048.jpg

Looking at dense trees at landward toe.

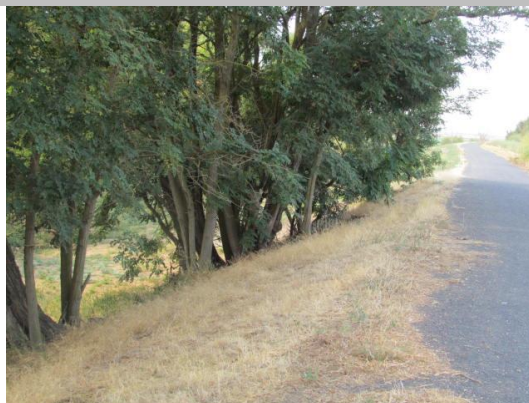
Photo 1 of 1 : SP_2016_NA0002_62_17_20160308_00014.jpg

Looking at dense trees on landward slope and toe.

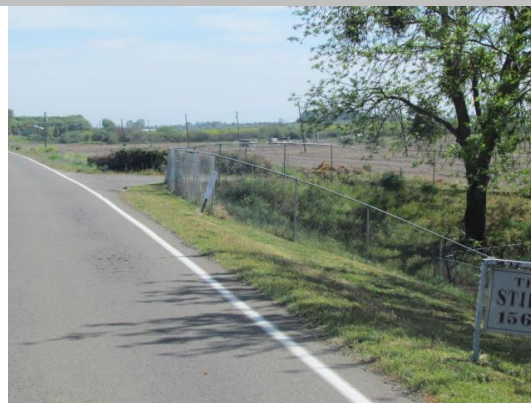
Photo 1 of 1 : SP_2016_NA0002_63_26_20160308_00024.jpg

Looking northeast at fence on landward shoulder and slope.

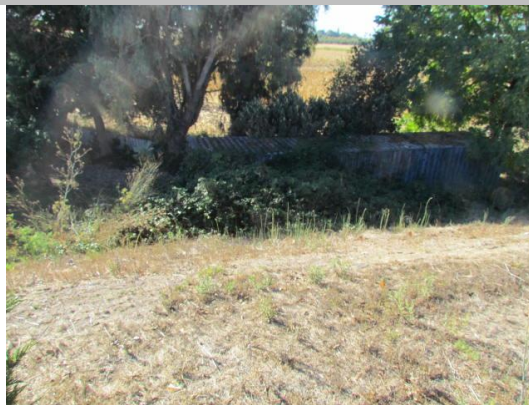
Photo 2 of 3 : SP_2016_NA0002_63_40_20160308_00038.jpg

Looking east at berryvines at landward toe.

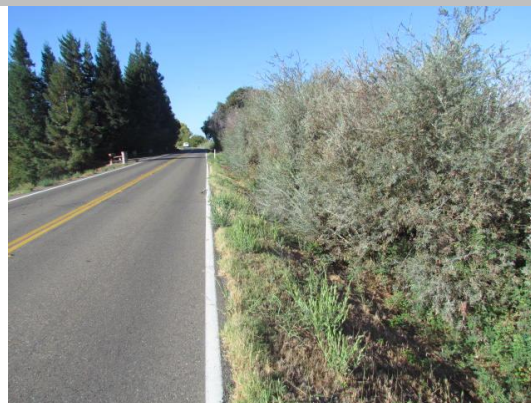
Photo 1 of 1 : SP_2016_NA0002_63_2_20160308_00001.jpg

Looking south at dense willows and trees on waterward slope.

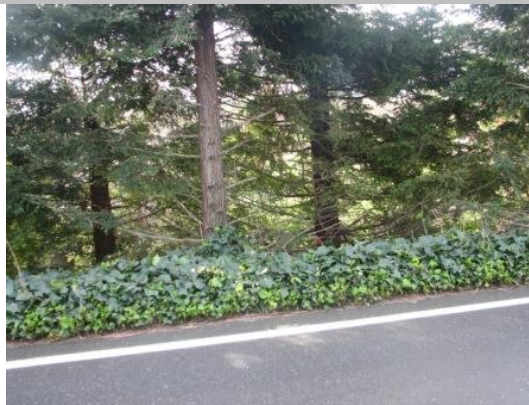
Photo 3 of 3 : SP_2016_NA0002_63_8_20160308_00007.jpg

Landscaping on landside slope blocking view of slope from LM .81 to 0.83.

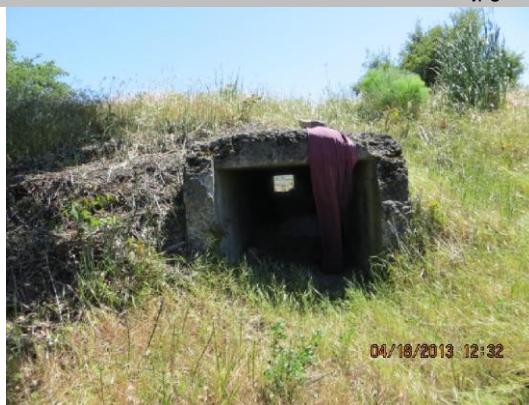
Photo 1 of 2 : UCIP_SP_2016_12212_19773.jpg

Concrete tunnel open on both ends.

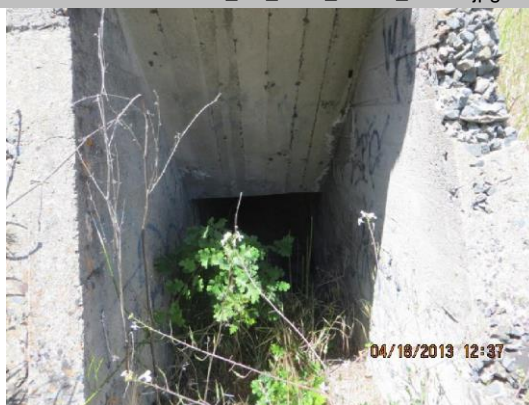
Photo 1 of 2 : UCIP_SP_2016_12213_19776.jpg

Tunnel open on LS shoulder.

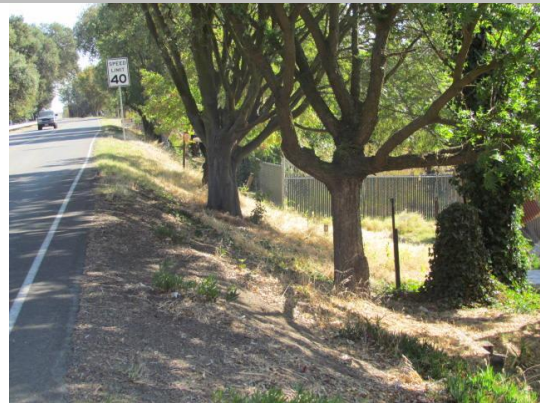
Photo 1 of 2 : SP_2016_NA0002_63_30_20160308_00030.jpg

Looking north at urban encroachments on landward slope and toe.

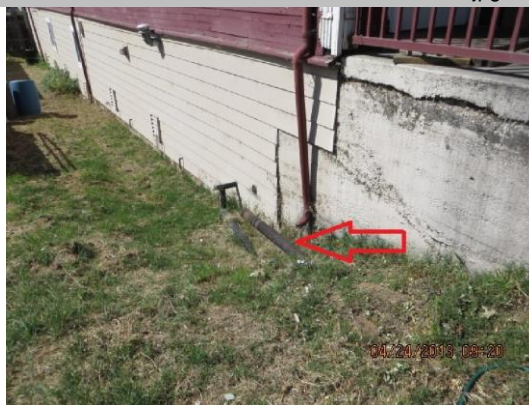
Photo 1 of 2 : UCIP_SP_2016_15966_26949.jpg

Pipe visible next to foundation on LS slope.

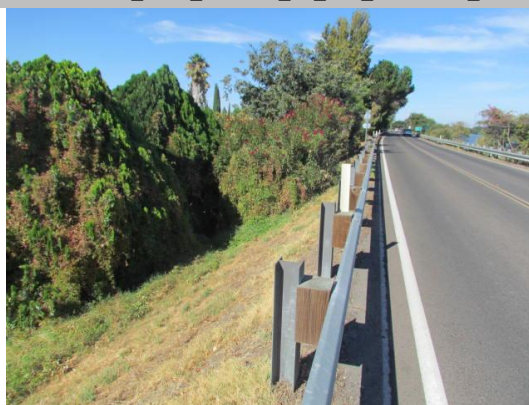
Photo 1 of 1 : SP_2016_NA0002_63_101_20160308_00068.jpg

Looking at dense landscaping on landward slope.

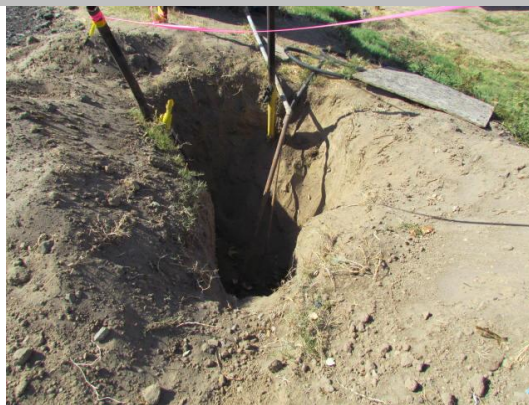
Photo 3 of 5 : SP_2016_NA0002_63_55_20160308_00052.jpg

Looking east at excavation on landward slope. (Spring 2014)

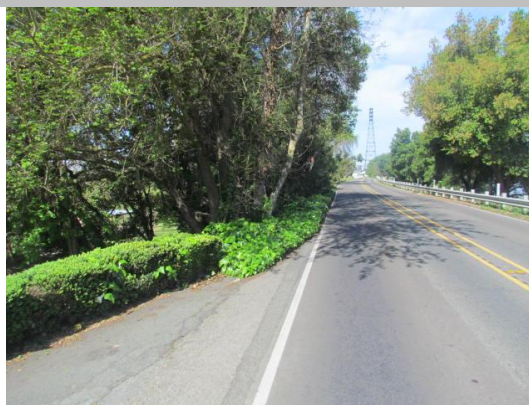
Photo 1 of 1 : SP_2016_NA0002_63_59_20160308_00056.jpg

Looking south at dense landscaping on landward slope.

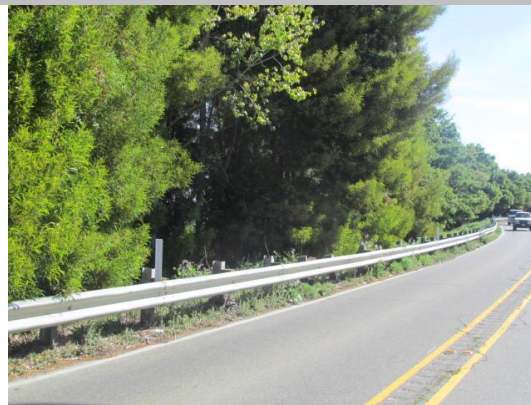
Photo 2 of 3 : SP_2016_NA0002_63_9_20160308_00009.jpg

Looking northwest at dense trees on waterward shoulder and slope.

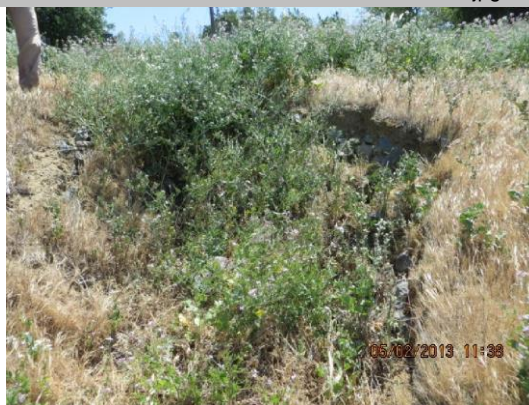
Photo 1 of 2 : UCIP_SP_2016_12814_20821.jpg

Erosion/sinkhole over pipe on WS slope.

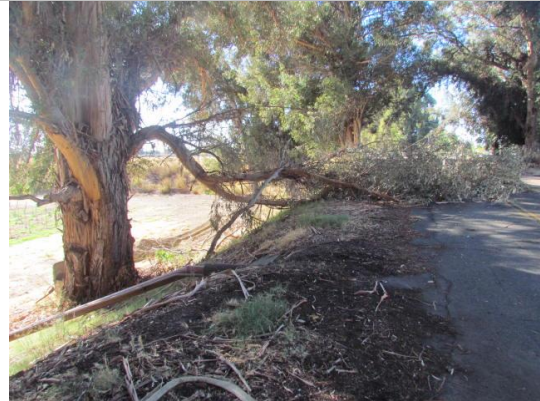
Photo 1 of 1 : SP_2016_NA0002_63_106_20160308_00072.jpg

Looking southeast at broken tree limb on landward shoulder.

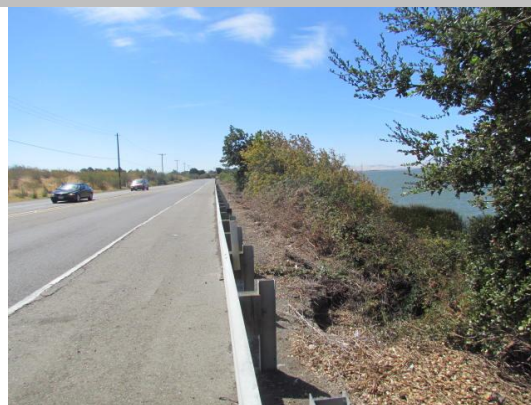
Photo 1 of 1 : SP_2016_NA0002_63_107_20160308_00073.jpg

Looking south at dense vegetation on waterward slope.

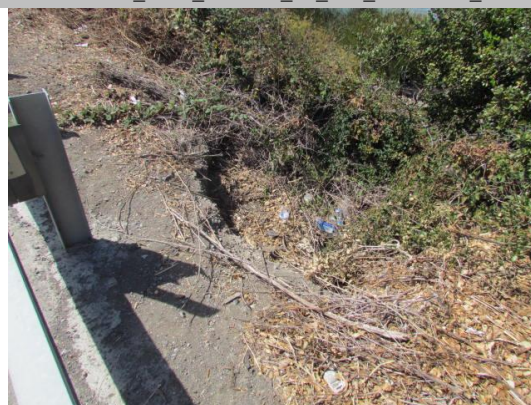
Photo 1 of 1 : SP_2016_NA0002_63_113_20160308_00074.jpg

Looking at erosion on waterward shoulder.
