**Flood Control Project Maintenance
Levee Inspections**
LMA District Cover Sheet
Spring 2017 Levee Inspection Results

Brannan Andrus Levee Maintenance District

Spring 2017 Levee Inspection Results

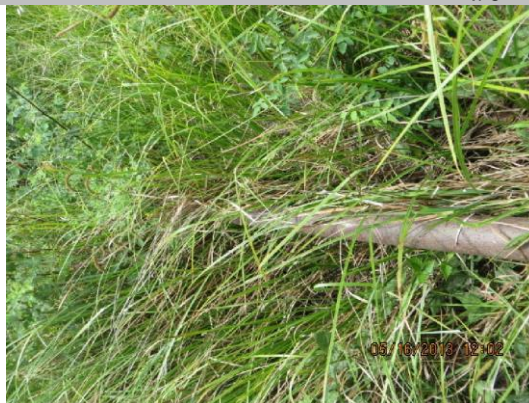
Photo 1 of 3 : UCIP_SP_2017_13560_22173.jpg

LM Start	0.61	Rating **	M	Issue No.	75
LM End	0.61	Issue Type +	En	Location *	WS
Category	Supplemental			GPS Latitude/Longitude	
				Start	End
Item	DWR UCIP Field Study			38.182213 °	38.182213 °
				-121.572357 °	-121.572357 °
DWR ID					
Comment Code					
Inspector Comment					
FS_ID:13560 DS_ID:21752 EP_NO: 2015 Repair Type: Non-Urgent Crossing Status: Found UCIP Comments: This pipe appears abandoned and should be removed. FIELD_STRUCT_DESC: 2-inch galvanized pipe through levee 2.0 feet below crown. Gas well drain (Permit No. 2015, 1959). FS Date: 5/16/2013

Pipe in grass on WS slope.

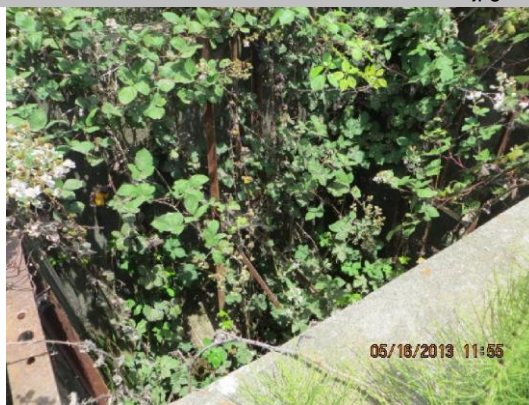
Photo 1 of 1 : UCIP_SP_2017_15984_26969.jpg

LM Start	0.75	Rating **	M	Issue No.	76
LM End	0.75	Issue Type +	En	Location *	WS
Category	Supplemental			GPS Latitude/Longitude	
				Start	End
Item	DWR UCIP Field Study			38.182212 °	38.182212 °
				-121.574987 °	-121.574987 °
DWR ID					
Comment Code					
Inspector Comment					
FS_ID:15984					
DS_ID:21753					
EP_NO: 11232					
Repair Type: Non-Urgent					
Crossing Status: Found					
UCIP Comments: Unable to locate any appurtances other than distro box. Need to verify proper abandonment.					
FIELD_STRUCT_DESC: 12-inch pipe through levee 3.2 feet below crown. Siphon breaker on landward slope. Concrete distribution box located landward of the toe (ABO No. 11232, 1975). 2" primer valve. Originally included in the 1954 O&M manual.					
FS Date: 5/16/2013

Concrete distribution box on LS toe.

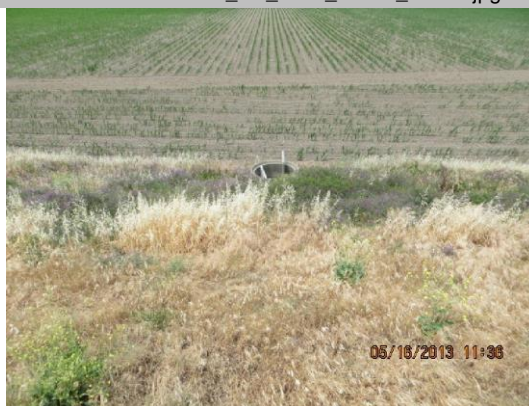
Photo 1 of 3 : UCIP_SP_2017_13558_22169.jpg

LM Start	1.22	Rating **	M	Issue No.	77
LM End	1.22	Issue Type +	En	Location *	WS
Category	Supplemental			GPS Latitude/Longitude	
				Start	End
Item	DWR UCIP Field Study			38.177669 °	38.177669 °
				-121.580222 °	-121.580222 °
DWR ID					
Comment Code					
Inspector Comment					
FS_ID:13558					
DS_ID:21754					
EP_NO: 11234					
Repair Type: Non-Urgent					
Crossing Status: Found					
UCIP Comments: Appears abandoned and should be done so properly.					
FIELD_STRUCT_DESC: 1 of 2: 8-inch steel pipe through levee 4.3 feet					
below crown. Pump in pump house on waterward berm. 60-inch					
diameter concrete standpipe on LS toe (ABO No. 11234, 1975).					
Originally included in the 1954 O&M manual.					
FS Date: 5/16/2013

Concrete standpipe on LS toe.

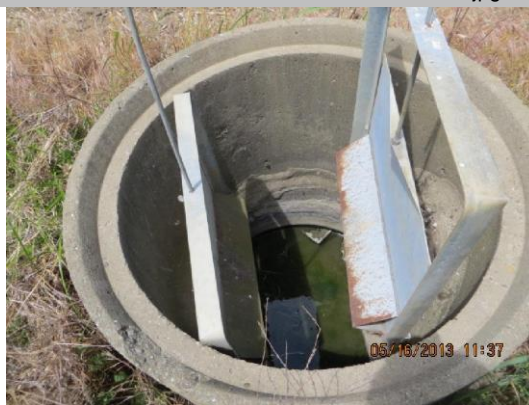
Photo 2 of 3 : UCIP_SP_2017_13558_22168.jpg

Concrete standpipe on LS toe.

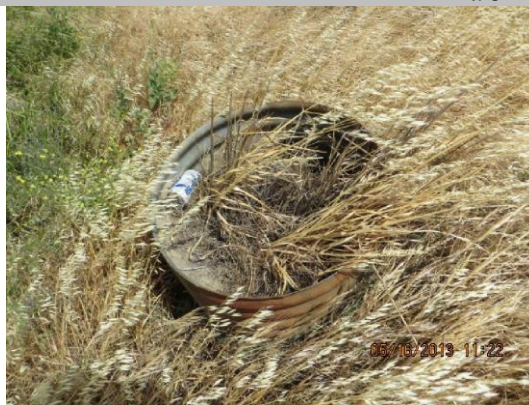
Photo 3 of 3 : UCIP_SP_2017_13554_22162.jpg

CMP riser on LS slope.

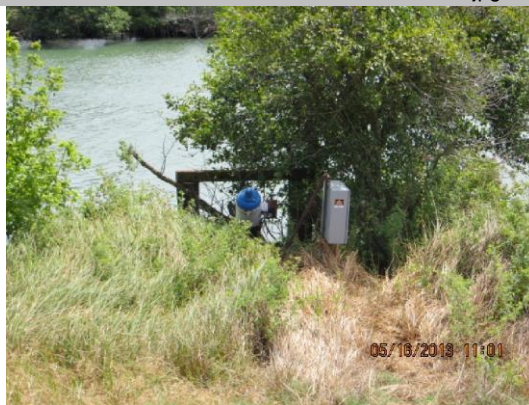
Photo 2 of 3 : UCIP_SP_2017_51471_22154.jpg

FS_ID:51471
DS_ID:21758
EP_NO: 11252
Repair Type: Non-Urgent
Crossing Status: Found
UCIP Comments: 04/06/2017 Landowner has installed a temporary pipe and removed old pipe. Photos and update courtesy of DWR Inspector, Richard Willoughby. 05/16/2013 Pipe rusted through at inlet to box. Good candidate for video inspection. (G. Wylie - DWR)
FIELD_STRUCT_DESC: *REMOVED* 3 of 3: 12-inch steel pipe through the levee 4.0 feet below the crown. Slant pump on bank. Switch box on berm, conduit through levee. Siphon breaker in 24-inch CMP riser on landward slope. Power pole and electrical panel at landward toe (ABO No. 11252, 1975). 7'X10' concrete distribution box on LS toe. As per Richard Willoughby, FPIIB Inspector, landowner has installed a temporary 12-inch PVC pipe on the WS and removed this pipe. New pipe forthcoming. Originally included in the 1954 O&M manual.
FS Date: 4/6/2017

Slant pump on WS toe.

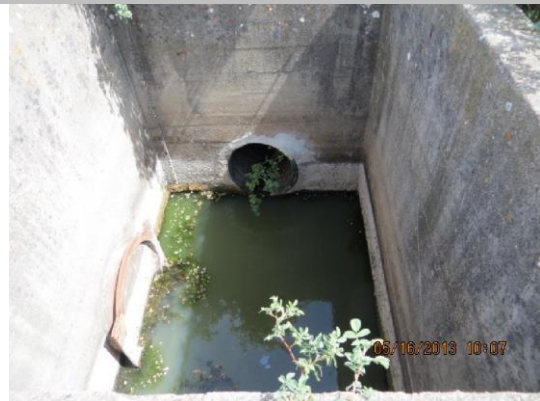
Photo 2 of 3 : UCIP_SP_2017_51299_22123.jpg

Concrete distribution box on LS toe.

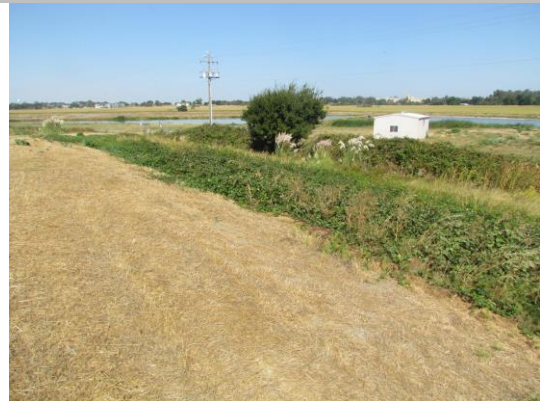
Photo 1 of 1 : SP_2017_NA0002_62_71_20170314_00057.jpg

LM Start	2.76	Rating **	U	Issue No.	71
LM End	2.76	Issue Type +	Ma	Location *	LS
Category	Earthen Levee			GPS Latitude/Longitude	
				Start	End
Item	Vegetation			38.157860 °	38.157860 °
				-121.588920 °	-121.588920 °
DWR ID	DWR_NA0002_01_f_2016_71				
Comment Code					
V2 : Remove the wild growth other than native grasses from the levee slopes.					
Inspector Comment					
Dense wildroses on landward slope.

Looking west at dense vines at landward toe.

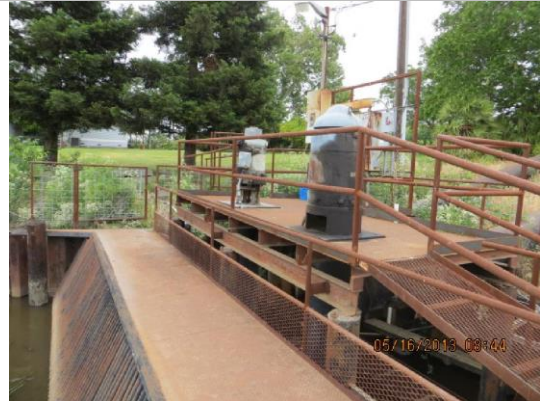
Photo 3 of 3 : UCIP_SP_2017_51302_22080.jpg

Pumping plant on LS toe.

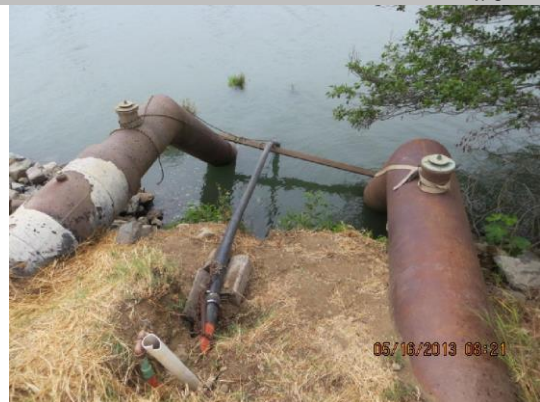
Photo 1 of 3 : UCIP_SP_2017_13487_22053.jpg

LM Start	3.99	Rating **	M	Issue No.	86
LM End	3.99	Issue Type +	En	Location *	LS
Category	Supplemental			GPS Latitude/Longitude	
				Start	End
Item	DWR UCIP Field Study			38.147653 °	38.147653 °
				-121.600491 °	-121.600491 °
DWR ID					
Comment Code					
Inspector Comment					
FS_ID:13487 DS_ID:21825 EP_NO: 11248 Repair Type: Non-Urgent Crossing Status: Found UCIP Comments: Leakage of pipe at WS toe creating erosion. Possible cavity collapse along pipe alignment on WS berm. FIELD_STRUCT_DESC: 2 of 2: 4-inch pipe through levee 4.0 feet below crown. Siphon breaker on waterward slope. Pump on landward side (ABO No. 11248, 1975). FS Date: 5/16/2013

Pipe visible between two large storm drain pipes on WS.

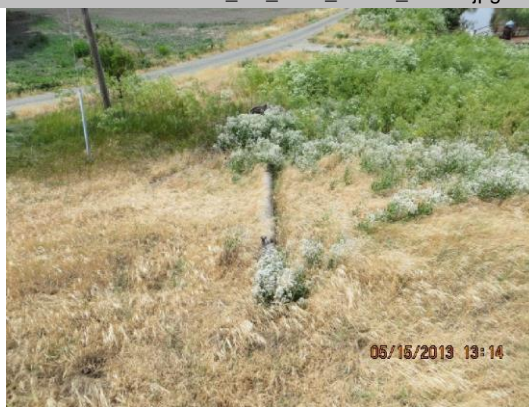
Photo 2 of 3 : UCIP_SP_2017_51308_22049.jpg

10-inch pipe visible on LS slope

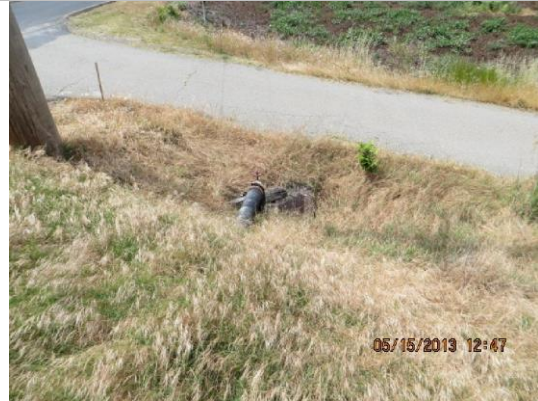
Photo 1 of 3 : UCIP_SP_2017_51345_22042.jpg

Pipe and concrete sump on LS.

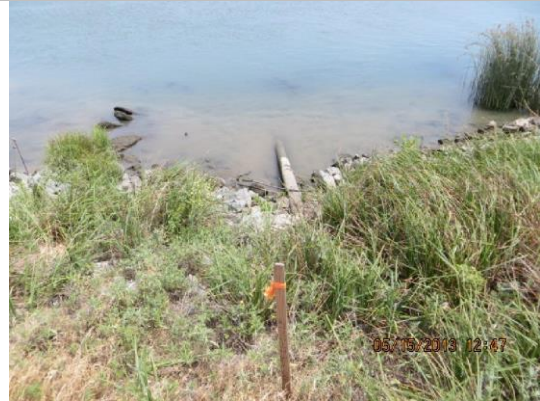
Photo 2 of 3 : UCIP_SP_2017_51345_22041.jpg

Pipe visible at waters edge on WS toe.

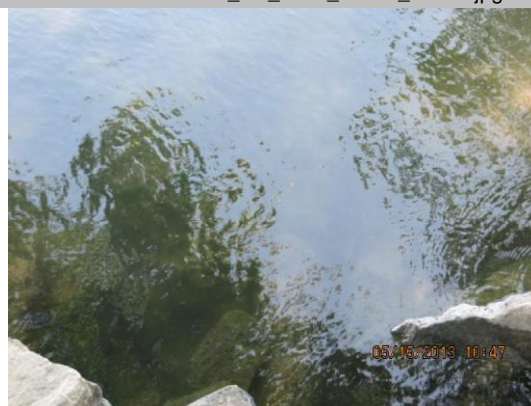
Photo 1 of 2 : UCIP_SP_2017_13442_21942.jpg

Pipe visible just under the water surface

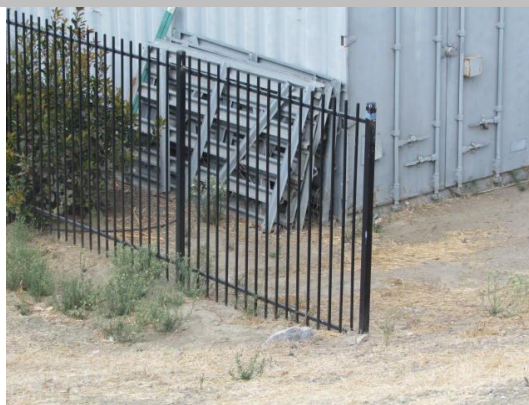
Photo 1 of 2 : SP_2017_NA0002_62_48_20170314_00033.jpg

Looking at close-up view of fence at landward toe.

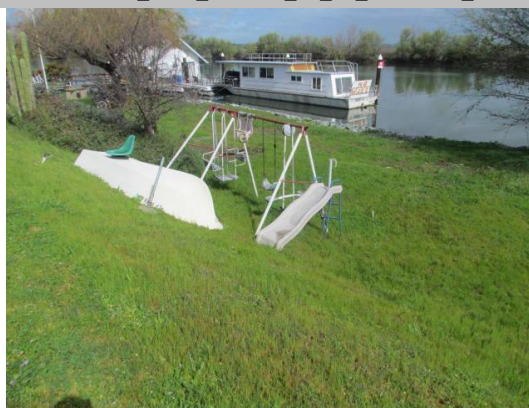
Photo 1 of 1 : SP_2017_NA0002_62_60_20170314_00046.jpg

Looking northeast at abandoned child's swing set at waterward toe.

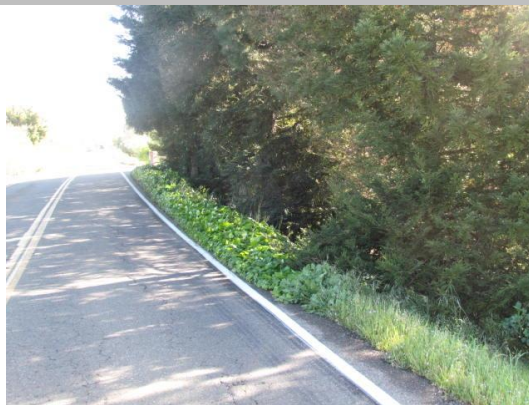
Photo 1 of 3 : SP_2017_NA0002_63_8_20170314_00007.jpg

Looking northeast at dense landscaping on landward slope and toe.
(Spring 2016)

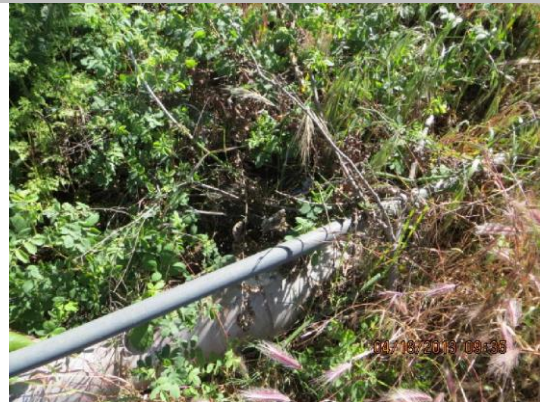
Photo 2 of 3 : UCIP_SP_2017_12164_19725.jpg

1.5-inch galvanized iron electrical conduit at same location as 12-inch pipe on WS slope.

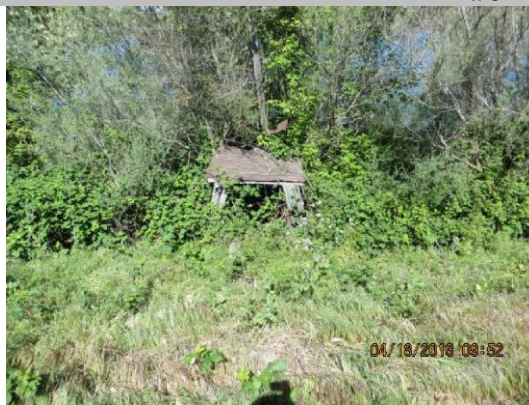
Photo 2 of 3 : UCIP_SP_2017_12165_19730.jpg

Pipe and pumphouse on WS berm.

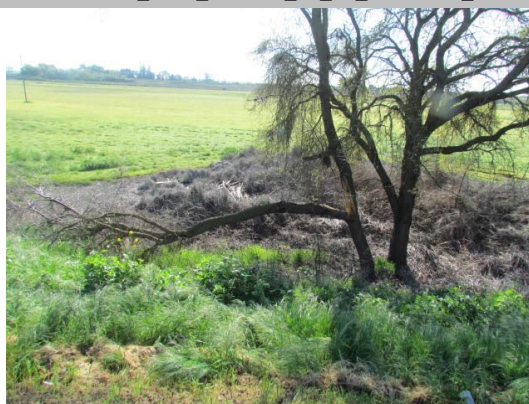
Photo 1 of 1 : SP_2017_NA0002_63_96_20170314_00062.jpg

Looking east at broken tree limb at landward toe.

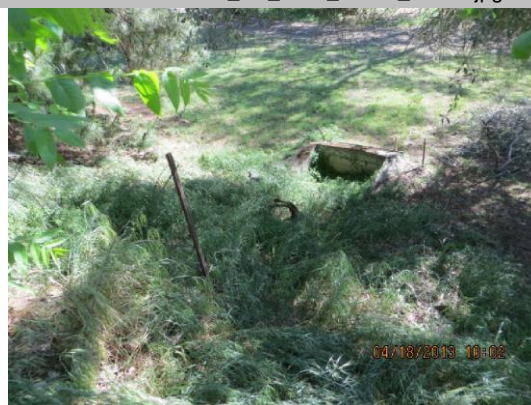
Photo 1 of 3 : UCIP_SP_2017_12183_19742.jpg

Concrete distribution box on LS toe.

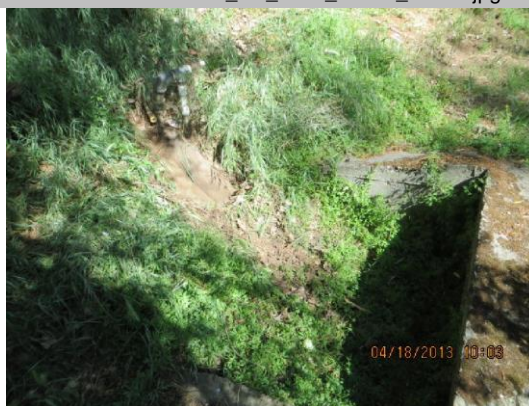
Photo 2 of 3 : UCIP_SP_2017_12183_19741.jpg

Distribution box and hose bib on LS toe.

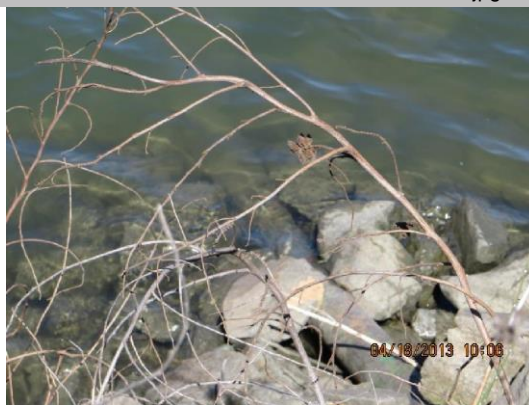
Photo 3 of 3 : UCIP_SP_2017_12183_19740.jpg

4-inch suction pipe on WS toe.

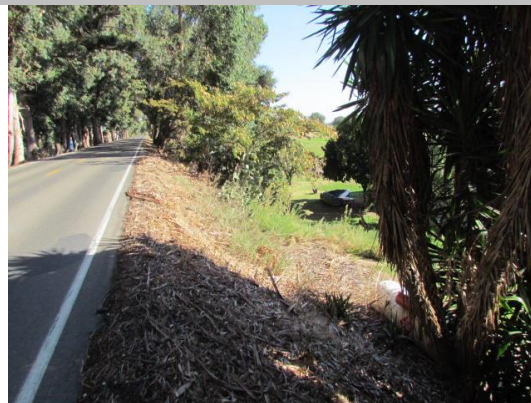
Photo 2 of 2 : SP_2017_NA0002_63_45_20170314_00046.jpg

Looking northeast at dense vegetation on landward slope and toe.

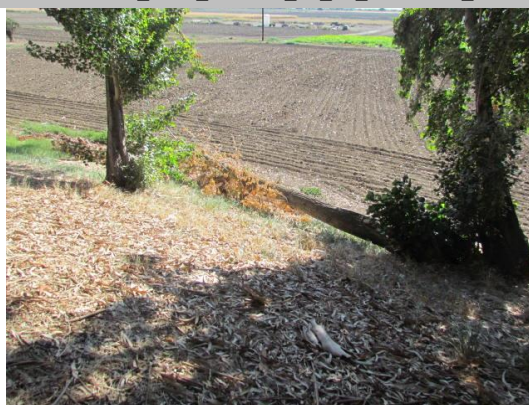
Photo 2 of 2 : SP_2017_NA0002_63_93_20170314_00059.jpg

Looking east at broken tree limb at landward toe.

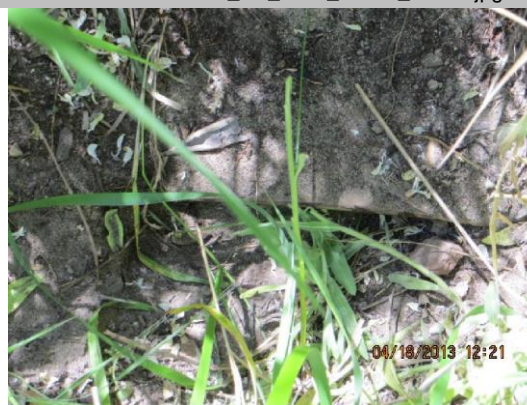
Photo 2 of 3 : UCIP_SP_2017_12211_19769.jpg

Evidence of pipe (buried) on LS in ditch.

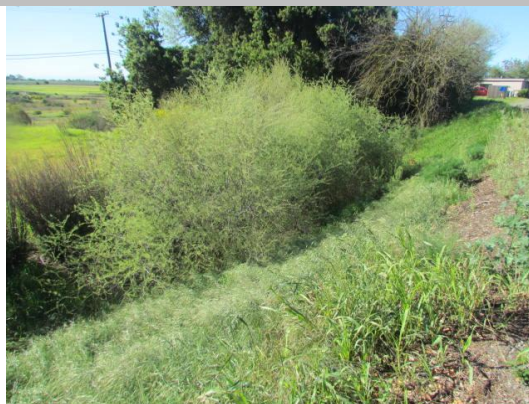
Photo 1 of 2 : SP_2017_NA0002_63_99_20170314_00065.jpg

Looking southwest at vegetation (willows) on landward slope and toe.

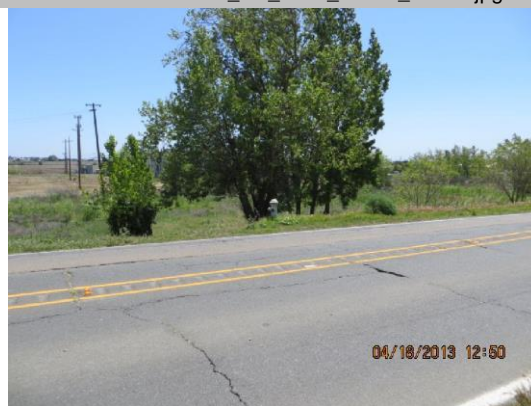
Photo 3 of 3 : UCIP_SP_2017_12214_19779.jpg

Fire hydrant on LS shoulder.

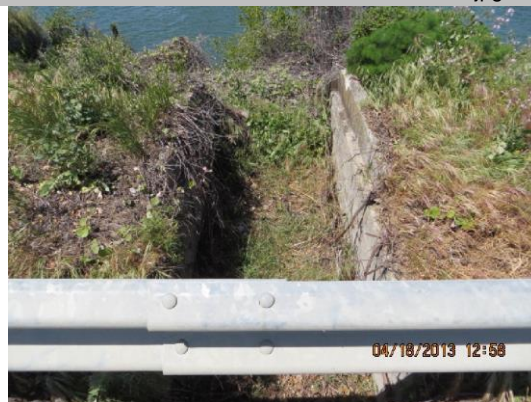
Photo 2 of 3 : UCIP_SP_2017_51316_19781.jpg

Tunnel opening on WS slope.

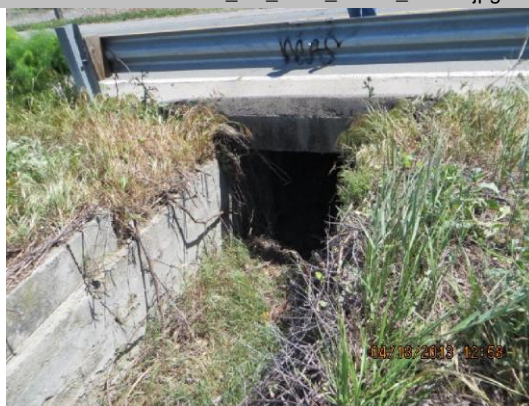
Photo 3 of 3 : UCIP_SP_2017_51316_19780.jpg

Tunnel opening on WS slope.

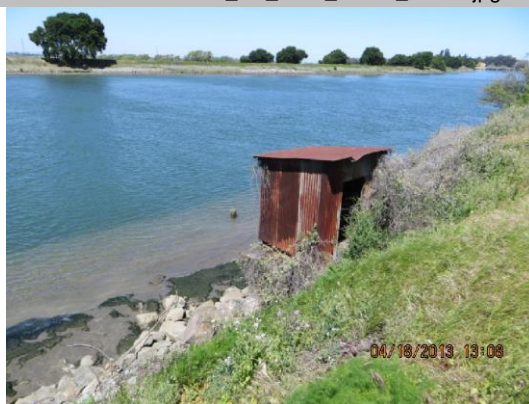
Photo 1 of 2 : UCIP_SP_2017_12217_19785.jpg

Pumphouse on WS slope.

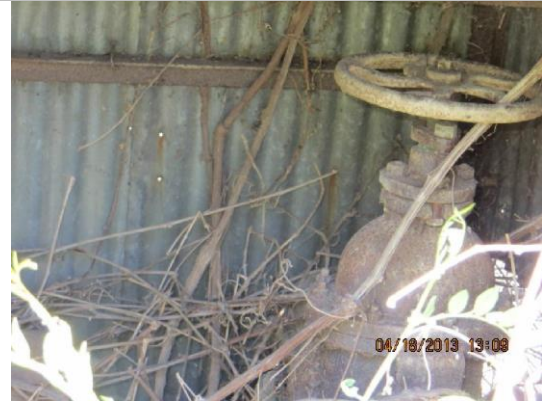
Photo 2 of 2 : UCIP_SP_2017_12217_19784.jpg

Slide gate in pumphouse on WS slope.

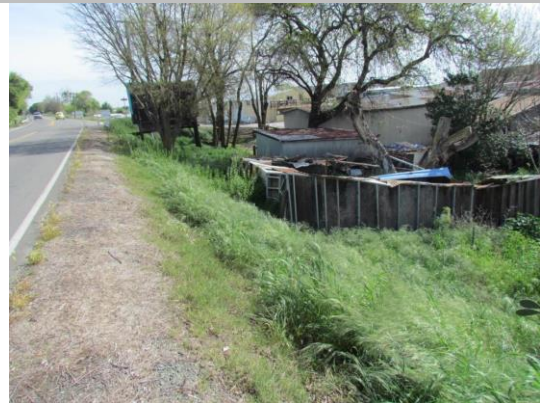
Photo 1 of 2 : SP_2017_NA0002_63_30_20170324_00185.jpg

Looking north at several encroachment along landward slope and toe.

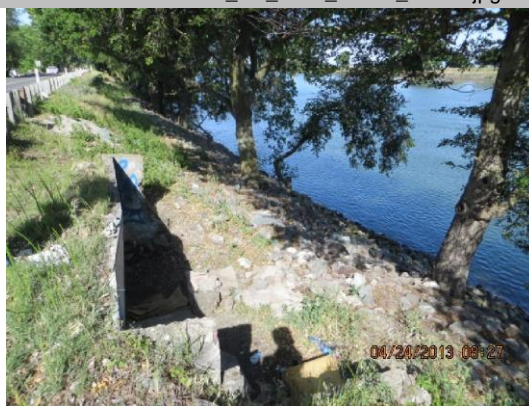
Photo 2 of 2 : UCIP_SP_2017_12724_20642.jpg

Foundation on WS shoulder.

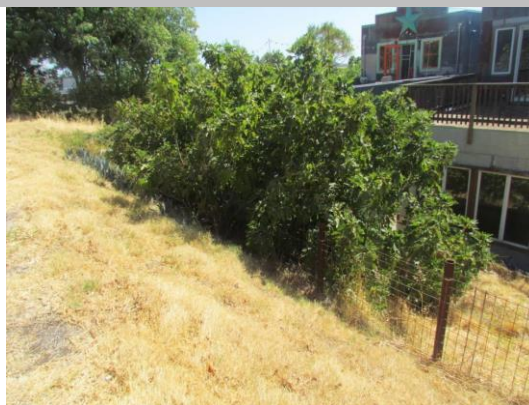
Photo 1 of 1 : SP_2017_NA0002_63_121_20170314_00091.jpg

Looking east at untrimmed fig tree at landward toe.

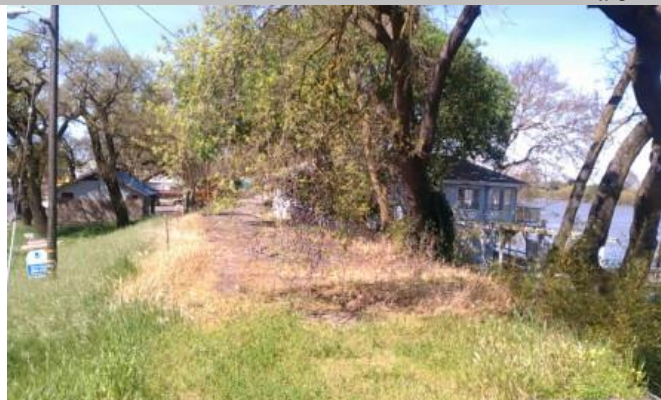
Photo 2 of 2 : SP_2017_NA0002_63_5_20170314_00004.jpg

Looking west at overhanging tree on waterside shoulder.

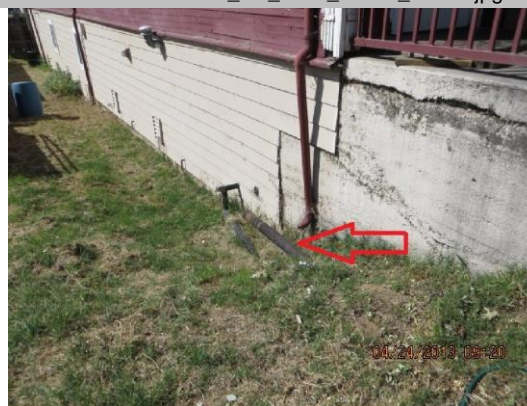
Photo 1 of 2 : UCIP_SP_2017_15966_26949.jpg

Pipe visible next to foundation on LS slope.

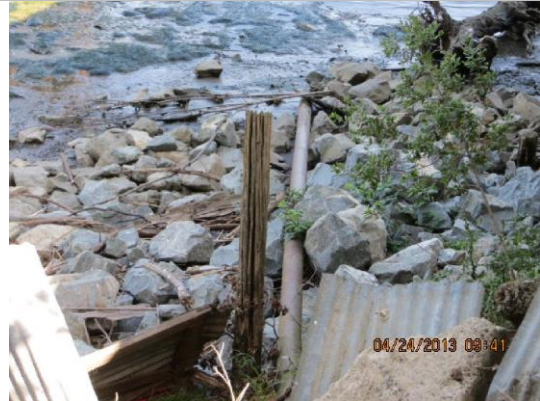
Photo 2 of 2 : UCIP_SP_2017_12745_20682.jpg

Pipe visible on WS toe.

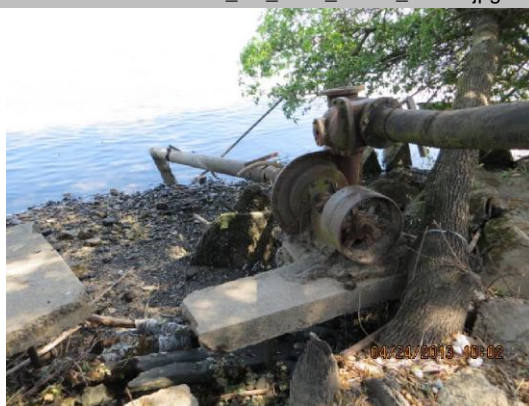
Photo 3 of 3 : UCIP_SP_2017_12746_20684.jpg

Pipe and pump on WS toe.

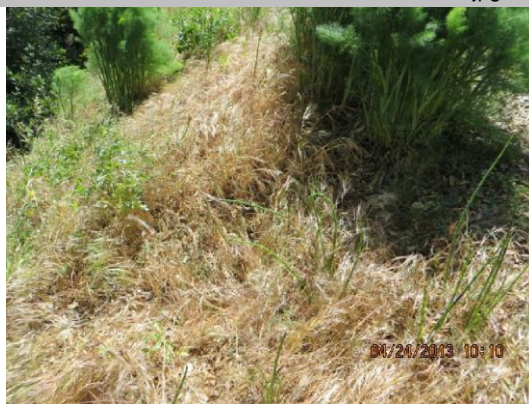
Photo 2 of 3 : UCIP_SP_2017_51317_20688.jpg

Possible sinkhole over pipe on WS shoulder.

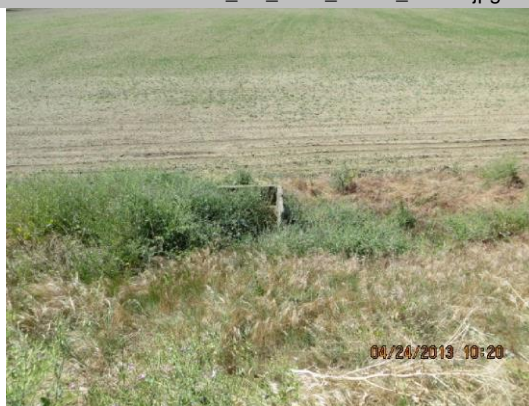
Photo 1 of 2 : UCIP_SP_2017_12748_20692.jpg

Concrete distribution box on LS toe.

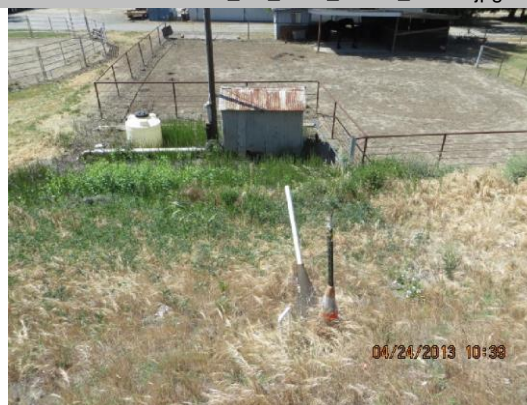
Photo 1 of 3 : UCIP_SP_2017_12752_20699.jpg

Pipe and pumphouse on LS.

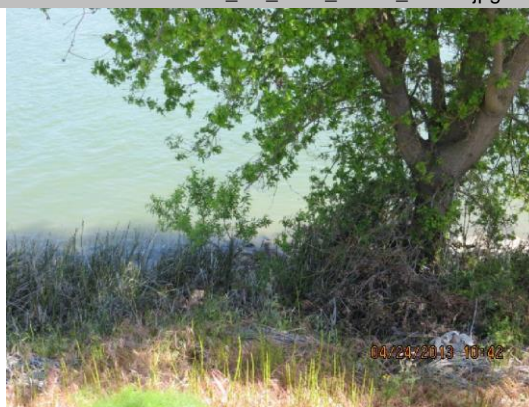
Photo 3 of 3 : UCIP_SP_2017_12752_20697.jpg

Pipe visible in water at left of tree.

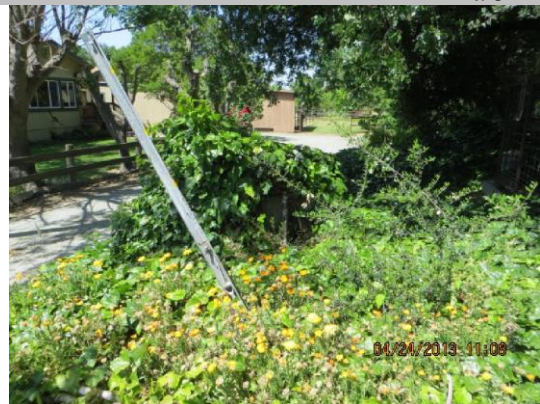
Photo 1 of 3 : UCIP_SP_2017_12768_20731.jpg

Concrete distribution box at LS toe.

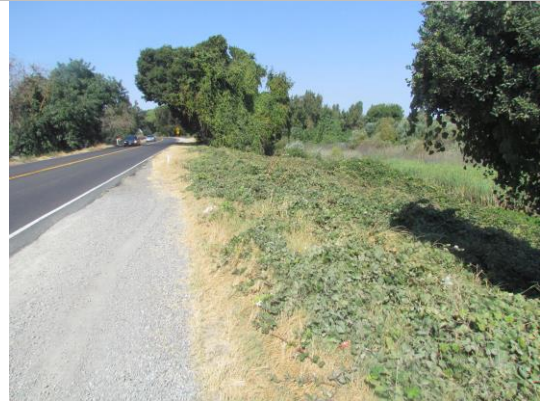
Photo 1 of 1 : SP_2017_NA0002_63_123_20170314_00092.jpg

Looking west at dense vines on waterward slope and toe.

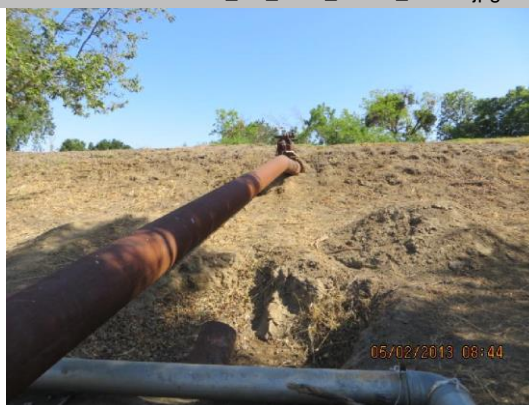
Photo 3 of 3 : UCIP_SP_2017_12773_20738.jpg

Pipe on LS slope with excavation in levee prism.

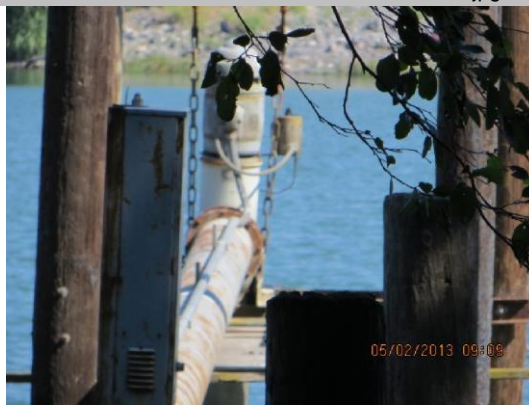
Photo 2 of 3 : UCIP_SP_2017_12776_20753.jpg

Pump on pier at WS toe.

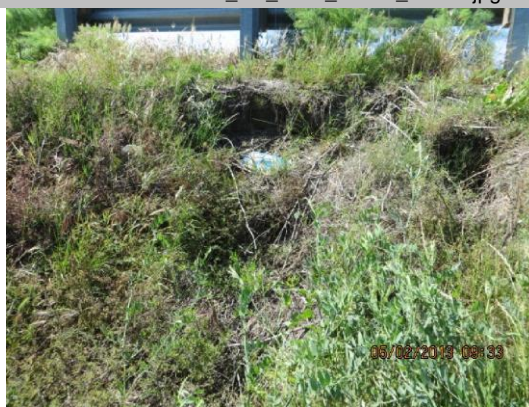
Photo 2 of 3 : UCIP_SP_2017_12778_20761.jpg

Erosion along pipe alignment at WS slope.

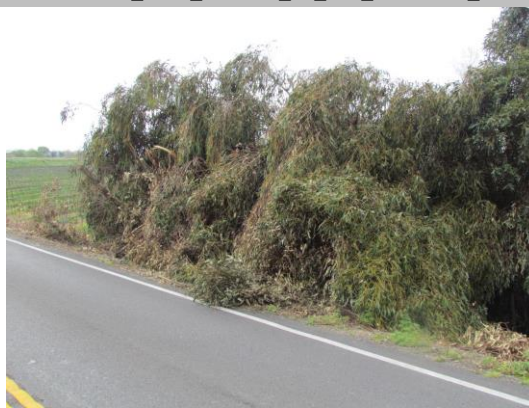
Photo 1 of 1 : SP_2017_NA0002_63_110_20170324_00189.jpg

Looking northeast at fallen tree on landward slope and toe.

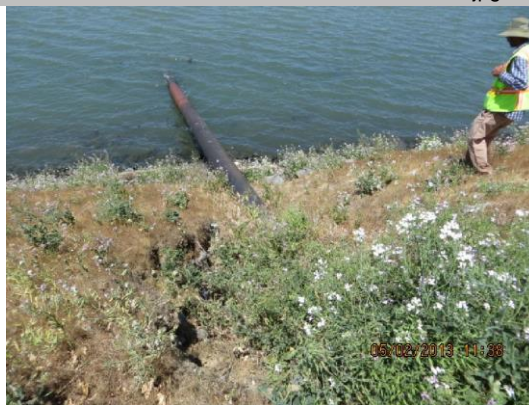
Photo 2 of 3 : UCIP_SP_2017_12814_20820.jpg

Pipe on WS slope.

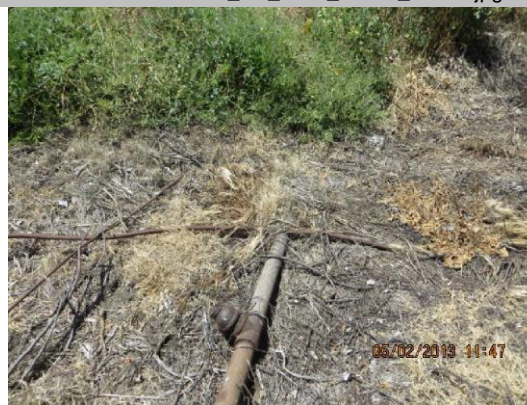
Photo 1 of 2 : UCIP_SP_2017_12817_20825.jpg

3.5-inch galvanized iron pipe on LS slope.

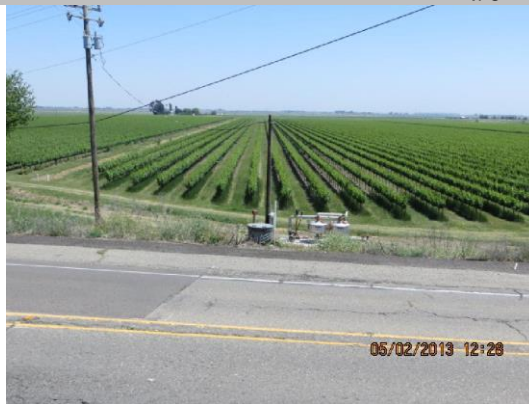
Photo 1 of 3 : UCIP_SP_2017_40795_20835.jpg

siphon breaker in 24-inch CMP riser on LS slope and filters at LS toe.

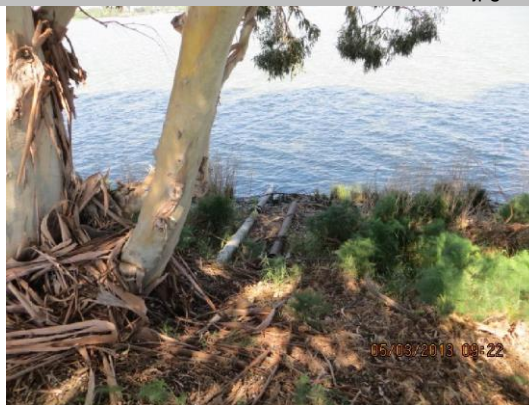
Photo 3 of 3 : UCIP_SP_2017_16143_27240.jpg

Pipe on WS slope.

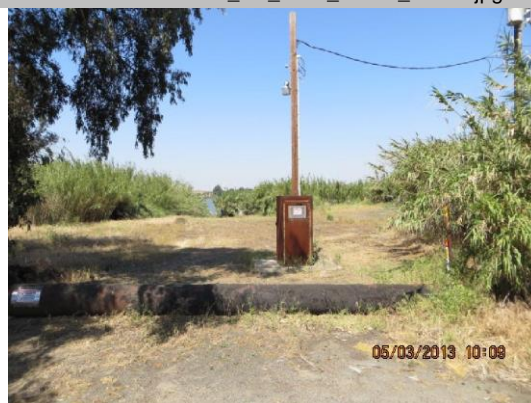
Photo 1 of 2 : UCIP_SP_2017_12886_20946.jpg

Gasline marker and vent to right of JP.

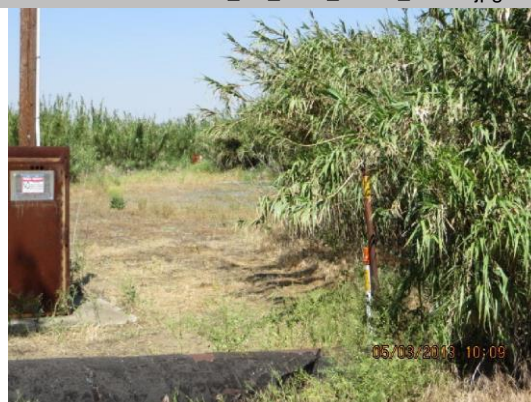
Photo 2 of 2 : UCIP_SP_2017_12886_20945.jpg

Gasline marker and vent to right of JP.

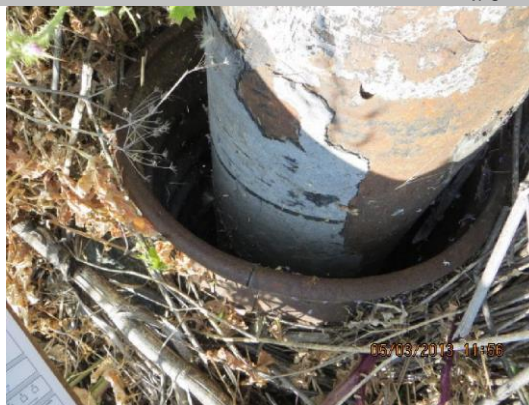
Photo 2 of 3 : UCIP_SP_2017_40528_21001.jpg

18-inch CMP with 12-inch irrigation pipe sleeved through it.

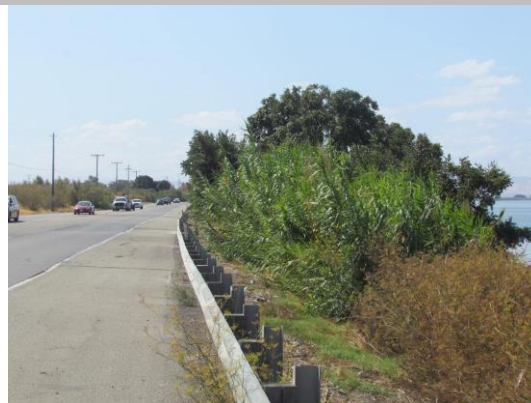
Photo 1 of 2 : SP_2017_NA0002_63_107_20170314_00073.jpg

Looking south at bamboo and other vegetation on waterward slope. (Fall 2016)
