**Flood Control Project Maintenance
Levee Inspections**
LMA District Cover Sheet
Spring 2018 Levee Inspection Results

Brannan Andrus Levee Maintenance District

Spring 2018 Levee Inspection Results

Waterway			Bank	Unit Miles
Unit No. 01 Georgiana Slough			Right	6.01
	Spring (March - May)	Summer (June - August)	(September - November) Fall	Winter (December - February)
Unit Maintenance Rating (Fall Only)				
Date of Inspection	4/5/2018 - 4/5/2018			
DWR Inspector	Keith Millard			
Accompanied By

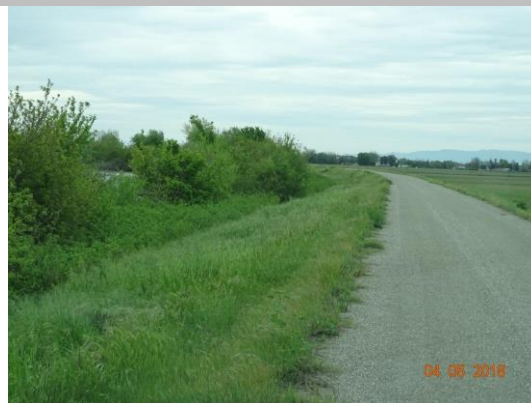
Photo 1 of 1 : SP_2018_NA0002_62_53_20180409_00107.jpg

Waterside vegetation should be reduced to 20' from crown.

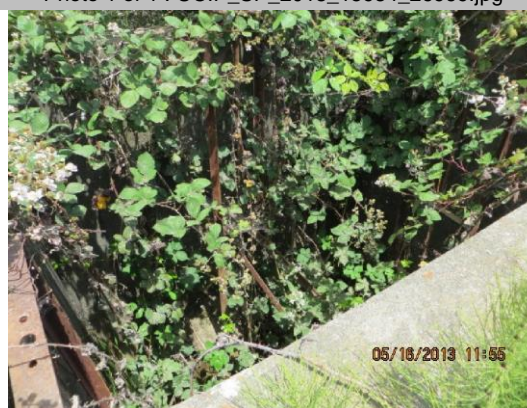
Photo 1 of 1 : UCIP_SP_2018_15984_26969.jpg

Comment Code					
Inspector Comment					
FS_ID:15984 DS_ID:21753 EP_NO: 11232 Repair Type: Non-Urgent Crossing Status: Found UCIP Comments: Unable to locate any appurtances other than distro box. Need to verify proper abandonment. FIELD_STRUCT_DESC: 12-inch steel irrigation pipe through the levee, 3.2 feet below the crown. Siphon breaker on the landside (LS) slope. Concrete distribution box located LS of the toe. 2-inch primer valve. (Automatic Board Order (ABO) issued as Permit No. 11232, 1975 - Mario Campi). [Additional Reference(s): DWR Levee Log, 2005. USACE Sacramento O&M Manual 103, June 1954, (Station ""R"" 279+70) Drawing No. 50-4-2631]. FS Date: 5/16/2013

Concrete distribution box on LS toe.

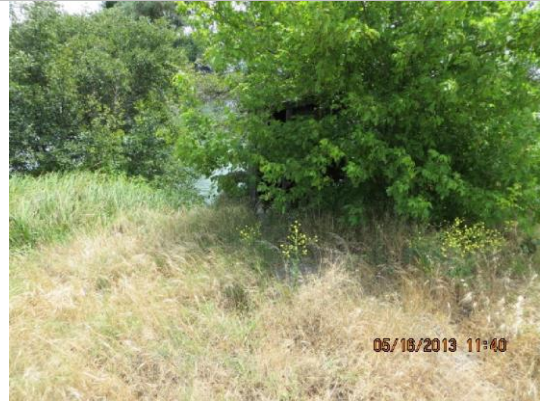
Photo 3 of 3 : UCIP_SP_2018_13558_22167.jpg

Comment Code						
Inspector Comment						
FS_ID:13558						
DS_ID:21754						
EP_NO: 11234						
Repair Type: Non-Urgent						
Crossing Status: Found						
UCIP Comments: Appears abandoned and should be done so properly.						
FIELD_STRUCT_DESC: 1 of 2: 8-inch steel irrigation pipe through the						
levee, 4.3 feet below the crown. Pump in pump house on the waterside						
(WS) berm. 60-inch diameter concrete standpipe on the landside (LS)						
toe. (Automatic Board Order (ABO) issued as Permit No. 11234, 1975 -						
Anthony and John Correia). [Additional Reference(s): USACE						
Sacramento O&M Manual 103, June 1954, (Station ""R"" 255+00)

Pumphouse on WS slope.

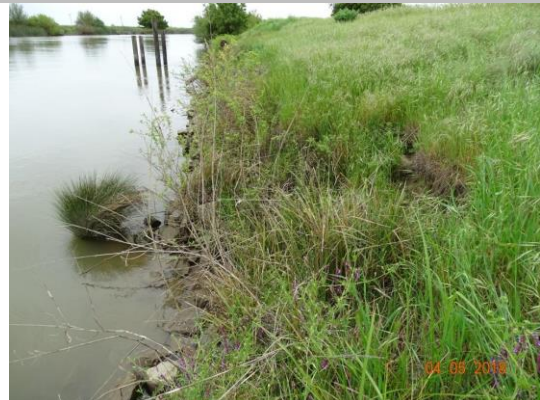
Photo 1 of 2 : SP_2018_NA0002_62_56_20180409_00108.jpg

LM Start	1.52	Rating **	M	Issue No.	56
LM End	1.52	Issue Type +	Ma	Location *	WS
Category	Earthen Levee			GPS Latitude/Longitude	
				Start	End
Item	Erosion / Bank Caving			38.173475 °	38.173475 °
				-121.580767 °	-121.580767 °
DWR ID	DWR_NA0002_01_s_2018_56				
Comment Code					
E2 : Schedule repair of erosion site prior to the next inspection.					
Inspector Comment					
Scallop erosion, 10 ft long. This scallop has received riprap in the past along with adjacent scallops. However this scallop has slumped again since then leaving exposed vertical soil above the slumped riprap. Should be repaired.

Erosion slump in area of previous repair. LM 1.52

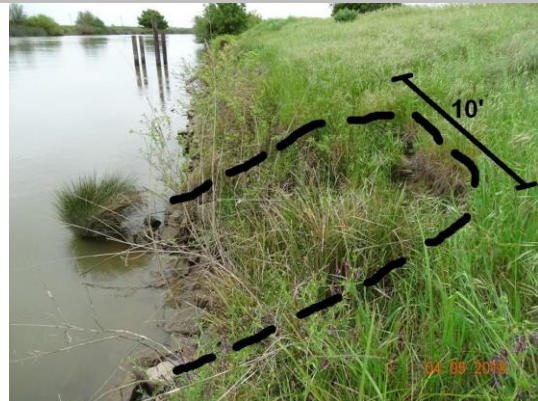
Photo 2 of 2 : SP_2018_NA0002_62_56_20180410_00114.jpg

LM Start	1.52	Rating **	M	Issue No.	56 (cont)	
LM End	1.52	Issue Type +	Ma	Location *	WS	
Category	Earthen Levee			GPS Latitude/Longitude		
				Start	End	
Item	Erosion / Bank Caving			38.173475 °	38.173475 °	
				-121.580767 °	-121.580767 °	
DWR ID	DWR_NA0002_01_s_2018_56					
Comment Code						
E2 : Schedule repair of erosion site prior to the next inspection.						
Inspector Comment						
Scallop erosion, 10 ft long. This scallop has received riprap in the past along with adjacent scallops. However this scallop has slumped again since then leaving exposed vertical soil above the slumped riprap. Should be repaired.

Erosion slump in area of previous repair. LM 1.52

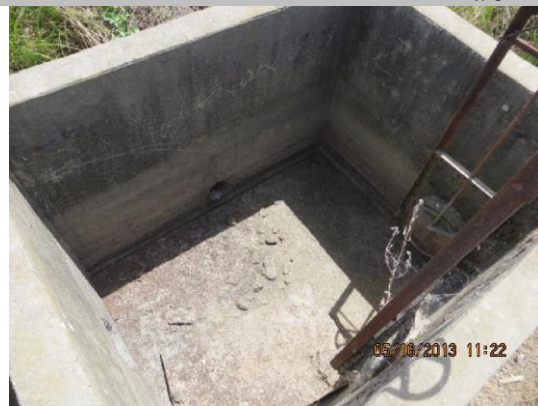
Photo 1 of 3 : UCIP_SP_2018_13554_22164.jpg

Comment Code					
Inspector Comment					
FS_ID:13554 DS_ID:21755 EP_NO: 11252 Repair Type: Non-Urgent Crossing Status: Found UCIP Comments: Pipe heavily rusted at distribution box. Good candidate for video inspection. FIELD_STRUCT_DESC: 1 of 3: 8-inch steel irrigation pipe through the levee, 4.6 feet below the crown. Pump and valve on the waterside (WS) slope. Siphon breaker in 24-inch corrugated metal riser unit on the landside (LS) shoulder. 7-foot by 10-foot concrete distribution box on the LS toe. (Automatic Board Order (ABO) issued as Permit No. 11252, 1975 - Hubert and Palmyra Vandermaele). [Additional Reference(s): DWR Levee Log, 2005. USACE Sacramento O&M Manual 103, June 1954, (Station ""R"" 237+13) Drawing No. 50-4-2631]. FS Date: 5/16/2013

7X10-foot concrete distribution box on LS toe.

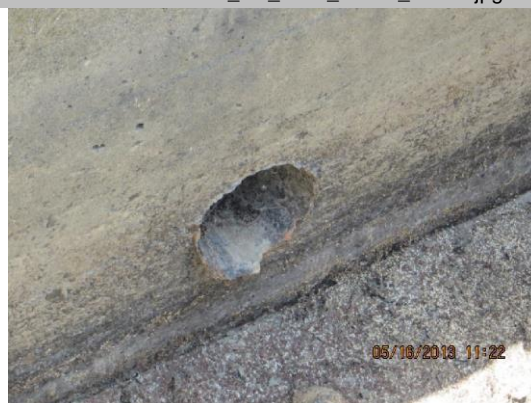
Photo 2 of 3 : UCIP_SP_2018_13554_22163.jpg

Comment Code					
Inspector Comment					
FS_ID:13554 DS_ID:21755 EP_NO: 11252 Repair Type: Non-Urgent Crossing Status: Found UCIP Comments: Pipe heavily rusted at distribution box. Good candidate for video inspection. FIELD_STRUCT_DESC: 1 of 3: 8-inch steel irrigation pipe through the levee, 4.6 feet below the crown. Pump and valve on the waterside (WS) slope. Siphon breaker in 24-inch corrugated metal riser unit on the landside (LS) shoulder. 7-foot by 10-foot concrete distribution box on the LS toe. (Automatic Board Order (ABO) issued as Permit No. 11252, 1975 - Hubert and Palmyra Vandermaele). [Additional Reference(s): DWR Levee Log, 2005. USACE Sacramento O&M Manual 103, June 1954, (Station ""R"" 237+13) Drawing No. 50-4-2631]. FS Date: 5/16/2013

Pipe shows excessive rust at inlet to distribution box on LS toe.

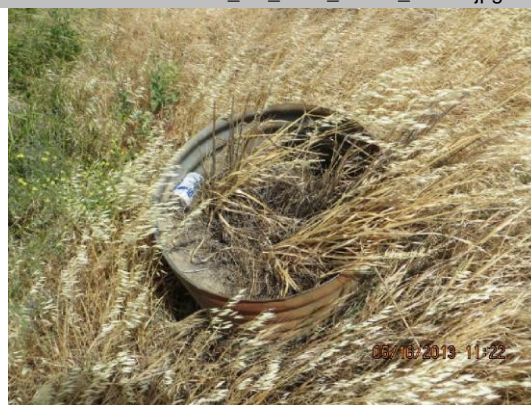
Photo 3 of 3 : UCIP_SP_2018_13554_22162.jpg

CMP riser on LS slope.

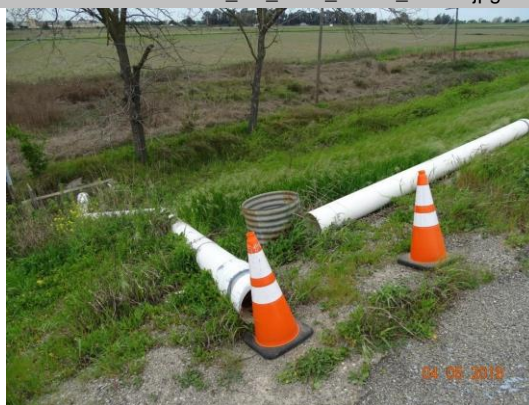
Photo 2 of 2 : UCIP_SP_2018_52615_77545.jpg

FS_ID:52615
DS_ID:21758
EP_NO: 11252
Repair Type: Non-Urgent
Crossing Status: Found
UCIP Comments: 04/06/2017 Landowner has installed a temporary pipe and removed old pipe. Photos and update courtesy of DWR Inspector, Richard Willoughby.05/16/2013 Pipe rusted through at inlet to box. Good candidate for video inspection. (G. Wylie - DWR)
FIELD_STRUCT_DESC: *REMOVED* 3 of 3: 12-inch steel pipe through the levee 4.0 feet below the crown. Slant pump on bank. Switch box on berm, conduit through levee. Siphon breaker in 24-inch CMP riser on landward slope. Power pole and electrical panel at landward toe (ABO No. 11252, 1975). 7'X10' concrete distribution box on LS toe. As per Richard Willoughby, FPIIB Inspector, landowner has installed a temporary 12-inch PVC pipe on the WS and removed this pipe. New pipe forthcoming. Originally included in the 1954 O&M manual.
FS Date: 4/6/2017

A view of disconnected temporary pipe on landside. Photo courtesy of DWR inspector Keith E Millard.

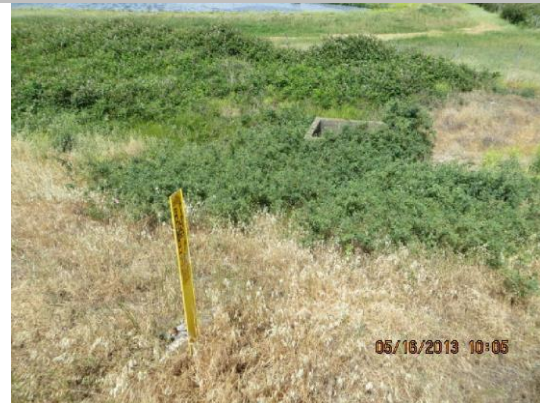
Photo 1 of 3 : UCIP_SP_2018_51299_22124.jpg

Comment Code						
Inspector Comment						
FS_ID:51299 DS_ID:21765 EP_NO: 11238 Repair Type: Urgent Crossing Status: Found UCIP Comments: 10/24/2016 Unable to access WS due to heavy vegetation--assume WS remains the same or erosion has progressed but not visible from levee crown. Pipe marker found on LS slope next to 12-inch irrigation pipe indicating high pressure unodorized natural gas pipeline however, unable to confirm if line is present or if it is parallel to levee or if it goes through levee. (O. Magana - DWR UCIP)05/16/2013 Erosion along pipe at WS toe goes into levee prism. Animal activity appears to be the cause of some pretty heavy erosion damage. Some settlement along the pipe alignment on crown may indicate other problems with this pipe. (W. Wylie - DWR UCIP) FIELD_STRUCT_DESC: 1 of 5: 12-inch irrigation steel pipe through levee 4 feet below crown. Siphon breaker is located on landside (LS) shoulder. A 7-foot by 9-foot concrete distribution box is located on LS toe. (12-inch pipe authorized under Permit No. 18549, 2009 - Stockton JACS LLC; previous 12-inch pipe was replaced and authorized under Automatic Board Order (ABO) issued as Permit No. 11238, 1975 - Gardiner Improvement Company). [Additional Reference(s): DWR Levee Log, 2005. USACE Sacramento O&M Manual Unit 103, June 1954, (Station "R" 182+63), Drawing No. 50-4-2631, 50-4-2634]. FS Date: 10/24/2016

Pipe visible on LS shoulder with concrete distribution box on LS toe.
Gasline marker placed at pipe.

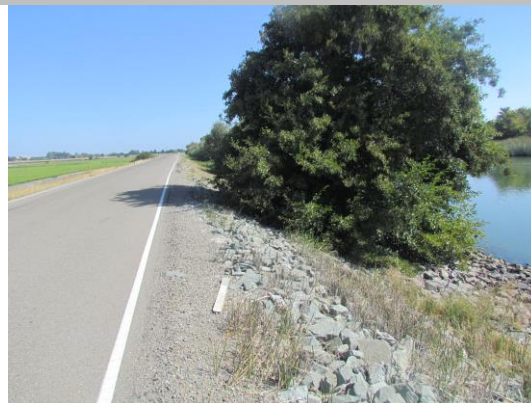
Photo 1 of 1 : SP_2018_NA0002_62_57_20180305_00041.jpg

Looking west at untrimmed tree on waterward slope.

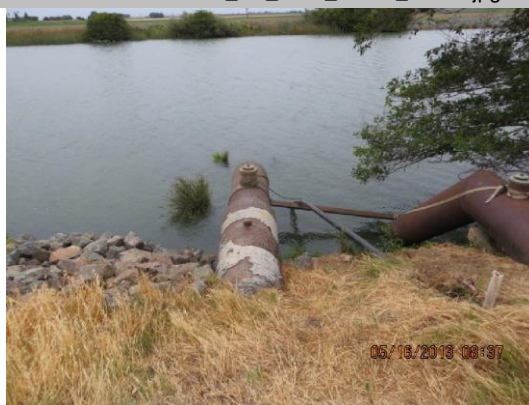
Photo 1 of 3 : UCIP_SP_2018_51302_22082.jpg

24-inch pipe and siphon breaker visible on WS slope.

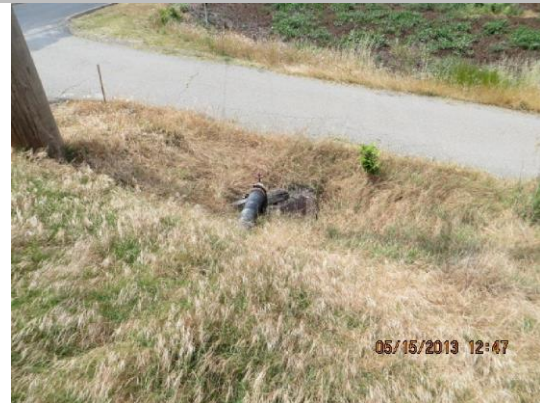
Photo 1 of 3 : UCIP_SP_2018_51345_22042.jpg

Pipe and concrete sump on LS.

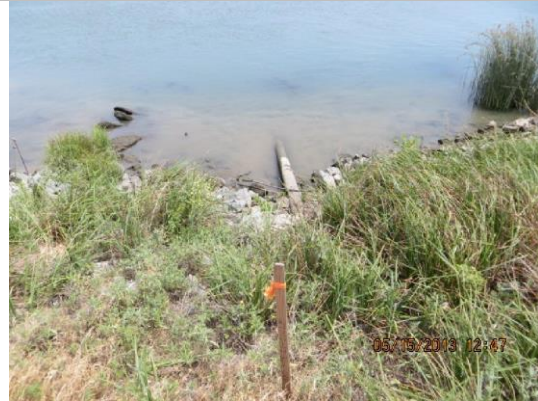
Photo 2 of 3 : UCIP_SP_2018_51345_22041.jpg

Pipe visible at waters edge on WS toe.

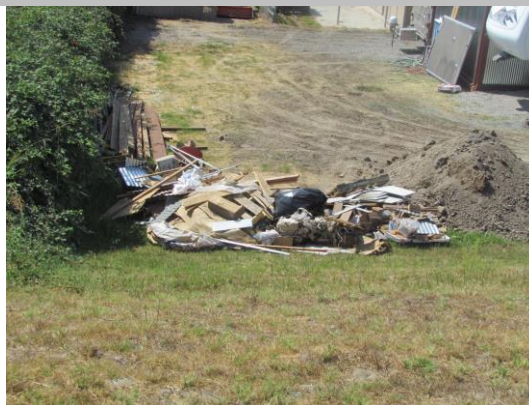
Photo 2 of 2 : SP_2018_NA0002_62_68_20180305_00053.jpg

Looking southwest at trash stockpile at landward toe. (Fall 2016)

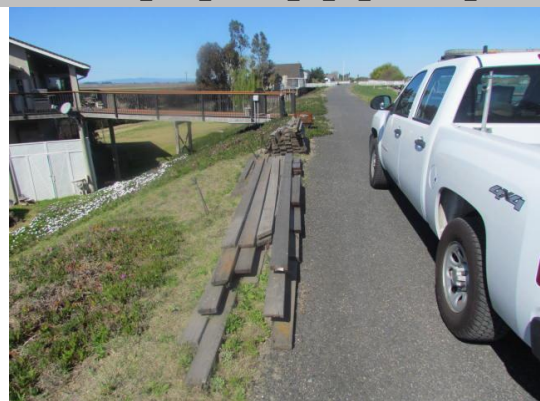
Photo 1 of 1 : SP_2018_NA0002_62_24_20180305_00020.jpg

Looking northwest at wooden boards on landside shoulder.

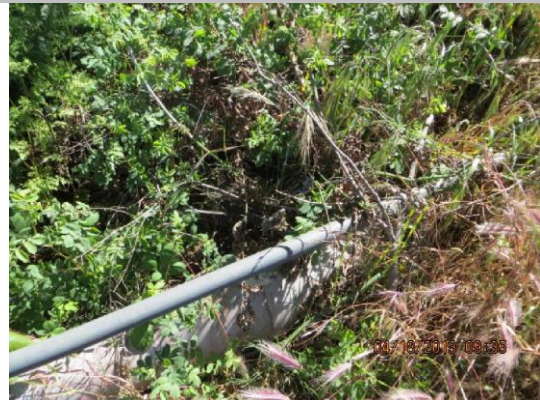
Photo 2 of 3 : UCIP_SP_2018_12164_19725.jpg

1.5-inch galvanized iron electrical conduit at same location as 12-inch pipe on WS slope.

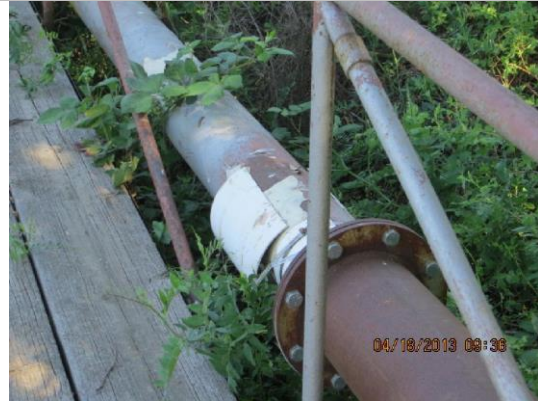
Photo 3 of 3 : UCIP_SP_2018_12164_19724.jpg

Multiple patches on Pipe along WS berm.

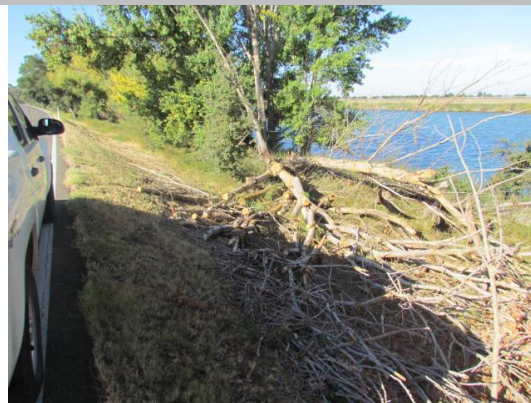
Photo 1 of 2 : SP_2018_NA0002_63_91_20180305_00060.jpg

Looking south west at fallen tree on waterward slope and berm.

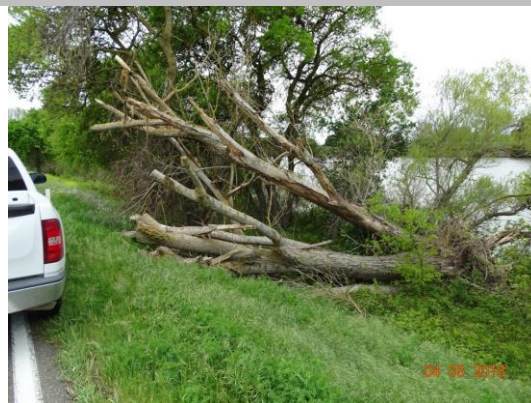
Photo 1 of 1 : SP_2018_NA0002_63_81_20180409_00211.jpg

Fallen tree on waterside should be removed.

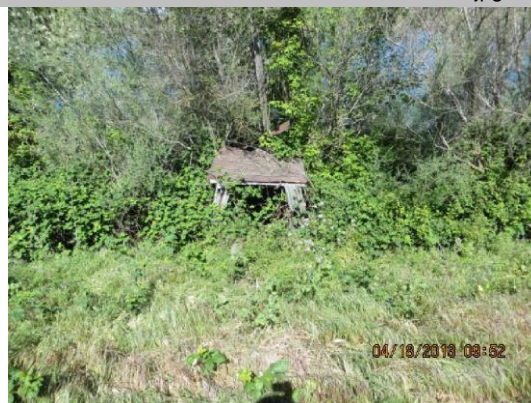
Photo 2 of 3 : UCIP_SP_2018_12165_19730.jpg

Pipe and pumphouse on WS berm.

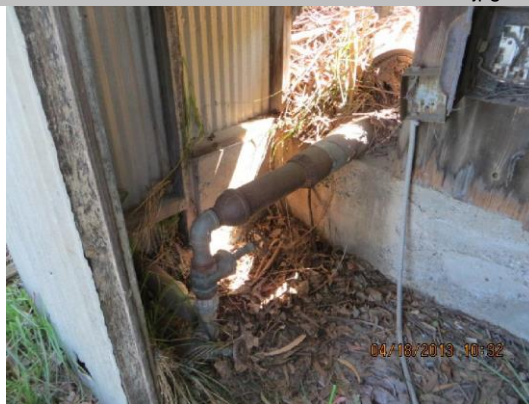
Photo 2 of 3 : UCIP_SP_2018_12185_19750.jpg

Pipe and shutoff valve at pumphouse on WS slope.

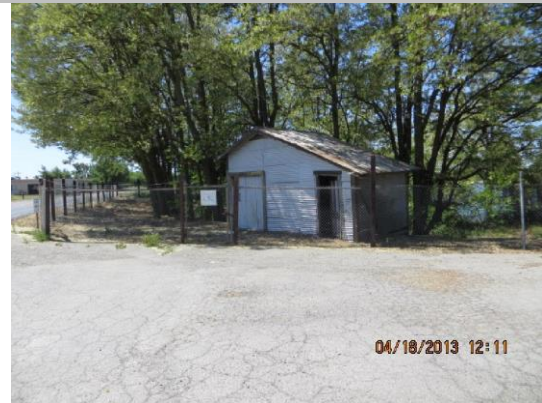
Photo 1 of 3 : UCIP_SP_2018_12211_19770.jpg

Possible pumphouse on WS shoulder.

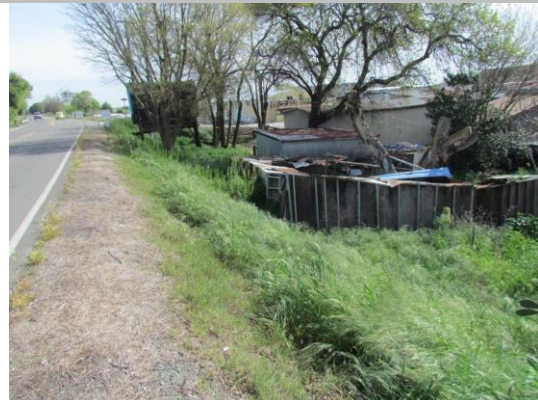
Photo 1 of 2 : SP_2018_NA0002_63_30_20180305_00038.jpg

Looking north at several encroachment along landside slope and toe.

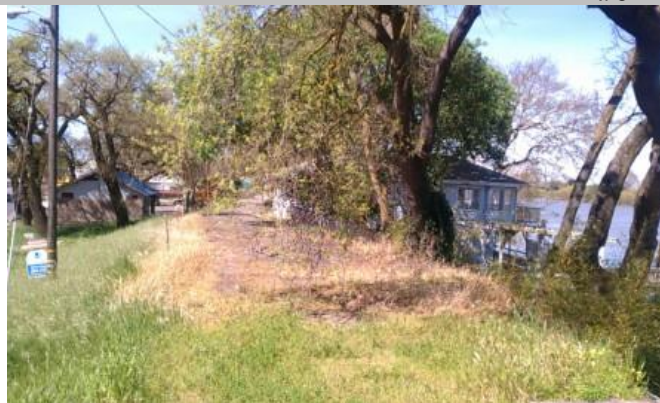
Photo 2 of 2 : SP_2018_NA0002_63_5_20180305_00005.jpg

Looking west at overhanging tree on waterside shoulder.

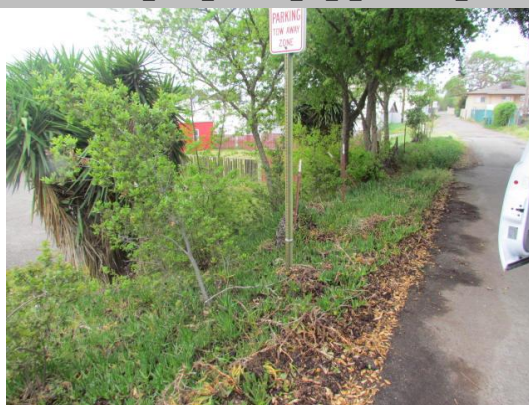
Photo 3 of 3 : SP_2018_NA0002_63_7_20180305_00008.jpg

Looking south at overgrown landscaping on landward slope. (Fall 2015)

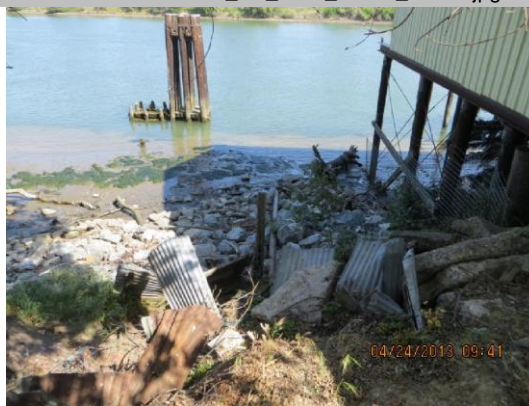
Photo 1 of 2 : UCIP_SP_2018_12745_20683.jpg

Pipe and wrecked pumphouse on WS toe.

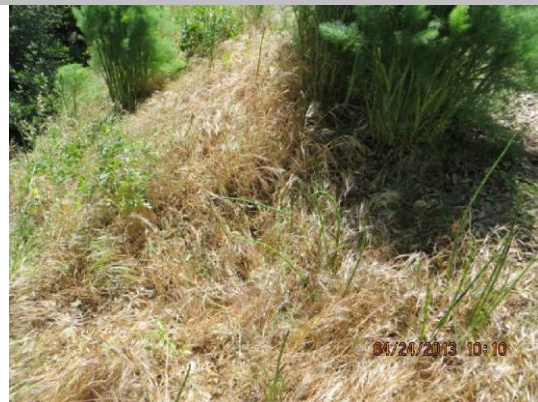
Photo 2 of 3 : UCIP_SP_2018_51317_20688.jpg

Possible sinkhole over pipe on WS shoulder.

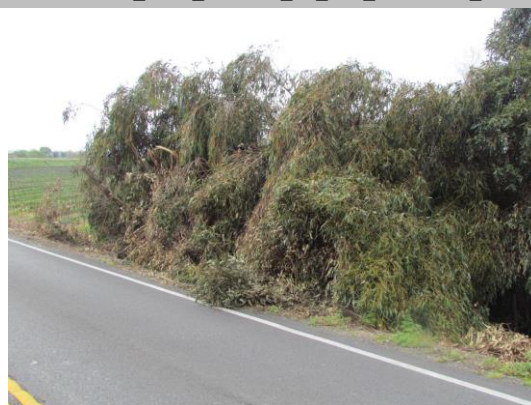
Photo 1 of 1 : SP_2018_NA0002_63_110_20180305_00087.jpg

Looking northeast at fallen tree on landward slope and toe.

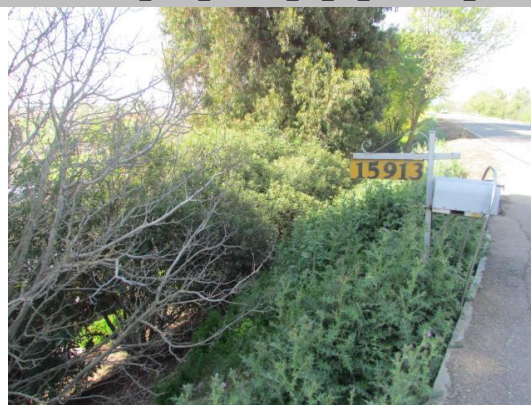
Photo 1 of 2 : SP_2018_NA0002_63_50_20180305_00051.jpg

Looking southwest at dense landscaping on landward slope.

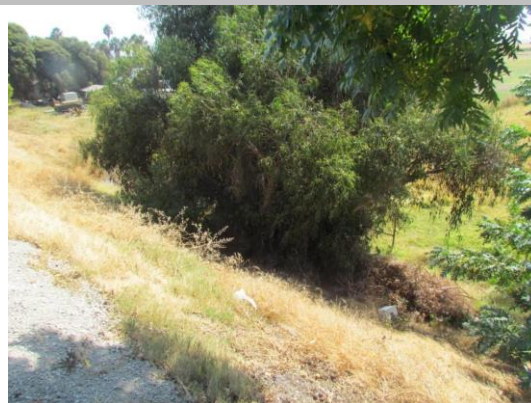
Photo 2 of 2 : SP_2018_NA0002_63_14_20180305_00021.jpg

Looking east at untrimmed tree on landward slope.

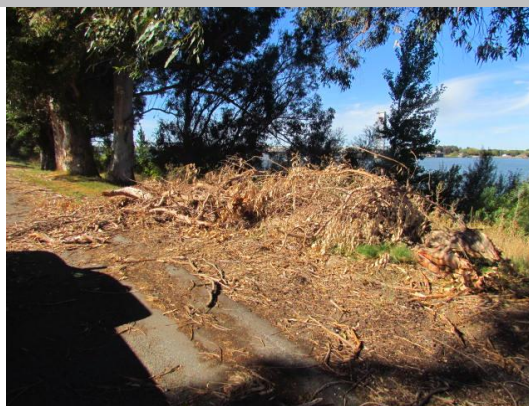
Photo 1 of 1 : SP_2018_NA0002_63_105_20180305_00077.jpg

Looking southwest at tree limbs on waterward shoulder.

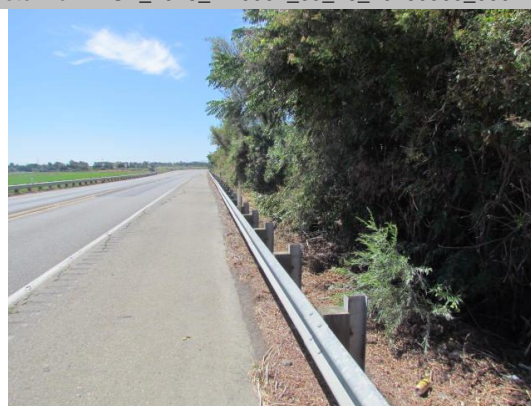
Photo 1 of 2 : SP_2018_NA0002_63_16_20180305_00022.jpg

Looking south at dense vegetation (trees) on waterward slope.

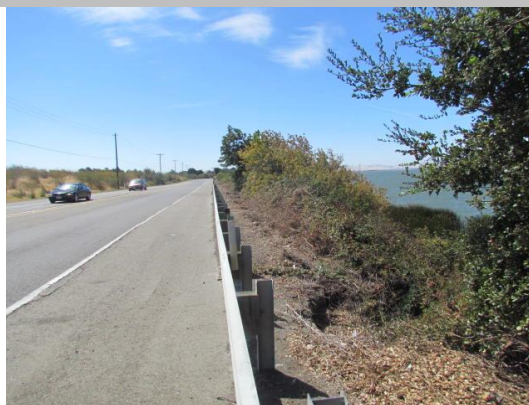
Photo 2 of 2 : SP_2018_NA0002_63_107_20180305_00083.jpg

Looking south at dense vegetation on waterward slope. (Fall 2015)
