**Flood Control Project Maintenance
Levee Inspections**
LMA District Cover Sheet
Spring 2019 Levee Inspection Results

Brannan Andrus Levee Maintenance District

Spring 2019 Levee Inspection Results

Waterway			Bank	Unit Miles
Unit No. 01 Georgiana Slough			Right	6.01
	Spring (March - May)	Summer (June - August)	(September - November) Fall	Winter (December - February)
Unit Maintenance Rating (Fall Only)				
Date of Inspection	4/23/2019 - 4/23/2019			
DWR Inspector	David Julian			
Accompanied By

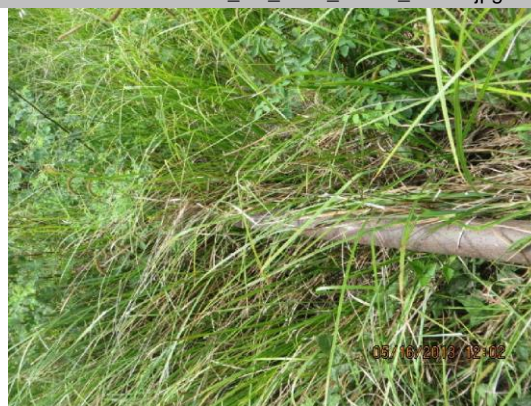
Photo 1 of 3 : UCIP_SP_2019_13560_22173.jpg

LM Start	0.61	Rating **	M	Issue No.	91
LM End	0.61	Issue Type +	En	Location *	
Category	Supplemental			GPS Latitude/Longitude	
				Start	End
Item	DWR UCIP Field Study			38.182213 °	38.182213 °
				-121.572357 °	-121.572357 °
DWR ID	21752				
Comment Code					
Inspector Comment					
FS_ID:13560					
DS_ID:21752					
EP_NO: 2015					
Repair Type: Non-Urgent					
Crossing Status: Found					
UCIP Comments: This pipe appears abandoned and should be removed.					
FIELD_STRUCT_DESC: 2-inch galvanized iron wastewater pipe through the levee, 2 feet below the crown. Gas well drain. (Permit No. 2015, 1954 - Brazos Oil and Gas Company). [Additional Reference(s): DWR Levee Log, 2005].					
FS Date: 5/16/2013

Pipe in grass on WS slope.

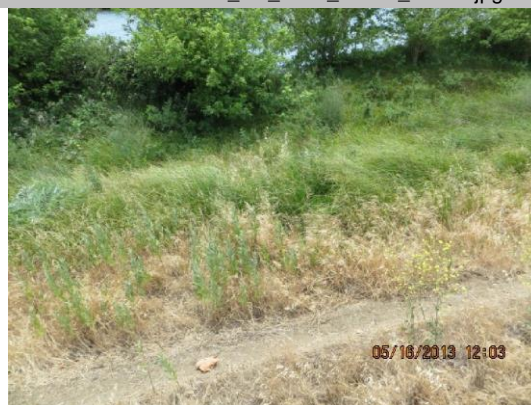
Photo 2 of 3 : UCIP_SP_2019_13560_22172.jpg

Pipe in grass on WS slope.

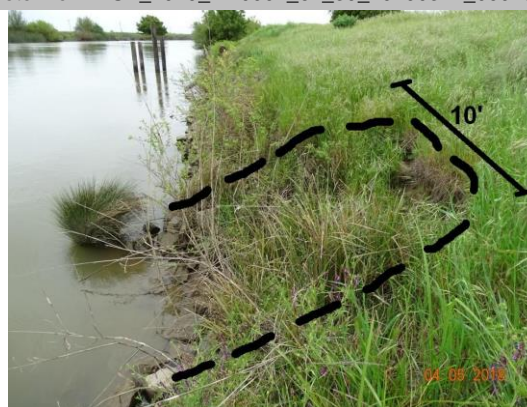
Photo 1 of 1 : SP_2019_NA0002_62_39_20190311_00023.jpg

LM Start	1.53	Rating **	M	Issue No.	39
LM End	1.54	Issue Type +	Ma	Location *	WS
Category	Supplemental			GPS Latitude/Longitude	
				Start	End
Item	2017 USACE Erosion Survey, DRAFT			38.173410 °	38.173178 °
				-121.580683 °	-121.580622 °
DWR ID	DWR_NA0002_01_f_2018_39				
Comment Code					
Inspector Comment					
2017 Site ID: GEO 5.5 R					
Status: Eroding New					
2017 Field Notes: Failed rock section, slump failure of bank to subvertical face.					
Site History:

Erosion slump in area of previous repair. LM 1.52

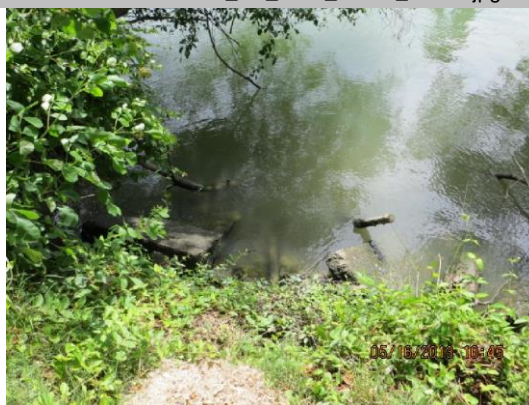
Photo 1 of 2 : UCIP_SP_2019_16123_27221.jpg

LM Start	2.34	Rating **	M	Issue No.	96
LM End	2.34	Issue Type +	En	Location *	
Category	Supplemental			GPS Latitude/Longitude	
				Start	End
Item	DWR UCIP Field Study			38.162332 °	38.162332 °
				-121.585032 °	-121.585032 °
DWR ID	21819				
Comment Code					
Inspector Comment					
FS_ID:16123 DS_ID:21819 EP_NO: N/A Repair Type: Non-Urgent Crossing Status: Found UCIP Comments: Pipe appears abandoned and should be done so properly. FIELD_STRUCT_DESC: 2-inch steel irrigation pipe through the levee, 3 feet below the crown. [Additional Reference(s): USACE Sacramento O&M Manual 103, June 1954, (Station ""R"" 196+99) Drawing No. 50-4-2631]. FS Date: 5/16/2013

Pipe visible in water at WS toe.

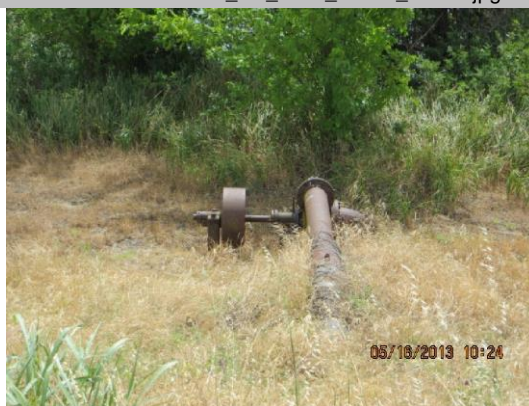
Photo 1 of 3 : UCIP_SP_2019_13545_22145.jpg

LM Start	2.50	Rating **	M	Issue No.	97
LM End	2.50	Issue Type +	En	Location *	
Category	Supplemental			GPS Latitude/Longitude	
				Start	End
Item	DWR UCIP Field Study			38.160147 °	38.160147 °
				-121.586088 °	-121.586088 °
DWR ID	21762				
Comment Code					
Inspector Comment					
FS_ID:13545 DS_ID:21762 EP_NO: N/A Repair Type: Non-Urgent Crossing Status: Found UCIP Comments: Pipe appears abandoned and should be done so properly. standpipe on LS is covered in brush. FIELD_STRUCT_DESC: 8-inch steel irrigation pipe through the levee, 3.4 feet below the crown. 6-inch pump on the waterside (WS). 36-inch concrete standpipe on the landside (LS) toe. [Additional Reference(s): DWR Levee Log, 2005. USACE Sacramento O&M Manual 103, June 1954, (Station ""R"" 188+39) Drawing No. 50-4-2631]. FS Date: 5/16/2013

Pipe and pump on WS slope.

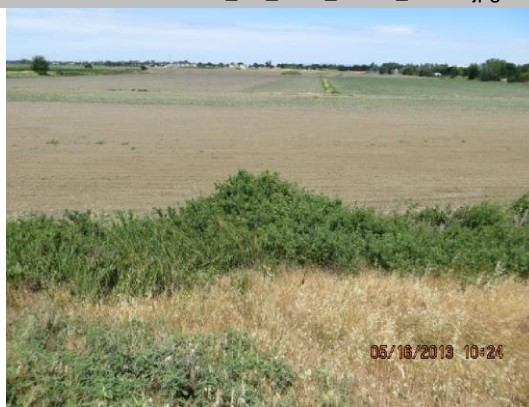
Photo 2 of 3 : UCIP_SP_2019_13545_22144.jpg

Standpipe covered in brush on LS toe.

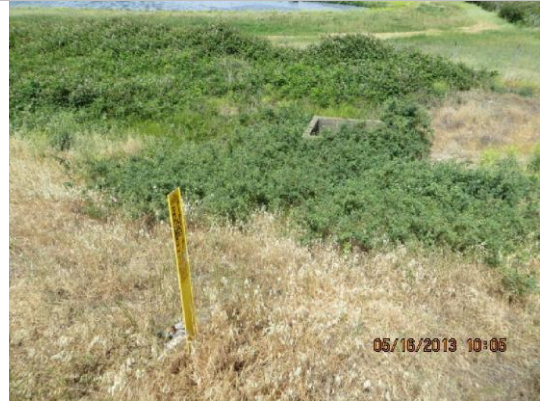
Photo 1 of 3 : UCIP_SP_2019_53386_22124.jpg

Pipe visible on LS shoulder with concrete distribution box on LS toe.
 Gasline marker placed at pipe.

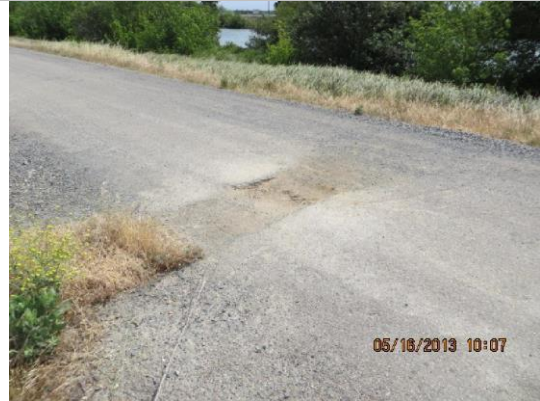
Photo 3 of 3 : UCIP_SP_2019_53386_22122.jpg

Subsidence along pipe alignment at crown.

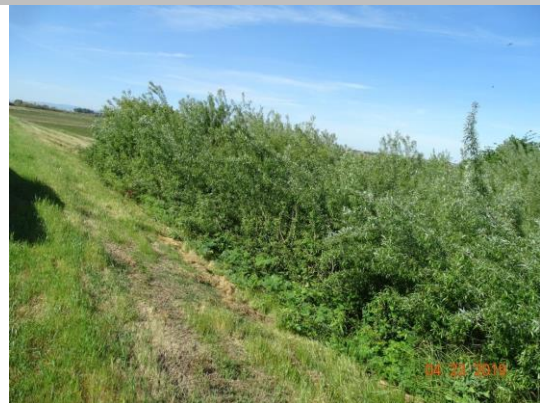
Photo 1 of 1 : SP_2019_NA0002_62_53_20190423_00100.jpg

View looking downstream at willows on the landside slope (Spring 2019).

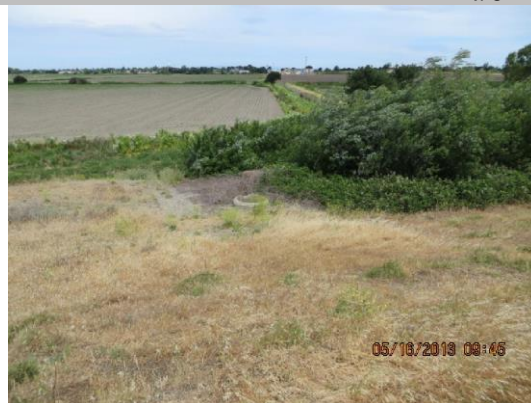
Photo 1 of 2 : UCIP_SP_2019_41561_27229.jpg

5-foot diameter concrete riser on LS toe, but no pipe visible.

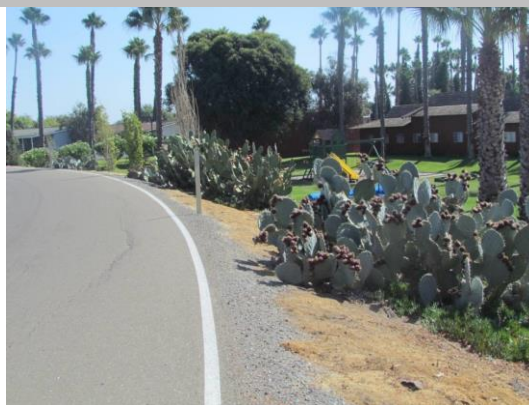
Photo 2 of 2 : SP_2019_NA0002_62_5_20190311_00006.jpg

Looking east at cactus on waterward slope near Oxbow Harbor. (Fall 2016)

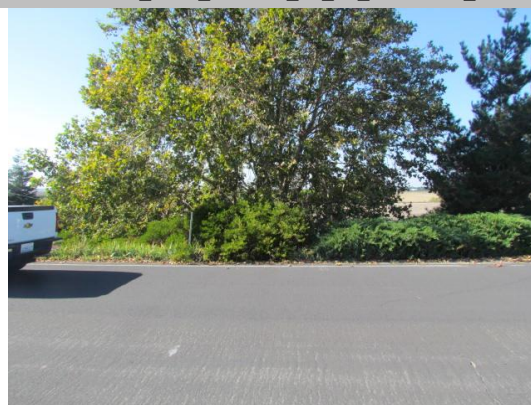
Photo 3 of 3 : SP_2019_NA0002_62_11_20190311_00009.jpg

Looking west at dense landscaping on landside slope.

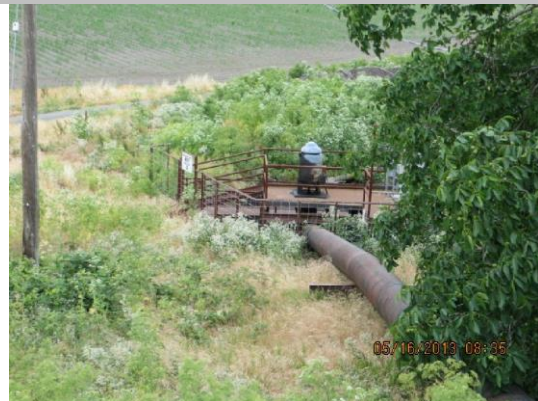
Photo 2 of 3 : UCIP_SP_2019_52693_22077.jpg

Pipe and pumping plant on LS slope.

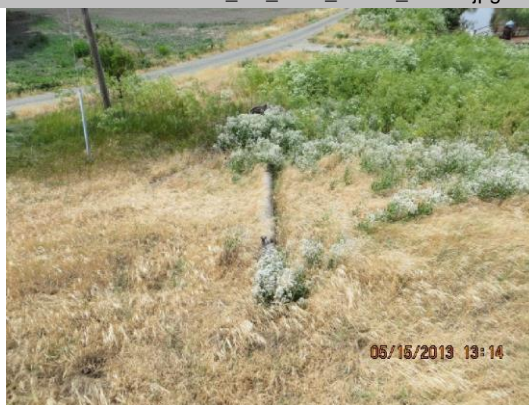
Photo 2 of 3 : UCIP_SP_2019_51308_22049.jpg

10-inch pipe visible on LS slope

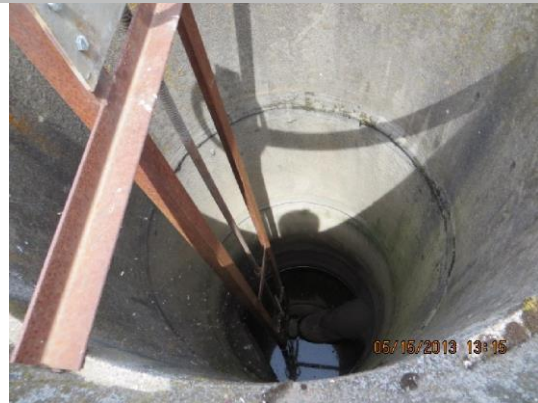
Photo 3 of 3 : UCIP_SP_2019_51308_22048.jpg

Concrete standpipe with slide gate at LS toe.

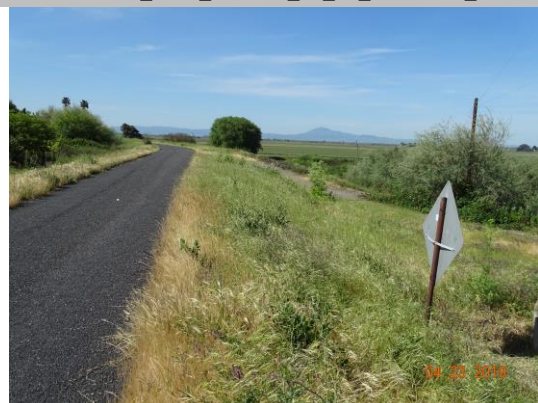
Photo 1 of 1 : SP_2019_NA0002_62_43_20190523_00112.jpg

LM Start	4.03	Rating **	U	Issue No.	43
LM End	4.29	Issue Type +	Ma	Location *	LS
Category	Earthen Levee			GPS Latitude/Longitude	
				Start	End
Item	Vegetation			38.147108 °	38.143694 °
				-121.600942 °	-121.600876 °
DWR ID	DWR_NA0002_01_s_2019_43				
Comment Code					
V1 : Control annual grass and weeds on the levee slopes and easements.					
Inspector Comment

View looking downstream at annual vegetation on the landside slope (Spring 2019).

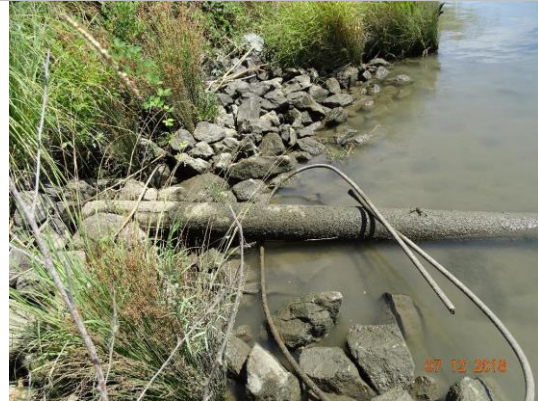
Photo 2 of 3 : UCIP_SP_2019_52692_77569.jpg

Pipe visible at waters edge on WS toe.

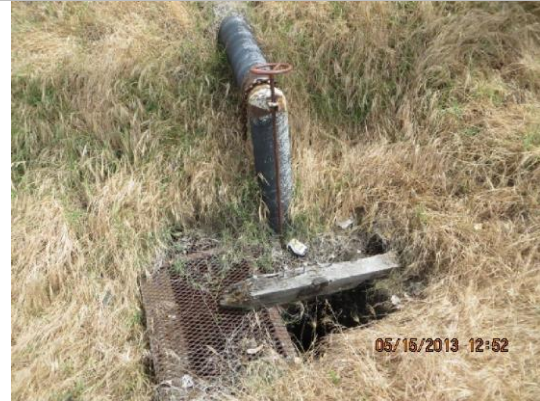
Photo 3 of 3 : UCIP_SP_2019_52692_22043.jpg

Pipe at entrance to concrete sump on LS.

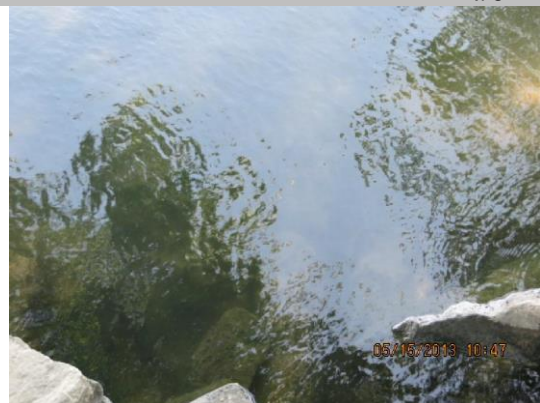
Photo 1 of 2 : UCIP_SP_2019_13442_21942.jpg

Pipe visible just under the water surface

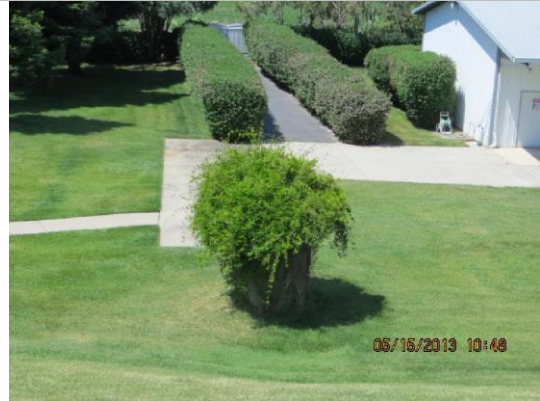
Photo 2 of 2 : UCIP_SP_2019_13442_21941.jpg

42-inch concrete riser on LS toe.

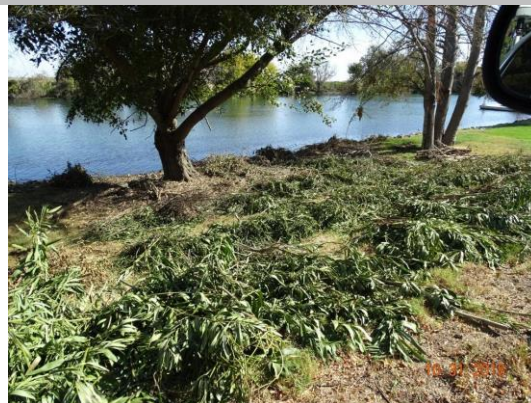
Photo 1 of 1 : SP_2019_NA0002_62_80_20190311_00048.jpg

View of prunings on the water side slope (October 2018).

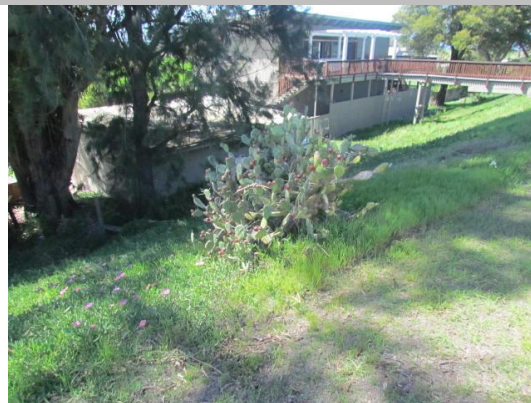
Photo 1 of 1 : SP_2019_NA0002_62_65_20190311_00040.jpg

Looking at cactus on landward slope.

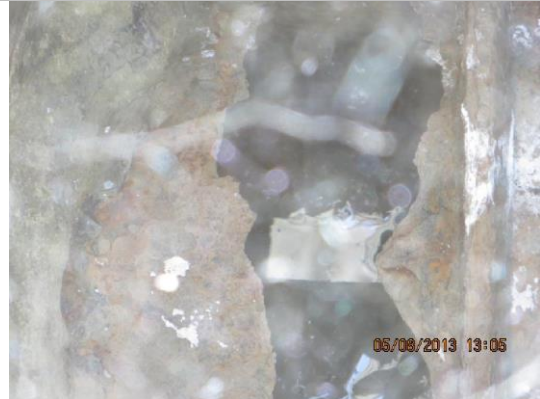
Photo 3 of 3 : UCIP_SP_2019_13090_21280.jpg

Pipe rusted through at slide gate inside concrete riser.

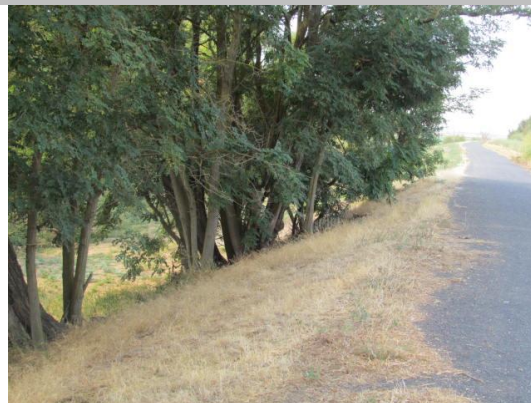
Photo 1 of 1 : SP_2019_NA0002_62_17_20190311_00010.jpg

Looking at dense trees on landward slope and toe.

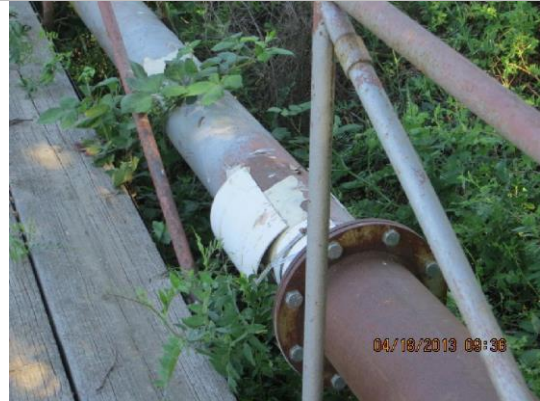
Photo 3 of 3 : UCIP_SP_2019_12164_19724.jpg

Multiple patches on Pipe along WS berm.

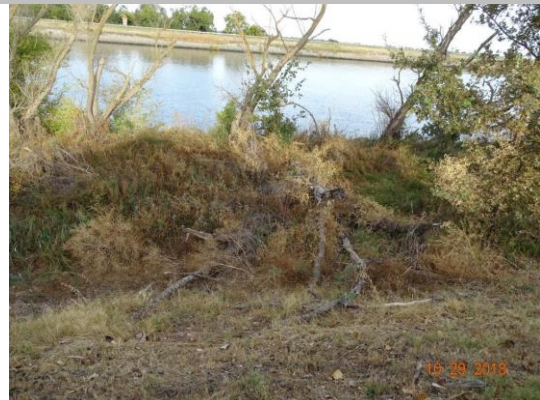
Photo 1 of 1 : SP_2019_NA0002_63_133_20190311_00078.jpg

View of down tree limbs on the waterside slope (October 2018).

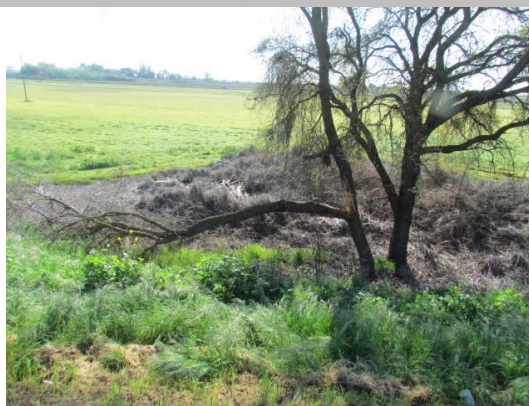
Photo 1 of 1 : SP_2019_NA0002_63_96_20190311_00055.jpg

Looking east at broken tree limb at landward toe.

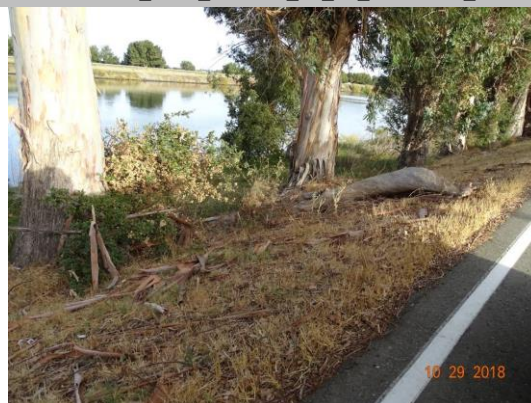
Photo 1 of 1 : SP_2019_NA0002_63_79_20190311_00040.jpg

View looking upstream at large tree limb on the waterside slope (October 2018).

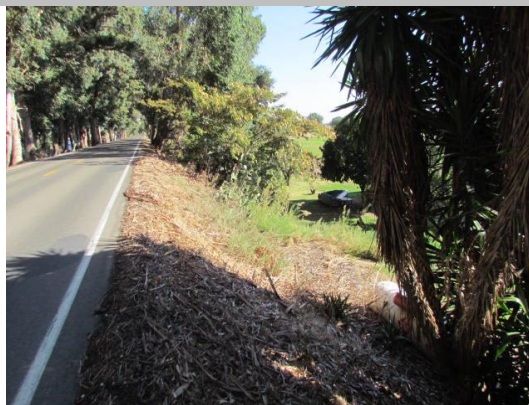
Photo 3 of 3 : SP_2019_NA0002_63_45_20190311_00026.jpg

Looking northeast at dense vegetation on landward slope and toe.

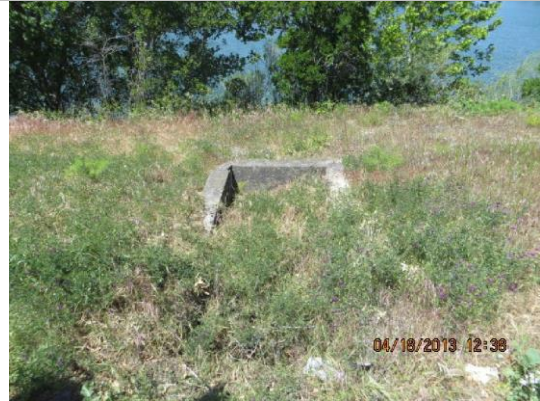
Photo 3 of 3 : UCIP_SP_2019_53513_19774.jpg

10'X5' concrete box on WS slope, filled with soil.

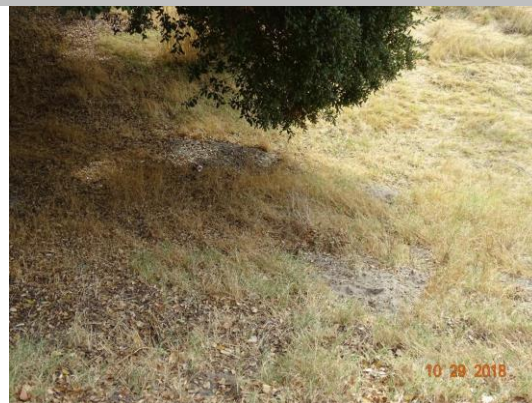
Photo 2 of 2 : SP_2019_NA0002_63_172_20190311_00104.jpg

View looking down the landside slope at several animal holes (October 2018).

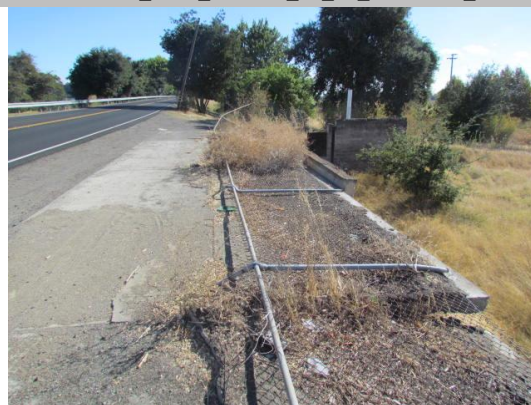
Photo 1 of 1 : SP_2019_NA0002_63_94_20190311_00054.jpg

Looking northeast at downed fence on landward shoulder.

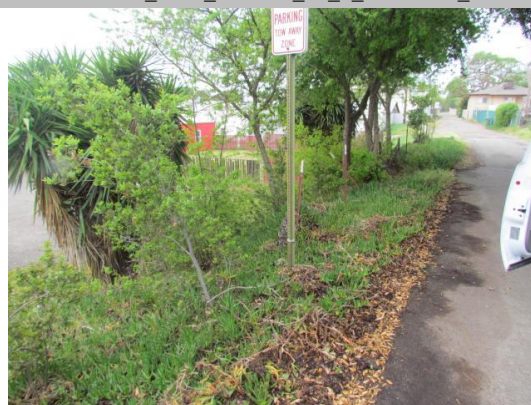
Photo 3 of 3 : SP_2019_NA0002_63_7_20190311_00003.jpg

Looking south at overgrown landscaping on landward slope. (Fall 2015)

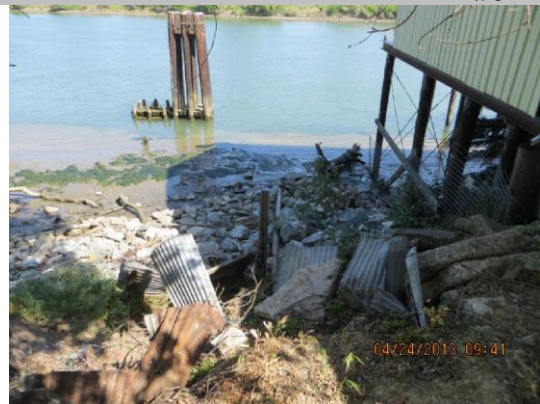
Photo 1 of 2 : UCIP_SP_2019_12745_20683.jpg

Pipe and wrecked pumphouse on WS toe.

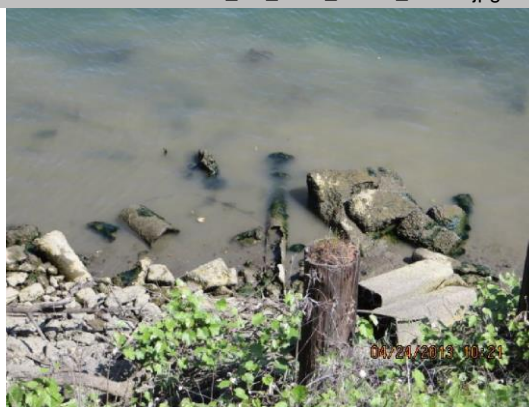
Photo 2 of 2 : UCIP_SP_2019_12748_20691.jpg

Rusted out pipe visible at WS toe.

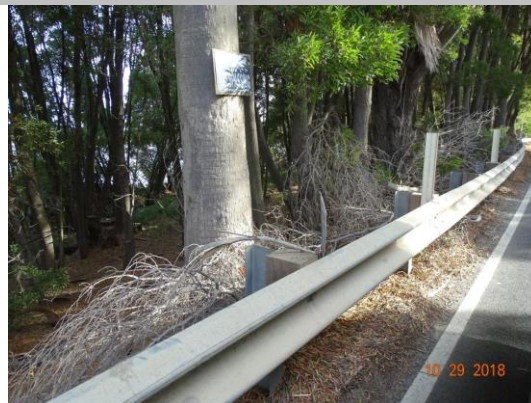
Photo 1 of 1 : SP_2019_NA0002_63_117_20190311_00072.jpg

View of prunings on the waterside slope (October 2018)

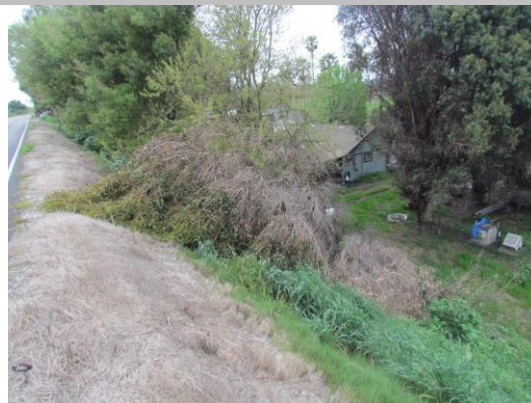
Photo 1 of 1 : SP_2019_NA0002_63_13_20190311_00014.jpg

Looking northeast at fallen tree on landward slope.

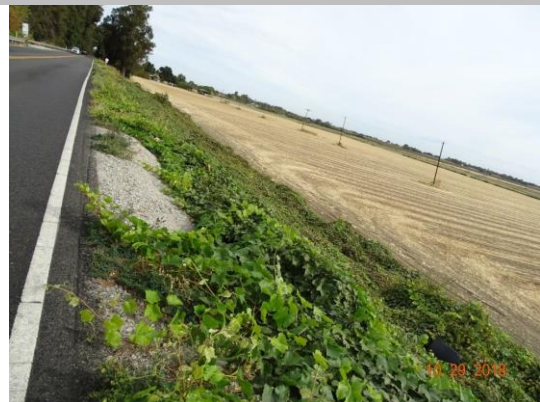
Photo 1 of 1 : SP_2019_NA0002_63_159_20190311_00095.jpg

View looking upstream at ivy on the landside slope (October 2018).

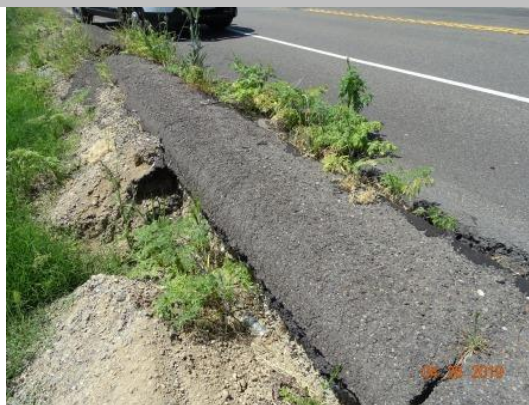
Photo 1 of 1 : SP_2019_NA0002_63_90_20190429_00204.jpg

View of small slip on the landside shoulder causing the edge of the road to crack and sink (Spring 2019).

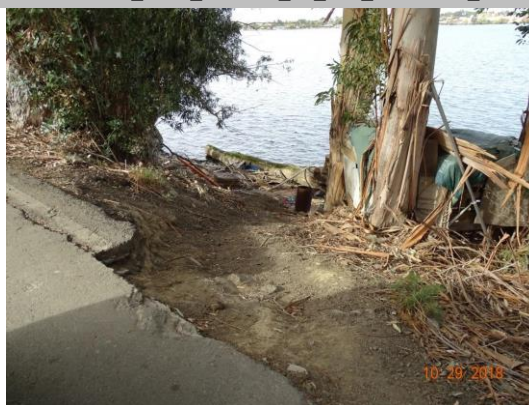
Photo 1 of 1 : SP_2019_NA0002_63_147_20190311_00088.jpg

View of path that is cutting into the waterside slope (October 2018).

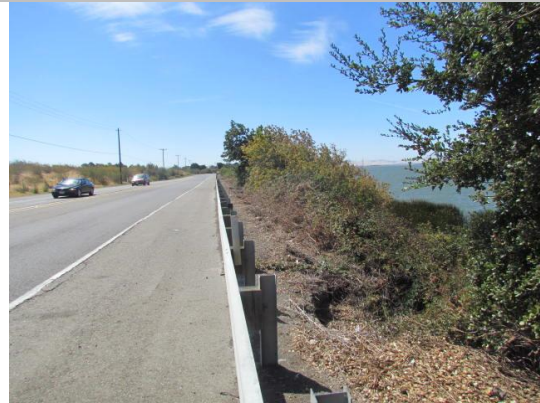
Photo 2 of 2 : SP_2019_NA0002_63_107_20190311_00066.jpg

Looking south at dense vegetation on waterward slope. (Fall 2015)
