**Flood Control Project Maintenance
Levee Inspections**
LMA District Cover Sheet
Spring 2020 Levee Inspection Results

Brannan Andrus Levee Maintenance District

Spring 2020 Levee Inspection Results

Waterway			Bank	Unit Miles
Unit No. 01 Georgiana Slough			Right	6.01
	Spring (March - May)	Summer (June - August)	(September - November) Fall	Winter (December - February)
Unit Maintenance Rating (Fall Only)				
Date of Inspection	4/2/2020 - 4/2/2020			
DWR Inspector	David Julian			
Accompanied By

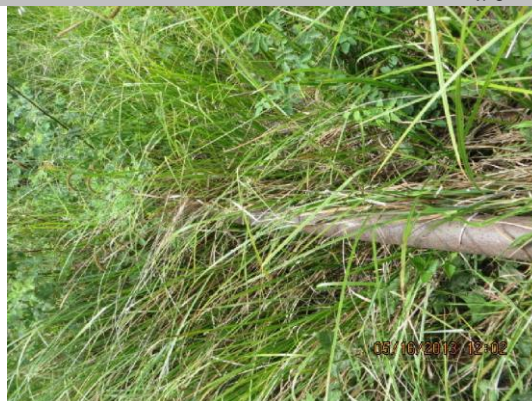
Photo 1 of 3 : UCIP_SP_2020_13560_22173.jpg

LM Start	0.61	Rating **	M	Issue No.	86
LM End	0.61	Issue Type +	En	Location *	
Category	Supplemental			GPS Latitude/Longitude	
				Start	End
Item	DWR UCIP Field Study			38.182213 °	38.182213 °
				-121.572357 °	-121.572357 °
DWR ID	21752				
Comment Code					
Inspector Comment					
DS_ID:21752					
FS_ID:13560					
EP_NO: 2015					
Repair Type: Non-Urgent					
Crossing Status: Found					
UCIP Comments: This pipe appears abandoned and should be removed.					
FIELD_STRUCT_DESC: 2-inch galvanized iron wastewater pipe through the levee, 2 feet below the crown. Gas well drain. (Permit No. 2015, 1954 - Brazos Oil and Gas Company). [Additional Reference(s): DWR Levee Log, 2005].					
FS Date: 5/16/2013

Pipe in grass on WS slope.

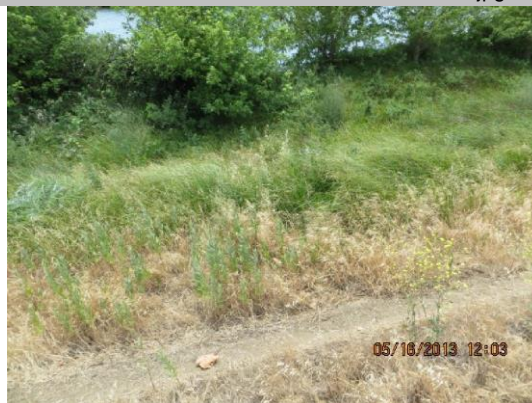
Photo 2 of 3 : UCIP_SP_2020_13560_22172.jpg

Pipe in grass on WS slope.

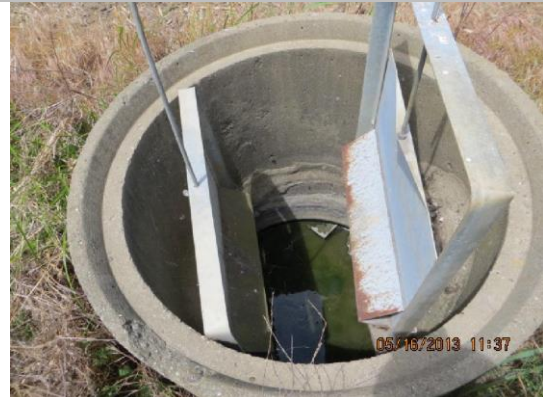
Photo 2 of 3 : UCIP_SP_2020_13558_22168.jpg

Concrete standpipe on LS toe.

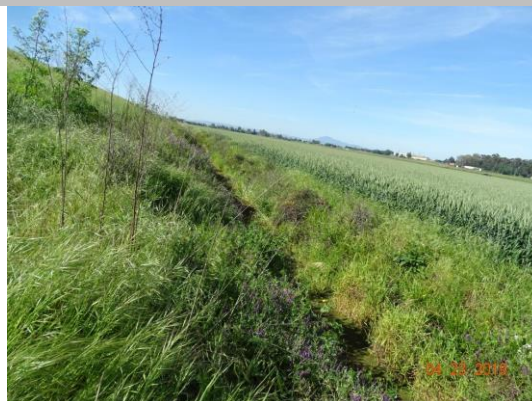
Photo 1 of 1 : SP_2020_NA0002_62_56_20200304_00018.jpg

View looking downstream at ditch at the landside toe (Spring 2019).

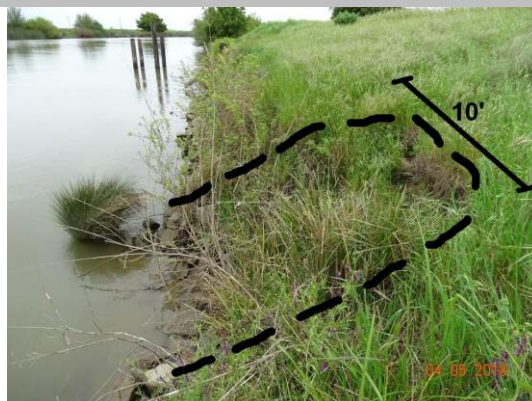
Photo 1 of 1 : SP_2020_NA0002_62_39_20200304_00012.jpg

LM Start	1.53	Rating **	M	Issue No.	39
LM End	1.54	Issue Type +	Ma	Location *	WS
Category	Supplemental			GPS Latitude/Longitude	
				Start	End
Item	2017 USACE Erosion Survey			38.173410 °	38.173178 °
				-121.580683 °	-121.580622 °
DWR ID	DWR_NA0002_01_f_2018_39				
Comment Code					
Inspector Comment					
2017 Site ID: GEO 5.5 R					
Status: Eroding New					
2017 Field Notes: Failed rock section, slump failure of bank to subvertical face.					
Site History:

Erosion slump in area of previous repair. LM 1.52

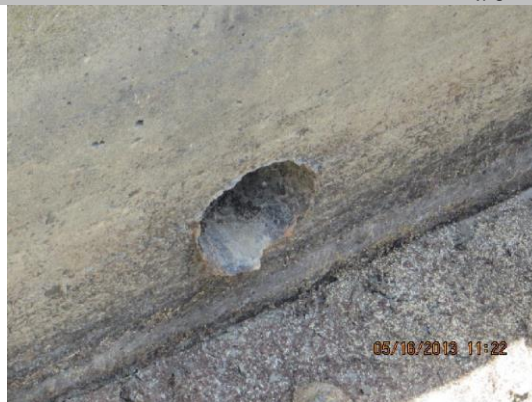
Photo 2 of 3 : UCIP_SP_2020_13554_22163.jpg

Comment Code					
Inspector Comment					
DS_ID:21755 FS_ID:13554 EP_NO: 11252 Repair Type: Non-Urgent Crossing Status: Found UCIP Comments: Pipe heavily rusted at distribution box. Good candidate for video inspection. FIELD_STRUCT_DESC: 1 of 3: 8-inch steel irrigation pipe through the levee, 4.6 feet below the crown. Pump and valve on the waterside (WS) slope. Siphon breaker in 24-inch corrugated metal riser unit on the landside (LS) shoulder. 7-foot by 10-foot concrete distribution box on the LS toe. (Automatic Board Order (ABO) issued as Permit No. 11252, 1975 - Hubert and Palmyra Vandermaele). [Additional Reference(s): DWR Levee Log, 2005. USACE Sacramento O&M Manual 103, June 1954, (Station ""R"" 237+13) Drawing No. 50-4-2631]. FS Date: 5/16/2013

Pipe shows excessive rust at inlet to distribution box on LS toe.

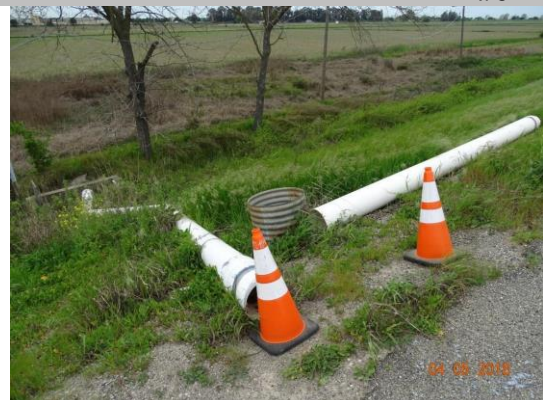
Photo 2 of 2 : UCIP_SP_2020_52615_77545.jpg

Comment Code					
Inspector Comment					
DS_ID:21758 FS_ID:52615 EP_NO: 11252 Repair Type: Non-Urgent Crossing Status: Found UCIP Comments: 04/06/2017 Landowner has installed a temporary pipe and removed old pipe. Photos and update courtesy of DWR Inspector, Richard Willoughby.05/16/2013 Pipe rusted through at inlet to box. Good candidate for video inspection. (G. Wylie - DWR) FIELD_STRUCT_DESC: *REMOVED* 3 of 3: 12-inch steel pipe through the levee 4.0 feet below the crown. Slant pump on bank. Switch box on berm, conduit through levee. Siphon breaker in 24-inch CMP riser on landward slope. Power pole and electrical panel at landward toe (ABO No. 11252, 1975). 7'X10' concrete distribution box on LS toe. As per Richard Willoughby, FPIIB Inspector, landowner has installed a temporary 12-inch PVC pipe on the WS and removed this pipe. New pipe forthcoming. Originally included in the 1954 O&M manual. FS Date: 4/6/2017

A view of disconnected temporary pipe on landside. Photo courtesy of DWR inspector Keith E Millard.

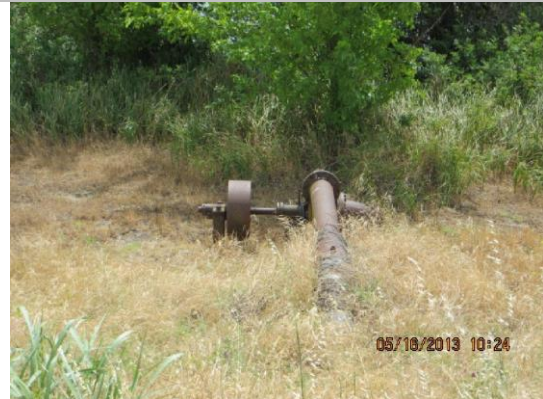
Photo 1 of 3 : UCIP_SP_2020_13545_22145.jpg

LM Start	2.50	Rating **	M	Issue No.	92	
LM End	2.50	Issue Type +	En	Location *		
Category	Supplemental			GPS Latitude/Longitude		
				Start	End	
Item	DWR UCIP Field Study			38.160147 °	38.160147 °	
				-121.586088 °	-121.586088 °	
DWR ID	21762					
Comment Code						
Inspector Comment						
DS_ID:21762 FS_ID:13545 EP_NO: N/A Repair Type: Non-Urgent Crossing Status: Found UCIP Comments: Pipe appears abandoned and should be done so properly. standpipe on LS is covered in brush. FIELD_STRUCT_DESC: 8-inch steel irrigation pipe through the levee, 3.4 feet below the crown. 6-inch pump on the waterside (WS). 36-inch concrete standpipe on the landside (LS) toe. [Additional Reference(s): DWR Levee Log, 2005. USACE Sacramento O&M Manual 103, June 1954, (Station ""R"" 188+39) Drawing No. 50-4-2631]. FS Date: 5/16/2013

Pipe and pump on WS slope.

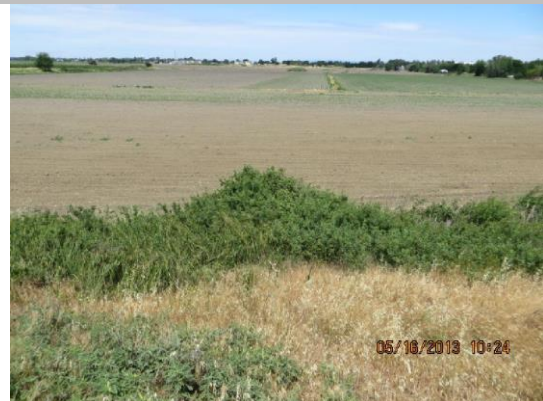
Photo 2 of 3 : UCIP_SP_2020_13545_22144.jpg

Standpipe covered in brush on LS toe.

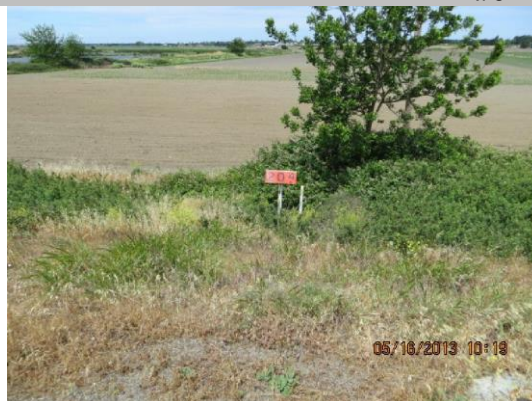
Photo 1 of 2 : UCIP_SP_2020_13525_22128.jpg

DS_ID:21764
 FS_ID:13525
 EP_NO: 17250
 Repair Type: Non-Urgent
 Crossing Status: Indicator Found
 UCIP Comments: Needs better location markers.
 FIELD_STRUCT_DESC: 24-inch steel natural gas pipeline through the levee, 117 feet below the crown. Possible sign on the LS toe. (Permit No. 17250, 2001 - Lodi Gas Storage, LLC).
 FS Date: 5/16/2013

Gasline marker on LS toe.

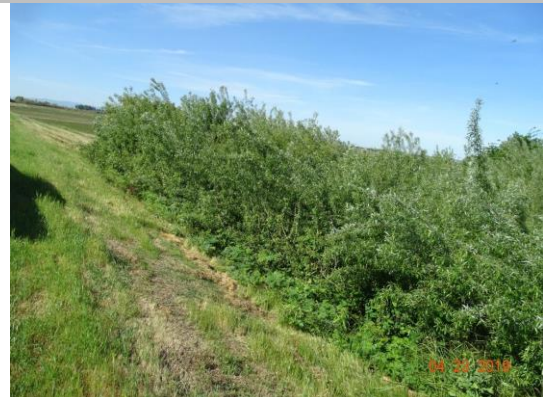
Photo 1 of 1 : SP_2020_NA0002_62_53_20200304_00017.jpg

View looking downstream at willows on the landside slope (Spring 2019).

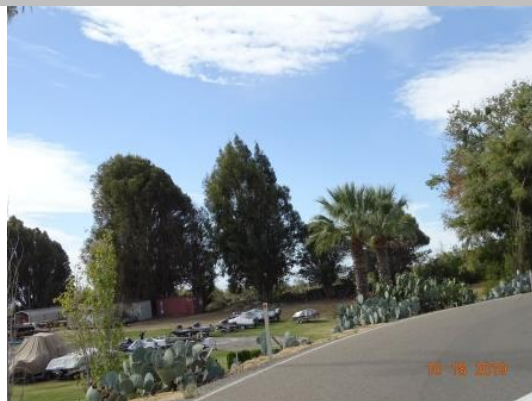
Photo 1 of 1 : SP_2020_NA0002_62_5_20200304_00003.jpg

View of cactus on the waterside slope (Fall 2019).

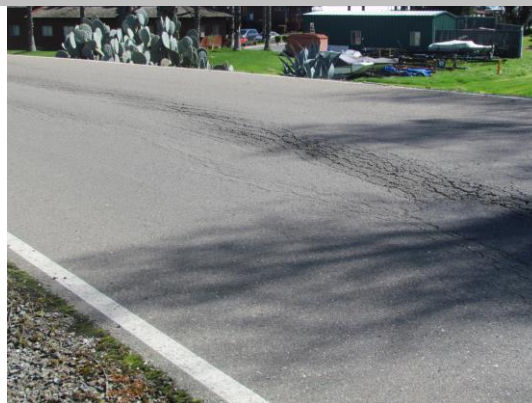
Photo 1 of 3 : SP_2020_NA0002_62_67_20200304_00026.jpg

LM Start	3.38	Rating **	A/W	Issue No.	67
LM End	3.40	Issue Type +	Ma	Location *	CR
Category	Earthen Levee			GPS Latitude/Longitude	
				Start	End
Item	Slope Stability			38.151430 °	38.151390 °
				-121.592085 °	-121.592517 °
DWR ID	DWR_NA0002_01_s_2017_67				
Comment Code					
S1 : Repair slope instability.					
Inspector Comment					
Appears to be beginning of a landside slump. LMA's Engineer (DCC) is monitoring site for movement.

Looking south at sloughing on landward shoulder.

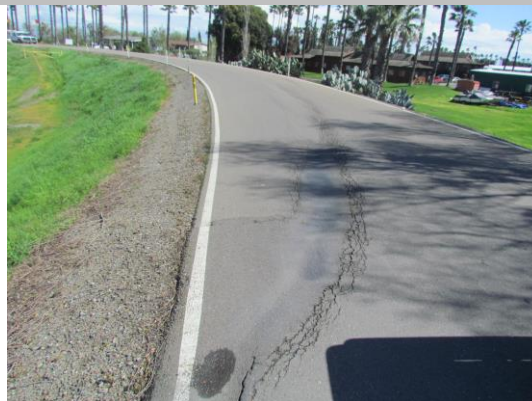
Photo 2 of 3 : SP_2020_NA0002_62_67_20200304_00027.jpg

Looking east at possible sloughing on landward shoulder.

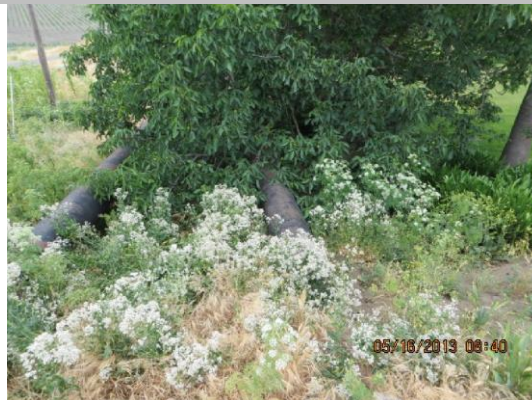
Photo 2 of 3 : UCIP_SP_2020_51302_22081.jpg

Pipe visible on LS slope.

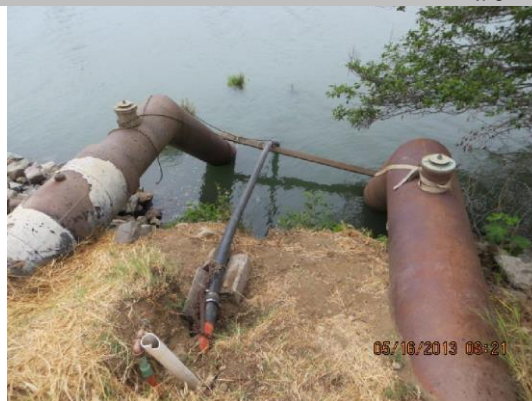
Photo 1 of 3 : UCIP_SP_2020_13487_22053.jpg

DS_ID:21825
 FS_ID:13487
 EP_NO: 11248
 Repair Type: Non-Urgent
 Crossing Status: Found
 UCIP Comments: Leakage of pipe at WS toe creating erosion.
 Possible cavity collapse along pipe alignment on WS berm.
 FIELD_STRUCT_DESC: 2 of 2: 4-inch pipe through levee 4.0 feet below crown. Siphon breaker on waterward slope. Pump on landward side (ABO No. 11248, 1975).
 FS Date: 5/16/2013

Pipe visible between two large storm drain pipes on WS.

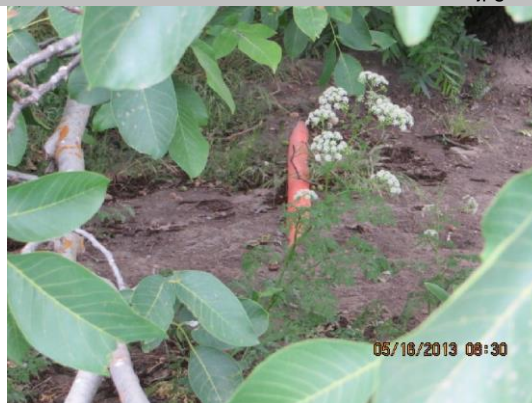
Photo 3 of 3 : UCIP_SP_2020_13487_22051.jpg

Pipe visible under walnut at LS slope.

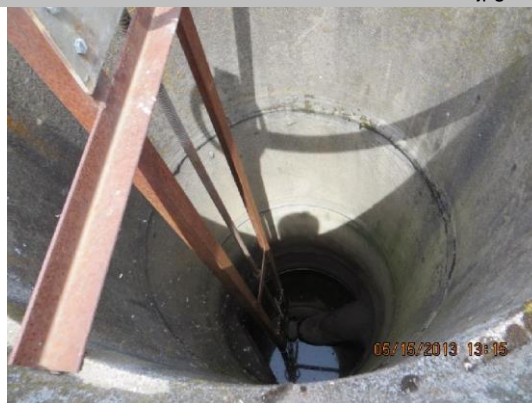
Photo 3 of 3 : UCIP_SP_2020_51308_22048.jpg

Concrete standpipe with slide gate at LS toe.

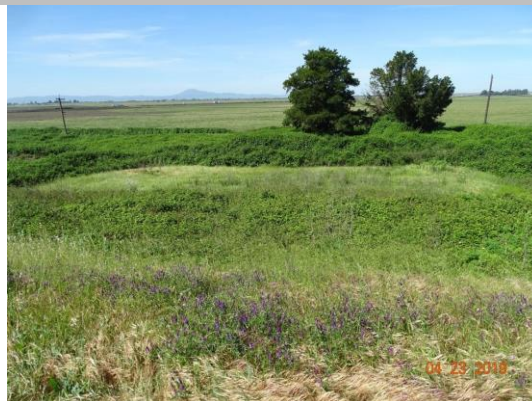
Photo 1 of 1 : SP_2020_NA0002_62_85_20200304_00034.jpg

View looking downslope at blackberries at the landside slope (Spring 2019).

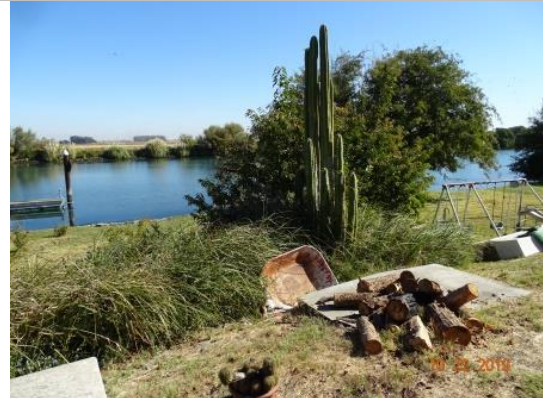
Photo 1 of 1 : SP_2020_NA0002_62_61_20200304_00023.jpg

View looking downstream at landscaping on the waterside slope (Fall 2019).

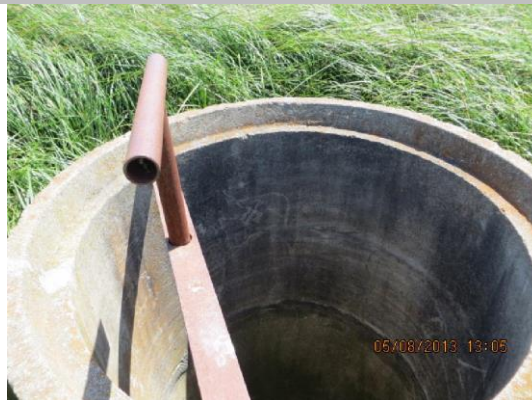
Photo 2 of 3 : UCIP_SP_2020_13090_21281.jpg

Slide gate in 48-inch Concrete riser on LS toe.

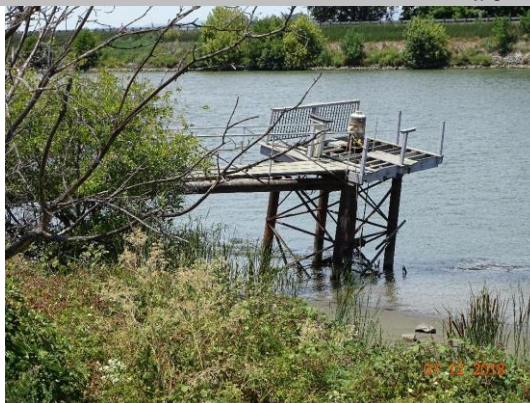
Photo 1 of 3 : UCIP_SP_2020_52689_77595.jpg

Pump platform on WS is distorted.

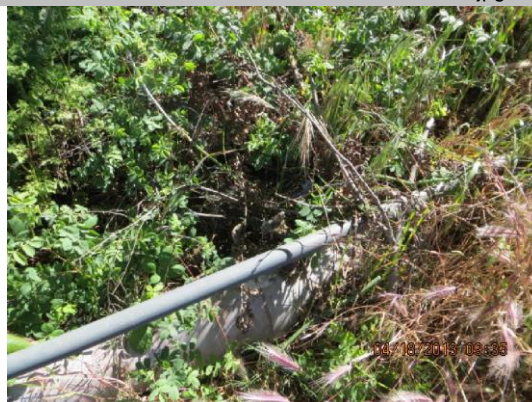
Photo 2 of 3 : UCIP_SP_2020_12164_19725.jpg

1.5-inch galvanized iron electrical conduit at same location as 12-inch pipe on WS slope.

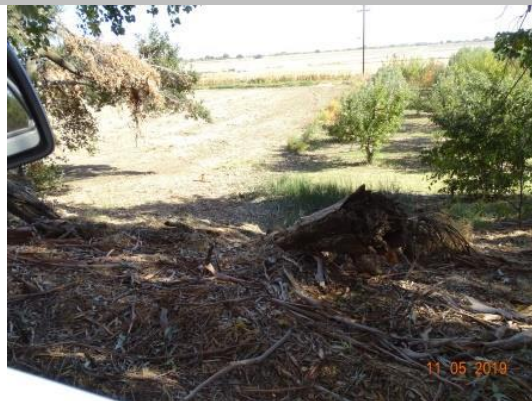
Photo 1 of 1 : SP_2020_NA0002_63_93_20200304_00053.jpg

Down tree on the landside slope and toe (Fall 2019).

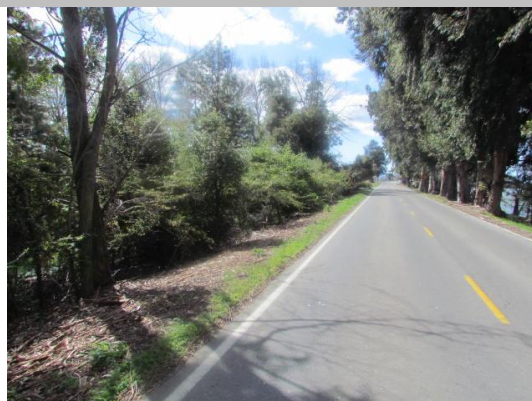
Photo 1 of 2 : SP_2020_NA0002_63_12_20200304_00007.jpg

Looking south at dense landscaping on landside slope and toe.

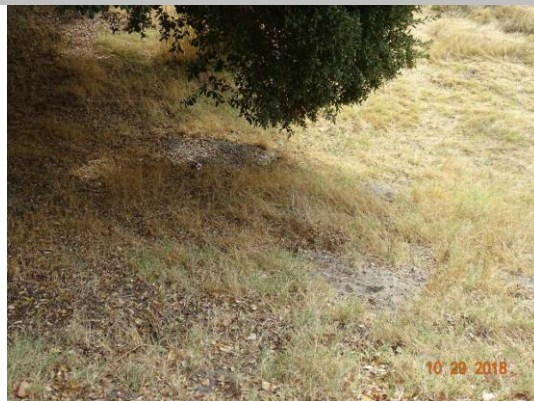
Photo 2 of 2 : SP_2020_NA0002_63_172_20200304_00093.jpg

View looking down the landside slope at several animal holes (October 2018).

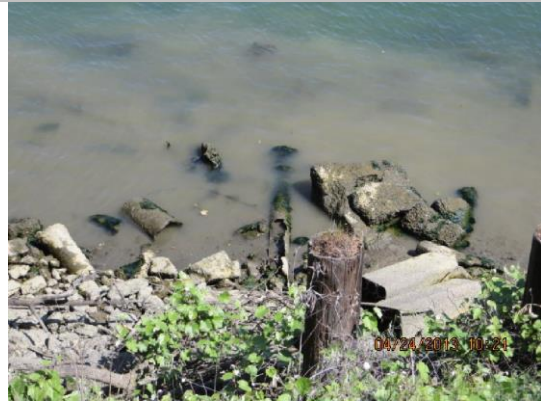
Photo 2 of 2 : UCIP_SP_2020_12748_20691.jpg

Rusted out pipe visible at WS toe.

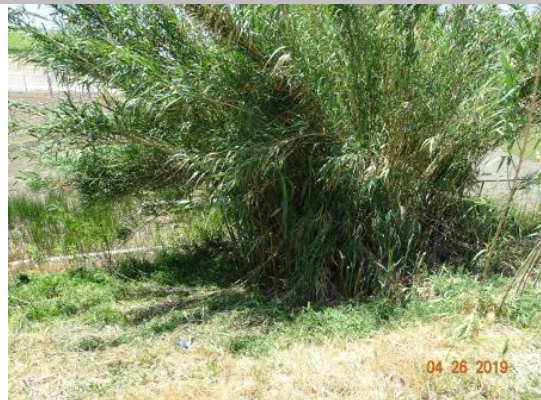
Photo 1 of 1 : SP_2020_NA0002_63_98_20200304_00057.jpg

View of arundo on the landside slope (Spring 2019).

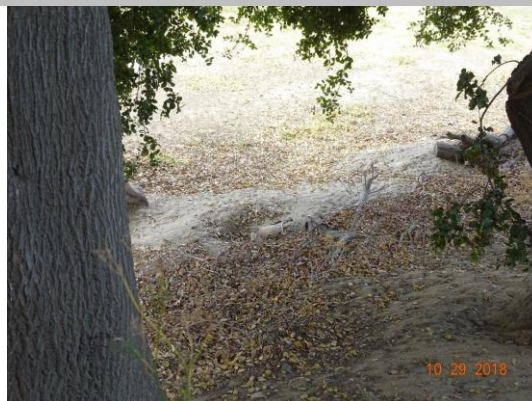
Photo 1 of 1 : SP_2020_NA0002_63_167_20200304_00089.jpg

View of several animal holes. Additional holes were found in the immediate vicinity.

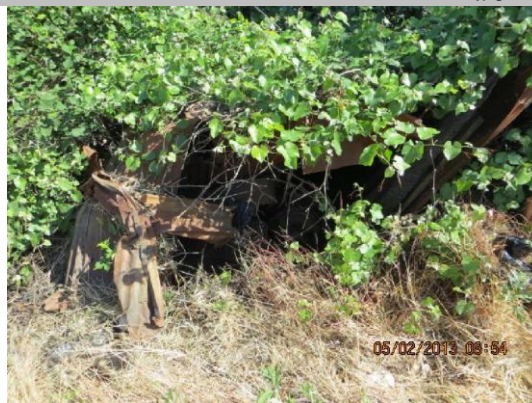
Photo 1 of 3 : UCIP_SP_2020_12774_20745.jpg

Broken down pumphouse on WS slope.

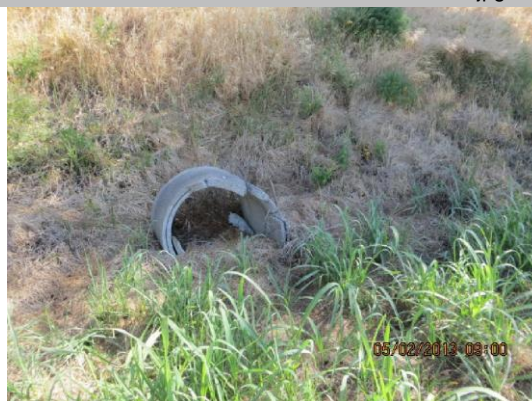
Photo 3 of 3 : UCIP_SP_2020_12774_20743.jpg

Broken Concrete standpipe on LS toe.

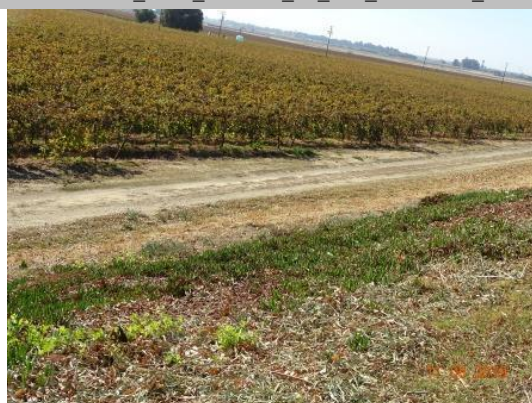
Photo 1 of 1 : SP_2020_NA0002_63_160_20200304_00086.jpg

View of ice plant on the landside slope (Fall 2019).

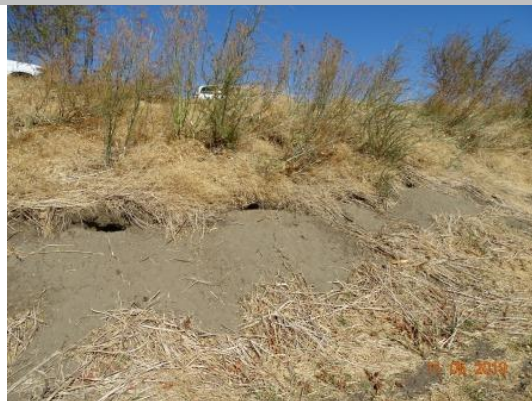
Photo 1 of 1 : SP_2020_NA0002_63_122_20200304_00074.jpg

View of multiple large squirrel holes in the landside slope (Fall 2019).

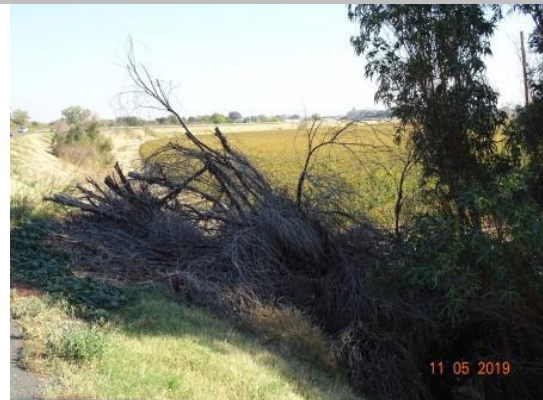
Photo 1 of 1 : SP_2020_NA0002_63_84_20200304_00048.jpg

View looking upstream at dead tree on the landside slope (Fall 2019).

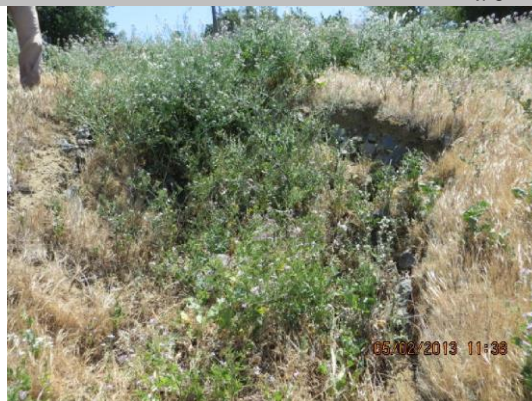
Photo 1 of 3 : UCIP_SP_2020_12814_20821.jpg

Erosion/sinkhole over pipe on WS slope.

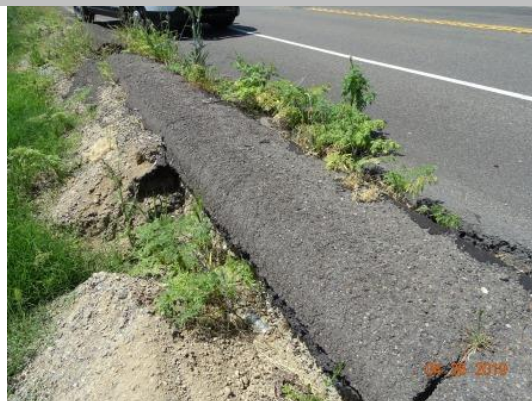
Photo 1 of 1 : SP_2020_NA0002_63_90_20200304_00052.jpg

View of small slip on the landside shoulder causing the edge of the road to crack and sink (Spring 2019).

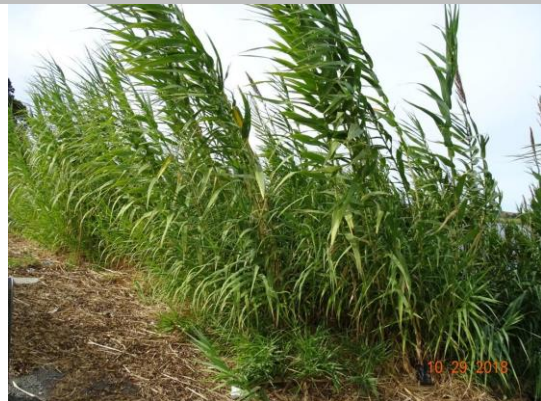
Photo 1 of 1 : SP_2020_NA0002_63_152_20200304_00083.jpg

View of arundo on waterside slope (October 2018).
