**Flood Control Project Maintenance
Levee Inspections
LMA District Cover Sheet**

Brannan Andrus Levee Maintenance District

Waterway			Bank	Unit Miles
Unit No. 01 Georgiana Slough			Right	6.01
	Spring (March - May)	Summer (June - August)	(September - November) Fall	Winter (December - February)
Unit Maintenance Rating (Fall Only)				
Date of Inspection	3/17/2021 - 3/17/2021			
DWR Inspector	David Julian			
Accompanied By

Levee Inspection Report By Mile - Spring 2021

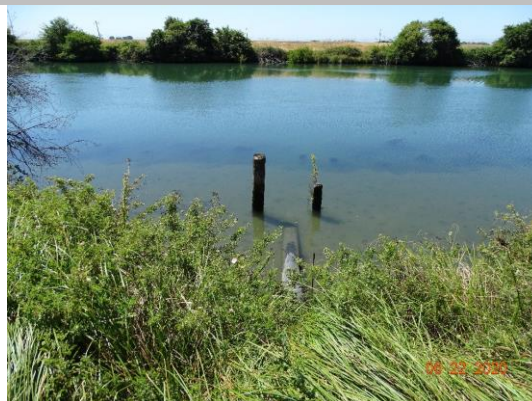
Photo 3 of 3 : UCIP_SP_2021_62290_89868.jpg

Comment Code						
Inspector Comment						
FS_ID:62290 DS_ID:21821 EP_NO: 11229 Repair Type: Non-Urgent Crossing Status: Found UCIP Comments: 06/22/2020 Record updated from No Action Needed to Non-Urgent. No permit has been identified authorizing pipe. Need to have CVFPB review ABO and determine current owner. Recommend owner to restore top cover grate of concrete standpipe and CMP riser to eliminate fall hazard. (O.Yakimov - DWR UCIP) FIELD_STRUCT_DESC: 12-inch steel irrigation siphon pipe through the levee, 4 feet below the crown. Siphon breaker in 10-inch high-density polyethylene riser unit on the landside (LS) shoulder. 1-inch air and vacuum valve. 36-inch diameter concrete distribution standpipe on the LS toe. (12-inch pipe [HLM 0.07] authorized under Automatic Board Order (ABO) issued as Permit No. 11229, 1975 - Paul and Gladys Bettencourt). [Additional Reference(s): DWR Levee Log, 2005 (HLM 0.07). USACE Sacramento O&M Manual, Unit 103, June 1954, Revised 29 December 2016, (Station 'R' 316+00), listed as 12-inch pipe. USACE As-Built Drawing No. 50-04-2631, Sheet 8, Station 316+00, March 1950]. FS Date: 6/22/2020 9:51:25 AM

Water-Side: View of pipe at riverbank

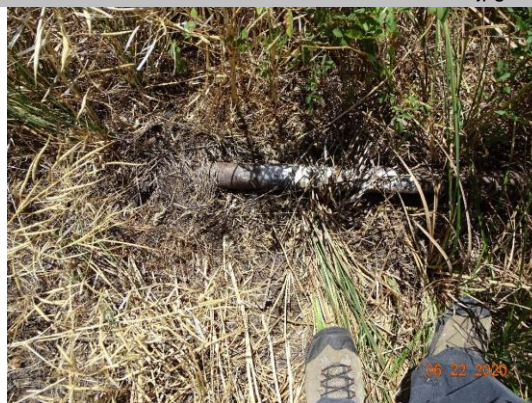
Photo 3 of 3 : UCIP_SP_2021_62295_89894.jpg

Water-Side: Pipe daylights on levee slope

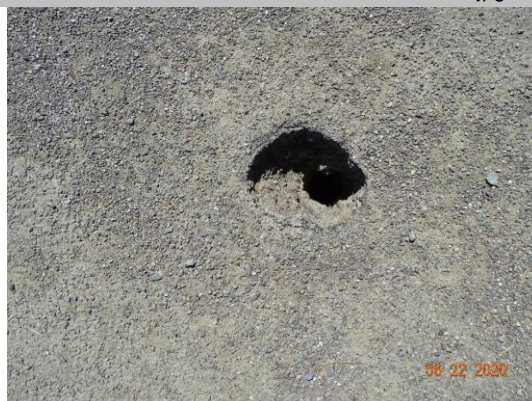
Photo 2 of 3 : UCIP_SP_2021_62296_89899.jpg

FS_ID:62296
DS_ID:21753
EP_NO: 11232
Repair Type: Urgent
Crossing Status: Found
UCIP Comments: 06/22/2020 Record updated from Non-Urgent to Urgent. Sinkhole in the center of crown measures 8-inch in diameter and 2-feet in depth. Damaged siphon breaker pipe on landside shoulder. Vegetation on waterside limits levee inspection at this crossing. Geophysical study indicates possible presence of pipe through levee. Owner needs to coordinate with the CVFPB to remove or abandon crossing according to Title 23 requirements. No permit has been identified authorizing pipe. Need to have CVFPB review ABO and determine current owner. (O.Yakimov - DWR UCIP)
05/16/2013 Unable to locate any appurtenances other than distribution box. Need to verify proper abandonment.
FIELD_STRUCT_DESC: 12-inch steel irrigation pipe through the levee, 3.2 feet below the crown. Siphon breaker on the landside (LS) slope. Concrete distribution box located LS of the toe. 2-inch primer valve. (12-inch pipe [HLM 0.75] authorized under Automatic Board Order (ABO) issued as Permit No. 11232, 1975 - Mario Campi). [Additional Reference(s): DWR Levee Log, 2005 (HLM 0.70). USACE Sacramento O&M Manual, Unit 103, June 1954, Revised 29 December 2016, (Station 'R' 279+70), listed as 12-inch pipe. USACE As-Built Drawing No. 50-04-2631, Sheet 7, Station 279+70, March 1950].

Top of Levee: View of sinkhole in the center of crown

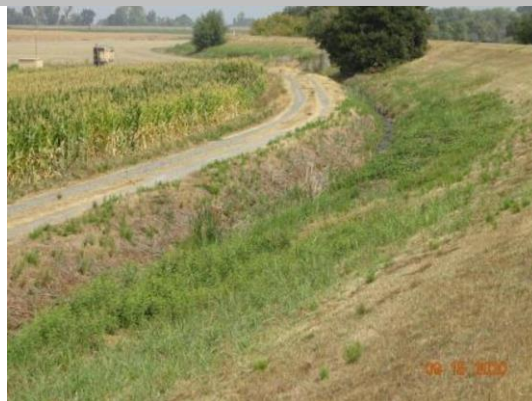
Photo 1 of 1 : SP_2021_NA0002_62_56_20210226_00020.jpg

View looking upstream at ditch at the landside toe (Fall 2020).

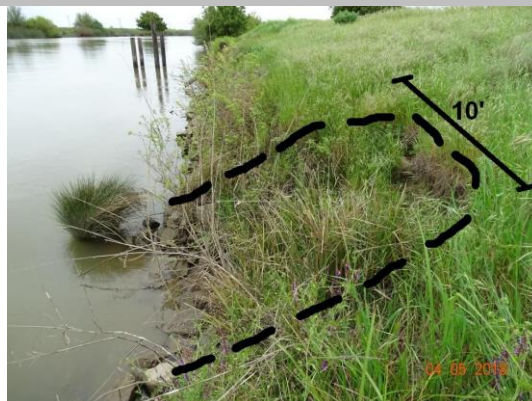
Photo 1 of 1 : SP_2021_NA0002_62_39_20210226_00014.jpg

2017 Site ID: GEO 5.5 R
 Status: Eroding New
 2017 Field Notes: Failed rock section, slump failure of bank to subvertical face.
 Site History:

Erosion slump in area of previous repair. LM 1.52

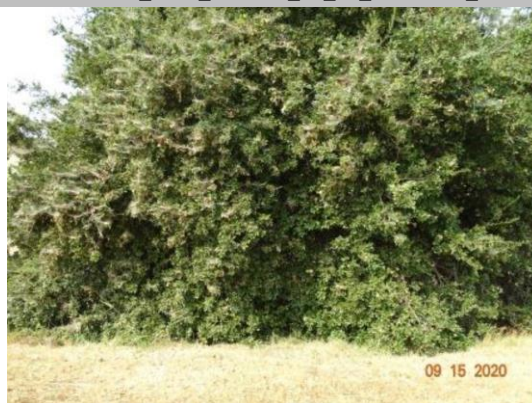
Photo 1 of 1 : SP_2021_NA0002_62_25_20210226_00010.jpg

View of thick tree on the landside slope (Fall 2020).

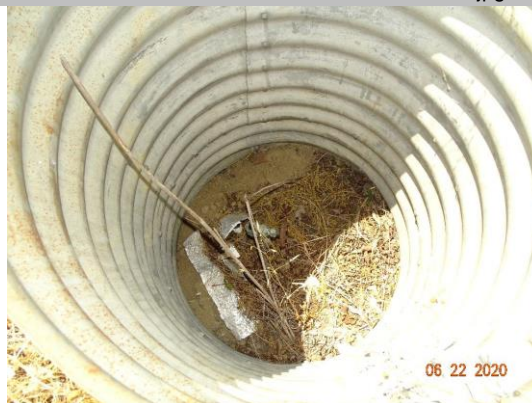
Photo 3 of 3 : UCIP_SP_2021_62304_89932.jpg

FS_ID:62304
DS_ID:21758
EP_NO: 11252
Repair Type: Non-Urgent
Crossing Status: Found
UCIP Comments: 06/22/2020 Record remains Non-Urgent. Old pipe segment is visible inside of concrete box at landside toe. Siphon breaker is still located in CMP riser on landside levee slope. 12-inch PVC pipe is connected to pump at riverbank on one side and discharges to concrete distribution box at landside toe. Pipe is temporarily dismantled on levee crown. Unable to find a permit for modification. Unable to locate a permit to confirm original pipe removal from levee. No permit has been identified authorizing original pipe through the levee. Need to have CVFPB review ABO and determine current owner. (O.Yakimov - DWR UCIP)
04/06/2017 Landowner has installed a temporary pipe and removed old pipe. Photos and update courtesy of DWR Inspector, Richard Willoughby. 05/16/2013 Pipe rusted through at inlet to box. Good candidate for video inspection. (G. Wylie - DWR)

Land-Side: CMP riser and siphon breaker on levee slope

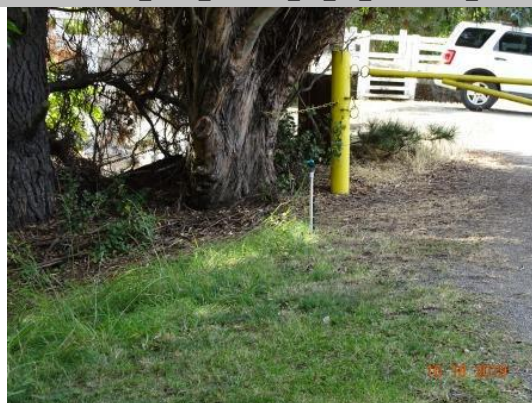
Photo 1 of 1 : SP_2021_NA0002_62_50_20210226_00017.jpg

View looking downstream at sprinkler emitter that is part of a larger sprinkler system on the waterside slope (Fall 2019).

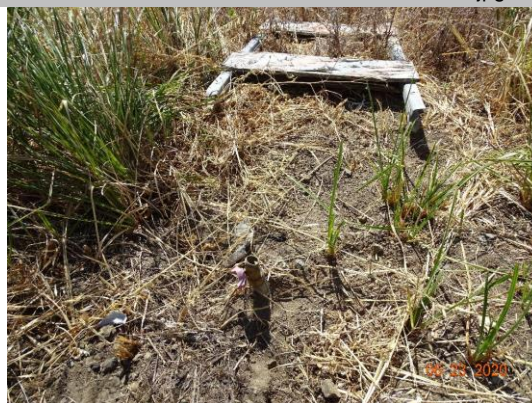
Photo 3 of 3 : UCIP_SP_2021_62317_89995.jpg

Water-Side: Siphon breaker on levee shoulder. Needs to be protected by a riser

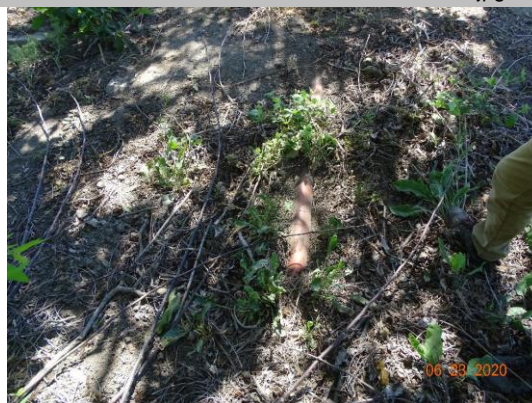
Photo 3 of 3 : UCIP_SP_2021_62329_90041.jpg

Water-Side: Pipe daylights on waterside slope

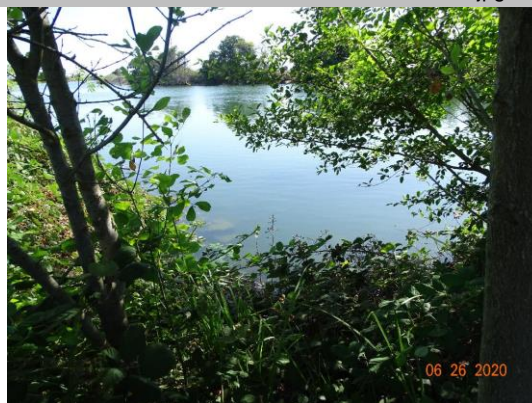
Photo 3 of 3 : UCIP_SP_2021_62337_90086.jpg

Water-Side: View of riverbank at the crossing. Pipe is under water

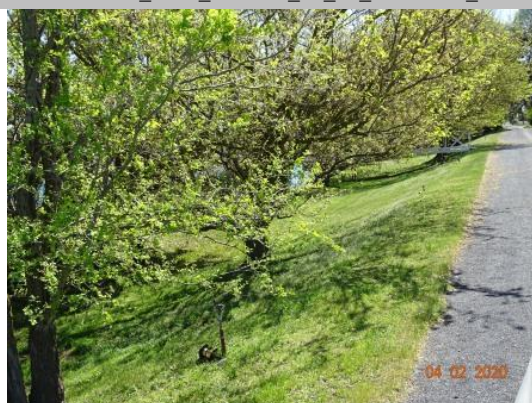
Photo 1 of 1 : SP_2021_NA0002_62_54_20210226_00019.jpg

View looking downstream at sprinklers on the waterside slope (Spring 2020).

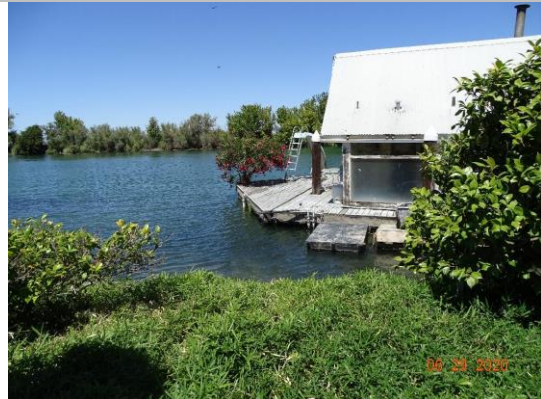
Photo 3 of 3 : UCIP_SP_2021_62390_90336.jpg

Water-Side: Floating house in the slough channel. Pipe not found on riverbank

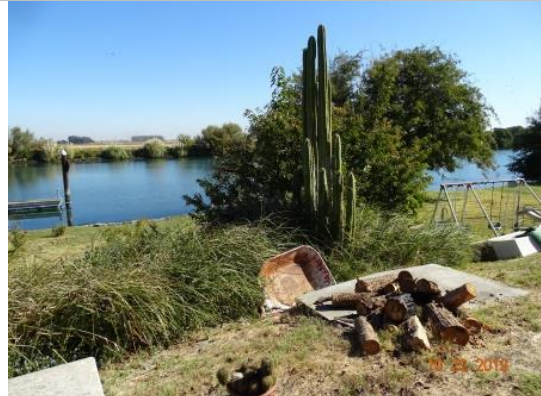
Photo 1 of 1 : SP_2021_NA0002_62_61_20210226_00025.jpg

View looking downstream at landscaping on the waterside slope (Fall 2019).

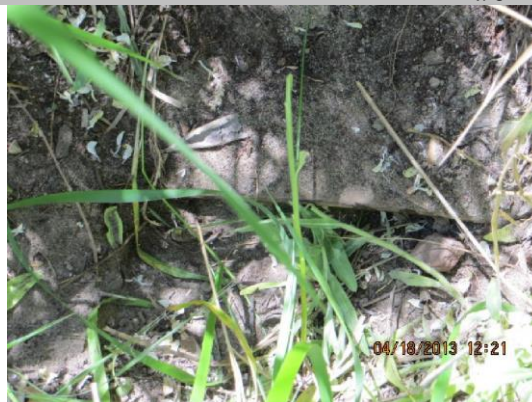
Photo 2 of 3 : UCIP_SP_2021_12211_19769.jpg

Evidence of pipe (buried) on LS in ditch.

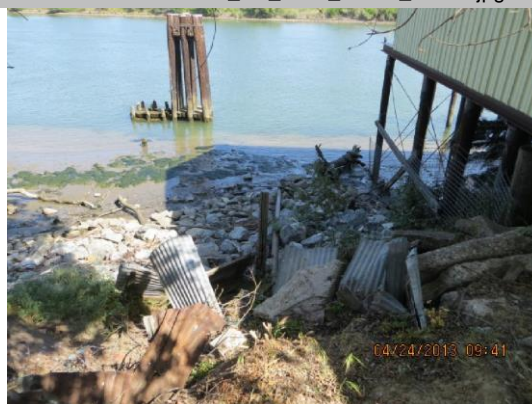
Photo 1 of 2 : UCIP_SP_2021_12745_20683.jpg

Pipe and wrecked pumphouse on WS toe.

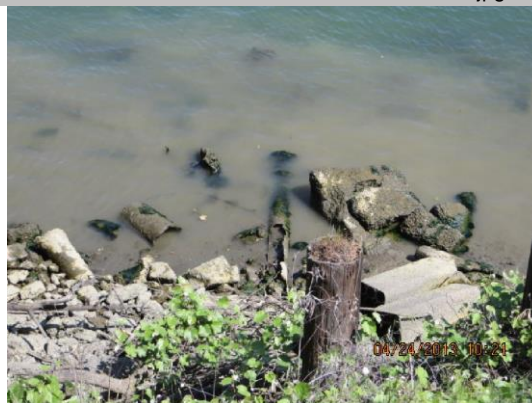
Photo 2 of 2 : UCIP_SP_2021_12748_20691.jpg

Rusted out pipe visible at WS toe.

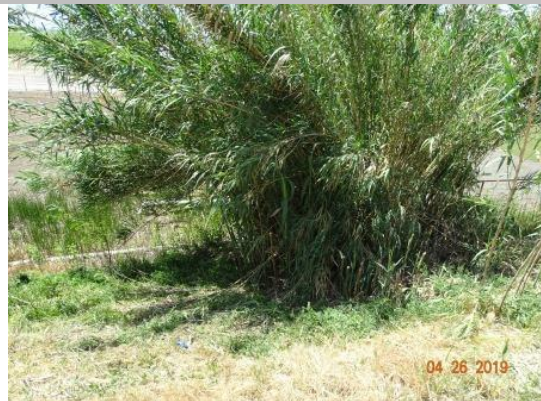
Photo 1 of 1 : SP_2021_NA0002_63_98_20210226_00038.jpg

View of arundo on the landside slope (Spring 2019).

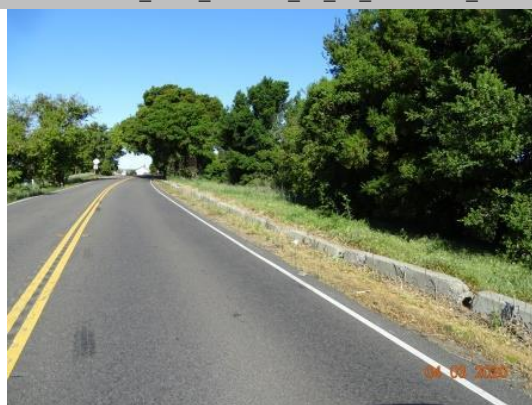
Photo 1 of 1 : SP_2021_NA0002_63_80_20210226_00029.jpg

View looking downstream concrete blocks used to block parking on the waterside slope (Spring 2020).

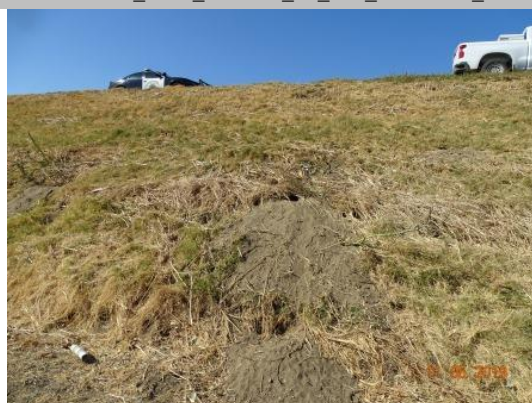
Photo 1 of 1 : SP_2021_NA0002_63_111_20210226_00044.jpg

View of multiple recent squirrel holes on the landside slope (Fall 2019).

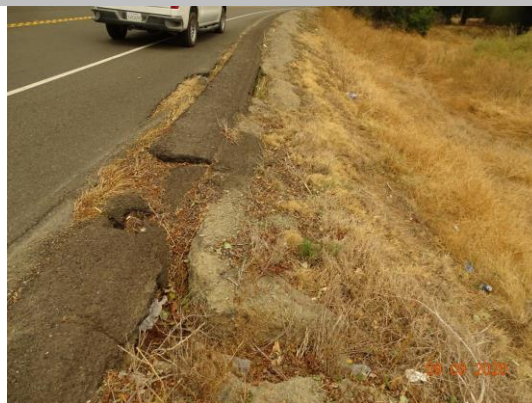
Photo 1 of 1 : SP_2021_NA0002_63_90_20210226_00034.jpg

View of small slip on the landside shoulder causing the edge of the road to crack and sink (Fall 2020).

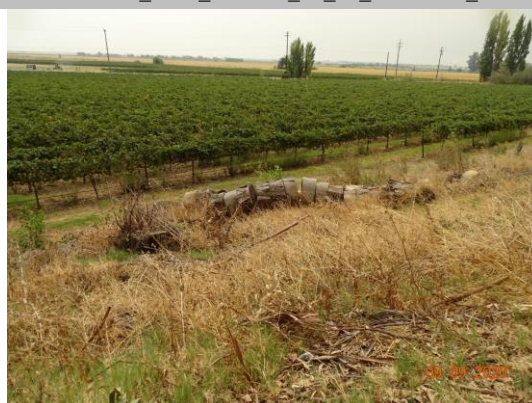
Photo 1 of 1 : SP_2021_NA0002_63_60_20210226_00015.jpg

View of chopped up tree trunk on the landside slope (Fall 2020).

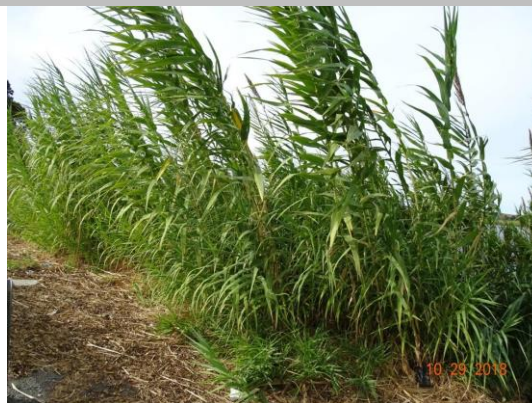
Photo 1 of 1 : SP_2021_NA0002_63_152_20210226_00054.jpg

View of arundo on waterside slope (October 2018).
