**Flood Control Project Maintenance  
Levee Inspections  
LMA District Cover Sheet**

**Brannan Andrus Levee Maintenance District**

**Flood Control Project Maintenance  
Levee Inspections  
Unit Cover Sheet**

| Waterway | | | Bank | Unit Miles |
|--|---|---|---|---|
| Unit No. 01 Georgiana Slough | | | Right | 6.01 |

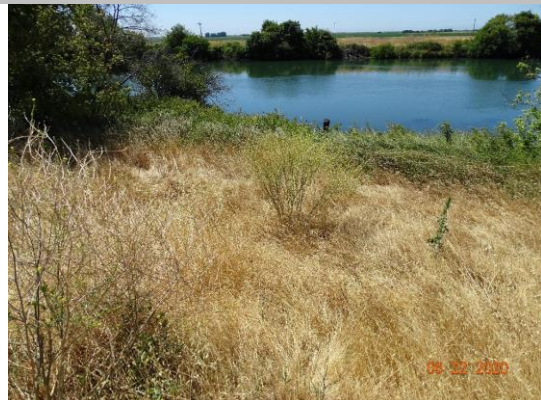
Photo 2 of 3 : UCIP\_SP\_2023\_62290\_89875.jpg

Water-Side: View of levee slope looking from crown

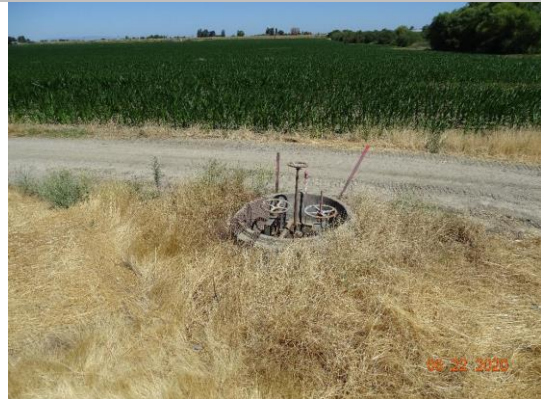
Photo 3 of 3 : UCIP\_SP\_2023\_62290\_89872.jpg

Land-Side: View of levee slope looking from crown

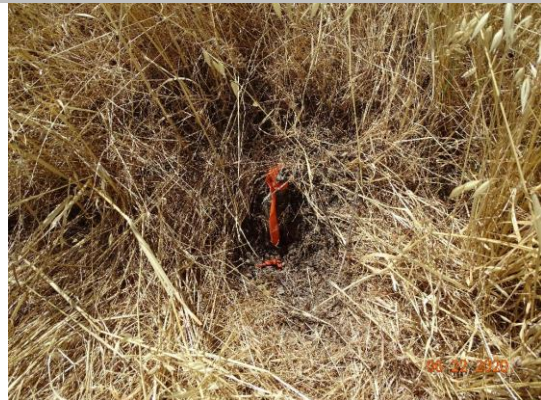
Photo 2 of 3 : UCIP\_SP\_2023\_62296\_89901.jpg

DS\_ID:21753  
FS\_ID:62296  
EP\_NO: 11232  
Repair Type: Urgent  
EVAL Issue: 2b, Levee Integrity  
Crossing Status: Found  
UCIP Comments: 06/22/2020 Record updated from Non-Urgent to Urgent. Sinkhole in the center of crown measures 8-inch in diameter and 2-feet in depth. Damaged siphon breaker pipe on landside shoulder. Vegetation on waterside limits levee inspection at this crossing. Geophysical study indicates possible presence of pipe through levee. Owner needs to coordinate with the CVFPB to remove or abandon crossing according to Title 23 requirements. No permit has been identified authorizing pipe. Need to have CVFPB review ABO and determine current owner. (O.Yakimov - DWR UCIP)  
05/16/2013 Unable to locate any appurtenances other than distribution box. Need to verify proper abandonment.  
FIELD\_STRUCT\_DESC: 12-inch steel irrigation pipe through the levee, 3.2 feet below the crown. Siphon breaker on the landside (LS) slope. Concrete distribution box located LS of the toe. 2-inch primer valve. (12-inch pipe [HLM 0.75] authorized under Automatic Board Order (ABO) issued as Permit No. 11232, 1975 - Mario Campi). [Additional Reference(s): DWR Levee Log, 2005 (HLM 0.70). USACE Sacramento O&M Manual, Unit 103, June 1954, Revised 29 December 2016, (Station 'R' 279+70), listed as 12-inch pipe. USACE As-Built Drawing No. 50-04-2631, Sheet 7, Station 279+70, March 1950].

Land-Side: Damaged siphon breaker pipe on levee shoulder

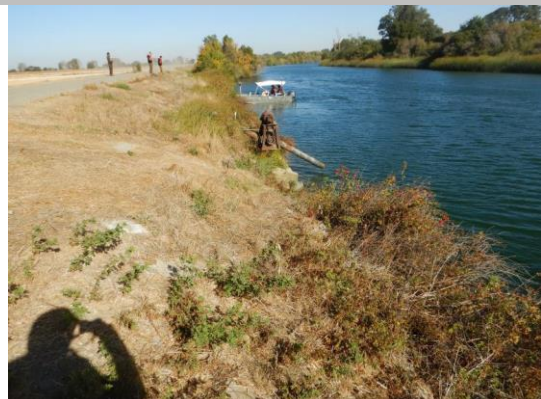
Photo 3 of 3 : SP\_2023\_NA0002\_62\_39\_20230206\_00010.jpg

| Site History: 2017 - Failed rock section, slump failure of bank to subvertical face. | | | | | |

USACE 2018 Erosion Photo #2

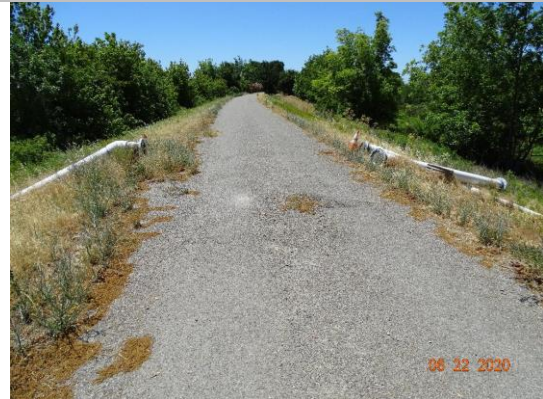
Photo 1 of 3 : UCIP\_SP\_2023\_62304\_89930.jpg

| DS_ID:21758<br>FS_ID:62304<br>EP_NO: 11252<br>Repair Type: Non-Urgent<br>EVAL Issue: 10, Unauthorized Modification or Non-Compliant Permit<br>Crossing Status: Found<br>UCIP Comments: 06/22/2020 Record remains Non-Urgent. Old pipe segment is visible inside of concrete box at landside toe. Siphon breaker is still located in CMP riser on landside levee slope. 12-inch PVC pipe is connected to pump at riverbank on one side and discharges to concrete distribution box at landside toe. Pipe is temporarily dismantled on levee crown. Unable to find a permit for modification. Unable to locate a permit to confirm original pipe removal from levee. No permit has been identified authorizing original pipe through the levee. Need to have CVFPB review ABO and determine current owner. (O.Yakimov - DWR UCIP)<br>04/06/2017 Landowner has installed a temporary pipe and removed old pipe. Photos and update courtesy of DWR Inspector, Richard Willoughby.05/16/2013 Pipe rusted through at inlet to box. Good candidate for video inspection. (G. Wylie - DWR)<br>FIELD_STRUCT_DESC: 12-inch steel pipe through the levee 4.0 feet below the crown. Slant pump on bank. Switch box on berm, conduit through levee. Siphon breaker in 24-inch CMP riser on landward slope. Power pole and electrical panel at landward toe. 7'X10' concrete distribution box on LS toe. (12-inch pipe [HLM 2.17] authorized under Automatic Board Order (ABO) issued as Permit No. 11252, 1975 - Hubert & Palmyra Vandermaele). [Additional Reference(s): DWR Levee Log, 2005 (HLM 2.17). USACE Sacramento O&M Manual, Unit 103, June 1954, Revised 29 December 2016, (Station 'R' 205+46), listed as 12-inch pipe. USACE As-Built Drawing No. 50-04-2631, Sheet 5, Station 205+46, March 1950].<br>FS Date: 6/22/2020 10:20:04 AM | | | | | | |

Top of Levee: View of levee crown looking downstream

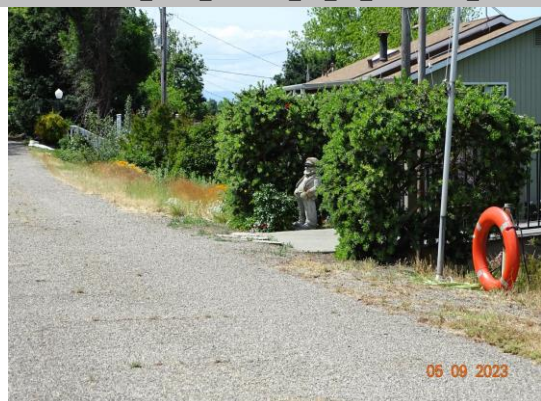
Photo 1 of 1 : SP\_2023\_NA0002\_62\_25\_20230517\_00092.jpg

View of the landscaping on the LS slope (Spring 2023).

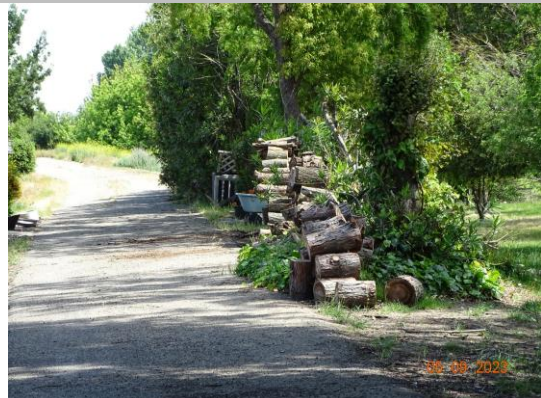
Photo 1 of 1 : SP\_2023\_NA0002\_62\_3\_20230517\_00091.jpg

View of the firewood on the WS shoulder (Spring 2023).

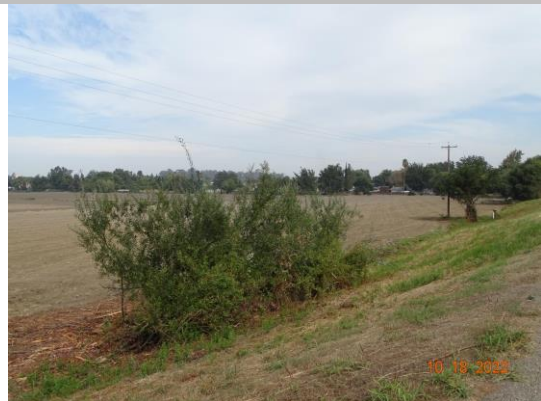
Photo 1 of 1 : SP\_2023\_NA0002\_62\_52\_20230206\_00015.jpg

View of the tree on the LS slope (Fall 2022).

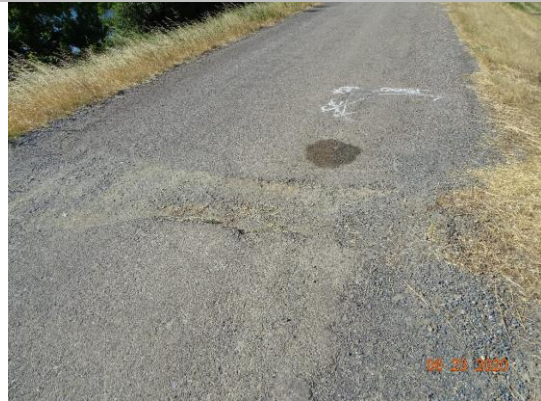
Photo 1 of 3 : UCIP\_SP\_2023\_62316\_89986.jpg

DS\_ID:21765  
FS\_ID:62316  
EP\_NO: 11238  
Repair Type: Non-Urgent  
EVAL Issue: 6, Levee Damage or Threat for Levee Damage  
Crossing Status: Found  
UCIP Comments: 06/23/2020 Record updated from Urgent to Non-Urgent. Visible cut in levee crown is due to emergency replacement of pipe section through levee crown in 2009. Erosion at riverbank within 10 feet from waterside levee toe is still present, but didn't grow in size. Dense vegetation on waterside limits inspection of levee at the crossing. No permit has been identified authorizing original pipe through the levee. Need to have CVFPB review ABO and determine current owner. (O.Yakimov - DWR UCIP)  
07/12/2018 Dense vegetation on both levee slopes. Unable to evaluate erosion on WS. Depression along pipe alignment on levee crown. Recommend internal inspection to determine pipe integrity through levee. (O.Yakimov-DWR UCIP)10/24/2016 Unable to access WS due to heavy vegetation--assume WS remains the same or erosion has progressed but not visible from levee crown. Pipe marker found on LS slope next to 12-inch irrigation pipe indicating high pressure non-odorized natural gas pipeline however, unable to confirm if line is present or if it is parallel to levee or if it goes through levee. (O. Magana - DWR UCIP)05/16/2013 Erosion along pipe at WS toe goes into levee prism. Animal activity appears to be the cause of some pretty heavy erosion damage. Some settlement along the pipe alignment on crown may indicate other problems with this pipe. (W. Wylie - DWR UCIP)

FIELD\_STRUCT\_DESC: 12-inch irrigation steel pipe through levee 4 feet below crown. Siphon breaker is located on landside (LS) shoulder. A 7-foot by 9-foot concrete distribution box is located on LS toe. (12-inch pipe [HLM 2.60] authorized under Automatic Board Order (ABO) issued as Permit No. 11238, 1975 - Gardiner Improvement Company). (Emergency replacement of 12-inch deteriorated section of pipe through levee crown was authorized under Permit 18549, 2010 - Stockton JACS LLC, and completed 07/17/2009). Pipe section was replaced with in-kind sized pipe raised within levee crown while maintaining minimum of 2-foot cover. [Additional Reference(s): DWR Levee Log, 2005 (HLM 2.55). USACE Sacramento O&M Manual, Unit 103, June 1954, Revised 29 December 2016, (Station 'R' 182+63), listed as 12-inch pipe. USACE As-Built Drawing No. 50-04-2631, Sheet 4, Station 182+63, March 1950].  
FS Date: 6/23/2020 10:57:12 AM

Top of Levee: View of levee crown looking downstream

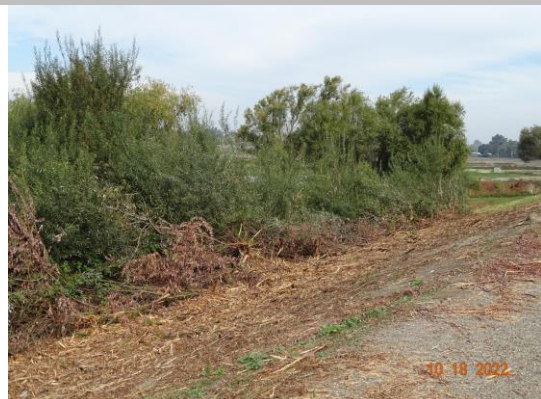
Photo 1 of 1 : SP\_2023\_NA0002\_62\_53\_20230206\_00016.jpg

View of the willows on the lower LS slope (Fall 2022).

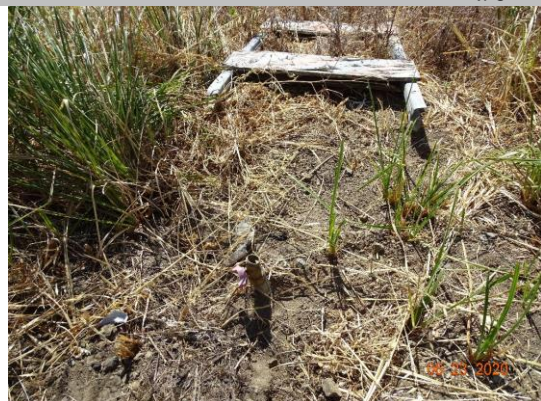
Photo 2 of 3 : UCIP\_SP\_2023\_62317\_89995.jpg

DS\_ID:21766  
FS\_ID:62317  
EP\_NO: N/A  
Repair Type: Non-Urgent  
EVAL Issue: 10, Unauthorized Modification or Non-Compliant Permit  
Crossing Status: Indicator Found  
UCIP Comments: 06/23/2020 Record remains Non-Urgent. Concrete standpipe on landside was removed. Diesel pump and media filtering facility installed on landside. Unable to find a permit for modification. Recommend owner to install a riser for siphon breaker on waterside shoulder. Pipe is running - no leaks detected. Updated coordinates of crossing. (O.Yakimov - DWR UCIP)  
05/16/2013 Appears abandoned  
FIELD\_STRUCT\_DESC: 12-inch steel irrigation pipe through the levee, at an unknown depth. 5-foot diameter concrete riser unit on the landside (LS) toe. (12-inch pipe authorized under Permit No. 13852, 1984 - A.T.J. Correia & D. Lee). [Additional Reference(s): DWR Levee Log, 2005 (HLM 2.97)].  
FS Date: 6/23/2020 11:46:59 AM

Water-Side: Siphon breaker on levee shoulder. Needs to be protected by a riser

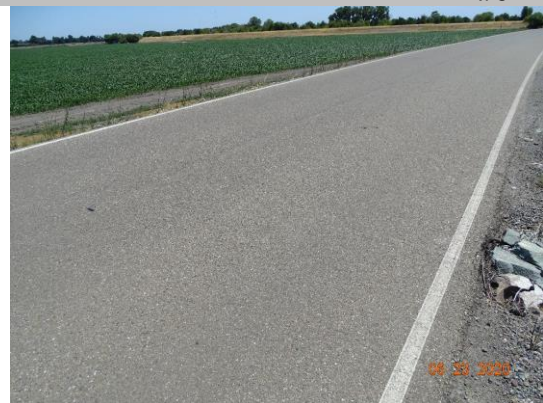
Photo 1 of 3 : UCIP\_SP\_2023\_62325\_90029.jpg

| DS_ID:21771<br>FS_ID:62325<br>EP_NO: 11238<br>Repair Type: Non-Urgent<br>EVAL Issue: 4b, Safety Issue<br>Crossing Status: Found<br>UCIP Comments: 06/23/2020 Record updated from No Action Needed<br>for avoid fall hazard. No permit has been identified authorizing<br>pipe. Need to have CVFPB review ABO and determine current owner.<br>(O.Yakimov - DWR UCIP)<br>FIELD_STRUCT_DESC: 8-inch steel irrigation pipe through the levee,<br>3.7 feet below the crown. Siphon breaker in 16-inch high-density<br>polyethylene riser unit on the landside (LS) shoulder. 36-inch diameter<br>concrete standpipe located LS of toe. (8-inch pipe [HLM 3.60]<br>authorized under Automatic Board Order (ABO) issued as Permit No.<br>11238, 1975 - Gardiner Improvement Company). [Additional<br>Reference(s): DWR Levee Log, 2005 (HLM 3.58). USACE Sacramento<br>O&M Manual, Unit 103, June 1954, Revised 29 December 2016,<br>(Station 'R' 127+98), listed as 8-inch pipe. USACE As-Built Drawing No.<br>50-04-2631, Sheet 2, Station 127+98, March 1950].<br>FS Date: 6/23/2020 4:38:39 PM | | | | | |

Top of Levee: View of levee crown looking upstream

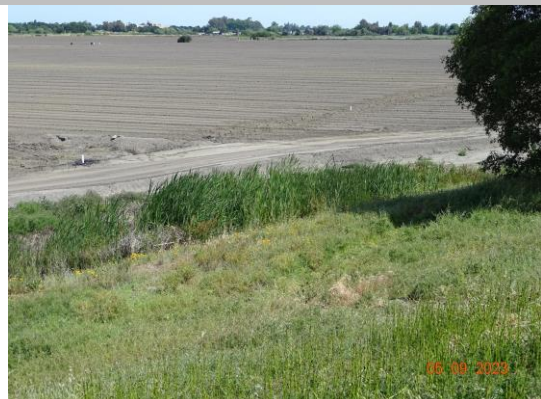
Photo 1 of 1 : SP\_2023\_NA0002\_62\_1\_20230517\_00088.jpg

| 45' wide contiuous wet spot at the landside toe. There is a ditch next to the spot but it does not look like it is the source of the moisture. | | | | | |

View of the seepage site on the LS toe (Spring 2023).

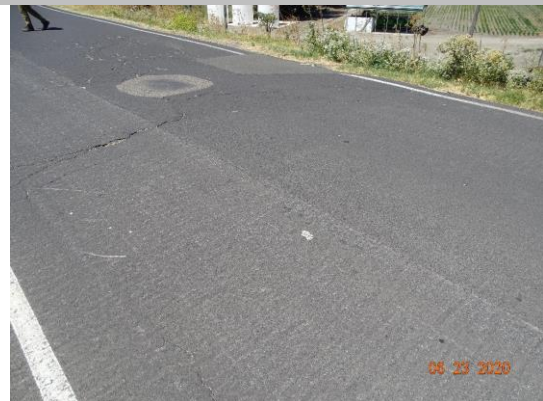
Photo 1 of 3 : UCIP\_SP\_2023\_62327\_90037.jpg

Top of Levee: View of levee crown looking downstream

DS\_ID:21772  
 FS\_ID:62327  
 EP\_NO: 11248  
 Repair Type: Non-Urgent  
 EVAL Issue: 10, Unauthorized Modification or Non-Compliant Permit  
 Crossing Status: Found  
 UCIP Comments: 06/23/2020 Record updated from No Action Needed to Non-Urgent. 20-inch steel drainage pipe sleeved through 24-inch steel pipe. Annular space between pipes seems to be grouted. Unable to find a permit for modification. Asphalt repair patches on levee crown. No permit has been identified authorizing pipe. Need to have CVFPB review ABO and determine current owner. (O.Yakimov - DWR UCIP)  
 FIELD\_STRUCT\_DESC: 20-inch steel drainage pipe sleeved through 24-inch steel pipe through the levee, 3 feet below the crown. Siphon breaker is located on the waterside (WS) slope. Pump is located on the landside (LS). (24-inch pipe [HLM 3.99] authorized under Automatic Board Order (ABO) issued as Permit No. 11248, 1975 - Reclamation District No.407). [Additional Reference(s): DWR Levee Log, 2005 (HLM 3.99), listed as 24-inch pipe. USACE Sacramento O&M Manual, Unit 103, June 1954, Revised 29 December 2016, (Station 'R' 107+76), listed as 26-inch pipe. USACE As-Built Drawing No. 50-04-2631, Sheet 2, Station 107+76, March 1950, listed as 26-inch pipe].

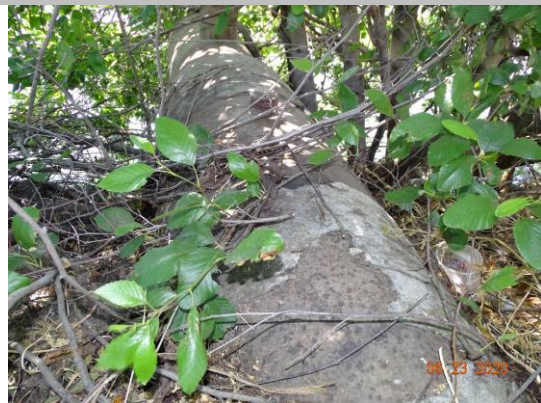
Photo 3 of 3 : UCIP\_SP\_2023\_62327\_90033.jpg

Water-Side: View of pipe at riverbank. Siphon breaker installed on the pipe at this place

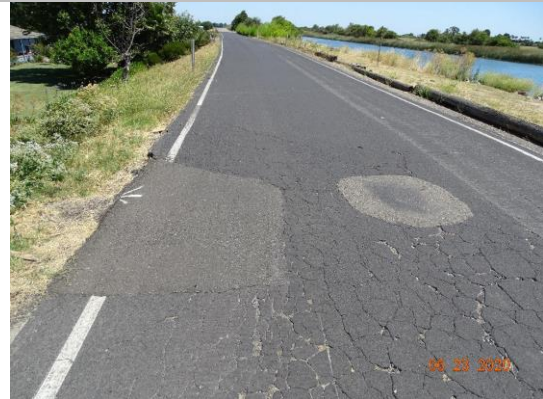
Photo 1 of 3 : UCIP\_SP\_2023\_62330\_90046.jpg

| DS_ID:21773<br>FS_ID:62330<br>EP_NO: 5534<br>Repair Type: Urgent<br>EVAL Issue: 1, Pipe Integrity<br>Crossing Status: Found<br>UCIP Comments: 06/23/2020 Record remains Urgent. Erosion site on landside shoulder has been repaired, but pipe integrity may still be compromised. Asphalt repair patches in levee crown pavement along pipe alignment. Recommend owner to perform pipe integrity test. Overgrown vegetation on landside slope limits inspection of levee at this crossing. (O.Yakimov - DWR UCIP)<br>07/12/2018 Levee crown on LS shoulder was repaved with asphalt. Dense vegetation limits visibility on LS levee slope and ability to evaluate erosion on LS. Crossing remains "Urgent". (O.Yakimov-DWR)10/24/2016 Internal erosion visible on LS where pipe daylights. LS road shoulder appears to be failing. Large sink hole patched and is visible on road/crown. Evidence of burrow activity that appear to be about 6-inches in diameter with depths greater than 3 feet. Burrow holes are located on LS hinge point just upstream of pipe and 3 holes visible on WS. Need to contact owner to address issue and recommend to stop use of crossing to avoid further damage to levee. (O. Magana - DWR UCIP)05/16/2013 Pot holes over pipe may indicate internal failure. Good candidate for video inspection. (W. Wylie - DWR UCIP) FIELD_STRUCT_DESC: 22-inch steel drainage pipe through the levee, 3 feet below the crown. Siphon breaker located on the waterside (WS) shoulder. Pump located on the landside (LS). This crossing replaces 24-inch pipe (see DSID 25663). (24-inch pipe authorized under Permit No. 5534, 1966 - Reclamation District No.407). [Additional Reference(s): DWR Levee Log, 2005 (HLM 3.99), listed as 24-inch pipe].<br>FS Date: 6/23/2020 10:47:15 AM | | | | | |

Top of Levee: View of levee crown looking upstream

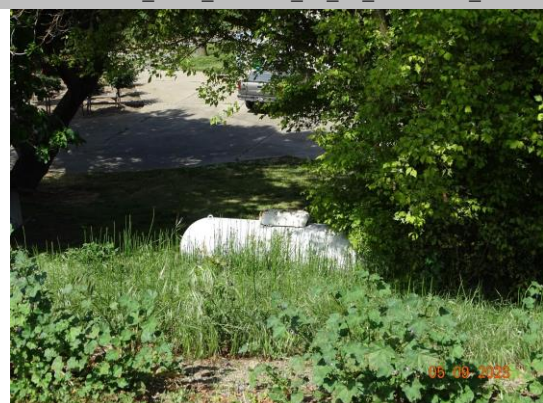
Photo 1 of 1 : SP\_2023\_NA0002\_62\_24\_20230517\_00087.jpg

View of the tank on the LS toe (Spring 2023).

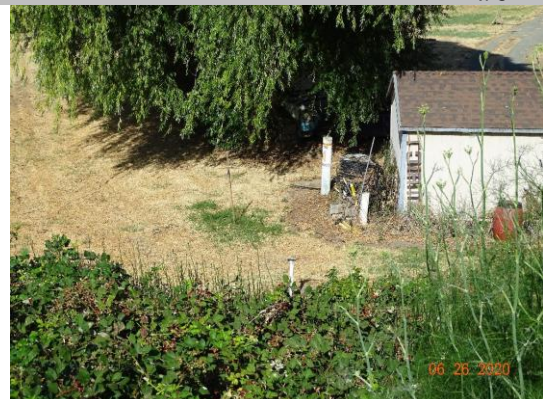
Photo 2 of 3 : UCIP\_SP\_2023\_62338\_90090.jpg

| DS_ID:21813<br>FS_ID:62338<br>EP_NO: 16762<br>Repair Type: Urgent<br>EVAL Issue: 1, Pipe Integrity<br>Crossing Status: Found<br>UCIP Comments: 06/26/2020 Record updated from No Action Needed to Urgent. Local landowner informed that leakage on landside occurs when pipe is running. Excess vegetation in pipe alignment is visible at the approximate leakage spot. Recommend pipe owner to perform pipe integrity test. (O.Yakimov - DWR UCIP)<br>FIELD_STRUCT_DESC: 10-inch steel irrigation pipe through the levee, 2 feet below the crown. Siphon breaker on the landside (LS) shoulder. Shutoff valve at the LS toe. This crossing replaces 10-inch pipe (see DSID 21779). (12-inch pipe authorized under Permit No. 16762, 1997 - Brannan Andrus Levee Maintenance District). [Additional Reference(s): DWR Levee Log, 2005 (HLM 4.21). USACE Sacramento O&M Manual, Unit 103, June 1954, Revised 29 December 2016, (Station 'R' 95+61), listed as 8-inch pipe. USACE As-Built Drawing No. 50-04-2672, Sheet 5, Station 95+61, 25 January 1951, listed as 8-inch pipe].<br>FS Date: 6/26/2020 1:25:20 PM | | | | | |

Land-Side: Levee slope. Shut-off valve at levee toe

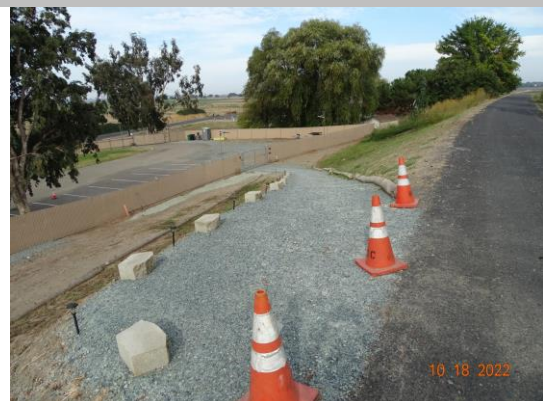
Photo 1 of 1 : SP\_2023\_NA0002\_62\_110\_20230206\_00033.jpg

View of the ramp going down the LS slope (Fall 2022).

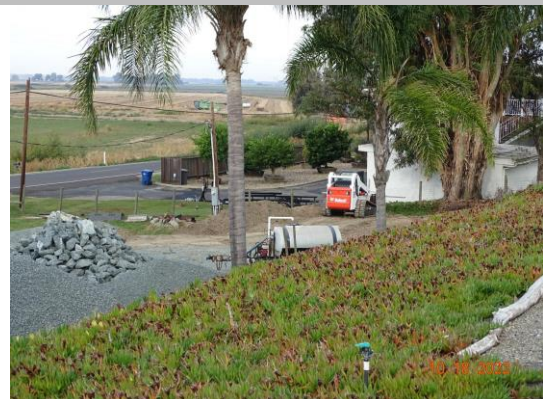
Photo 1 of 1 : SP\_2023\_NA0002\_62\_76\_20230206\_00028.jpg

View of the iceplants on the LS slope (Fall 2022).

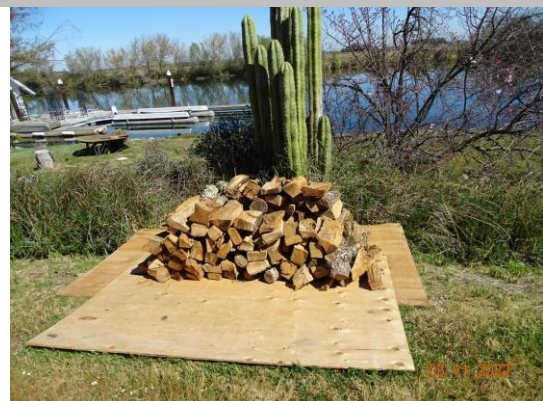
Photo 1 of 1 : SP\_2023\_NA0002\_62\_136\_20230206\_00041.jpg

View of firewood on the waterside hinge (Spring 2022).

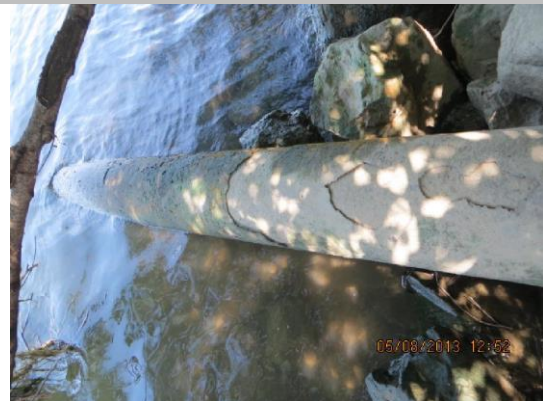
Photo 1 of 3 : UCIP\_SP\_2023\_62394\_21275.jpg

10-inch pipe at WS toe.

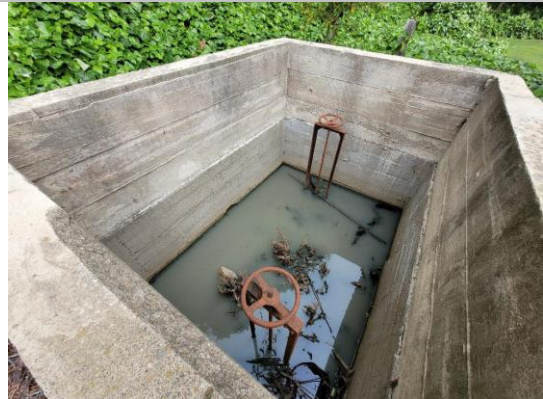
Photo 1 of 3 : UCIP\_SP\_2023\_74880\_112077.jpg

Land-Side: View inside of concrete distribution box at levee toe

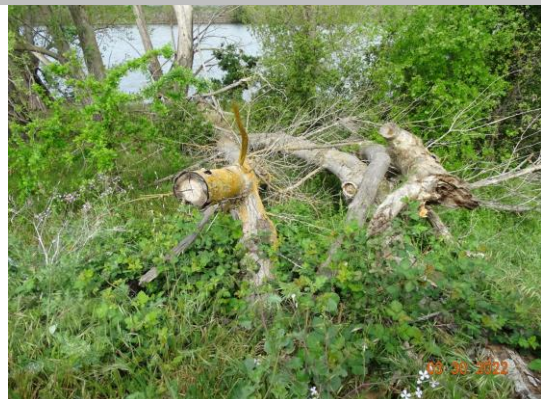
Photo 1 of 1 : SP\_2023\_NA0002\_63\_47\_20230206\_00010.jpg

View of down tree on the waterside slope (Spring 2022).

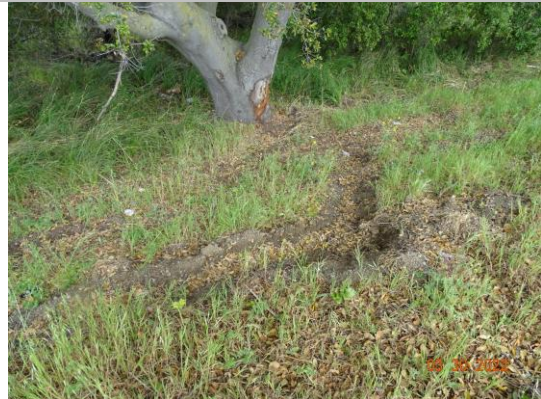
Photo 1 of 1 : SP\_2023\_NA0002\_63\_66\_20230206\_00020.jpg

View of damage due to vehicle going off the road on the waterside slope (Spring 2022).

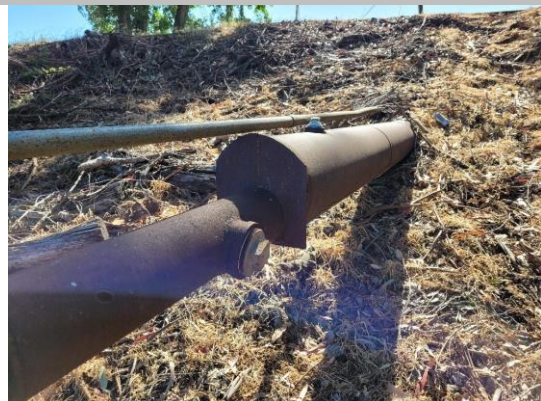
Photo 2 of 3 : UCIP\_SP\_2023\_74939\_112138.jpg

Water-Side: Sleeving point on levee slope. Annular space covered with steel plate

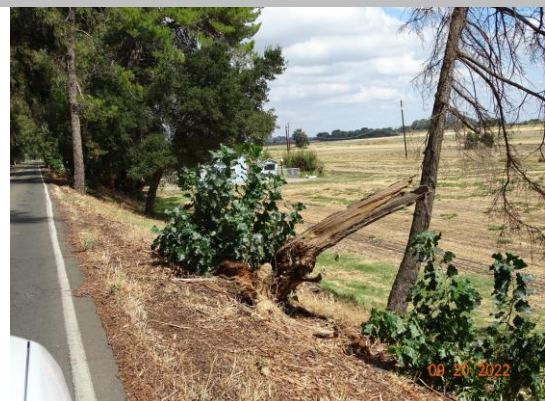
Photo 1 of 1 : SP\_2023\_NA0002\_63\_137\_20230206\_00061.jpg

View of the tree on the LS slope (Fall 2022).

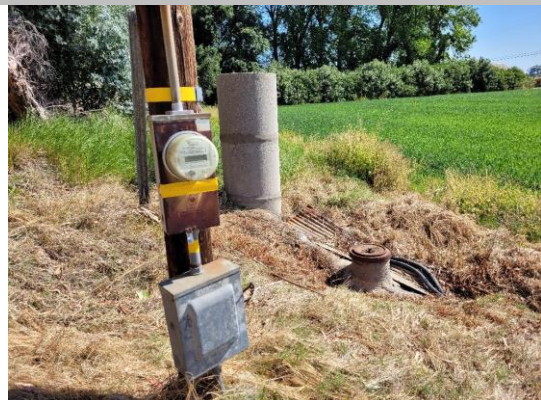
Photo 2 of 3 : UCIP\_SP\_2023\_74945\_112153.jpg

Land-Side: Service pole with electrical panel and concrete standpipe at levee toe

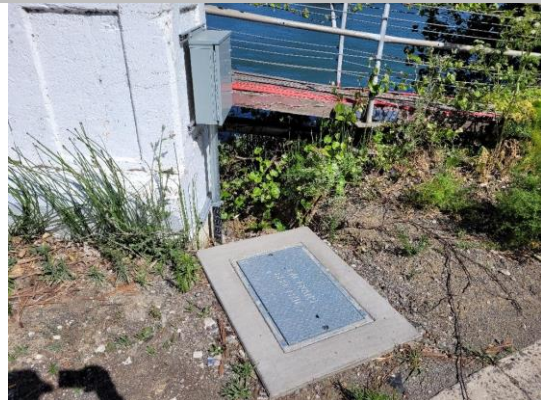
Photo 2 of 3 : UCIP\_SP\_2023\_75041\_112188.jpg

Water-Side: Electrical boxes on upstream side of bridge

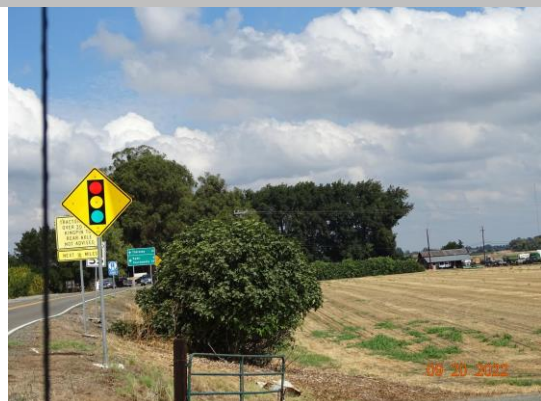
Photo 1 of 1 : SP\_2023\_NA0002\_63\_120\_20230206\_00054.jpg

View of the fig tree on the LS slope (Fall 2022).

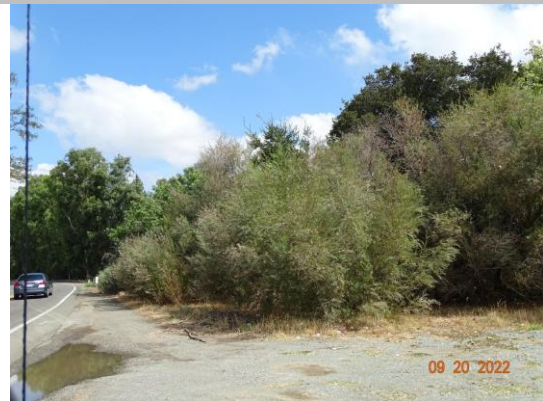
Photo 1 of 1 : SP\_2023\_NA0002\_63\_99\_20230206\_00048.jpg

View of the vegetation on the LS slope (Fall 2022).

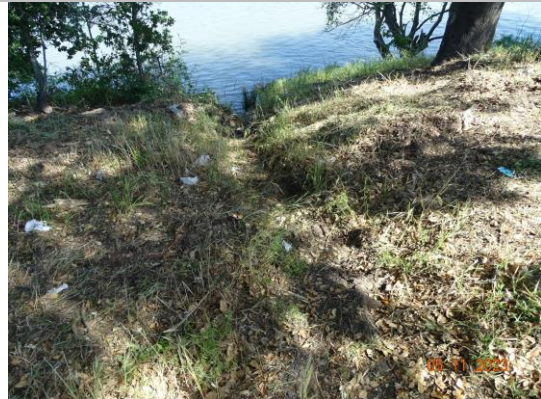
Photo 1 of 1 : SP\_2023\_NA0002\_63\_82\_20230518\_00147.jpg

View of the footpath down the WS slope (Spring 2023).

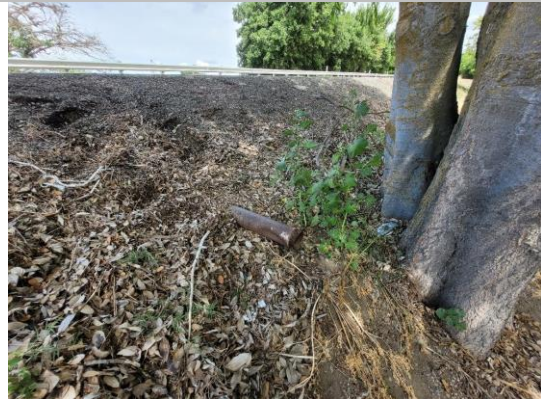
Photo 1 of 3 : UCIP\_SP\_2023\_75144\_112311.jpg

Land-Side: Open pipe end next to the tree

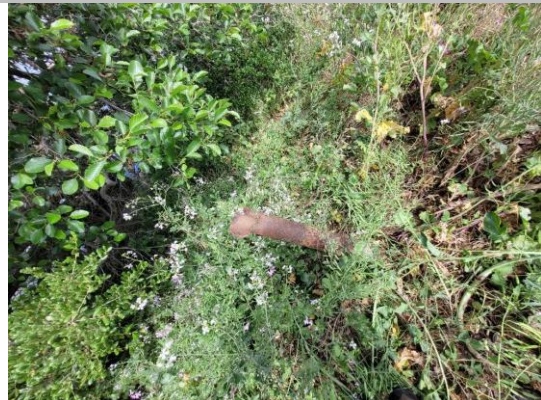
Photo 2 of 3 : UCIP\_SP\_2023\_75144\_112308.jpg

Water-Side: Pipe found on levee slope with its end open

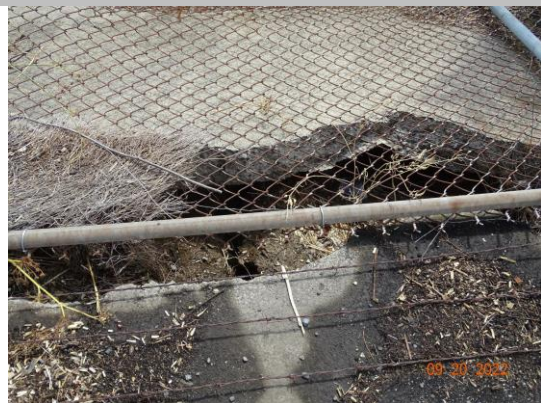
Photo 1 of 2 : SP\_2023\_NA0002\_63\_167\_20230206\_00066.jpg

View of the erosion below the crack in the concrete (Fall 2022).

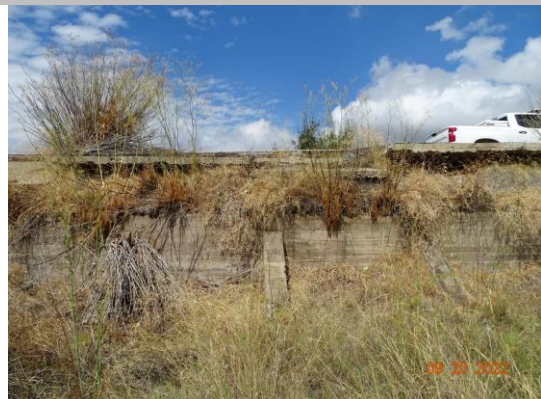
Photo 2 of 2 : SP\_2023\_NA0002\_63\_167\_20230206\_00067.jpg

Looking up the LS slope with the retaining wall in the foreground (Fall 2022).

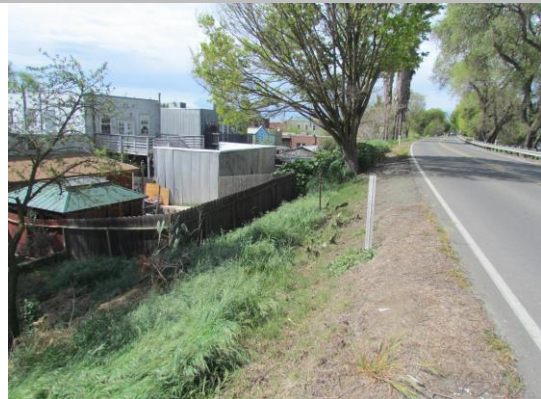
Photo 2 of 2 : SP\_2023\_NA0002\_63\_30\_20230206\_00008.jpg

Looking south at several encroachments along landward slope and toe.

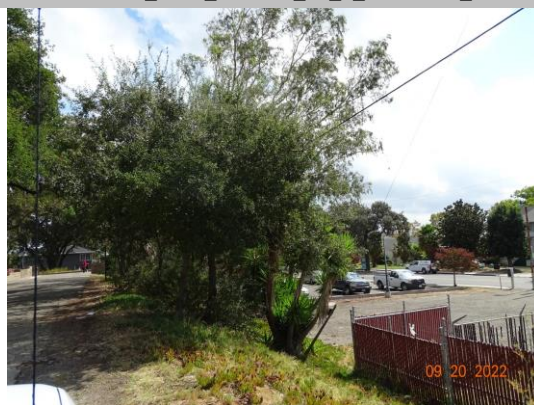
Photo 1 of 1 : SP\_2023\_NA0002\_63\_7\_20230206\_00001.jpg

View of the landscaping on the LS slope (Fall 2022).

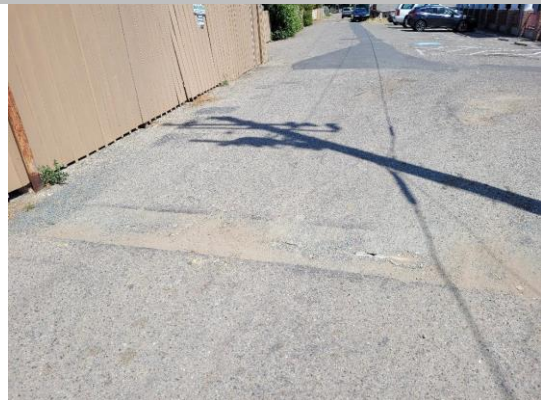
Photo 2 of 3 : UCIP\_SP\_2023\_77173\_115377.jpg

Top of Levee: Paved cut in levee crown pavement

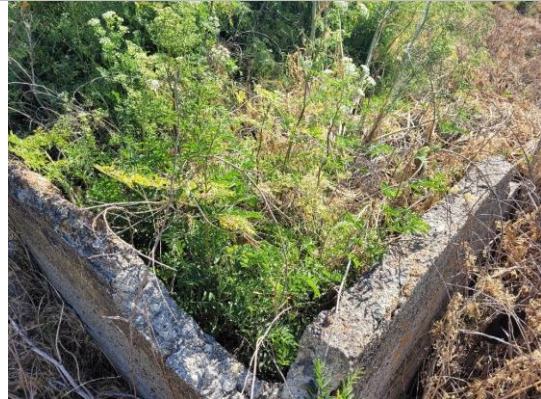
Photo 1 of 3 : UCIP\_SP\_2023\_75396\_112826.jpg

Land-Side: Concrete distribution box at levee toe missing parts of walls, filled with dirt

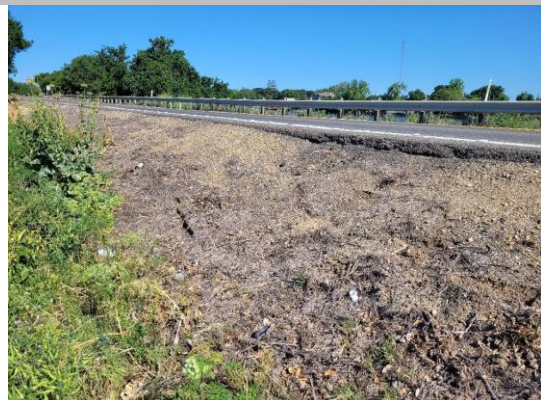
Photo 2 of 3 : UCIP\_SP\_2023\_75396\_112831.jpg

Land-Side: Another view of depression on landside slope along pipe alignment

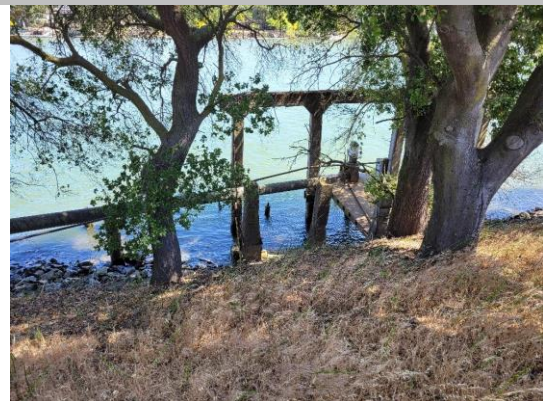
Photo 1 of 3 : UCIP\_SP\_2023\_75439\_112924.jpg

Water-Side: View of levee slope looking from crown. Pump on pier

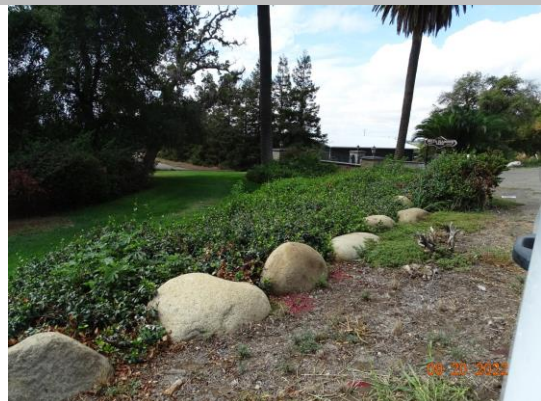
Photo 1 of 1 : SP\_2023\_NA0002\_63\_123\_20230206\_00055.jpg

View of the landscaping on the LS slope (Fall 2022).

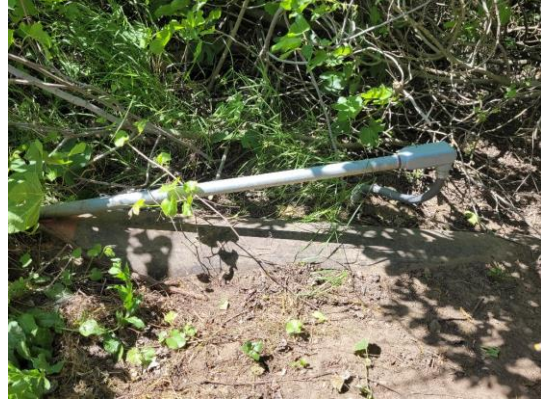
Photo 1 of 3 : UCIP\_SP\_2023\_75458\_112962.jpg

Water-Side: Electrical conduit comes out on levee slope

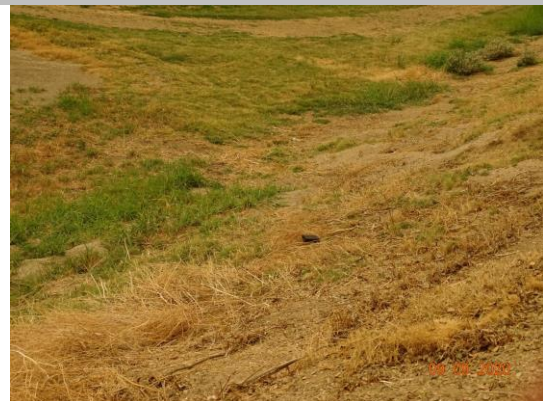
Photo 1 of 1 : SP\_2023\_NA0002\_63\_124\_20230206\_00056.jpg

View looking downstream at animal holes in the landside slope (Fall 2020).

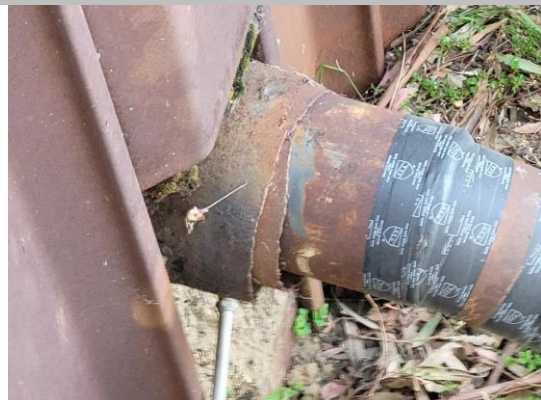
Photo 2 of 3 : UCIP\_SP\_2023\_75510\_113159.jpg

Water-Side: View of double sleeving at the retaining wall

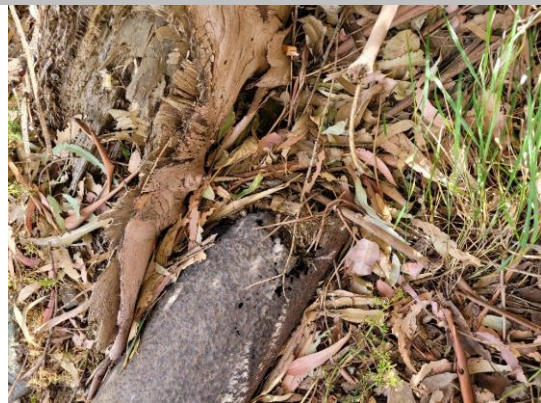
Photo 3 of 3 : UCIP\_SP\_2023\_75518\_113174.jpg

Water-Side: Through holes in pipe on levee slope

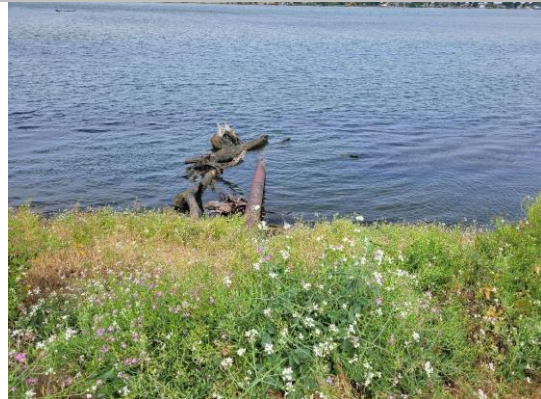
Photo 3 of 3 : UCIP\_SP\_2023\_75525\_113178.jpg

Water-Side: View of levee slope looking from crown. Erosion noted in last inspection not found

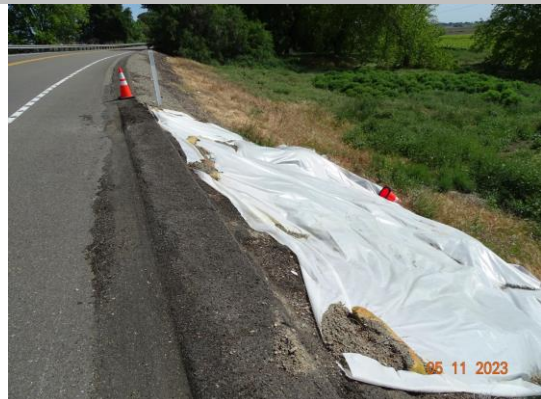
Photo 1 of 1 : SP\_2023\_NA0002\_63\_90\_20230518\_00155.jpg

View of the repaired shoulder and plastic cover on the LS slope (Spring 2023).

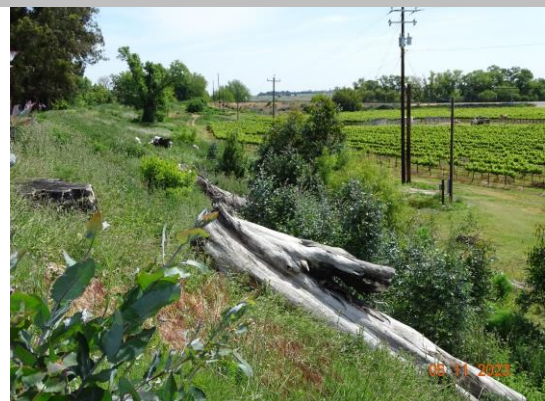
Photo 1 of 1 : SP\_2023\_NA0002\_63\_62\_20230518\_00151.jpg

View of the tree limbs on the LS slope (Spring 2023).

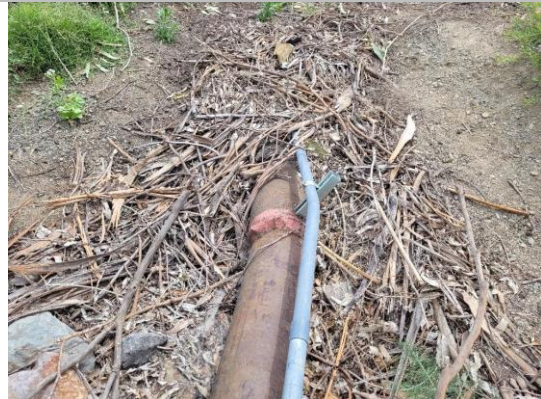
Photo 1 of 3 : UCIP\_SP\_2023\_75561\_113219.jpg

Water-Side: 8-inch welded to 10-inch pipe on levee shoulder

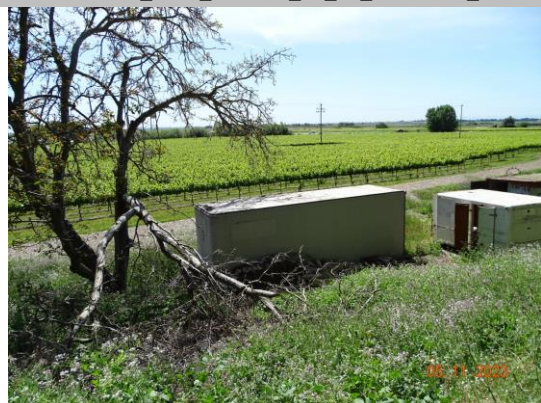
Photo 1 of 1 : SP\_2023\_NA0002\_63\_35\_20230518\_00156.jpg

View of the container on the LS toe (Spring 2023).

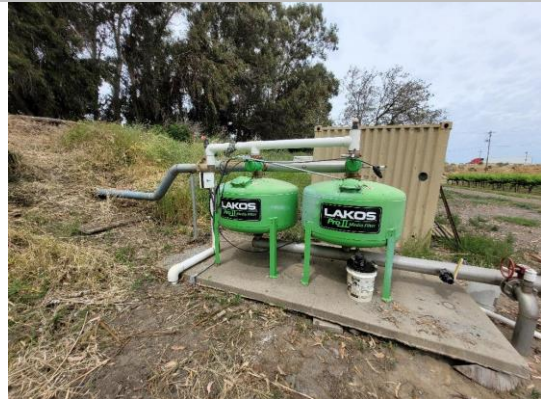
Photo 1 of 3 : UCIP\_SP\_2023\_75567\_113240.jpg

Land-Side: Sand filters installed at levee toe

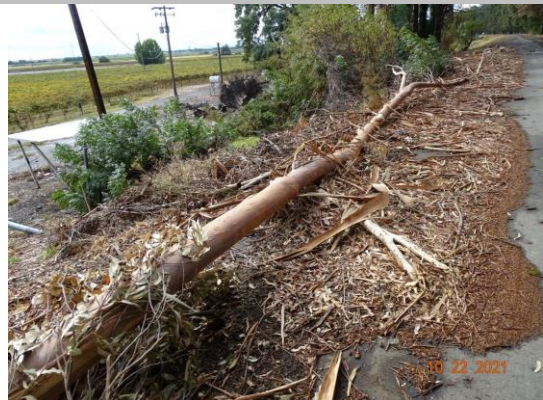
Photo 1 of 1 : SP\_2023\_NA0002\_63\_72\_20230206\_00028.jpg

View of large down tree limb on the landside hinge (Fall 2021).

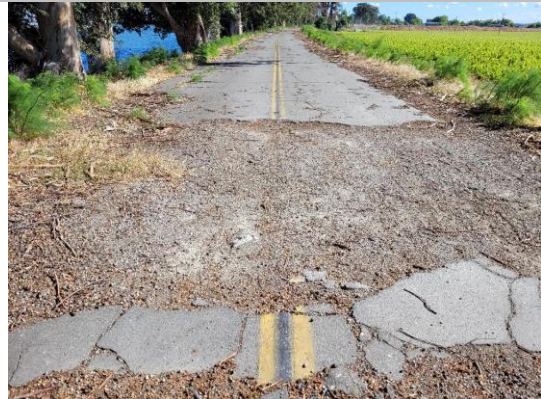
Photo 1 of 3 : UCIP\_SP\_2023\_75571\_113254.jpg

Top of Levee: View of levee crown looking upstream. Removed pavement from the top of crown in pipe alignment

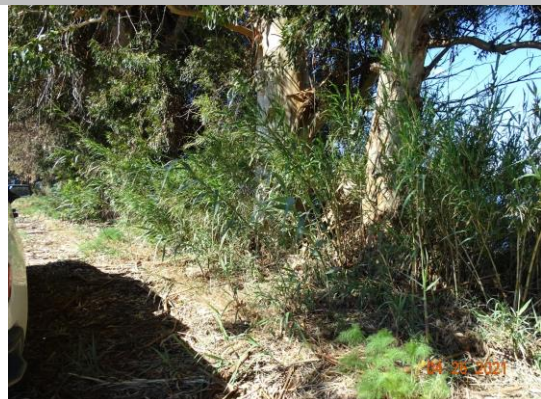
Photo 1 of 1 : SP\_2023\_NA0002\_63\_92\_20230206\_00041.jpg

View of arundo on the waterside slope (Spring 2021).

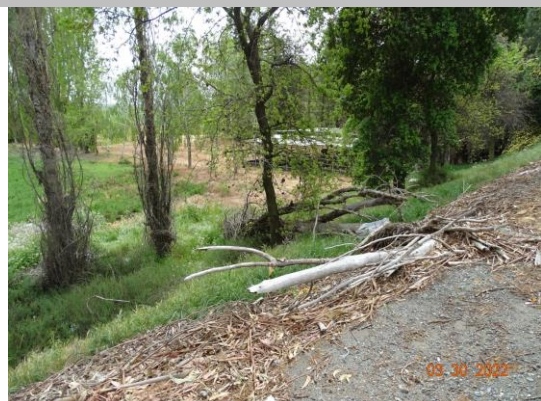
Photo 1 of 1 : SP\_2023\_NA0002\_63\_106\_20230206\_00051.jpg

View of down tree on the landside slope (Spring 2022).

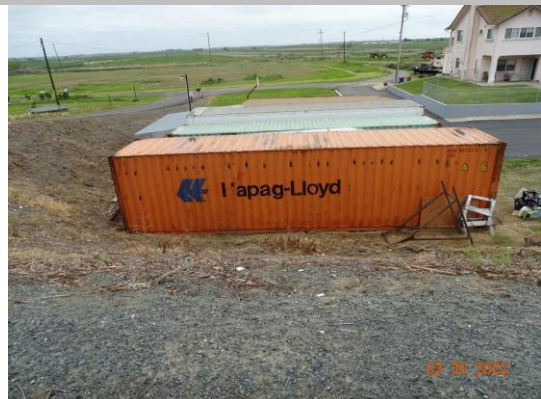
Photo 1 of 1 : SP\_2023\_NA0002\_63\_87\_20230206\_00038.jpg

View of shipping container recently placed at landside toe (Spring 2022).

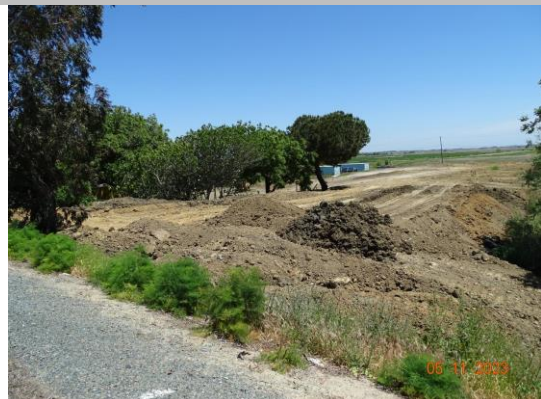
Photo 1 of 1 : SP\_2023\_NA0002\_63\_36\_20230518\_00162.jpg

View of the excavated material on the lower LS slope and toe (Spring 2023).

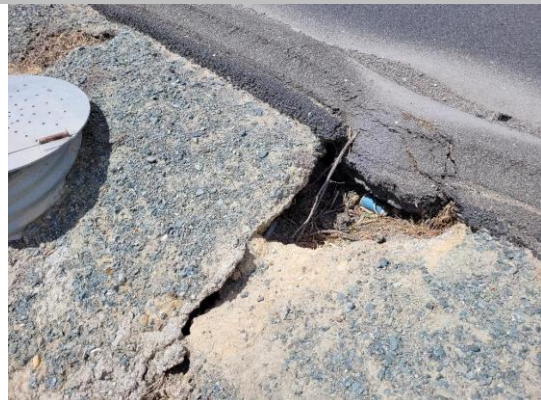
Photo 2 of 3 : UCIP\_SP\_2023\_75625\_113354.jpg

Land-Side: Erosion on levee shoulder around CMP riser
