Flood Control Project Maintenance  
Levee Inspections  
LMA District Cover Sheet

Brannan Andrus Levee Maintenance District

**Flood Control Project Maintenance  
Levee Inspections  
Unit Cover Sheet**

Waterway			Bank	Unit Miles
Unit No. 01 Georgiana Slough			Right	6.01
	Spring (March - May)	Summer (June - August)	(September - November) Fall	Winter (December - February)
Unit Maintenance Rating (Fall Only)				
Date of Inspection	4/17/2024 - 4/17/2024			
DWR Inspector	Gregg McMillon			
Accompanied By	Emily Pappalardo DCC Engineering

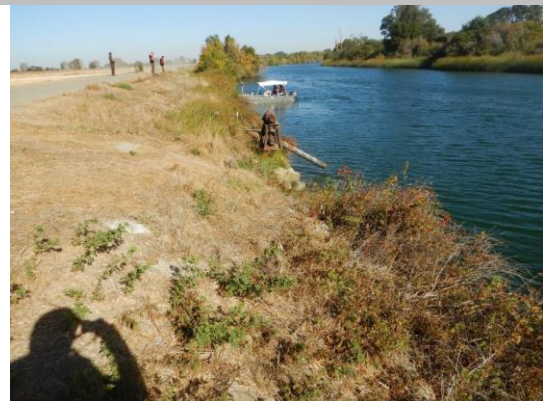
Photo 3 of 3 : SP\_2024\_NA0002\_62\_39\_20240301\_00012.jpg

LM Start	1.53	Rating **	M	Issue No.	39
LM End	1.54	Issue Type +	Ma	Location *	WS
Category	Supplemental			GPS Latitude/Longitude	
				Start	End
Item	2018 USACE Erosion Survey			38.173410°	38.173178°
				-121.580683°	-121.580622°
DWR ID	DWR_NA0002_01_s_2022_39				
Comment Code					
Inspector Comment					
2018 Site ID: GEO 5.5 R					
Status: Eroding					
2018 Field Notes: Site extended downstream.					
Site History: 2017 - Failed rock section, slump failure of bank to subvertical face.

USACE 2018 Erosion Photo #2

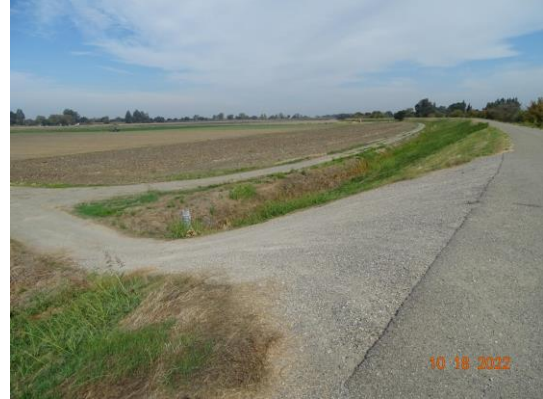
Photo 1 of 1 : SP\_2024\_NA0002\_62\_74\_20240301\_00026.jpg

View of the ramp going down the LS slope (Fall 2022).

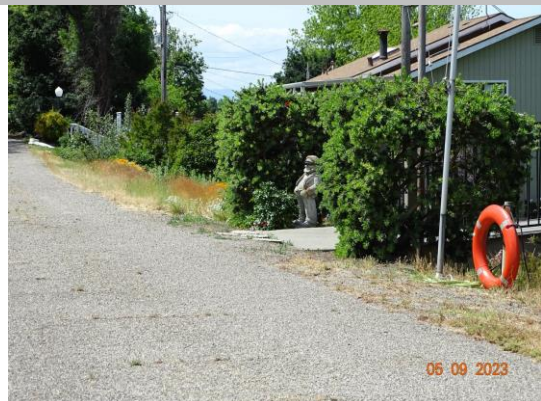
Photo 1 of 1 : SP\_2024\_NA0002\_62\_25\_20240301\_00007.jpg

View of the landscaping on the LS slope (Spring 2023).

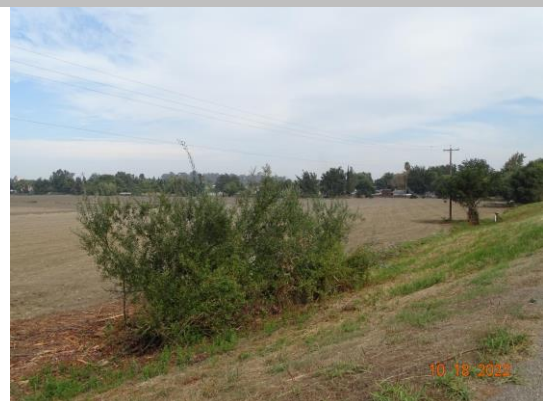
Photo 1 of 1 : SP\_2024\_NA0002\_62\_52\_20240301\_00016.jpg

View of the tree on the LS slope (Fall 2022).

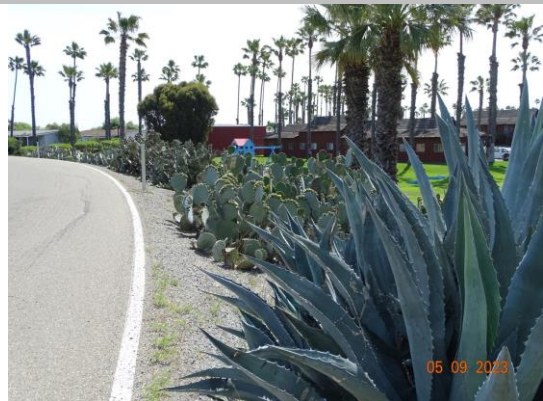
Photo 1 of 1 : SP\_2024\_NA0002\_62\_5\_20240301\_00003.jpg

View of the cactus on the WS slope (Spring 2023).

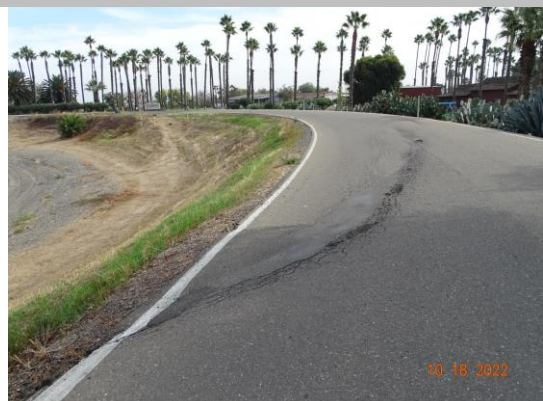
Photo 1 of 1 : SP\_2024\_NA0002\_62\_67\_20240301\_00024.jpg

LM Start	3.38	Rating **	A/W	Issue No.	67
LM End	3.40	Issue Type +	Ma	Location *	CR
Category	Earthen Levee			GPS Latitude/Longitude	
				Start	End
Item	Slope Stability			38.151430°	38.151390°
				-121.592085°	-121.592517°
DWR ID	DWR_NA0002_01_s_2017_67				
Comment Code					
S1 : Repair slope instability.					
Inspector Comment					
Appears to be beginning of a landslide slump. LMA's Engineer (DCC) is monitoring site for movement.

View of the depression on the levee crown (Fall 2022).

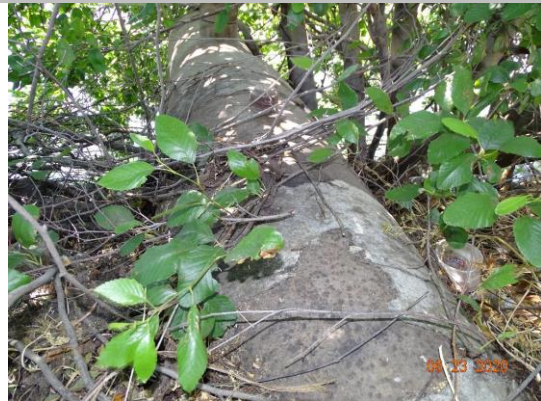
Photo 3 of 3 : UCIP\_SP\_2024\_62327\_90033.jpg

Water-Side: View of pipe at riverbank. Siphon breaker installed on the pipe at this place

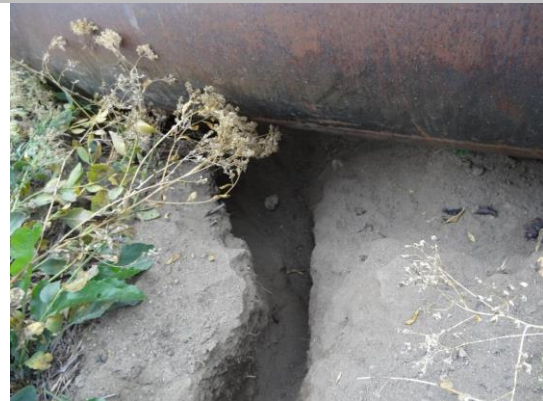
Photo 3 of 3 : UCIP\_SP\_2024\_62330\_76442.jpg

Comment Code					
Inspector Comment					
DS_ID:21773 FS_ID:62330 EP_NO: 5534 Repair Type: Urgent EVAL Issue: 1, Pipe Integrity Crossing Status: Found UCIP Comments: 06/23/2020 Record remains Urgent. Erosion site on landside shoulder has been repaired, but pipe integrity may still be compromised. Asphalt repair patches in levee crown pavement along pipe alignment. Recommend owner to perform pipe integrity test. Overgrown vegetation on landside slope limits inspection of levee at this crossing. (O.Yakimov - DWR UCIP) 07/12/2018 Levee crown on LS shoulder was repaved with asphalt. Dense vegetation limits visibility on LS levee slope and ability to evaluate erosion on LS. Crossing remains "Urgent". (O.Yakimov-DWR)10/24/2016 Internal erosion visible on LS where pipe daylights. LS road shoulder appears to be failing. Large sink hole patched and is visible on road/crown. Evidence of burrow activity that appear to be about 6-inches in diameter with depths greater than 3 feet. Burrow holes are located on LS hinge point just upstream of pipe and 3 holes visible on WS. Need to contact owner to address issue and recommend to stop use of crossing to avoid further damage to levee. (O. Magana - DWR UCIP)05/16/2013 Pot holes over pipe may indicate internal failure. Good candidate for video inspection. (W. Wylie - DWR UCIP) FIELD_STRUCT_DESC: 22-inch steel drainage pipe through the levee, 3 feet below the crown. Siphon breaker located on the waterside (WS) shoulder. Pump located on the landside (LS). This crossing replaces 24-inch pipe (see DSID 25663). (24-inch pipe authorized under Permit No. 5534, 1966 - Reclamation District No.407). [Additional Reference(s): DWR Levee Log, 2005 (HLM 3.99), listed as 24-inch pipe]. FS Date: 6/23/2020 10:47:15 AM

Evidence of internal erosion visible on LS.

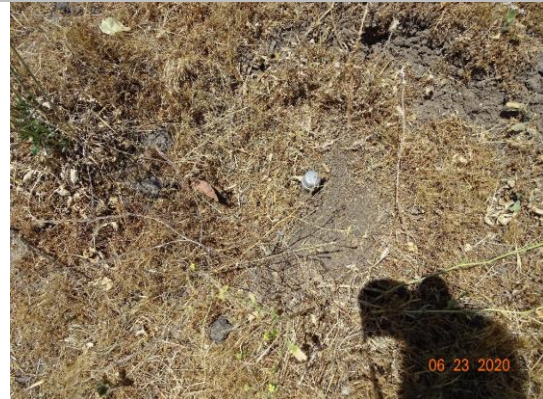
Photo 1 of 3 : UCIP\_SP\_2024\_62331\_90057.jpg

DS\_ID:21774  
FS\_ID:62331  
EP\_NO: 11238  
Repair Type: Non-Urgent  
EVAL Issue: 10, Unauthorized Modification or Non-Compliant Permit  
Crossing Status: Found  
UCIP Comments: 06/23/2020 Record remains Non-Urgent. Scour hole around air release pipe on waterside shoulder has been repaired, pipe is capped. Flanged coupler installed on pipe on landside levee shoulder and a new pipe put on landside levee slope to pumping plant bypassing concrete standpipe. Concrete standpipe with slide gate is abandoned. Diesel pump and media filtering facility installed on landside off levee toe. Unable to find a permit for modification. No permit has been identified authorizing pipe. Need to have CVFPB review ABO and determine current owner. (O.Yakimov - DWR UCIP)  
10/24/2016 Unable to determine if WS primer pipe is leaking or if settling is occurring at pipe. Need to contact owner to determine when upgrades to WS were completed. (O. Magana - DWR UCIP)

Land-Side: Air vent/primer line on levee shoulder

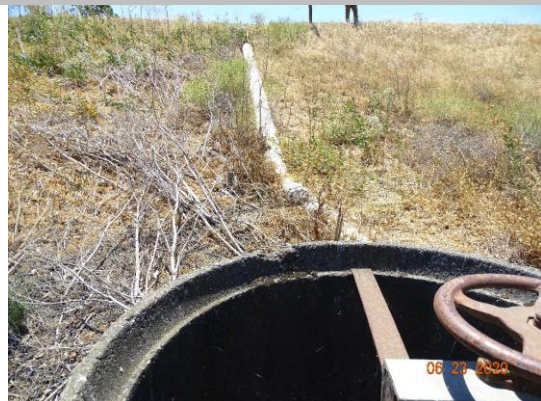
Photo 3 of 3 : UCIP\_SP\_2024\_62331\_90058.jpg

Land-Side: Abandoned concrete standpipe and levee slope on background

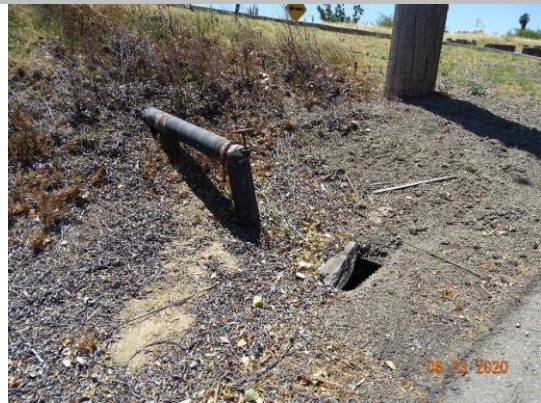
Photo 3 of 3 : UCIP\_SP\_2024\_62333\_90062.jpg

DS\_ID:21775  
FS\_ID:62333  
EP\_NO: 11238  
Repair Type: Urgent  
EVAL Issue: 2b, Levee Integrity  
Crossing Status: Found  
UCIP Comments: 06/23/2020 Record remains Urgent. Levee slope subsidence in pipe alignment on landside is more than 2-feet-deep. Sinkhole on waterside shoulder at public road pavement keeps growing and measures 3' x 2' x 0.75' deep. Missing cover on the top of vault at landside toe creates fall hazard. No permit has been identified authorizing pipe. Need to have CVFPB review ABO and determine current owner. (O.Yakimov - DWR UCIP)  
07/12/2018 Hole on LS shoulder under concrete blocks is still present, although haven't increased in size. Part of cover on concrete sump is still missing which is public safety issue. Crossing remain "Urgent" because of potential pipe failure signs. Recommend internal inspection to determine condition of pipe through levee. (DWR-O.Yakimov)  
12/30/2016 Left message with Ms. Cabral to inform her that we are working with LMA to find additional information about crossing. Spoke with Andy Giannini, LMA representative, regarding the UCIP report and Mr. Giannini believes the hole is due to ground squirrel activity. According to Mr. Giannini, the issue with ground squirrel has been resolved and the hole filled. Records indicate pipe was installed in the 1950s and authorized under Permit No. 11238 in 1975. This pipe could be about 62 years old. Crossing remains Urgent due to the uncertainty of pipe integrity through levee. Recommend having owner complete an internal inspection of the pipe through the levee to determine integrity of pipe. (O. Magana - DWR UCIP)12/28/2016 Contacted Andy Giannini, LMA representative, and provided him with UCIP report to review. (O. Magana - DWR UCIP)12/27/2016 Contacted Rebecca Cabral, property sales agent from Century 21 Farm & Ranch M&M and Associates, at 1-707-374-3900 to inquire about the property owner for this area. Mrs. Cabral was unaware of pipe through levee and has requested photos to share with client. She was not able to provide me with the current property owner information but mentioned that she will contact me next week (week ending Jan 6, 2017). (O. Magana - DWR UCIP)10/24/2016 Section of cover is still missing. Potential pipe failure through levee. Sink hole is present on LS shoulder. Need to contact owner to stop use of pipe to avoid further damage to levee. Recommend internal inspection of pipe to determine integrity of pipe wall. (O. Magana - DWR UCIP)05/08/2013 Missing cover on concrete sump is an immediate hazard and should be repaired. (W. Wylie - DWR UCIP)

Land-Side: Open concrete spill box, pipe and levee slope

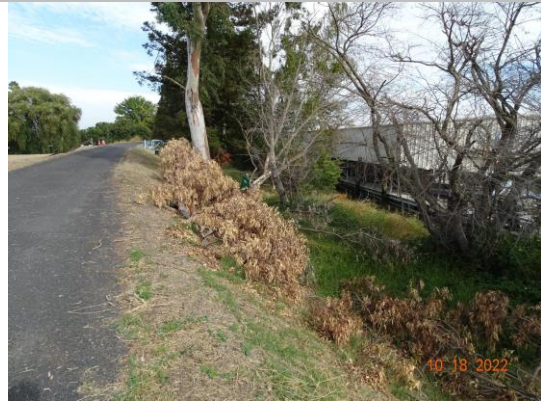
Photo 1 of 1 : SP\_2024\_NA0002\_62\_108\_20240301\_00029.jpg

View of the tree limbs on the WS slope (Fall 2022).

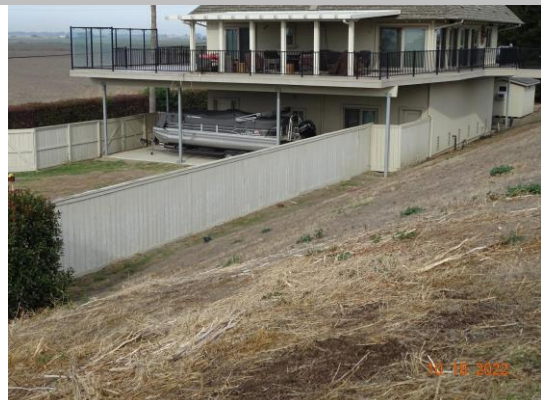
Photo 1 of 1 : SP\_2024\_NA0002\_62\_48\_20240301\_00014.jpg

View of the fence on the LS toe (Fall 2022).

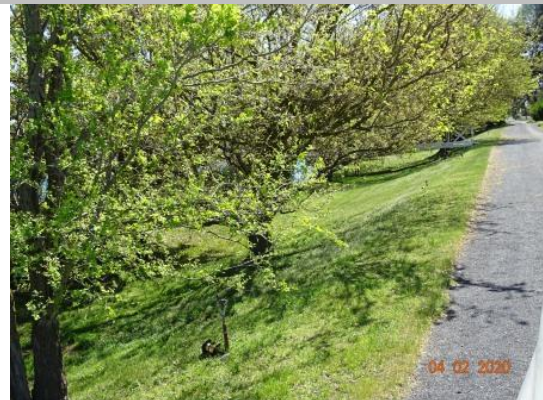
Photo 1 of 1 : SP\_2024\_NA0002\_62\_54\_20240301\_00017.jpg

View looking downstream at sprinklers on the waterside slope (Spring 2020).

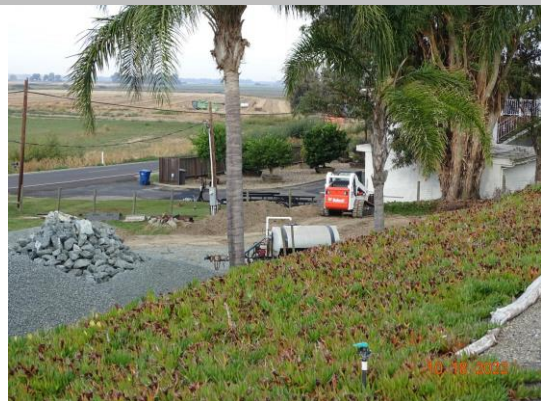
Photo 1 of 1 : SP\_2024\_NA0002\_62\_76\_20240301\_00027.jpg

View of the iceplants on the LS slope (Fall 2022).

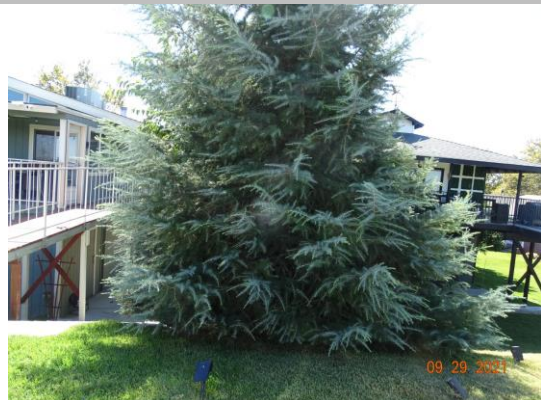
Photo 1 of 1 : SP\_2024\_NA0002\_62\_118\_20240301\_00034.jpg

View of landscaping tree on the landside slope (Fall 2021).

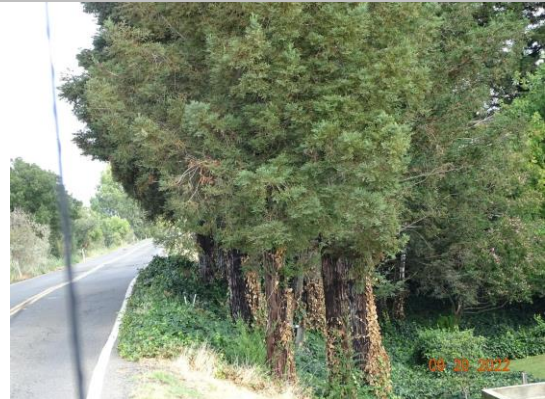
Photo 1 of 1 : SP\_2024\_NA0002\_63\_8\_20240301\_00002.jpg

View of the landscaping on the LS shoulder and slope (Fall 2022).

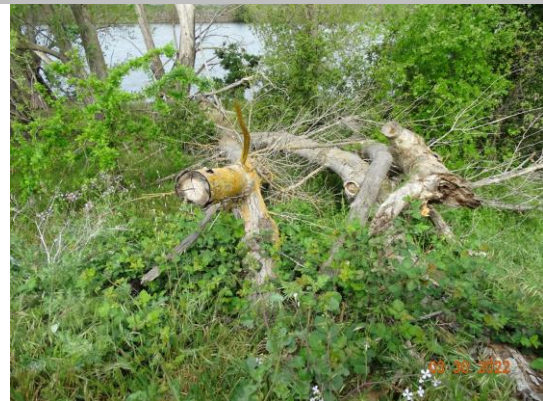
Photo 1 of 1 : SP\_2024\_NA0002\_63\_47\_20240301\_00014.jpg

View of downed tree on the waterside slope (Spring 2022).

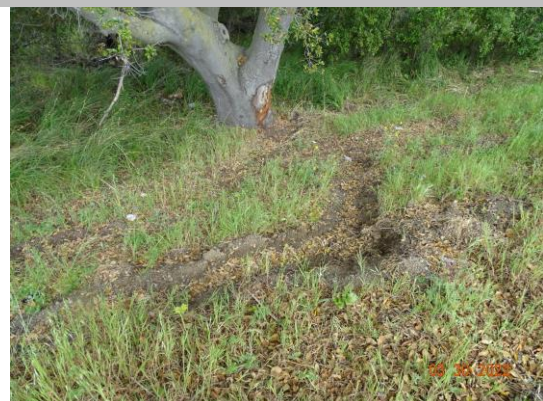
Photo 1 of 1 : SP\_2024\_NA0002\_63\_66\_20240301\_00023.jpg

View of damage due to vehicle going off the road on the waterside slope (Spring 2022).

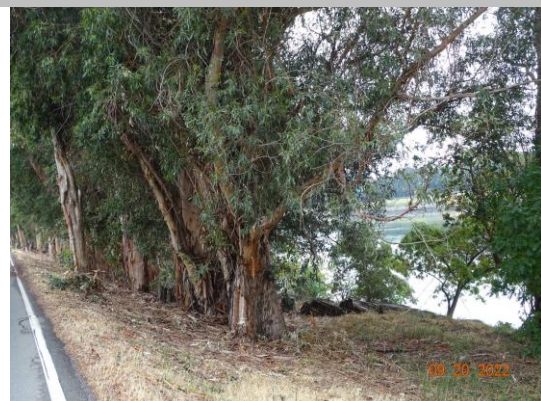
Photo 1 of 1 : SP\_2024\_NA0002\_63\_78\_20240301\_00036.jpg

View of the stump and logs on the WS slope (Fall 2022).

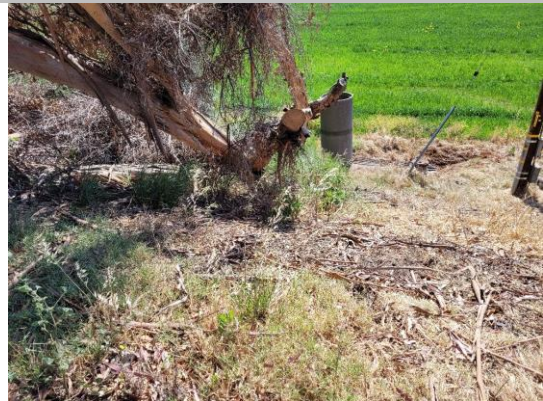
Photo 1 of 3 : UCIP\_SP\_2024\_74945\_112152.jpg

Land-Side: View of levee slope looking from crown. CMP riser buried in debris on levee slope

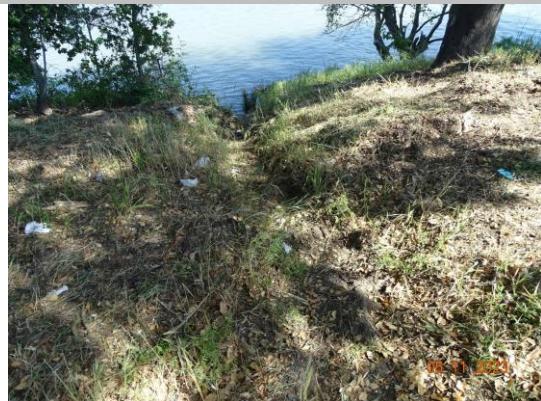
Photo 1 of 1 : SP\_2024\_NA0002\_63\_82\_20240301\_00039.jpg

View of the footpath down the WS slope (Spring 2023).

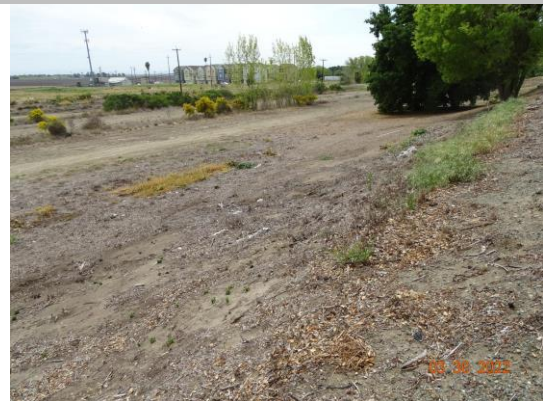
Photo 1 of 1 : SP\_2024\_NA0002\_63\_104\_20240301\_00052.jpg

View of animal holes on the landside slope (Spring 2022).

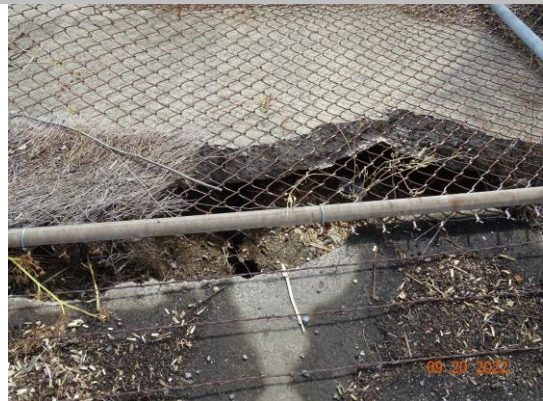
Photo 1 of 2 : SP\_2024\_NA0002\_63\_167\_20240301\_00067.jpg

View of the erosion below the crack in the concrete (Fall 2022).

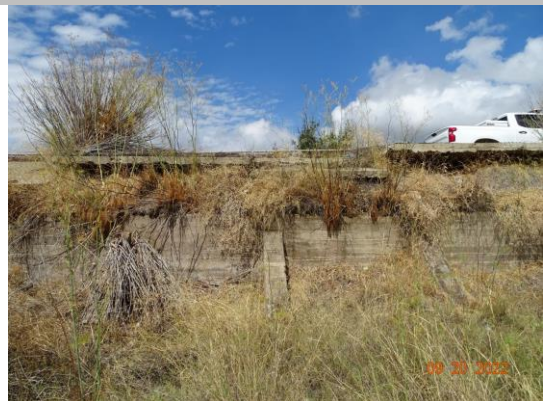
Photo 2 of 2 : SP\_2024\_NA0002\_63\_167\_20240301\_00068.jpg

Looking up the LS slope with the retaining wall in the foreground (Fall 2022).

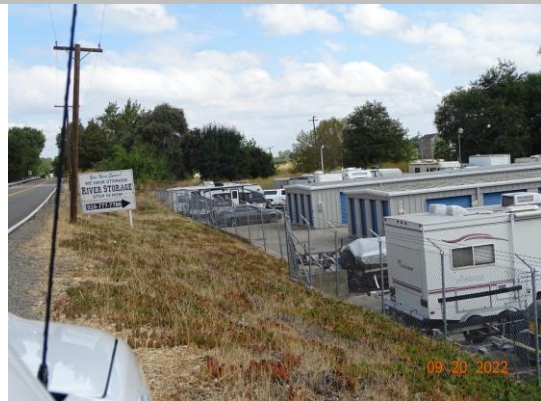
Photo 1 of 1 : SP\_2024\_NA0002\_63\_94\_20240301\_00046.jpg

View of the fence along the LS toe (Fall 2022).

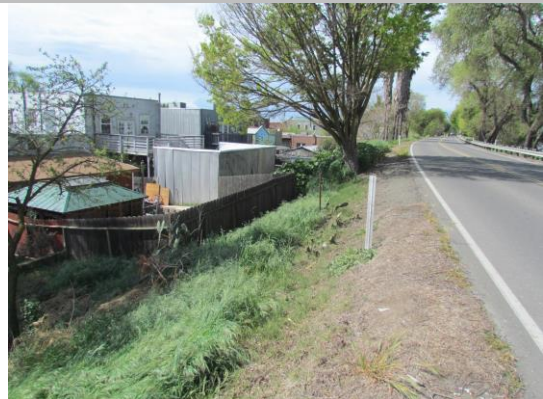
Photo 2 of 2 : SP\_2024\_NA0002\_63\_30\_20240301\_00008.jpg

Looking south at several encroachments along landward slope and toe.

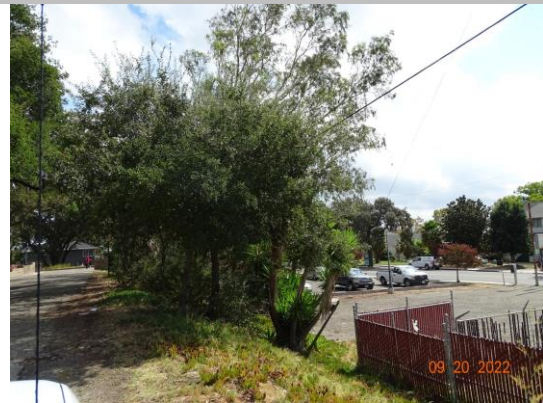
Photo 1 of 1 : SP\_2024\_NA0002\_63\_7\_20240301\_00001.jpg

View of the landscaping on the LS slope (Fall 2022).

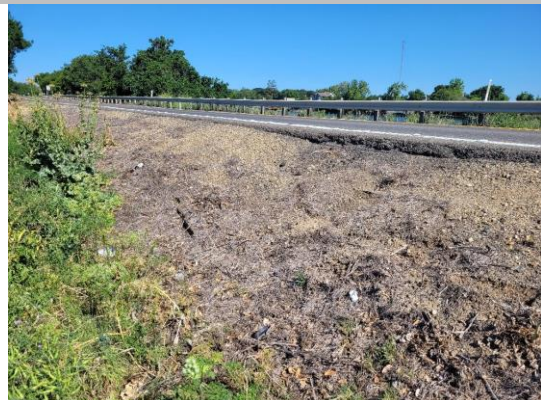
Photo 2 of 3 : UCIP\_SP\_2024\_75396\_112831.jpg

Land-Side: Another view of depression on landside slope along pipe alignment

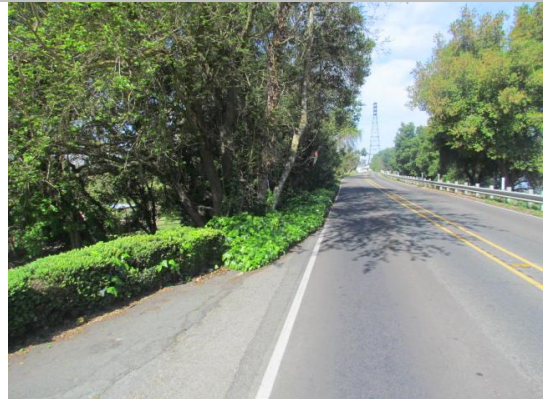
Photo 1 of 1 : SP\_2024\_NA0002\_63\_59\_20240301\_00019.jpg

Looking west at dense landscaping on landward slope.

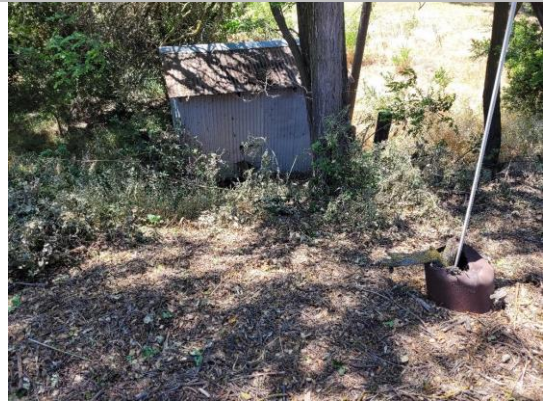
Photo 2 of 3 : UCIP\_SP\_2024\_78969\_112950.jpg

Land-Side: View of levee slope looking from crown. Pumphouse at the toe, damaged steel riser on the slope

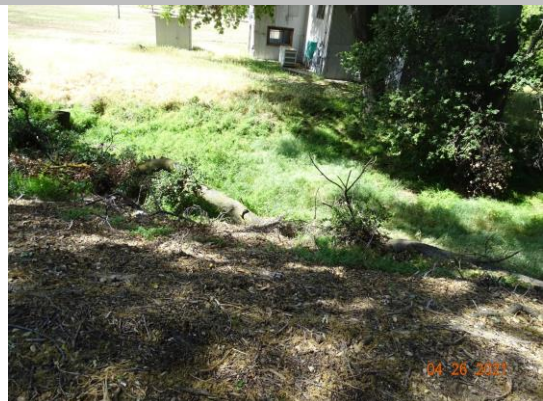
Photo 1 of 1 : SP\_2024\_NA0002\_63\_169\_20240301\_00069.jpg

View of downed tree limb on the landside slope (Spring 2021).

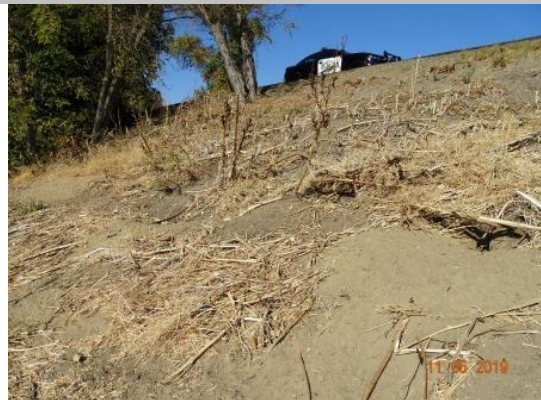
Photo 1 of 1 : SP\_2024\_NA0002\_63\_128\_20240301\_00059.jpg

View of multiple large squirrel holes in landside slope (Fall 2019).

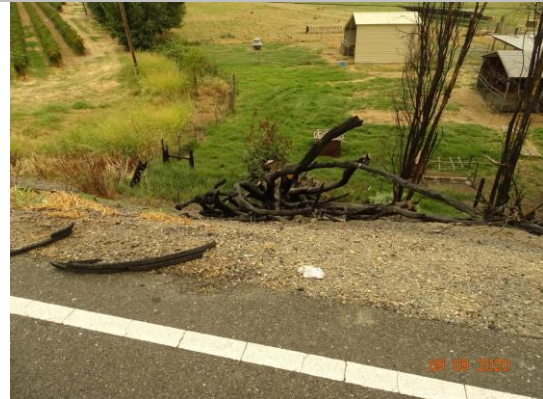
Photo 1 of 1 : SP\_2024\_NA0002\_63\_84\_20240301\_00040.jpg

View looking downslope at burned tree on the landside slope (Fall 2020).

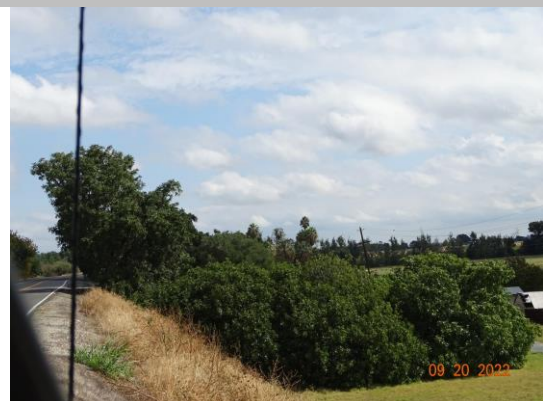
Photo 1 of 1 : SP\_2024\_NA0002\_63\_118\_20240301\_00055.jpg

View of the fig tree on the LS slope (Fall 2022).

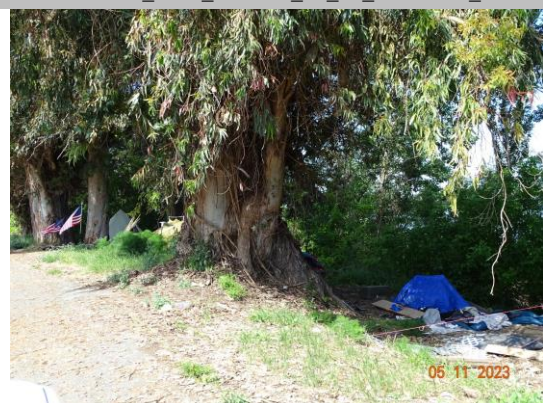
Photo 1 of 1 : SP\_2024\_NA0002\_63\_34\_20240301\_00009.jpg

View of the tents on the WS slope (Spring 2023).

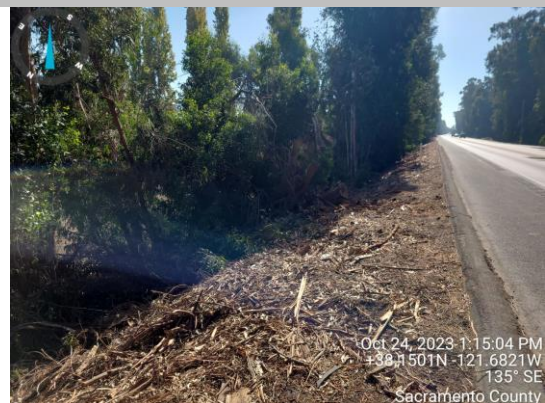
Photo 1 of 1 : SP\_2024\_NA0002\_63\_158\_20240301\_00064.jpg

View of downed trees on the landside slope. Fall 2023.

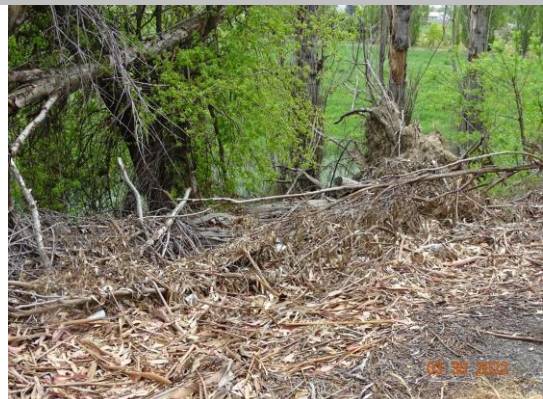
Photo 1 of 1 : SP\_2024\_NA0002\_63\_157\_20240301\_00063.jpg

View of downed tree on the landside slope (Spring 2022).

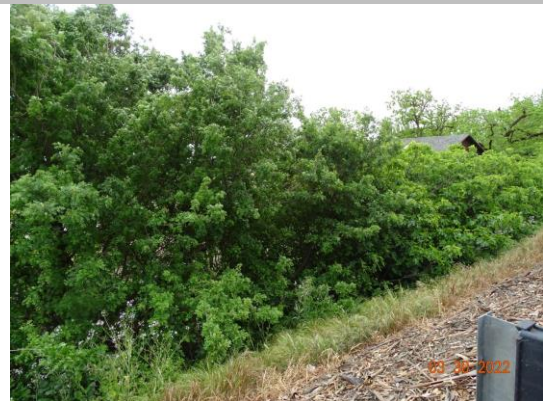
Photo 1 of 1 : SP\_2024\_NA0002\_63\_85\_20240301\_00041.jpg

View of thick trees on the landside slope (Spring 2022).

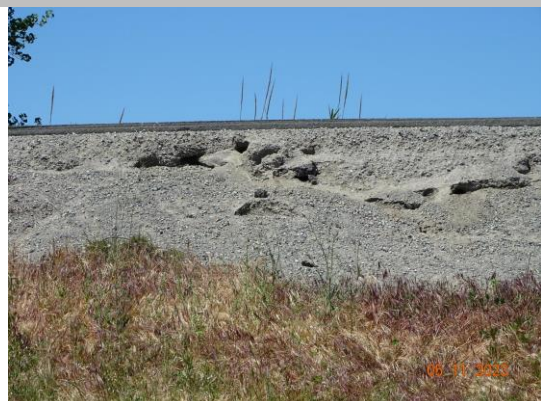
Photo 1 of 1 : SP\_2024\_NA0002\_63\_67\_20240301\_00024.jpg

View of rodent holes on the upper LS slope (Spring 2023).
