**Flood Control Project Maintenance  
Levee Inspections**

## Maintenance Issue Types Only, Levee Inspection Report By Mile - Spring 2015

### Brannan Andrus Levee Maintenance District

Waterway	Bank	Unit Miles	Inspection Start/End	Inspector
Unit No. 01 Georgiana Slough	Right	6.01	03/11/2015 03/11/2015	Richard Willoughby

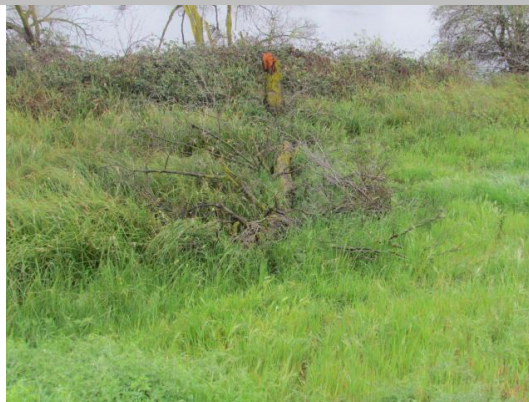
Photo 1 of 1 : SP\_2015\_NA0002\_62\_59\_20150313\_00053.jpg

Looking east at downed tree on waterward toe.

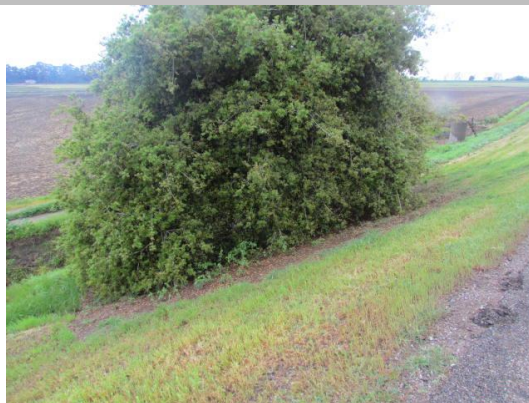
Photo 1 of 3 : SP\_2015\_NA0002\_62\_25\_20150313\_00055.jpg

Looking northwest at untrimmed tree at landward toe. (Spring 2015)

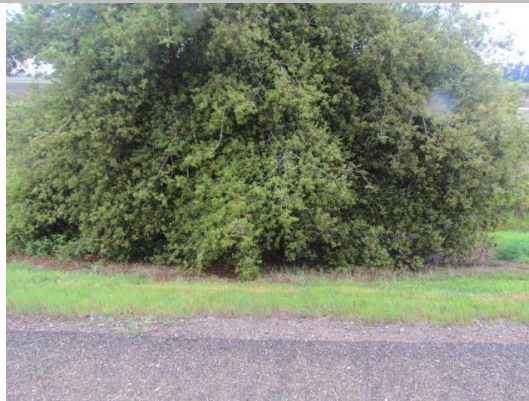
Photo 2 of 3 : SP\_2015\_NA0002\_62\_25\_20150313\_00054.jpg

Looking west at untrimmed tree at landward toe. (Spring 2015)

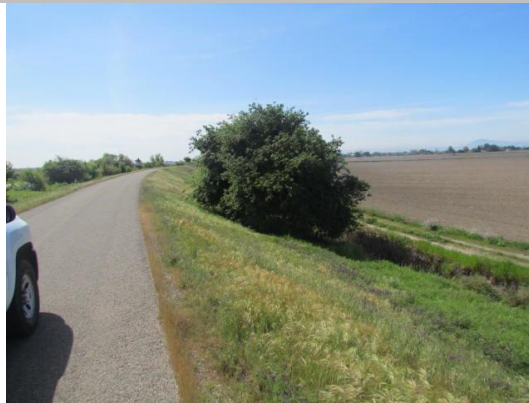
Photo 3 of 3 : SP\_2015\_NA0002\_62\_25\_20150309\_00020.jpg

Looking southwest at an untrimmed tree on landward slope and toe.  
(Spring 2014)

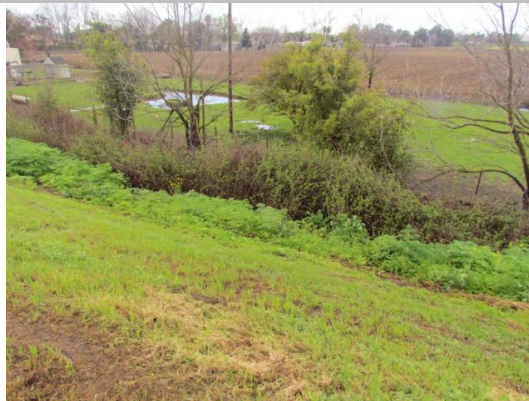
Photo 1 of 1 : SP\_2015\_NA0002\_62\_26\_20150313\_00056.jpg

Looking southwest at dense vegetation at landward toe.

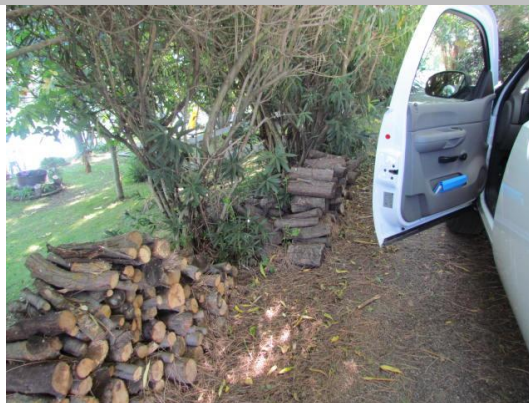
Photo 1 of 3 : SP\_2015\_NA0002\_62\_3\_20150309\_00002.jpg

Looking east at firewood on waterside shoulder.

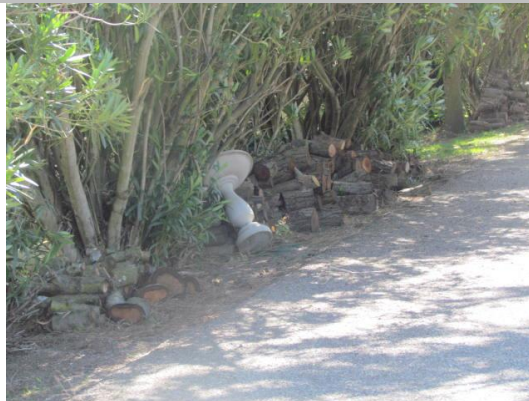
Photo 2 of 3 : SP\_2015\_NA0002\_62\_3\_20150309\_00003.jpg

Looking southeast at firewood on waterside shoulder.

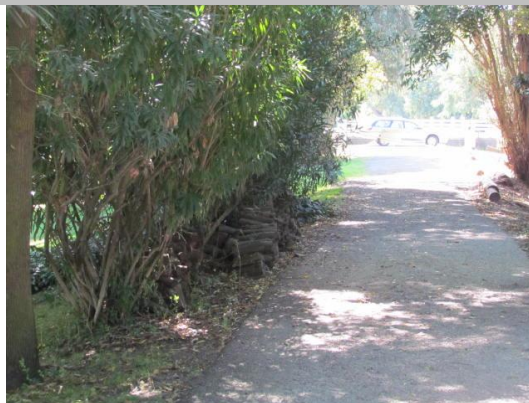
Photo 3 of 3 : SP\_2015\_NA0002\_62\_3\_20150309\_00004.jpg

Looking south at firewood on waterside shoulder.

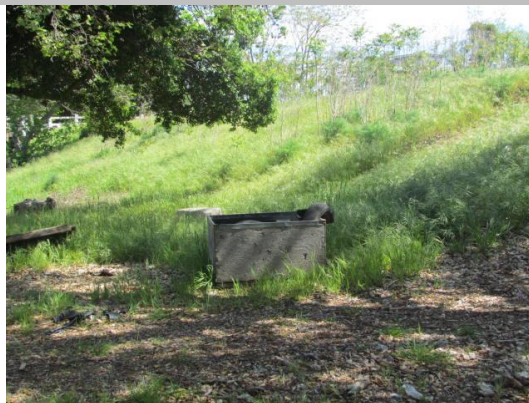
Photo 1 of 1 : SP\_2015\_NA0002\_62\_8\_20150309\_00007.jpg

Looking northeast at garbage at landward toe.

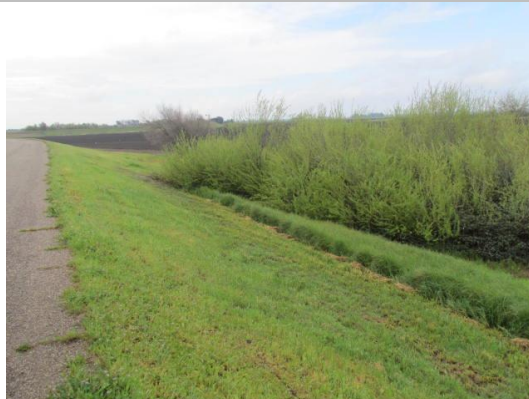
Photo 1 of 3 : SP\_2015\_NA0002\_62\_55\_20150313\_00058.jpg

Looking southwest at dense vegetation at landward toe. (Spring 2015)

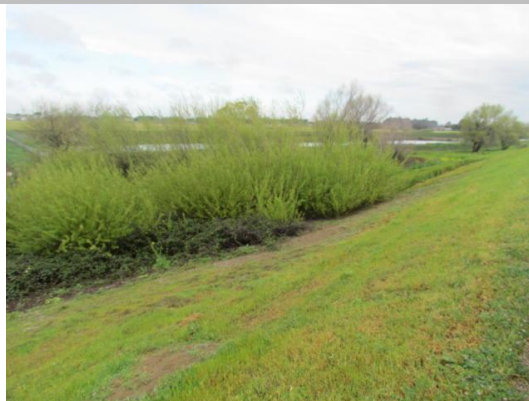
Photo 2 of 3 : SP\_2015\_NA0002\_62\_55\_20150313\_00059.jpg

Looking north at dense vegetation withing fifteen feet of landward toe.

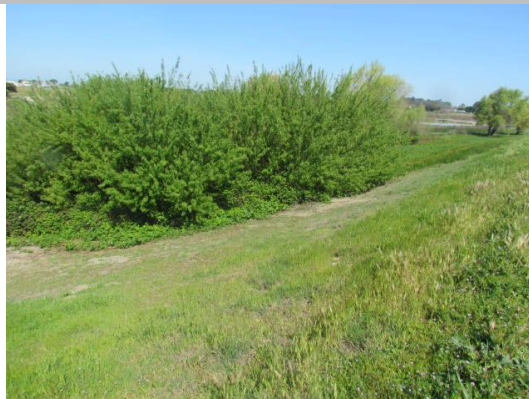
Photo 3 of 3 : SP\_2015\_NA0002\_62\_55\_20150309\_00035.jpg

Looking north at dense vegetation within fifteen feet of landward toe.

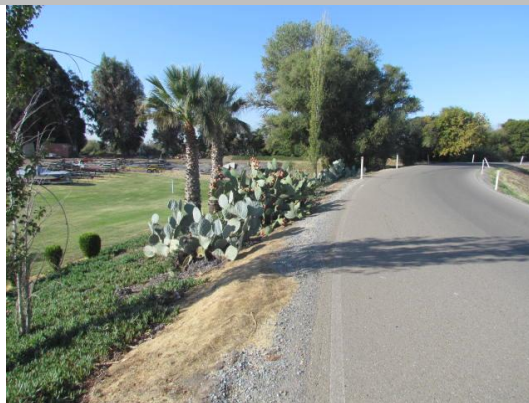
Photo 1 of 1 : SP\_2015\_NA0002\_62\_5\_20150309\_00006.jpg

Looking south at cacti on waterward slope near Oxbow Harbor.

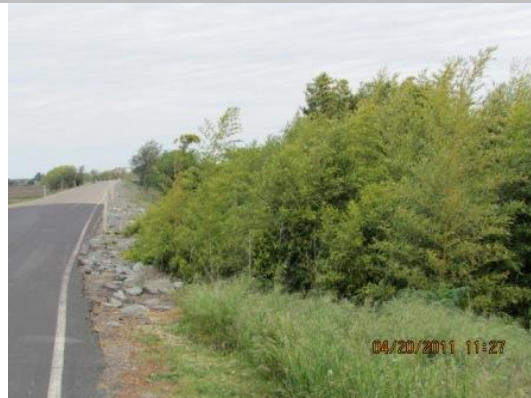
Photo 1 of 3 : SP\_2015\_NA0002\_62\_10\_20150309\_00008.jpg

Looking west at dense vegetation on waterside slope.

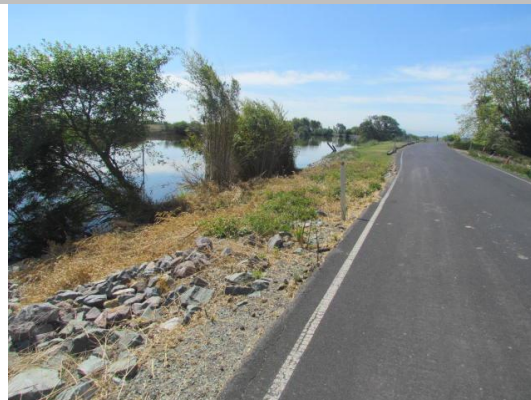
Photo 2 of 3 : SP\_2015\_NA0002\_62\_10\_20150309\_00009.jpg

Looking south at dead willows on waterward slope. (Spring 2013)

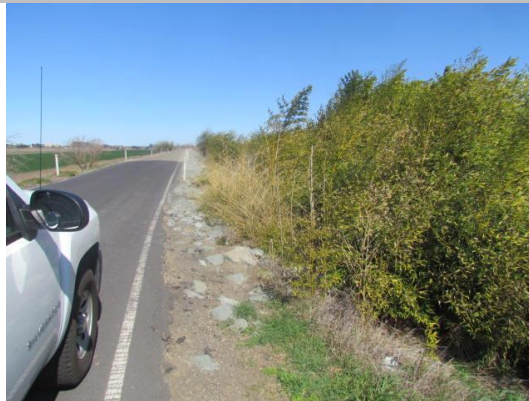
Photo 3 of 3 : SP\_2015\_NA0002\_62\_10\_20150309\_00010.jpg

Looking west at dense vegetation on waterside slope spring 2012.

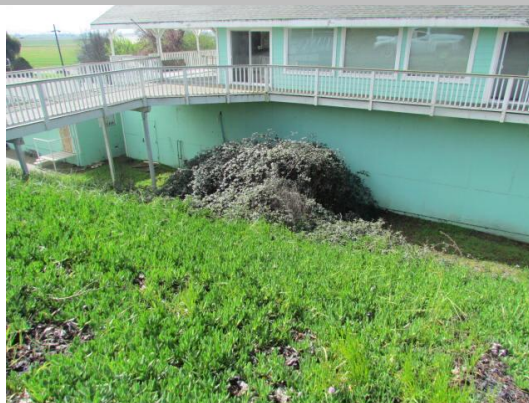
Photo 1 of 1 : SP\_2015\_NA0002\_62\_1\_20150313\_00060.jpg

Looking west at dense vegetation at landward toe. (Spring 2015)

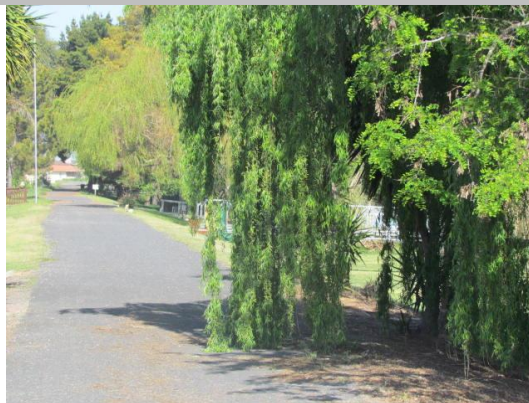
Photo 1 of 1 : SP\_2015\_NA0002\_62\_31\_20150309\_00022.jpg

Looking north at overhanging tree limbs on landward shoulder.

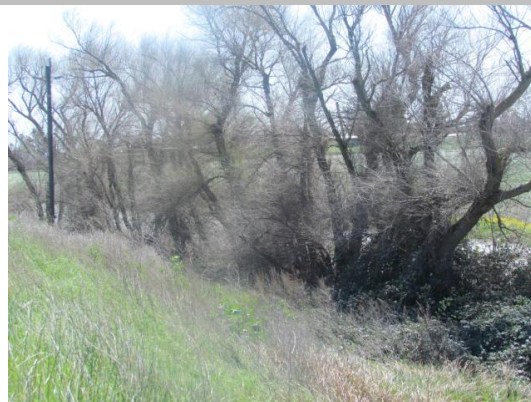
Photo 1 of 3 : SP\_2015\_NA0002\_62\_23\_20150309\_00016.jpg

Looking south at trees, berry vines, and wild rose on landside toe.

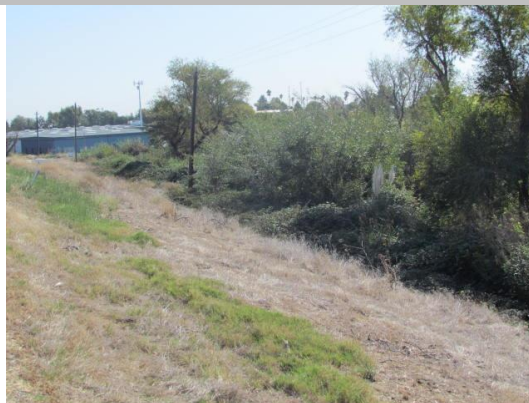
Photo 2 of 3 : SP\_2015\_NA0002\_62\_23\_20150309\_00017.jpg

Looking east at dense vegetation on landward toe.

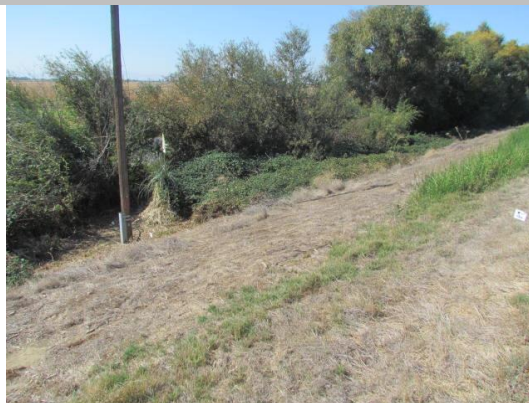
Photo 3 of 3 : SP\_2015\_NA0002\_62\_23\_20150309\_00018.jpg

Looking south at dense berry vines and trees on the landward slope and toe.

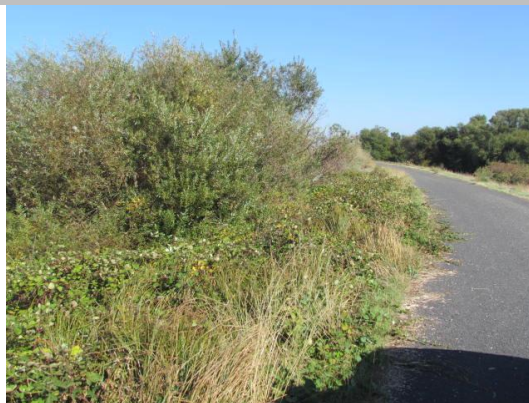
Photo 1 of 1 : SP\_2015\_NA0002\_62\_18\_20150309\_00014.jpg

Looking south at dense vegetation on waterside slope.

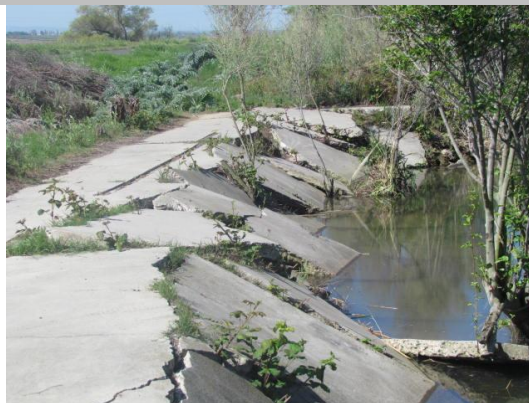
Photo 1 of 4 : SP\_2015\_NA0002\_62\_53\_20150309\_00031.jpg

LM Start	5.72	Rating **	M	Issue No.	53
LM End	5.72	Issue Type +	Ma	Location *	WS
Category	Earthen Levee			GPS Latitude/Longitude	
				Start	End
Item	Encroachments				o
					o
DWR ID	DWR_NA0002_01_s _ 2014_53				
Action/Comments					
Material Inspector Comments: Concrete slabs on water ward berm area. Possible undermining. The Slab should be removed or broken up in place to meet Title 23 standard for Rip Rap.

Looking north at a collapsed concrete slab on waterward berm.

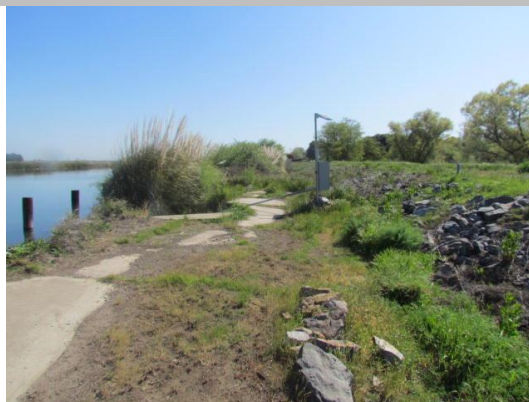
Photo 2 of 4 : SP\_2015\_NA0002\_62\_53\_20150309\_00032.jpg

Looking south at south end of a concrete slab on waterward berm.

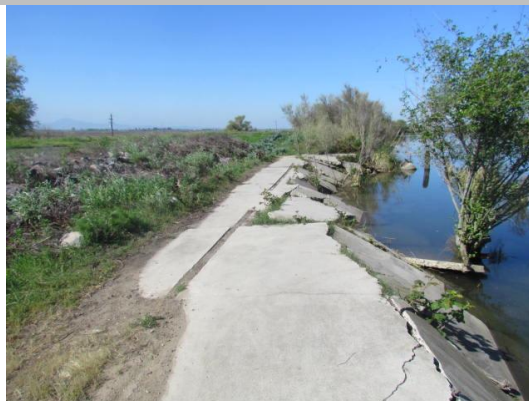
Photo 3 of 4 : SP\_2015\_NA0002\_62\_53\_20150309\_00033.jpg

LM Start	5.72	Rating **	M	Issue No.	53 (cont)		
LM End	5.72	Issue Type +	Ma	Location *	WS		
Category	Earthen Levee			GPS Latitude/Longitude			
				Start	End		
Item	Encroachments				°		°
					°		°
DWR ID	DWR_NA0002_01_s_2014_53						
Action/Comments							
Material							
Inspector Comments: Concrete slabs on water ward berm area.							
Possible undermining. The Slab should be removed or broken up in							
place to meet Title 23 standard for Rip Rap.

Looking north at a collapsed concrete slab on waterward berm.

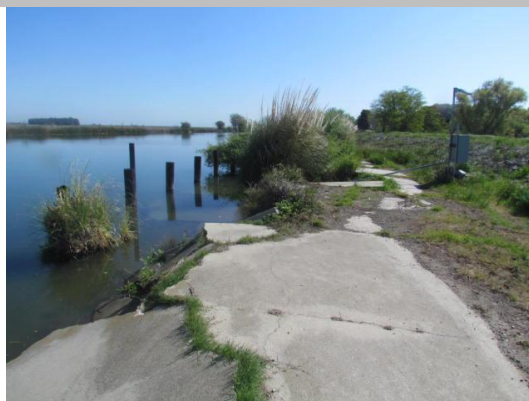
Photo 4 of 4 : SP\_2015\_NA0002\_62\_53\_20150309\_00034.jpg

Looking south at a collapsed concrete slab on waterward berm.

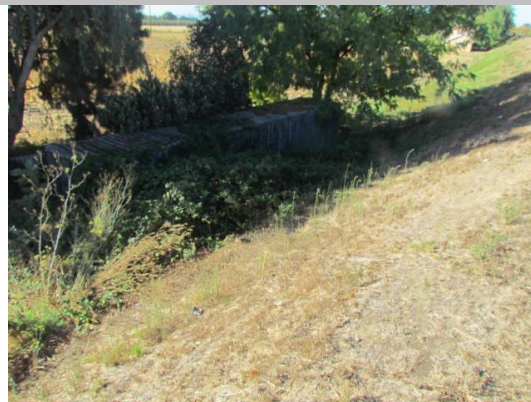
Photo 1 of 3 : SP\_2015\_NA0002\_63\_40\_20150309\_00037.jpg

Looking southeast at berryvines at landward toe.

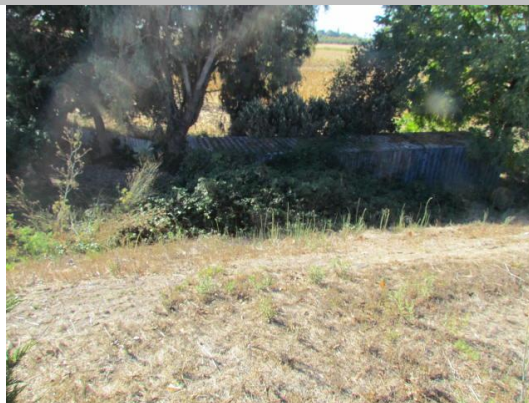
Photo 2 of 3 : SP\_2015\_NA0002\_63\_40\_20150309\_00038.jpg

Looking east at berryvines at landward toe.

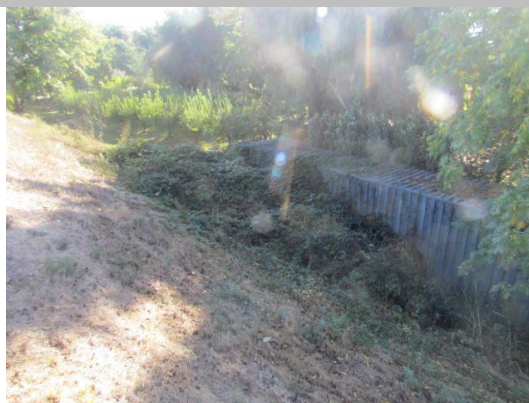
Photo 3 of 3 : SP\_2015\_NA0002\_63\_40\_20150309\_00039.jpg

Looking northeast at berryvines at landward toe.

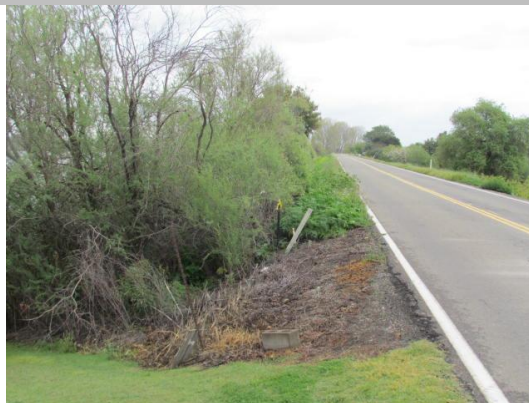
Photo 1 of 2 : SP\_2015\_NA0002\_63\_2\_20150309\_00001.jpg

Looking north at dense vegetation on waterward slope.

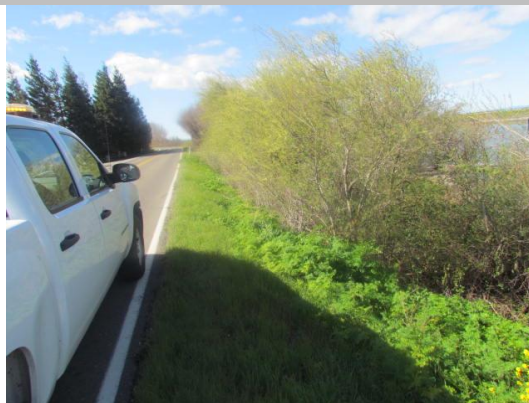
Photo 2 of 2 : SP\_2015\_NA0002\_63\_2\_20150309\_00002.jpg

Looking south at dense vegetation on waterside slope.

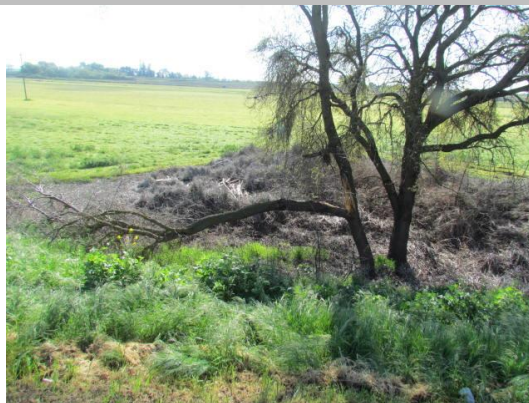
Photo 1 of 1 : SP\_2015\_NA0002\_63\_96\_20150313\_00095.jpg

LM Start	1.40	Rating **	M	Issue No.	96
LM End	1.40	Issue Type +	Ma	Location *	LS
Category	Earthen Levee			GPS Latitude/Longitude	
				Start	End
Item	Encroachments			38.179543 °	38.179543 °
				-121.587226 °	-121.587226 °
DWR ID	DWR_NA0002_02_s _ 2015_96				
Action/Comments					
Tree or limb Inspector Comments: Broken tree branch on landward toe.

Looking east at broken tree limb at landward toe.

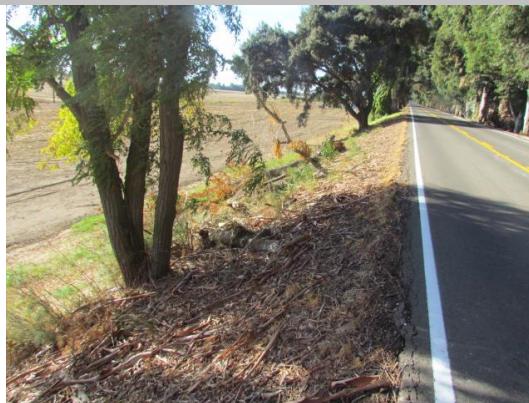
Photo 1 of 2 : SP\_2015\_NA0002\_63\_97\_20150309\_00056.jpg

Looking southeast at tree limb on landward slope.

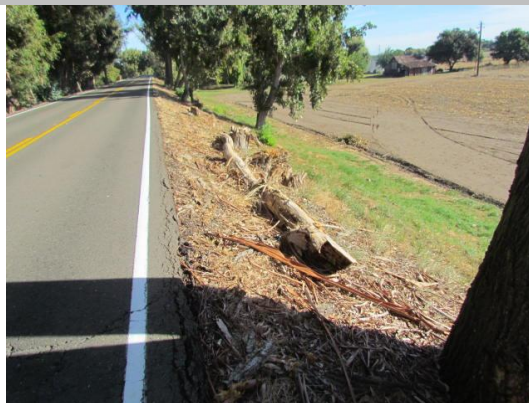
Photo 2 of 2 : SP\_2015\_NA0002\_63\_97\_20150309\_00057.jpg

Looking northeast at tree limb on landward slope.

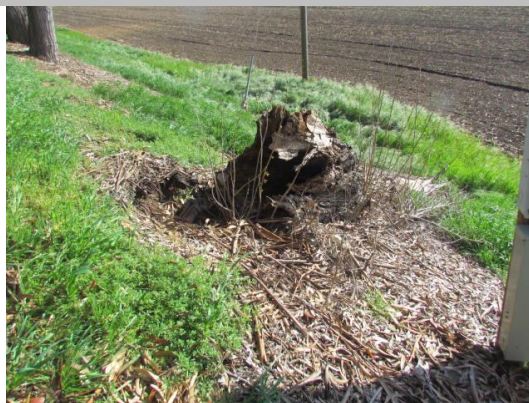
Photo 1 of 2 : SP\_2015\_NA0002\_63\_108\_20150313\_00096.jpg

Looking northeast at fallen tree and hole on landward shoulder. (Spring 2015)

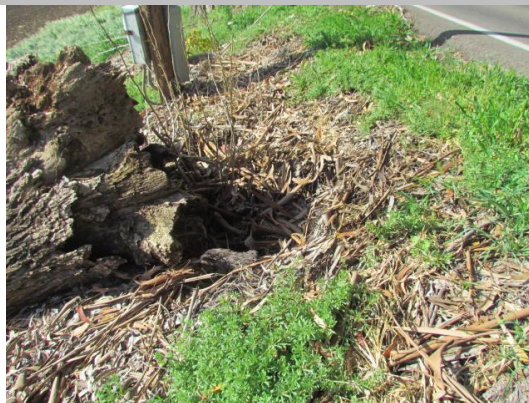
Photo 2 of 2 : SP\_2015\_NA0002\_63\_108\_20150313\_00097.jpg

Looking southeast at fallen tree and hole on landward shoulder and slope. (Spring 2015).

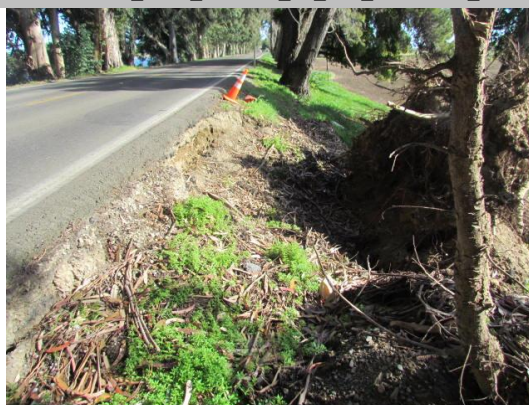
Photo 1 of 4 : SP\_2015\_NA0002\_63\_109\_20150313\_00098.jpg

LM Start	1.80	Rating **	U	Issue No.	109
LM End	1.80	Issue Type +	Ma	Location *	LS
Category	Earthen Levee			GPS Latitude/Longitude	
				Start	End
Item	Erosion / Bank Caving			38.174526 °	38.174526 °
				-121.590715 °	-121.590715 °
DWR ID	DWR_NA0002_02_s _ 2015_109				
Action/Comments					
Schedule repair of erosion site prior to the next inspection. Inspector Comments: Forty-eight inch by eighteen inch diameter hole on landward shoulder cause by fallen tree.

Looking north at hole and tree stump on landward shoulder. (Spring 2015)

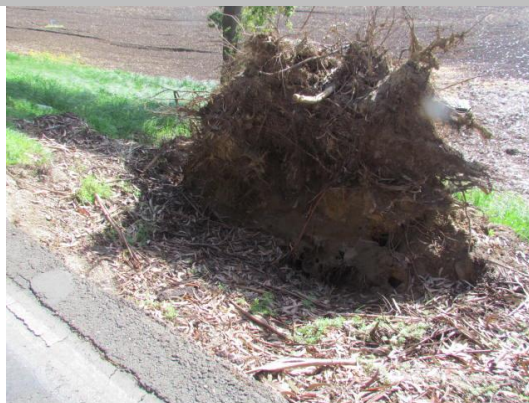
Photo 2 of 4 : SP\_2015\_NA0002\_63\_109\_20150313\_00099.jpg

Looking east at tree stump on landward slope. (Spring 2015).

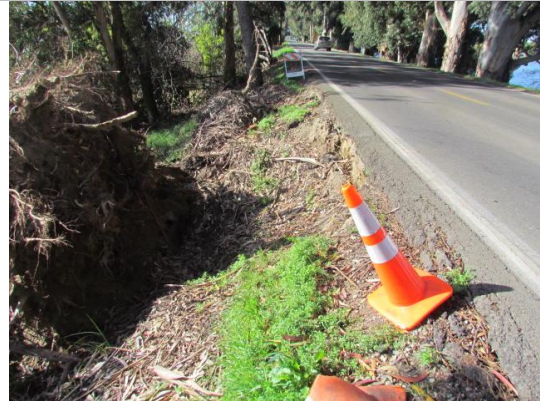
Photo 3 of 4 : SP\_2015\_NA0002\_63\_109\_20150313\_00100.jpg

LM Start	1.80	Rating **	U	Issue No.	109 (cont)
LM End	1.80	Issue Type +	Ma	Location *	LS
Category	Earthen Levee			GPS Latitude/Longitude	
				Start	End
Item	Erosion / Bank Caving			38.174526 °	38.174526 °
				-121.590715 °	-121.590715 °
DWR ID	DWR_NA0002_02_s_2015_109				
Action/Comments					
Schedule repair of erosion site prior to the next inspection. Inspector Comments: Forty-eight inch by eighteen inch diameter hole on landward shoulder cause by fallen tree.

Looking south at hole at landward shoulder. (Spring 2015)

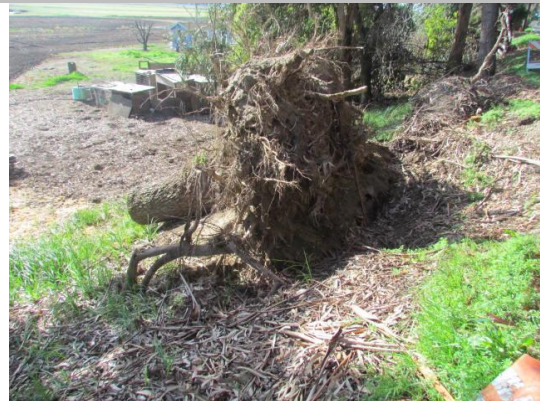
Photo 4 of 4 : SP\_2015\_NA0002\_63\_109\_20150313\_00101.jpg

Looking southeast at tree stump on landward slope. (Spring 2015).

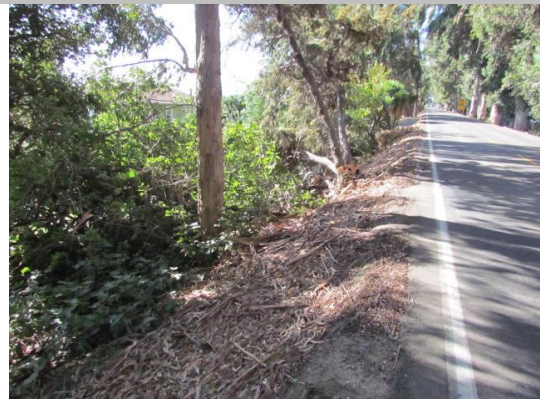
Photo 1 of 2 : SP\_2015\_NA0002\_63\_45\_20150309\_00043.jpg

Looking southeast at dense vegetation on landward slope.

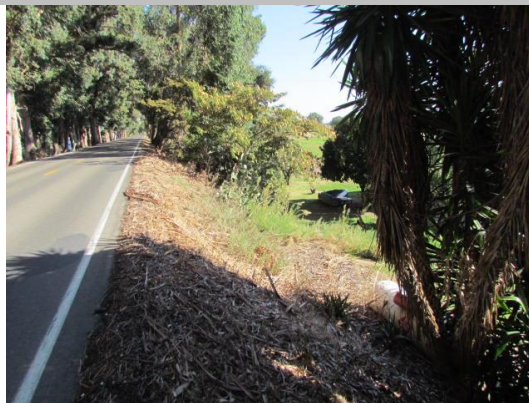
Photo 2 of 2 : SP\_2015\_NA0002\_63\_45\_20150309\_00044.jpg

Looking north at dense vegetation on landward slope and toe.

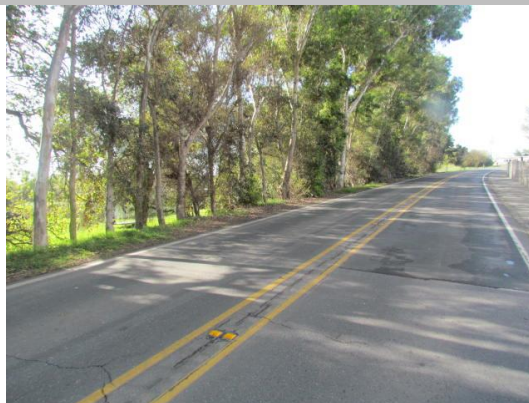
Photo 1 of 1 : SP\_2015\_NA0002\_63\_25\_20150313\_00102.jpg

Looking southeast at trees at landward shoulder. (Spring 2015)

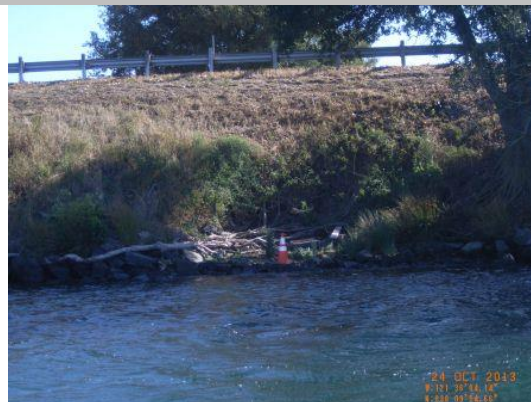
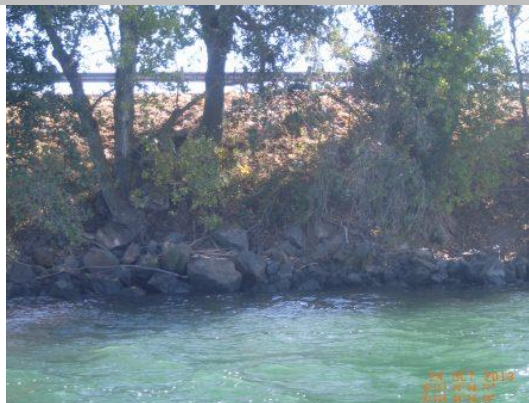
LM Start	2.65	Rating **	M	Issue No.	38
LM End	2.74	Issue Type +	Ma	Location *	WS
Category	Supplemental			GPS Latitude/Longitude	
				Start	End
Item	USACE Erosion Survey			38.165303 °	38.164682 °
				-121.600477 °	-121.601804 °
DWR ID	DWR_NA0002_02_f_2014_38				
Action/Comments					
Inspector Comments: 2009 - Large scallop from rotational failure. One fallen tree and one large tree with half of its root structure exposed. 2013: No observed changes. [2013 Site ID: SAC_18-0_L]

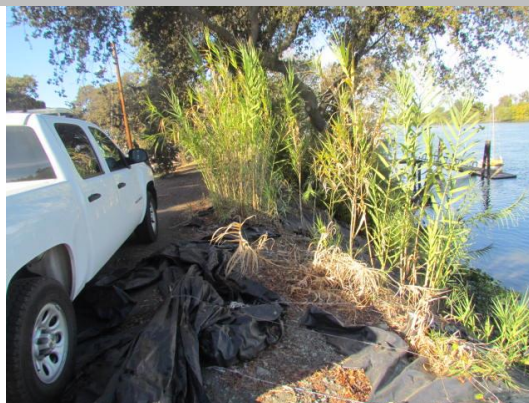
Photo 1 of 1 : SP\_2015\_NA0002\_63\_104\_20150309\_00061.jpg

Looking southwest at bamboo on waterward slope.

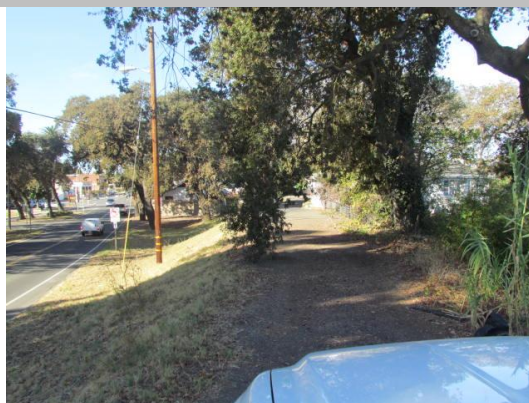
Photo 1 of 2 : SP\_2015\_NA0002\_63\_5\_20150309\_00003.jpg

Looking south at overhanging tree on waterward shoulder. (Fall 2014)

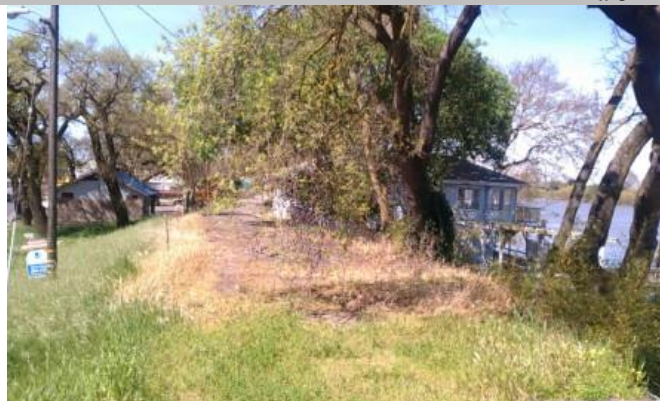
Photo 2 of 2 : SP\_2015\_NA0002\_63\_5\_20150309\_00004.jpg

Looking south at overhanging tree on waterside shoulder.

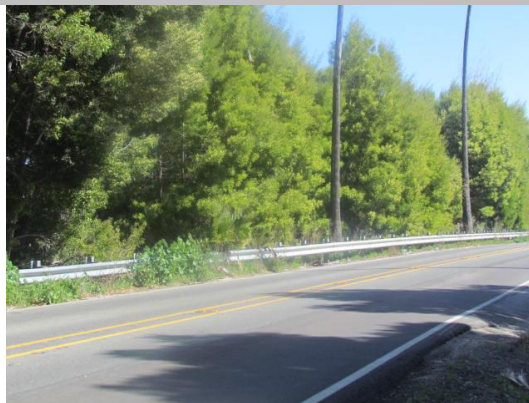
Photo 1 of 3 : SP\_2015\_NA0002\_63\_9\_20150309\_00008.jpg

Looking southeast at dense trees on landside slope and toe.

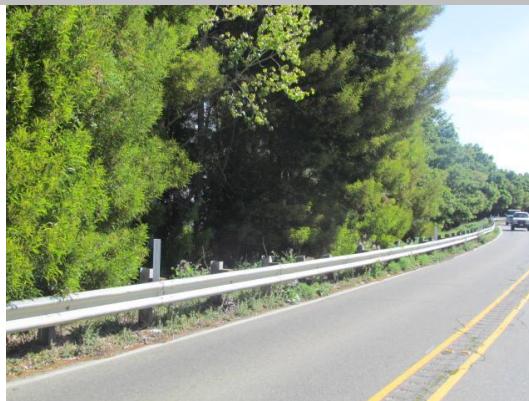
Photo 2 of 3 : SP\_2015\_NA0002\_63\_9\_20150309\_00009.jpg

Looking northwest at dense trees on waterward shoulder and slope.

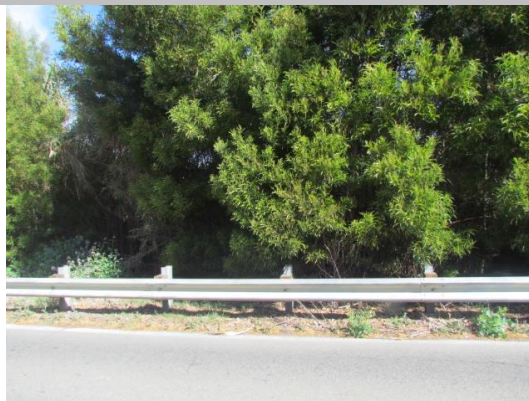
Photo 3 of 3 : SP\_2015\_NA0002\_63\_9\_20150309\_00010.jpg

Looking west at dense trees on waterward should and slope.

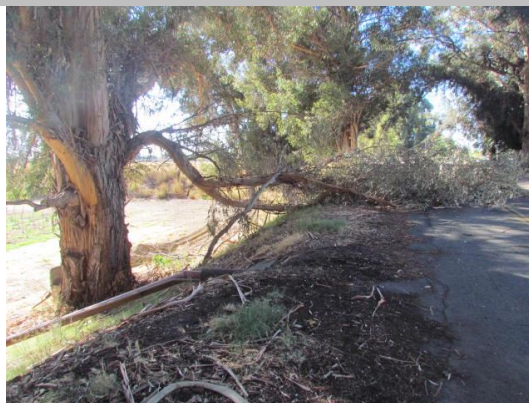
Photo 1 of 1 : SP\_2015\_NA0002\_63\_106\_20150309\_00063.jpg

Looking southeast at broken tree limb on landward shoulder.

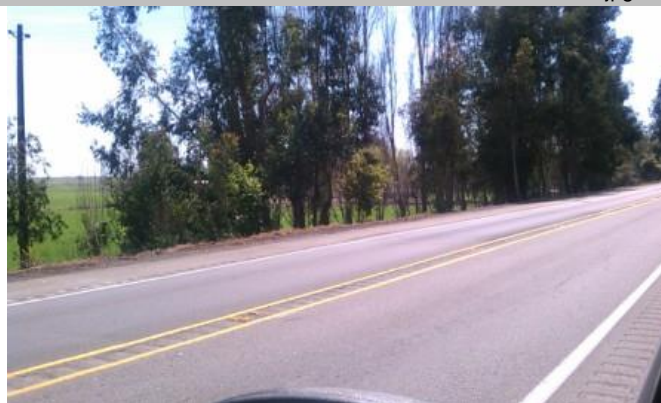
Photo 1 of 1 : SP\_2015\_NA0002\_63\_44\_20150309\_00042.jpg

Looking southeast at trees on landside shoulder and slope.

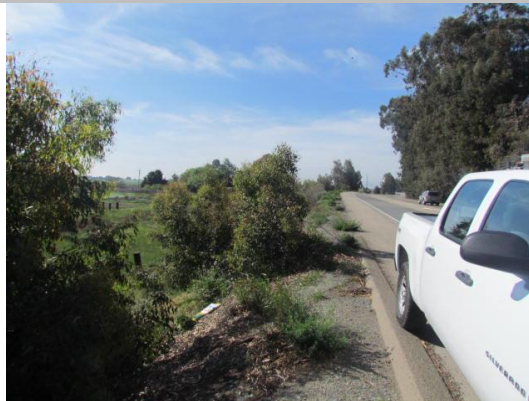
Photo 1 of 2 : SP\_2015\_NA0002\_63\_48\_20150309\_00046.jpg

Looking south at trees on landward slope.

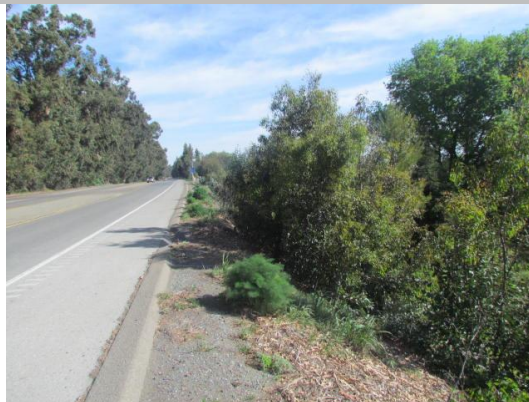
Photo 2 of 2 : SP\_2015\_NA0002\_63\_48\_20150309\_00047.jpg

Looking north at dense trees on landward slope and toe.

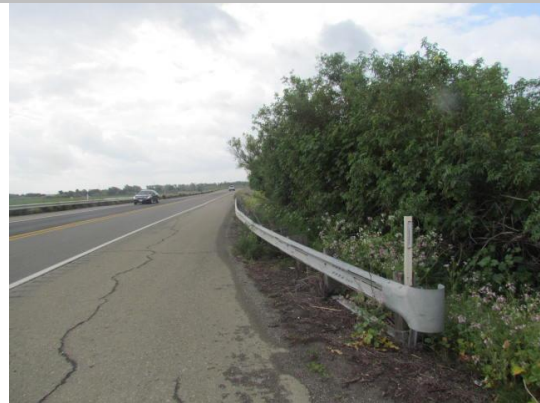
Photo 1 of 2 : SP\_2015\_NA0002\_63\_16\_20150309\_00015.jpg

Looking south at dense vegetation on waterward shoulder and slope.

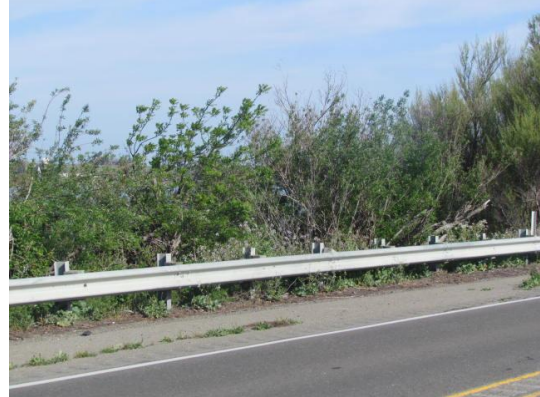
Photo 2 of 2 : SP\_2015\_NA0002\_63\_16\_20150309\_00016.jpg

Looking west at dense vegetation on waterward shoulder and slope.
