**Flood Control Project Maintenance
Levee Inspections**

Maintenance Issue Types Only, Levee Inspection Report By Mile - Spring 2016

Brannan Andrus Levee Maintenance District

Waterway	Bank	Unit Miles	Inspection Start/End	Inspector
Unit No. 01 Georgiana Slough	Right	6.01	03/22/2016 03/22/2016	Richard Willoughby

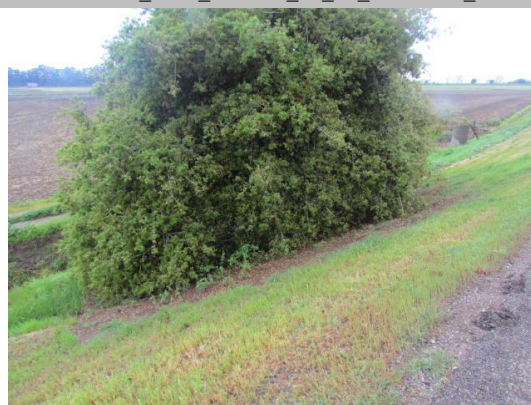
Photo 1 of 3 : SP_2016_NA0002_62_25_20160308_00024.jpg

LM Start	0.00	Rating **	M	Issue No.	62
LM End	6.01	Issue Type +	Ma	Location *	LS
Category	Earthen Levee			GPS Latitude/Longitude	
				Start	End
Item	Vegetation			38.186448 °	38.129578 °
				-121.562704 °	-121.578600 °
DWR ID	DWR_NA0002_01_s _ 2016_62				
Comment Code					
V1 : Control annual grass and weeds on the levee slopes and easements.					
Inspector Comment

Looking northwest at untrimmed tree at landward toe. (Spring 2015)

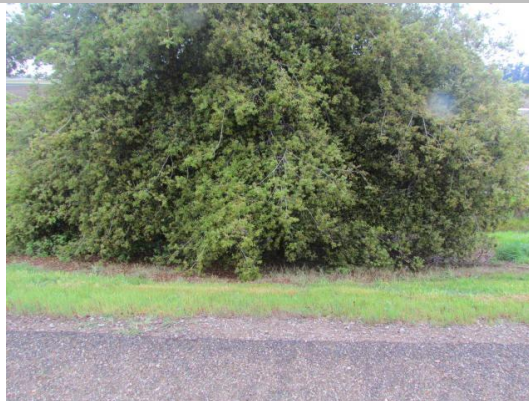
Photo 2 of 3 : SP_2016_NA0002_62_25_20160308_00025.jpg

Looking west at untrimmed tree at landward toe. (Spring 2015)

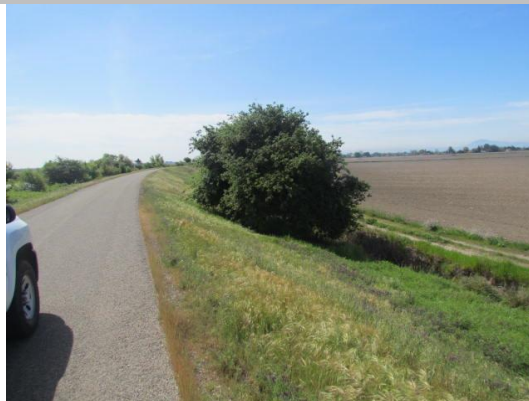
Photo 3 of 3 : SP_2016_NA0002_62_25_20160308_00026.jpg

Looking southwest at an untrimmed tree on landward slope and toe. (Spring 2014)

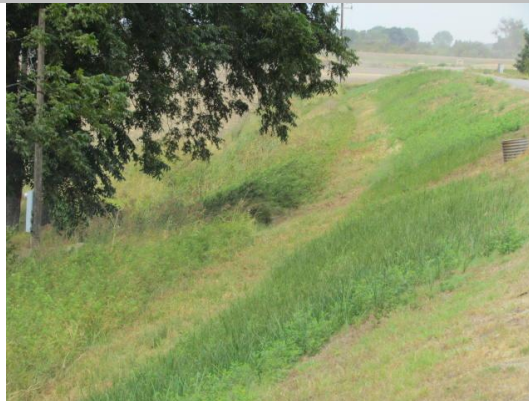
Photo 1 of 2 : SP_2016_NA0002_62_26_20160308_00027.jpg

LM Start	2.20	Rating **	M	Issue No.	26
LM End	2.22	Issue Type +	Ma	Location *	LS
Category	Earthen Levee			GPS Latitude/Longitude	
				Start	End
Item	Vegetation			38.164138 °	38.163797 °
				-121.584078 °	-121.584225 °
DWR ID	DWR_NA0002_01_s _ 2013_26				
Comment Code					
V2 : Remove the wild growth other than native grasses from the levee slopes.					
Inspector Comment					
Control wild growth at landside toe.

Looking west at dense vegetation at landward toe.

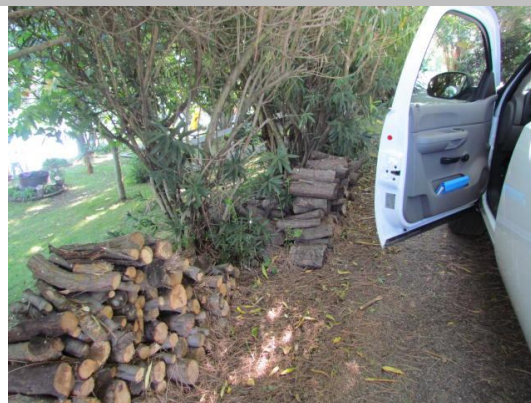
Photo 1 of 3 : SP_2016_NA0002_62_3_20160308_00003.jpg

Looking east at firewood on waterside shoulder.

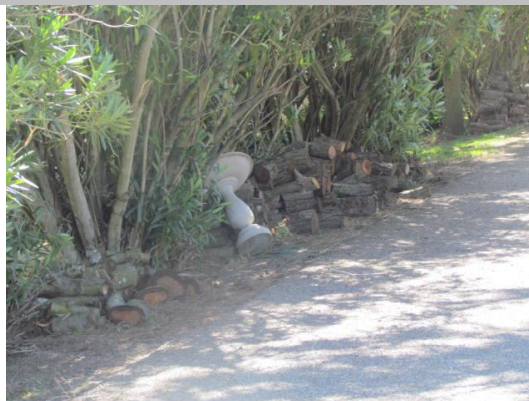
Photo 2 of 3 : SP_2016_NA0002_62_3_20160308_00004.jpg

Looking southeast at firewood on waterside shoulder.

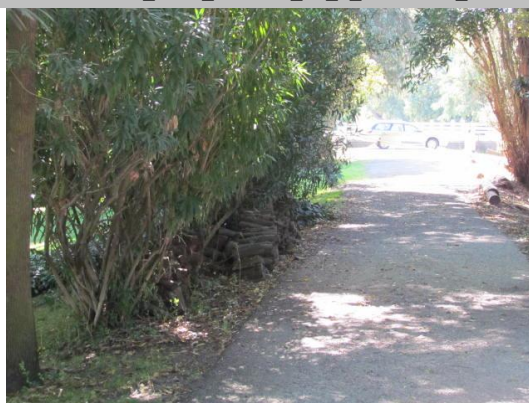
Photo 3 of 3 : SP_2016_NA0002_62_3_20160308_00005.jpg

Looking south at firewood on waterside shoulder.

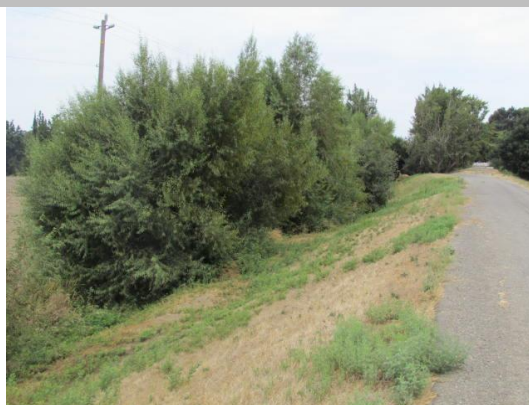
Photo 1 of 1 : SP_2016_NA0002_62_28_20160308_00029.jpg

LM Start	2.45	Rating **	U	Issue No.	28
LM End	2.49	Issue Type +	Ma	Location *	LS
Category	Earthen Levee			GPS Latitude/Longitude	
				Start	End
Item	Vegetation			38.160805 °	38.160281 °
				-121.585782 °	-121.586007 °
DWR ID	DWR_NA0002_01_s _ 2013_28				
Comment Code					
V2 : Remove the wild growth other than native grasses from the levee slopes.					
Inspector Comment					
Dense vegetation and wild roses on landside slope and toe.

Look west at dense vegetation at landward toe.

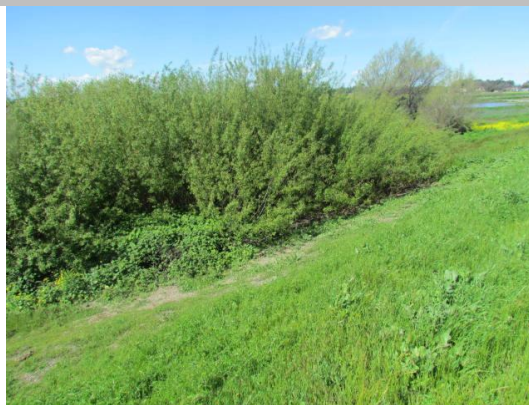
Photo 1 of 4 : SP_2016_NA0002_62_55_20160323_00102.jpg

LM Start	3.00	Rating **	U	Issue No.	55
LM End	3.00	Issue Type +	Ma	Location *	LS
Category	Earthen Levee			GPS Latitude/Longitude	
				Start	End
Item	Vegetation			38.156493 °	38.156493 °
				-121.592481 °	-121.592481 °
DWR ID	DWR_NA0002_01_s _ 2014_55				
Comment Code					
V2 : Remove the wild growth other than native grasses from the levee slopes.					
Inspector Comment					
Dense vegetation on landward toe.

Looking northwest at dense vegetation at landward toe. (Spring 2016)

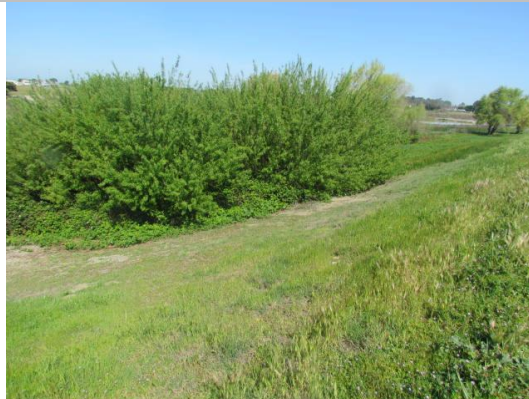
Photo 4 of 4 : SP_2016_NA0002_62_55_20160308_00051.jpg

Looking north at dense vegetation within fifteen feet of landward toe.

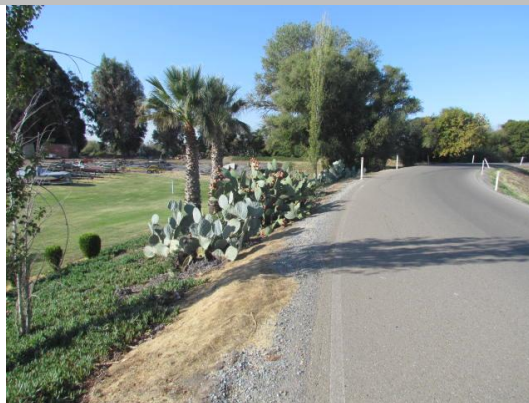
Photo 1 of 1 : SP_2016_NA0002_62_5_20160308_00006.jpg

Looking south at cacti on waterward slope near Oxbow Habor.

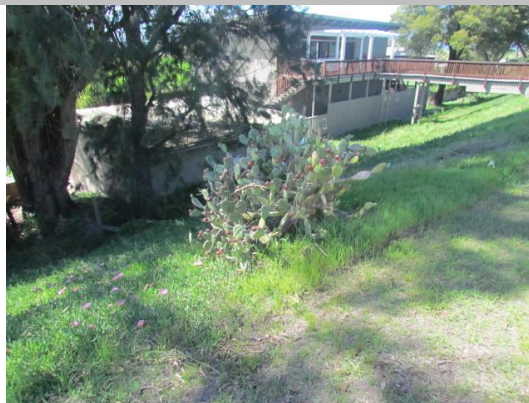
Photo 1 of 1 : SP_2016_NA0002_62_65_20160323_00103.jpg

Looking south at cactus on landward slope.

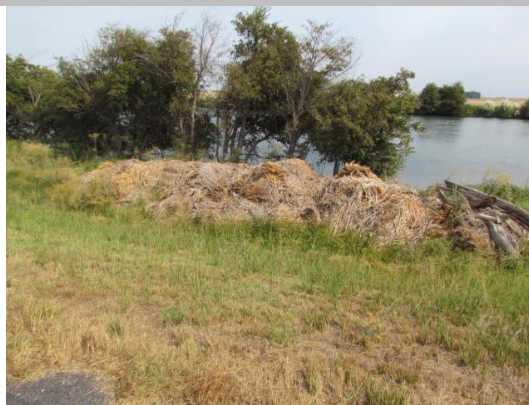
Photo 1 of 1 : SP_2016_NA0002_62_47_20160308_00037.jpg

LM Start	5.29	Rating **	M	Issue No.	47
LM End	5.29	Issue Type +	Ma	Location *	WS
Category	Earthen Levee			GPS Latitude/Longitude	
				Start	End
Item	Encroachments			38.131802 °	38.131802 °
				-121.590465 °	-121.590465 °
DWR ID	DWR_NA0002_01_f_2015_47				
Comment Code					
PR : Prunings					
Inspector Comment					
Prunings piles on waterward berm should be removed or burned.

Looking at pruning piles on waterward berm.

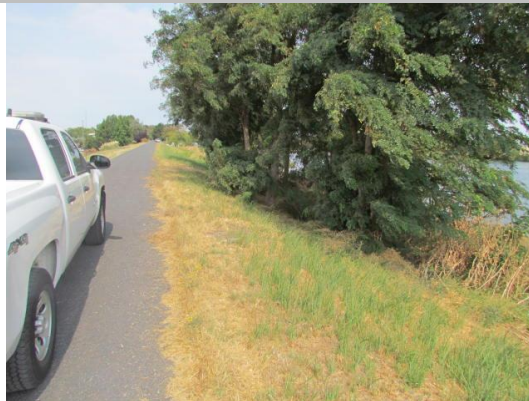
Photo 1 of 1 : SP_2016_NA0002_62_2_20160308_00002.jpg

Looking at untrimmed trees on waterward slope.

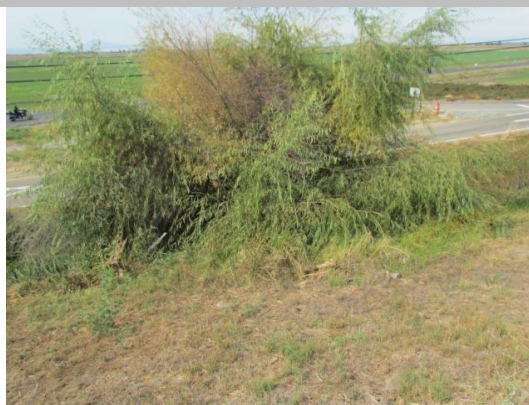
Photo 1 of 1 : SP_2016_NA0002_62_54_20160308_00048.jpg

Looking at dense trees at landward toe.

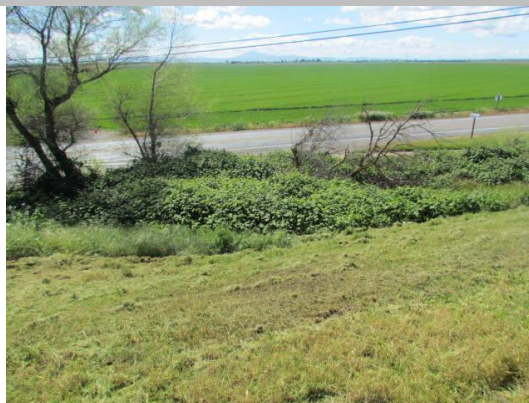
Photo 1 of 6 : SP_2016_NA0002_62_23_20160323_00105.jpg

Looking south at vegetation at landward toe. (Spring 2016)

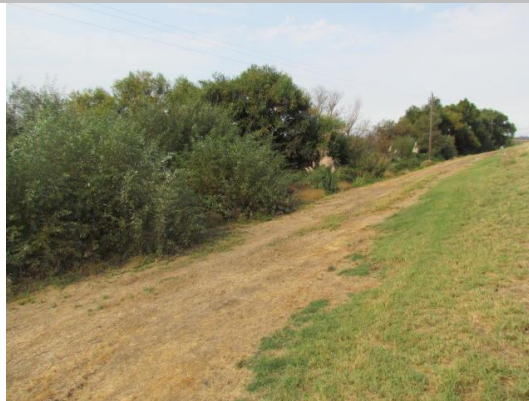
Photo 2 of 6 : SP_2016_NA0002_62_23_20160308_00018.jpg

Looking west at dense vegetation at landward toe.

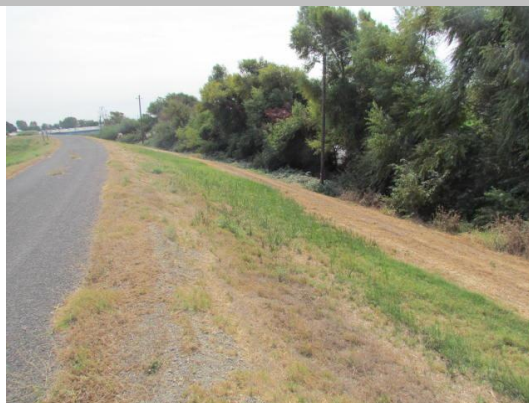
Photo 3 of 6 : SP_2016_NA0002_62_23_20160308_00019.jpg

Looking east at dense vegetation at landward toe.

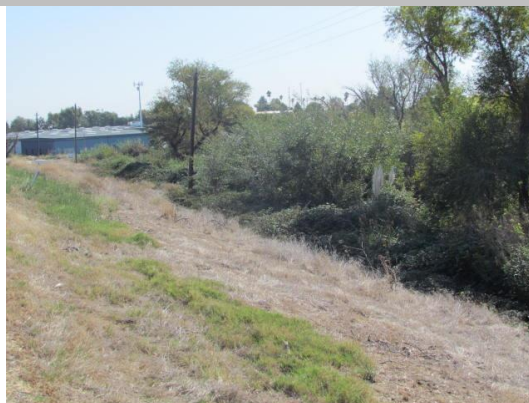
Photo 4 of 6 : SP_2016_NA0002_62_23_20160308_00020.jpg

Looking east at dense vegetation on landward toe.

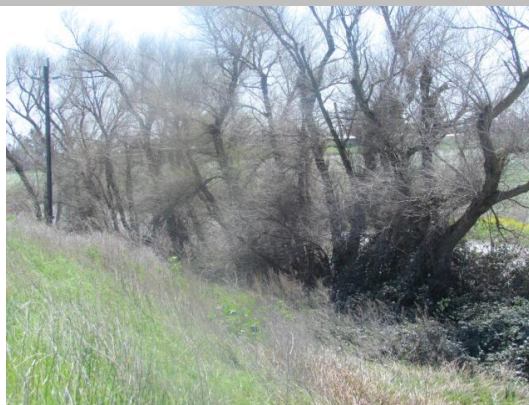
Photo 6 of 6 : SP_2016_NA0002_62_23_20160308_00022.jpg

Looking south at trees, berry vines, and wild rose on landside toe.

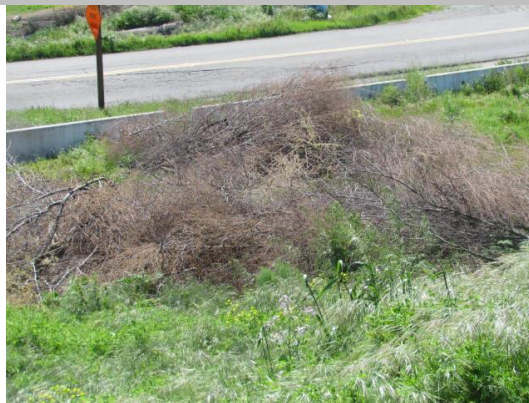
Photo 1 of 1 : SP_2016_NA0002_62_64_20160323_00106.jpg

Looking southwest at prunings at landward toe and berm.

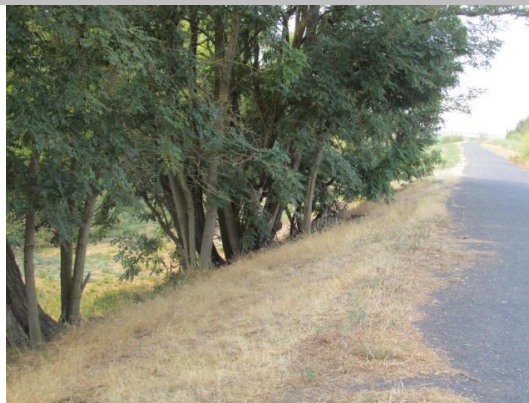
Photo 1 of 1 : SP_2016_NA0002_62_17_20160308_00014.jpg

Looking at dense trees on landward slope and toe.

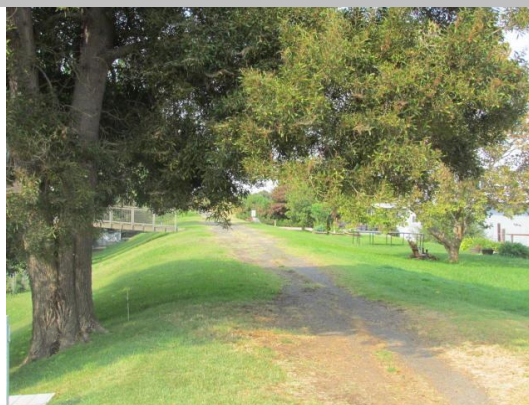
Photo 1 of 1 : SP_2016_NA0002_62_51_20160308_00041.jpg

Looking at tree overhanging levee crown.

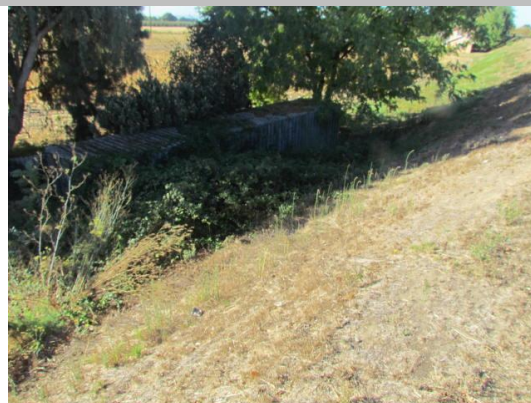
Photo 1 of 3 : SP_2016_NA0002_63_40_20160308_00037.jpg

Looking southeast at berryvines at landward toe.

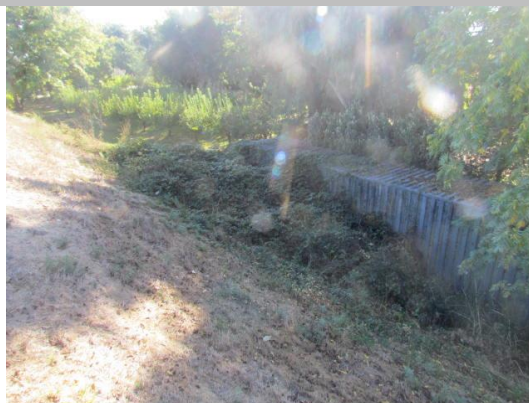
Photo 3 of 3 : SP_2016_NA0002_63_40_20160308_00039.jpg

Looking northeast at berryvines at landward toe.

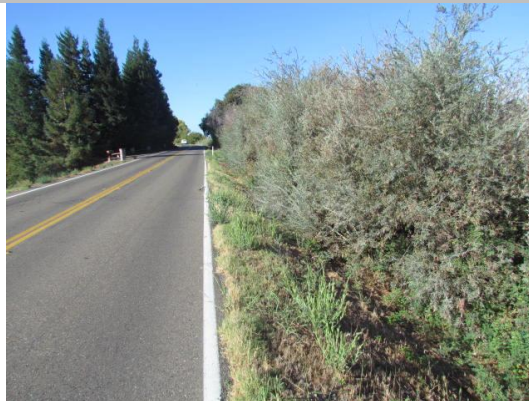
Photo 1 of 1 : SP_2016_NA0002_63_2_20160308_00001.jpg

Looking south at dense willows and trees on waterward slope.

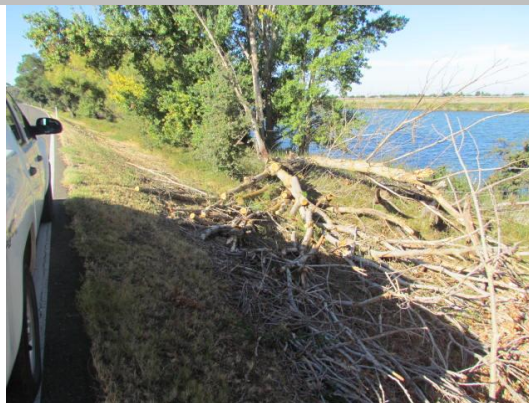
Photo 1 of 2 : SP_2016_NA0002_63_91_20160308_00057.jpg

Looking south west at fallen tree on waterward slope and berm.

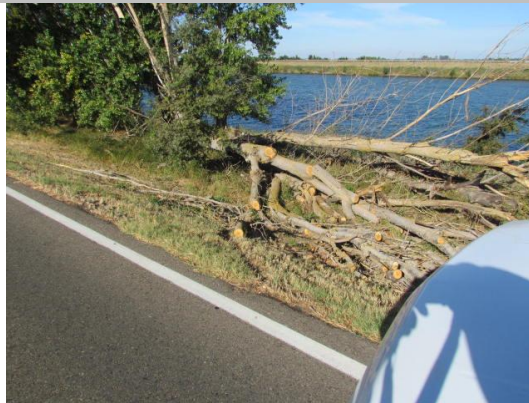
Photo 2 of 2 : SP_2016_NA0002_63_91_20160308_00058.jpg

Looking west at fallen tree on waterward slope and berm.

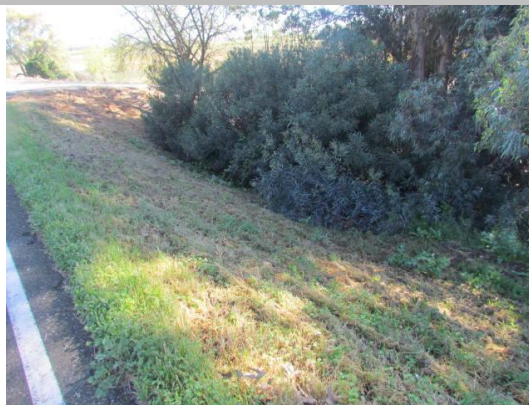
Photo 1 of 4 : SP_2016_NA0002_63_27_20160323_00169.jpg

Looking east at dense vegetation at landward toe.

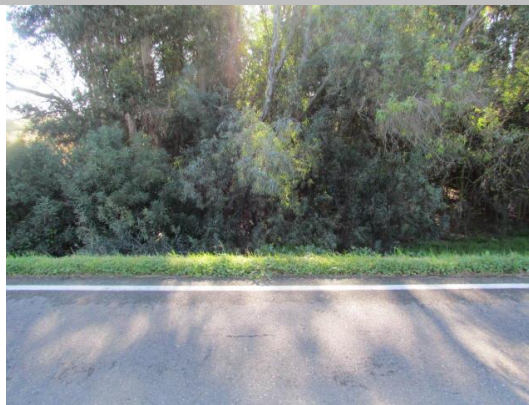
Photo 2 of 4 : SP_2016_NA0002_63_27_20160323_00170.jpg

Looking east at dense vegetation at landward toe.

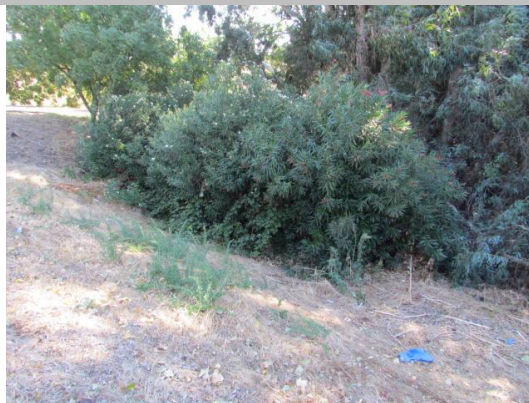
Photo 3 of 4 : SP_2016_NA0002_63_27_20160308_00025.jpg

Looking north at dense vegetation on landward toe.

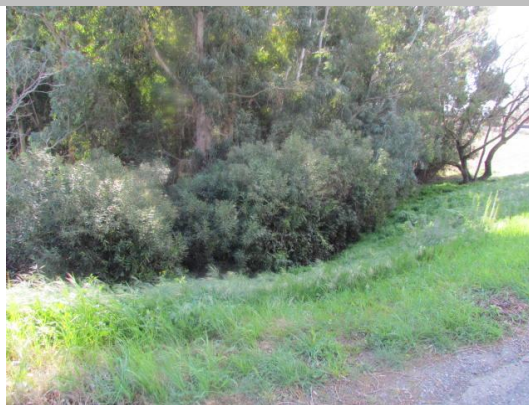
Photo 4 of 4 : SP_2016_NA0002_63_27_20160308_00026.jpg

Looking southeast at dense trees on landside toe.

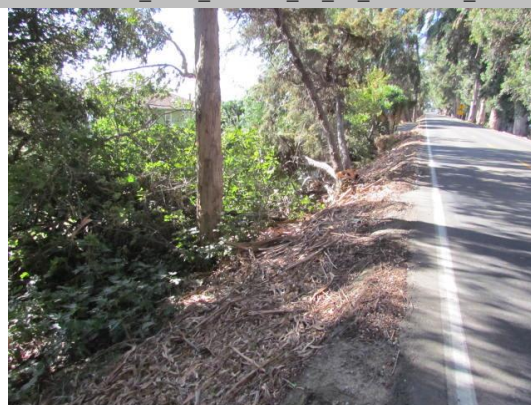
Photo 1 of 2 : SP_2016_NA0002_63_45_20160308_00041.jpg

Looking southeast at dense vegetation on landward slope.

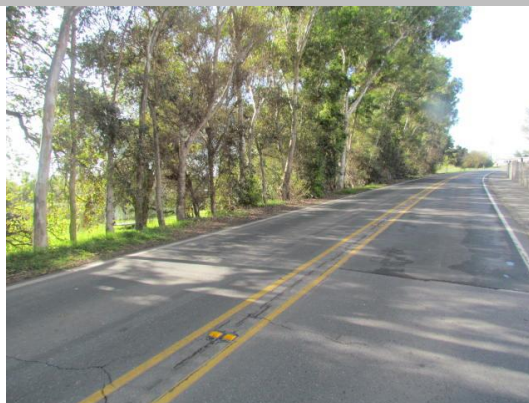
Photo 1 of 1 : SP_2016_NA0002_63_25_20160308_00023.jpg

Looking southeast at trees at landward shoulder. (Spring 2015)

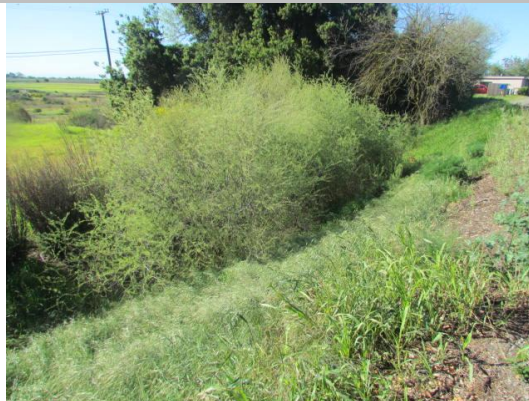
Photo 1 of 2 : SP_2016_NA0002_63_99_20160323_00171.jpg

Looking southwest at vegetation (willows) on landward slope and toe.

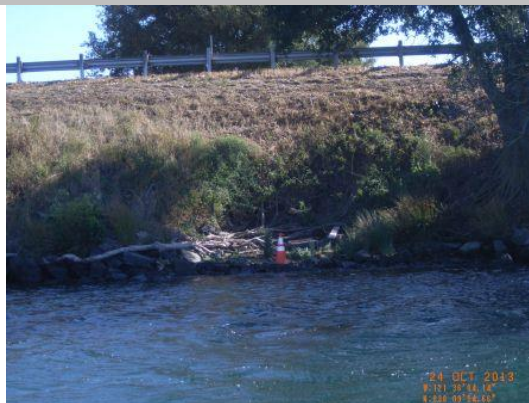
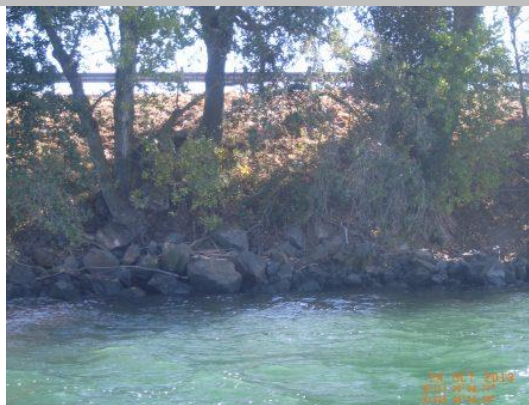
Photo 1 of 2 : SP_2016_NA0002_63_37_20160308_00034.jpg

LM Start	2.66	Rating **	M	Issue No.	37
LM End	2.74	Issue Type +	Ma	Location *	WS
Category	Supplemental			GPS Latitude/Longitude	
				Start	End
Item	2015 USACE Erosion Survey, DRAFT			38.165303 °	38.164682 °
				-121.600477 °	-121.601804 °
DWR ID	DWR_NA0002_02_s _ 2016_37				
Comment Code					
Inspector Comment					
2009 - Large scallop from rotational failure. One fallen tree and one large tree with half of its root structure exposed. 2015: Large tree expected to pop out within next couple of years, will take very large chunk of levee out. [2015 Site ID: SAC_18-0_L]

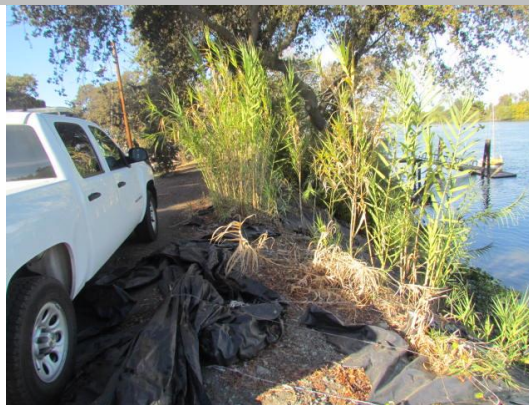
Photo 1 of 1 : SP_2016_NA0002_63_104_20160308_00070.jpg

Looking southwest at bamboo on waterward slope.

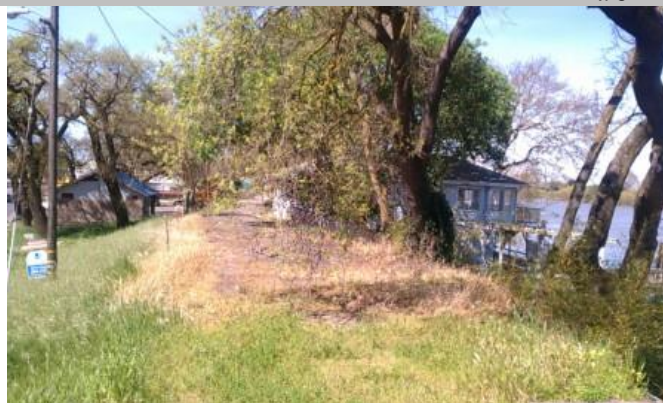
Photo 2 of 2 : SP_2016_NA0002_63_5_20160308_00004.jpg

Looking south at overhanging tree on waterside shoulder.

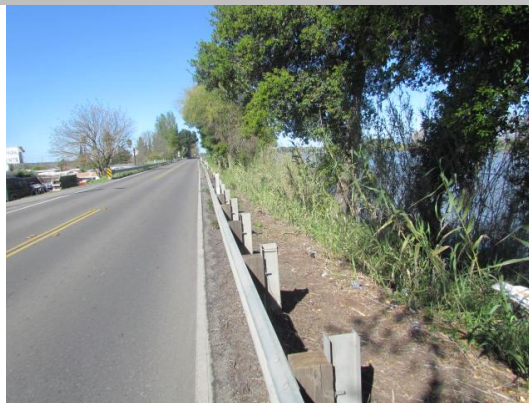
Photo 1 of 1 : SP_2016_NA0002_63_100_20160323_00173.jpg

Looking southwest at vegetation (bamboo) on waterward slope.

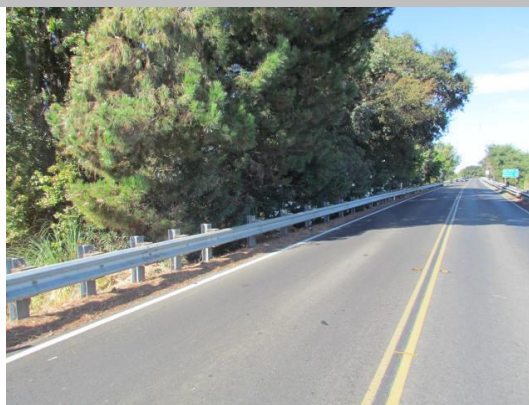
Photo 1 of 1 : SP_2016_NA0002_63_22_20160308_00021.jpg

Looking south at dense vegetation (trees) on landward slope and toe.

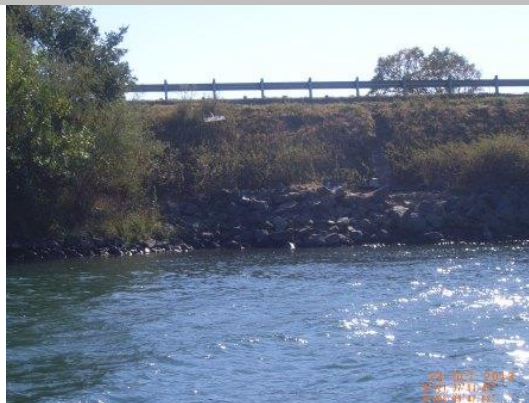
Photo 1 of 1 : SP_2016_NA0002_63_20_20160308_00019.jpg

LM Start	3.62	Rating **	U	Issue No.	20
LM End	3.73	Issue Type +	Ma	Location *	WS
Category	Supplemental			GPS Latitude/Longitude	
				Start	End
Item	2015 USACE Erosion Survey, DRAFT			38.162959 °	38.163334 °
				-121.617323 °	-121.619312 °
DWR ID	DWR_NA0002_02_s _ 2016_20				
Comment Code					
Inspector Comment					
2008 - Overstepped levee section with pocket erosion. Plans for repair currently in the design phase. 2010 - Very steep slope with slumps, longitudinal cracking, and overturned trees. 2011 - Upgraded to CRITICAL. Sections of vertical slope with highway on top. Heavy vegetation in front of most of the erosion pockets. 2015: New rock placed on the levee slope for most of the downstream end, but bad spots still remain. [2015 Site ID: SAC 16-8 L]

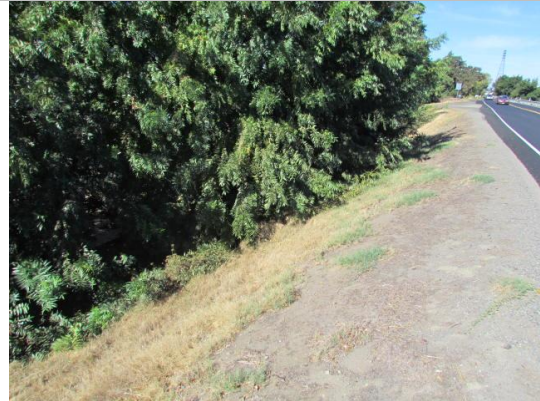
Photo 1 of 1 : SP_2016_NA0002_63_102_20160308_00069.jpg

Looking south at dense trees on landward slope and toe.

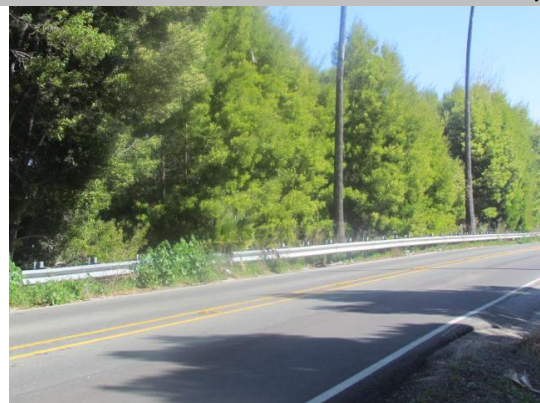
Photo 1 of 3 : SP_2016_NA0002_63_9_20160308_00008.jpg

Looking southeast at dense trees on landside slope and toe.

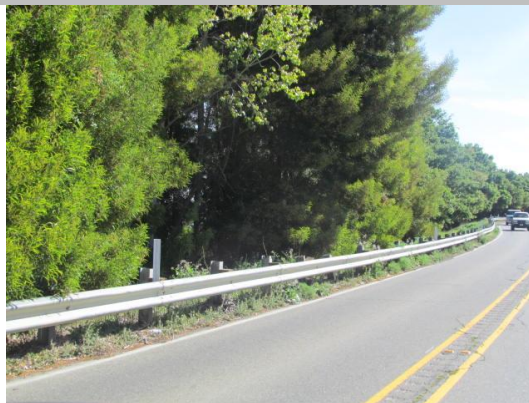
Photo 2 of 3 : SP_2016_NA0002_63_9_20160308_00009.jpg

Looking northwest at dense trees on waterward shoulder and slope.

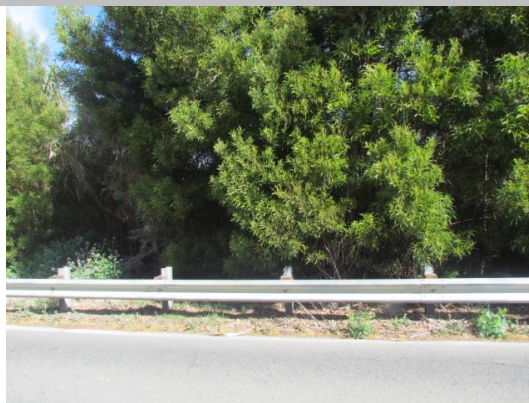
Photo 3 of 3 : SP_2016_NA0002_63_9_20160308_00010.jpg

Looking west at dense trees on waterward should and slope.

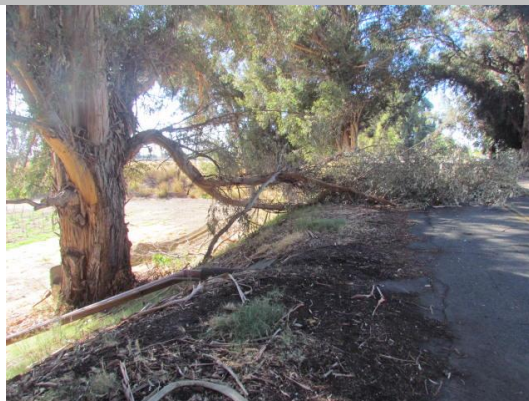
Photo 1 of 1 : SP_2016_NA0002_63_106_20160308_00072.jpg

Looking southeast at broken tree limb on landward shoulder.

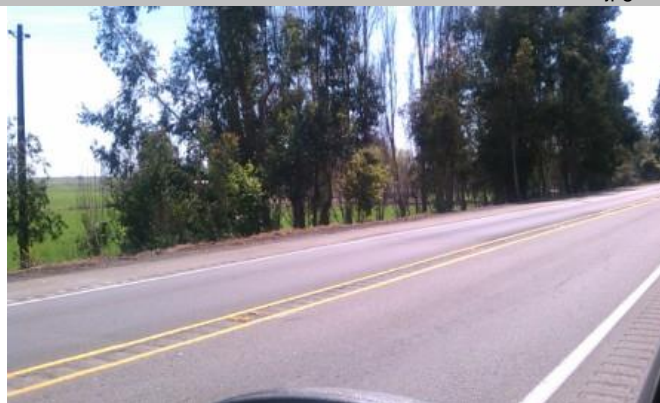
Photo 1 of 1 : SP_2016_NA0002_63_44_20160308_00040.jpg

Looking southeast at trees on landside shoulder and slope.

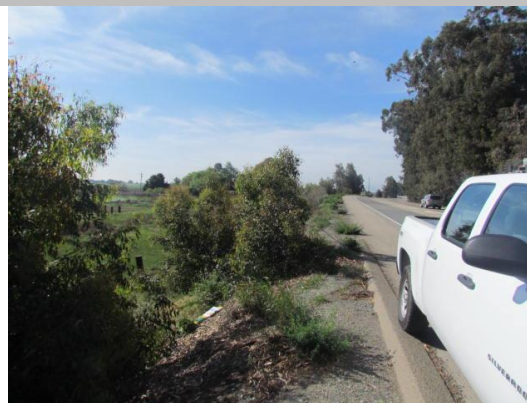
Photo 1 of 2 : SP_2016_NA0002_63_48_20160308_00044.jpg

Looking south at trees on landward slope.

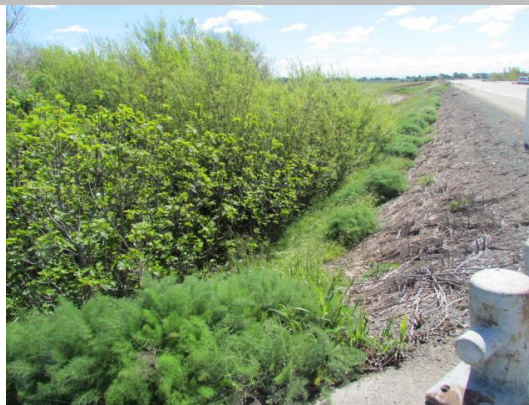
Photo 1 of 2 : SP_2016_NA0002_63_116_20160323_00177.jpg

LM Start	9.32	Rating **	U	Issue No.	116
LM End	9.35	Issue Type +	Ma	Location *	LS
Category	Earthen Levee			GPS Latitude/Longitude	
				Start	End
Item	Vegetation			38.136024 °	38.135699 °
				-121.686206 °	-121.686170 °
DWR ID	DWR_NA0002_02_s _ 2016_116				
Comment Code					
V2 : Remove the wild growth other than native grasses from the levee slopes.					
Inspector Comment					
Dense vegetation on landward slope and toe.

Looking south at dense vegetation on landward slope and toe.

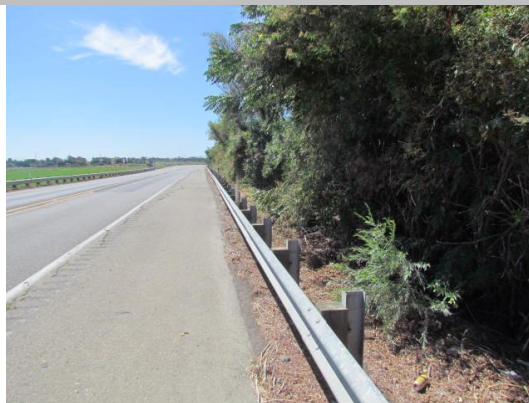
Photo 1 of 2 : SP_2016_NA0002_63_16_20160308_00015.jpg

LM Start	9.60	Rating **	U	Issue No.	16
LM End	9.71	Issue Type +	Ma	Location *	WS
Category	Earthen Levee			GPS Latitude/Longitude	
				Start	End
Item	Trim / Thin Trees			38.132095 °	38.130537 °
				-121.686243 °	-121.686737 °
DWR ID	DWR_NA0002_02_s _ 2012_16				
Comment Code					
T3 : Trim and thin trees to allow visibility of the ground and room to flood fight.					
Inspector Comment					
Untrimmed trees within twenty foot zone on waterward slope.

Looking south at dense vegetation (trees) on waterward slope.

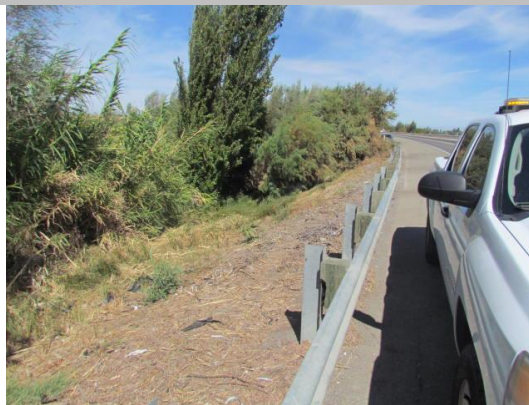
Photo 2 of 2 : SP_2016_NA0002_63_16_20160308_00016.jpg

Looking north at dense vegetation (trees) on waterward slope.

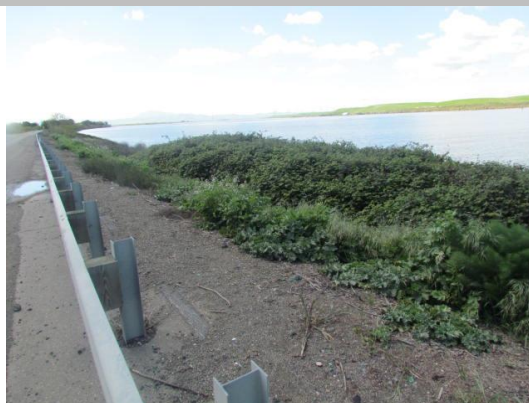
Photo 1 of 2 : SP_2016_NA0002_63_117_20160323_00179.jpg

Looking west at dense vegetation (vines) on waterward slope.

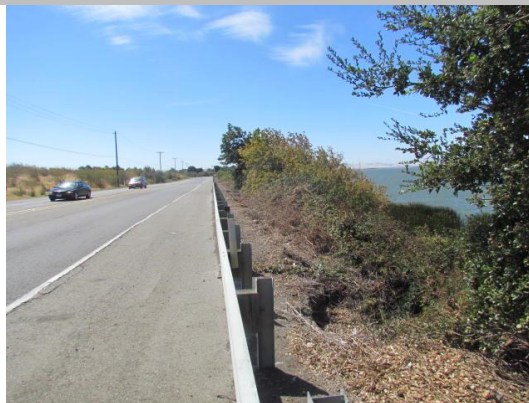
Photo 1 of 1 : SP_2016_NA0002_63_107_20160308_00073.jpg

Looking south at dense vegetation on waterward slope.

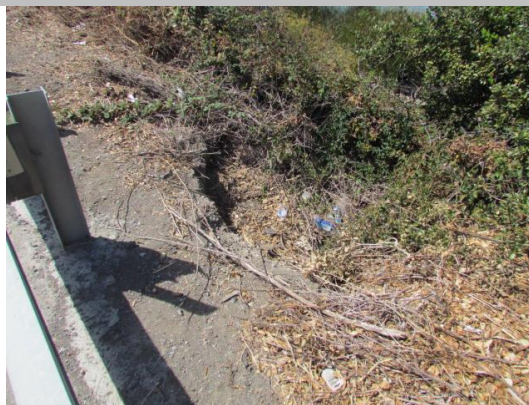
Photo 1 of 1 : SP_2016_NA0002_63_113_20160308_00074.jpg

Looking at erosion on waterward shoulder.
