**Flood Control Project Maintenance
Levee Inspections**

Maintenance Issue Types Only, Levee Inspection Report By Mile - Spring 2017

Brannan Andrus Levee Maintenance District

Waterway	Bank	Unit Miles	Inspection Start/End	Inspector
Unit No. 01 Georgiana Slough	Right	6.01	03/21/2017 03/21/2017	Richard Willoughby

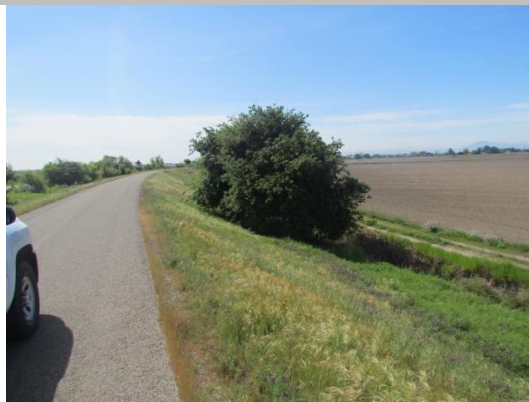
Photo 3 of 3 : SP_2017_NA0002_62_25_20170314_00022.jpg

Looking southwest at an untrimmed tree on landward slope and toe. (Spring 2014)

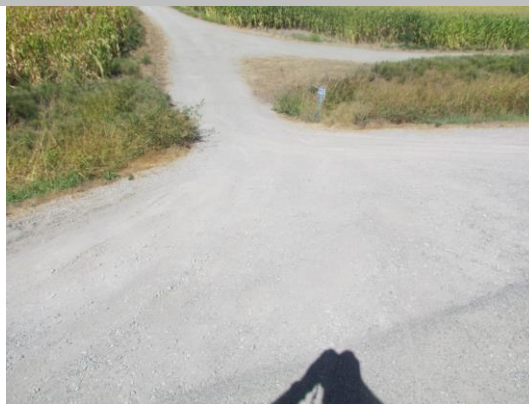
Photo 1 of 3 : SP_2017_NA0002_62_74_20170314_00062.jpg

LM Start	1.79	Rating **	U	Issue No.	74
LM End	1.79	Issue Type +	Ma	Location *	LS
Category	Earthen Levee			GPS Latitude/Longitude	
				Start	End
Item	Slope Stability			38.169625 °	38.169625 °
				-121.581542 °	-121.581542 °
DWR ID	DWR_NA0002_01_f_2016_74				
Comment Code					
S3 : Repair the levee slope damaged by vehicle traffic and prevent access where possible.					
Inspector Comment					
Landowner is damaging landward slope by using it as a ramp to access his property.

Looking west at slope damage on waterward slope.

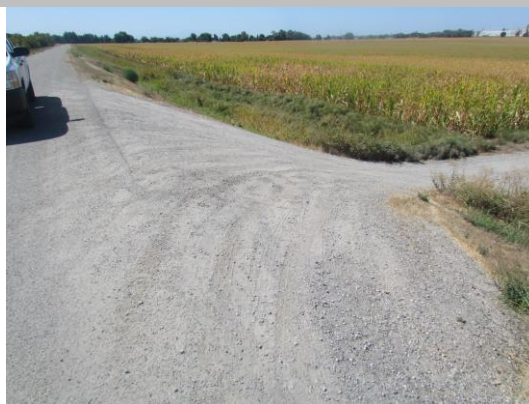
Photo 2 of 3 : SP_2017_NA0002_62_74_20170314_00063.jpg

Looking south at slope damage on waterward slope.

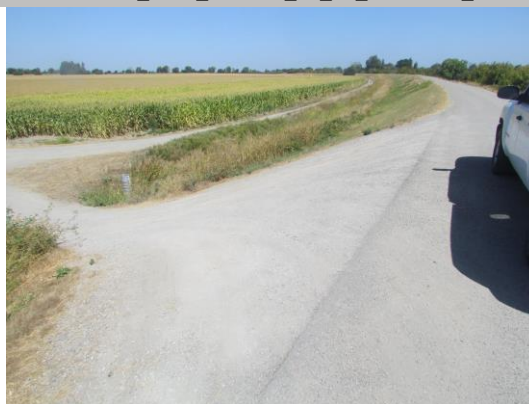
Photo 3 of 3 : SP_2017_NA0002_62_74_20170314_00064.jpg

Looking north at slope damage on waterward slope.

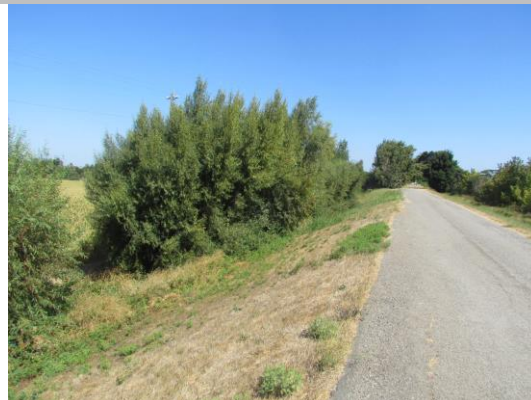
Photo 2 of 2 : SP_2017_NA0002_62_28_20170314_00026.jpg

Look west at dense vegetation at landward toe. (Fall 2016)

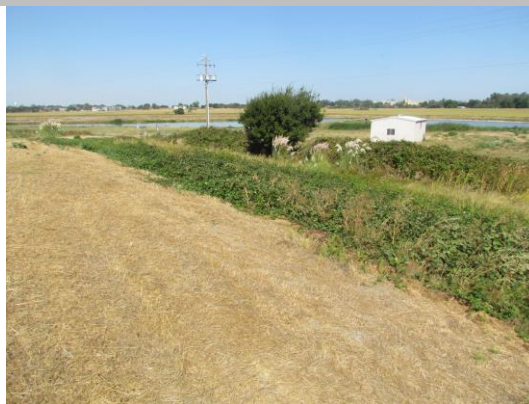
Photo 1 of 1 : SP_2017_NA0002_62_71_20170314_00057.jpg

Looking west at dense vines at landward toe.

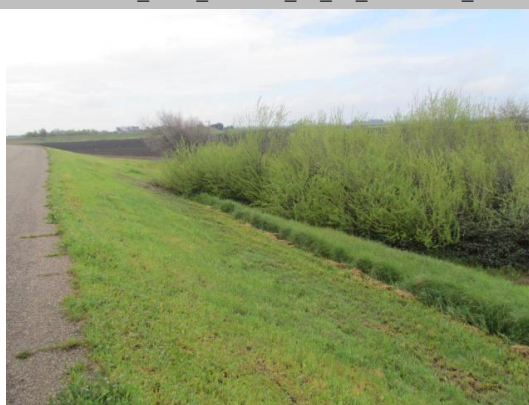
Photo 2 of 4 : SP_2017_NA0002_62_55_20170314_00042.jpg

Looking southwest at dense vegetation at landward toe. (Spring 2015)

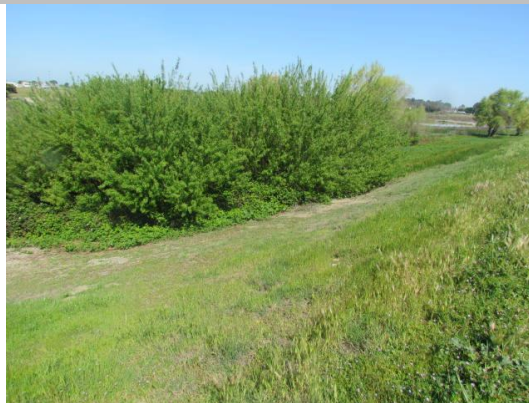
Photo 4 of 4 : SP_2017_NA0002_62_55_20170314_00044.jpg

Looking north at dense vegetation within fifteen feet of landward toe.

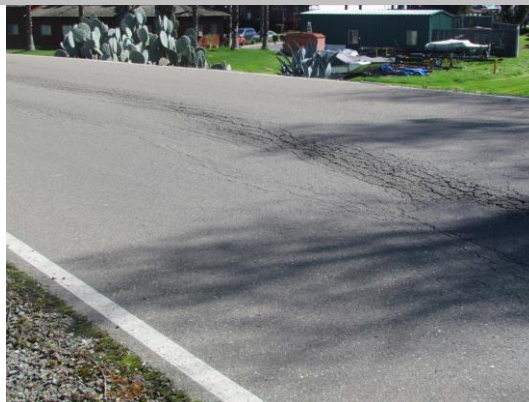
Photo 1 of 3 : SP_2017_NA0002_62_67_20170324_00111.jpg

LM Start	3.38	Rating **	U	Issue No.	67
LM End	3.40	Issue Type +	Ma	Location *	CR
Category	Earthen Levee			GPS Latitude/Longitude	
				Start	End
Item	Slope Stability			38.151430 °	38.151390 °
				-121.592085 °	-121.592517 °
DWR ID	DWR_NA0002_01_s _ 2017_67				
Comment Code					
S1 : Repair slope instability.					
Inspector Comment					
Appears to be a slip from waterside to landside.

Looking south at sloughing on landward shoulder.

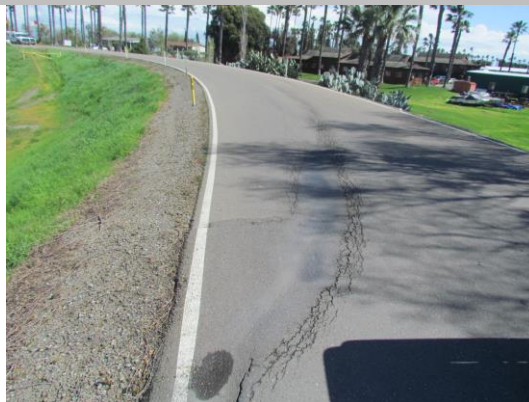
Photo 2 of 3 : SP_2017_NA0002_62_67_20170324_00110.jpg

Looking east at possible sloughing on landward shoulder.

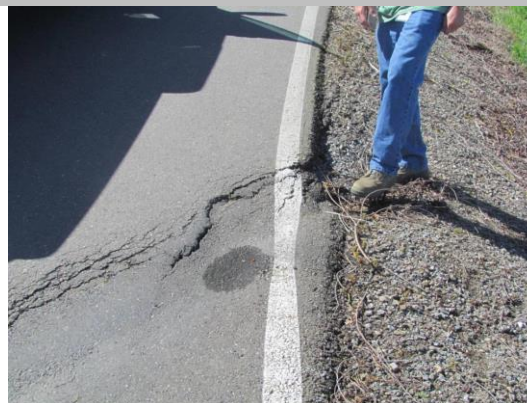
Photo 3 of 3 : SP_2017_NA0002_62_67_20170324_00112.jpg

LM Start	3.38	Rating **	U	Issue No.	67 (cont)	
LM End	3.40	Issue Type +	Ma	Location *	CR	
Category	Earthen Levee			GPS Latitude/Longitude		
				Start		End
Item	Slope Stability			38.151430 °		38.151390 °
				-121.592085 °		-121.592517 °
DWR ID	DWR_NA0002_01_s _ 2017_67					
Comment Code						
S1 : Repair slope instability.						
Inspector Comment						
Appears to be a slip from waterside to landside.

Looking at downstream corner of slough.

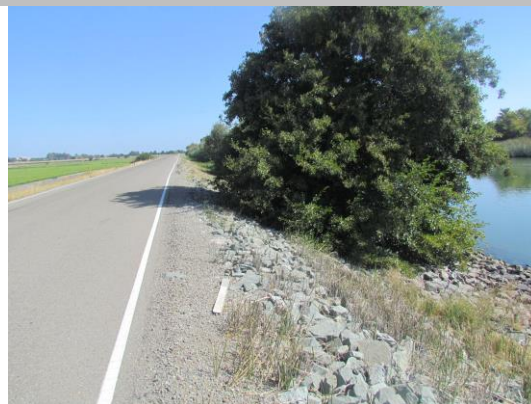
Photo 1 of 1 : SP_2017_NA0002_62_57_20170314_00045.jpg

Looking west at untrimmed tree on waterward slope.

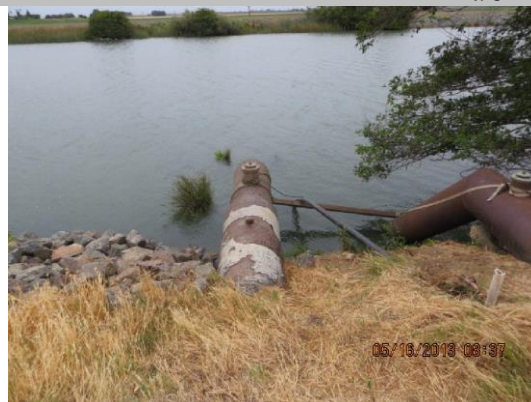
Photo 1 of 3 : UCIP_SP_2017_51302_22082.jpg

LM Start	3.99	Rating **	A/W	Issue No.	85
LM End	3.99	Issue Type +	Ma	Location *	WS
Category	Supplemental			GPS Latitude/Longitude	
				Start	End
Item	DWR UCIP LMA Responsibility			38.147677 °	38.147677 °
				-121.600501 °	-121.600501 °
DWR ID					
Comment Code					
Inspector Comment					
FS_ID:51302 DS_ID:21772 EP_NO: 11248 Repair Type: No Action Needed Crossing Status: Found UCIP Comments: FIELD_STRUCT_DESC: 1 of 2: 24-inch steel drainage pipe (26-inch pipe referenced in O&M manual) through levee, 3 feet below the crown. Siphon breaker is located on the waterside (WS) slope. Pump is located on the landside (LS). (Automatic Board Order (ABO) issued as Permit No. 11248, 1975 – Reclamation District No. 407) [Additional Reference(s): DWR Levee Log, 2005. USACE Sacramento O&M Manual Unit 103, June 1954, Drawing No. 50-4-2631, page 2631/2, (Station 107+76)]. FS Date: 5/16/2013

24-inch pipe and siphon breaker visible on WS slope.

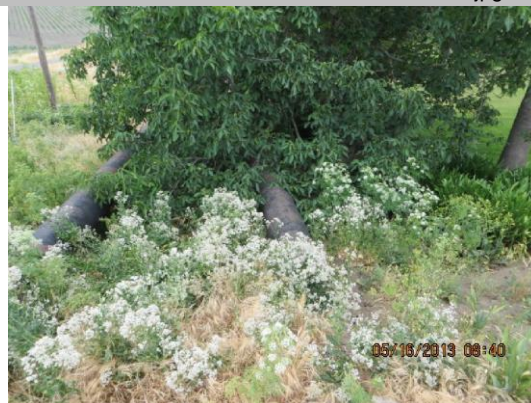
Photo 2 of 3 : UCIP_SP_2017_51302_22081.jpg

Pipe visible on LS slope.

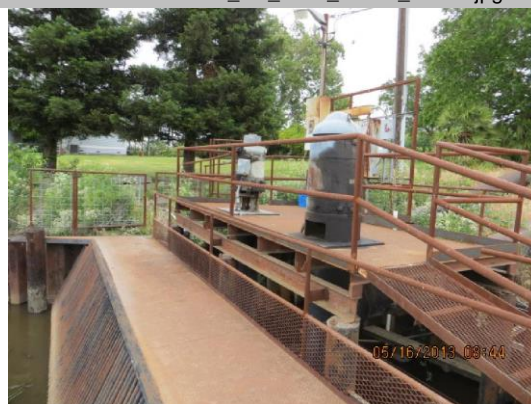
Photo 3 of 3 : UCIP_SP_2017_51302_22080.jpg

Pumping plant on LS toe.

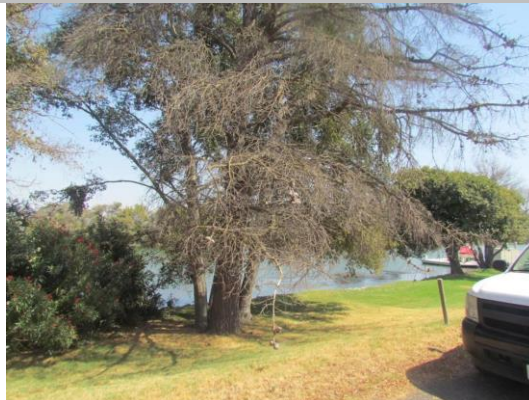
Photo 2 of 2 : SP_2017_NA0002_62_62_20170314_00050.jpg

Looking downstream at dead pine tree on waterward berm.

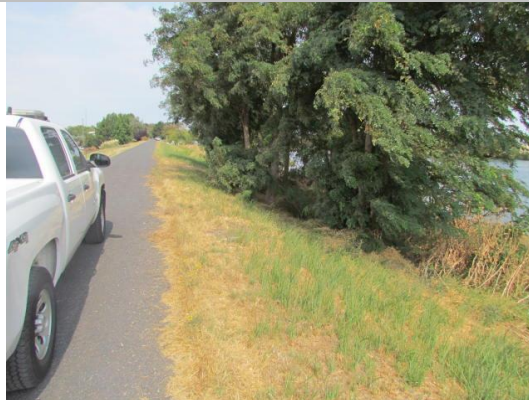
Photo 1 of 1 : SP_2017_NA0002_62_2_20170314_00001.jpg

Looking at untrimmed trees on waterward slope.

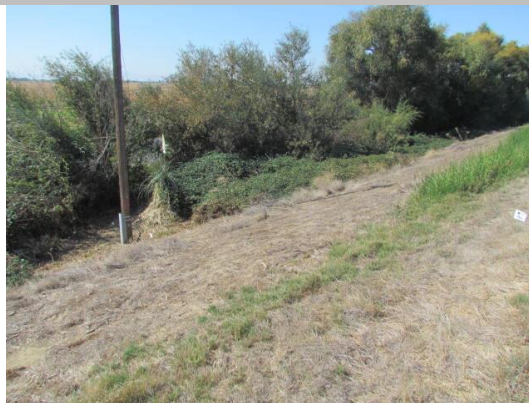
Photo 5 of 6 : SP_2017_NA0002_62_23_20170314_00017.jpg

Looking south at dense berry vines and trees on the landward slope and toe.

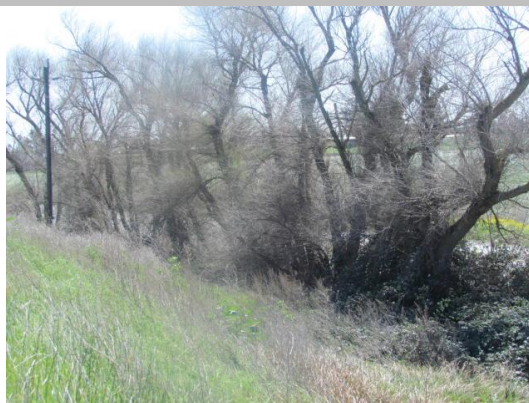
Photo 6 of 6 : SP_2017_NA0002_62_23_20170314_00018.jpg

Looking south at trees, berry vines, and wild rose on landside toe.

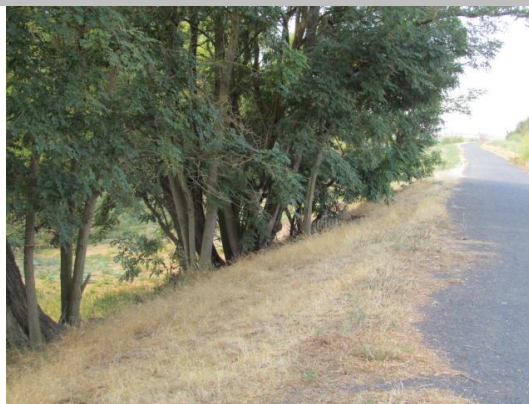
Photo 1 of 1 : SP_2017_NA0002_62_17_20170314_00011.jpg

Looking at dense trees on landward slope and toe.

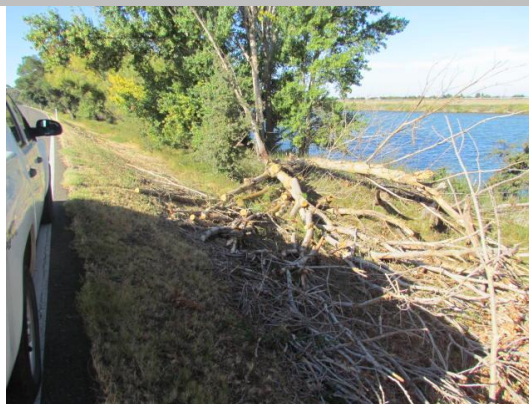
Photo 1 of 2 : SP_2017_NA0002_63_91_20170314_00054.jpg

Looking south west at fallen tree on waterward slope and berm.

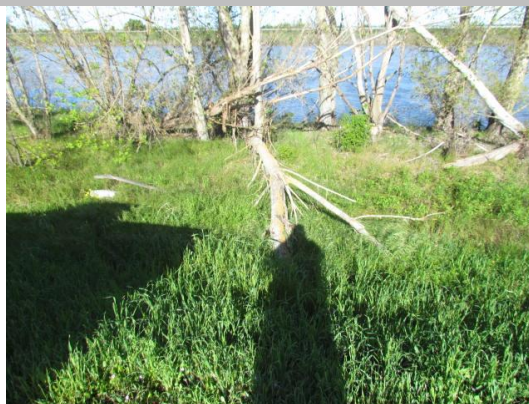
Photo 1 of 2 : SP_2017_NA0002_63_92_20170314_00056.jpg

Looking west at fallen tree branch on waterward berm. (Spring 2016)

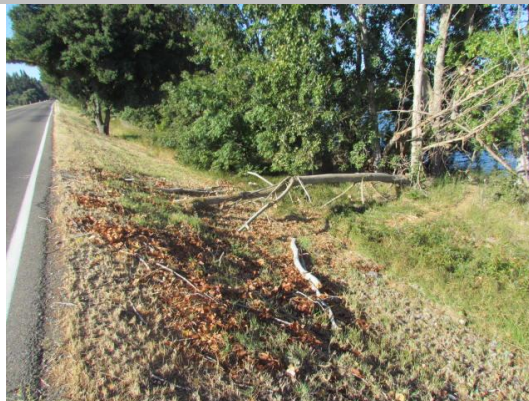
Photo 2 of 2 : SP_2017_NA0002_63_92_20170314_00057.jpg

Looking at fallen tree on waterward slope and berm. (Spring 2015)

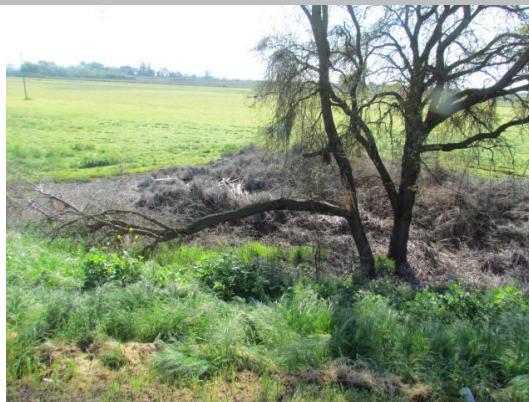
Photo 1 of 1 : SP_2017_NA0002_63_96_20170314_00062.jpg

LM Start	1.40	Rating **	M	Issue No.	96
LM End	1.40	Issue Type +	Ma	Location *	LS
Category	Earthen Levee			GPS Latitude/Longitude	
				Start	End
Item	Encroachments			38.179543 °	38.179543 °
				-121.587226 °	-121.587226 °
DWR ID	DWR_NA0002_02_s_2015_96				
Comment Code					
TR : Tree or limb					
Inspector Comment					
Broken tree branch on landward toe.

Looking east at broken tree limb at landward toe.

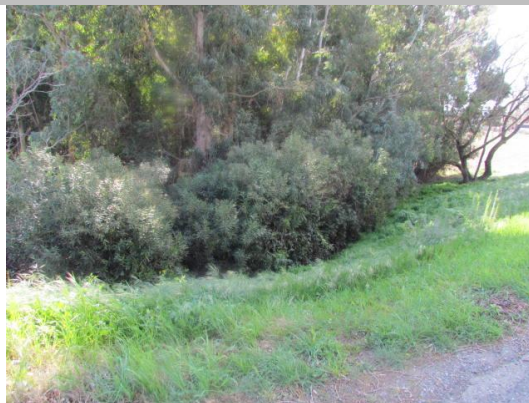
Photo 4 of 4 : SP_2017_NA0002_63_27_20170314_00032.jpg

Looking southeast at dense trees on landside toe.

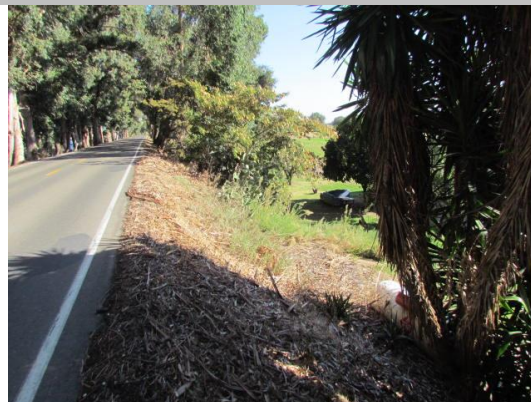
Photo 2 of 2 : SP_2017_NA0002_63_45_20170314_00046.jpg

Looking northeast at dense vegetation on landward slope and toe.

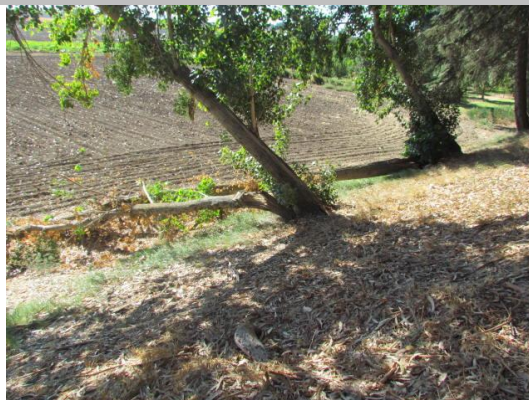
Photo 1 of 2 : SP_2017_NA0002_63_93_20170314_00058.jpg

LM Start	1.87	Rating **	M	Issue No.	93
LM End	1.89	Issue Type +	Ma	Location *	LS
Category	Earthen Levee			GPS Latitude/Longitude	
				Start	End
Item	Encroachments			38.173571 °	38.173288 °
				-121.591343 °	-121.591531 °
DWR ID	DWR_NA0002_02_f_2015_93				
Comment Code					
TR : Tree or limb					
Inspector Comment					
Broken tree limbs on landward slope and toe.

Looking southeast at broken tree limb on landward slope.

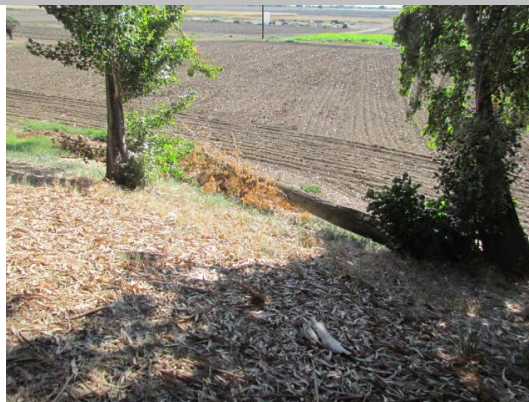
Photo 2 of 2 : SP_2017_NA0002_63_93_20170314_00059.jpg

Looking east at broken tree limb at landward toe.

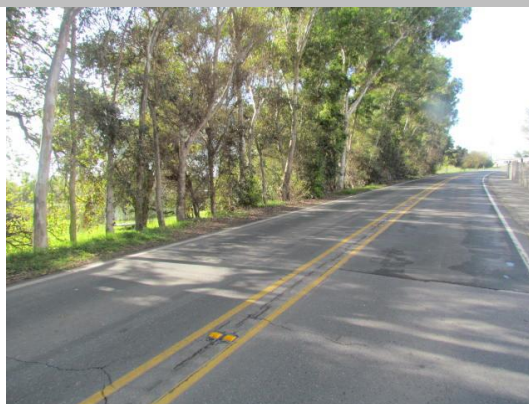
Photo 1 of 1 : SP_2017_NA0002_63_25_20170314_00027.jpg

Looking southeast at trees at landward shoulder. (Spring 2015)

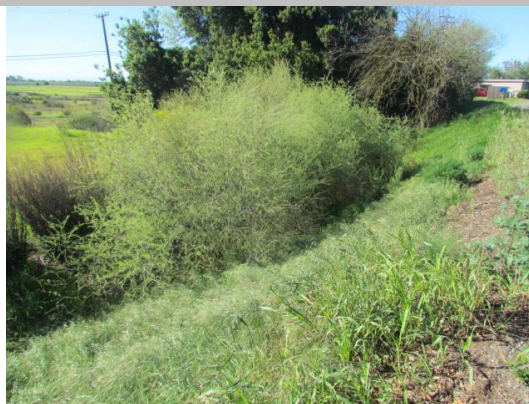
Photo 1 of 2 : SP_2017_NA0002_63_99_20170314_00065.jpg

Looking southwest at vegetation (willows) on landward slope and toe.

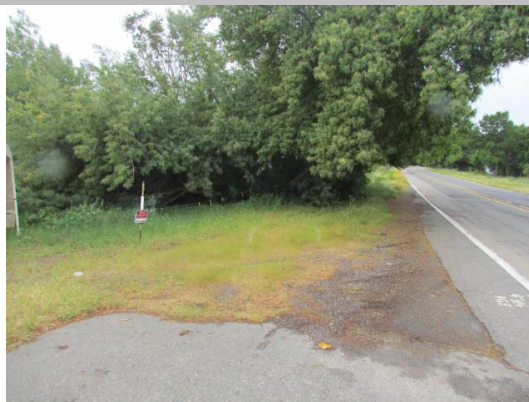
Photo 2 of 2 : SP_2017_NA0002_63_29_20170314_00035.jpg

Looking southwest at dense vegetation on landward slope.

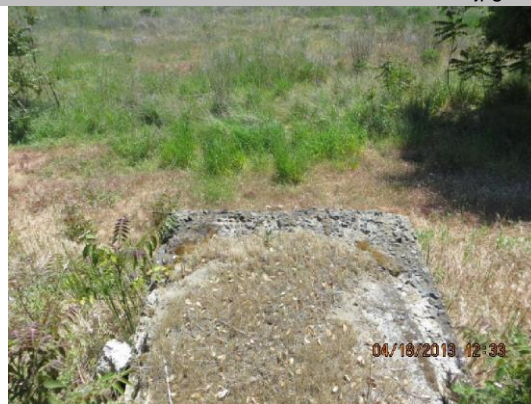
Photo 2 of 3 : UCIP_SP_2017_51314_19772.jpg

FS_ID:51314
DS_ID:21879
EP_NO: N/A
Repair Type: Urgent
Crossing Status: Found
UCIP Comments: 10/24/2016 same as previous inspection culvert is open on both ends. WS blocked by blankets -- WS structure is being used as a shelter. (O. Magana - DWR UCIP)04/18/2013 Culvert open on both ends. Needs to be abandoned properly. (W. Wylie - DWR UCIP)
FIELD_STRUCT_DESC: *ABANDONED* 3.5-foot by 3.5-foot open concrete culvert through levee, 6 feet below the crown. [Additional Reference(s): DWR Levee Log, 2005. USACE Sacramento O&M Manual Unit 103, June 1954, (RM 18.16), Drawing No. 6-13-1100].
FS Date: 10/24/2016

Top of concrete tunnel on LS shoulder.

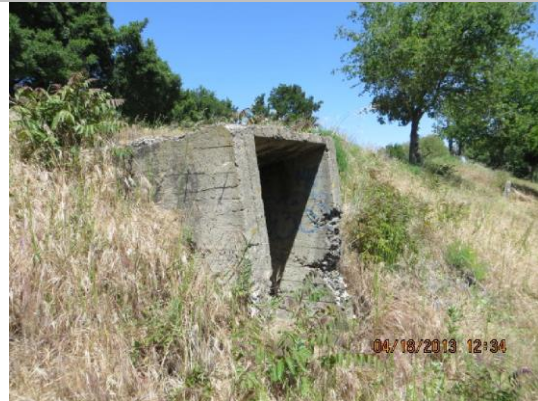
Photo 3 of 3 : UCIP_SP_2017_51314_19771.jpg

Concrete tunnel on LS shoulder.

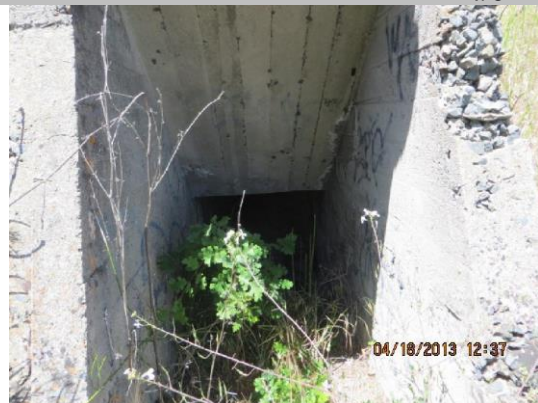
Photo 1 of 3 : UCIP_SP_2017_51315_19776.jpg

Tunnel open on LS shoulder.

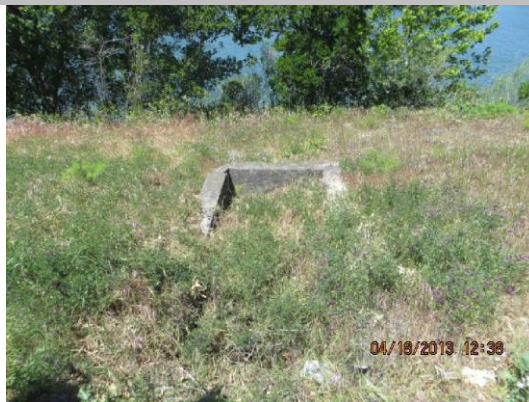
Photo 3 of 3 : UCIP_SP_2017_51315_19774.jpg

10'X5' concrete box on WS slope, filled with soil.

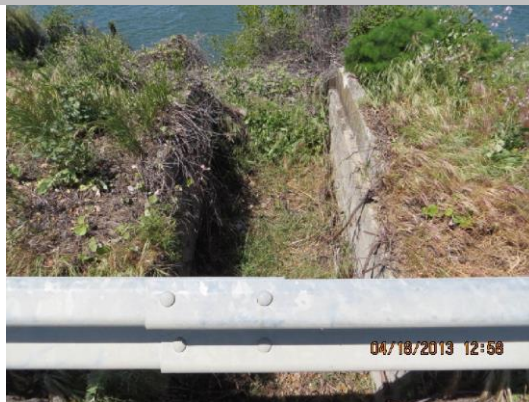
Photo 2 of 3 : UCIP_SP_2017_51316_19781.jpg

Tunnel opening on WS slope.

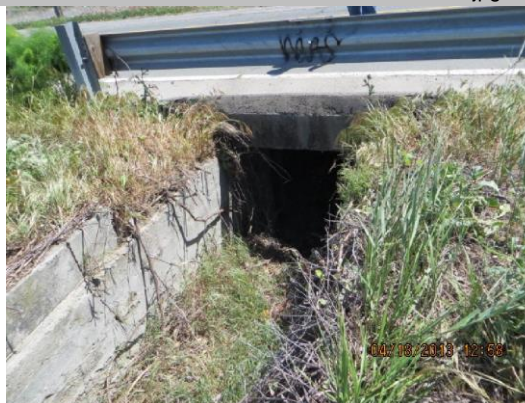
Photo 3 of 3 : UCIP_SP_2017_51316_19780.jpg

Tunnel opening on WS slope.

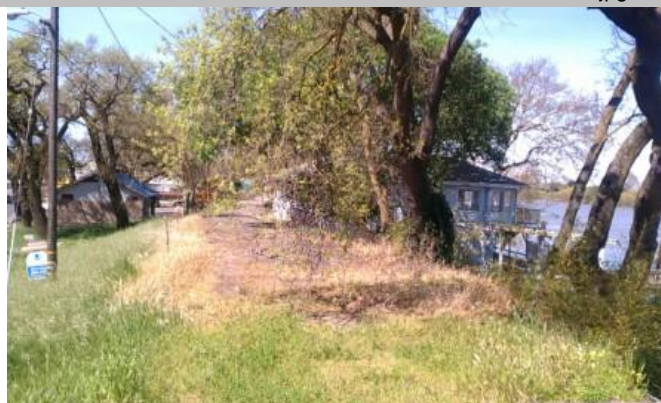
Photo 2 of 2 : SP_2017_NA0002_63_5_20170314_00004.jpg

Looking west at overhanging tree on waterside shoulder.

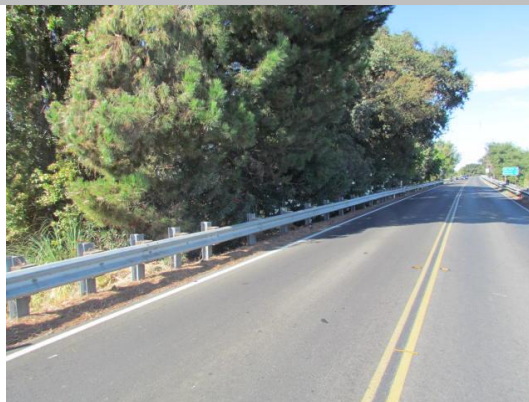
Photo 1 of 1 : SP_2017_NA0002_63_22_20170314_00025.jpg

Looking south at dense vegetation (trees) on landward slope and toe.

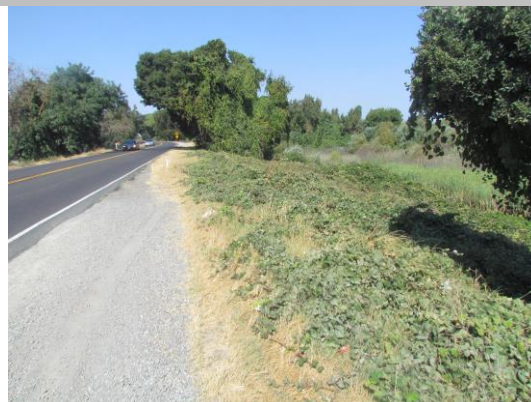
Photo 1 of 1 : SP_2017_NA0002_63_123_20170314_00092.jpg

Looking west at dense vines on waterward slope and toe.

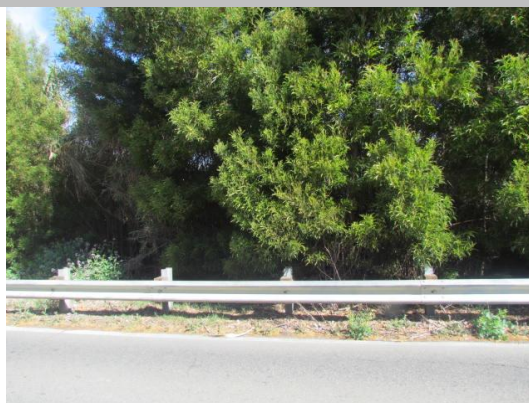
Photo 3 of 3 : SP_2017_NA0002_63_9_20170314_00012.jpg

Looking north at dense trees on waterward should and slope.

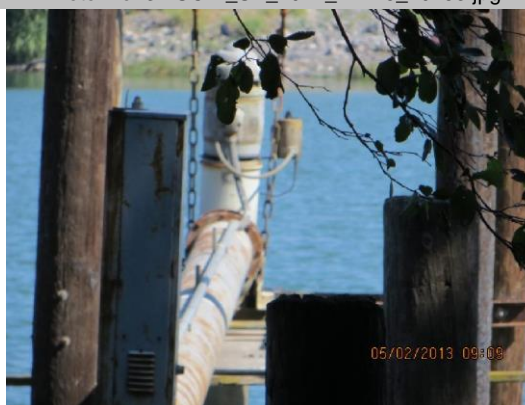
Photo 2 of 3 : UCIP_SP_2017_12776_20753.jpg

Pump on pier at WS toe.

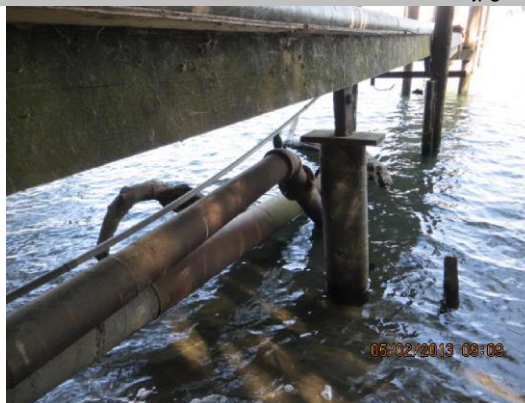
Photo 3 of 3 : UCIP_SP_2017_12776_20752.jpg

Pipe under pier.

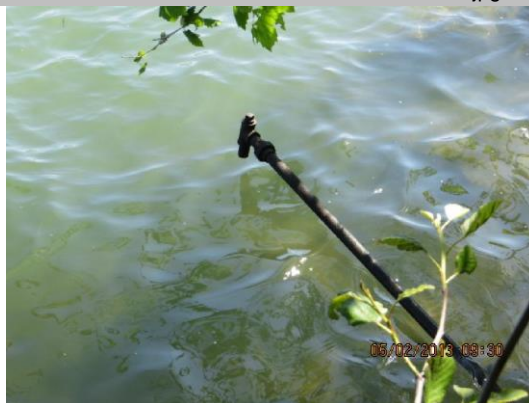
Photo 1 of 3 : UCIP_SP_2017_12778_20762.jpg

Conduit at WS toe.

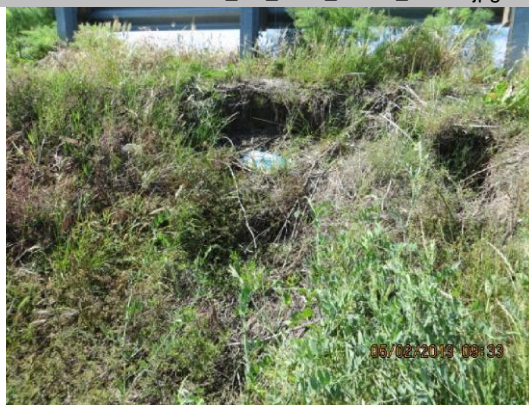
Photo 2 of 3 : UCIP_SP_2017_12778_20761.jpg

Erosion along pipe alignment at WS slope.

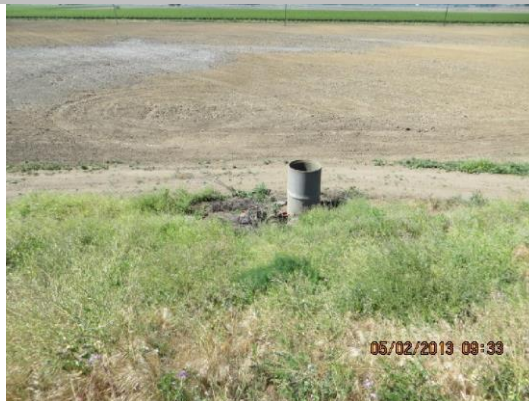
Photo 3 of 3 : UCIP_SP_2017_12778_20760.jpg

Concrete standpipe and pump on LS toe.

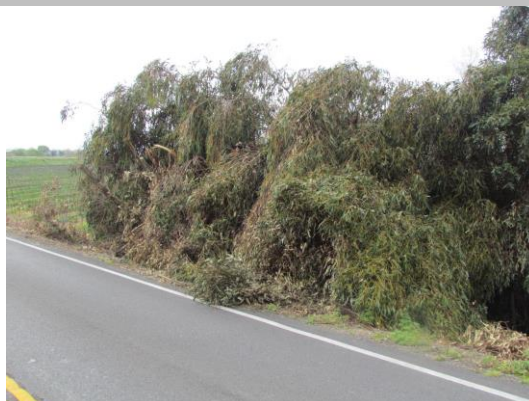
Photo 1 of 1 : SP_2017_NA0002_63_110_20170324_00189.jpg

Looking northeast at fallen tree on landward slope and toe.

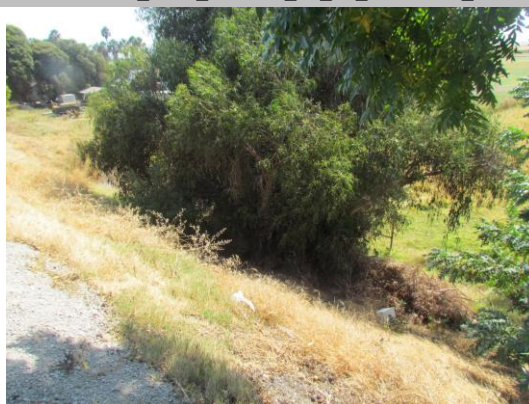
Photo 2 of 2 : SP_2017_NA0002_63_14_20170314_00018.jpg

Looking east at untrimmed tree on landward slope.

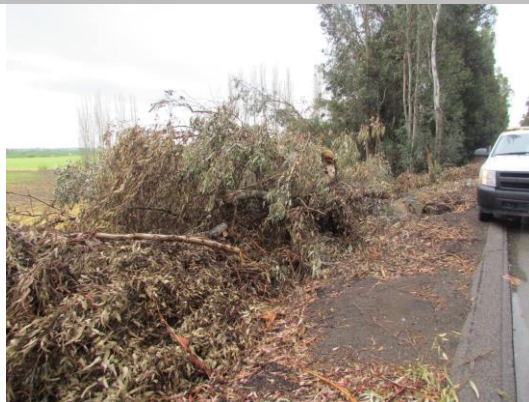
Photo 1 of 4 : SP_2017_NA0002_63_106_20170324_00192.jpg

Looking southeast at fallen tree prunings on landward shoulder and slope.

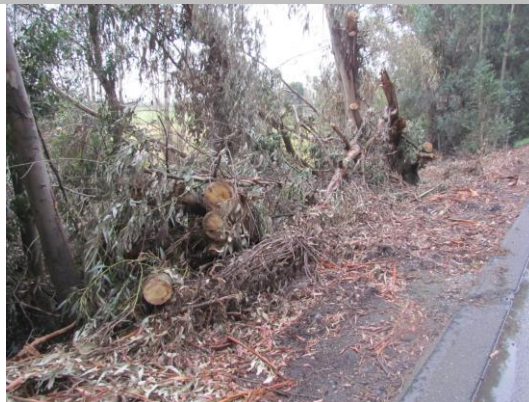
Photo 4 of 4 : SP_2017_NA0002_63_106_20170324_00195.jpg

Looking southeast at second fallen tree prunings on landward shoulder and slope.

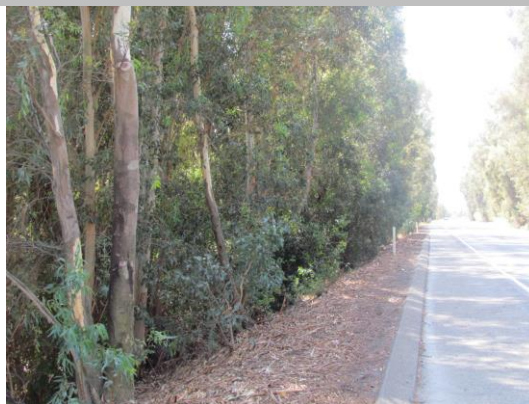
Photo 1 of 1 : SP_2017_NA0002_63_44_20170314_00044.jpg

Looking south at untrimmed trees along landward slope.

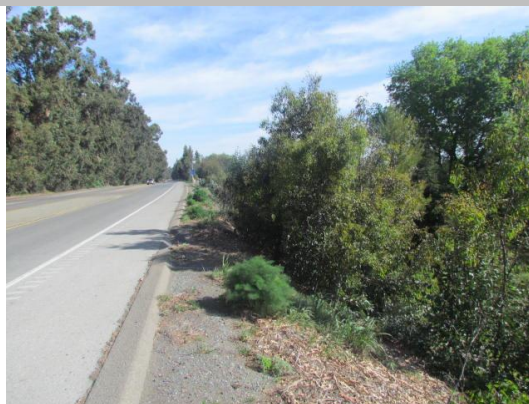
Photo 2 of 2 : SP_2017_NA0002_63_48_20170314_00048.jpg

Looking north at dense trees on landward slope and toe.

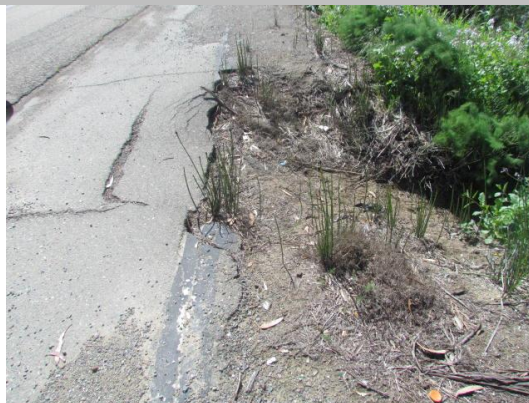
Photo 3 of 4 : SP_2017_NA0002_63_115_20170314_00084.jpg

Looking south at erosion on waterward shoulder.

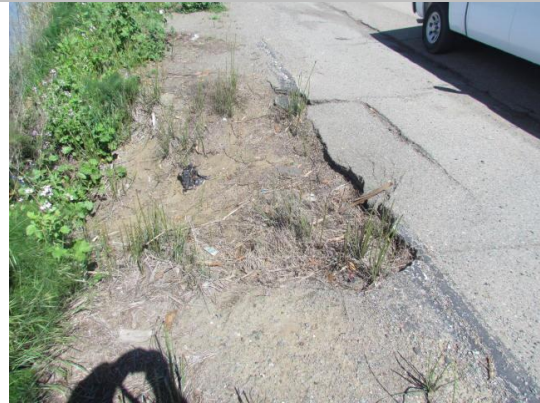
Photo 4 of 4 : SP_2017_NA0002_63_115_20170314_00085.jpg

Looking north at foot erosion at waterward shoulder and slope.

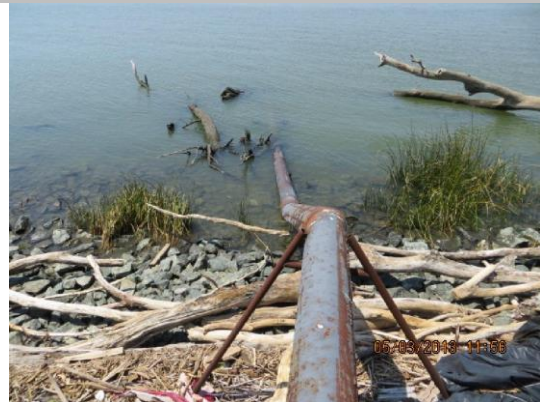
Photo 1 of 3 : UCIP_SP_2017_40528_21002.jpg

Pipe on WS slope.

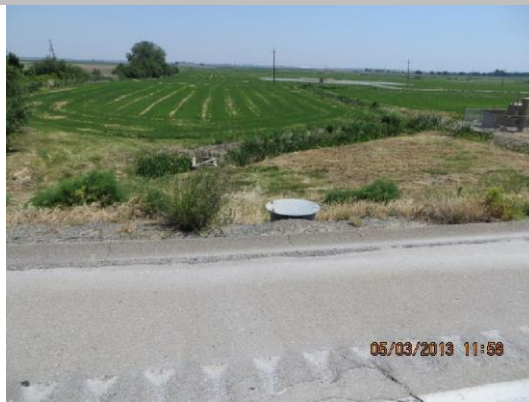
Photo 3 of 3 : UCIP_SP_2017_40528_21000.jpg

Standpipe and concrete box at LS.

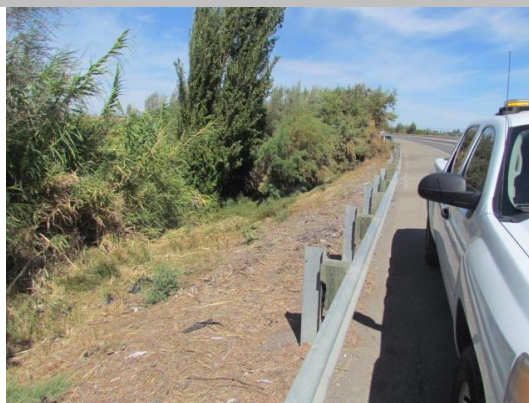
Photo 2 of 2 : SP_2017_NA0002_63_16_20170314_00020.jpg

Looking north at dense vegetation (trees) on waterward slope.

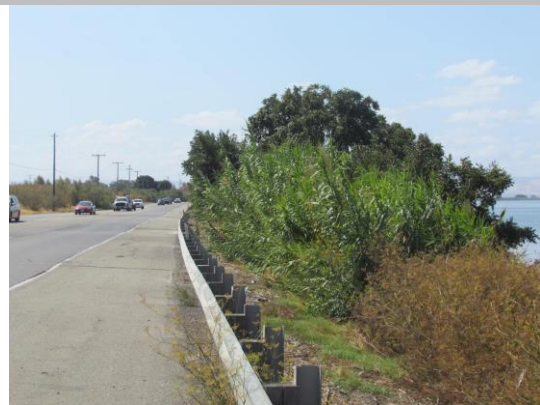
Photo 1 of 2 : SP_2017_NA0002_63_107_20170314_00073.jpg

Looking south at bamboo and other vegetation on waterward slope. (Fall 2016)

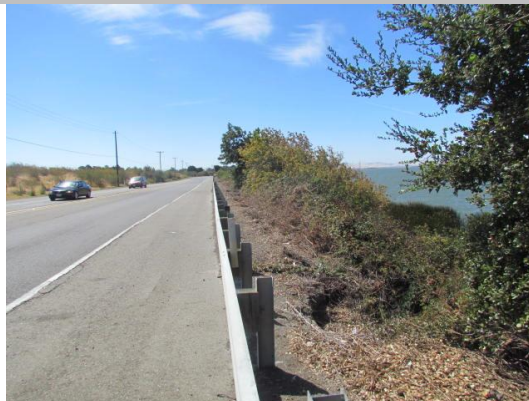
Photo 2 of 2 : SP_2017_NA0002_63_107_20170314_00074.jpg

Looking south at dense vegetation on waterward slope. (Fall 2015)

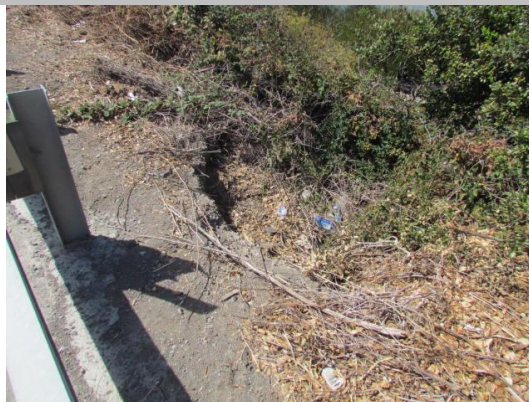
Photo 1 of 1 : SP_2017_NA0002_63_113_20170314_00081.jpg

Looking at erosion on waterward shoulder.
