**Flood Control Project Maintenance
Levee Inspections**

Maintenance Issue Types Only, Levee Inspection Report By Mile - Spring 2018

Brannan Andrus Levee Maintenance District

Waterway	Bank	Unit Miles	Inspection Start/End	Inspector
Unit No. 01 Georgiana Slough	Right	6.01	04/05/2018 04/05/2018	Keith Millard

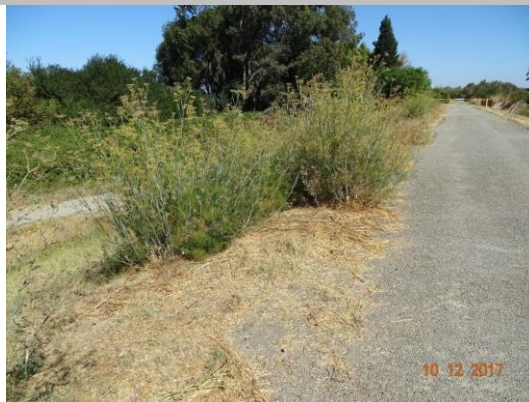
Photo 1 of 1 : SP_2018_NA0002_62_43_20180305_00031.jpg

LM Start	0.02	Rating **	M	Issue No.	43
LM End	2.25	Issue Type +	Ma	Location *	LS
Category	Earthen Levee			GPS Latitude/Longitude	
				Start	End
Item	Vegetation			38.186345 °	38.163432 °
				-121.562957 °	-121.584426 °
DWR ID	DWR_NA0002_01_f_2017_43				
Comment Code					
V1 : Control annual grass and weeds on the levee slopes and easements.					
Inspector Comment

Looking northeast at the landside slope.

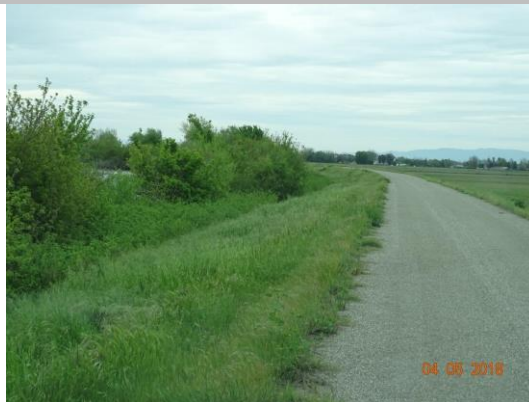
Photo 1 of 1 : SP_2018_NA0002_62_53_20180409_00107.jpg

LM Start	0.02	Rating **	M	Issue No.	53
LM End	2.29	Issue Type +	Ma	Location *	WS
Category	Earthen Levee			GPS Latitude/Longitude	
				Start	End
Item	Vegetation			38.186344 °	38.162909 °
				-121.562959 °	-121.584706 °
DWR ID	DWR_NA0002_01_s_2018_53				
Comment Code					
V1 : Control annual grass and weeds on the levee slopes and easements.					
Inspector Comment

Waterside vegetation should be reduced to 20' from crown.

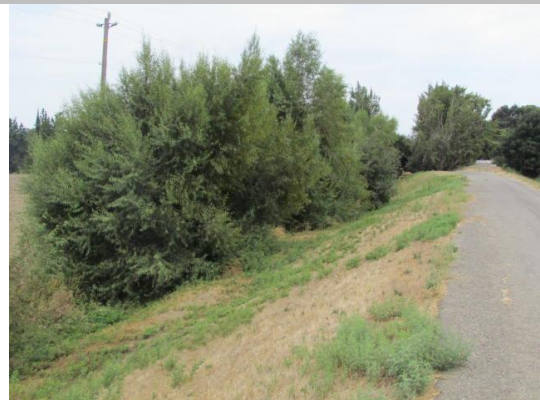
Photo 1 of 2 : SP_2018_NA0002_62_28_20180305_00024.jpg

Look west at dense vegetation at landward toe. (Spring 2016)

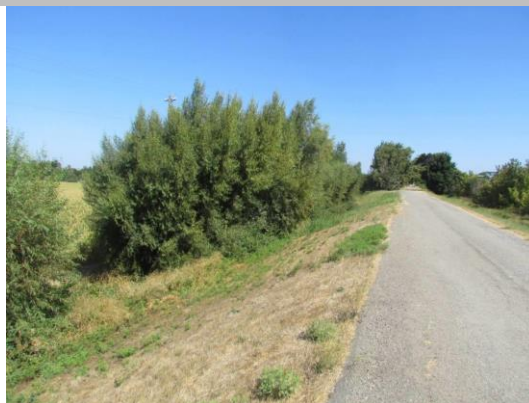
Photo 2 of 2 : SP_2018_NA0002_62_28_20180305_00025.jpg

Look west at dense vegetation at landward toe. (Fall 2016)

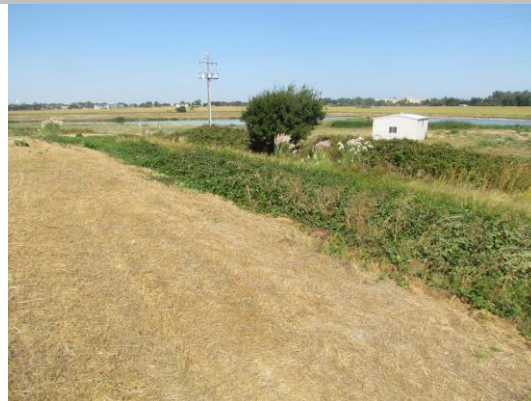
Photo 1 of 1 : SP_2018_NA0002_62_71_20180305_00054.jpg

Looking west at dense vines at landward toe.

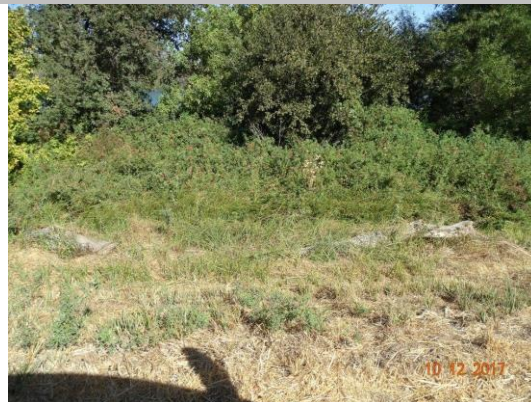
Photo 1 of 1 : SP_2018_NA0002_62_45_20180305_00032.jpg

LM Start	2.79	Rating **	M	Issue No.	69
LM End	4.04	Issue Type +	Ma	Location *	LS
Category	Earthen Levee			GPS Latitude/Longitude	
				Start	End
Item	Vegetation			38.157925 °	38.146984 °
				-121.589473 °	-121.601028 °
DWR ID	DWR_NA0002_01_s_2018_69				
Comment Code					
V1 : Control annual grass and weeds on the levee slopes and easements.					
Inspector Comment

Looking east at the waterside slope.

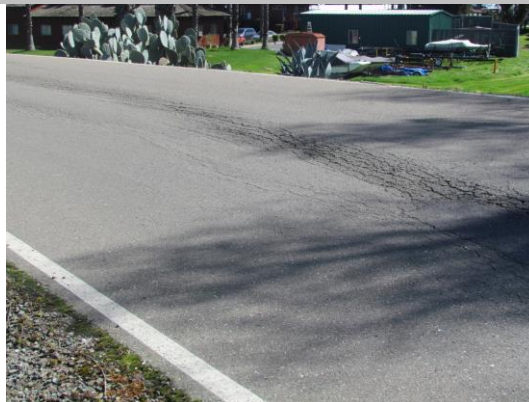
Photo 1 of 3 : SP_2018_NA0002_62_67_20180305_00049.jpg

LM Start	3.38	Rating **	A/W	Issue No.	67
LM End	3.40	Issue Type +	Ma	Location *	CR
Category	Earthen Levee			GPS Latitude/Longitude	
				Start	End
Item	Slope Stability			38.151430 °	38.151390 °
				-121.592085 °	-121.592517 °
DWR ID	DWR_NA0002_01_s_2017_67				
Comment Code					
S1 : Repair slope instability.					
Inspector Comment					
Appears to be beginning of a landside slump. LMA's Engineer (DCC) is monitoring site for movement.

Looking south at sloughing on landward shoulder.

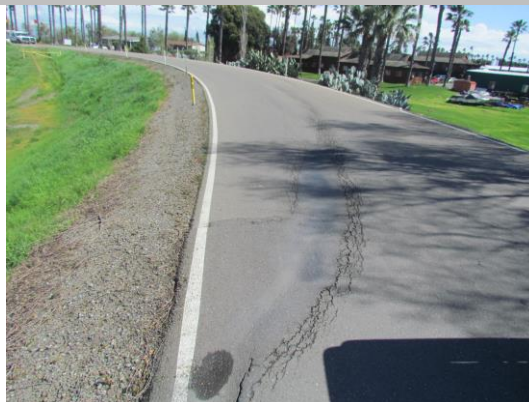
Photo 2 of 3 : SP_2018_NA0002_62_67_20180305_00050.jpg

Looking east at possible sloughing on landward shoulder.

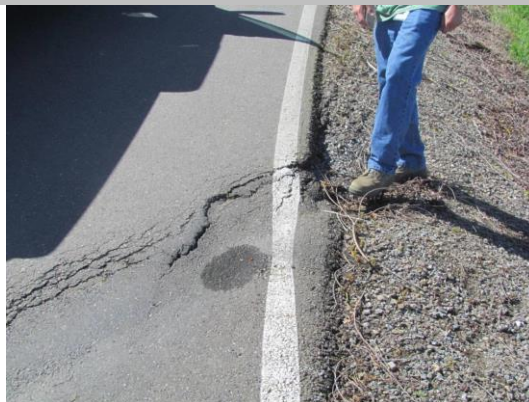
Photo 3 of 3 : SP_2018_NA0002_62_67_20180305_00051.jpg

Looking at downstream corner of slough.

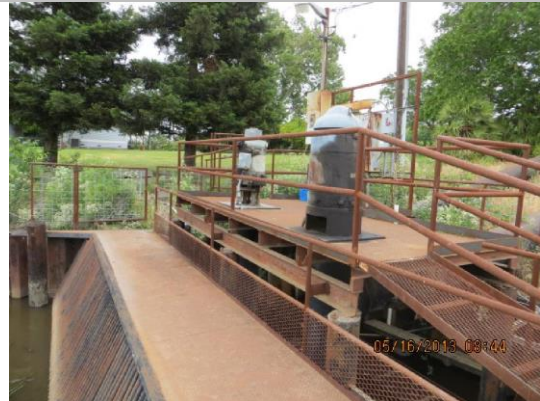
Photo 3 of 3 : UCIP_SP_2018_51302_22080.jpg

Comment Code						
Inspector Comment						
FS_ID:51302 DS_ID:21772 EP_NO: 11248 Repair Type: No Action Needed Crossing Status: Found UCIP Comments: FIELD_STRUCT_DESC: 1 of 2: 24-inch steel drainage pipe through levee, 3 feet below the crown. Siphon breaker is located on the waterside (WS) slope. Pump is located on the landside (LS). (24-inch pipe [HLM 3.99] authorized under Automatic Board Order (ABO) issued as Permit No. 11248, 1975 – Reclamation District No. 407) [Additional Reference(s): DWR Levee Log, 2005. USACE Sacramento O&M Manual Unit 103, June 1954, Drawing No. 50-4-2631, page 2631/2, (Station 107+76), 26-inch listed]. FS Date: 5/16/2013

Pumping plant on LS toe.

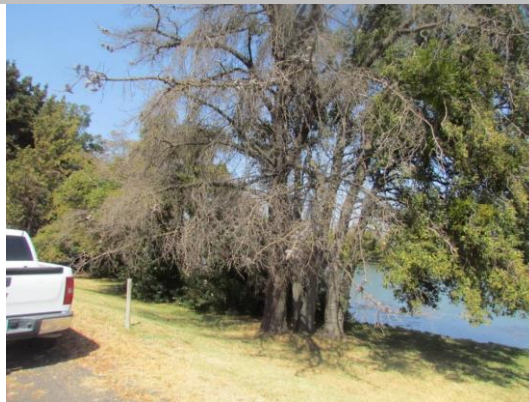
Photo 1 of 2 : SP_2018_NA0002_62_62_20180305_00045.jpg

Looking upstream at dead pine tree on waterward berm.

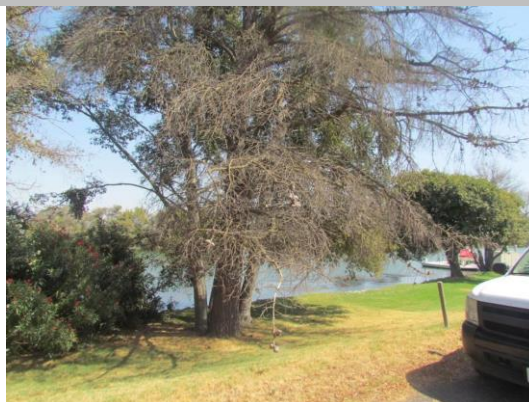
Photo 2 of 2 : SP_2018_NA0002_62_62_20180305_00046.jpg

Looking downstream at dead pine tree on waterward berm.

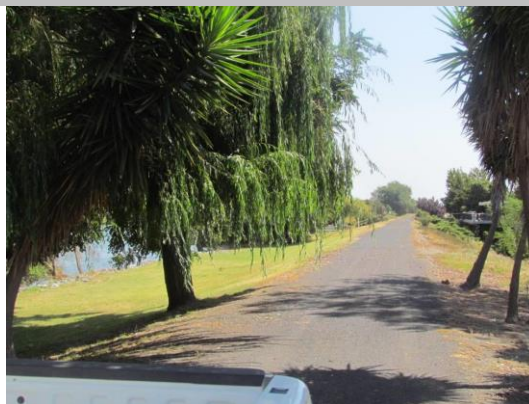
Photo 1 of 1 : SP_2018_NA0002_62_31_20180305_00026.jpg

Looking southeast at tree over levee crown.

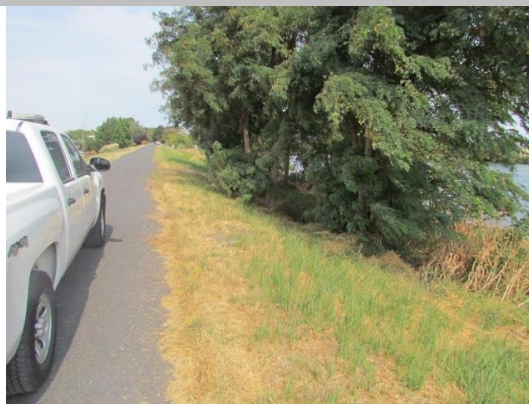
Photo 1 of 1 : SP_2018_NA0002_62_2_20180305_00002.jpg

LM Start	5.33	Rating **	M	Issue No.	2
LM End	5.33	Issue Type +	Ma	Location *	WS
Category	Earthen Levee			GPS Latitude/Longitude	
				Start	End
Item	Trim / Thin Trees			38.131327 °	38.131327 °
				-121.589980 °	-121.589980 °
DWR ID	DWR_NA0002_01_s _ 2012_2				
Comment Code					
T1 : Trim trees to at least five feet above ground level.					
Inspector Comment

Looking at untrimmed trees on waterward slope.

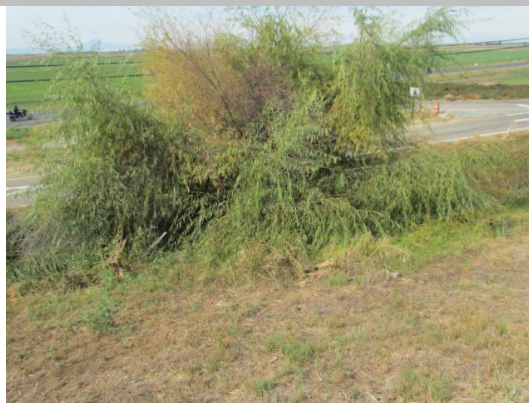
Photo 1 of 1 : SP_2018_NA0002_62_54_20180305_00037.jpg

Looking at dense trees at landward toe.

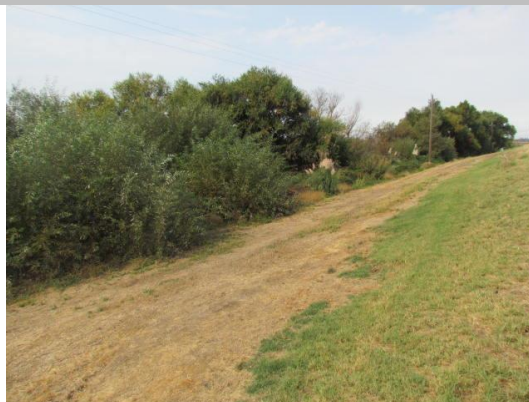
Photo 2 of 6 : SP_2018_NA0002_62_23_20180305_00015.jpg

LM Start	5.43	Rating **	U	Issue No.	23
LM End	5.57	Issue Type +	Ma	Location *	LS
Category	Earthen Levee			GPS Latitude/Longitude	
				Start	End
Item	Vegetation			38.130253 °	38.129359 °
				-121.588822 °	-121.586487 °
DWR ID	DWR_NA0002_01_s _ 2012_23				
Comment Code					
V2 : Remove the wild growth other than native grasses from the levee slopes.					
Inspector Comment					
Control vegetation at landside toe.

Looking west at dense vegetation at landward toe.

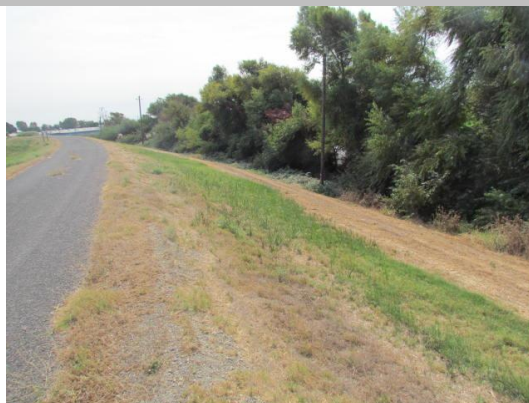
Photo 3 of 6 : SP_2018_NA0002_62_23_20180305_00016.jpg

Looking east at dense vegetation at landward toe.

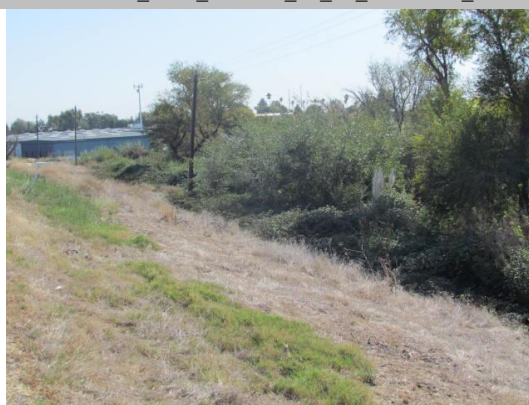
Photo 4 of 6 : SP_2018_NA0002_62_23_20180305_00017.jpg

Looking east at dense vegetation on landward toe.

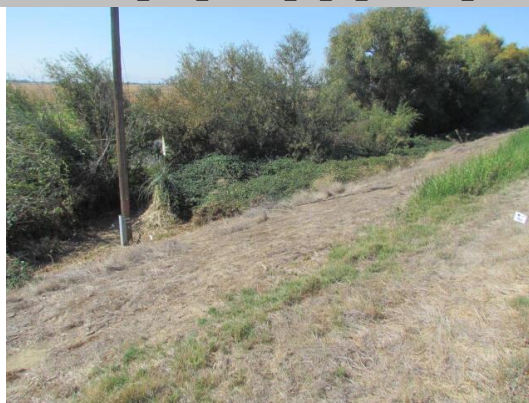
Photo 5 of 6 : SP_2018_NA0002_62_23_20180305_00018.jpg

Looking south at dense berry vines and trees on the landward slope and toe.

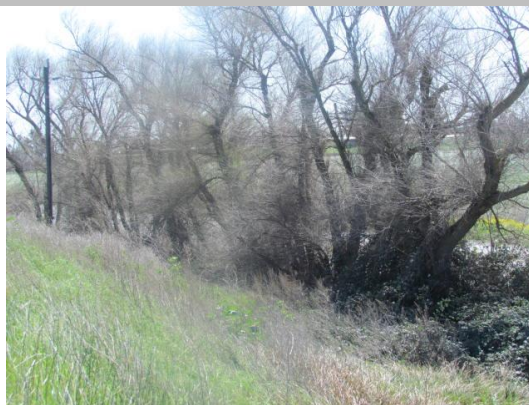
Photo 6 of 6 : SP_2018_NA0002_62_23_20180305_00019.jpg

Looking south at trees, berry vines, and wild rose on landside toe.

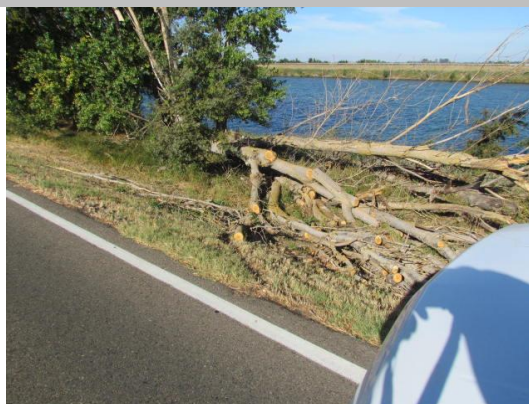
Photo 2 of 2 : SP_2018_NA0002_63_91_20180305_00061.jpg

Looking west at fallen tree on waterward slope and berm.

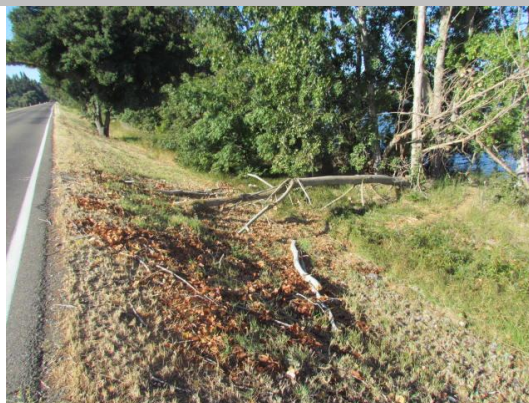
Photo 2 of 2 : SP_2018_NA0002_63_92_20180305_00063.jpg

Looking at fallen tree on waterward slope and berm. (Spring 2015)

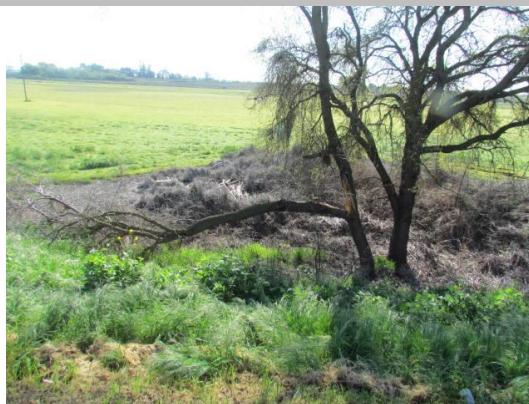
Photo 1 of 1 : SP_2018_NA0002_63_96_20180305_00068.jpg

LM Start	1.40	Rating **	M	Issue No.	96
LM End	1.40	Issue Type +	Ma	Location *	LS
Category	Earthen Levee			GPS Latitude/Longitude	
				Start	End
Item	Encroachments			38.179543 °	38.179543 °
				-121.587226 °	-121.587226 °
DWR ID	DWR_NA0002_02_s_2015_96				
Comment Code					
TR : Tree or limb					
Inspector Comment					
Broken tree branch on landside toe.

Looking east at broken tree limb at landward toe.

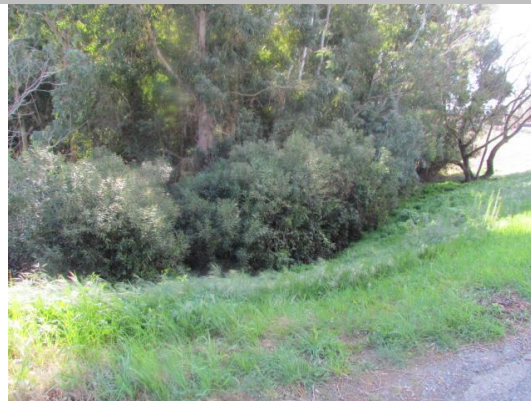
Photo 4 of 4 : SP_2018_NA0002_63_27_20180305_00034.jpg

Looking southeast at dense trees on landside toe.

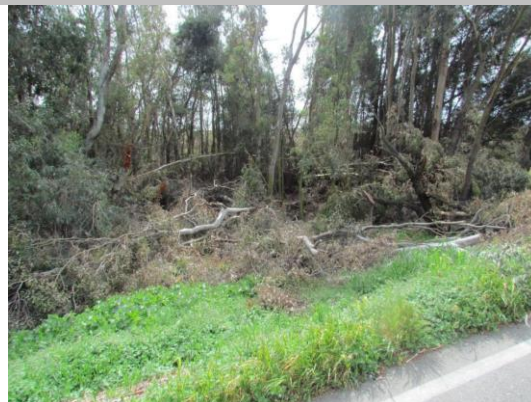
Photo 2 of 2 : SP_2018_NA0002_63_109_20180305_00086.jpg

Looking west at fallen tree on waterward slope.

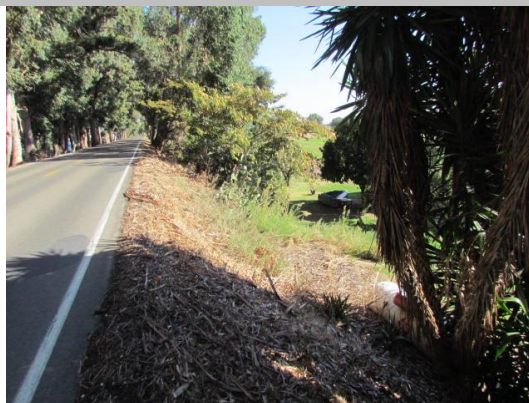
Photo 2 of 2 : SP_2018_NA0002_63_45_20180305_00048.jpg

Looking northeast at dense vegetation on landward slope and toe.

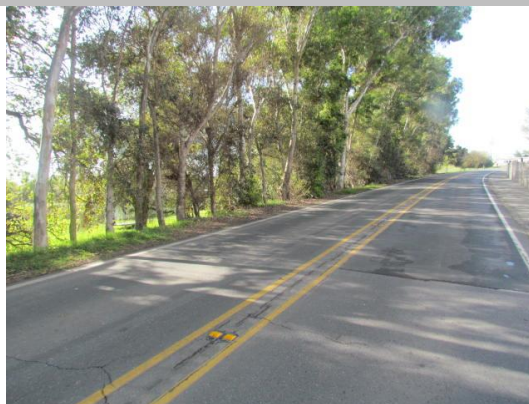
Photo 1 of 1 : SP_2018_NA0002_63_25_20180305_00029.jpg

Looking southeast at trees at landward shoulder. (Spring 2015)

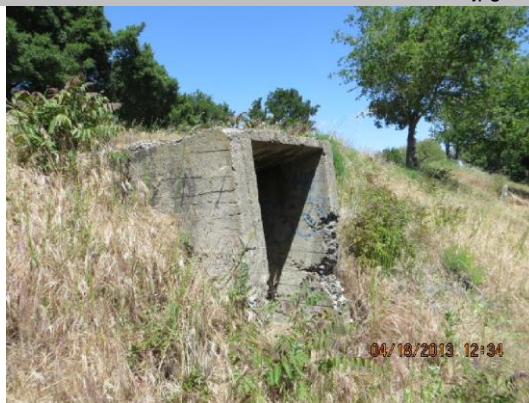
Photo 3 of 3 : UCIP_SP_2018_51314_19771.jpg

Comment Code						
Inspector Comment						
FS_ID:51314 DS_ID:21879 EP_NO: N/A Repair Type: Urgent Crossing Status: Found UCIP Comments: 10/24/2016 same as previous inspection culvert is open on both ends. WS blocked by blankets -- WS structure is being used as a shelter. (O. Magana - DWR UCIP)04/18/2013 Culvert open on both ends. Needs to be abandoned properly. (W. Wylie - DWR UCIP) FIELD_STRUCT_DESC: *ABANDONED* 42-inch by 42-inch open reinforced concrete drainage culvert through the levee, 6 feet below the crown. [Additional Reference(s): DWR Levee Log, 2005, 3-foot by 3.5-foot culvert listed. USACE Sacramento O&M Manual 103, June 1954, (RM 18.16) Drawing No. 6-13-1100]. FS Date: 10/24/2016

Concrete tunnel on LS shoulder.

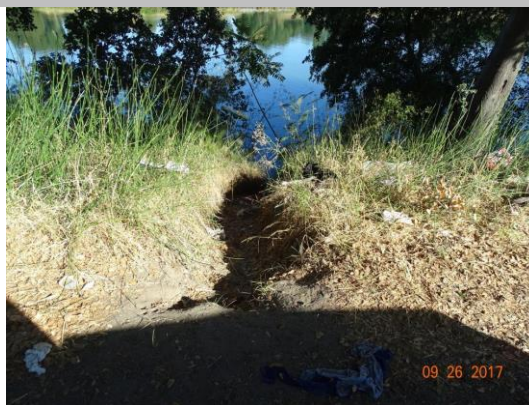
Photo 1 of 1 : SP_2018_NA0002_63_82_20180305_00056.jpg

LM Start	2.56	Rating **	M	Issue No.	82
LM End	2.56	Issue Type +	Ma	Location *	WS
Category	Earthen Levee			GPS Latitude/Longitude	
				Start	End
Item	Slope Stability			38.165898 °	38.165898 °
				-121.598888 °	-121.598888 °
DWR ID	DWR_NA0002_02_f_2017_82				
Comment Code					
S2 : Repair the levee slope damaged by foot traffic and prevent access where possible.					
Inspector Comment

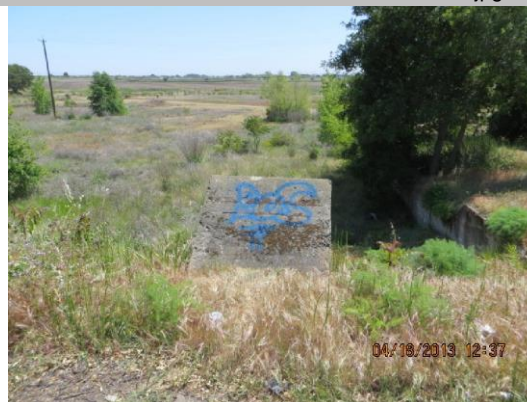
Photo 2 of 3 : UCIP_SP_2018_51315_19775.jpg

FS_ID:51315
DS_ID:21880
EP_NO: N/A
Repair Type: Urgent
Crossing Status: Found
UCIP Comments: 10/24/2016 same as previous inspection concrete box culvert will need to be abandoned properly. (O. Magana - DWR UCIP)04/18/2013 tunnel should be abandoned properly. (W. Wylie - DWR UCIP)
FIELD_STRUCT_DESC: *ABANDONED* 48-inch by 48-inch reinforced concrete drainage culvert through the levee, 6.5-inches below the crown. [Additional Reference(s): DWR Levee Log, 2005. USACE Sacramento O&M Manual 103, June 1954, (RM 18.13) 3-foot by 3-foot concrete box listed, Drawing No. 6-13-1100].
FS Date: 10/24/2016

Concrete tunnel on LS shoulder.

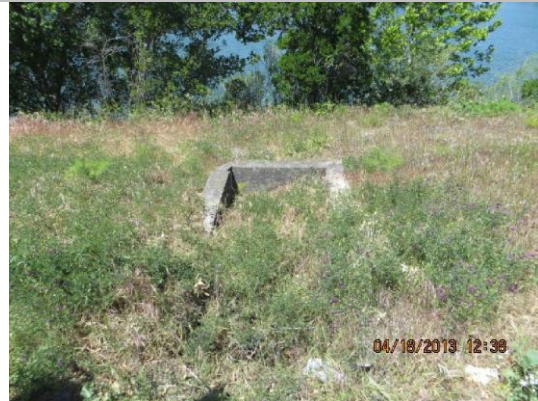
Photo 3 of 3 : UCIP_SP_2018_51315_19774.jpg

Comment Code						
Inspector Comment						
FS_ID:51315 DS_ID:21880 EP_NO: N/A Repair Type: Urgent Crossing Status: Found UCIP Comments: 10/24/2016 same as previous inspection concrete box culvert will need to be abandoned properly. (O. Magana - DWR UCIP)04/18/2013 tunnel should be abandoned properly. (W. Wylie - DWR UCIP) FIELD_STRUCT_DESC: *ABANDONED* 48-inch by 48-inch reinforced concrete drainage culvert through the levee, 6.5-inches below the crown. [Additional Reference(s): DWR Levee Log, 2005. USACE Sacramento O&M Manual 103, June 1954, (RM 18.13) 3-foot by 3-foot concrete box listed, Drawing No. 6-13-1100]. FS Date: 10/24/2016

10'X5' concrete box on WS slope, filled with soil.

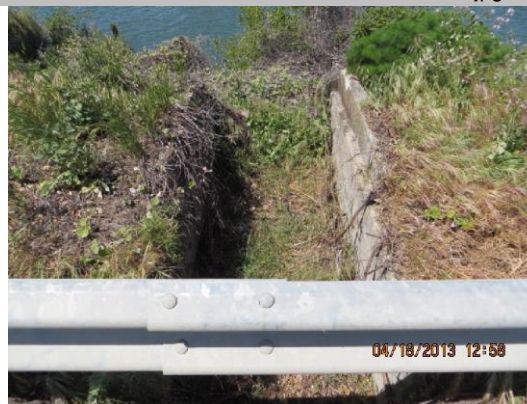
Photo 2 of 3 : UCIP_SP_2018_51316_19781.jpg

Tunnel opening on WS slope.

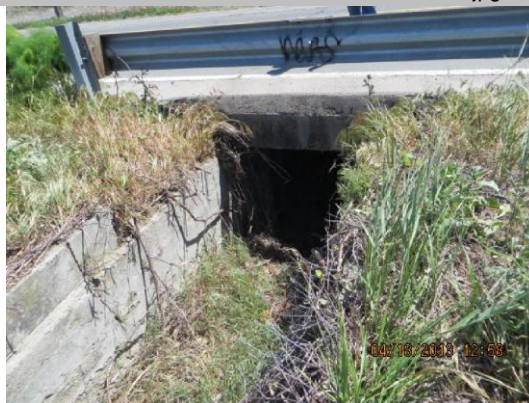
Photo 3 of 3 : UCIP_SP_2018_51316_19780.jpg

Tunnel opening on WS slope.

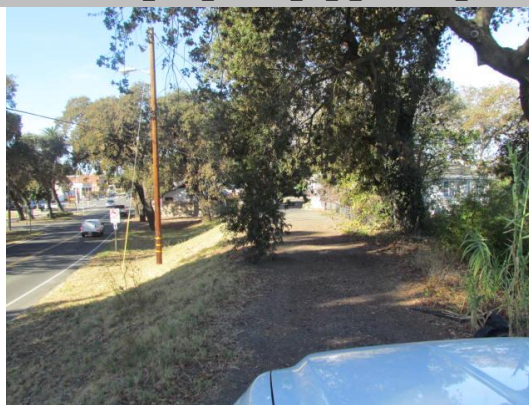
Photo 1 of 2 : SP_2018_NA0002_63_5_20180305_00004.jpg

Looking west at overhanging tree on waterward shoulder. (Fall 2014)

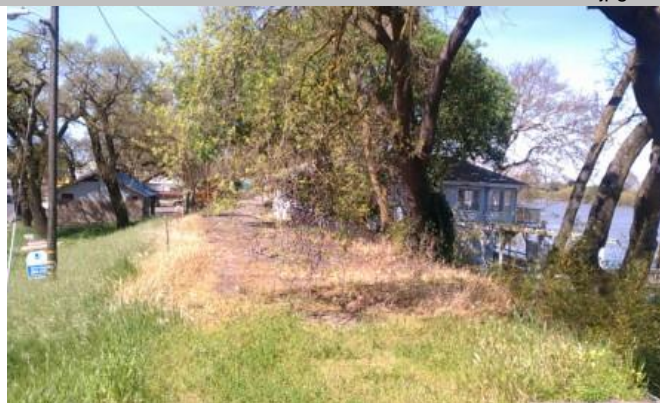
Photo 2 of 2 : SP_2018_NA0002_63_5_20180305_00005.jpg

Looking west at overhanging tree on waterside shoulder.

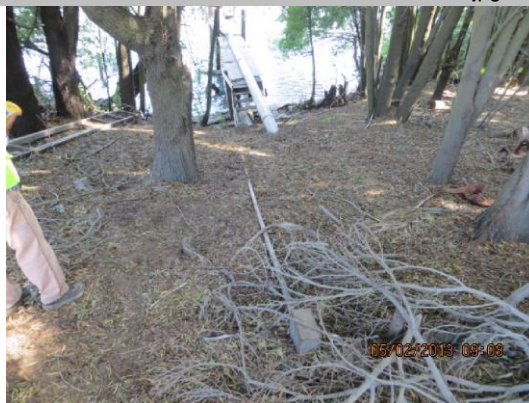
Photo 1 of 3 : UCIP_SP_2018_12776_20754.jpg

Pipe and electrical conduit on WS slope.

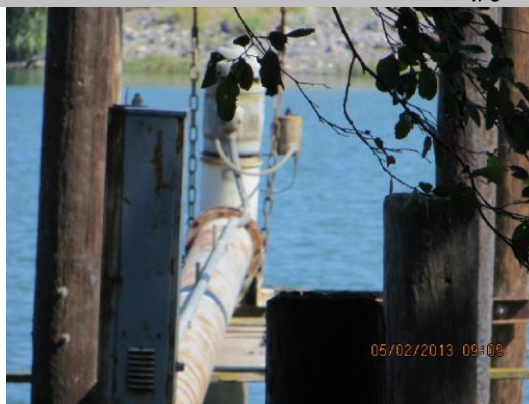
Photo 2 of 3 : UCIP_SP_2018_12776_20753.jpg

Pump on pier at WS toe.

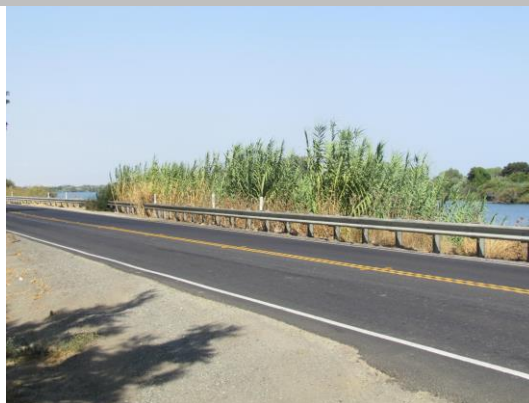
Photo 1 of 2 : SP_2018_NA0002_63_11_20180305_00015.jpg

Looking northwest at bambao on waterward slope. (Fall 2016)

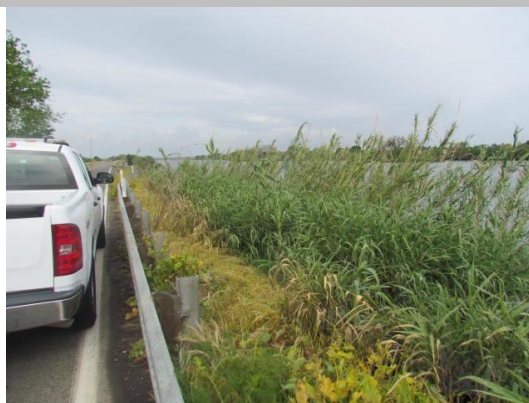
Photo 2 of 2 : SP_2018_NA0002_63_11_20180305_00016.jpg

Looking west at bamboo on waterward slope. (Spring 2016)

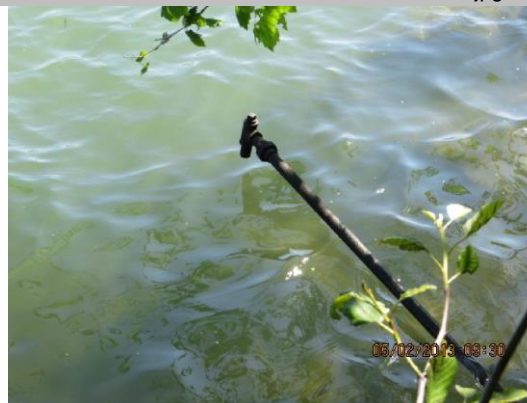
Photo 1 of 3 : UCIP_SP_2018_12778_20762.jpg

Conduit at WS toe.

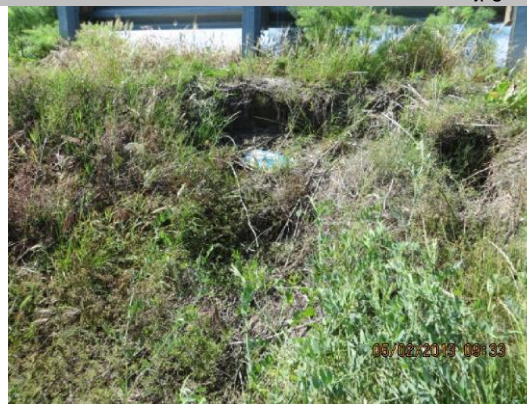
Photo 2 of 3 : UCIP_SP_2018_12778_20761.jpg

Erosion along pipe alignment at WS slope.

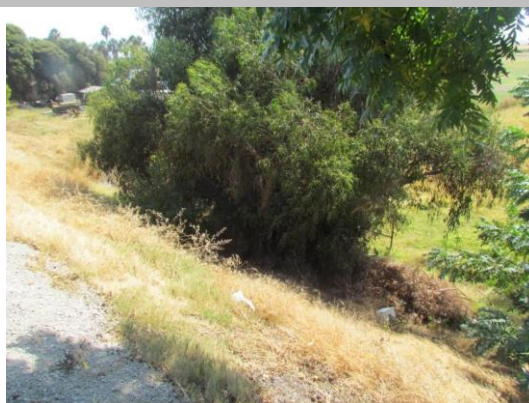
Photo 2 of 2 : SP_2018_NA0002_63_14_20180305_00021.jpg

Looking east at untrimmed tree on landward slope.

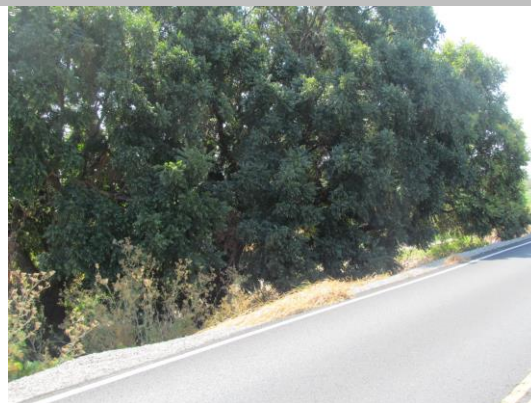
Photo 1 of 1 : SP_2018_NA0002_63_112_20180305_00089.jpg

Looking south at untrimmed trees on landward slope.

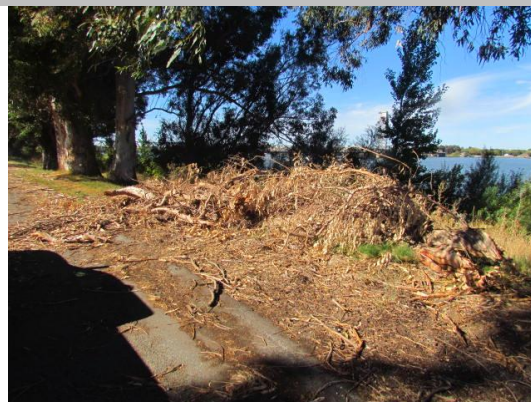
Photo 1 of 1 : SP_2018_NA0002_63_105_20180305_00077.jpg

Looking southwest at tree limbs on waterward shoulder.

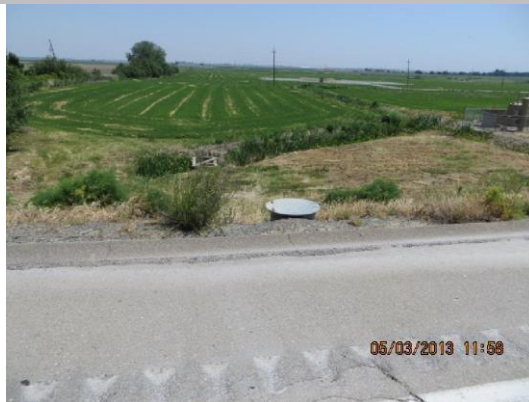
Photo 3 of 3 : UCIP_SP_2018_40528_21000.jpg

Standpipe and concrete box at LS.

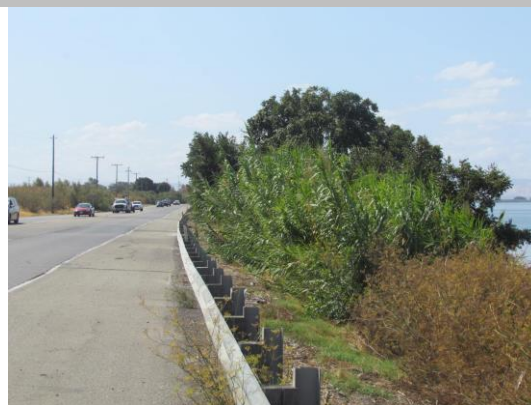
Photo 1 of 2 : SP_2018_NA0002_63_107_20180305_00082.jpg

Looking south at bamboo and other vegetation on waterward slope. (Fall 2016)
