**Flood Control Project Maintenance  
Levee Inspections**

## Maintenance Issue Types Only, Levee Inspection Report By Mile - Spring 2019

### Brannan Andrus Levee Maintenance District

Waterway	Bank	Unit Miles	Inspection Start/End	Inspector
Unit No. 01 Georgiana Slough	Right	6.01	04/23/2019 04/23/2019	David Julian

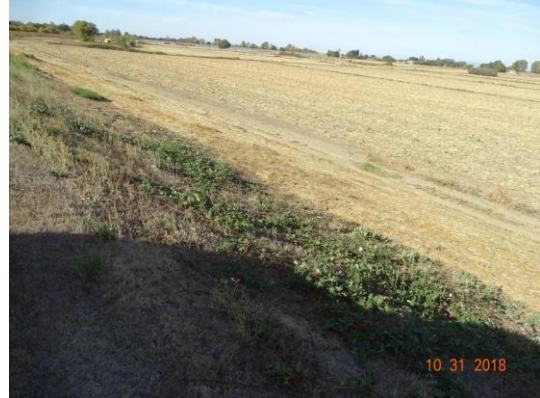
Photo 1 of 1 : SP\_2019\_NA0002\_62\_41\_20190311\_00024.jpg

View looking slightly downstream of newly established black berries (October 2018).

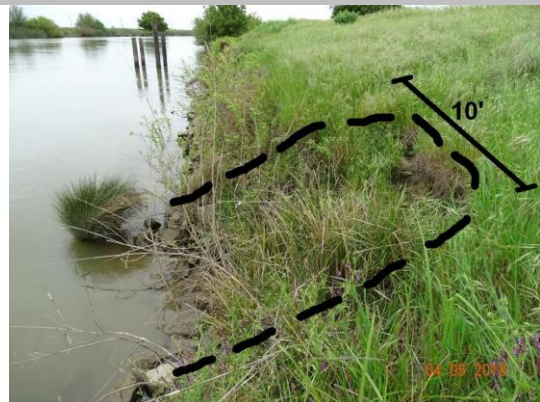
Photo 1 of 1 : SP\_2019\_NA0002\_62\_39\_20190311\_00023.jpg

LM Start	1.53	Rating **	M	Issue No.	39
LM End	1.54	Issue Type +	Ma	Location *	WS
Category	Supplemental			GPS Latitude/Longitude	
				Start	End
Item	2017 USACE Erosion Survey, DRAFT			38.173410 °	38.173178 °
				-121.580683 °	-121.580622 °
DWR ID	DWR_NA0002_01_f_2018_39				
Comment Code					
Inspector Comment					
2017 Site ID: GEO 5.5 R					
Status: Eroding New					
2017 Field Notes: Failed rock section, slump failure of bank to subvertical face.					
Site History:

Erosion slump in area of previous repair. LM 1.52

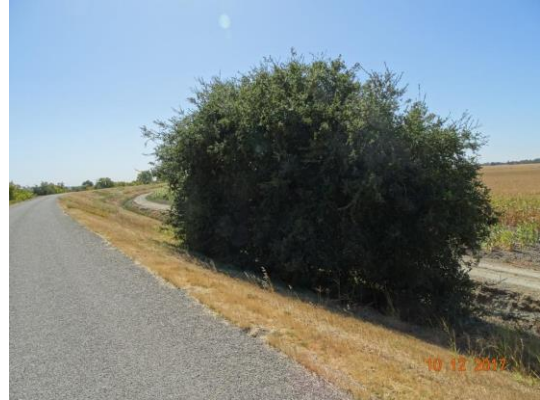
Photo 1 of 1 : SP\_2019\_NA0002\_62\_25\_20190311\_00016.jpg

Looking southwest at the landside slope.

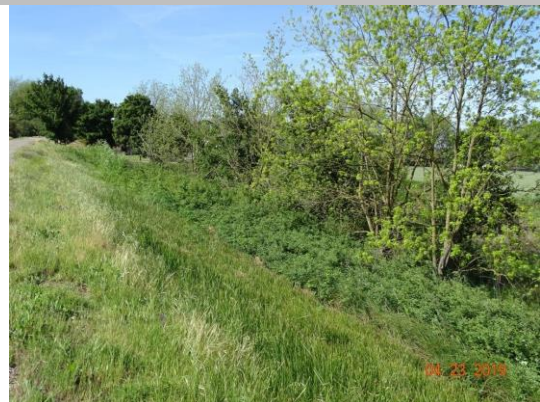
Photo 1 of 1 : SP\_2019\_NA0002\_62\_42\_20190423\_00099.jpg

View looking downstream at vegetation on the landside slope (Spring 2019).

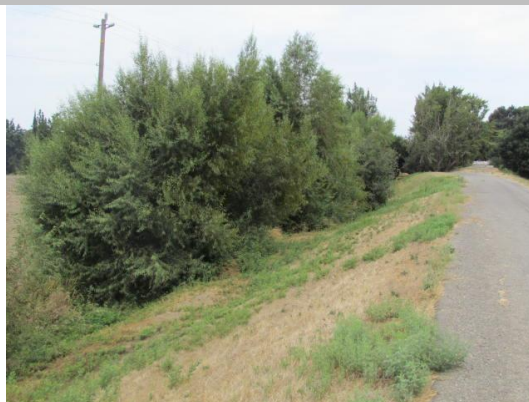
Photo 1 of 2 : SP\_2019\_NA0002\_62\_28\_20190311\_00017.jpg

Look west at dense vegetation at landward toe. (Spring 2016)

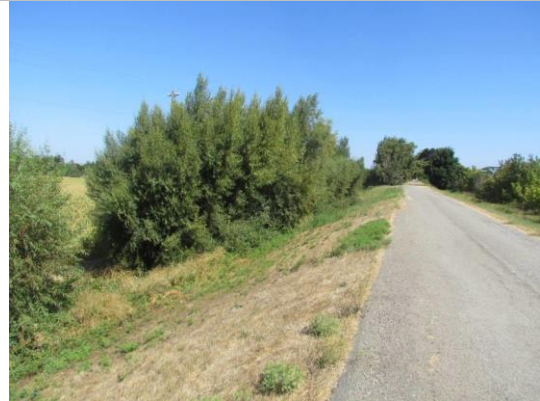
Photo 2 of 2 : SP\_2019\_NA0002\_62\_28\_20190311\_00018.jpg

Look west at dense vegetation at landward toe. (Fall 2016)

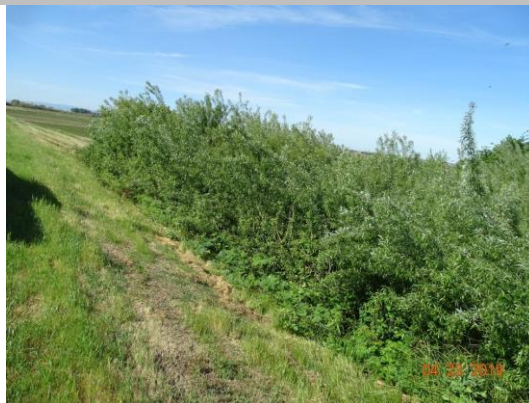
Photo 1 of 1 : SP\_2019\_NA0002\_62\_53\_20190423\_00100.jpg

View looking downstream at willows on the landside slope (Spring 2019).

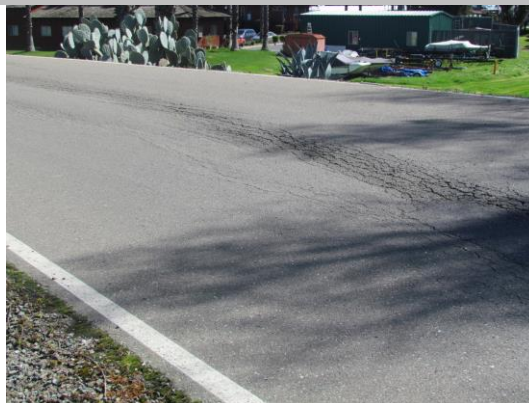
Photo 1 of 3 : SP\_2019\_NA0002\_62\_67\_20190311\_00042.jpg

LM Start	3.38	Rating **	A/W	Issue No.	67
LM End	3.40	Issue Type +	Ma	Location *	CR
Category	Earthen Levee			GPS Latitude/Longitude	
				Start	End
Item	Slope Stability			38.151430 °	38.151390 °
				-121.592085 °	-121.592517 °
DWR ID	DWR_NA0002_01_s_2017_67				
Comment Code					
S1 : Repair slope instability.					
Inspector Comment					
Appears to be beginning of a landside slump. LMA's Engineer (DCC) is monitoring site for movement.

Looking south at sloughing on landward shoulder.

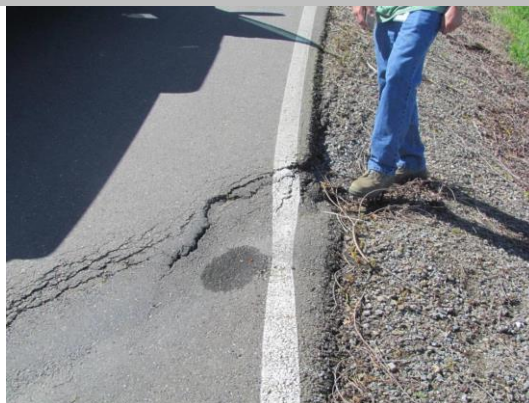
Photo 3 of 3 : SP\_2019\_NA0002\_62\_67\_20190311\_00044.jpg

Looking at downstream corner of slough.

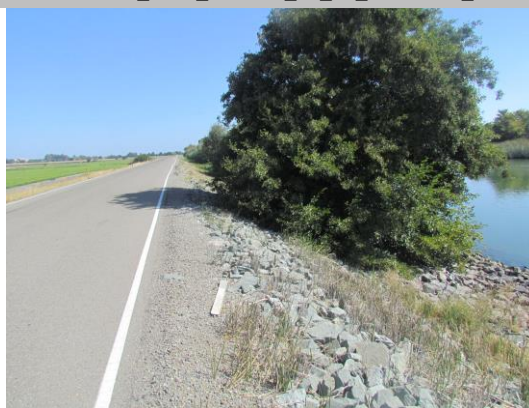
Photo 1 of 1 : SP\_2019\_NA0002\_62\_57\_20190311\_00034.jpg

Looking west at untrimmed tree on waterward slope.

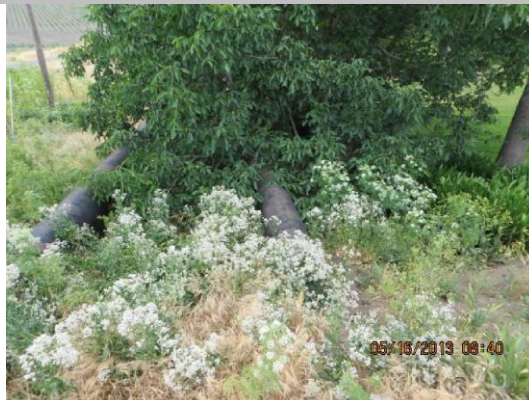
Photo 2 of 3 : UCIP\_SP\_2019\_51302\_22081.jpg

Pipe visible on LS slope.

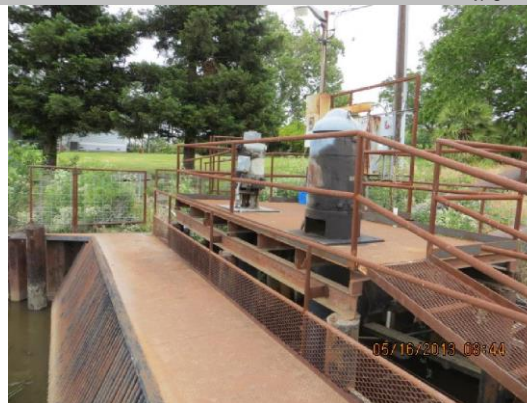
Photo 3 of 3 : UCIP\_SP\_2019\_51302\_22080.jpg

Pumping plant on LS toe.

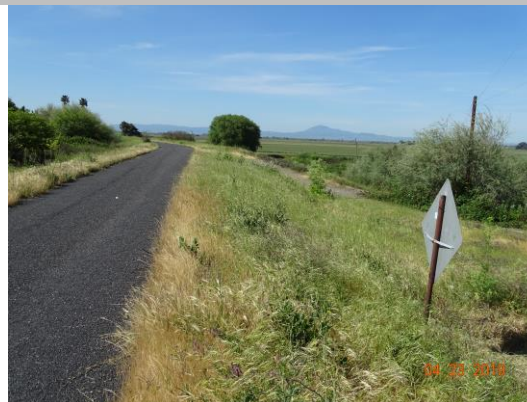
Photo 1 of 1 : SP\_2019\_NA0002\_62\_43\_20190523\_00112.jpg

View looking downstream at annual vegetation on the landside slope (Spring 2019).

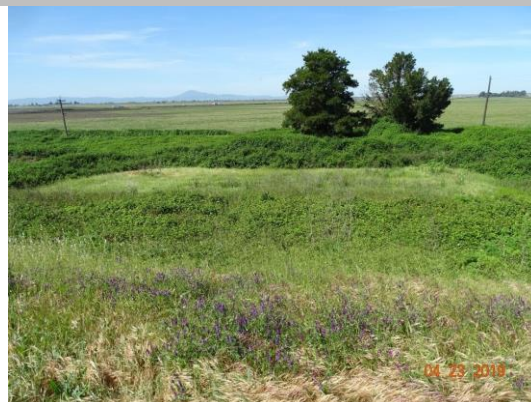
Photo 1 of 1 : SP\_2019\_NA0002\_62\_85\_20190423\_00106.jpg

View looking downslope at blackberries at the landside slope (Spring 2019).

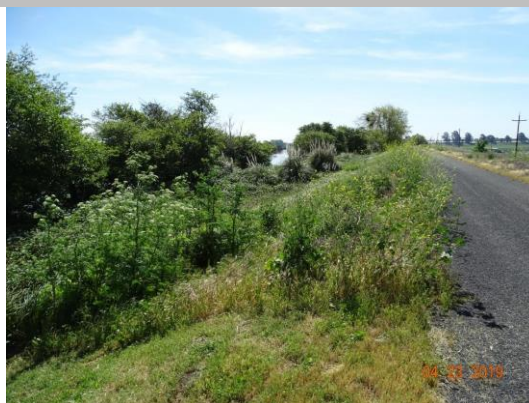
Photo 1 of 1 : SP\_2019\_NA0002\_62\_88\_20190423\_00109.jpg

View looking downstream at annual vegetation on the waterside slope (Spring 2019).

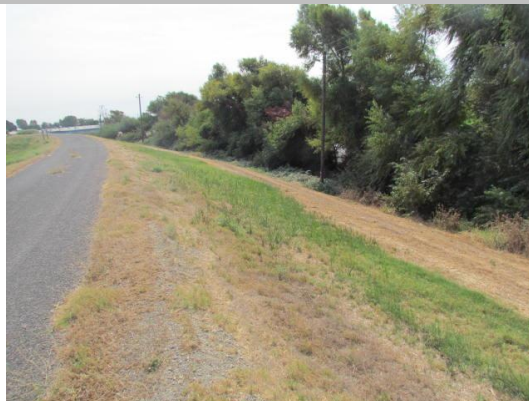
Photo 3 of 3 : SP\_2019\_NA0002\_62\_23\_20190311\_00014.jpg

Looking east at dense vegetation at landward toe.

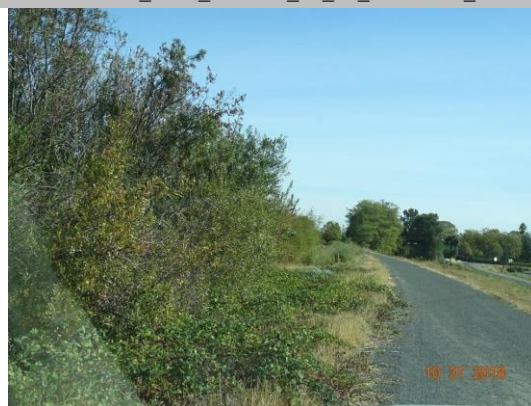
Photo 1 of 1 : SP\_2019\_NA0002\_62\_81\_20190311\_00049.jpg

View of vegetation on the water side slope (October 2018).

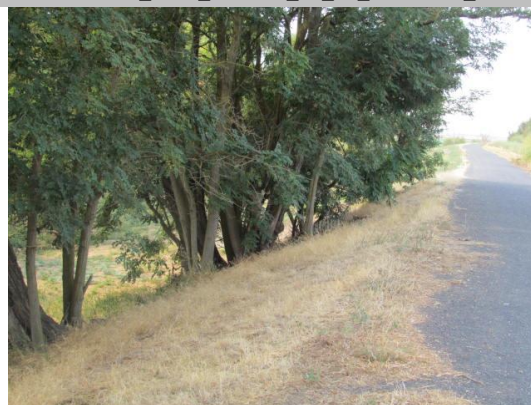
Photo 1 of 1 : SP\_2019\_NA0002\_62\_17\_20190311\_00010.jpg

Looking at dense trees on landward slope and toe.

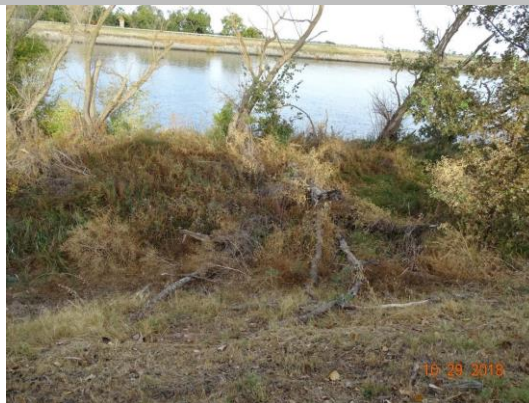
Photo 1 of 1 : SP\_2019\_NA0002\_63\_133\_20190311\_00078.jpg

View of down tree limbs on the waterside slope (October 2018).

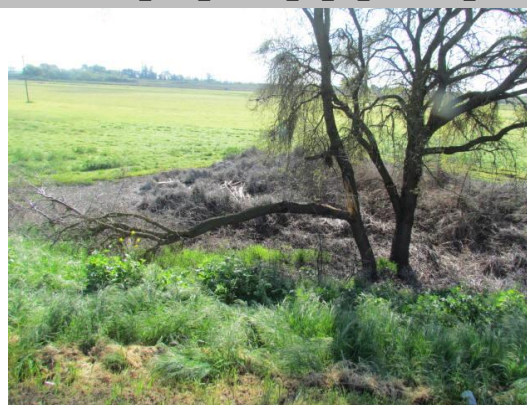
Photo 1 of 1 : SP\_2019\_NA0002\_63\_96\_20190311\_00055.jpg

Looking east at broken tree limb at landward toe.

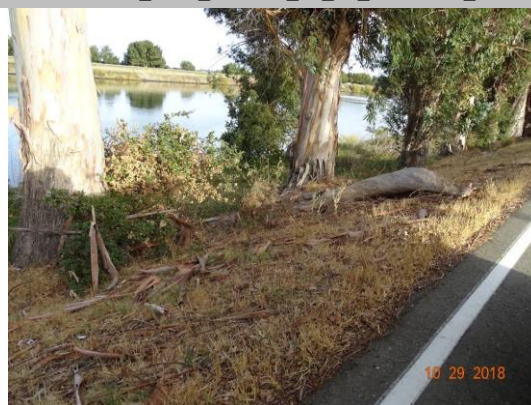
Photo 1 of 1 : SP\_2019\_NA0002\_63\_79\_20190311\_00040.jpg

View looking upstream at large tree limb on the waterside slope (October 2018).

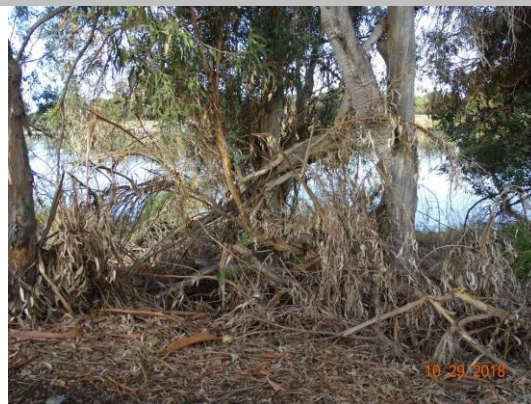
Photo 1 of 1 : SP\_2019\_NA0002\_63\_137\_20190311\_00080.jpg

View of downed tree limbs on waterside slope (October 2018).

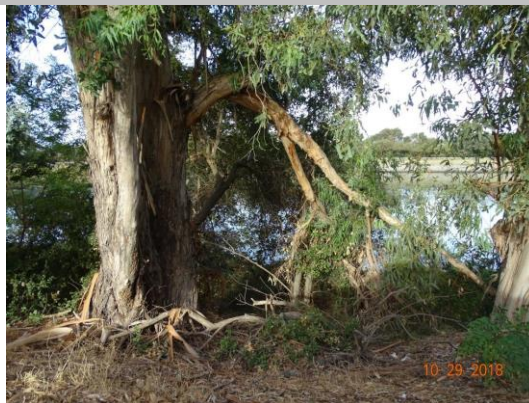
Photo 1 of 1 : SP\_2019\_NA0002\_63\_83\_20190311\_00044.jpg

View of down tree limb on waterside slope (October 2018).

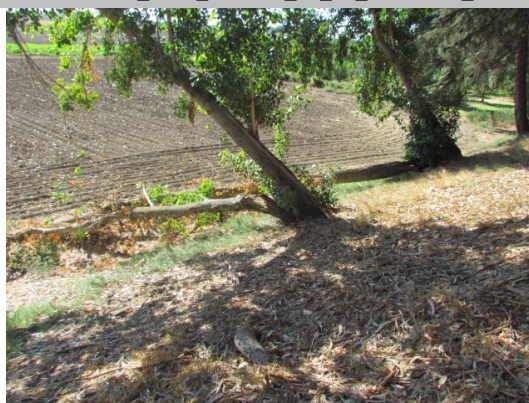
Photo 1 of 2 : SP\_2019\_NA0002\_63\_93\_20190311\_00052.jpg

LM Start	1.88	Rating **	M	Issue No.	93
LM End	1.89	Issue Type +	Ma	Location *	LS
Category	Earthen Levee			GPS Latitude/Longitude	
				Start	End
Item	Encroachments			38.173403 °	38.173221 °
				-121.591389 °	-121.591512 °
DWR ID	DWR_NA0002_02_f_2015_93				
Comment Code					
TR : Tree or limb					
Inspector Comment					
Broken tree limbs are on the landside slope and toe.

Looking southeast at broken tree limb on landward slope.

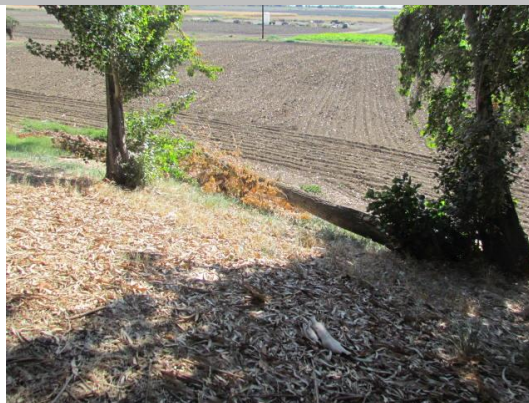
Photo 2 of 2 : SP\_2019\_NA0002\_63\_93\_20190311\_00053.jpg

Looking east at broken tree limb at landward toe.

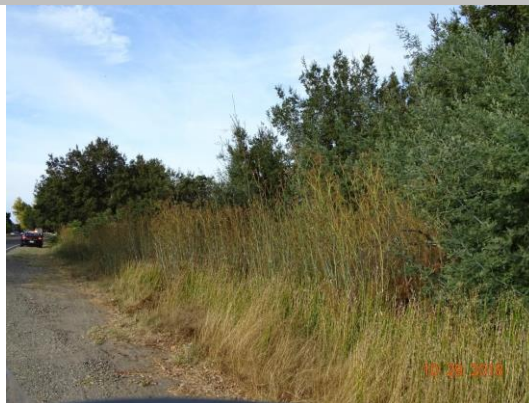
Photo 1 of 1 : SP\_2019\_NA0002\_63\_86\_20190311\_00046.jpg

View looking downstream at vegetation on waterside slope (October 2018).

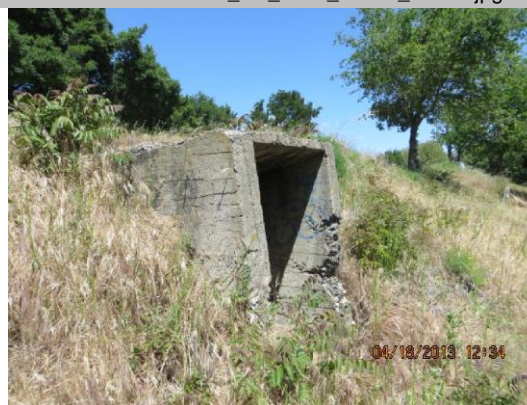
Photo 3 of 3 : UCIP\_SP\_2019\_53389\_19771.jpg

Comment Code						
Inspector Comment						
FS_ID:53389 DS_ID:21879 EP_NO: N/A Repair Type: Non-Urgent Crossing Status: Found UCIP Comments: 07/12/2018 Tunnel is open on both sides. No integrity issue observed, therefore crossing downgraded to "Non-Urgent". (O.Yakimov-DWR UCIP)10/24/2016 same as previous inspection culvert is open on both ends. WS blocked by blankets -- WS structure is being used as a shelter. (O. Magana - DWR UCIP)04/18/2013 Culvert open on both ends. Needs to be abandoned properly. (W. Wylie - DWR UCIP) FIELD_STRUCT_DESC: *ABANDONED* 42-inch by 42-inch open reinforced concrete drainage culvert through the levee, 6 feet below the crown. [Additional Reference(s): DWR Levee Log, 2005, 3-foot by 3.5-foot culvert listed. USACE Sacramento O&M Manual 103, June 1954, (RM 18.16) Drawing No. 6-13-1100]. FS Date: 7/12/2018 2:59:33 PM

Concrete tunnel on LS shoulder.

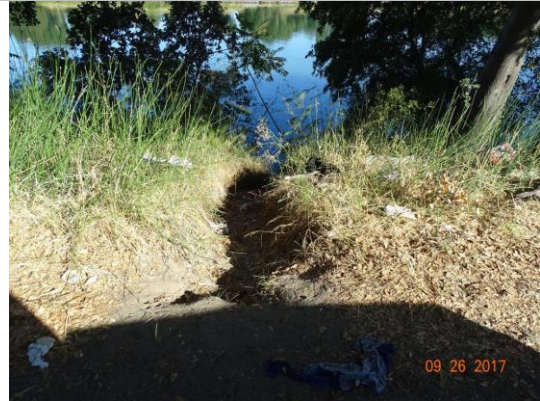
Photo 1 of 1 : SP\_2019\_NA0002\_63\_82\_20190311\_00043.jpg

LM Start	2.56	Rating **	M	Issue No.	82
LM End	2.56	Issue Type +	Ma	Location *	WS
Category	Earthen Levee			GPS Latitude/Longitude	
				Start	End
Item	Slope Stability			38.165898 °	38.165898 °
				-121.598888 °	-121.598888 °
DWR ID	DWR_NA0002_02_f _ 2017_82				
Comment Code					
S2 : Repair the levee slope damaged by foot traffic and prevent access where possible.					
Inspector Comment					
There is a footpath digging into the levee slope.

Looking northwest at the waterside slope.

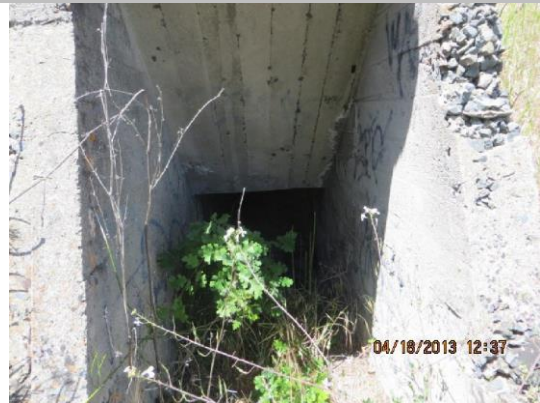
Photo 1 of 3 : UCIP\_SP\_2019\_53513\_19776.jpg

Comment Code						
Inspector Comment						
FS_ID:53513 DS_ID:21880 EP_NO: N/A Repair Type: Non-Urgent Crossing Status: Found UCIP Comments: 07/12/2018 Tunnel is open on both sides. No integrity issue observed, therefore crossing downgraded to "Non-Urgent". (O.Yakimov-DWR UCIP)10/24/2016 same as previous inspection concrete box culvert will need to be abandoned properly. (O. Magana - DWR UCIP)04/18/2013 tunnel should be abandoned properly. (W. Wylie - DWR UCIP) FIELD_STRUCT_DESC: *ABANDONED* 48-inch by 48-inch reinforced concrete drainage culvert through the levee, 6.5-inches below the crown. [Additional Reference(s): DWR Levee Log, 2005. USACE Sacramento O&M Manual 103, June 1954, (RM 18.13) 3-foot by 3-foot concrete box listed, Drawing No. 6-13-1100]. FS Date: 7/12/2018 9:05:37 AM

Tunnel open on LS shoulder.

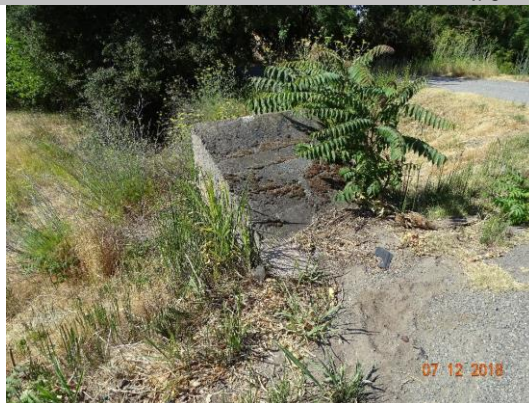
Photo 2 of 3 : UCIP\_SP\_2019\_53513\_77578.jpg

Concrete tunnel on LS shoulder.

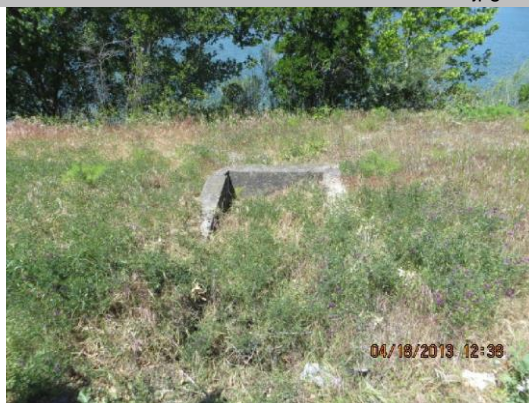
Photo 3 of 3 : UCIP\_SP\_2019\_53513\_19774.jpg

10'X5' concrete box on WS slope, filled with soil.

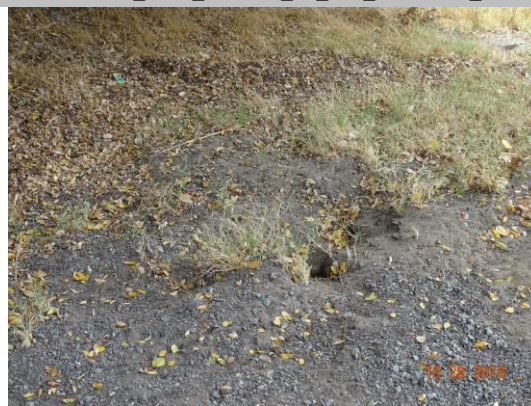
Photo 1 of 2 : SP\_2019\_NA0002\_63\_172\_20190311\_00103.jpg

View of animal hole on the landside slope (October 2018)

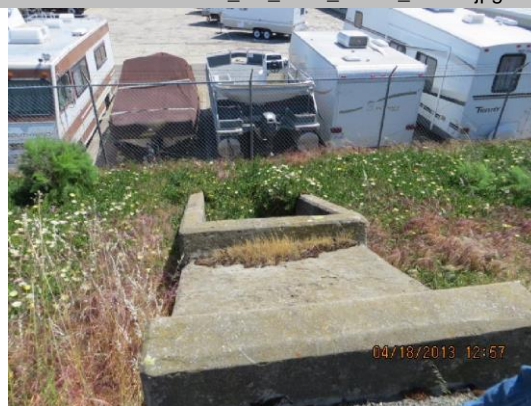
Photo 1 of 3 : UCIP\_SP\_2019\_53514\_19782.jpg

Entrance to tunnel on LS slope.

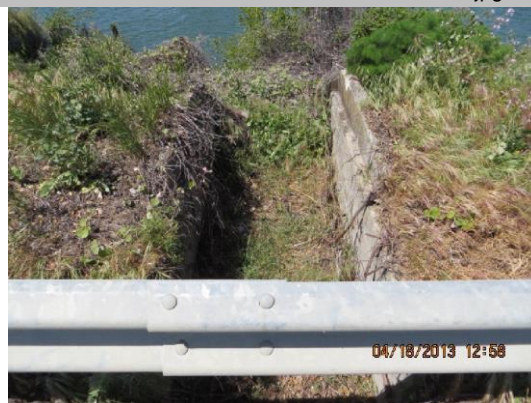
Photo 2 of 3 : UCIP\_SP\_2019\_53514\_19781.jpg

Tunnel opening on WS slope.

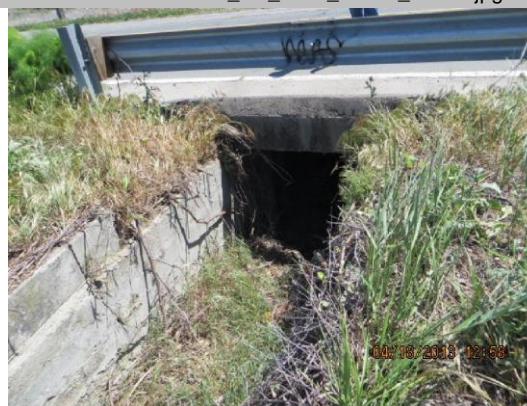
Photo 3 of 3 : UCIP\_SP\_2019\_53514\_19780.jpg

Tunnel opening on WS slope.

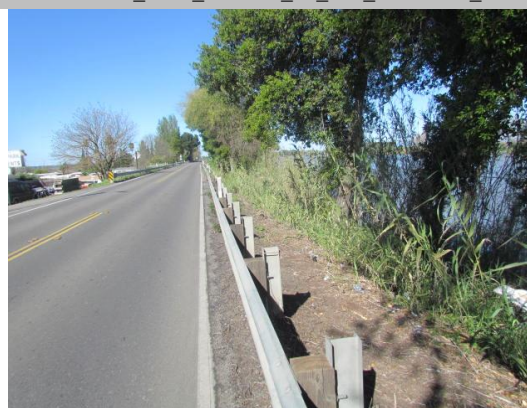
Photo 1 of 1 : SP\_2019\_NA0002\_63\_100\_20190311\_00060.jpg

Looking southwest at vegetation (bamboo) on waterward slope.

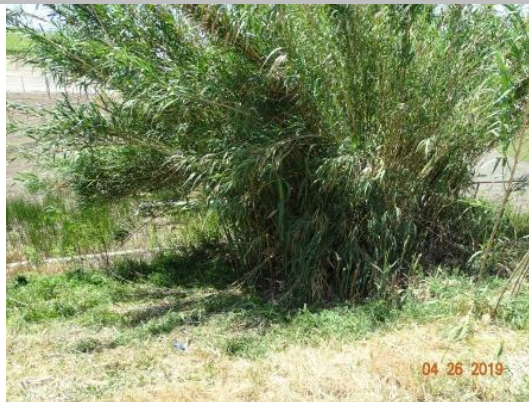
Photo 1 of 1 : SP\_2019\_NA0002\_63\_98\_20190429\_00207.jpg

View of arundo on the landside slope (Spring 2019).

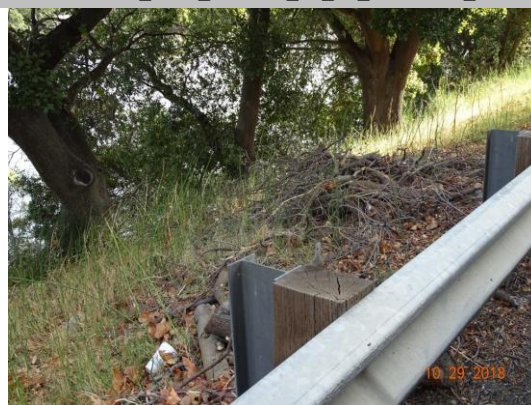
Photo 1 of 1 : SP\_2019\_NA0002\_63\_85\_20190311\_00045.jpg

View of prunings on the waterside slope (October 2018).

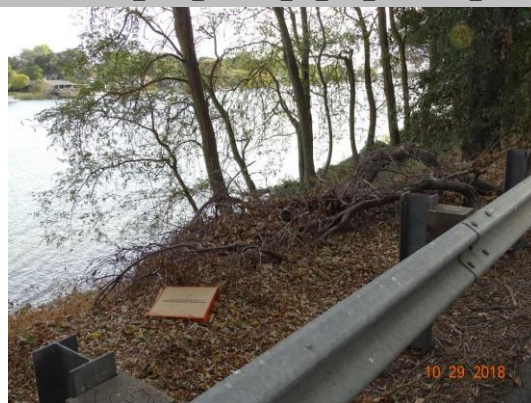
Photo 1 of 1 : SP\_2019\_NA0002\_63\_113\_20190311\_00069.jpg

View of prunings on the waterside slope (October 2018).

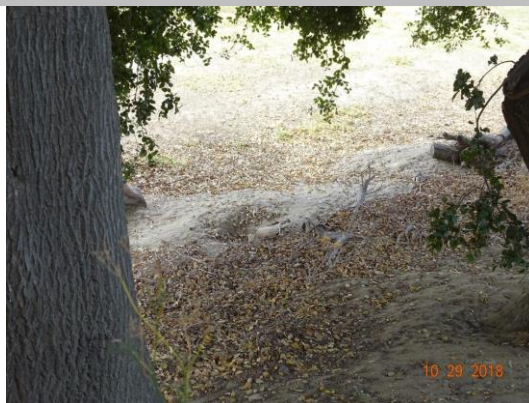
Photo 1 of 1 : SP\_2019\_NA0002\_63\_167\_20190311\_00100.jpg

View of several animal holes. Additional holes were found in the immediate vicinity.

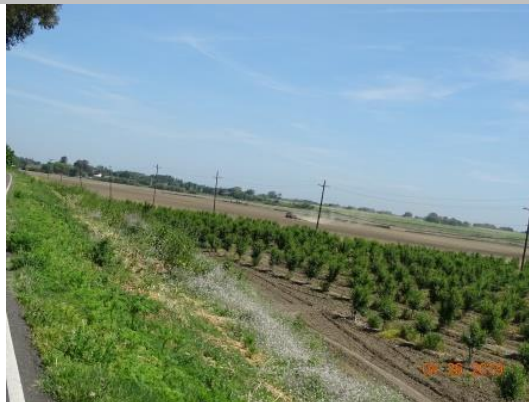
Photo 1 of 1 : SP\_2019\_NA0002\_63\_95\_20190429\_00205.jpg

View looking upstream at annual vegetation at the bottom of the landside slope (Spring 2019)

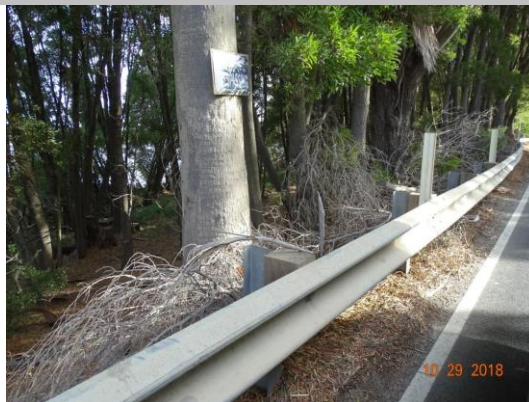
Photo 1 of 1 : SP\_2019\_NA0002\_63\_117\_20190311\_00072.jpg

View of prunings on the waterside slope (October 2018)

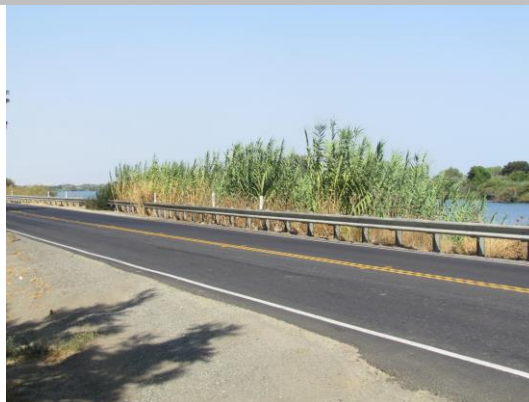
Photo 1 of 2 : SP\_2019\_NA0002\_63\_11\_20190311\_00010.jpg

Looking northwest at arundo on waterward slope. (Fall 2016)

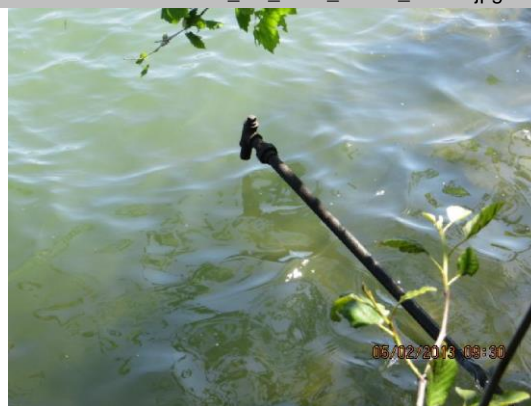
Photo 1 of 3 : UCIP\_SP\_2019\_12778\_20762.jpg

Conduit at WS toe.

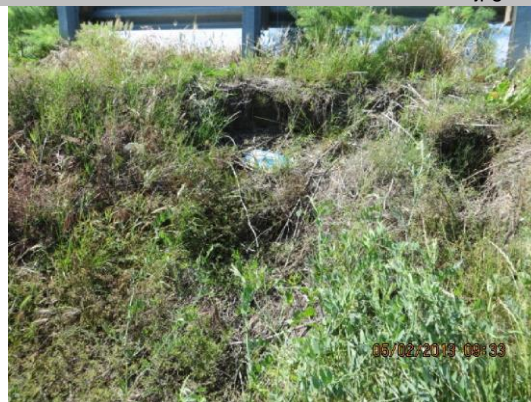
Photo 2 of 3 : UCIP\_SP\_2019\_12778\_20761.jpg

Erosion along pipe alignment at WS slope.

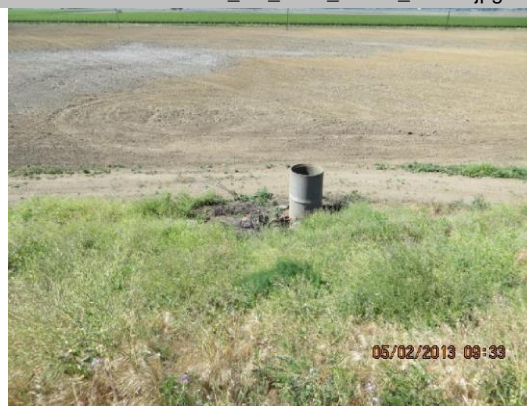
Photo 3 of 3 : UCIP\_SP\_2019\_12778\_20760.jpg

Concrete standpipe and pump on LS toe.

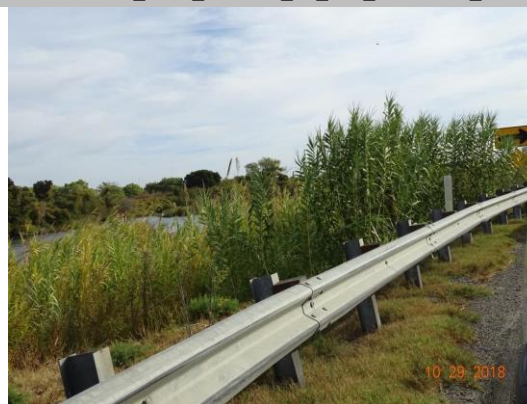
Photo 1 of 1 : SP\_2019\_NA0002\_63\_129\_20190311\_00076.jpg

View looking upstream at arundo on waterside shoulder (October 2018).

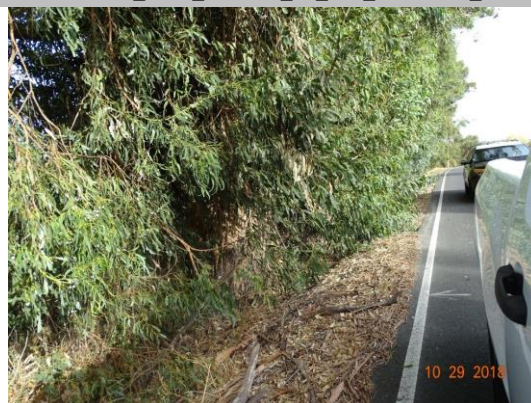
Photo 1 of 1 : SP\_2019\_NA0002\_63\_132\_20190311\_00077.jpg

View looking upstream at thick tree branches on the waterside slope (October 2018).

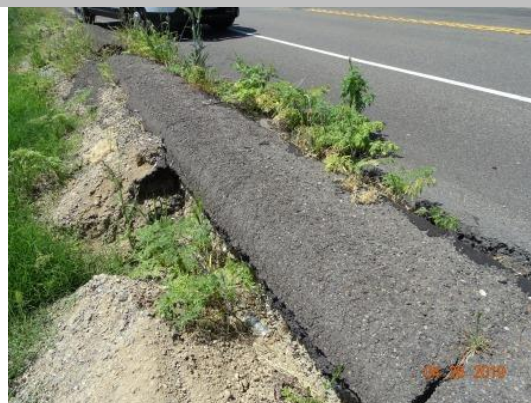
Photo 1 of 1 : SP\_2019\_NA0002\_63\_90\_20190429\_00204.jpg

View of small slip on the landside shoulder causing the edge of the road to crack and sink (Spring 2019).

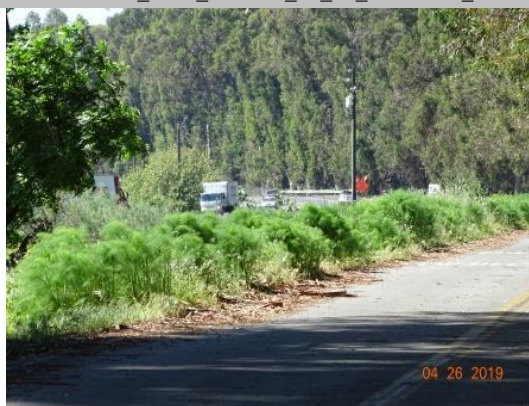
Photo 1 of 1 : SP\_2019\_NA0002\_63\_65\_20190429\_00196.jpg

View looking downstream annual vegetation on the landside slope (Spring 2019).

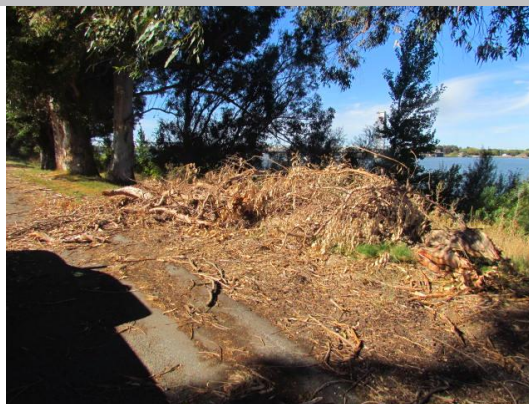
Photo 1 of 1 : SP\_2019\_NA0002\_63\_105\_20190311\_00063.jpg

Looking southwest at tree limbs on waterward shoulder.

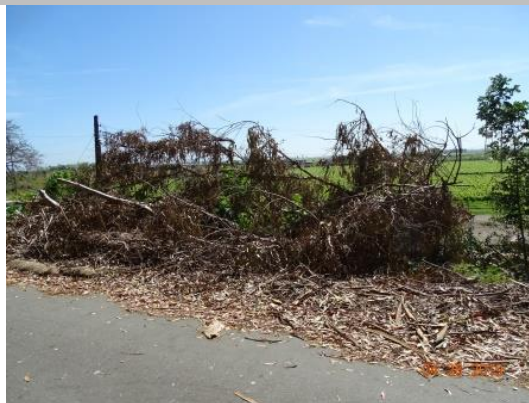
Photo 1 of 1 : SP\_2019\_NA0002\_63\_64\_20190429\_00195.jpg

View of tree limbs on the landside shoulder (Spring 2019).

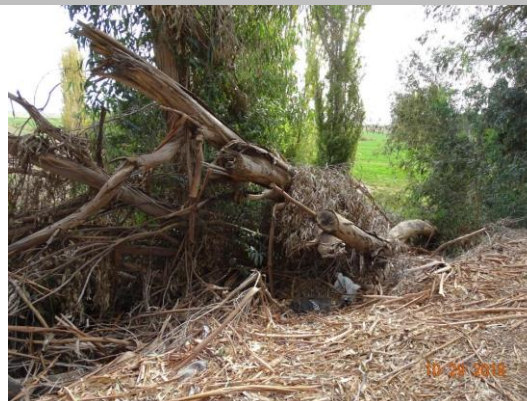
Photo 1 of 1 : SP\_2019\_NA0002\_63\_158\_20190311\_00094.jpg

View of down tree on landside slope (October 2018).

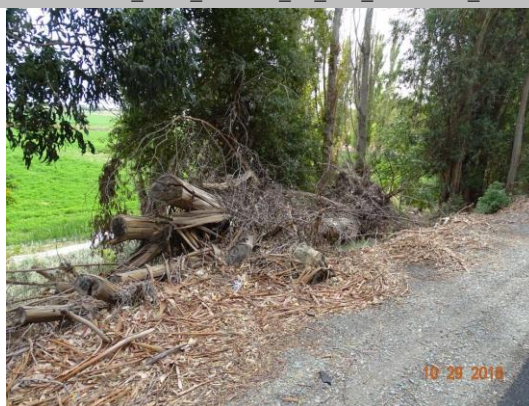
Photo 1 of 1 : SP\_2019\_NA0002\_63\_157\_20190311\_00093.jpg

View of down tree on landside slope (October 2018).

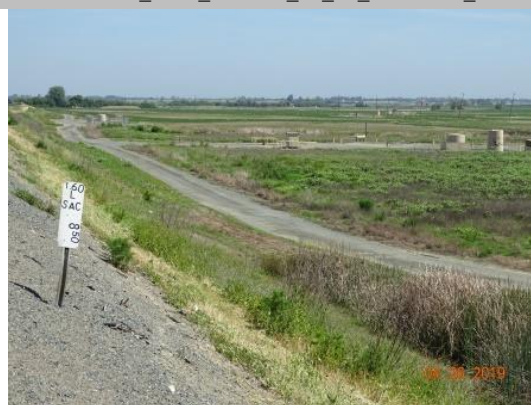
Photo 1 of 1 : SP\_2019\_NA0002\_63\_28\_20190429\_00202.jpg

View looking upstream at annual vegetation on the bottom half of the landside slope (Spring 2019).

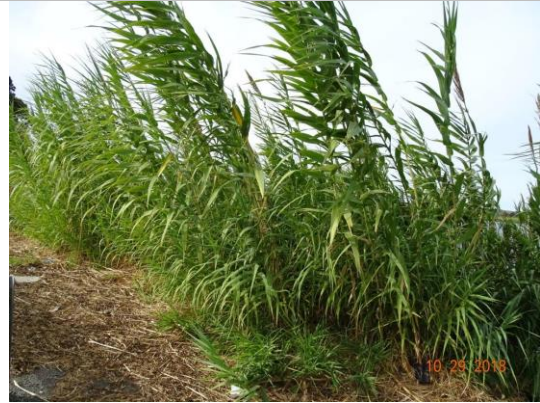
Photo 1 of 1 : SP\_2019\_NA0002\_63\_152\_20190311\_00091.jpg

View of arundo on waterside slope (October 2018).

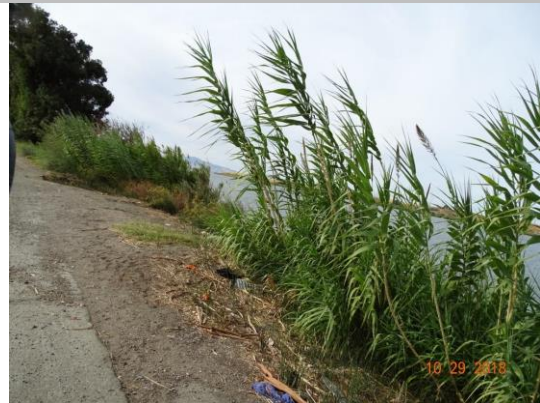
Photo 1 of 1 : SP\_2019\_NA0002\_63\_153\_20190311\_00092.jpg

View of arundo on waterside slope (October 2018).

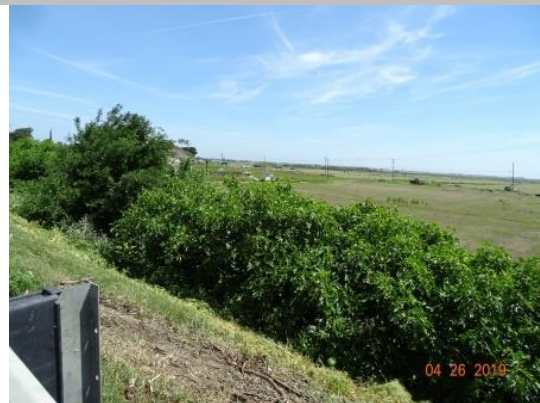
Photo 1 of 1 : SP\_2019\_NA0002\_63\_72\_20190429\_00201.jpg

View looking downslope at fig tree on the landside slope (Spring 2019).

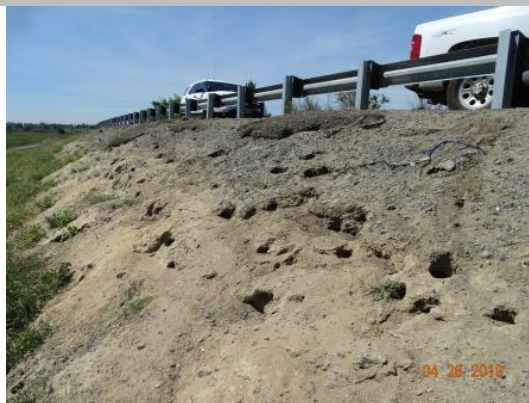
Photo 2 of 2 : SP\_2019\_NA0002\_63\_67\_20190429\_00200.jpg

View looking downstream at animal holes on the landside slope (Spring 2019).

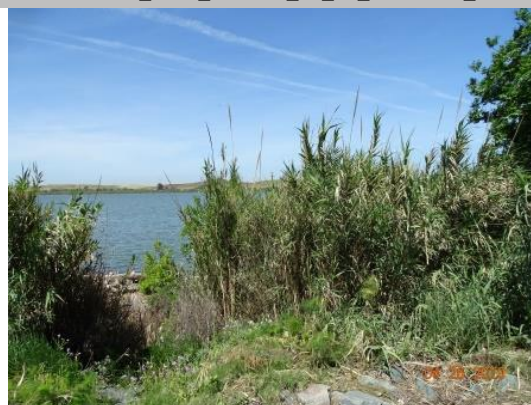
Photo 1 of 1 : SP\_2019\_NA0002\_63\_63\_20190429\_00197.jpg

View of arundo on the waterside slope (Spring 2019).

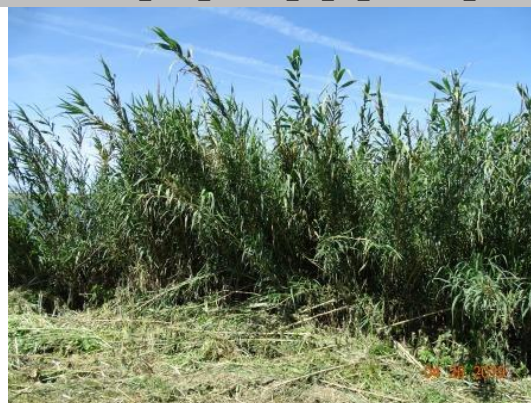
Photo 1 of 1 : SP\_2019\_NA0002\_63\_16\_20190429\_00198.jpg

View of arundo on the waterside slope (Spring 2019).

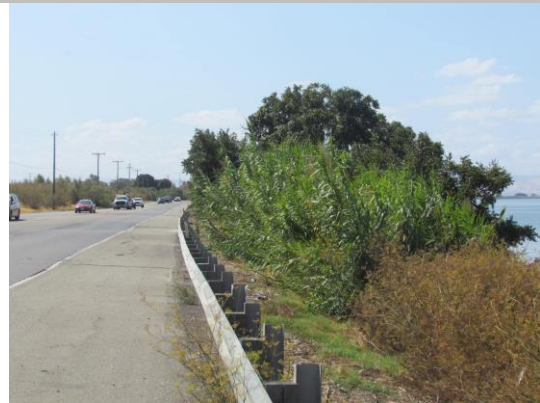
Photo 1 of 2 : SP\_2019\_NA0002\_63\_107\_20190311\_00065.jpg

Looking south at arundo and other vegetation on waterward slope. (Fall 2016)

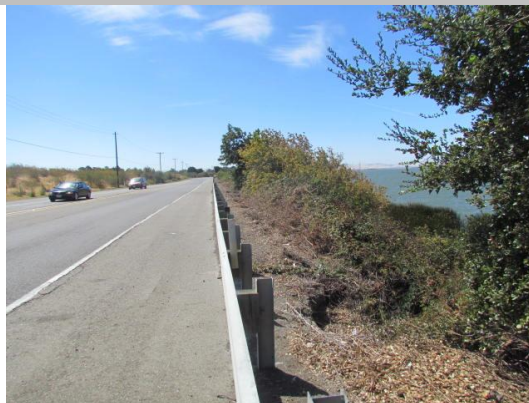
Photo 2 of 2 : SP\_2019\_NA0002\_63\_107\_20190311\_00066.jpg

Looking south at dense vegetation on waterward slope. (Fall 2015)

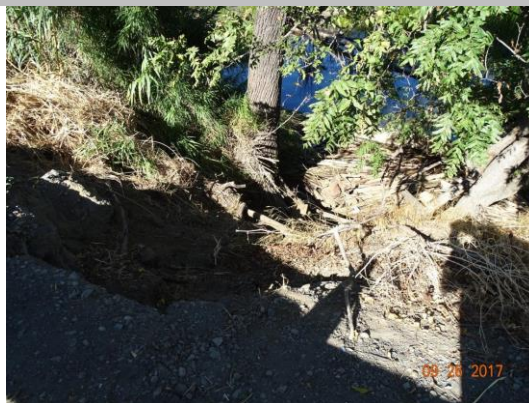
Photo 1 of 1 : SP\_2019\_NA0002\_63\_119\_20190311\_00073.jpg

Looking northwest at the waterside slope.
