**Flood Control Project Maintenance
Levee Inspections**

Maintenance Issue Types Only, Levee Inspection Report By Mile - Spring 2020

Brannan Andrus Levee Maintenance District

Waterway	Bank	Unit Miles	Inspection Start/End	Inspector
Unit No. 01 Georgiana Slough	Right	6.01	04/02/2020 04/02/2020	David Julian

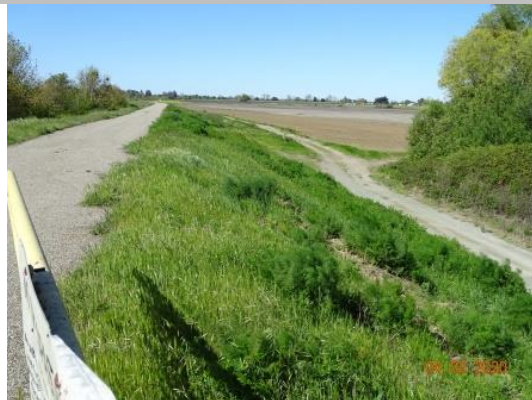
Photo 1 of 1 : SP_2020_NA0002_62_30_20200406_00082.jpg

LM Start	0.01	Rating **	M	Issue No.	30
LM End	2.05	Issue Type +	Ma	Location *	LS
Category	Earthen Levee			GPS Latitude/Longitude	
				Start	End
Item	Vegetation			38.186420 °	38.166243 °
				-121.562802 °	-121.583452 °
DWR ID	DWR_NA0002_01_s_2020_30				
Comment Code					
V1 : Control annual grass and weeds on the levee slopes and easements.					
Inspector Comment

View looking downstream at annual vegetation on the landside slope (Spring 2020).

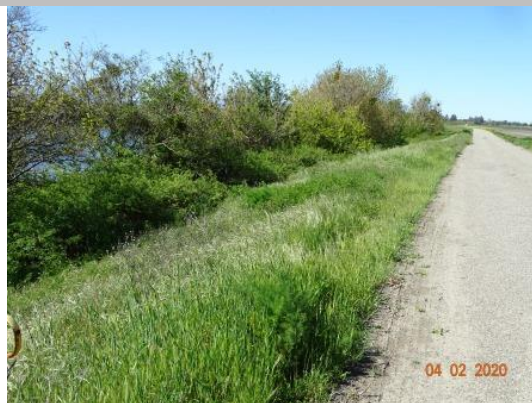
Photo 1 of 1 : SP_2020_NA0002_62_29_20200406_00081.jpg

LM Start	0.01	Rating **	M	Issue No.	29
LM End	2.18	Issue Type +	Ma	Location *	WS
Category	Earthen Levee			GPS Latitude/Longitude	
				Start	End
Item	Vegetation			38.186420 °	38.164448 °
				-121.562802 °	-121.583948 °
DWR ID	DWR_NA0002_01_s_2020_29				
Comment Code					
V1 : Control annual grass and weeds on the levee slopes and easements.					
Inspector Comment

View looking downstream at annual vegetation on the waterside slope (Spring 2020).

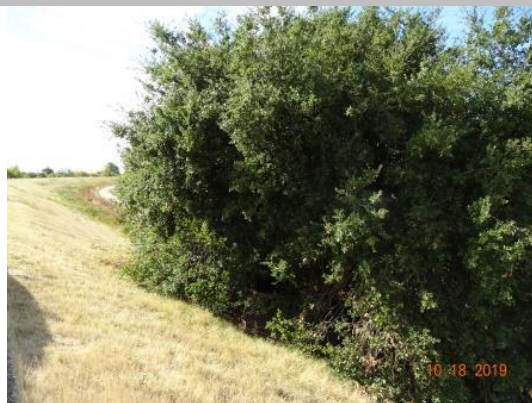
Photo 1 of 1 : SP_2020_NA0002_62_25_20200304_00007.jpg

LM Start	1.56	Rating **	U	Issue No.	25	
LM End	1.56	Issue Type +	Ma	Location *	LS	
Category	Earthen Levee			GPS Latitude/Longitude		
				Start		End
Item	Trim / Thin Trees			38.172869 °		38.172869 °
				-121.580681 °		-121.580681 °
DWR ID	DWR_NA0002_01_s_2012_25					
Comment Code						
T1 : Trim trees to at least five feet above ground level.						
Inspector Comment						
Tree blocking landside toe.

View looking downstream at thick tree on the landside slope (Fall 2019).

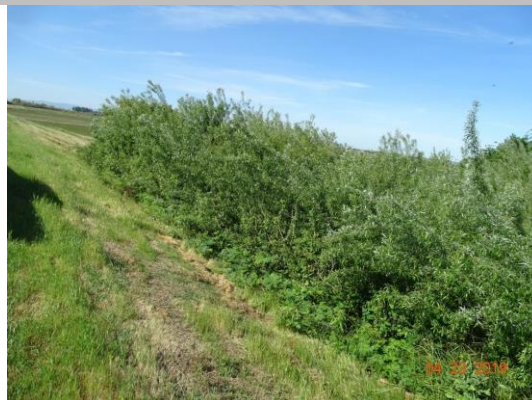
Photo 1 of 1 : SP_2020_NA0002_62_53_20200304_00017.jpg

View looking downstream at willows on the landside slope (Spring 2019).

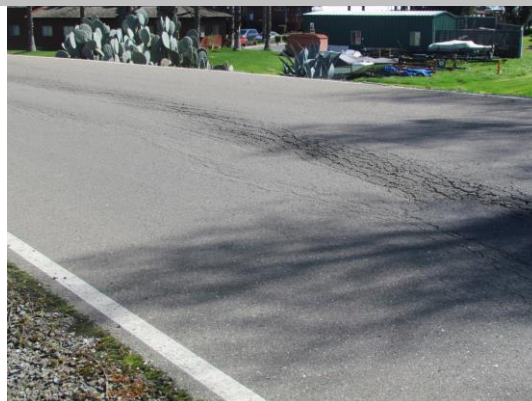
Photo 1 of 3 : SP_2020_NA0002_62_67_20200304_00026.jpg

LM Start	3.38	Rating **	A/W	Issue No.	67
LM End	3.40	Issue Type +	Ma	Location *	CR
Category	Earthen Levee			GPS Latitude/Longitude	
				Start	End
Item	Slope Stability			38.151430 °	38.151390 °
				-121.592085 °	-121.592517 °
DWR ID	DWR_NA0002_01_s_2017_67				
Comment Code					
S1 : Repair slope instability.					
Inspector Comment					
Appears to be beginning of a landside slump. LMA's Engineer (DCC) is monitoring site for movement.

Looking south at sloughing on landward shoulder.

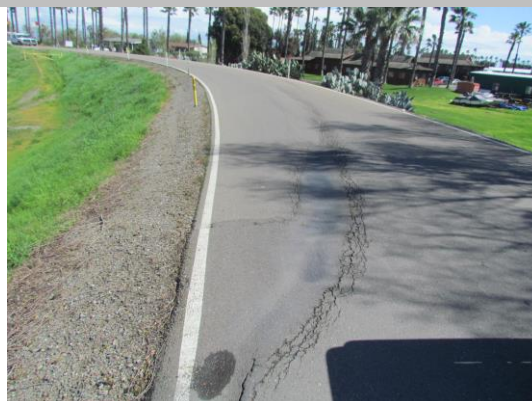
Photo 2 of 3 : SP_2020_NA0002_62_67_20200304_00027.jpg

Looking east at possible sloughing on landward shoulder.

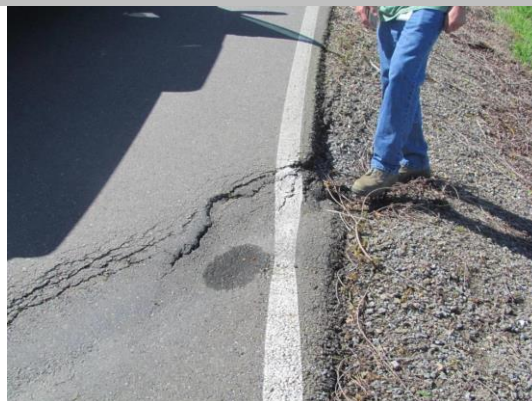
Photo 3 of 3 : SP_2020_NA0002_62_67_20200304_00028.jpg

Looking at downstream corner of slough.

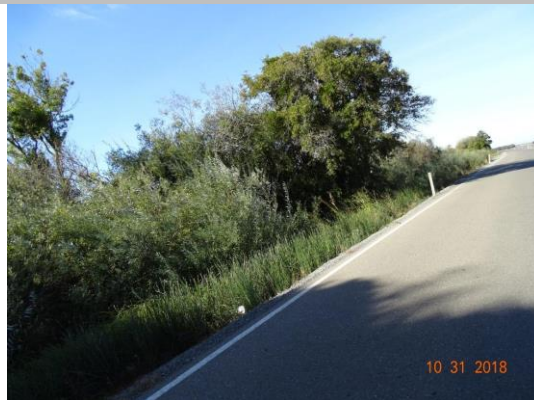
Photo 1 of 1 : SP_2020_NA0002_62_59_20200304_00021.jpg

View looking downstream at vegetation on the water side slope (October 2018).

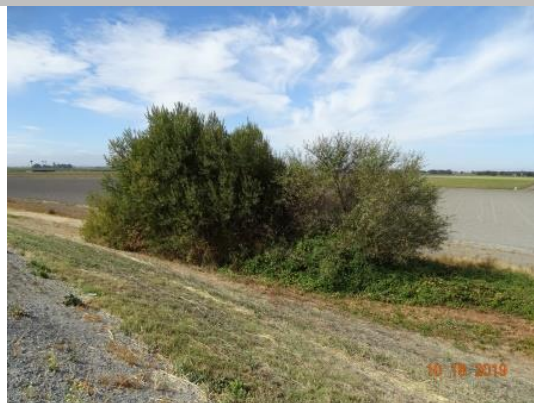
Photo 1 of 1 : SP_2020_NA0002_62_46_20200304_00014.jpg

LM Start	3.74	Rating **	M	Issue No.	46
LM End	3.74	Issue Type +	Ma	Location *	LS
Category	Earthen Levee			GPS Latitude/Longitude	
				Start	End
Item	Trim / Thin Trees			38.150841 °	38.150841 °
				-121.598161 °	-121.598161 °
DWR ID	DWR_NA0002_01_f_2017_46				
Comment Code					
T1 : Trim trees to at least five feet above ground level.					
Inspector Comment

View looking downstream at thick tree on the landside slope (Fall 2019).

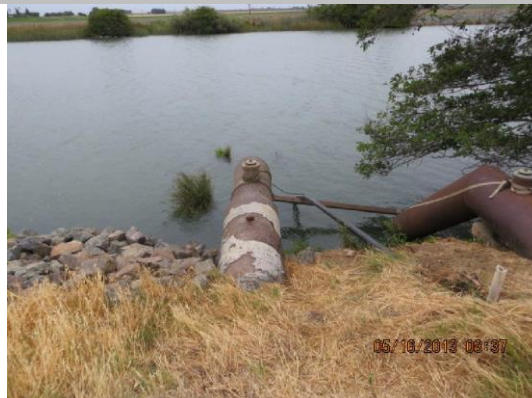
Photo 1 of 3 : UCIP_SP_2020_51302_22082.jpg

Comment Code						
Inspector Comment						
DS_ID:21772 FS_ID:51302 EP_NO: 11248 Repair Type: No Action Needed Crossing Status: Found UCIP Comments: FIELD_STRUCT_DESC: 1 of 2: 24-inch steel drainage pipe through levee, 3 feet below the crown. Siphon breaker is located on the waterside (WS) slope. Pump is located on the landside (LS). (24-inch pipe [HLM 3.99] authorized under Automatic Board Order (ABO) issued as Permit No. 11248, 1975 – Reclamation District No. 407) [Additional Reference(s): DWR Levee Log, 2005. USACE Sacramento O&M Manual Unit 103, June 1954, Drawing No. 50-4-2631, page 2631/2, (Station 107+76), 26-inch listed]. FS Date: 5/16/2013

24-inch pipe and siphon breaker visible on WS slope.

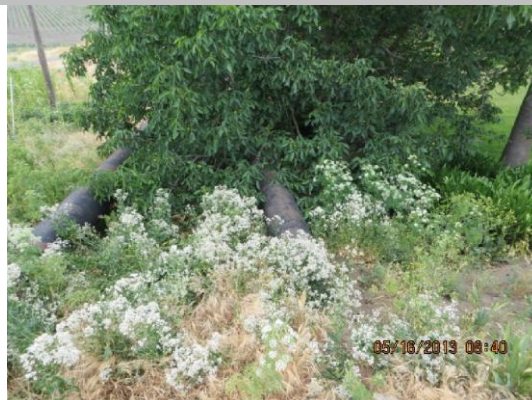
Photo 2 of 3 : UCIP_SP_2020_51302_22081.jpg

Pipe visible on LS slope.

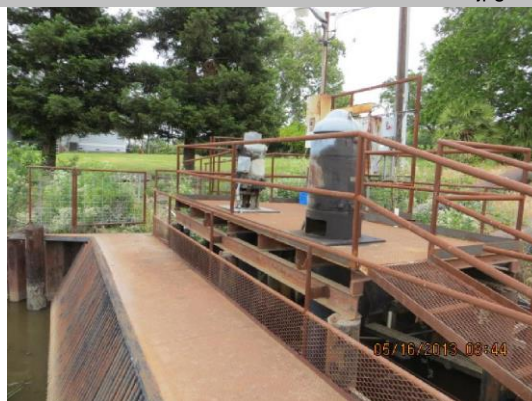
Photo 3 of 3 : UCIP_SP_2020_51302_22080.jpg

Pumping plant on LS toe.

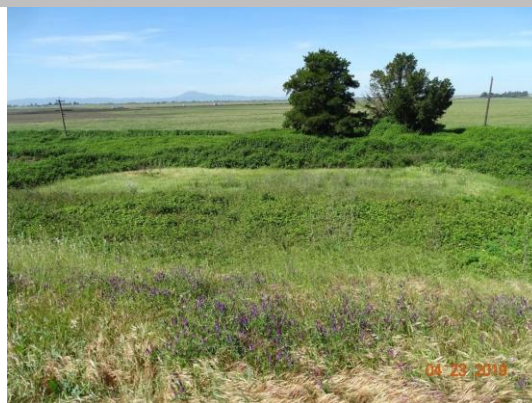
Photo 1 of 1 : SP_2020_NA0002_62_85_20200304_00034.jpg

View looking downslope at blackberries at the landside slope (Spring 2019).

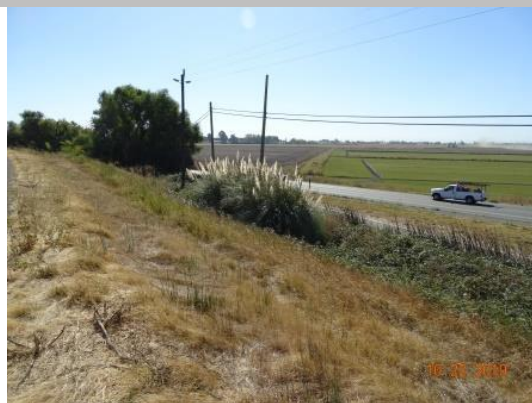
Photo 1 of 1 : SP_2020_NA0002_62_23_20200304_00006.jpg

View looking downstream at vegetation at the landside toe (Fall 2019).

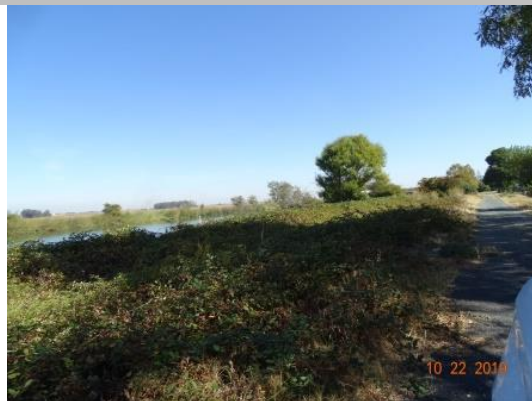
Photo 1 of 2 : SP_2020_NA0002_62_81_20200505_00087.jpg

View of blackberries covering the waterside shoulder and slope (Fall 2019).

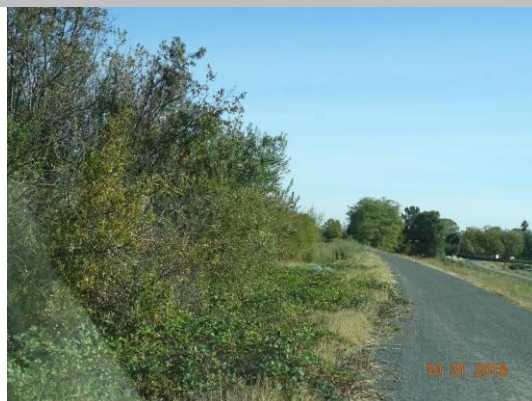
Photo 2 of 2 : SP_2020_NA0002_62_81_20200304_00032.jpg

View of vegetation on the waterside slope (October 2018).

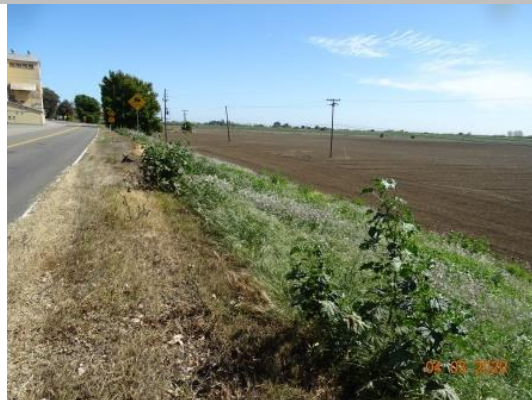
Photo 1 of 1 : SP_2020_NA0002_63_129_20200406_00189.jpg

View looking upstream at annual vegetation on the landside slope (Spring 2020).

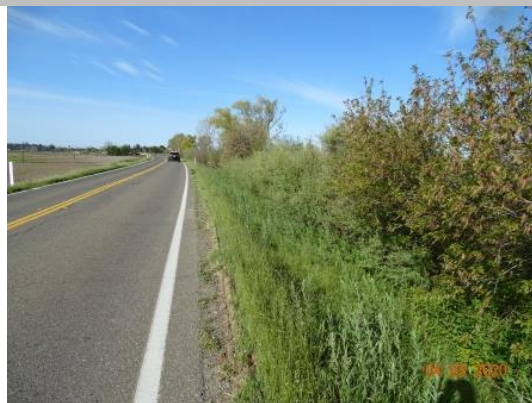
Photo 1 of 1 : SP_2020_NA0002_63_51_20200406_00182.jpg

View looking downstream at annual vegetation on the waterside slope (Spring 2020).

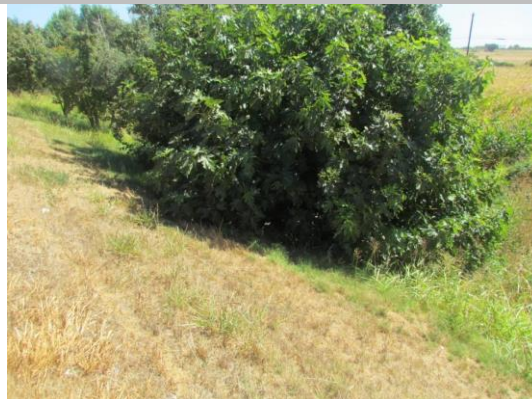
Photo 1 of 1 : SP_2020_NA0002_63_97_20200304_00056.jpg

Looking east at untrimmed fig tree at landward toe.

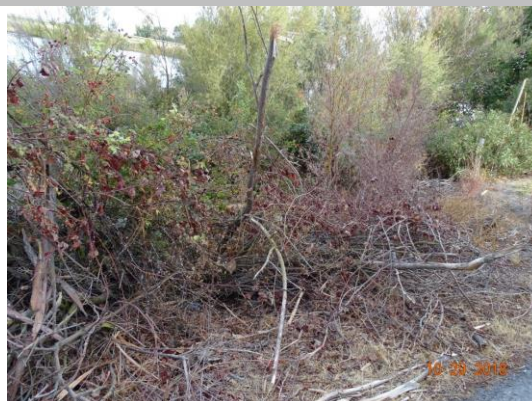
Photo 1 of 1 : SP_2020_NA0002_63_76_20200304_00041.jpg

View of prunings on the waterside shoulder (October 2018).

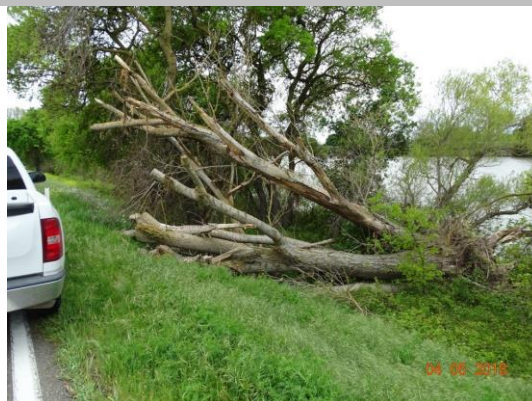
Photo 1 of 1 : SP_2020_NA0002_63_81_20200304_00046.jpg

View of fallen tree on the waterside.

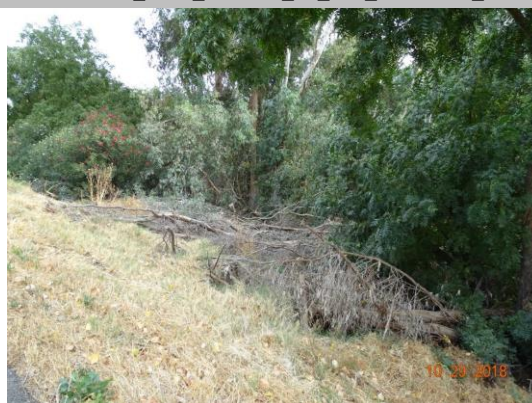
Photo 1 of 1 : SP_2020_NA0002_63_174_20200304_00094.jpg

View of downed trees on landside slope (October 2018).

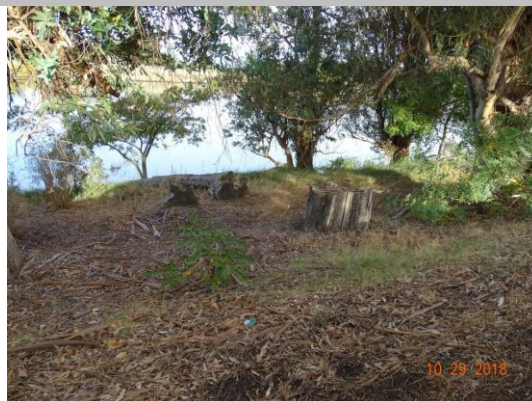
Photo 1 of 1 : SP_2020_NA0002_63_78_20200304_00043.jpg

View of tree stump on the waterside slope (October 2018).

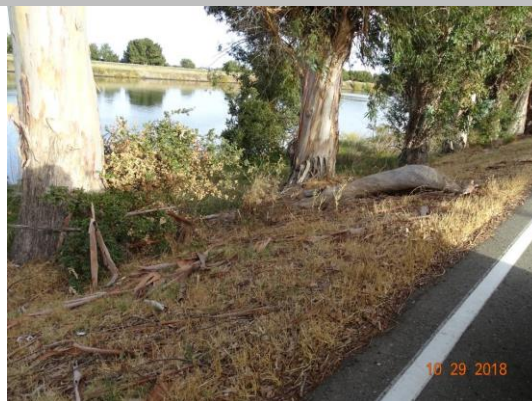
Photo 1 of 1 : SP_2020_NA0002_63_79_20200304_00044.jpg

View looking upstream at large tree limb on the waterside slope (October 2018).

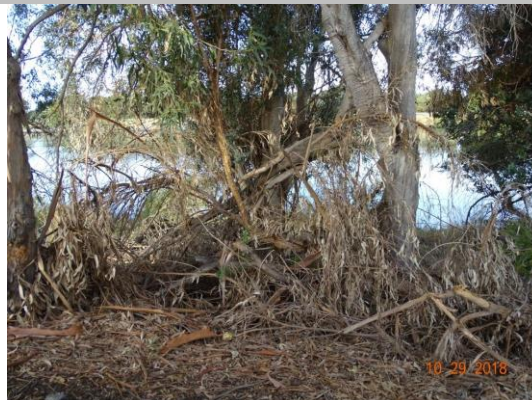
Photo 1 of 1 : SP_2020_NA0002_63_137_20200304_00081.jpg

View of downed tree limbs on waterside slope (October 2018).

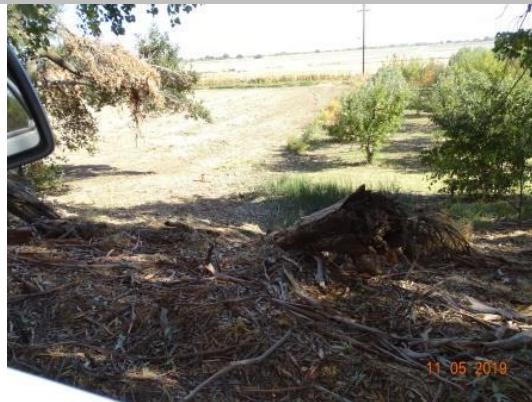
Photo 1 of 1 : SP_2020_NA0002_63_93_20200304_00053.jpg

LM Start	1.88	Rating **	U	Issue No.	93
LM End	1.89	Issue Type +	Ma	Location *	LS
Category	Earthen Levee			GPS Latitude/Longitude	
				Start	End
Item	Encroachments			38.173403 °	38.173221 °
				-121.591389 °	-121.591512 °
DWR ID	DWR_NA0002_02_f_2015_93				
Comment Code					
TR : Tree or limb					
Inspector Comment					
Broken tree limbs are on the landside slope and toe.

Down tree on the landside slope and toe (Fall 2019).

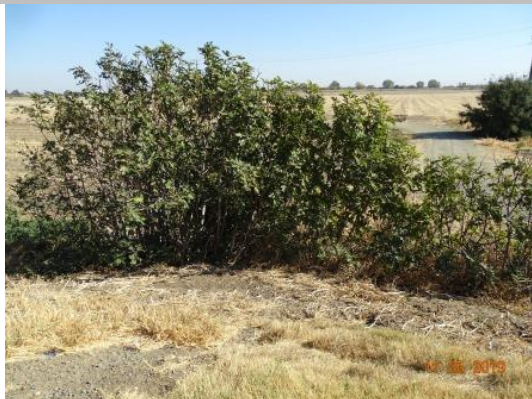
Photo 1 of 1 : SP_2020_NA0002_63_120_20200304_00073.jpg

View of young fig tree on the landside slope (Fall 2019).

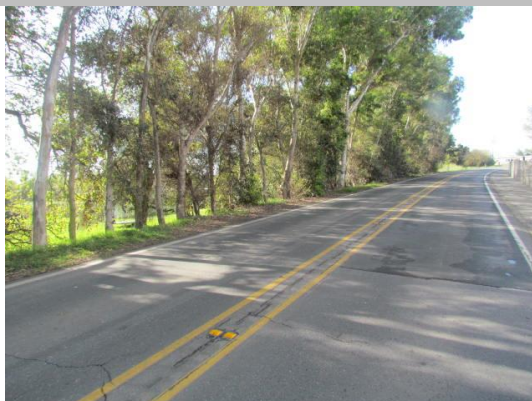
Photo 1 of 1 : SP_2020_NA0002_63_25_20200304_00011.jpg

Looking southeast at trees at landward shoulder. (Spring 2015)

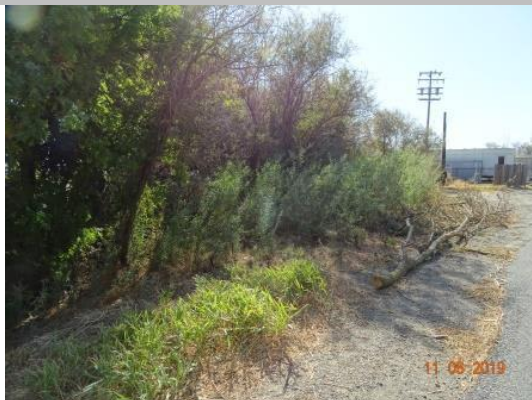
Photo 1 of 1 : SP_2020_NA0002_63_131_20200304_00076.jpg

View of tree limb on landside shoulder (Fall 2019).

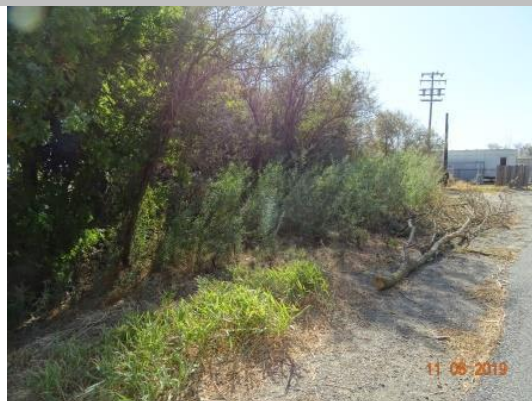
Photo 1 of 1 : SP_2020_NA0002_63_99_20200304_00058.jpg

View looking downstream at vegetation on the landside slope (Fall 2019).

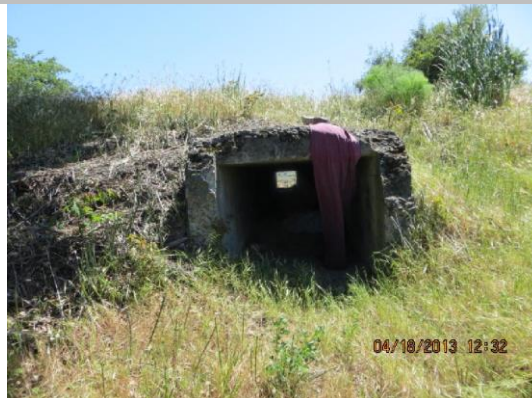
Photo 1 of 3 : UCIP_SP_2020_53389_19773.jpg

Comment Code					
Inspector Comment					
DS_ID:21879					
FS_ID:53389					
EP_NO: N/A					
Repair Type: Non-Urgent					
Crossing Status: Found					
UCIP Comments: 07/12/2018 Tunnel is open on both sides. No integrity issue observed, therefore crossing downgraded to "Non-Urgent". (O.Yakimov-DWR UCIP)10/24/2016 same as previous inspection culvert is open on both ends. WS blocked by blankets -- WS structure is being used as a shelter. (O. Magana - DWR UCIP)04/18/2013 Culvert open on both ends. Needs to be abandoned properly. (W. Wylie - DWR UCIP)					
FIELD_STRUCT_DESC: *ABANDONED* 42-inch by 42-inch open reinforced concrete drainage culvert through the levee, 6 feet below the crown. [Additional Reference(s): DWR Levee Log, 2005, 3-foot by 3.5-foot culvert listed. USACE Sacramento O&M Manual 103, June 1954, (RM 18.16) Drawing No. 6-13-1100].					
FS Date: 7/12/2018 2:59:33 PM

Concrete tunnel open on both ends.

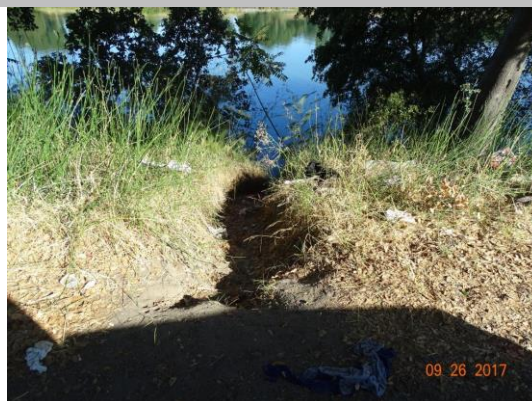
Photo 1 of 1 : SP_2020_NA0002_63_82_20200304_00047.jpg

LM Start	2.56	Rating **	M	Issue No.	82
LM End	2.56	Issue Type +	Ma	Location *	WS
Category	Earthen Levee			GPS Latitude/Longitude	
				Start	End
Item	Slope Stability			38.165898 °	38.165898 °
				-121.598888 °	-121.598888 °
DWR ID	DWR_NA0002_02_f_2017_82				
Comment Code					
S2 : Repair the levee slope damaged by foot traffic and prevent access where possible.					
Inspector Comment					
There is a footpath digging into the levee slope.

Looking northwest at the waterside slope.

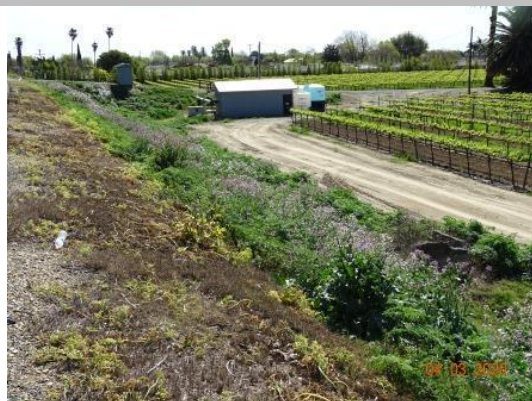
Photo 1 of 1 : SP_2020_NA0002_63_114_20200406_00188.jpg

View looking upstream at annual vegetation on the landside slope (Spring 2020).

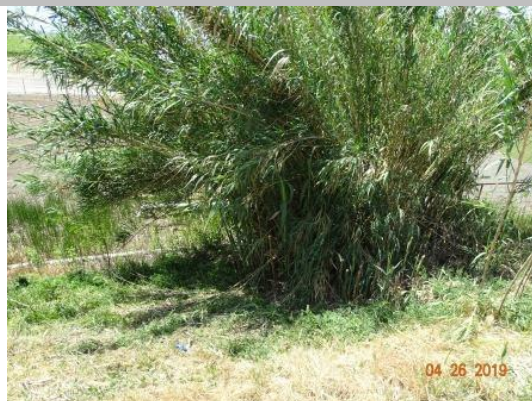
Photo 1 of 1 : SP_2020_NA0002_63_98_20200304_00057.jpg

View of arundo on the landside slope (Spring 2019).

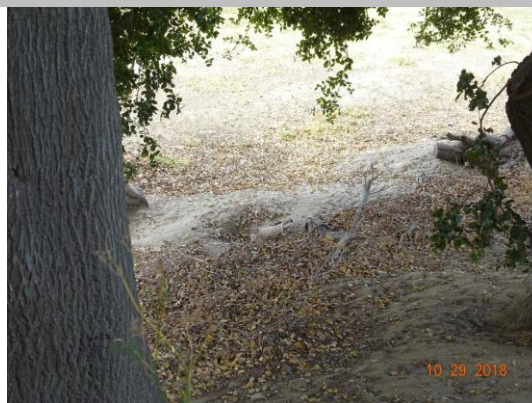
Photo 1 of 1 : SP_2020_NA0002_63_167_20200304_00089.jpg

View of several animal holes. Additional holes were found in the immediate vicinity.

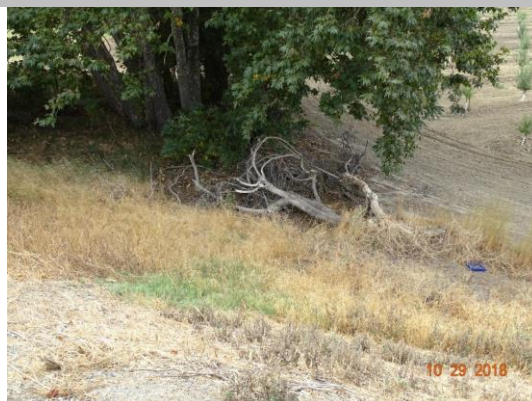
Photo 1 of 1 : SP_2020_NA0002_63_165_20200304_00088.jpg

View of downed tree limbs on the landside toe (October 2018).

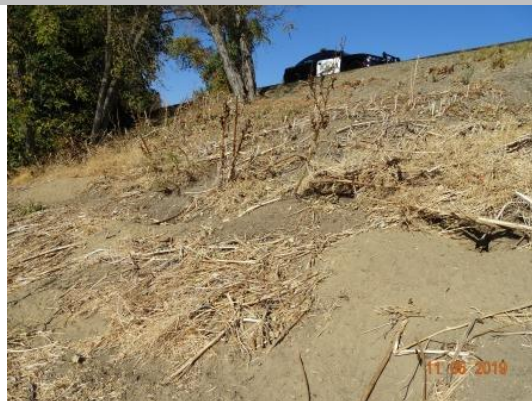
Photo 1 of 1 : SP_2020_NA0002_63_128_20200304_00075.jpg

View of multiple large squirrel holes in landside slope (Fall 2019).

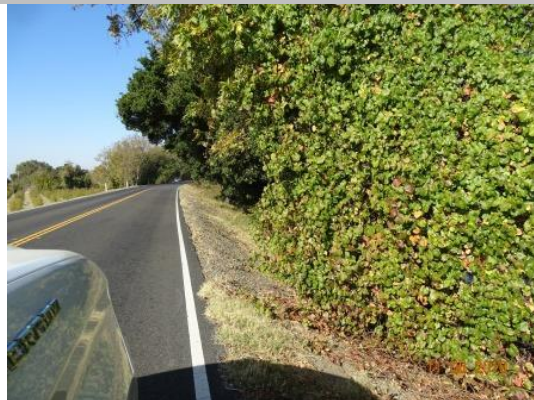
Photo 1 of 1 : SP_2020_NA0002_63_62_20200304_00029.jpg

View looking downstream at wild grapes on the waterside slope encroaching onto slope (Fall 2019).

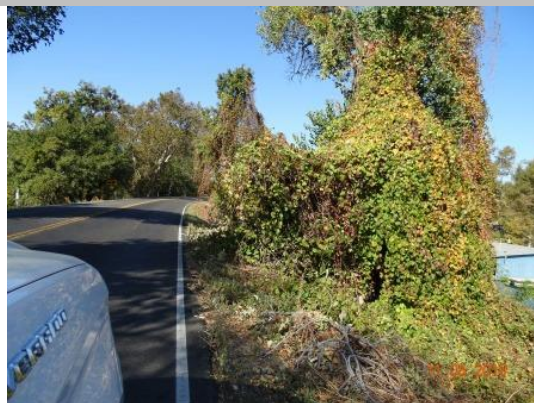
Photo 1 of 1 : SP_2020_NA0002_63_65_20200304_00031.jpg

View looking downstream at wild grapes on the waterside slope encroaching onto slope (Fall 2019).

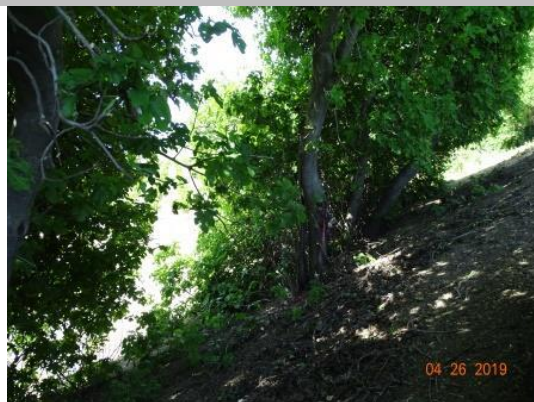
Photo 1 of 1 : SP_2020_NA0002_63_163_20200304_00087.jpg

View looking downstream at fig tree on the landside slope (Spring 2019).

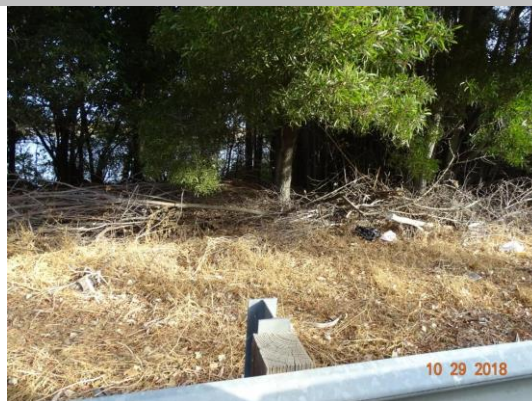
Photo 1 of 1 : SP_2020_NA0002_63_115_20200304_00068.jpg

View of prunings on the waterside slope (October 2018).

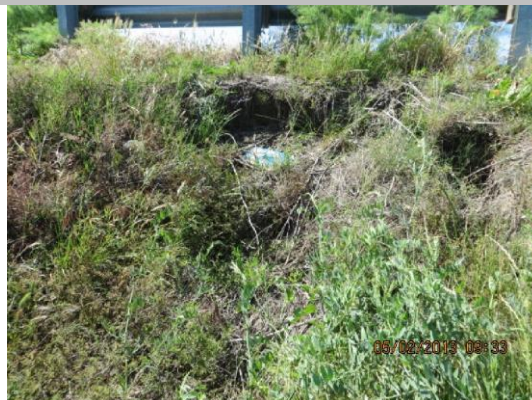
Photo 2 of 3 : UCIP_SP_2020_12778_20761.jpg

Erosion along pipe alignment at WS slope.

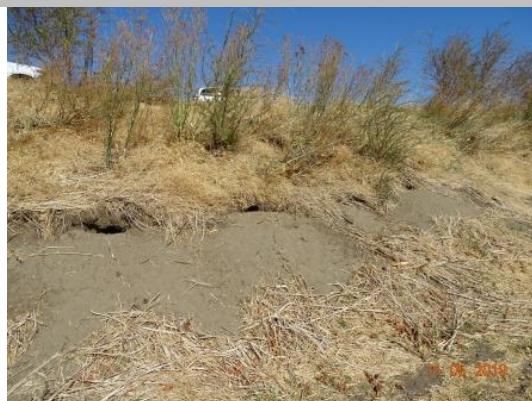
Photo 1 of 1 : SP_2020_NA0002_63_122_20200304_00074.jpg

View of multiple large squirrel holes in the landside slope (Fall 2019).

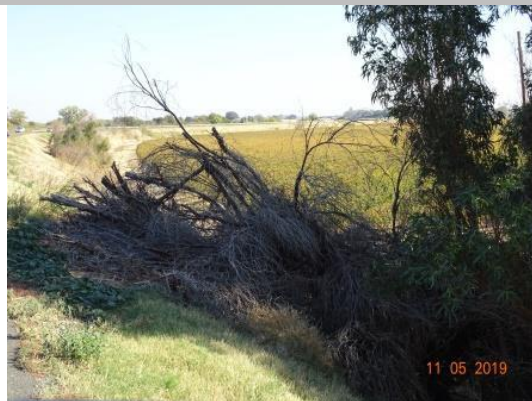
Photo 1 of 1 : SP_2020_NA0002_63_84_20200304_00048.jpg

View looking upstream at dead tree on the landside slope (Fall 2019).

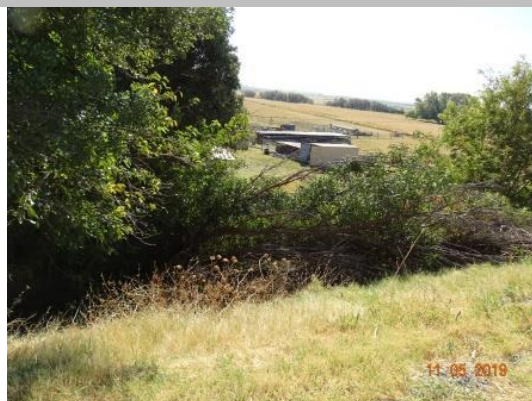
Photo 1 of 1 : SP_2020_NA0002_63_13_20200304_00009.jpg

View of fallen tree on the landside slope (Fall 2019).

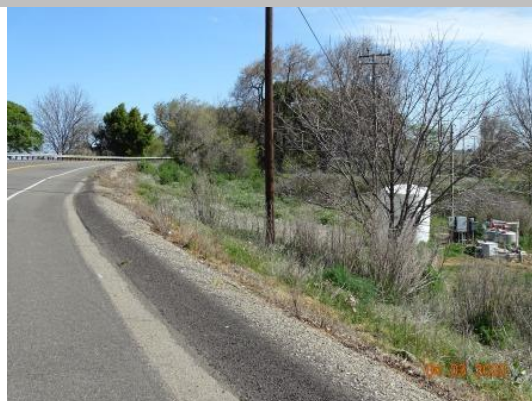
Photo 1 of 1 : SP_2020_NA0002_63_63_20200406_00187.jpg

View looking upstream at annual vegetation on the landside slope (Spring 2020).

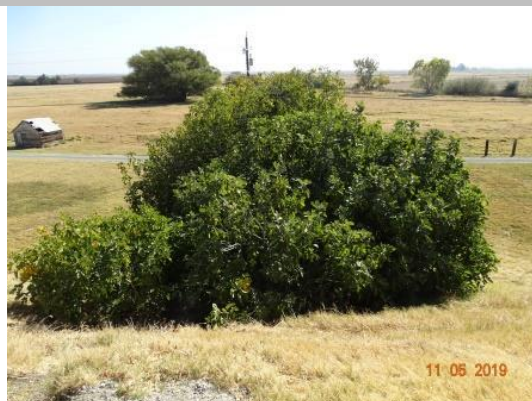
Photo 1 of 1 : SP_2020_NA0002_63_118_20200304_00071.jpg

View of fig tree on the landside slope (Fall 2019).

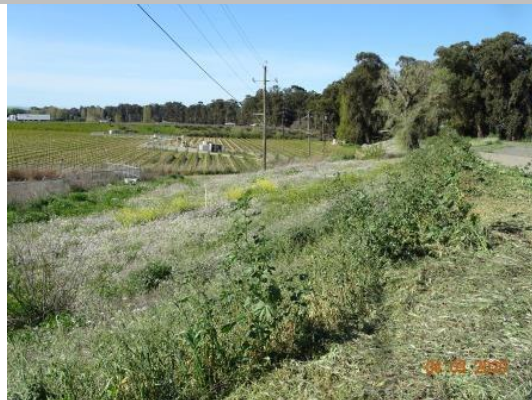
Photo 1 of 1 : SP_2020_NA0002_63_96_20200406_00185.jpg

View looking downstream at thick annual vegetation on the landside slope (Spring 2020).

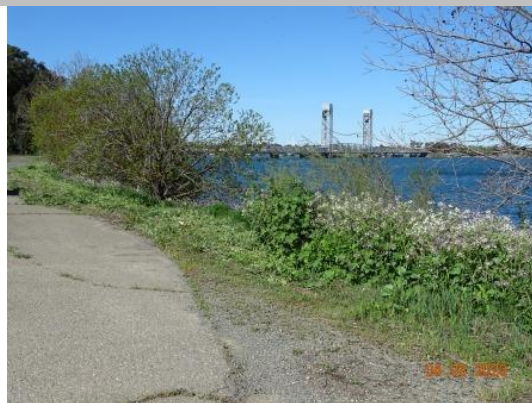
Photo 1 of 1 : SP_2020_NA0002_63_87_20200406_00184.jpg

View looking downstream at thick annual vegetation on the waterside slope (Spring 2020).

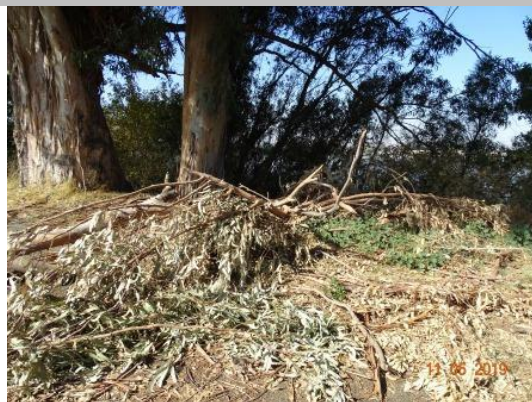
Photo 1 of 1 : SP_2020_NA0002_63_105_20200304_00061.jpg

View of down tree limbs on waterside shoulder (Fall 2019).

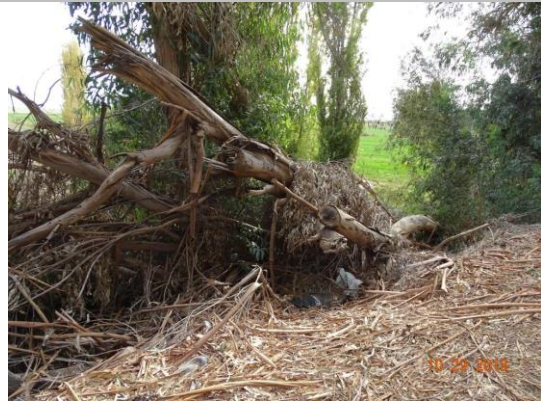
Photo 1 of 1 : SP_2020_NA0002_63_158_20200304_00085.jpg

View of down tree on landside slope (October 2018).

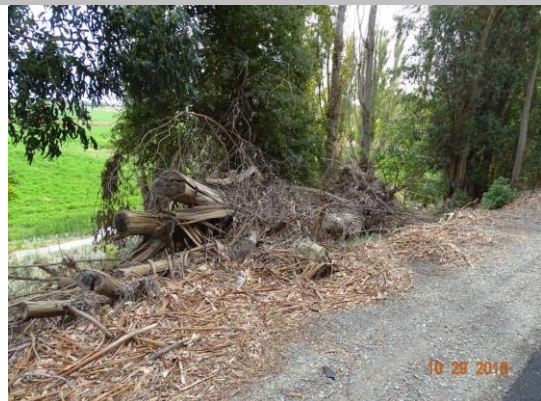
Photo 1 of 1 : SP_2020_NA0002_63_157_20200304_00084.jpg

View of downed tree on landside slope (October 2018).

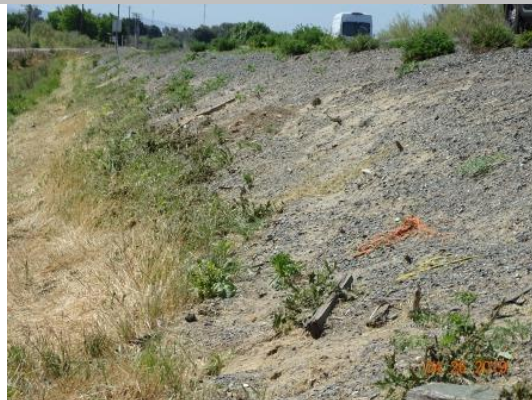
Photo 1 of 2 : SP_2020_NA0002_63_67_20200304_00032.jpg

View looking downstream at animal holes on the landside slope (Spring 2019).

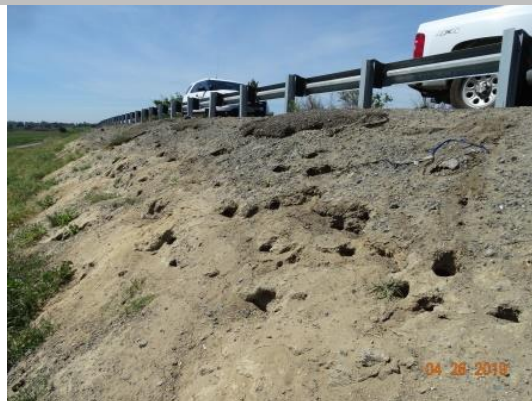
Photo 2 of 2 : SP_2020_NA0002_63_67_20200304_00033.jpg

View looking downstream at animal holes on the landside slope (Spring 2019).
