**Flood Control Project Maintenance  
Levee Inspections**

**Maintenance Issue Types Only, Levee Inspection Report By Mile - Spring 2021**

**Brannan Andrus Levee Maintenance District**

Waterway	Bank	Unit Miles	Inspection Start/End	Inspector
Unit No. 01 Georgiana Slough	Right	6.01	03/17/2021 03/17/2021	David Julian

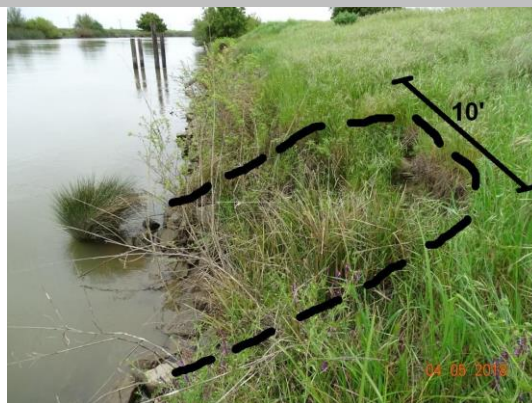
Photo 1 of 1 : SP\_2021\_NA0002\_62\_39\_20210226\_00014.jpg

LM Start	1.53	Rating **	M	Issue No.	39
LM End	1.54	Issue Type +	Ma	Location *	WS
Category	Supplemental			GPS Latitude/Longitude	
				Start	End
Item	2017 USACE Erosion Survey			38.173410 °	38.173178 °
				-121.580683 °	-121.580622 °
DWR ID	DWR_NA0002_01_f_2018_39				
Comment Code					
Inspector Comment					
2017 Site ID: GEO 5.5 R					
Status: Eroding New					
2017 Field Notes: Failed rock section, slump failure of bank to subvertical face.					
Site History:

Erosion slump in area of previous repair. LM 1.52

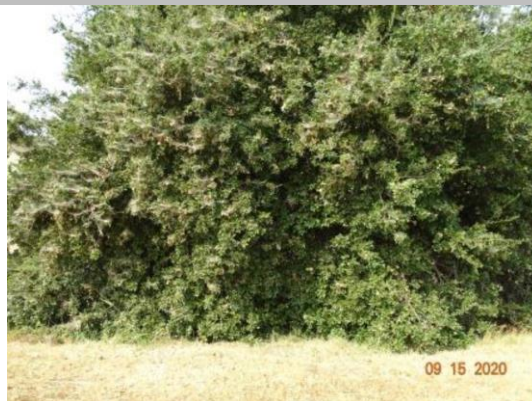
Photo 1 of 1 : SP\_2021\_NA0002\_62\_25\_20210226\_00010.jpg

LM Start	1.56	Rating **	U	Issue No.	25	
LM End	1.56	Issue Type +	Ma	Location *	LS	
Category	Earthen Levee			GPS Latitude/Longitude		
				Start		End
Item	Trim / Thin Trees			38.172869 °		38.172869 °
				-121.580681 °		-121.580681 °
DWR ID	DWR_NA0002_01_s_2012_25					
Comment Code						
T1 : Trim trees to at least five feet above ground level.						
Inspector Comment						
Tree blocking landside toe.

View of thick tree on the landside slope (Fall 2020).

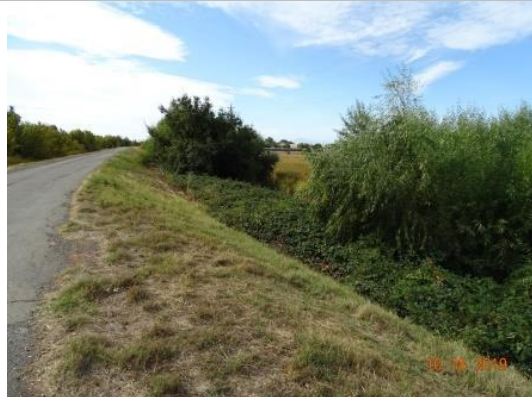
Photo 1 of 1 : SP\_2021\_NA0002\_62\_28\_20210226\_00011.jpg

View looking downstream at thick vegetation on the landside slope (Fall 2019).

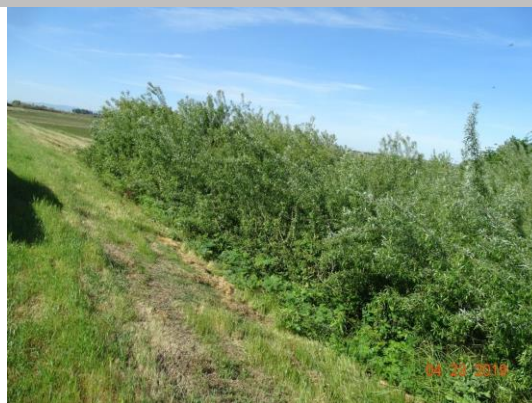
Photo 1 of 1 : SP\_2021\_NA0002\_62\_53\_20210226\_00018.jpg

View looking downstream at willows on the landside slope (Spring 2019).

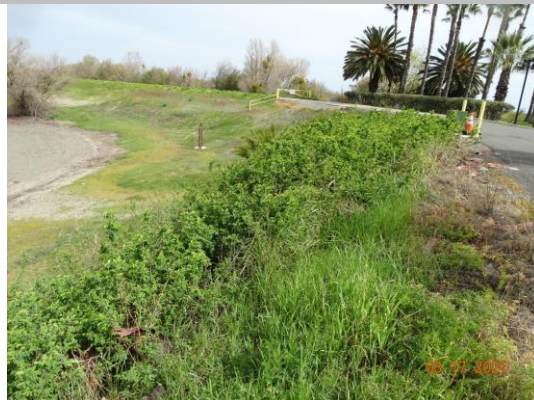
Photo 1 of 1 : SP\_2021\_NA0002\_62\_127\_20210317\_00237.jpg

LM Start	3.18	Rating **	M	Issue No.	2
LM End	3.32	Issue Type +	Ma	Location *	LS
Category	Earthen Levee			GPS Latitude/Longitude	
				Start	End
Item	Vegetation			38.153977 °	38.152151 °
				-121.592589 °	-121.591529 °
DWR ID	DWR_NA0002_01_s_2021_2				
Comment Code					
V1 : Control annual grass and weeds on the levee slopes and easements.					
Inspector Comment

View of thick wild roses on the landside slope (Spring 2021).

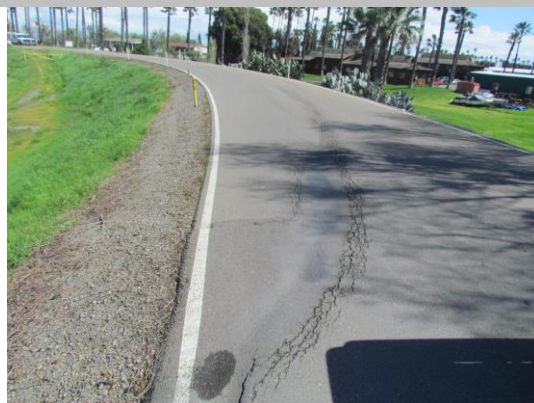
Photo 1 of 1 : SP\_2021\_NA0002\_62\_67\_20210226\_00029.jpg

LM Start	3.38	Rating **	A/W	Issue No.	67
LM End	3.40	Issue Type +	Ma	Location *	CR
Category	Earthen Levee			GPS Latitude/Longitude	
				Start	End
Item	Slope Stability			38.151430 °	38.151390 °
				-121.592085 °	-121.592517 °
DWR ID	DWR_NA0002_01_s_2017_67				
Comment Code					
S1 : Repair slope instability.					
Inspector Comment					
Appears to be beginning of a landside slump. LMA's Engineer (DCC) is monitoring site for movement.

Looking east at possible sloughing on landward shoulder.

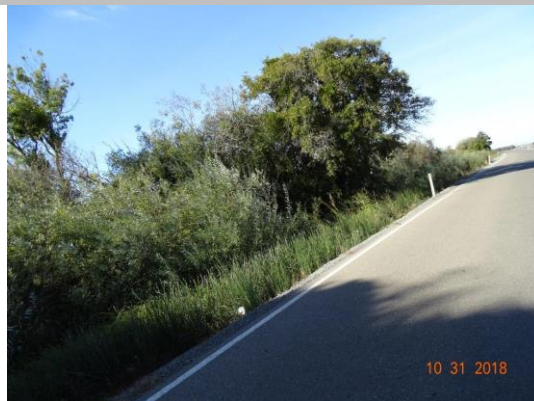
Photo 1 of 1 : SP\_2021\_NA0002\_62\_59\_20210226\_00023.jpg

LM Start	3.43	Rating **	U	Issue No.	59
LM End	3.95	Issue Type +	Ma	Location *	WS
Category	Earthen Levee			GPS Latitude/Longitude	
				Start	End
Item	Vegetation			38.151448 °	38.145753 °
				-121.592898 °	-121.601660 °
DWR ID	DWR_NA0002_01_f_2018_59				
Comment Code					
V2 : Remove the wild growth other than native grasses from the levee slopes.					
Inspector Comment

View looking downstream at vegetation on the water side slope (October 2018).

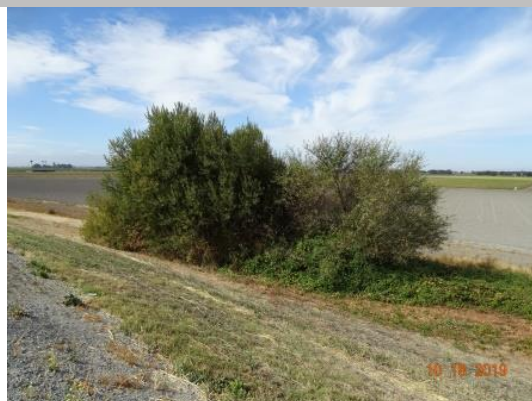
Photo 1 of 1 : SP\_2021\_NA0002\_62\_46\_20210226\_00015.jpg

View looking downstream at thick tree on the landside slope (Fall 2019).

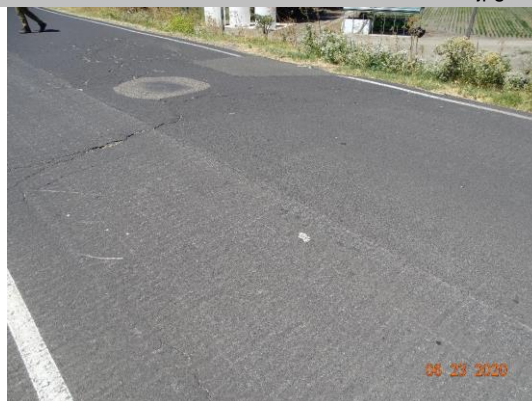
Photo 1 of 3 : UCIP\_SP\_2021\_62327\_90037.jpg

FS\_ID:62327  
DS\_ID:21772  
EP\_NO: 11248  
Repair Type: Non-Urgent  
Crossing Status: Found  
UCIP Comments: 06/23/2020 Record updated from No Action Needed to Non-Urgent. 20-inch steel drainage pipe sleeved through 24-inch steel pipe. Annular space between pipes seems to be grouted. Unable to find a permit for modification. Asphalt repair patches on levee crown. No permit has been identified authorizing pipe. Need to have CVFPB review ABO and determine current owner. (O.Yakimov - DWR UCIP)  
FIELD\_STRUCT\_DESC: 20-inch steel drainage pipe sleeved through 24-inch steel pipe through the levee, 3 feet below the crown. Siphon breaker is located on the waterside (WS) slope. Pump is located on the landside (LS). (24-inch pipe [HLM 3.99] authorized under Automatic Board Order (ABO) issued as Permit No. 11248, 1975 - Reclamation District No.407). [Additional Reference(s): DWR Levee Log, 2005 (HLM 3.99), listed as 24-inch pipe. USACE Sacramento O&M Manual, Unit 103, June 1954, Revised 29 December 2016, (Station 'R' 107+76), listed as 26-inch pipe. USACE As-Built Drawing No. 50-04-2631, Sheet 2, Station 107+76, March 1950, listed as 26-inch pipe].

Top of Levee: View of levee crown looking downstream

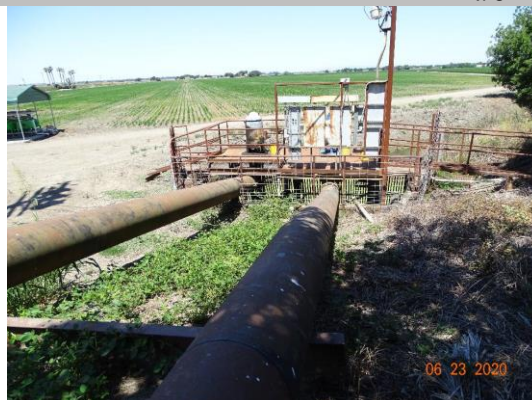
Photo 2 of 3 : UCIP\_SP\_2021\_62327\_90036.jpg

Land-Side: View of levee slope looking from crown

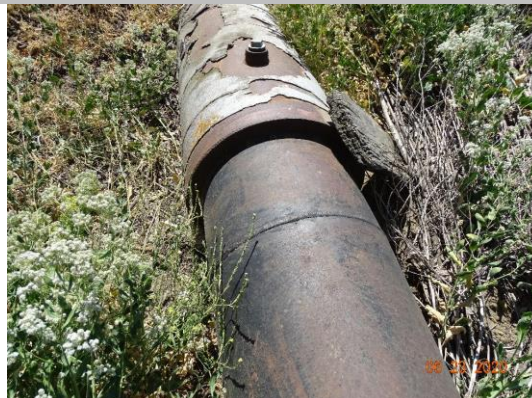
Photo 3 of 3 : UCIP\_SP\_2021\_62327\_90035.jpg

Land-Side: Pipe sleeving point on levee slope

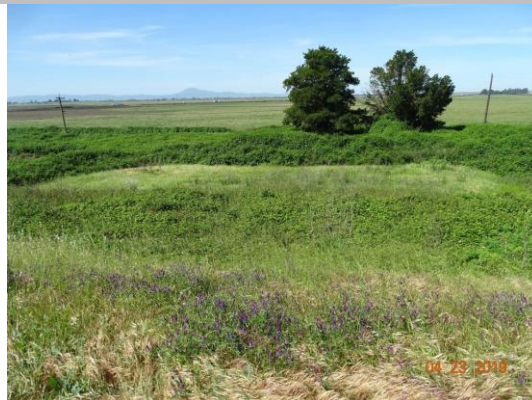
Photo 1 of 1 : SP\_2021\_NA0002\_62\_85\_20210226\_00035.jpg

View looking downslope at blackberries at the landside slope (Spring 2019).

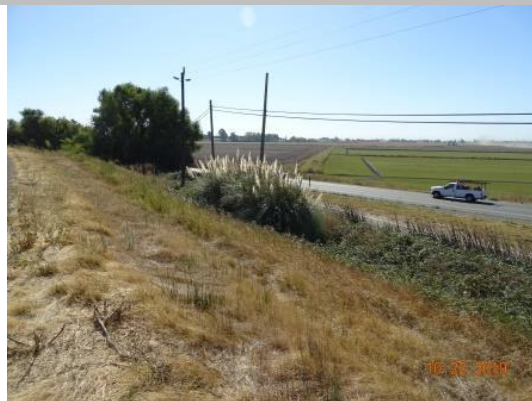
Photo 1 of 1 : SP\_2021\_NA0002\_62\_23\_20210226\_00009.jpg

View looking downstream at vegetation at the landside toe (Fall 2019).

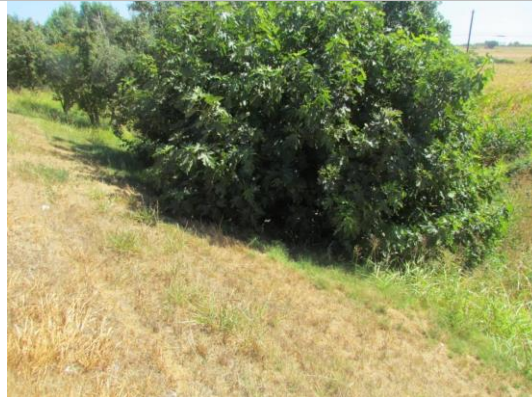
Photo 1 of 1 : SP\_2021\_NA0002\_63\_97\_20210226\_00037.jpg

Looking east at untrimmed fig tree at landward toe.

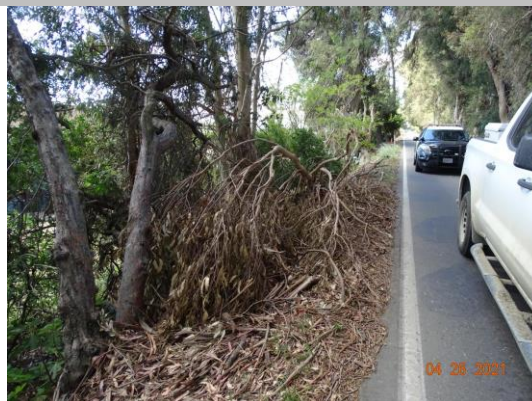
Photo 1 of 1 : SP\_2021\_NA0002\_63\_96\_20210426\_00161.jpg

Down tree limb on the landside hinge (Spring 2021).

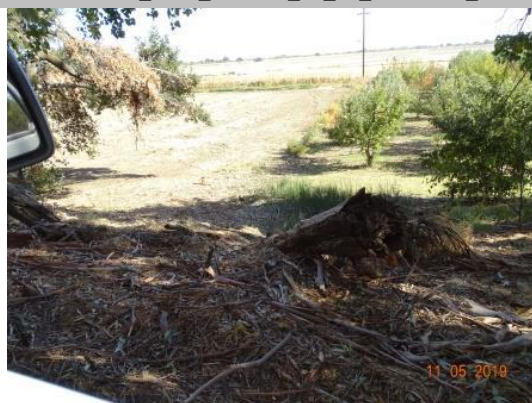
Photo 1 of 1 : SP\_2021\_NA0002\_63\_93\_20210226\_00035.jpg

LM Start	1.88	Rating **	U	Issue No.	93
LM End	1.89	Issue Type +	Ma	Location *	LS
Category	Earthen Levee			GPS Latitude/Longitude	
				Start	End
Item	Encroachments			38.173403 °	38.173221 °
				-121.591389 °	-121.591512 °
DWR ID	DWR_NA0002_02_f_2015_93				
Comment Code					
TR : Tree or limb					
Inspector Comment					
Broken tree limbs are on the landside slope and toe.

Down tree on the landside slope and toe (Fall 2019).

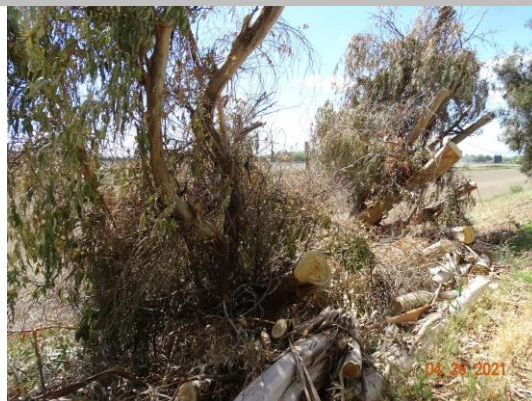
Photo 1 of 1 : SP\_2021\_NA0002\_63\_95\_20210426\_00159.jpg

View of down tree limbs on the landside slope (Spring 2021).

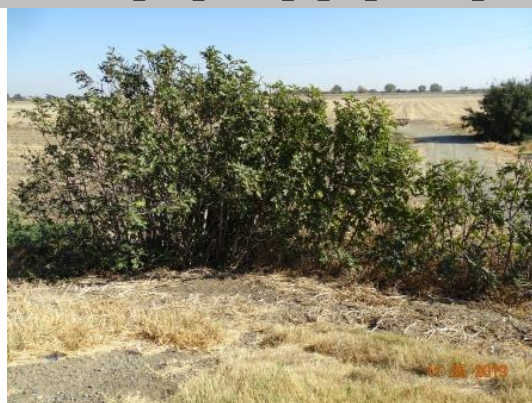
Photo 1 of 1 : SP\_2021\_NA0002\_63\_120\_20210226\_00048.jpg

LM Start	2.16	Rating **	M	Issue No.	120
LM End	2.16	Issue Type +	Ma	Location *	LS
Category	Earthen Levee			GPS Latitude/Longitude	
				Start	End
Item	Trim / Thin Trees			38.169853 °	38.169853 °
				-121.593828 °	-121.593828 °
DWR ID	DWR_NA0002_02_f_2016_120				
Comment Code					
T2 : Thin trees to allow visibility of the ground and room to flood fight.					
Inspector Comment					
Fig tree on the landside slope.

View of young fig tree on the landside slope (Fall 2019).

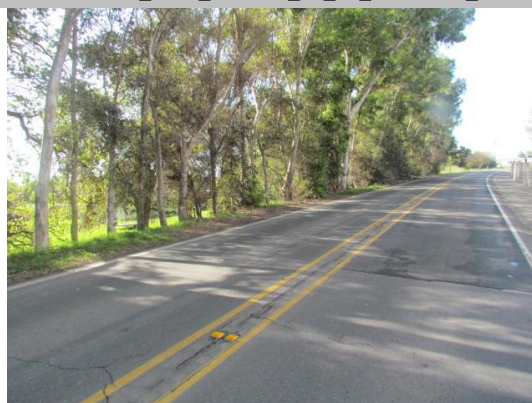
Photo 1 of 1 : SP\_2021\_NA0002\_63\_25\_20210226\_00005.jpg

LM Start	2.34	Rating **	M	Issue No.	25
LM End	2.38	Issue Type +	Ma	Location *	LS
Category	Earthen Levee			GPS Latitude/Longitude	
				Start	End
Item	Trim / Thin Trees			38.167627 °	38.167152 °
				-121.595538 °	-121.595997 °
DWR ID	DWR_NA0002_02_s_2012_25				
Comment Code					
T2 : Thin trees to allow visibility of the ground and room to flood fight.					
Inspector Comment

Looking southeast at trees at landward shoulder. (Spring 2015)

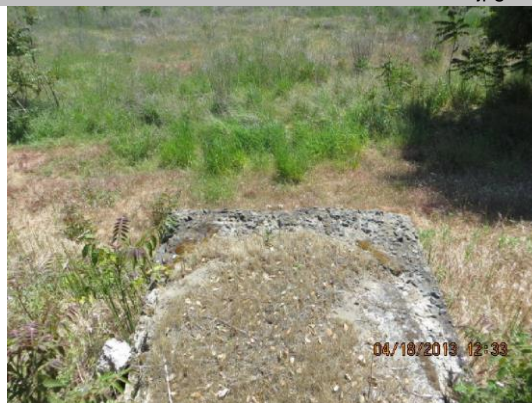
Photo 2 of 3 : UCIP\_SP\_2021\_53389\_19772.jpg

Top of concrete tunnel on LS shoulder.

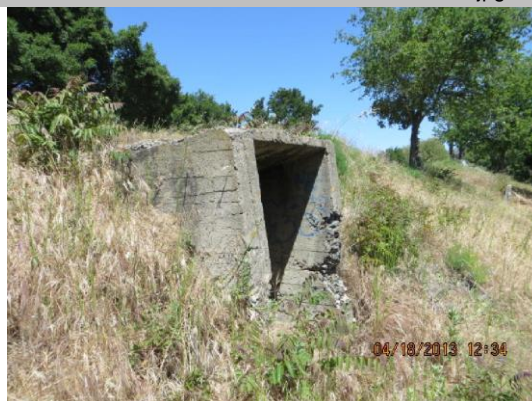
Photo 3 of 3 : UCIP\_SP\_2021\_53389\_19771.jpg

Concrete tunnel on LS shoulder.

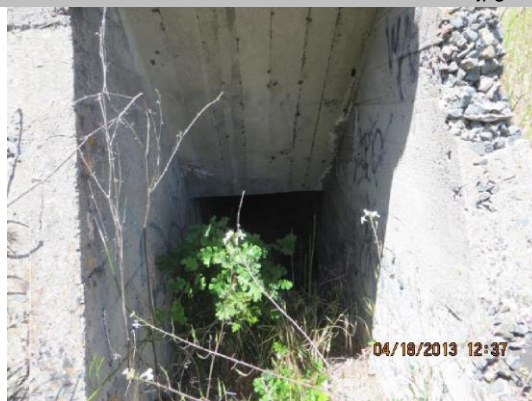
Photo 1 of 3 : UCIP\_SP\_2021\_53513\_19776.jpg

Comment Code						
Inspector Comment						
FS_ID:53513 DS_ID:21880 EP_NO: N/A Repair Type: Non-Urgent Crossing Status: Found UCIP Comments: 07/12/2018 Tunnel is open on both sides. No integrity issue observed, therefore crossing downgraded to "Non-Urgent". (O.Yakimov-DWR UCIP)10/24/2016 same as previous inspection concrete box culvert will need to be abandoned properly. (O. Magana - DWR UCIP)04/18/2013 tunnel should be abandoned properly. (W. Wylie - DWR UCIP) FIELD_STRUCT_DESC: *ABANDONED* 48-inch by 48-inch reinforced concrete drainage culvert through the levee, 6.5-inches below the crown. [Additional Reference(s): DWR Levee Log, 2005. USACE Sacramento O&M Manual 103, June 1954, (RM 18.13) 3-foot by 3-foot concrete box listed, Drawing No. 6-13-1100]. FS Date: 7/12/2018 9:05:37 AM

Tunnel open on LS shoulder.

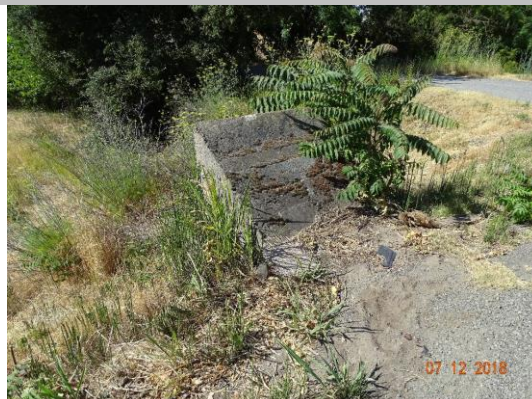
Photo 2 of 3 : UCIP\_SP\_2021\_53513\_77578.jpg

Concrete tunnel on LS shoulder.

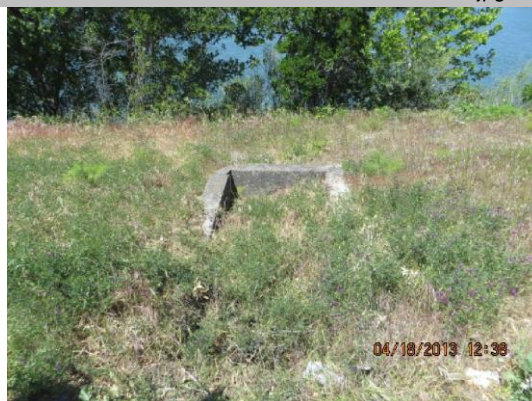
Photo 3 of 3 : UCIP\_SP\_2021\_53513\_19774.jpg

10'X5' concrete box on WS slope, filled with soil.

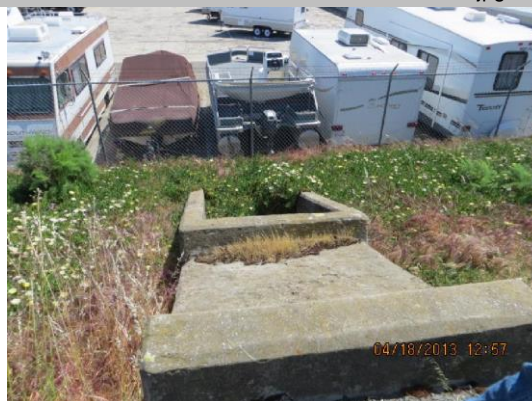
Photo 1 of 3 : UCIP\_SP\_2021\_53514\_19782.jpg

Comment Code					
Inspector Comment					
FS_ID:53514 DS_ID:21882 EP_NO: N/A Repair Type: Non-Urgent Crossing Status: Found UCIP Comments: 07/12/2018 Tunnel is open on both ends. No integrity issue observed, therefore crossing downgraded to "Non-Urgent". (O.Yakimov-DWR UCIP)10/24/2016 same as previous inspection tunnel is opened on both ends. (O. Magana - DWR UCIP)04/18/2013 Tunnel open on both ends and should be abandoned properly. (W. Wylie - DWR UCIP) FIELD_STRUCT_DESC: *ABANDONED* 48-inch by 72-inch reinforced concrete drainage culvert through the levee, 1 foot below the crown. [Additional Reference(s): DWR Levee Log, 2005, 4-foot by 4.5-foot culvert listed. USACE Sacramento O&M Manual 103, June 1954, (RM 17.89) 48-inch by 52-inch concrete box listed, Drawing No. 6-13-1100]. FS Date: 7/12/2018 9:07:49 AM

Entrance to tunnel on LS slope.

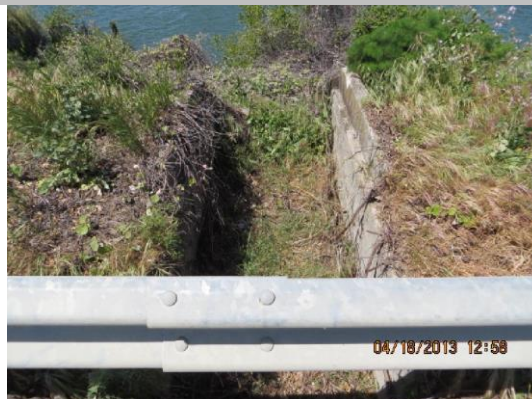
Photo 2 of 3 : UCIP\_SP\_2021\_53514\_19781.jpg

Tunnel opening on WS slope.

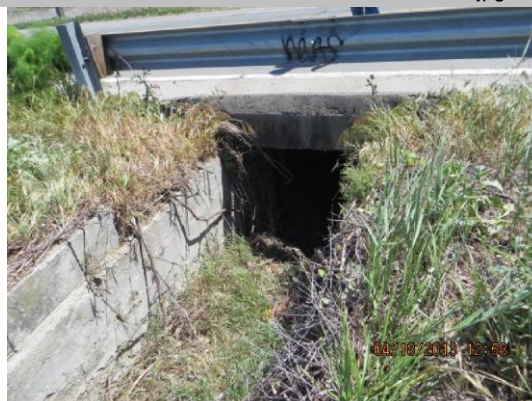
Photo 3 of 3 : UCIP\_SP\_2021\_53514\_19780.jpg

Tunnel opening on WS slope.

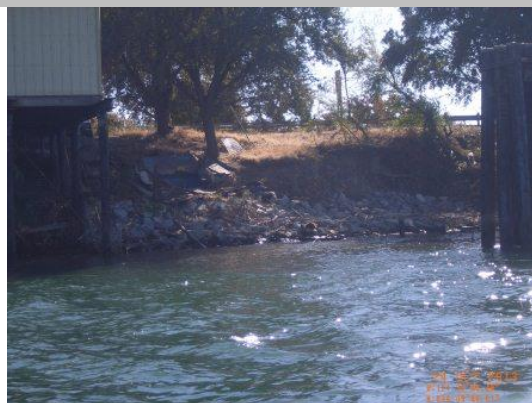
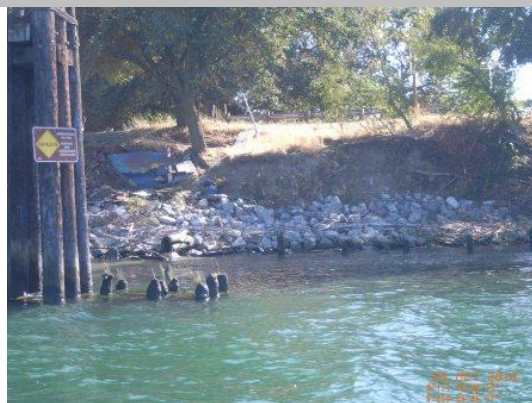
LM Start	3.40	Rating **	M	Issue No.	64
LM End	3.40	Issue Type +	Ma	Location *	WS
Category	Earthen Levee			GPS Latitude/Longitude	
				Start	End
Item	Slope Stability			38.162449 °	38.162449 °
				-121.613390 °	-121.613390 °
DWR ID	DWR_NA0002_02_s _ 2020_64				
Comment Code					
S2 : Repair the levee slope damaged by foot traffic and prevent access where possible.					
Inspector Comment

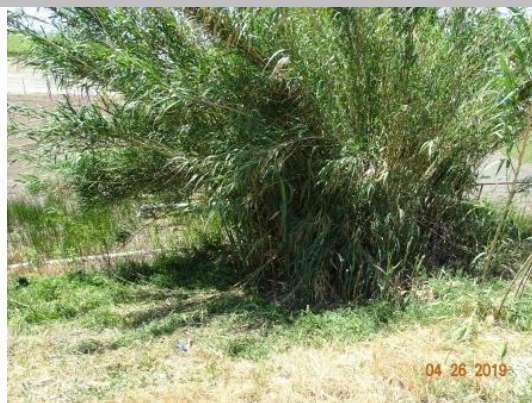
Photo 1 of 1 : SP\_2021\_NA0002\_63\_98\_20210226\_00038.jpg

View of arundo on the landside slope (Spring 2019).

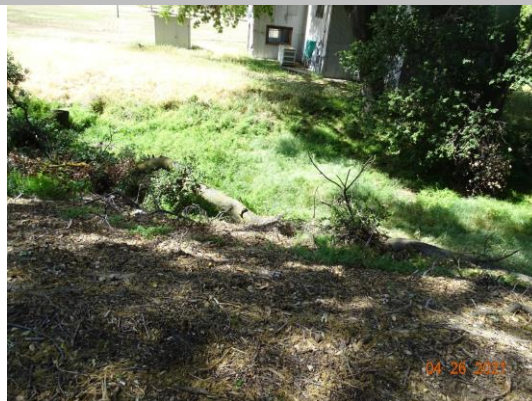
Photo 1 of 1 : SP\_2021\_NA0002\_63\_169\_20210426\_00158.jpg

View of down tree limb on the landside slope (Spring 2021).

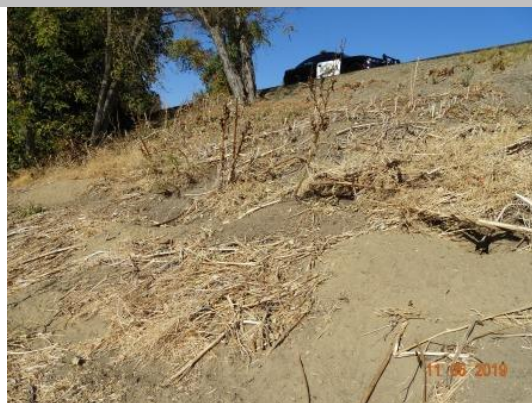
Photo 1 of 1 : SP\_2021\_NA0002\_63\_128\_20210226\_00051.jpg

View of multiple large squirrel holes in landside slope (Fall 2019).

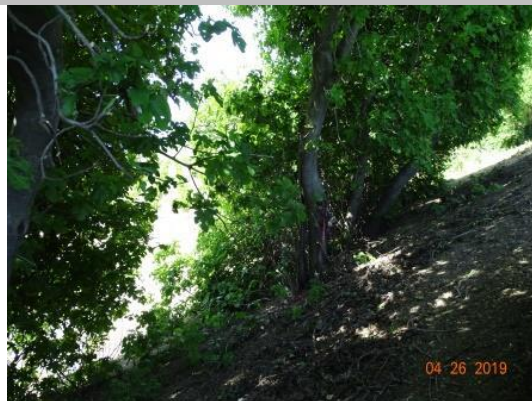
Photo 1 of 1 : SP\_2021\_NA0002\_63\_163\_20210226\_00057.jpg

View looking downstream at fig tree on the landside slope (Spring 2019).

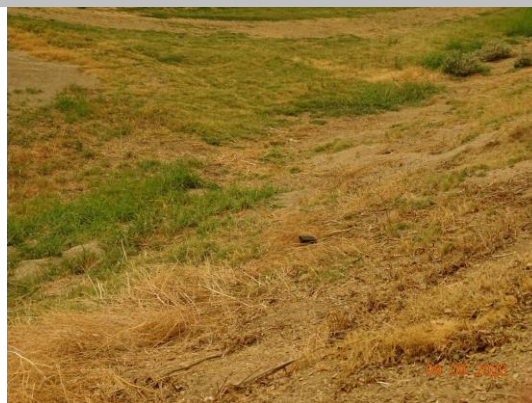
Photo 1 of 1 : SP\_2021\_NA0002\_63\_124\_20210226\_00050.jpg

View looking downstream at animal holes in the landside slope (Fall 2020).

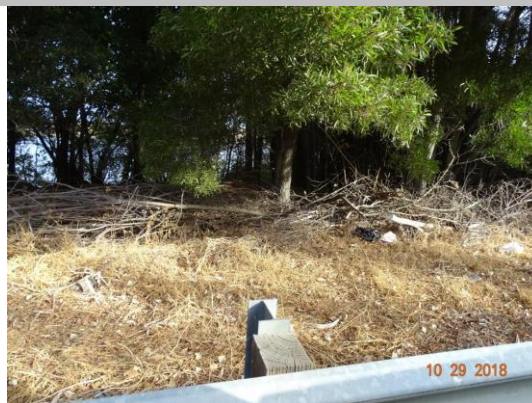
Photo 1 of 1 : SP\_2021\_NA0002\_63\_115\_20210226\_00045.jpg

View of prunings on the waterside slope (October 2018).

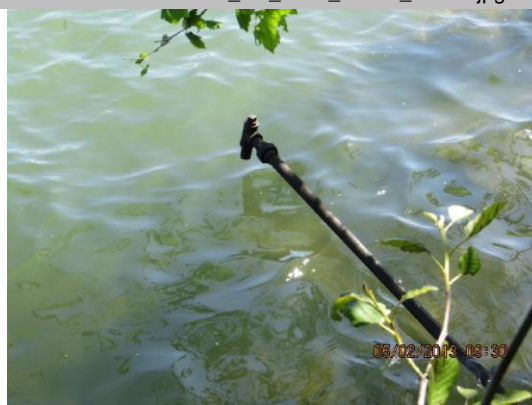
Photo 1 of 3 : UCIP\_SP\_2021\_12778\_20762.jpg

LM Start	5.77	Rating **	M	Issue No.	33	
LM End	5.77	Issue Type +	Ma	Location *		
Category	Supplemental			GPS Latitude/Longitude		
				Start		End
Item	DWR UCIP LMA Responsibility			38.172940 °		38.172940 °
				-121.653700 °		-121.653700 °
DWR ID	21912					
Comment Code						
Inspector Comment						
FS_ID:12778 DS_ID:21912 EP_NO: N/A Repair Type: Non-Urgent Crossing Status: Found UCIP Comments: Pipe abandoned. Erosion on WS slope at location where pipe should be. FIELD_STRUCT_DESC: *ABANDONED* 12-inch drainage pipe of an unknown material through the levee, 13 feet below the crown. Pump and gate valve in pump house at the landside (LS) toe. 1.5-inch electrical conduit along pipe at same location. 42-inch concrete standpipe at the LS toe. [Additional Reference(s): USACE Sacramento O&M Manual 102, April 1959, (RM 14.8) (Reclamation District No. 2067) steel pipe listed FS Date: 5/2/2013

Conduit at WS toe.

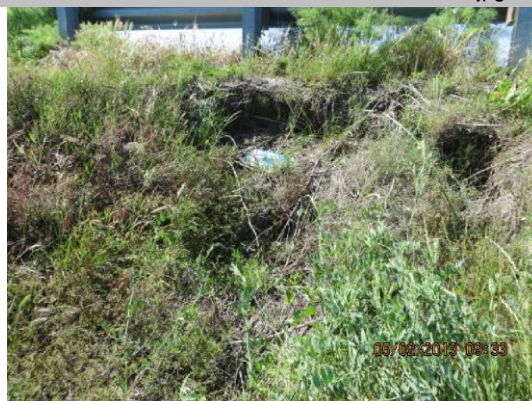
Photo 2 of 3 : UCIP\_SP\_2021\_12778\_20761.jpg

Erosion along pipe alignment at WS slope.

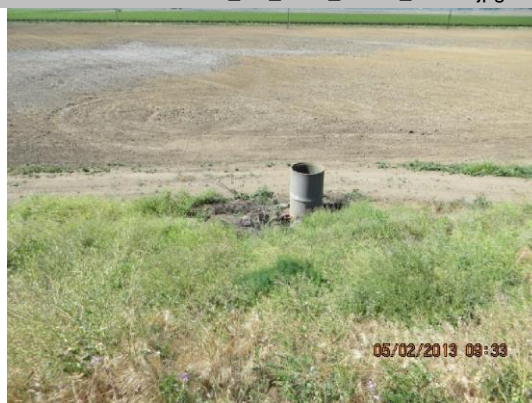
Photo 3 of 3 : UCIP\_SP\_2021\_12778\_20760.jpg

Concrete standpipe and pump on LS toe.

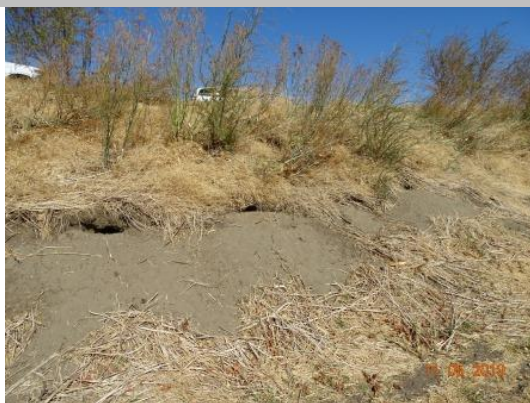
Photo 1 of 1 : SP\_2021\_NA0002\_63\_122\_20210226\_00049.jpg

View of multiple large squirrel holes in the landside slope (Fall 2019).

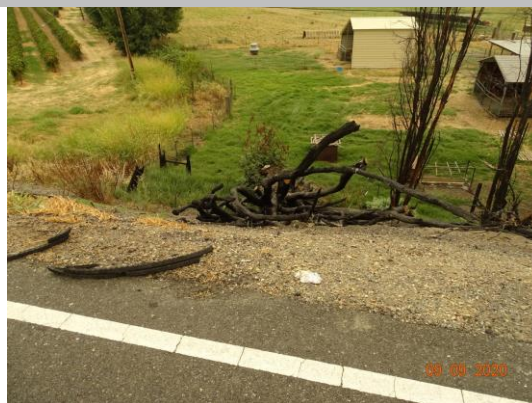
Photo 1 of 1 : SP\_2021\_NA0002\_63\_84\_20210226\_00032.jpg

View looking downslope at burned tree on the landside slope (Fall 2020).

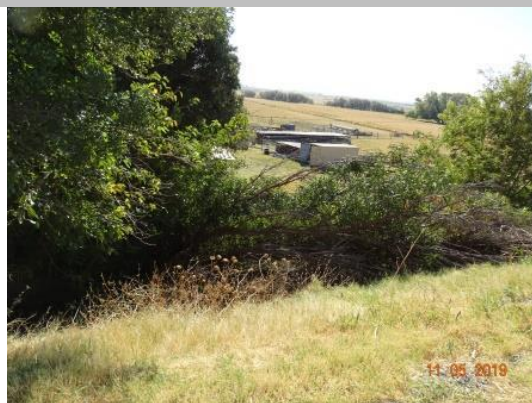
Photo 1 of 1 : SP\_2021\_NA0002\_63\_13\_20210226\_00004.jpg

View of fallen tree on the landside slope (Fall 2019).

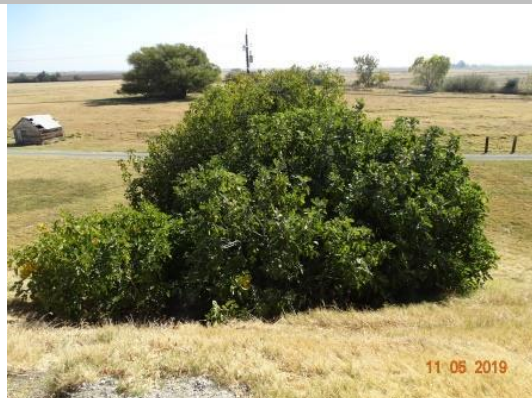
Photo 1 of 1 : SP\_2021\_NA0002\_63\_118\_20210226\_00046.jpg

View of fig tree on the landside slope (Fall 2019).

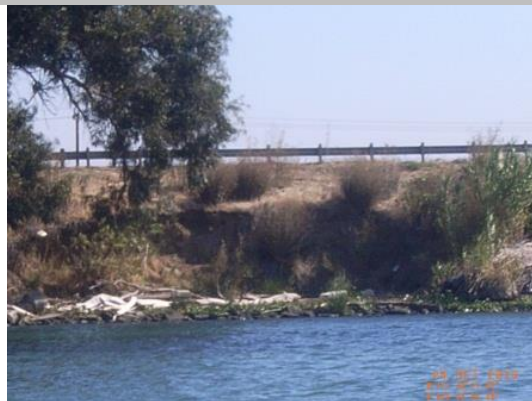
Photo 1 of 1 : SP\_2021\_NA0002\_63\_71\_20210226\_00022.jpg

LM Start	6.98	Rating **	U	Issue No.	71
LM End	7.04	Issue Type +	Ma	Location *	WS
Category	Supplemental			GPS Latitude/Longitude	
				Start	End
Item	2017 USACE Erosion Survey			38.166583 °	38.165794 °
				-121.670684 °	-121.671014 °
DWR ID	DWR_NA0002_02_f_2018_71				
Comment Code					
Inspector Comment					
2017 Site ID: SAC 13.6 L					
Status: Critical					
2017 Field Notes: upgraded to critical. nearly vertical face from levee hinge. trees with large root balls likely to fail.					
Site History: 2011 - Large section of bank slumped off.

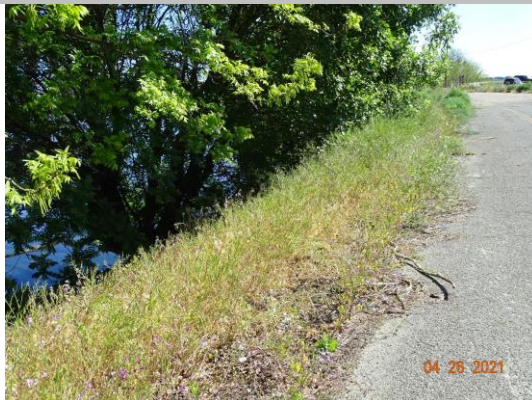
Photo 1 of 1 : SP\_2021\_NA0002\_63\_51\_20210426\_00148.jpg

View looking upstream at vegetation on the waterside slope (Spring 2021).

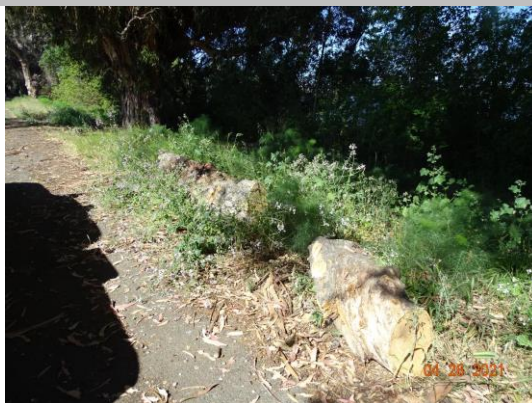
Photo 1 of 1 : SP\_2021\_NA0002\_63\_83\_20210426\_00150.jpg

View of cut-up tree limb on the waterside hinge (Spring 2021).

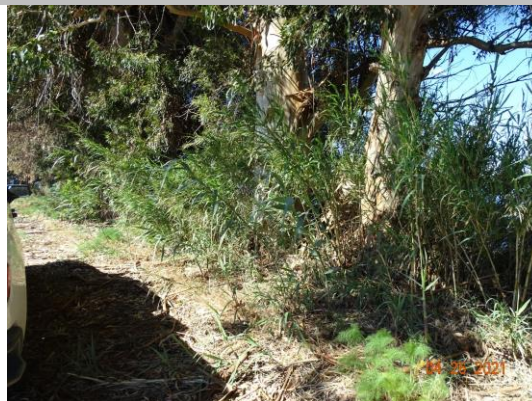
Photo 1 of 1 : SP\_2021\_NA0002\_63\_92\_20210426\_00154.jpg

View of arundo on the waterside slope (Spring 2021).

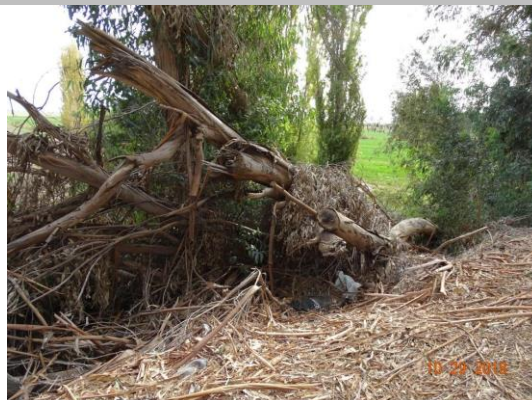
Photo 1 of 1 : SP\_2021\_NA0002\_63\_158\_20210226\_00056.jpg

View of down tree on landside slope (October 2018).

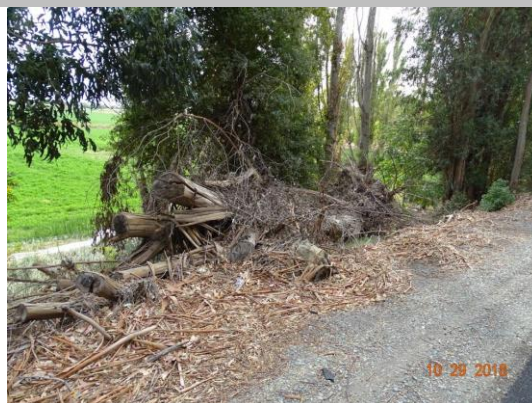
Photo 1 of 1 : SP\_2021\_NA0002\_63\_157\_20210226\_00055.jpg

View of downed tree on landside slope (October 2018).

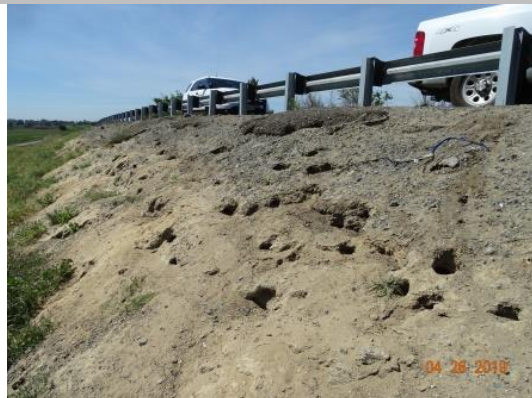
Photo 2 of 2 : SP\_2021\_NA0002\_63\_67\_20210226\_00018.jpg

View looking downstream at animal holes on the landside slope (Spring 2019).

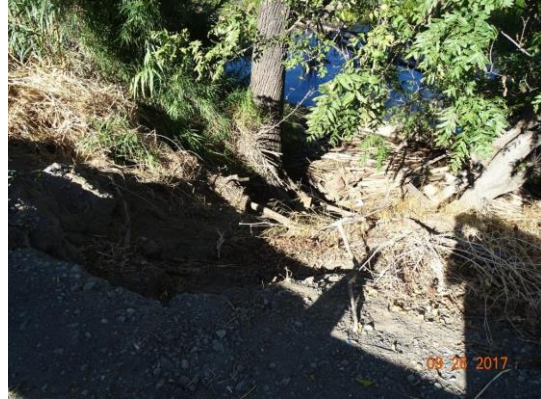
Photo 1 of 1 : SP\_2021\_NA0002\_63\_119\_20210226\_00047.jpg

Looking northwest at the waterside slope.
