**Flood Control Project Maintenance
Levee Inspections**

Maintenance Issue Types Only, Levee Inspection Report By Mile - Spring 2022

Brannan Andrus Levee Maintenance District

Waterway	Bank	Unit Miles	Inspection Start/End	Inspector
Unit No. 01 Georgiana Slough	Right	6.01	03/11/2022 03/11/2022	David Julian

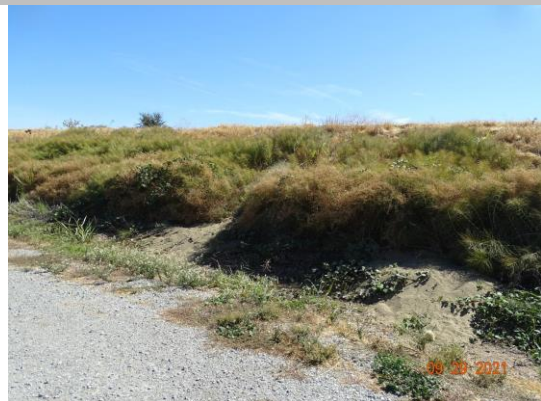
Photo 1 of 1 : SP_2022_NA0002_62_133_20220310_00037.jpg

View of animal holes at the landside toe (Fall 2021).

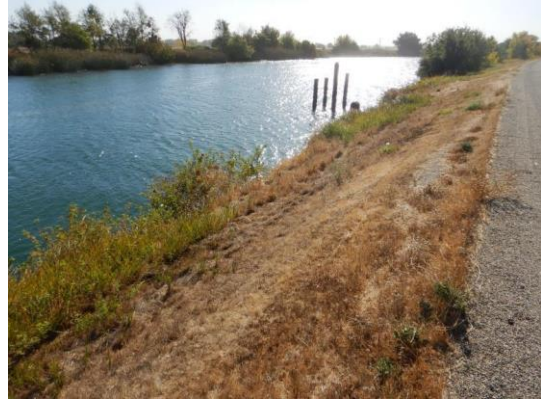
Photo 1 of 2 : SP_2022_NA0002_62_39_20220310_00011.jpg

LM Start	1.53	Rating **	M	Issue No.	39
LM End	1.54	Issue Type +	Ma	Location *	WS
Category	Supplemental			GPS Latitude/Longitude	
				Start	End
Item	2018 USACE Erosion Survey			38.173410 °	38.173178 °
				-121.580683 °	-121.580622 °
DWR ID	DWR_NA0002_01_s_2022_39				
Comment Code					
Inspector Comment					
2018 Site ID: GEO 5.5 R					
Status: Eroding					
2018 Field Notes: Site extended downstream.					
Site History: 2017 - Failed rock section, slump failure of bank to subvertical face.

USACE 2018 Erosion Photo #1

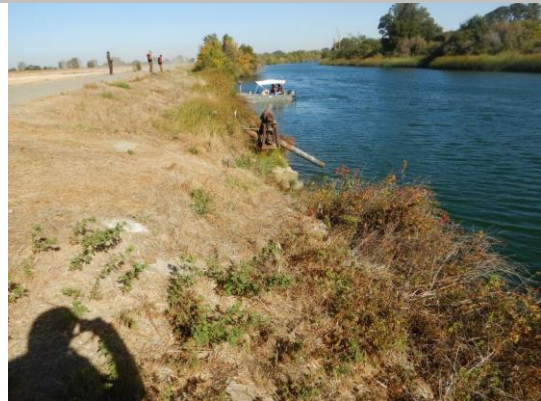
Photo 2 of 2 : SP_2022_NA0002_62_39_20220310_00012.jpg

USACE 2018 Erosion Photo #2

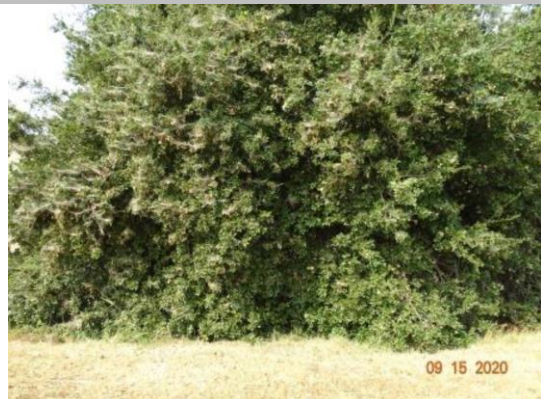
Photo 1 of 1 : SP_2022_NA0002_62_25_20220310_00008.jpg

LM Start	1.56	Rating **	U	Issue No.	25
LM End	1.56	Issue Type +	Ma	Location *	LS
Category	Earthen Levee			GPS Latitude/Longitude	
				Start	End
Item	Trim / Thin Trees			38.172869 °	38.172869 °
				-121.580681 °	-121.580681 °
DWR ID	DWR_NA0002_01_s_2012_25				
Comment Code					
T1 : Trim and thin trees to at least five feet above ground level to allow visibility of the ground and room to flood fight.					
Inspector Comment					
Tree blocking landside toe.

View of thick tree on the landside slope (Fall 2020).

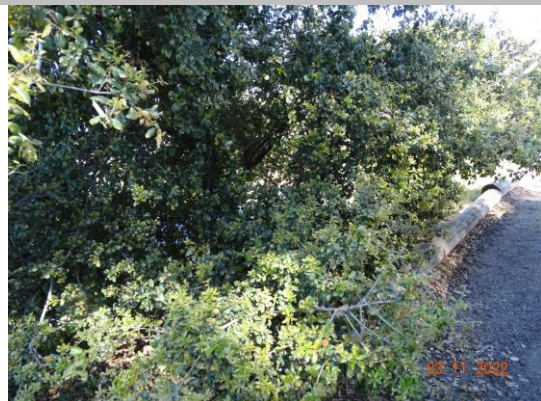
Photo 1 of 1 : SP_2022_NA0002_62_72_20220311_00240.jpg

View of thick tree on the landside shoulder (Spring 2022).

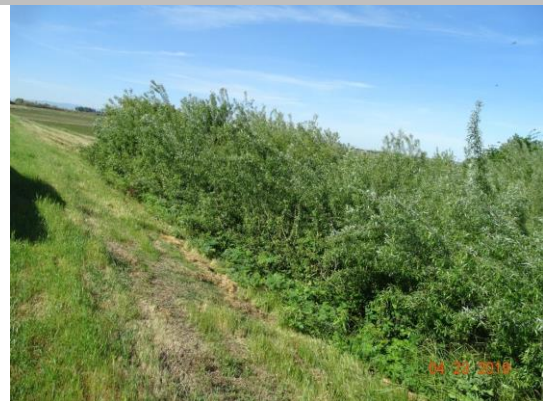
Photo 1 of 1 : SP_2022_NA0002_62_53_20220310_00017.jpg

View looking downstream at willows on the landside slope (Spring 2019).

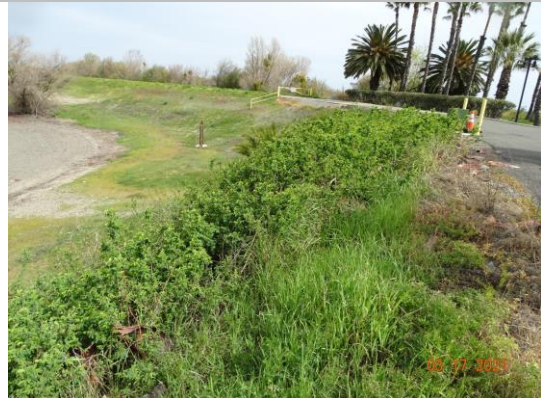
Photo 1 of 1 : SP_2022_NA0002_62_127_20220310_00034.jpg

View of thick wild roses on the landside slope (Spring 2021).

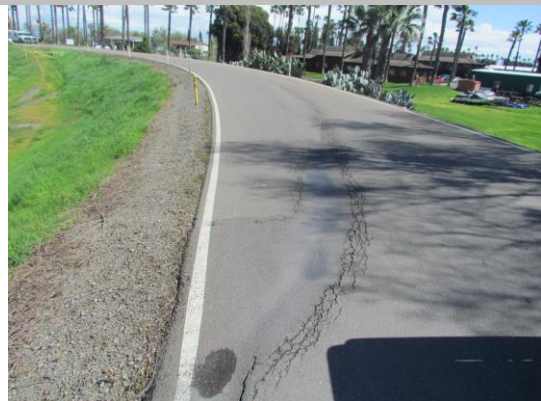
Photo 1 of 1 : SP_2022_NA0002_62_67_20220310_00027.jpg

LM Start	3.38	Rating **	A/W	Issue No.	67
LM End	3.40	Issue Type +	Ma	Location *	CR
Category	Earthen Levee			GPS Latitude/Longitude	
				Start	End
Item	Slope Stability			38.151430 °	38.151390 °
				-121.592085 °	-121.592517 °
DWR ID	DWR_NA0002_01_s_2017_67				
Comment Code					
S1 : Repair slope instability.					
Inspector Comment					
Appears to be beginning of a landside slump. LMA's Engineer (DCC) is monitoring site for movement.

Looking east at possible sloughing on landward shoulder.

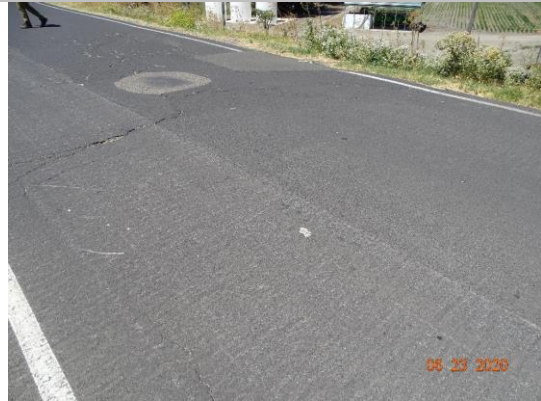
Photo 1 of 3 : UCIP_SP_2022_62327_90037.jpg

Comment Code						
Inspector Comment						
FS_ID:62327 DS_ID:21772 EP_NO: 11248 Repair Type: Non-Urgent Crossing Status: Found UCIP Comments: 06/23/2020 Record updated from No Action Needed to Non-Urgent. 20-inch steel drainage pipe sleeved through 24-inch steel pipe. Annular space between pipes seems to be grouted. Unable to find a permit for modification. Asphalt repair patches on levee crown. No permit has been identified authorizing pipe. Need to have CVFPB review ABO and determine current owner. (O.Yakimov - DWR UCIP) FIELD_STRUCT_DESC: 20-inch steel drainage pipe sleeved through 24-inch steel pipe through the levee, 3 feet below the crown. Siphon breaker is located on the waterside (WS) slope. Pump is located on the landside (LS). (24-inch pipe [HLM 3.99] authorized under Automatic Board Order (ABO) issued as Permit No. 11248, 1975 - Reclamation District No.407). [Additional Reference(s): DWR Levee Log, 2005 (HLM 3.99), listed as 24-inch pipe. USACE Sacramento O&M Manual, Unit 103, June 1954, Revised 29 December 2016, (Station 'R' 107+76), listed as 26-inch pipe. USACE As-Built Drawing No. 50-04-2631, Sheet 2, Station 107+76, March 1950, listed as 26-inch pipe]. FS Date: 6/23/2020 9:27:29 AM

Top of Levee: View of levee crown looking downstream

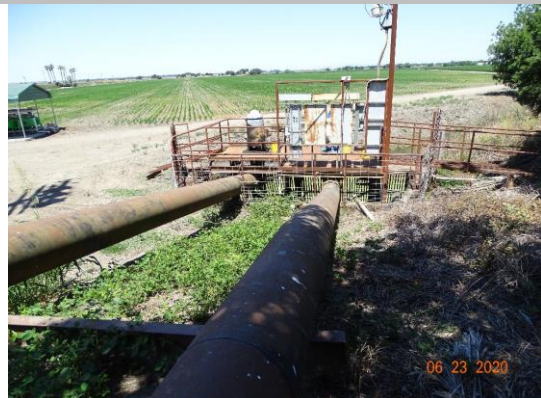
Photo 2 of 3 : UCIP_SP_2022_62327_90036.jpg

Land-Side: View of levee slope looking from crown

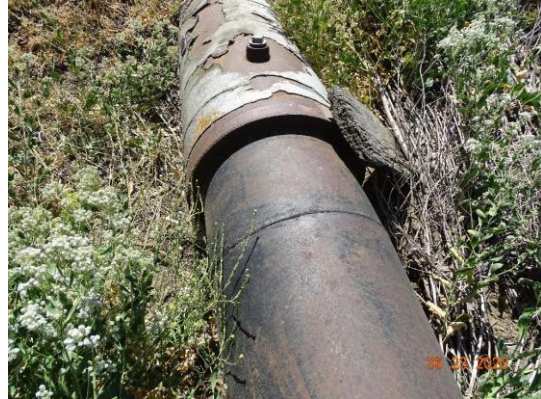
Photo 3 of 3 : UCIP_SP_2022_62327_90035.jpg

Land-Side: Pipe sleeving point on levee slope

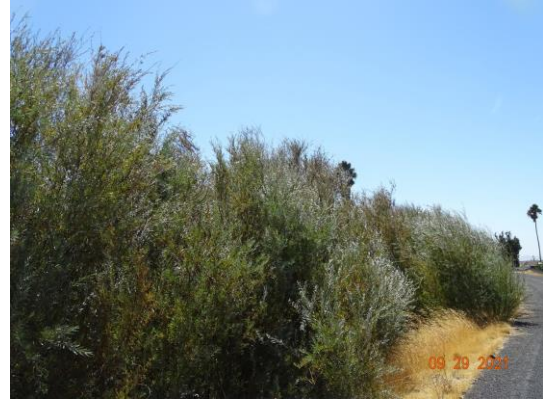
Photo 1 of 1 : SP_2022_NA0002_62_4_20220310_00003.jpg

View looking downstream at willows on the waterside slope (Fall 2021).

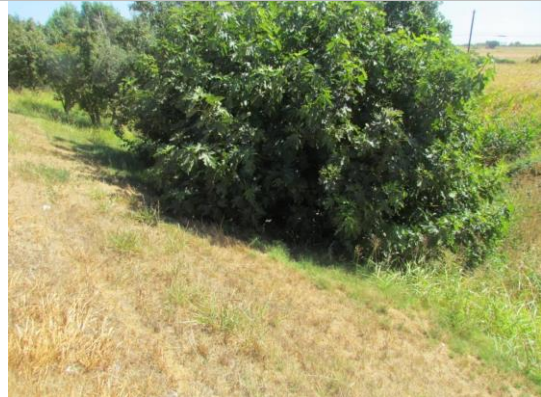
Photo 1 of 1 : SP_2022_NA0002_63_97_20220329_00045.jpg

Looking east at untrimmed fig tree at landward toe.

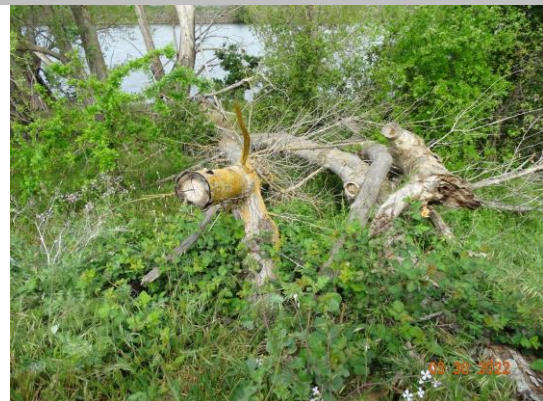
Photo 1 of 1 : SP_2022_NA0002_63_47_20220401_00152.jpg

View of down tree on the waterside slope (Spring 2022).

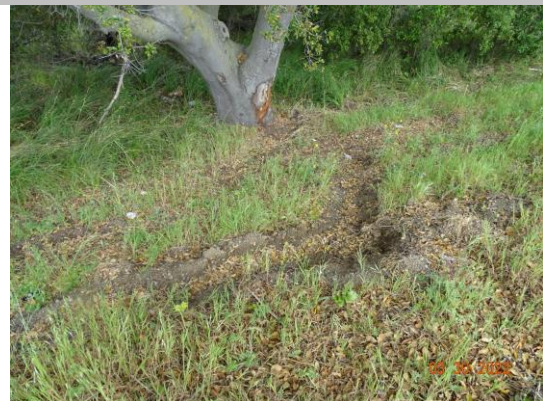
Photo 1 of 1 : SP_2022_NA0002_63_66_20220401_00153.jpg

LM Start	1.14	Rating **	U	Issue No.	66	
LM End	1.14	Issue Type +	Ma	Location *	WS	
Category	Earthen Levee			GPS Latitude/Longitude		
				Start		End
Item	Erosion / Vehicle Traffic			38.182772 °		38.182772 °
				-121.584689 °		-121.584689 °
DWR ID	DWR_NA0002_02_s_2022_66					
Comment Code						
E6 : Repair the levee slope damaged by vehicle traffic and prevent access where possible.						
Inspector Comment

View of damage to slope due vehicle going off the road on the waterside slope (Spring 2022).

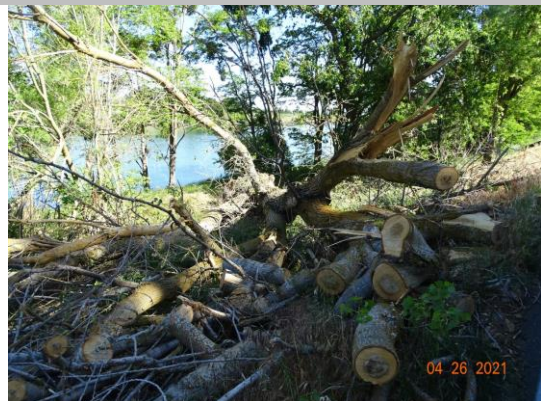
Photo 1 of 1 : SP_2022_NA0002_63_52_20220329_00014.jpg

View of downed tree and limbs on waterside slope (Spring 2021).

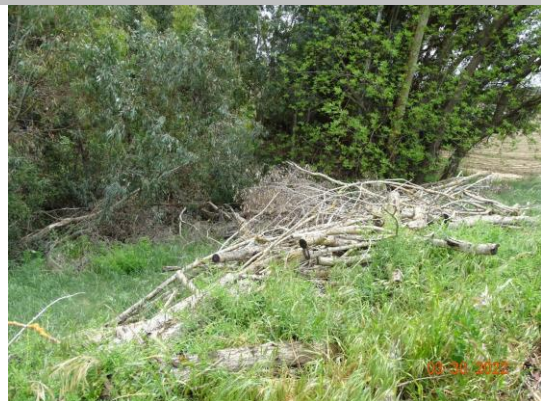
Photo 1 of 1 : SP_2022_NA0002_63_102_20220401_00168.jpg

View of pruned tree limbs on the landside shoulder (Spring 2022).

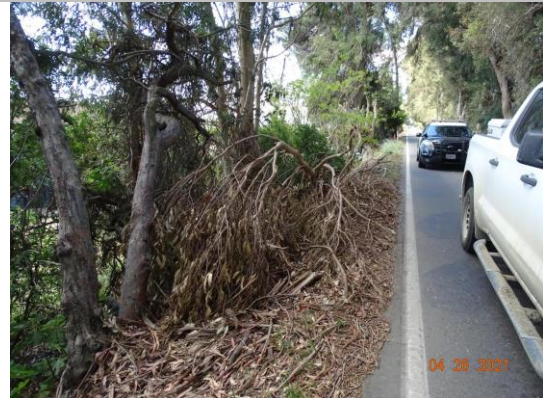
Photo 1 of 1 : SP_2022_NA0002_63_96_20220329_00044.jpg

Down tree limb on the landside hinge (Spring 2021).

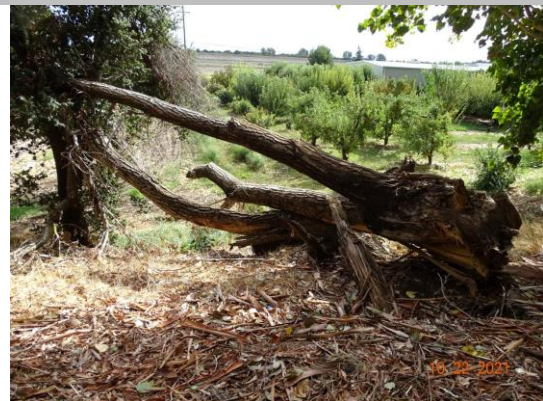
Photo 1 of 1 : SP_2022_NA0002_63_137_20220329_00060.jpg

View of large down tree on the landside slope (Fall 2021).

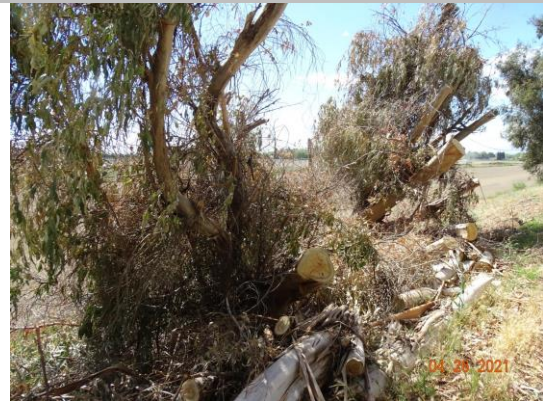
Photo 1 of 1 : SP_2022_NA0002_63_95_20220329_00043.jpg

View of down tree limbs on the landside slope (Spring 2021).

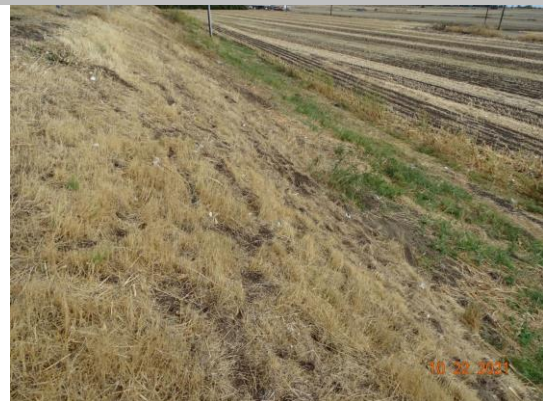
Photo 1 of 1 : SP_2022_NA0002_63_136_20220329_00059.jpg

View of animal holes in the landside slope (Fall 2021).

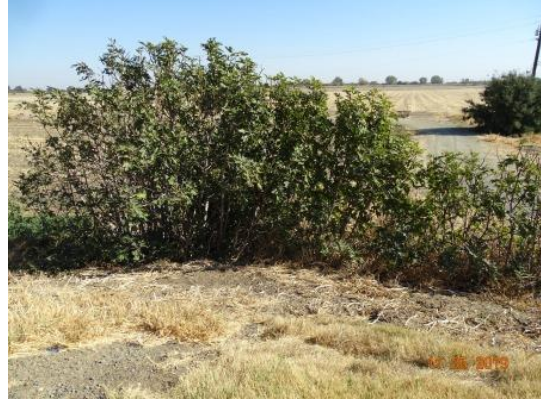
Photo 1 of 1 : SP_2022_NA0002_63_120_20220329_00053.jpg

View of young fig tree on the landside slope (Fall 2019).

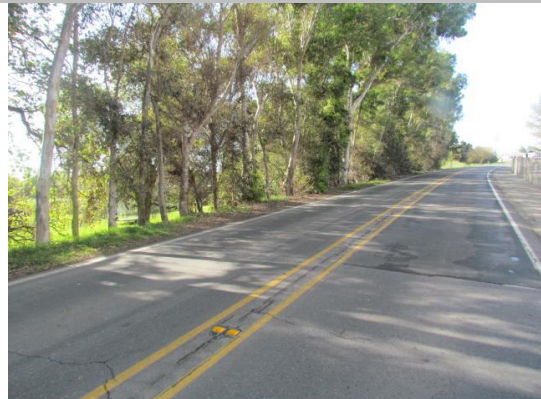
Photo 1 of 1 : SP_2022_NA0002_63_25_20220329_00004.jpg

Looking southeast at trees at landward shoulder. (Spring 2015)

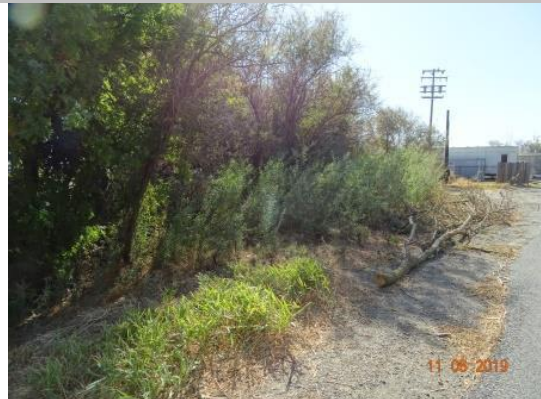
Photo 1 of 1 : SP_2022_NA0002_63_99_20220329_00047.jpg

View looking downstream at vegetation on the landside slope (Fall 2019).

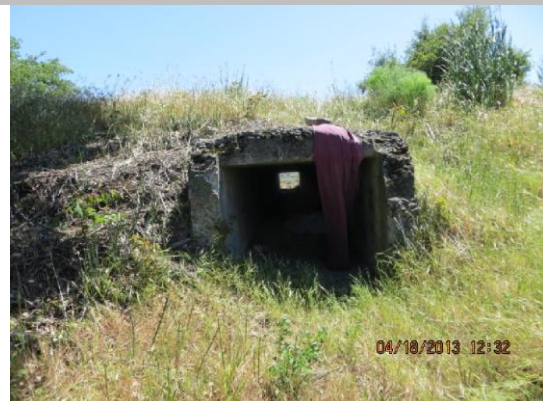
Photo 1 of 3 : UCIP_SP_2022_53389_19773.jpg

Comment Code					
Inspector Comment					
FS_ID:53389 DS_ID:21879 EP_NO: N/A Repair Type: Urgent Crossing Status: Found UCIP Comments: 07/12/2018 Tunnel is open on both sides. No integrity issue observed, therefore crossing downgraded to "Non-Urgent". (O.Yakimov-DWR UCIP)10/24/2016 same as previous inspection culvert is open on both ends. WS blocked by blankets -- WS structure is being used as a shelter. (O. Magana - DWR UCIP)04/18/2013 Culvert open on both ends. Needs to be abandoned properly. (W. Wylie - DWR UCIP) FIELD_STRUCT_DESC: *ABANDONED* 42-inch by 42-inch open reinforced concrete drainage culvert through the levee, 6 feet below the crown. [Additional Reference(s): DWR Levee Log, 2005, 3-foot by 3.5-foot culvert listed. USACE Sacramento O&M Manual 103, June 1954, (RM 18.16) Drawing No. 6-13-1100]. FS Date: 7/12/2018 2:59:33 PM

Concrete tunnel open on both ends.

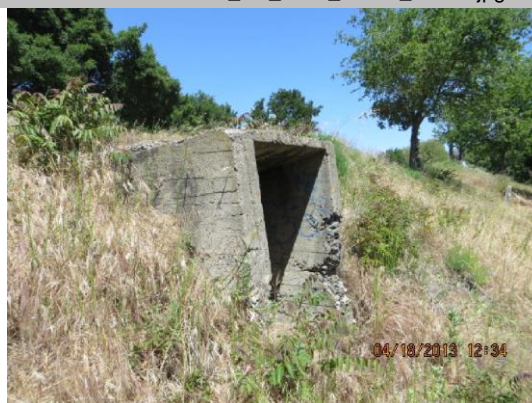
Photo 3 of 3 : UCIP_SP_2022_53389_19771.jpg

Concrete tunnel on LS shoulder.

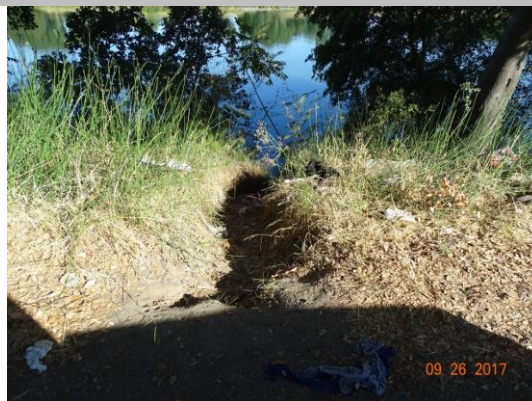
Photo 1 of 1 : SP_2022_NA0002_63_82_20220329_00034.jpg

LM Start	2.56	Rating **	M	Issue No.	82
LM End	2.56	Issue Type +	Ma	Location *	WS
Category	Earthen Levee			GPS Latitude/Longitude	
				Start	End
Item	Erosion / Foot Traffic			38.165898 °	38.165898 °
				-121.598888 °	-121.598888 °
DWR ID	DWR_NA0002_02_f_2017_82				
Comment Code					
E3 : Repair the levee slope damaged by foot traffic and prevent access where possible.					
Inspector Comment					
There is a footpath digging into the levee slope.

Looking northwest at the waterside slope.

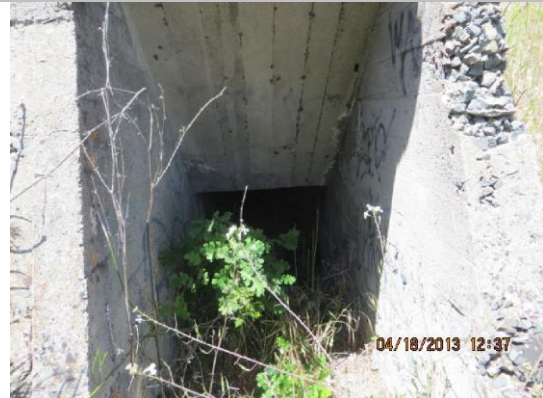
Photo 1 of 3 : UCIP_SP_2022_53513_19776.jpg

Comment Code						
Inspector Comment						
FS_ID:53513 DS_ID:21880 EP_NO: N/A Repair Type: Non-Urgent Crossing Status: Found UCIP Comments: 07/12/2018 Tunnel is open on both sides. No integrity issue observed, therefore crossing downgraded to "Non-Urgent". (O.Yakimov-DWR UCIP)10/24/2016 same as previous inspection concrete box culvert will need to be abandoned properly. (O. Magana - DWR UCIP)04/18/2013 tunnel should be abandoned properly. (W. Wylie - DWR UCIP) FIELD_STRUCT_DESC: *ABANDONED* 48-inch by 48-inch reinforced concrete drainage culvert through the levee, 6.5-inches below the crown. [Additional Reference(s): DWR Levee Log, 2005. USACE Sacramento O&M Manual 103, June 1954, (RM 18.13) 3-foot by 3-foot concrete box listed, Drawing No. 6-13-1100]. FS Date: 7/12/2018 9:05:37 AM

Tunnel open on LS shoulder.

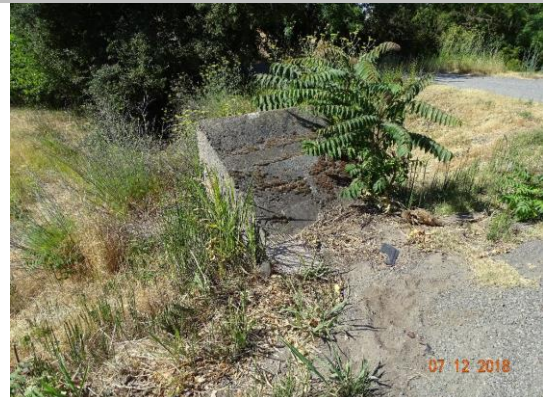
Photo 2 of 3 : UCIP_SP_2022_53513_77578.jpg

Concrete tunnel on LS shoulder.

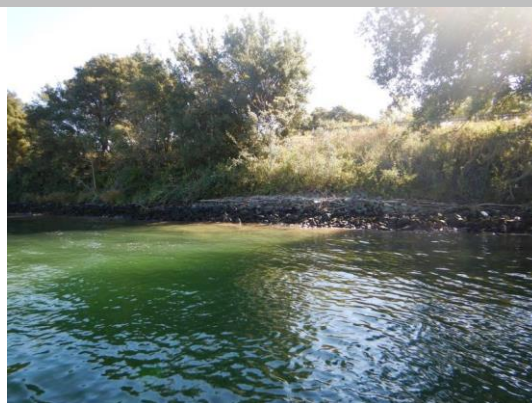
Photo 1 of 2 : SP_2022_NA0002_63_71_20220329_00028.jpg

USACE 2018 Erosion Photo #1

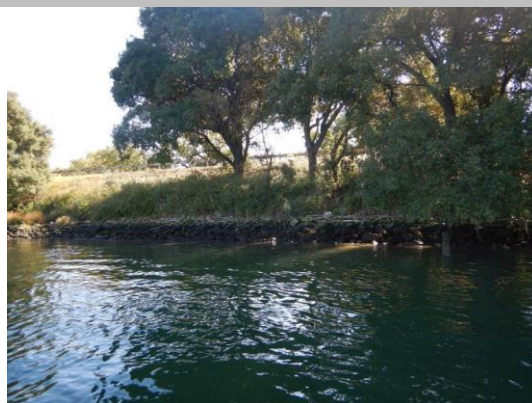
Photo 2 of 2 : SP_2022_NA0002_63_71_20220329_00029.jpg

USACE 2018 Erosion Photo #2

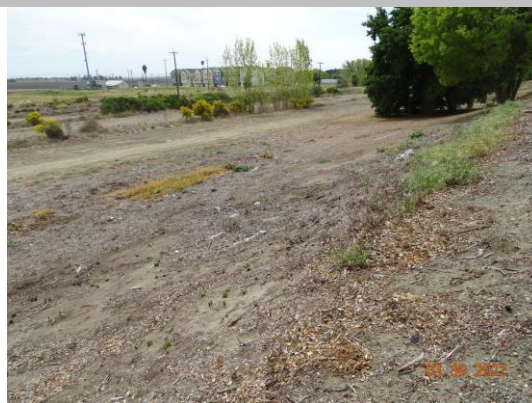
Photo 1 of 1 : SP_2022_NA0002_63_104_20220401_00167.jpg

View of animal holes on the landside slope (Spring 2022).

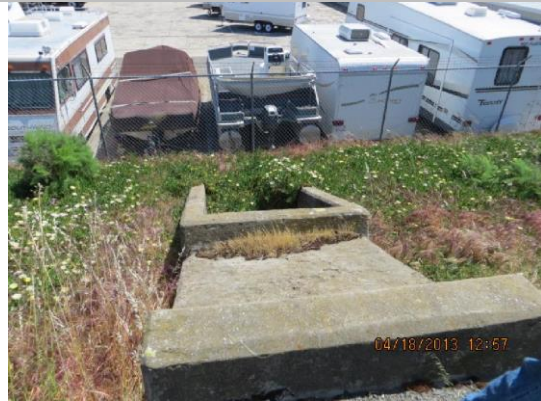
Photo 1 of 3 : UCIP_SP_2022_53514_19782.jpg

Comment Code						
Inspector Comment						
FS_ID:53514 DS_ID:21882 EP_NO: N/A Repair Type: Urgent Crossing Status: Found UCIP Comments: 07/12/2018 Tunnel is open on both ends. No integrity issue observed, therefore crossing downgraded to "Non-Urgent". (O.Yakimov-DWR UCIP)10/24/2016 same as previous inspection tunnel is opened on both ends. (O. Magana - DWR UCIP)04/18/2013 Tunnel open on both ends and should be abandoned properly. (W. Wylie - DWR UCIP) FIELD_STRUCT_DESC: *ABANDONED* 48-inch by 72-inch reinforced concrete drainage culvert through the levee, 1 foot below the crown. [Additional Reference(s): DWR Levee Log, 2005, 4-foot by 4.5-foot culvert listed. USACE Sacramento O&M Manual 103, June 1954, (RM 17.89) 48-inch by 52-inch concrete box listed, Drawing No. 6-13-1100]. FS Date: 7/12/2018 9:07:49 AM

Entrance to tunnel on LS slope.

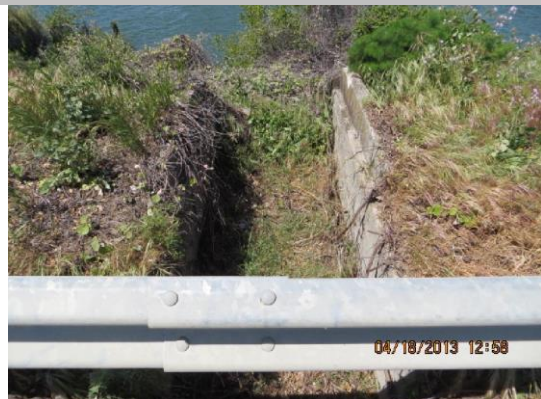
Photo 2 of 3 : UCIP_SP_2022_53514_19781.jpg

Tunnel opening on WS slope.

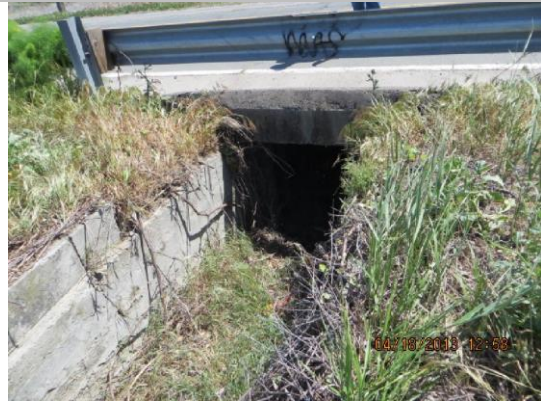
Photo 3 of 3 : UCIP_SP_2022_53514_19780.jpg

Tunnel opening on WS slope.

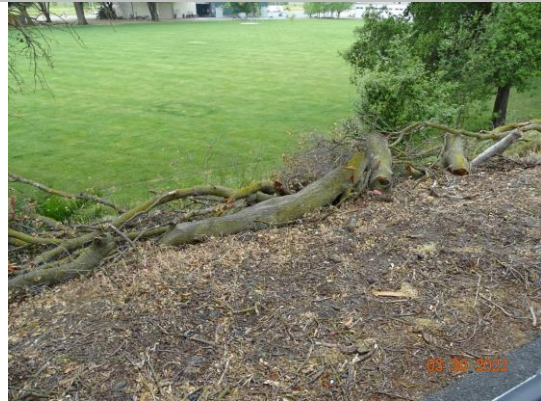
Photo 1 of 1 : SP_2022_NA0002_63_93_20220401_00165.jpg

View of cut up tree limbs on the landside shoulder (Spring 2022).

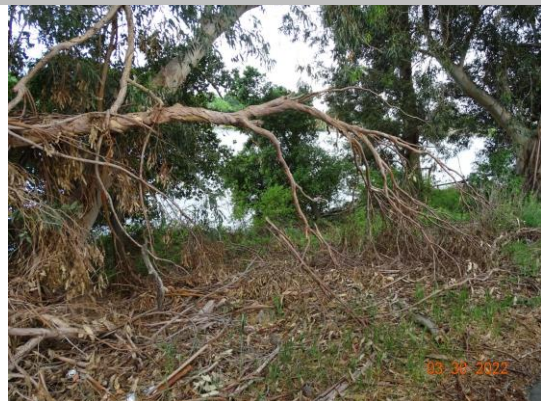
Photo 1 of 1 : SP_2022_NA0002_63_74_20220401_00154.jpg

View of down tree limb on the waterside slope (Spring 2022).

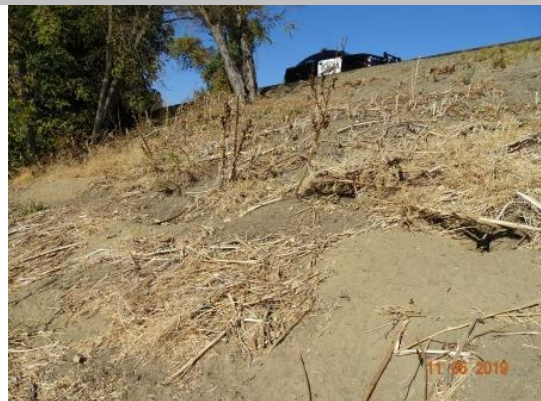
Photo 1 of 1 : SP_2022_NA0002_63_128_20220329_00057.jpg

View of multiple large squirrel holes in landside slope (Fall 2019).

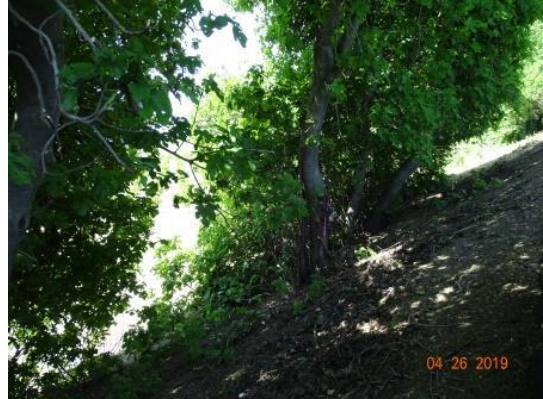
Photo 1 of 1 : SP_2022_NA0002_63_163_20220329_00063.jpg

View looking downstream at fig tree on the landside slope (Spring 2019).

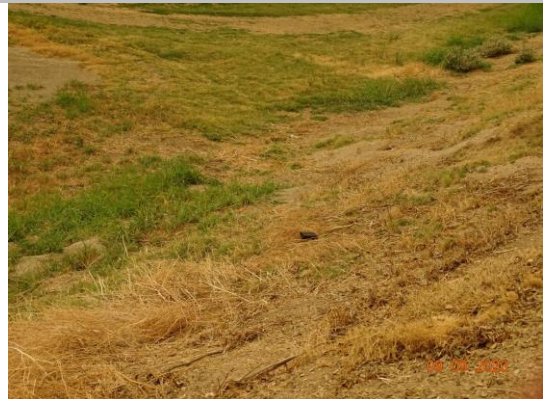
Photo 1 of 1 : SP_2022_NA0002_63_124_20220329_00055.jpg

View looking downstream at animal holes in the landside slope (Fall 2020).

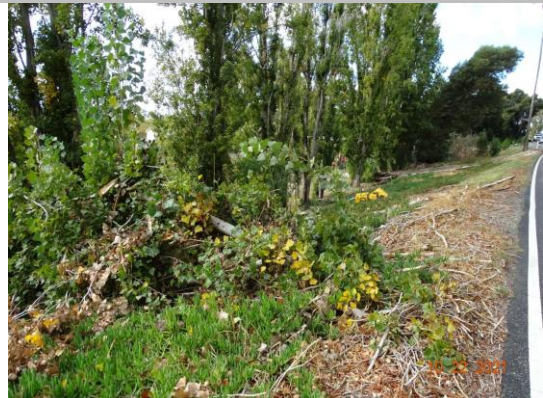
Photo 1 of 1 : SP_2022_NA0002_63_132_20220329_00058.jpg

View looking downstream at two down trees on the landside slope (Fall 2021).

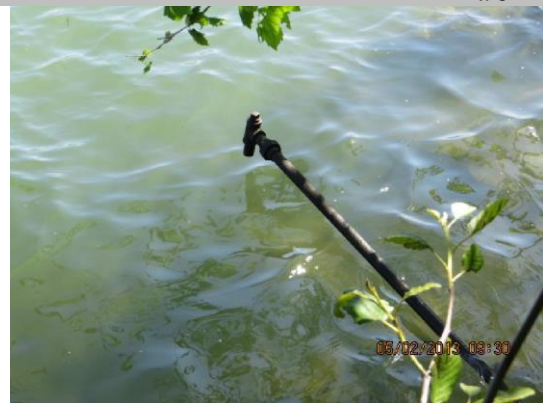
Photo 1 of 3 : UCIP_SP_2022_12778_20762.jpg

Conduit at WS toe.

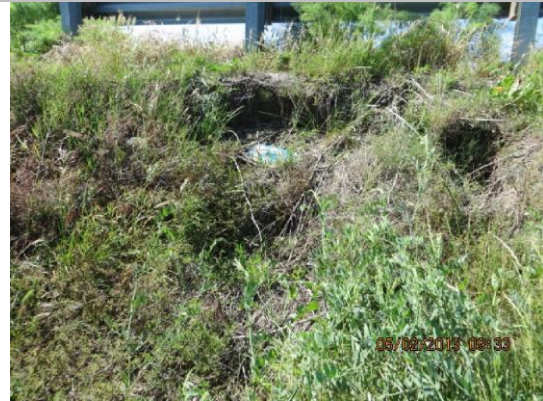
Photo 2 of 3 : UCIP_SP_2022_12778_20761.jpg

Erosion along pipe alignment at WS slope.

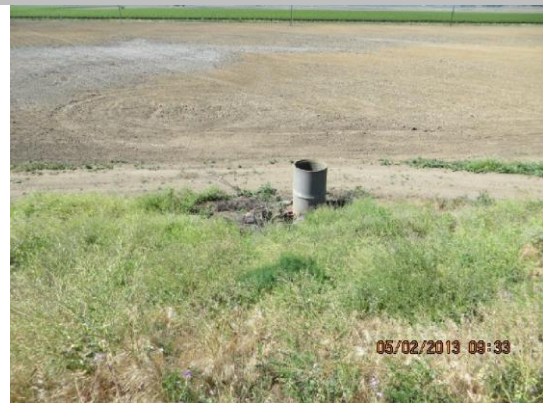
Photo 3 of 3 : UCIP_SP_2022_12778_20760.jpg

Concrete standpipe and pump on LS toe.

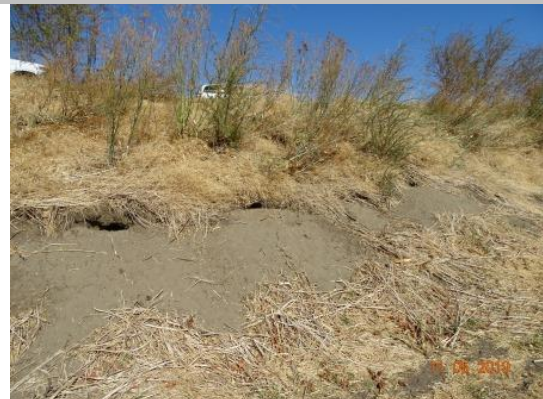
Photo 1 of 1 : SP_2022_NA0002_63_122_20220329_00054.jpg

View of multiple large squirrel holes in the landside slope (Fall 2019).

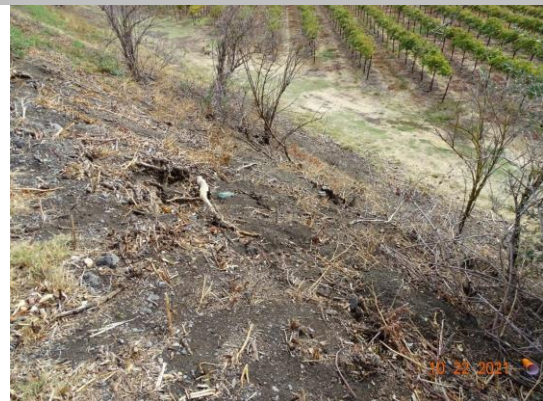
Photo 1 of 1 : SP_2022_NA0002_63_126_20220329_00056.jpg

View looking down slope at squirrel holes in the landside slope (Fall 2021).

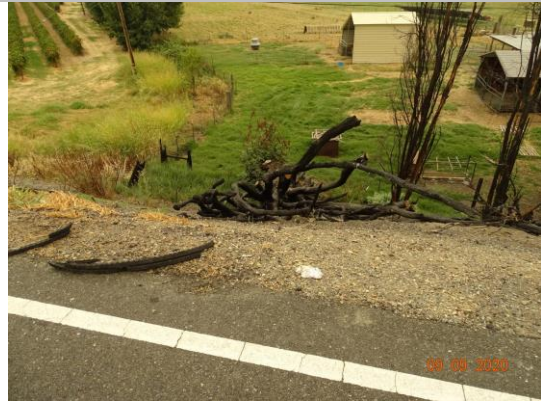
Photo 1 of 1 : SP_2022_NA0002_63_84_20220329_00036.jpg

View looking downslope at burned tree on the landside slope (Fall 2020).

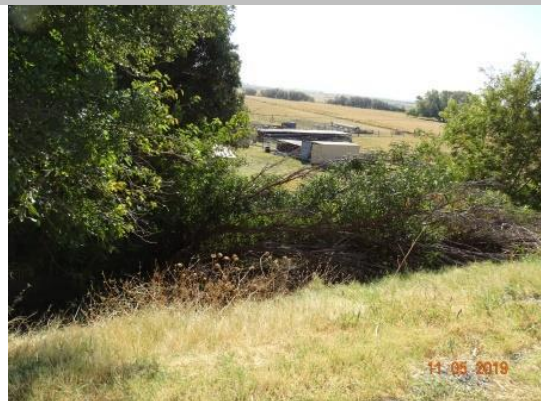
Photo 1 of 1 : SP_2022_NA0002_63_13_20220329_00003.jpg

View of fallen tree on the landside slope (Fall 2019).

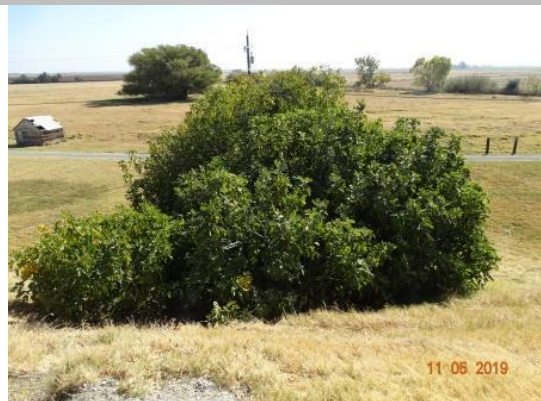
Photo 1 of 1 : SP_2022_NA0002_63_118_20220329_00051.jpg

View of fig tree on the landside slope (Fall 2019).

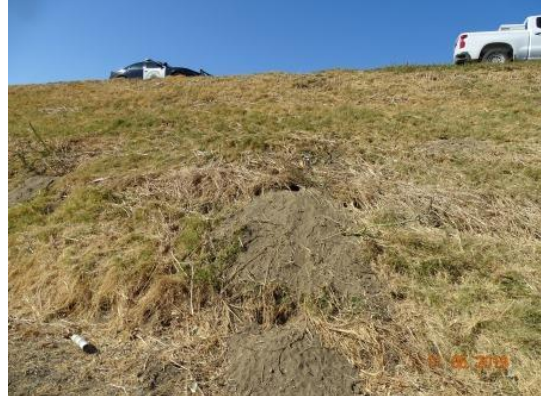
Photo 1 of 1 : SP_2022_NA0002_63_111_20220329_00050.jpg

View of multiple recent squirrel holes on the landside slope (Fall 2019).

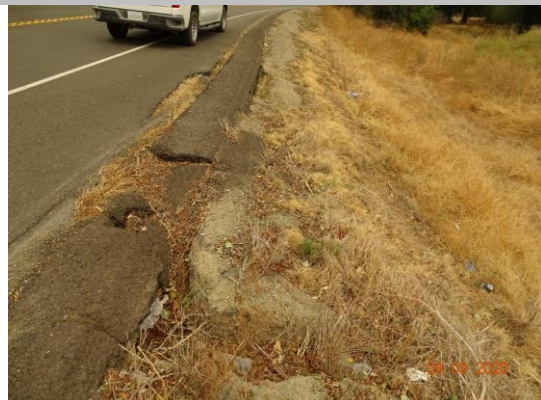
Photo 1 of 1 : SP_2022_NA0002_63_90_20220329_00040.jpg

View of small slip on the landside shoulder causing the edge of the road to crack and sink (Fall 2020).

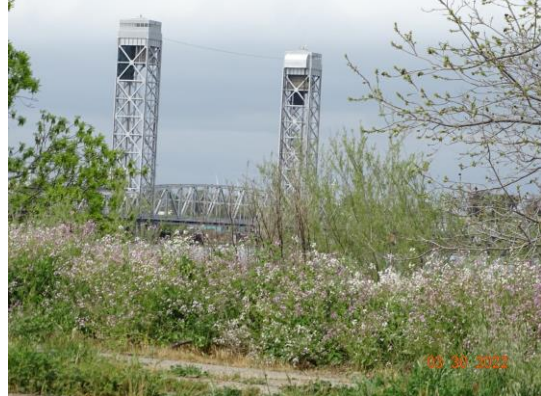
Photo 1 of 1 : SP_2022_NA0002_63_75_20220401_00155.jpg

View of thick vegetation on the waterside slope (Spring 2022).

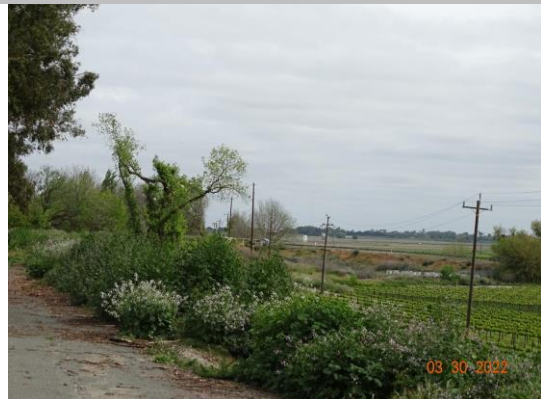
Photo 1 of 1 : SP_2022_NA0002_63_55_20220401_00156.jpg

View looking upstream at vegetation on the landside slope (Spring 2022).

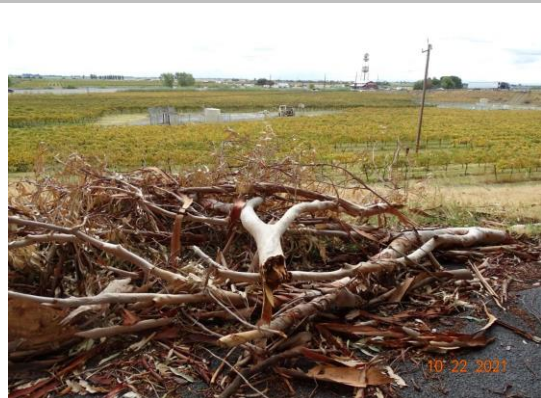
Photo 1 of 1 : SP_2022_NA0002_63_58_20220329_00017.jpg

View of down tree limbs on the landside hinge (Fall 2021).

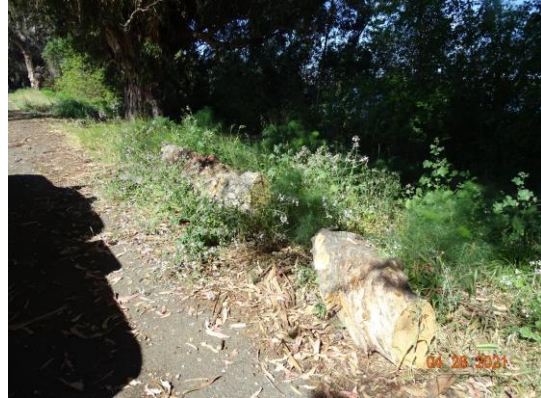
Photo 1 of 1 : SP_2022_NA0002_63_83_20220329_00035.jpg

View of cut-up tree limb on the waterside hinge (Spring 2021).

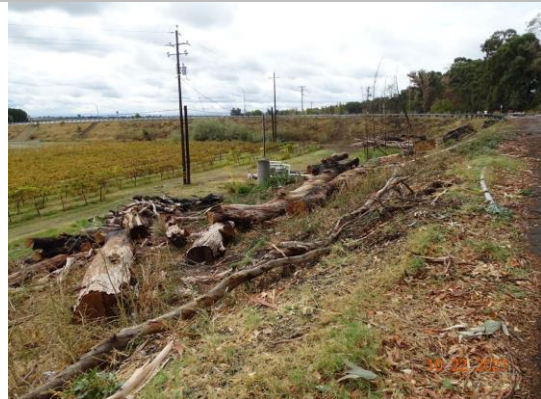
Photo 1 of 1 : SP_2022_NA0002_63_62_20220329_00020.jpg

View looking downstream at large down tree trunks on the landside slope (Fall 2021).

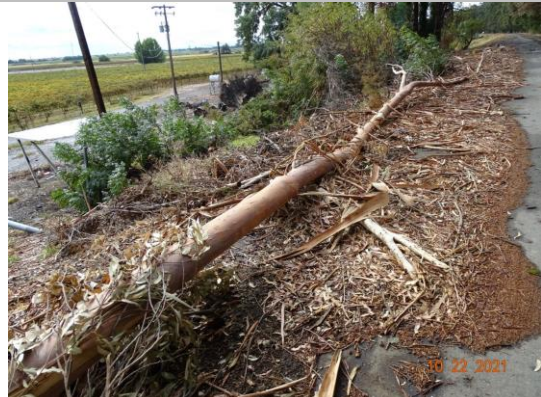
Photo 1 of 1 : SP_2022_NA0002_63_72_20220329_00030.jpg

View of large down tree limb on the landside hinge (Fall 2021).

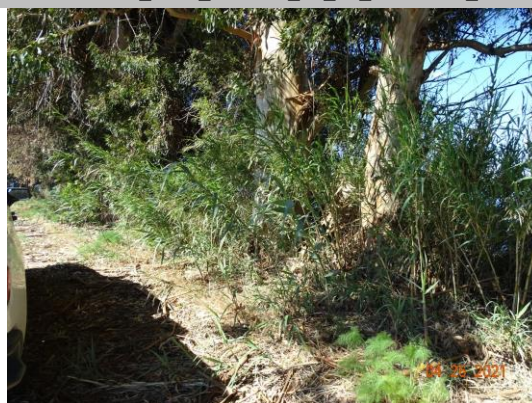
Photo 1 of 1 : SP_2022_NA0002_63_92_20220329_00041.jpg

View of arundo on the waterside slope (Spring 2021).

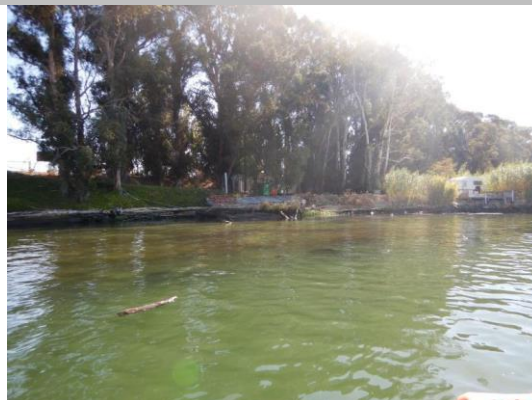
Photo 2 of 2 : SP_2022_NA0002_63_69_20220329_00027.jpg

USACE 2018 Erosion Photo #2

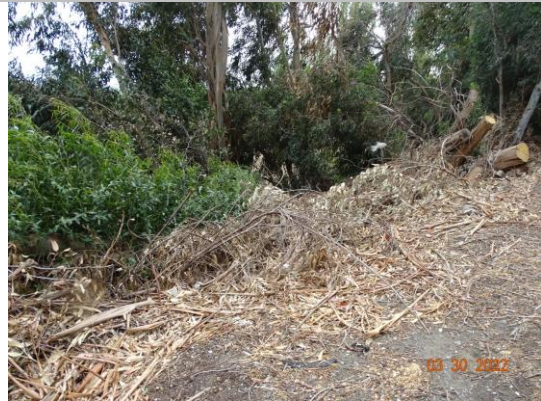
Photo 1 of 1 : SP_2022_NA0002_63_158_20220401_00164.jpg

View of down trees on the landside slope (Spring 2022).

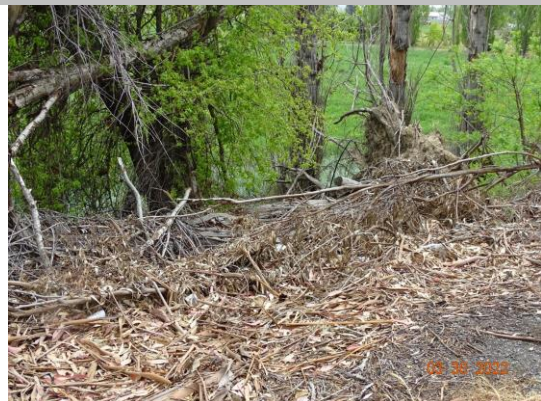
Photo 1 of 1 : SP_2022_NA0002_63_157_20220401_00163.jpg

View of down tree on the landside slope (Spring 2022).

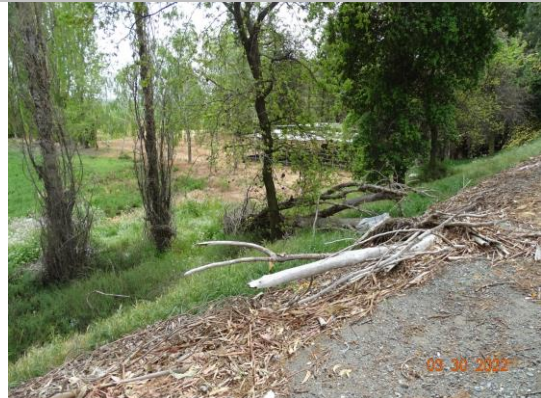
Photo 1 of 1 : SP_2022_NA0002_63_106_20220401_00161.jpg

View of down tree on the landside slope (Spring 2022).

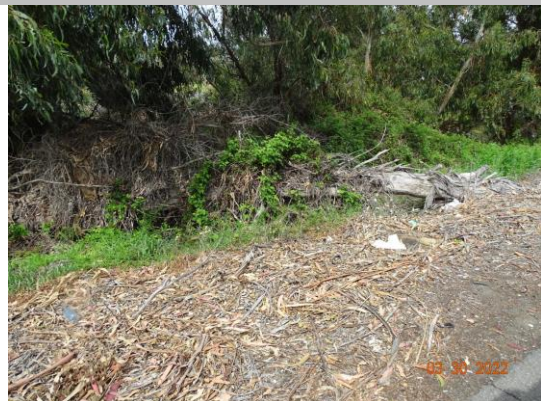
Photo 1 of 1 : SP_2022_NA0002_63_77_20220401_00158.jpg

View of trees needing trimming on the waterside slope (Spring 2022).

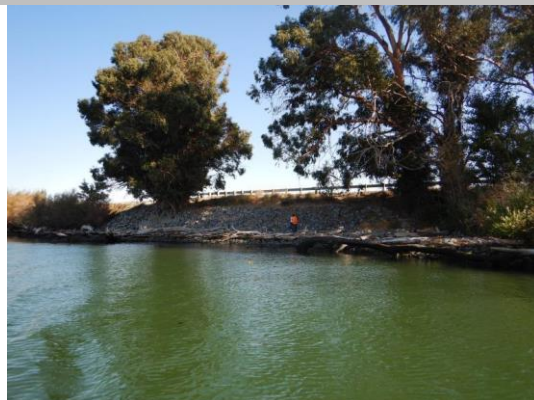
Photo 2 of 2 : SP_2022_NA0002_63_68_20220329_00025.jpg

USACE 2018 Erosion Photo #2

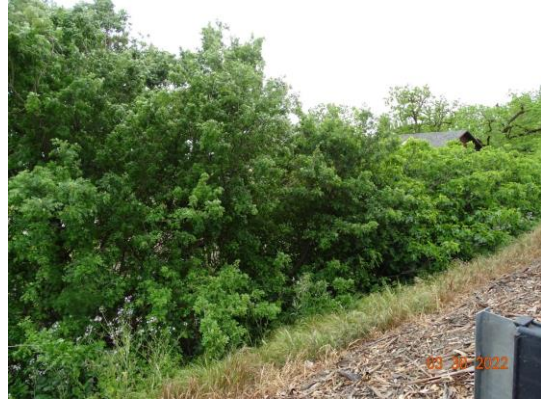
Photo 1 of 1 : SP_2022_NA0002_63_85_20220401_00160.jpg

View of thick trees on the landside slope (Spring 2022).

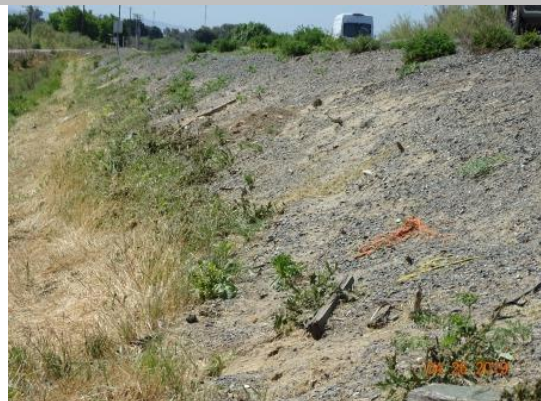
Photo 1 of 2 : SP_2022_NA0002_63_67_20220329_00022.jpg

View looking downstream at animal holes on the landside slope (Spring 2019).

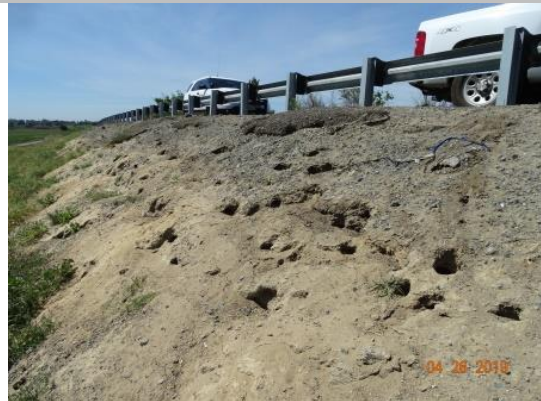
Photo 2 of 2 : SP_2022_NA0002_63_67_20220329_00023.jpg

View looking downstream at animal holes on the landside slope (Spring 2019).

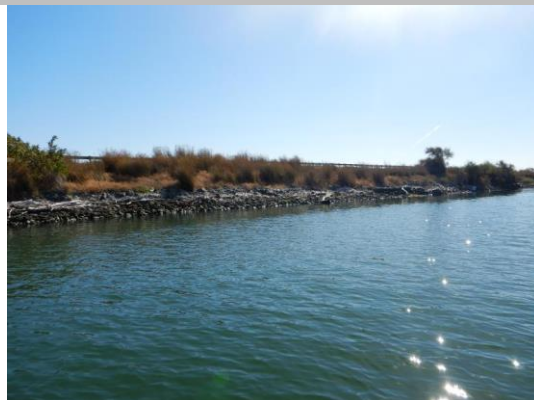
Photo 2 of 2 : SP_2022_NA0002_63_51_20220329_00013.jpg

USACE 2018 Erosion Photo #2

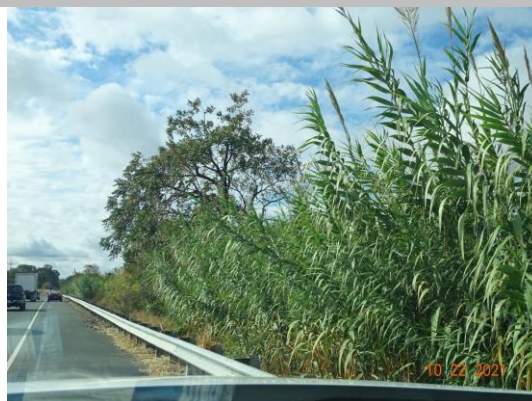
Photo 1 of 1 : SP_2022_NA0002_63_89_20220329_00039.jpg

View looking downstream at arundo on the waterside slope (Fall 2021).

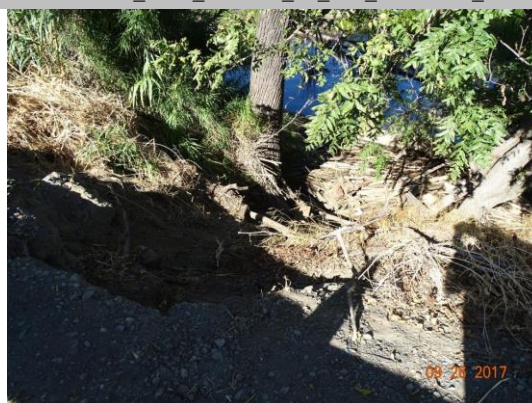
Photo 1 of 1 : SP_2022_NA0002_63_119_20220329_00052.jpg

Looking northwest at the waterside slope.
