**Flood Control Project Maintenance
Levee Inspections**

Maintenance Issue Types Only, Levee Inspection Report By Mile - Spring 2023

Brannan Andrus Levee Maintenance District

Waterway	Bank	Unit Miles	Inspection Start/End	Inspector
Unit No. 01 Georgiana Slough	Right	6.01	05/09/2023 05/09/2023	Saskia Donovan

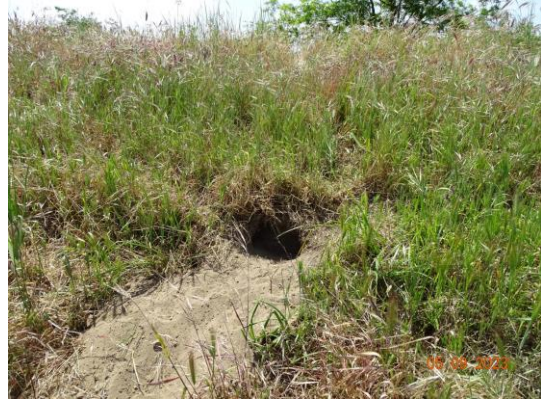
Photo 1 of 1 : SP_2023_NA0002_62_133_20230517_00095.jpg

LM Start	0.81	Rating **	M	Issue No.	133
LM End	0.83	Issue Type +	Ma	Location *	LS
Category	Earthen Levee			GPS Latitude/Longitude	
				Start	End
Item	Animal Control			38.182147°	38.182085°
				-121.575962°	-121.576350°
DWR ID	DWR_NA0002_01_f_2021_133				
Comment Code					
A1 : Exterminate rodents and backfill and compact or grout burrows.					
Inspector Comment					
Spring 2023: Some holes have been grouted but new ones have appeared.

View of a new rodent hole on the LS slope (Spring 2023).

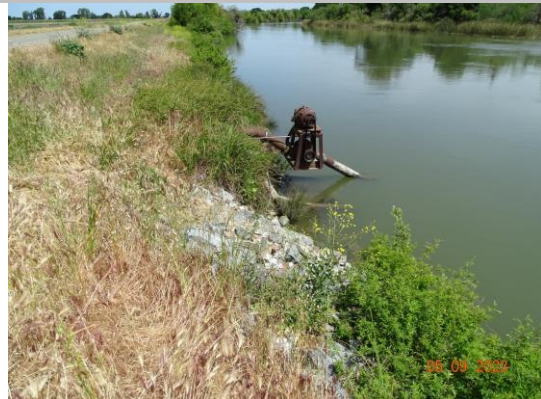
Photo 1 of 3 : SP_2023_NA0002_62_39_20230517_00093.jpg

LM Start	1.53	Rating **	M	Issue No.	39
LM End	1.54	Issue Type +	Ma	Location *	WS
Category	Supplemental			GPS Latitude/Longitude	
				Start	End
Item	2018 USACE Erosion Survey			38.173410°	38.173178°
				-121.580683°	-121.580622°
DWR ID	DWR_NA0002_01_s_2022_39				
Comment Code					
Inspector Comment					
2018 Site ID: GEO 5.5 R					
Status: Eroding					
2018 Field Notes: Site extended downstream.					
Site History: 2017 - Failed rock section, slump failure of bank to subvertical face.

View of the erosion on the WS (Spring 2023).

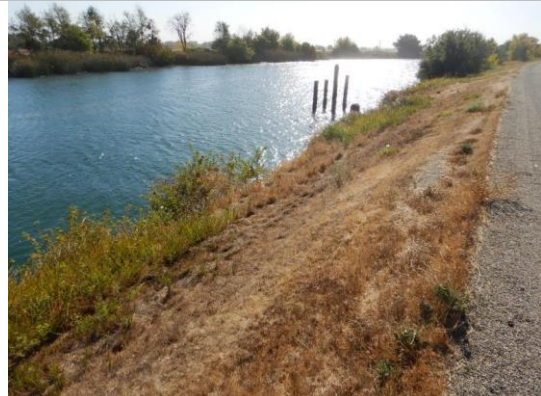
Photo 2 of 3 : SP_2023_NA0002_62_39_20230206_00009.jpg

USACE 2018 Erosion Photo #1

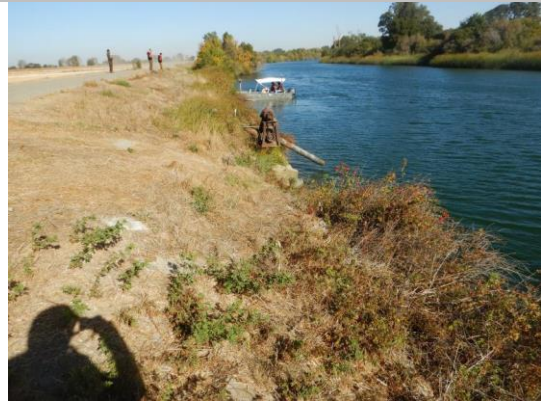
Photo 3 of 3 : SP_2023_NA0002_62_39_20230206_00010.jpg

USACE 2018 Erosion Photo #2

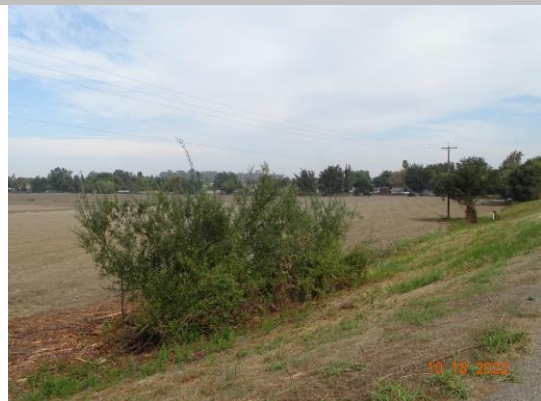
Photo 1 of 1 : SP_2023_NA0002_62_52_20230206_00015.jpg

View of the tree on the LS slope (Fall 2022).

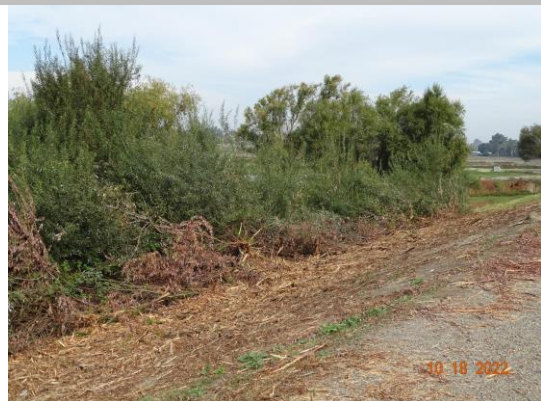
Photo 1 of 1 : SP_2023_NA0002_62_53_20230206_00016.jpg

LM Start	3.00	Rating **	U	Issue No.	53
LM End	3.00	Issue Type +	Ma	Location *	LS
Category	Earthen Levee			GPS Latitude/Longitude	
				Start	End
Item	Trim / Thin Trees			38.156537°	38.156537°
				-121.592498°	-121.592498°
DWR ID	DWR_NA0002_01_f_2018_53				
Comment Code					
T1 : Trim and thin trees to at least five feet above ground level to allow visibility of the ground and room to flood fight.					
Inspector Comment					
Trim willows on the landside slope.

View of the willows on the lower LS slope (Fall 2022).

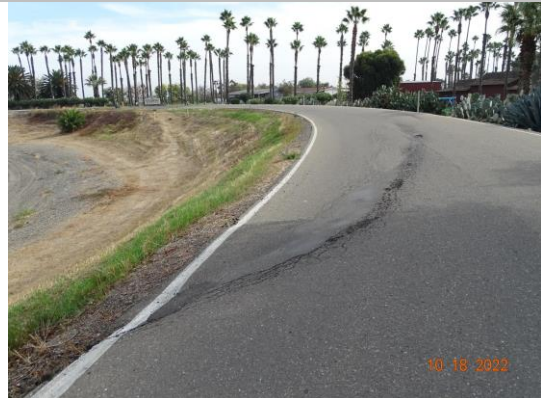
Photo 1 of 1 : SP_2023_NA0002_62_67_20230206_00025.jpg

LM Start	3.38	Rating **	A/W	Issue No.	67
LM End	3.40	Issue Type +	Ma	Location *	CR
Category	Earthen Levee			GPS Latitude/Longitude	
				Start	End
Item	Slope Stability			38.151430°	38.151390°
				-121.592085°	-121.592517°
DWR ID	DWR_NA0002_01_s_2017_67				
Comment Code					
S1 : Repair slope instability.					
Inspector Comment					
Appears to be beginning of a landside slump. LMA's Engineer (DCC) is monitoring site for movement.

View of the depression on the levee crown (Fall 2022).

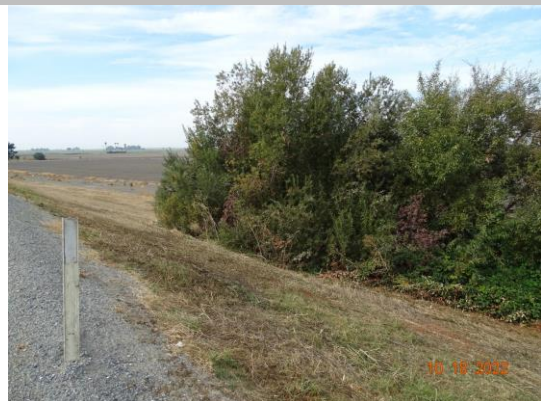
Photo 1 of 1 : SP_2023_NA0002_62_46_20230206_00011.jpg

View of the trees on the LS slope (Fall 2022).

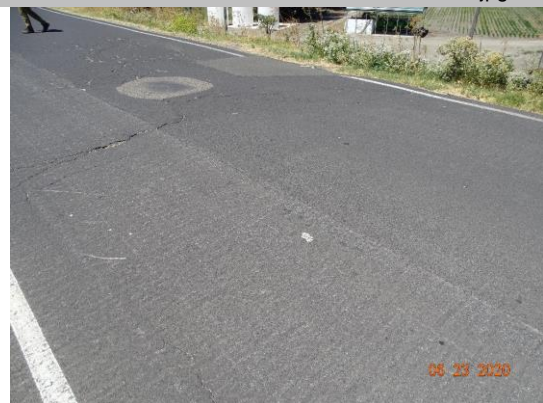
Photo 1 of 3 : UCIP_SP_2023_62327_90037.jpg

Comment Code						
Inspector Comment						
DS_ID:21772 FS_ID:62327 EP_NO: 11248 Repair Type: Non-Urgent EVAL Issue: 10, Unauthorized Modification or Non-Compliant Permit Crossing Status: Found UCIP Comments: 06/23/2020 Record updated from No Action Needed to Non-Urgent. 20-inch steel drainage pipe sleeved through 24-inch steel pipe. Annular space between pipes seems to be grouted. Unable to find a permit for modification. Asphalt repair patches on levee crown. No permit has been identified authorizing pipe. Need to have CVFPB review ABO and determine current owner. (O.Yakimov - DWR UCIP) FIELD_STRUCT_DESC: 20-inch steel drainage pipe sleeved through 24-inch steel pipe through the levee, 3 feet below the crown. Siphon breaker is located on the waterside (WS) slope. Pump is located on the landside (LS). (24-inch pipe [HLM 3.99] authorized under Automatic Board Order (ABO) issued as Permit No. 11248, 1975 - Reclamation District No.407). [Additional Reference(s): DWR Levee Log, 2005 (HLM 3.99), listed as 24-inch pipe. USACE Sacramento O&M Manual, Unit 103, June 1954, Revised 29 December 2016, (Station 'R' 107+76), listed as 26-inch pipe. USACE As-Built Drawing No. 50-04-2631, Sheet 2, Station 107+76, March 1950, listed as 26-inch pipe]. FS Date: 6/23/2020 9:27:29 AM

Top of Levee: View of levee crown looking downstream

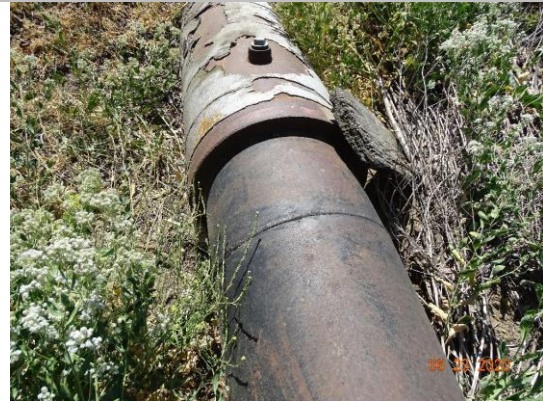
Photo 2 of 3 : UCIP_SP_2023_62327_90035.jpg

Land-Side: Pipe sleeving point on levee slope

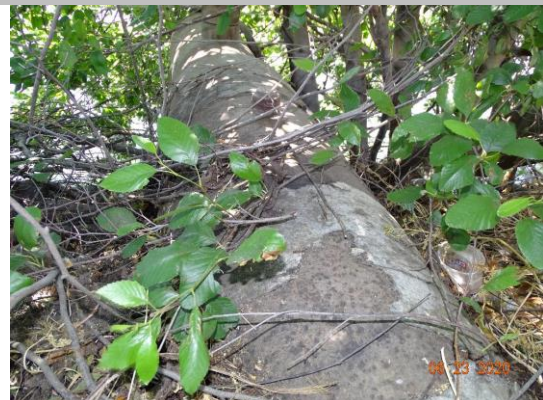
Photo 3 of 3 : UCIP_SP_2023_62327_90033.jpg

Water-Side: View of pipe at riverbank. Siphon breaker installed on the pipe at this place

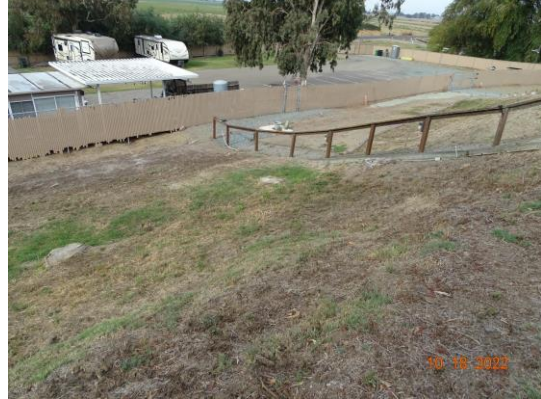
Photo 1 of 1 : SP_2023_NA0002_62_109_20230206_00032.jpg

View of the tree stumps on the LS slope (Fall 2022).

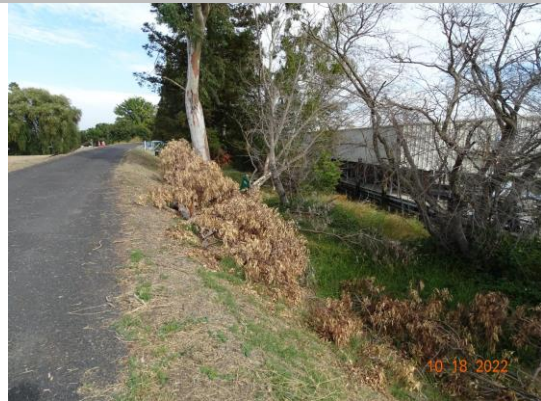
Photo 1 of 1 : SP_2023_NA0002_62_108_20230206_00031.jpg

LM Start	4.28	Rating **	M	Issue No.	108
LM End	4.28	Issue Type +	Ma	Location *	WS
Category	Earthen Levee			GPS Latitude/Longitude	
				Start	End
Item	Trim / Thin Trees			38.143706°	38.143706°
				-121.600903°	-121.600903°
DWR ID	DWR_NA0002_01_f_2022_108				
Comment Code					
T2 : Tree or limb.					
Inspector Comment					
There are tree limbs on the WS slope.

View of the tree limbs on the WS slope (Fall 2022).

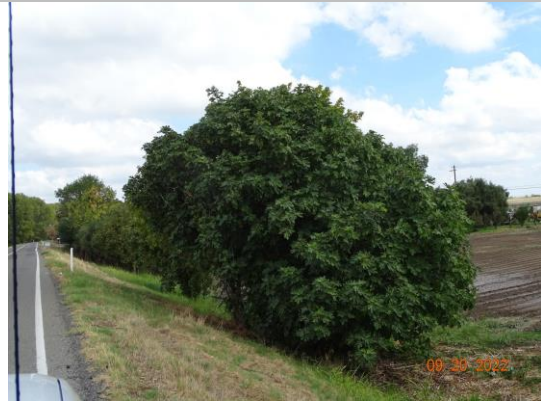
Photo 1 of 1 : SP_2023_NA0002_63_97_20230206_00046.jpg

View of the fig tree on the LS slope (Fall 2022).

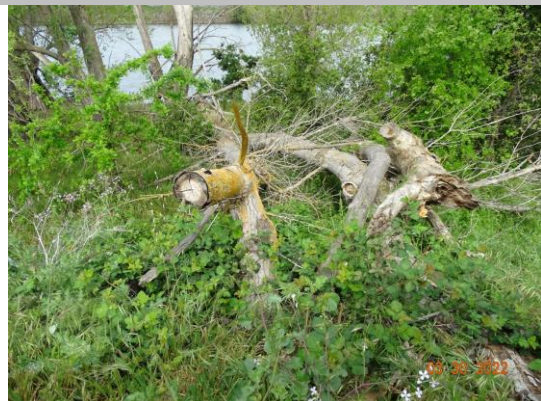
Photo 1 of 1 : SP_2023_NA0002_63_47_20230206_00010.jpg

View of down tree on the waterside slope (Spring 2022).

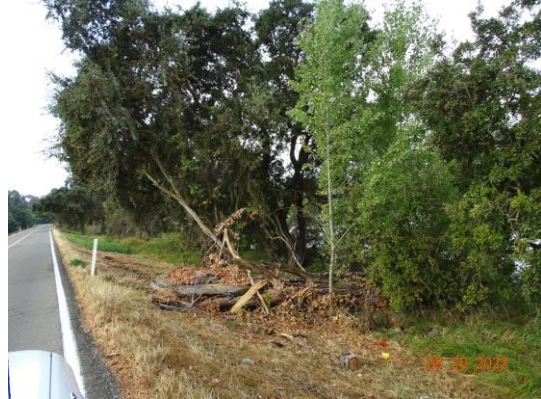
Photo 1 of 1 : SP_2023_NA0002_63_166_20230206_00065.jpg

View of the tree on the WS slope (Fall 2022).

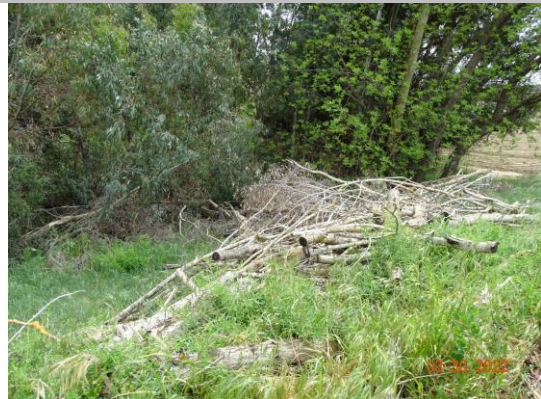
Photo 1 of 1 : SP_2023_NA0002_63_102_20230206_00049.jpg

View of pruned tree limbs on the landside shoulder (Spring 2022).

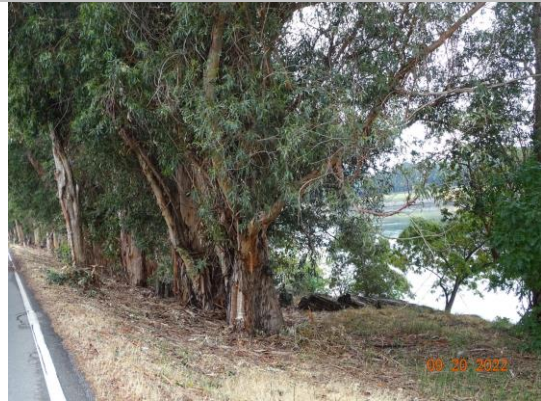
Photo 1 of 1 : SP_2023_NA0002_63_78_20230206_00031.jpg

View of the stump and logs on the WS slope (Fall 2022).

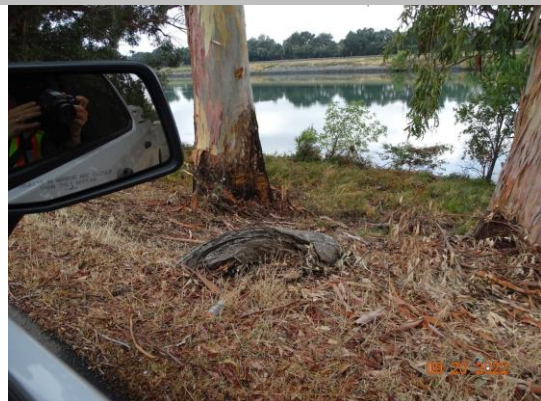
Photo 1 of 1 : SP_2023_NA0002_63_79_20230206_00032.jpg

View of the tree limb on the WS slope (Fall 2022).

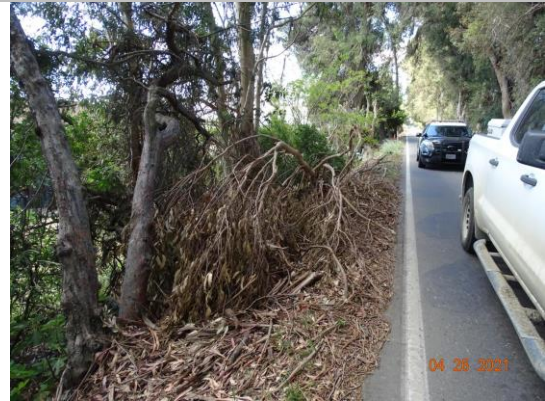
Photo 1 of 1 : SP_2023_NA0002_63_96_20230206_00045.jpg

Down tree limb on the landside hinge (Spring 2021).

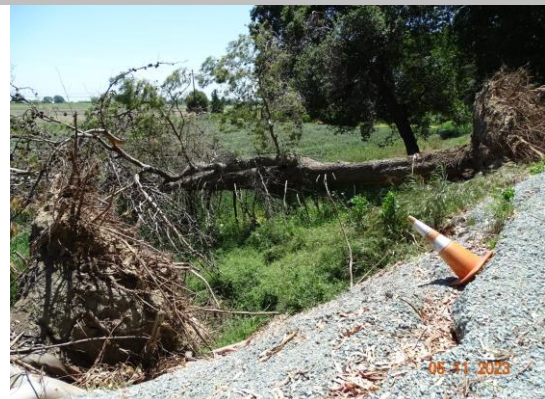
Photo 1 of 1 : SP_2023_NA0002_63_38_20230518_00165.jpg

View of the fallen trees with root balls on the LS slope (Spring 2023).

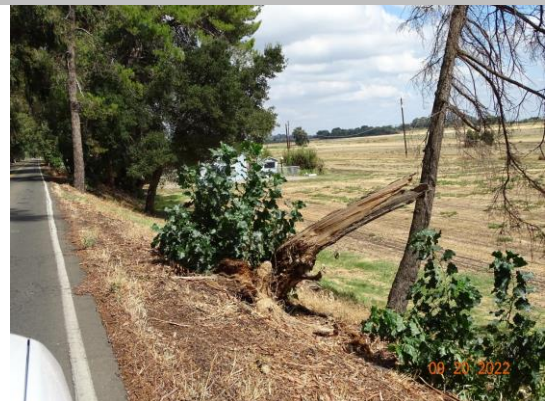
Photo 1 of 1 : SP_2023_NA0002_63_137_20230206_00061.jpg

View of the tree on the LS slope (Fall 2022).

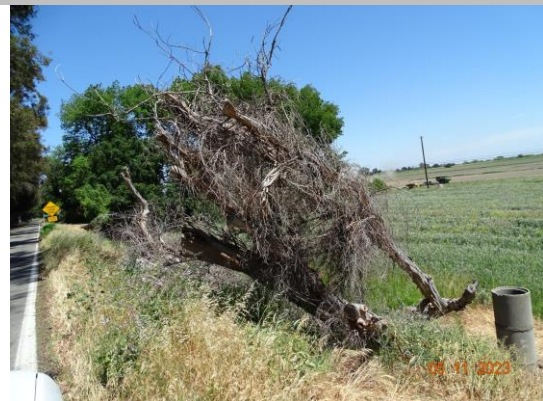
Photo 1 of 1 : SP_2023_NA0002_63_95_20230518_00163.jpg

View of the tree limbs on the LS slope (Spring 2023).

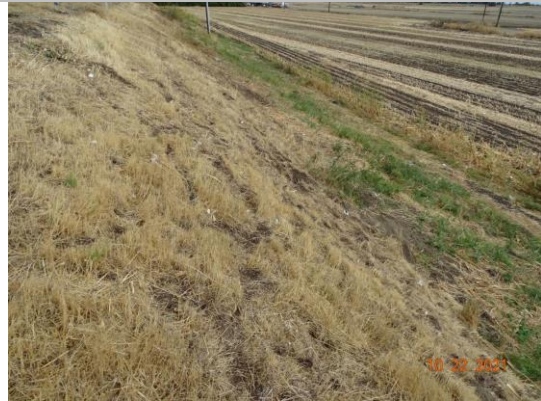
Photo 1 of 1 : SP_2023_NA0002_63_136_20230206_00060.jpg

View of animal holes in the landside slope (Fall 2021).

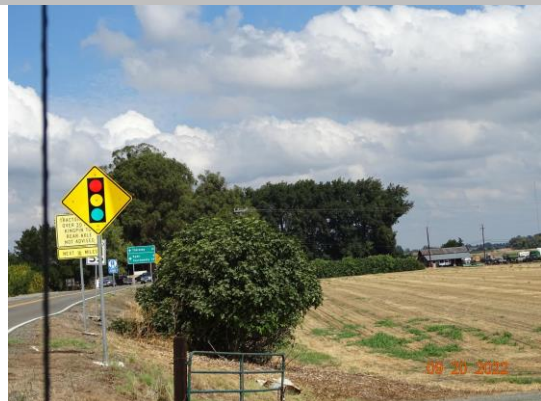
Photo 1 of 1 : SP_2023_NA0002_63_120_20230206_00054.jpg

View of the fig tree on the LS slope (Fall 2022).

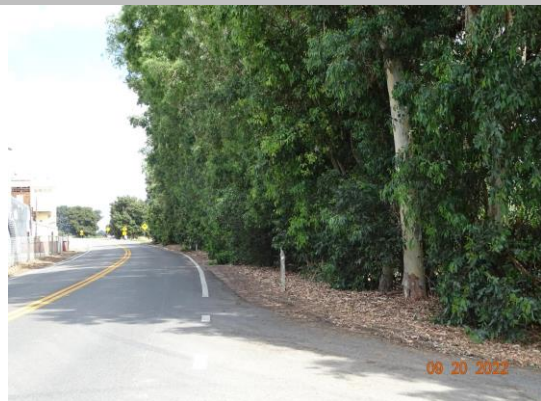
Photo 1 of 1 : SP_2023_NA0002_63_25_20230206_00005.jpg

View of the trees along the LS shoulder (Fall 2022).

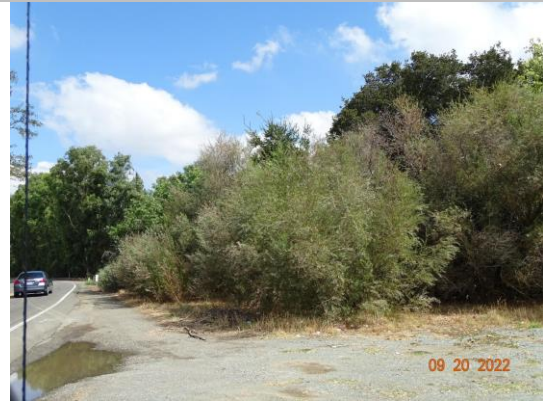
Photo 1 of 1 : SP_2023_NA0002_63_99_20230206_00048.jpg

View of the vegetation on the LS slope (Fall 2022).

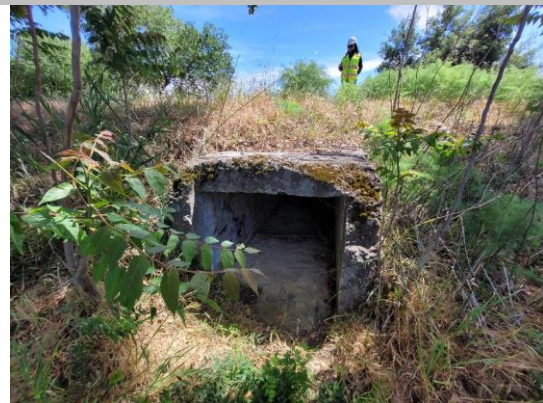
Photo 1 of 3 : UCIP_SP_2023_75100_112246.jpg

Comment Code						
Inspector Comment						
DS_ID:21879 FS_ID:75100 EP_NO: N/A Repair Type: Urgent EVAL Issue: 1, Pipe Integrity Crossing Status: Found UCIP Comments: 04/19/2022 Record updated from Non-Urgent to Urgent. Flood risk to landside due to the tunnel is open on both ends. DMP internal video inspection has found integrity issues. LOF of crossing is between 5 and 6. Crossing will be monitored until funding becomes available to address the issues. No permit has been identified authorizing pipe. (O.Yakimov - DWR UCIP) 07/12/2018 Tunnel is open on both sides. No integrity issue observed, therefore crossing downgraded to "Non-Urgent". (O.Yakimov-DWR UCIP)10/24/2016 same as previous inspection culvert is open on both ends. WS blocked by blankets -- WS structure is being used as a shelter. (O. Magana - DWR UCIP)04/18/2013 Culvert open on both ends. Needs to be abandoned properly. (W. Wylie - DWR UCIP) FIELD_STRUCT_DESC: 42-inch by 42-inch open reinforced concrete culvert through the levee, 6 feet below the crown. [Additional Reference(s): DWR Levee Log, 2005 (HLM 2.54), listed as abandoned 3-feet by 3.5-foot open concrete culvert. USACE Sacramento O&M Manual 103, June 1954, (RM 18.16) Drawing No. 6-13-1100]. USACE As-Built Drawing No. 06-13-1100, January 1933, Sheet 18, RM 18.16, listed as 3.5-foot by 3.5-foot concrete box]. FS Date: 4/19/2022 11:02:31 AM

Water-Side: View of the waterward end of tunnel

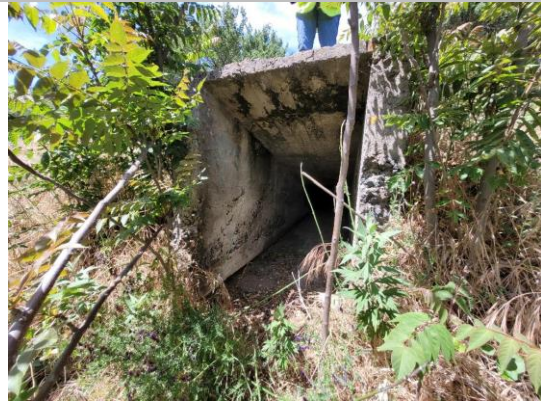
Photo 2 of 3 : UCIP_SP_2023_75100_112250.jpg

Land-Side: View of the landward end of tunnel

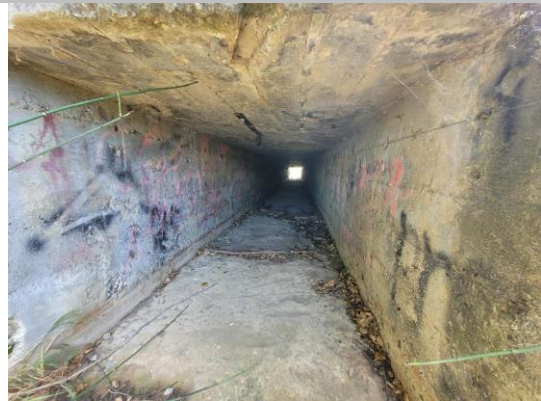
Photo 3 of 3 : UCIP_SP_2023_75100_112247.jpg

Overview of Levee: Photo taken inside of tunnel

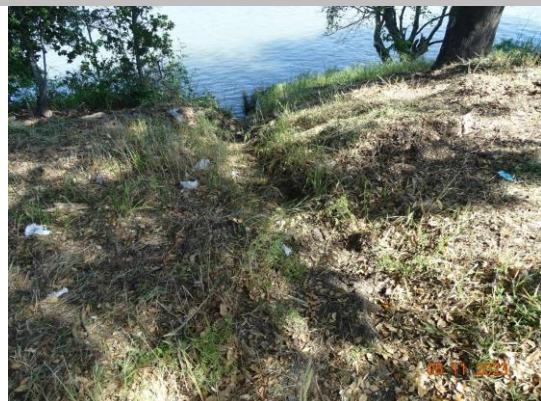
Photo 1 of 1 : SP_2023_NA0002_63_82_20230518_00147.jpg

LM Start	2.56	Rating **	M	Issue No.	82
LM End	2.56	Issue Type +	Ma	Location *	WS
Category	Earthen Levee			GPS Latitude/Longitude	
				Start	End
Item	Erosion / Foot Traffic			38.165898°	38.165898°
				-121.598888°	-121.598888°
DWR ID	DWR_NA0002_02_f_2017_82				
Comment Code					
E3 : Repair the levee slope damaged by foot traffic and prevent access where possible.					
Inspector Comment					
There is a footpath digging into the levee slope.

View of the footpath down the WS slope (Spring 2023).

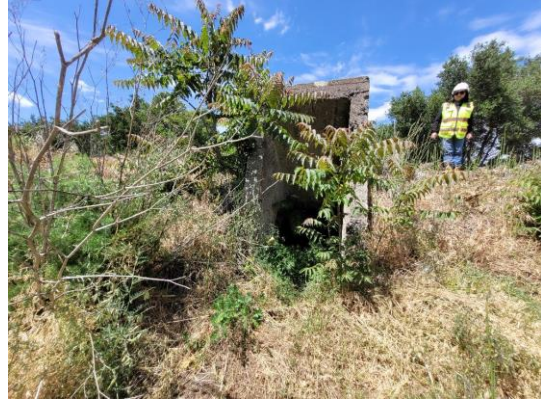
Photo 1 of 3 : UCIP_SP_2023_75101_112251.jpg

Comment Code						
Inspector Comment						
DS_ID:21880 FS_ID:75101 EP_NO: N/A Repair Type: Urgent EVAL Issue: 3b, Flood Risk Crossing Status: Found UCIP Comments: 04/19/2022 Record updated from Non-Urgent to Urgent. Flood risk to landside due to the tunnel is open on both ends. DMP internal video inspection has found pipe integrity issues. LOF of crossing is greater than or equal to 4.1 and less than 5. Crossing will be monitored until funding becomes available for rehabilitation. No permit has been identified authorizing pipe. (O.Yakimov - DWR UCIP) 07/12/2018 Tunnel is open on both sides. No integrity issue observed, therefore crossing downgraded to "Non-Urgent". (O.Yakimov-DWR UCIP) 10/24/2016 same as previous inspection concrete box culvert will need to be abandoned properly. (O. Magana - DWR UCIP) 04/18/2013 tunnel should be abandoned properly. (W. Wylie - DWR UCIP) FIELD_STRUCT_DESC: 48-inch by 48-inch reinforced concrete culvert through the levee, 6.5-inches below the crown. [Additional Reference(s): DWR Levee Log, 2005 (HLM 2.57), listed as abandoned 4-feet by 4-feet open concrete culvert. USACE Sacramento O&M Manual 103, June 1954, (RM 18.13) 3-foot by 3-foot concrete box listed, Drawing No. 6-13-1100]. USACE As-Built Drawing No. 06-13-1100, January 1933, Sheet 18, RM 18.13, listed as 3-foot by 3-foot concrete box]. FS Date: 4/19/2022 11:22:54 AM

Land-Side: View of the landward end of tunnel

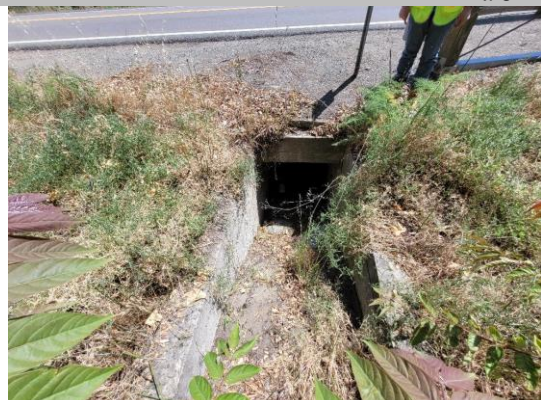
Photo 2 of 3 : UCIP_SP_2023_75101_112254.jpg

Water-Side: View of the waterward end of tunnel

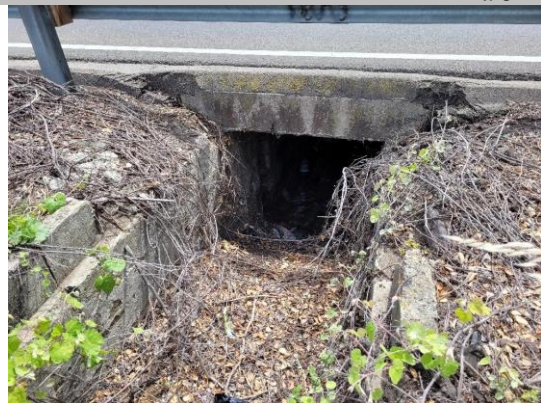
Photo 2 of 3 : UCIP_SP_2023_75147_112327.jpg

Water-Side: View of the waterward end of tunnel

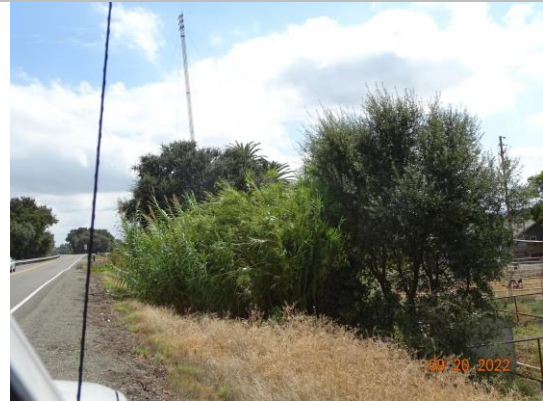
Photo 1 of 1 : SP_2023_NA0002_63_98_20230206_00047.jpg

View of the arundo on the LS slope (Fall 2022).

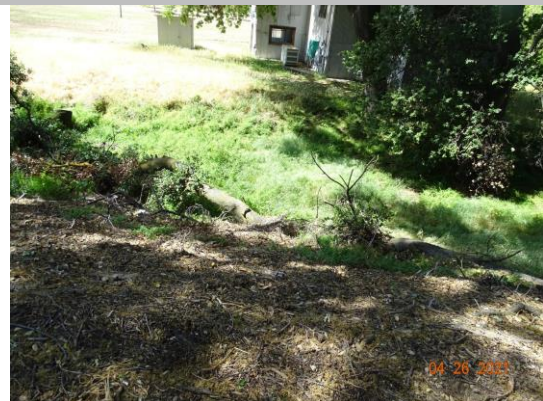
Photo 1 of 1 : SP_2023_NA0002_63_169_20230206_00068.jpg

View of down tree limb on the landside slope (Spring 2021).

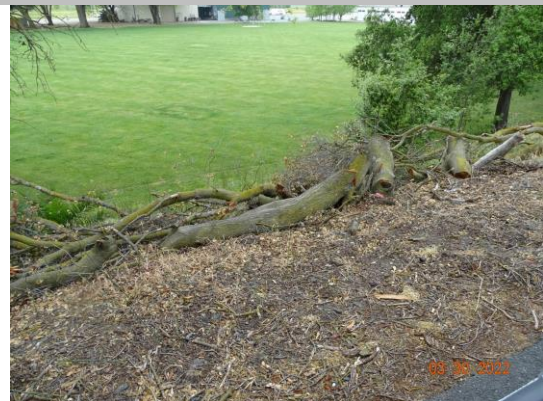
Photo 1 of 1 : SP_2023_NA0002_63_93_20230206_00042.jpg

View of cut up tree limbs on the landside shoulder (Spring 2022).

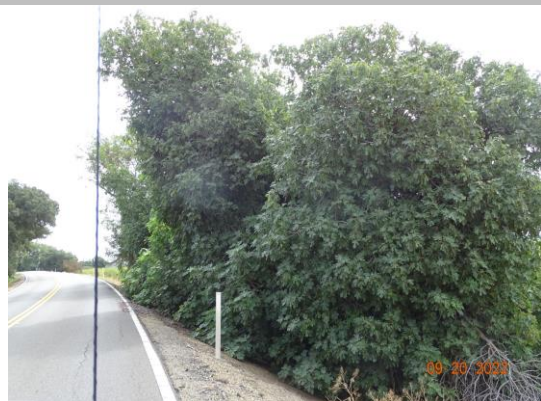
Photo 1 of 1 : SP_2023_NA0002_63_163_20230206_00064.jpg

View of the fig tree on the LS slope (Fall 2022).

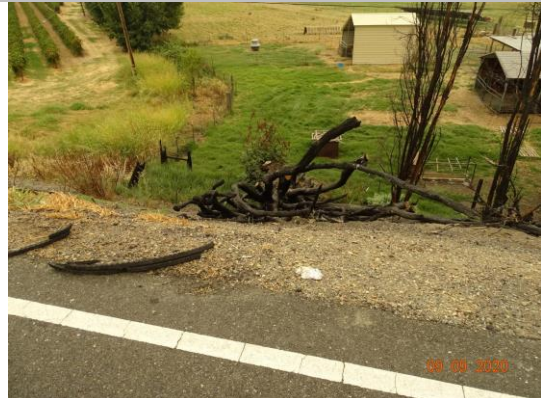
Photo 1 of 1 : SP_2023_NA0002_63_84_20230206_00036.jpg

View looking downslope at burned tree on the landside slope (Fall 2020).

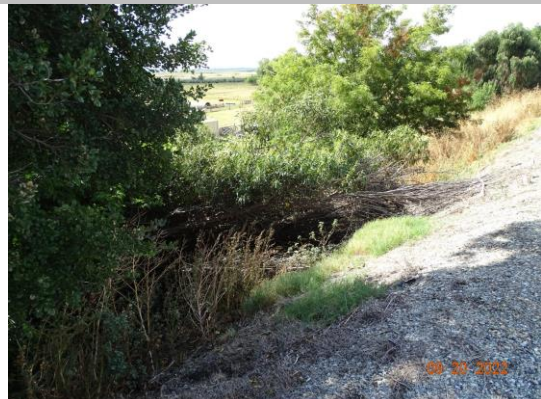
Photo 1 of 1 : SP_2023_NA0002_63_13_20230206_00004.jpg

View of the fallen tree on the LS slope (Fall 2022).

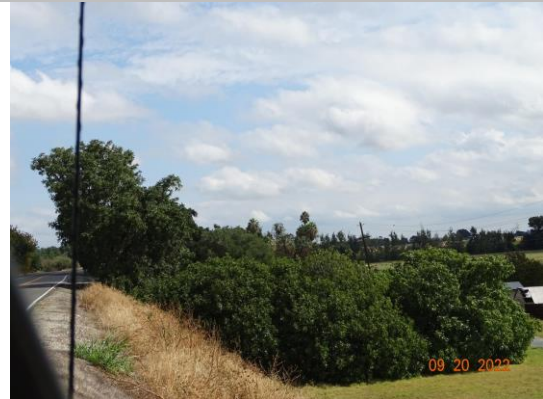
Photo 1 of 1 : SP_2023_NA0002_63_118_20230206_00053.jpg

View of the fig tree on the LS slope (Fall 2022).

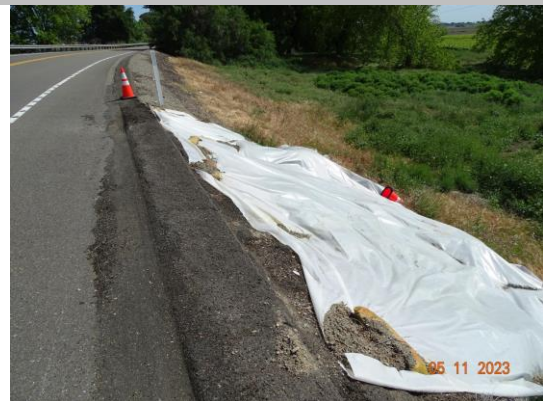
Photo 1 of 1 : SP_2023_NA0002_63_90_20230518_00155.jpg

View of the repaired shoulder and plastic cover on the LS slope (Spring 2023).

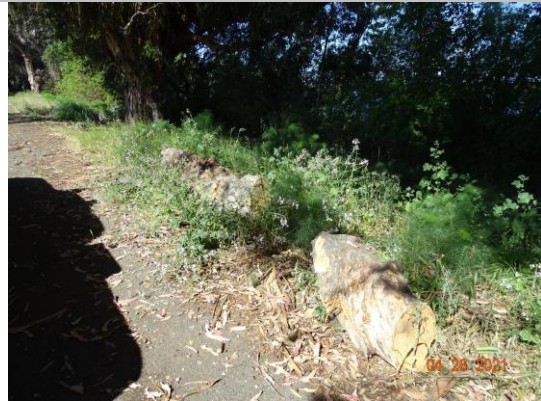
Photo 1 of 1 : SP_2023_NA0002_63_83_20230206_00035.jpg

View of cut-up tree limb on the waterside hinge (Spring 2021).

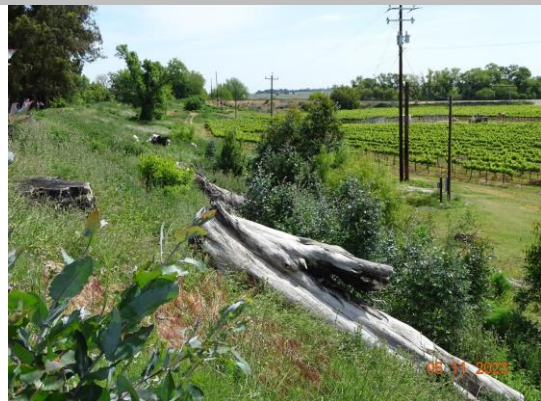
Photo 1 of 1 : SP_2023_NA0002_63_62_20230518_00151.jpg

View of the tree limbs on the LS slope (Spring 2023).

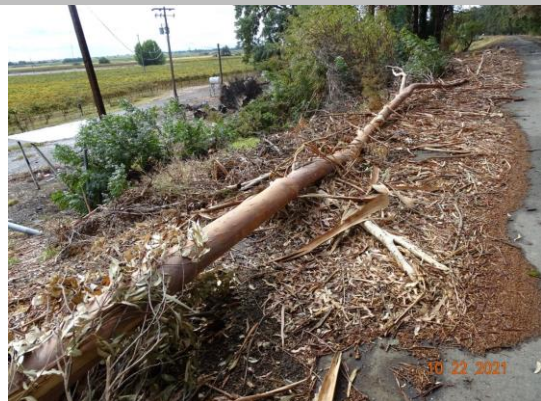
Photo 1 of 1 : SP_2023_NA0002_63_72_20230206_00028.jpg

View of large down tree limb on the landside hinge (Fall 2021).

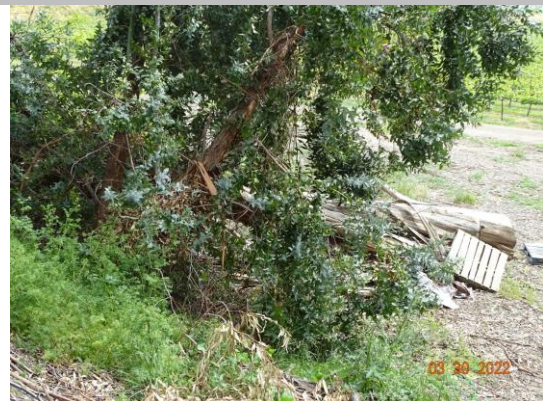
Photo 1 of 1 : SP_2023_NA0002_63_65_20230206_00019.jpg

View of large down tree on the landside slope (Spring 2022).

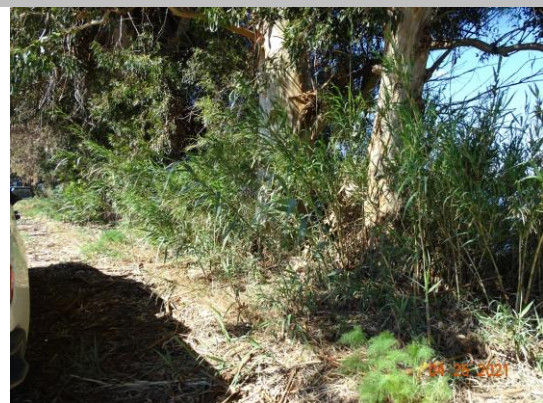
Photo 1 of 1 : SP_2023_NA0002_63_92_20230206_00041.jpg

View of arundo on the waterside slope (Spring 2021).

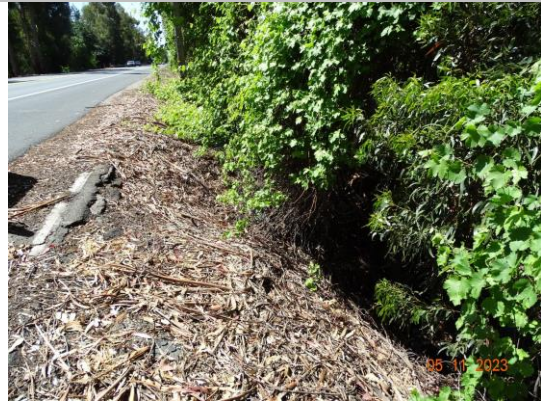
Photo 1 of 3 : SP_2023_NA0002_63_69_20230518_00157.jpg

View of the scour at LM 8.37 (Spring 2023).

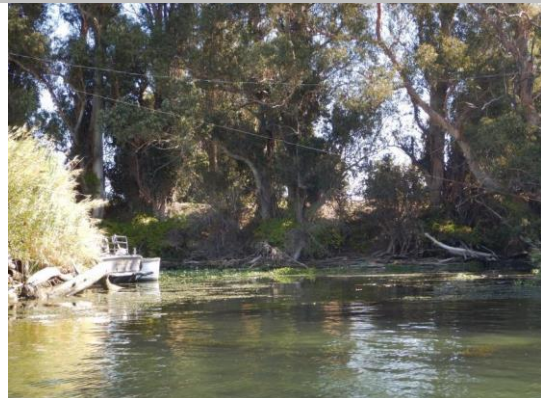
Photo 2 of 3 : SP_2023_NA0002_63_69_20230206_00024.jpg

USACE 2018 Erosion Photo #1

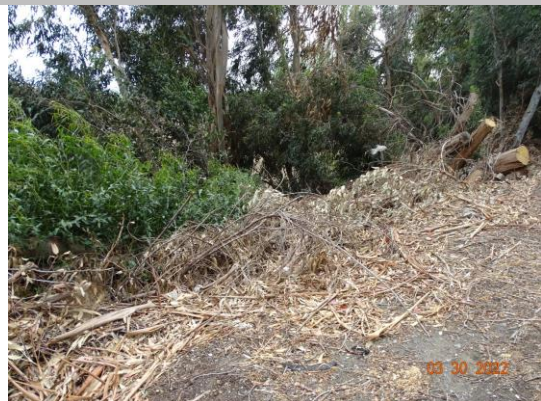
Photo 1 of 1 : SP_2023_NA0002_63_158_20230206_00063.jpg

View of down trees on the landside slope (Spring 2022).

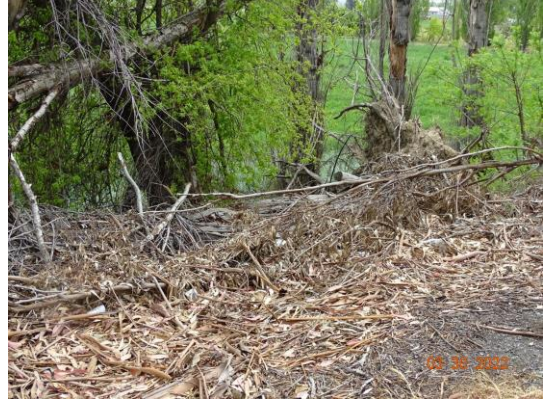
Photo 1 of 1 : SP_2023_NA0002_63_157_20230206_00062.jpg

View of down tree on the landside slope (Spring 2022).

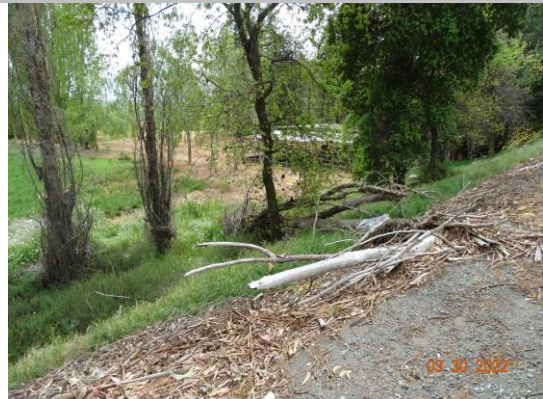
Photo 1 of 1 : SP_2023_NA0002_63_106_20230206_00051.jpg

View of down tree on the landside slope (Spring 2022).

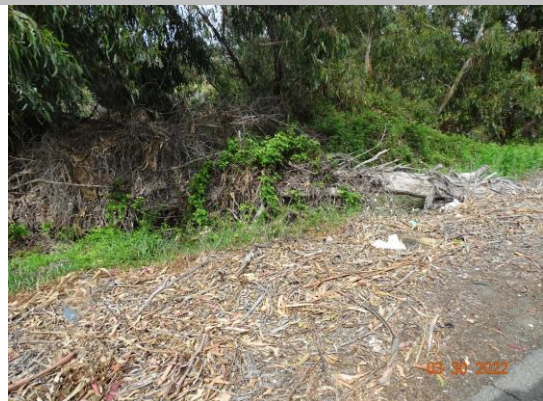
Photo 1 of 1 : SP_2023_NA0002_63_77_20230206_00030.jpg

View of downed trees needing removal on the waterside slope (Spring 2022).

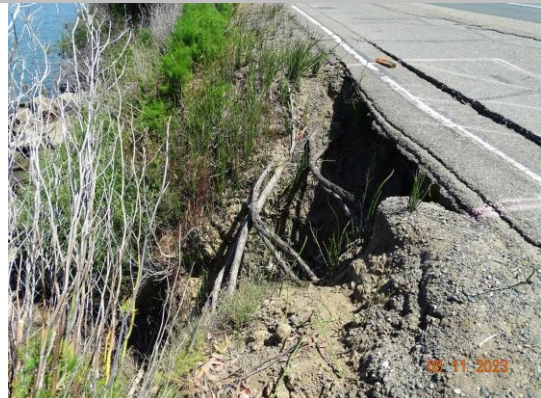
Photo 2 of 4 : SP_2023_NA0002_63_68_20230518_00160.jpg

Erosion at LM 9.10 by turnout (Spring 2023).

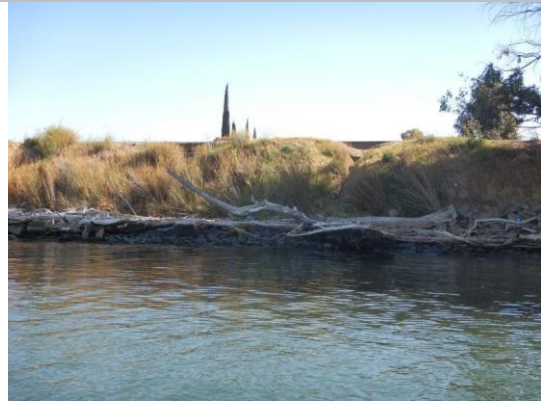
Photo 3 of 4 : SP_2023_NA0002_63_68_20230206_00022.jpg

USACE 2018 Erosion Photo #1

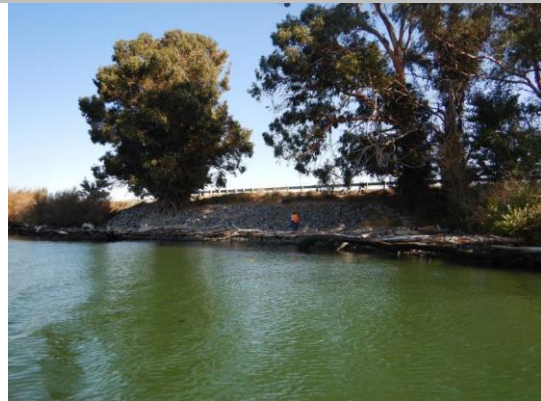
Photo 4 of 4 : SP_2023_NA0002_63_68_20230206_00023.jpg

USACE 2018 Erosion Photo #2

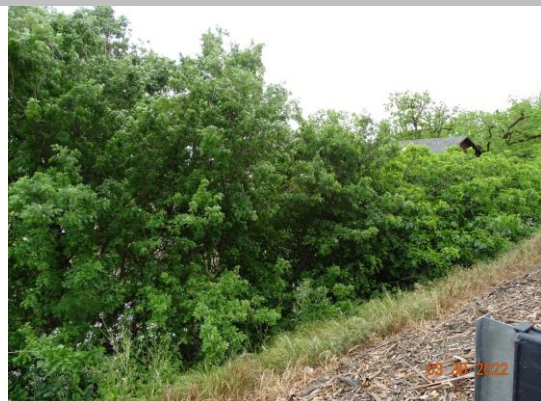
Photo 1 of 1 : SP_2023_NA0002_63_85_20230206_00037.jpg

View of thick trees on the landside slope (Spring 2022).

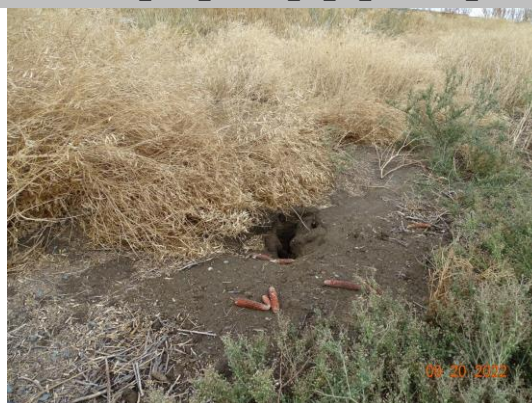
Photo 2 of 2 : SP_2023_NA0002_63_67_20230206_00021.jpg

View of animal hole on the LS slope (Fall 2022).

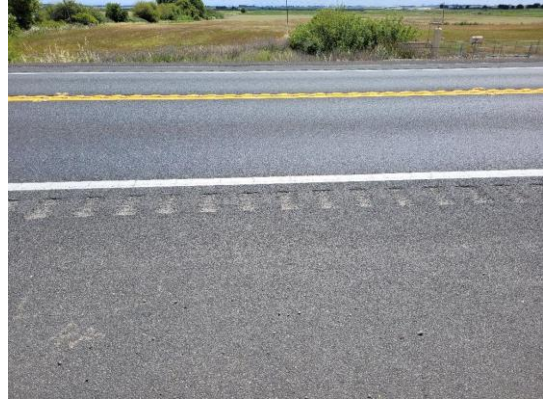
Photo 1 of 3 : UCIP_SP_2023_75626_113358.jpg

Top of Levee: View of levee crown looking from waterside

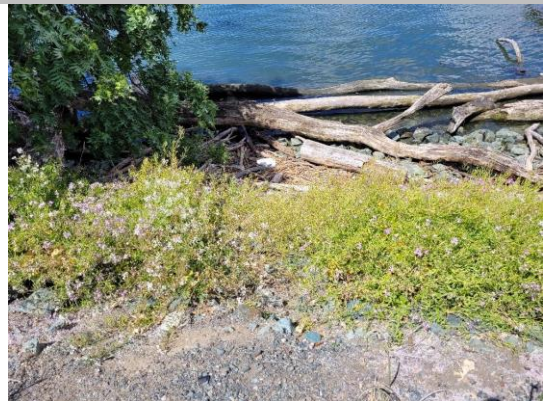
Photo 2 of 3 : UCIP_SP_2023_75626_113357.jpg

Water-Side: View of levee slope looking from crown

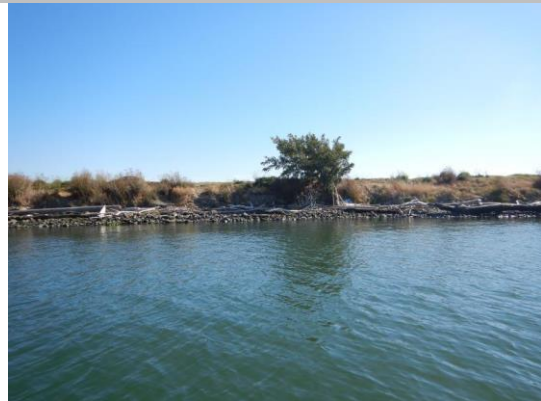
Photo 1 of 2 : SP_2023_NA0002_63_51_20230206_00012.jpg

USACE 2018 Erosion Photo #1

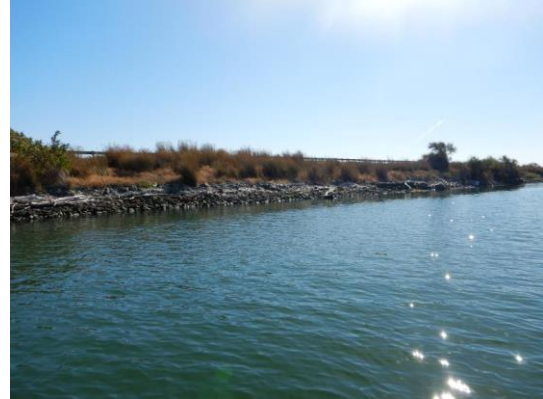
Photo 2 of 2 : SP_2023_NA0002_63_51_20230206_00013.jpg

USACE 2018 Erosion Photo #2

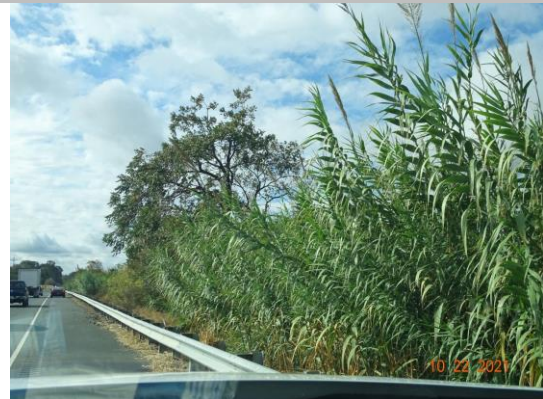
Photo 1 of 1 : SP_2023_NA0002_63_89_20230206_00039.jpg

View looking downstream at arundo on the waterside slope (Fall 2021).
