**Flood Control Project Maintenance
Levee Inspections**

Maintenance Issue Types Only, Levee Inspection Report By Mile - Spring 2024

Brannan Andrus Levee Maintenance District

Waterway	Bank	Unit Miles	Inspection Start/End	Inspector
Unit No. 01 Georgiana Slough	Right	6.01	04/17/2024 04/17/2024	Gregg McMillon

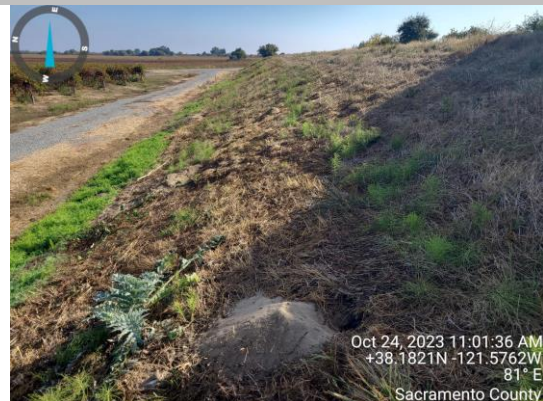
Photo 1 of 1 : SP_2024_NA0002_62_133_20240301_00036.jpg

View of rodent holes on the landside slope. Fall 2023.

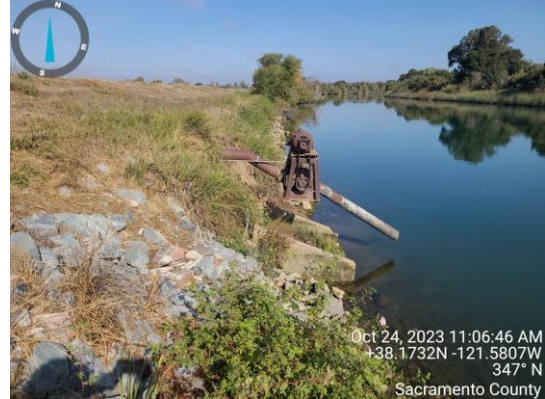
Photo 1 of 3 : SP_2024_NA0002_62_39_20240301_00010.jpg

LM Start	1.53	Rating **	M	Issue No.	39
LM End	1.54	Issue Type +	Ma	Location *	WS
Category	Supplemental			GPS Latitude/Longitude	
				Start	End
Item	2018 USACE Erosion Survey			38.173410°	38.173178°
				-121.580683°	-121.580622°
DWR ID	DWR_NA0002_01_s_2022_39				
Comment Code					
Inspector Comment					
2018 Site ID: GEO 5.5 R					
Status: Eroding					
2018 Field Notes: Site extended downstream.					
Site History: 2017 - Failed rock section, slump failure of bank to subvertical face.

View of erosion on the waterside slope. Fall 2023.

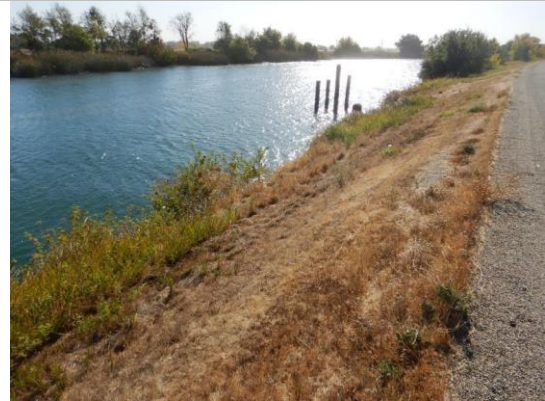
Photo 2 of 3 : SP_2024_NA0002_62_39_20240301_00011.jpg

USACE 2018 Erosion Photo #1

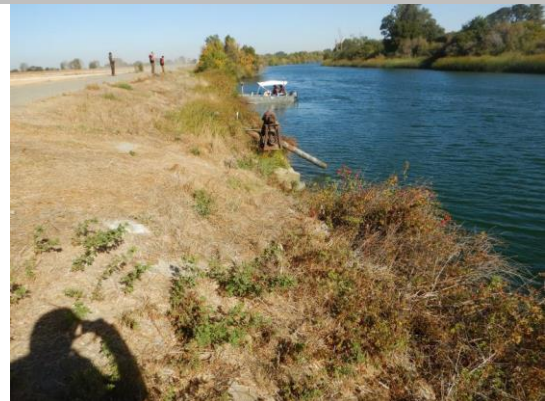
Photo 3 of 3 : SP_2024_NA0002_62_39_20240301_00012.jpg

USACE 2018 Erosion Photo #2

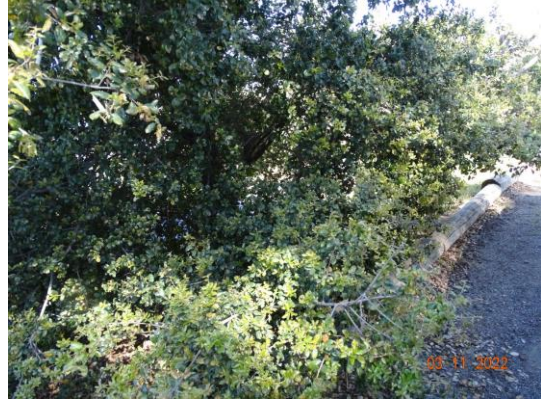
Photo 1 of 1 : SP_2024_NA0002_62_72_20240301_00025.jpg

View of thick tree on the landside shoulder (Spring 2022).

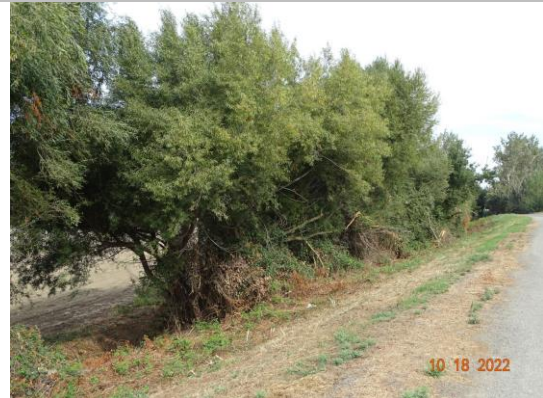
Photo 1 of 1 : SP_2024_NA0002_62_28_20240301_00008.jpg

View of the vegetation on the LS toe (Fall 2022).

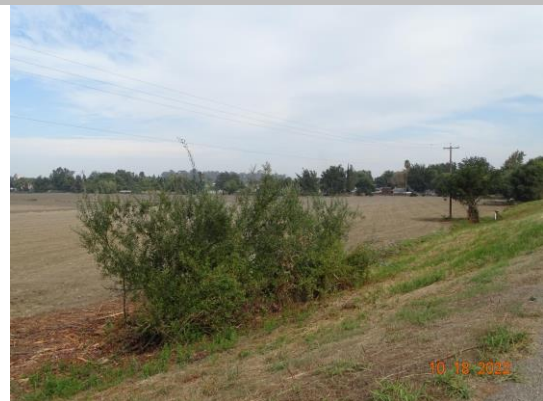
Photo 1 of 1 : SP_2024_NA0002_62_52_20240301_00016.jpg

LM Start	2.58	Rating **	M	Issue No.	52
LM End	2.58	Issue Type +	Ma	Location *	LS
Category	Earthen Levee			GPS Latitude/Longitude	
				Start	End
Item	Trim / Thin Trees			38.158999°	38.158999°
				-121.586621°	-121.586621°
DWR ID	DWR_NA0002_01_f_2017_29				
Comment Code					
T1 : Trim and thin trees to at least five feet above ground level to allow visibility of the ground and room to flood fight.					
Inspector Comment

View of the tree on the LS slope (Fall 2022).

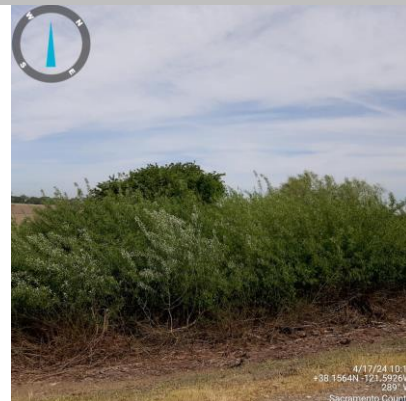
Photo 1 of 1 : SP_2024_NA0002_62_44_20240422_00084.jpg

LM Start	2.99	Rating **	U	Issue No.	44
LM End	3.01	Issue Type +	Ma	Location *	LS
Category	Earthen Levee			GPS Latitude/Longitude	
				Start	End
Item	Vegetation			38.156668°	38.156361°
				-121.592395°	-121.592515°
DWR ID	DWR_NA0002_01_s_2024_44				
Comment Code					
V2 : Remove the wild growth and woody vegetation other than native grasses from the levee slopes.					
Inspector Comment					
Trim or remove tall bushes on LS shoulder.

View of excessive growth on LS shoulder. (Spring 2024)

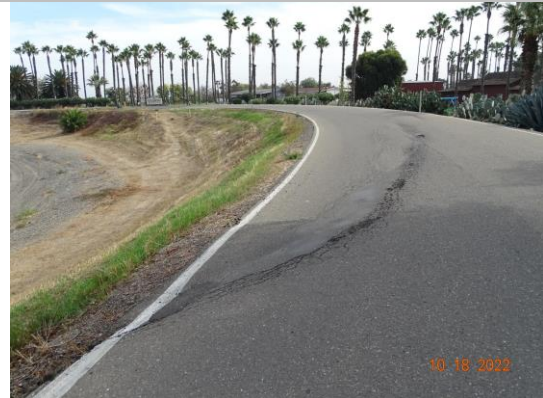
Photo 1 of 1 : SP_2024_NA0002_62_67_20240301_00024.jpg

LM Start	3.38	Rating **	A/W	Issue No.	67
LM End	3.40	Issue Type +	Ma	Location *	CR
Category	Earthen Levee			GPS Latitude/Longitude	
				Start	End
Item	Slope Stability			38.151430°	38.151390°
				-121.592085°	-121.592517°
DWR ID	DWR_NA0002_01_s_2017_67				
Comment Code					
S1 : Repair slope instability.					
Inspector Comment					
Appears to be beginning of a landside slump. LMA's Engineer (DCC) is monitoring site for movement.

View of the depression on the levee crown (Fall 2022).

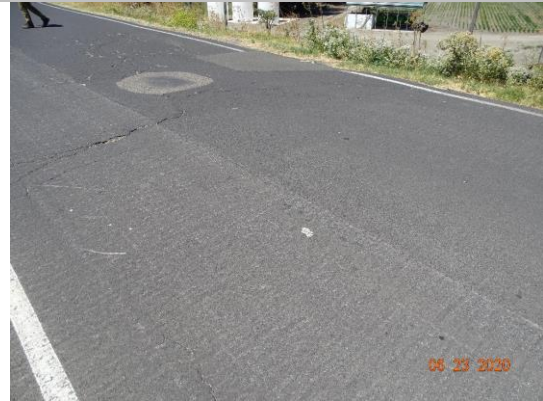
Photo 1 of 3 : UCIP_SP_2024_62327_90037.jpg

Top of Levee: View of levee crown looking downstream

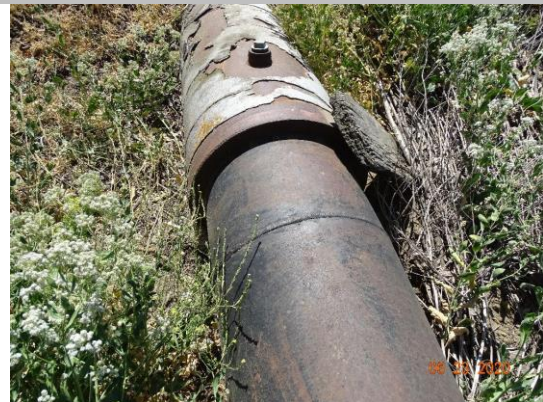
Photo 2 of 3 : UCIP_SP_2024_62327_90035.jpg

Land-Side: Pipe sleeving point on levee slope

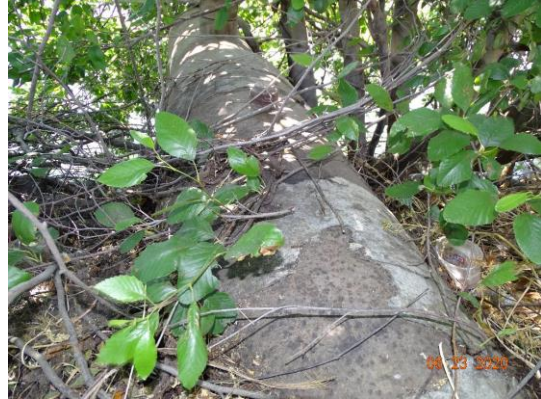
Photo 3 of 3 : UCIP_SP_2024_62327_90033.jpg

Water-Side: View of pipe at riverbank. Siphon breaker installed on the pipe at this place

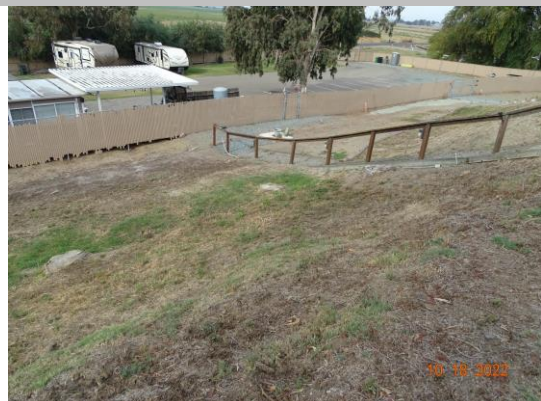
Photo 1 of 1 : SP_2024_NA0002_62_109_20240301_00030.jpg

View of the tree stumps on the LS slope (Fall 2022).

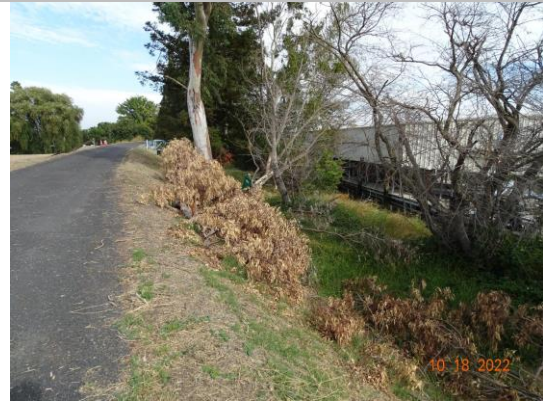
Photo 1 of 1 : SP_2024_NA0002_62_108_20240301_00029.jpg

View of the tree limbs on the WS slope (Fall 2022).

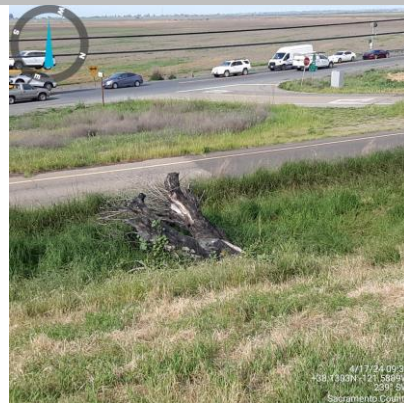
Photo 1 of 1 : SP_2024_NA0002_62_34_20240422_00085.jpg

LM Start	5.42	Rating **	M	Issue No.	34
LM End	5.42	Issue Type +	Ma	Location *	LS
Category	Earthen Levee			GPS Latitude/Longitude	
				Start	End
Item	Trim / Thin Trees			38.130387°	38.130387°
				-121.588962°	-121.588962°
DWR ID	DWR_NA0002_01_s_2024_34				
Comment Code					
T3 : Fallen tree with root ball.					
Inspector Comment					
Fallen, burned up tree on LS slope.

View of fallen tree to be removed from LS slope. (Spring 2024)

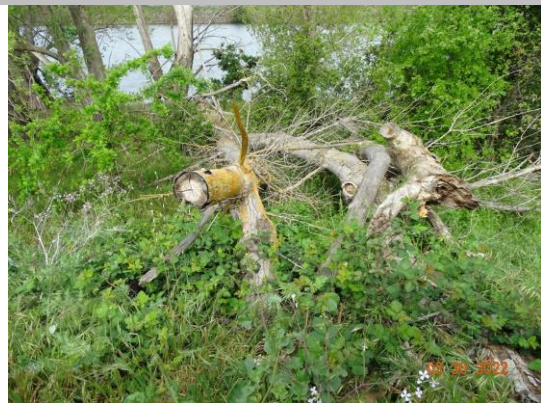
Photo 1 of 1 : SP_2024_NA0002_63_47_20240301_00014.jpg

View of downed tree on the waterside slope (Spring 2022).

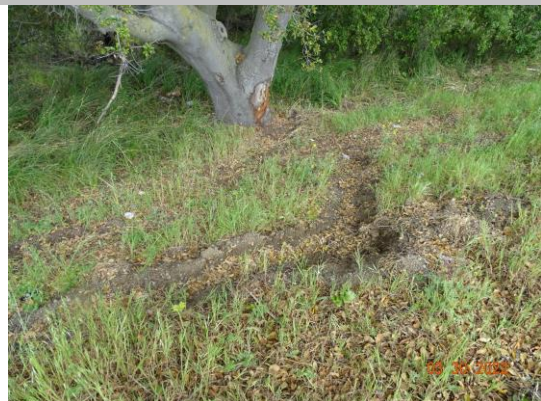
Photo 1 of 1 : SP_2024_NA0002_63_66_20240301_00023.jpg

LM Start	1.14	Rating **	U	Issue No.	66
LM End	1.14	Issue Type +	Ma	Location *	WS
Category	Earthen Levee			GPS Latitude/Longitude	
				Start	End
Item	Erosion / Vehicle Traffic			38.182772°	38.182772°
				-121.584689°	-121.584689°
DWR ID	DWR_NA0002_02_s_2022_66				
Comment Code					
E6 : Repair the levee slope damaged by vehicle traffic and prevent access where possible.					
Inspector Comment

View of damage due to vehicle going off the road on the waterside slope (Spring 2022).

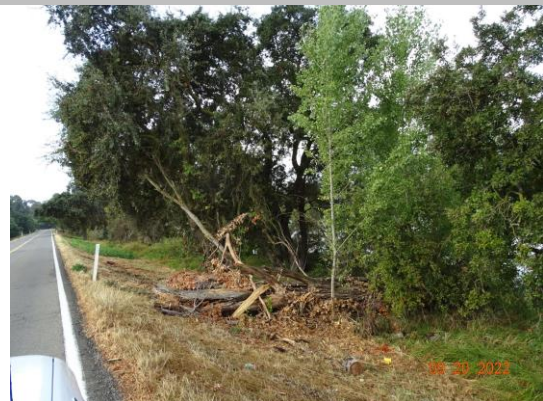
Photo 1 of 1 : SP_2024_NA0002_63_166_20240301_00066.jpg

View of the tree on the WS slope (Fall 2022).

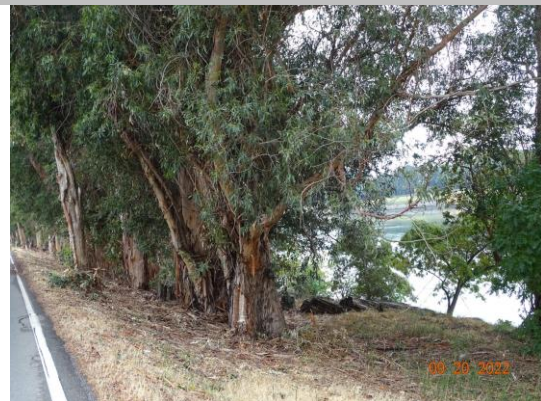
Photo 1 of 1 : SP_2024_NA0002_63_78_20240301_00036.jpg

View of the stump and logs on the WS slope (Fall 2022).

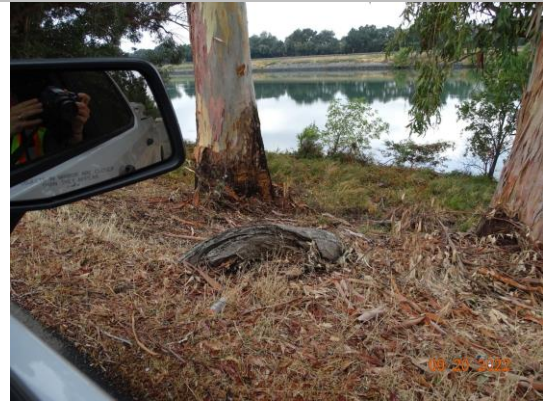
Photo 1 of 1 : SP_2024_NA0002_63_79_20240301_00037.jpg

View of the tree limb on the WS slope (Fall 2022).

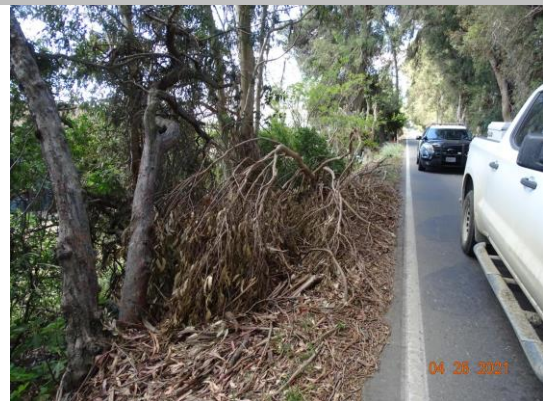
Photo 1 of 1 : SP_2024_NA0002_63_96_20240301_00048.jpg

Downed tree limb on the landside hinge (Spring 2021).

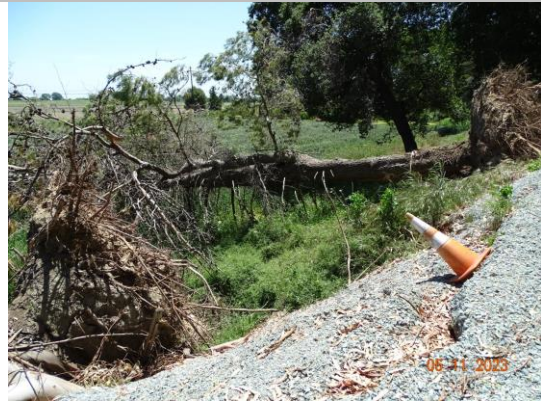
Photo 1 of 1 : SP_2024_NA0002_63_38_20240301_00012.jpg

View of the fallen trees with root balls on the LS slope (Spring 2023).

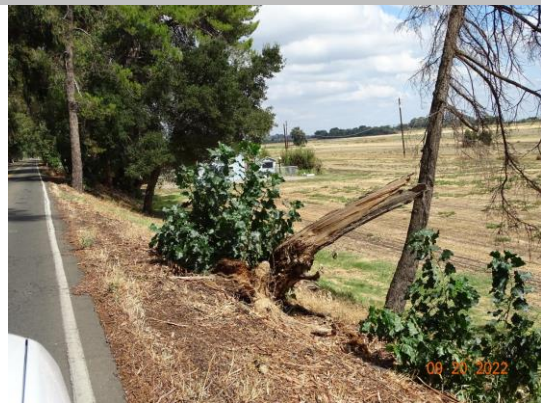
Photo 1 of 1 : SP_2024_NA0002_63_137_20240301_00062.jpg

View of the tree on the LS slope (Fall 2022).

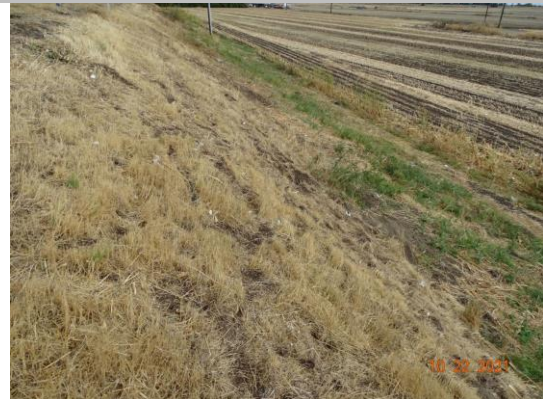
Photo 1 of 1 : SP_2024_NA0002_63_136_20240301_00061.jpg

View of animal holes in the landside slope (Fall 2021).

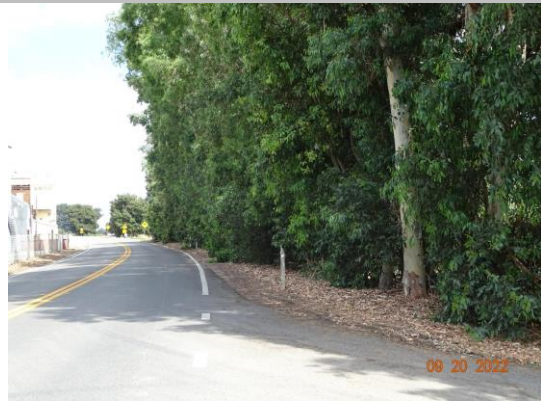
Photo 1 of 1 : SP_2024_NA0002_63_25_20240301_00005.jpg

View of the trees along the LS shoulder (Fall 2022).

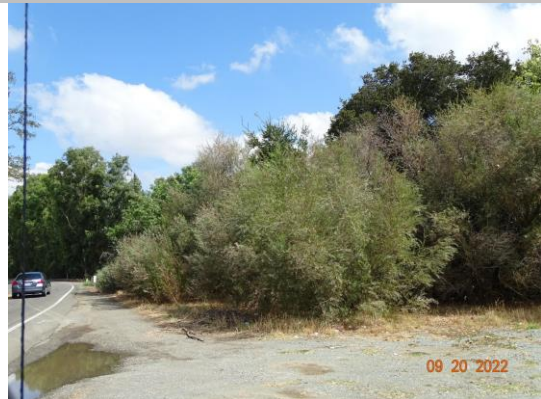
Photo 1 of 1 : SP_2024_NA0002_63_99_20240301_00051.jpg

View of the vegetation on the LS slope (Fall 2022).

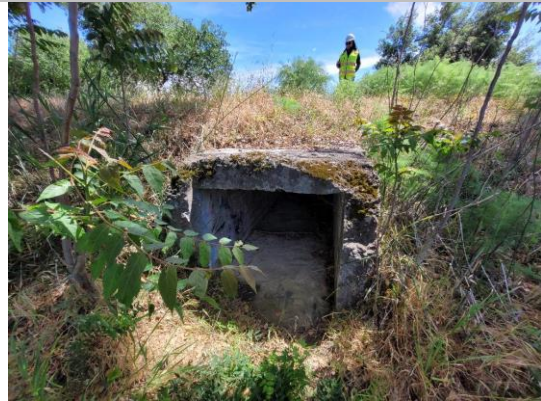
Photo 1 of 3 : UCIP_SP_2024_75100_112246.jpg

Water-Side: View of the waterward end of tunnel

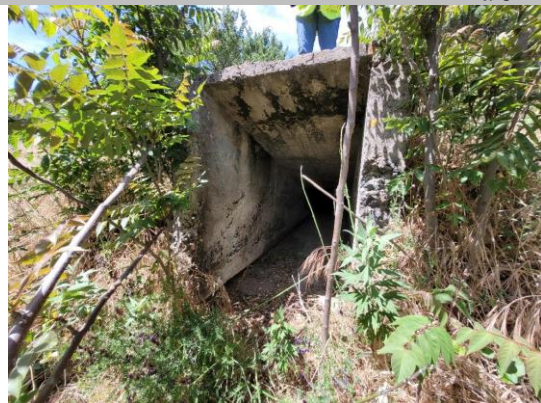
Photo 2 of 3 : UCIP_SP_2024_75100_112250.jpg

Land-Side: View of the landward end of tunnel

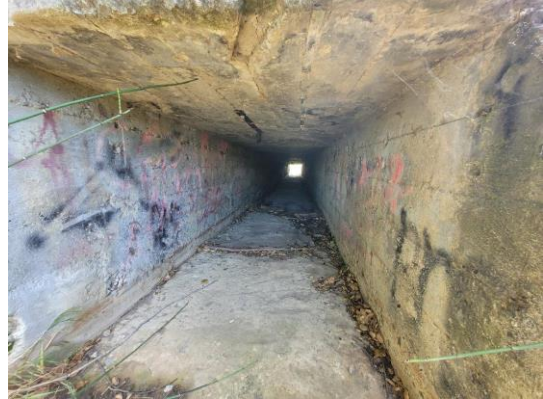
Photo 3 of 3 : UCIP_SP_2024_75100_112247.jpg

Overview of Levee: Photo taken inside of tunnel

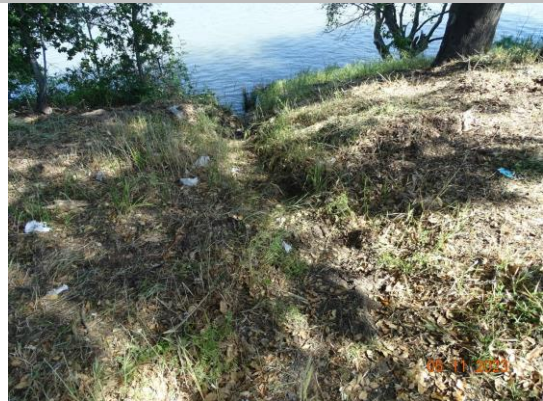
Photo 1 of 1 : SP_2024_NA0002_63_82_20240301_00039.jpg

LM Start	2.56	Rating **	M	Issue No.	82
LM End	2.56	Issue Type +	Ma	Location *	WS
Category	Earthen Levee			GPS Latitude/Longitude	
				Start	End
Item	Erosion / Foot Traffic			38.165898°	38.165898°
				-121.598888°	-121.598888°
DWR ID	DWR_NA0002_02_f_2017_82				
Comment Code					
E3 : Repair the levee slope damaged by foot traffic and prevent access where possible.					
Inspector Comment					
There is a footpath digging into the levee slope.

View of the footpath down the WS slope (Spring 2023).

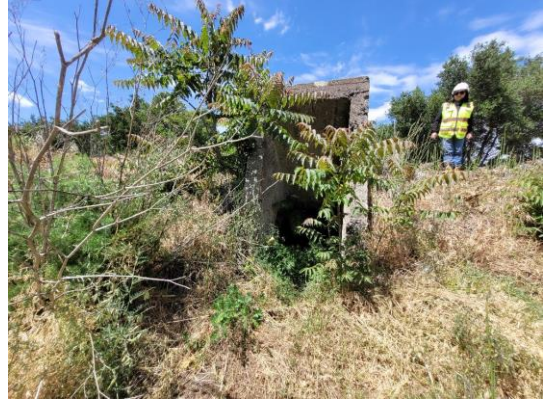
Photo 1 of 3 : UCIP_SP_2024_75101_112251.jpg

Land-Side: View of the landward end of tunnel

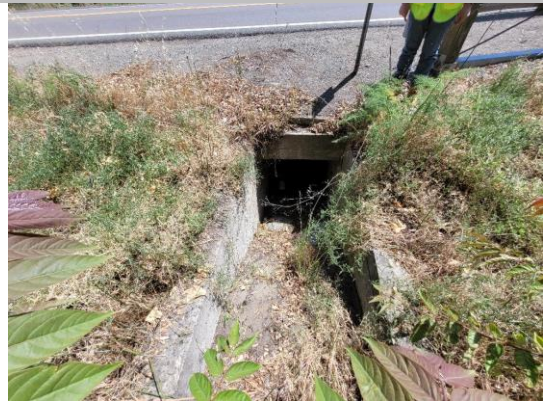
Photo 2 of 3 : UCIP_SP_2024_75101_112254.jpg

Water-Side: View of the waterward end of tunnel

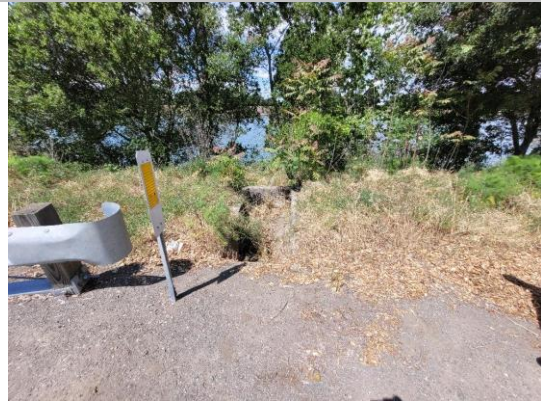
Photo 3 of 3 : UCIP_SP_2024_75101_112253.jpg

Water-Side: View of levee slope looking from crown. Concrete box on levee shoulder

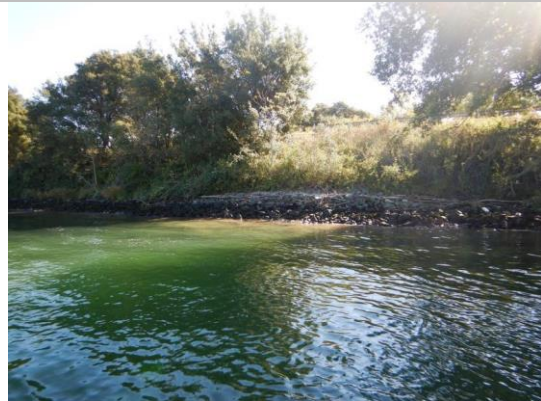
Photo 1 of 2 : SP_2024_NA0002_63_71_20240301_00032.jpg

USACE 2018 Erosion Photo #1

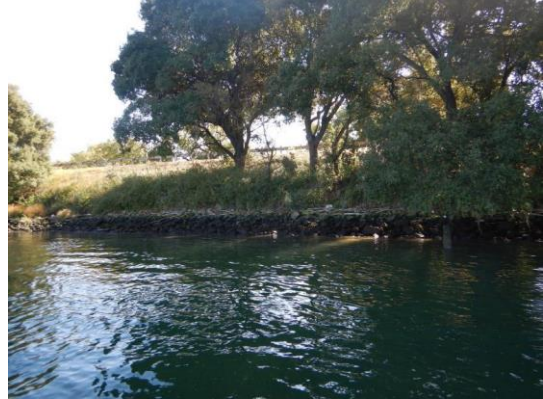
Photo 2 of 2 : SP_2024_NA0002_63_71_20240301_00033.jpg

USACE 2018 Erosion Photo #2

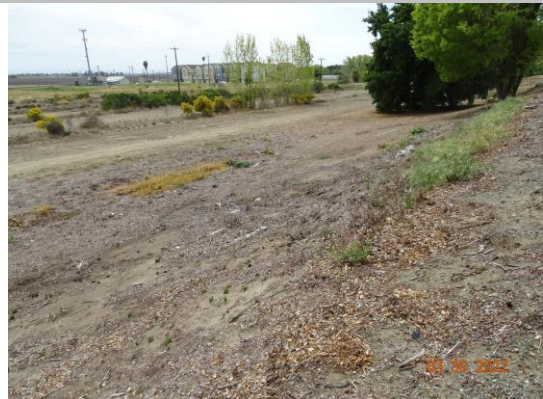
Photo 1 of 1 : SP_2024_NA0002_63_104_20240301_00052.jpg

View of animal holes on the landside slope (Spring 2022).

Comment Code					
A1 : Exterminate rodents and backfill and compact or grout burrows.					
Inspector Comment

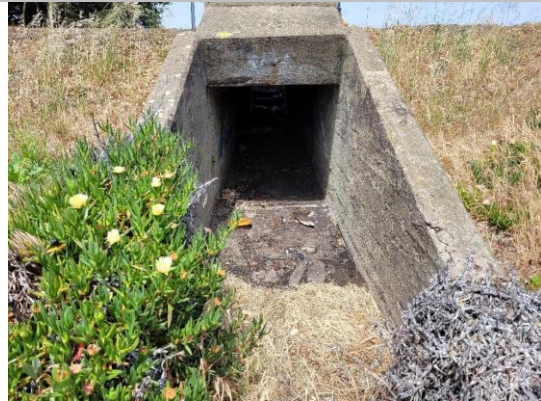
Photo 1 of 3 : UCIP_SP_2024_75147_112322.jpg

Land-Side: View of the landward end of tunnel

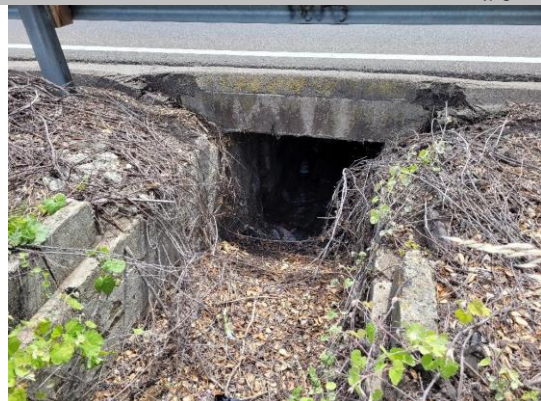
Photo 2 of 3 : UCIP_SP_2024_75147_112327.jpg

Water-Side: View of the waterward end of tunnel

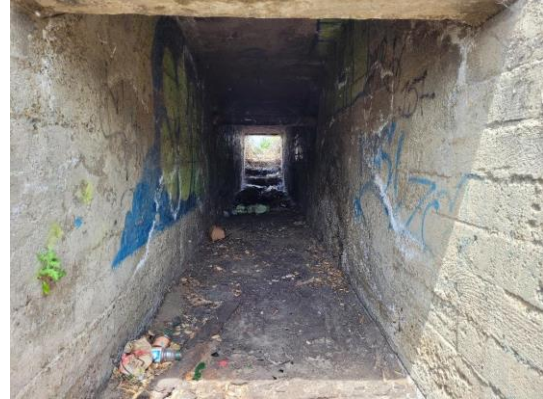
Photo 3 of 3 : UCIP_SP_2024_75147_112323.jpg

Overview of Levee: Photo taken inside of the tunnel

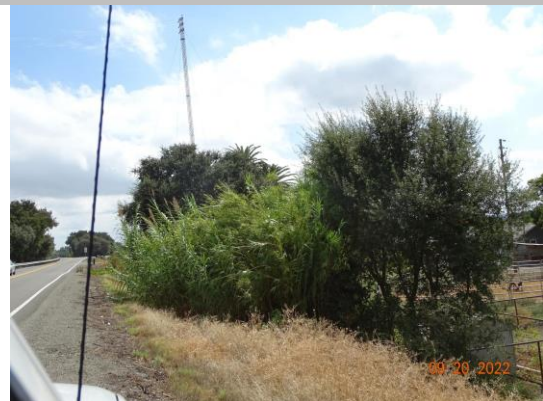
Photo 1 of 1 : SP_2024_NA0002_63_98_20240301_00050.jpg

View of the arundo on the LS slope (Fall 2022).

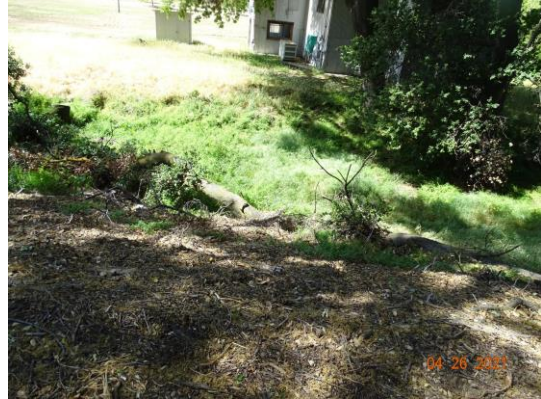
Photo 1 of 1 : SP_2024_NA0002_63_169_20240301_00069.jpg

View of downed tree limb on the landside slope (Spring 2021).

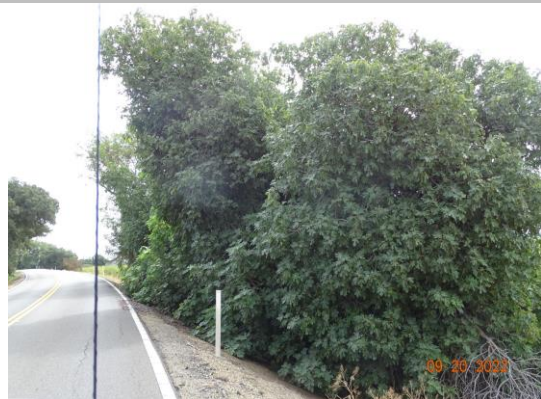
Photo 1 of 1 : SP_2024_NA0002_63_163_20240301_00065.jpg

View of the fig tree on the LS slope (Fall 2022).

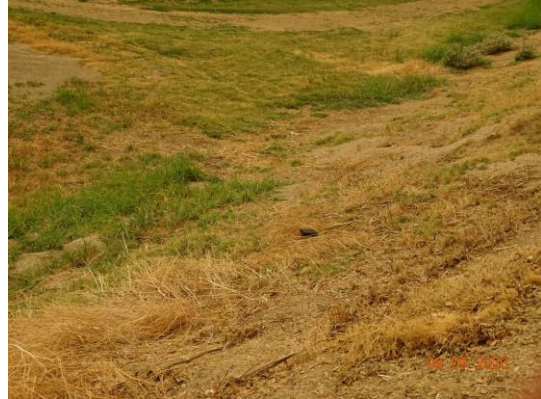
Photo 1 of 1 : SP_2024_NA0002_63_124_20240301_00058.jpg

View looking downstream at animal holes in the landside slope (Fall 2020).

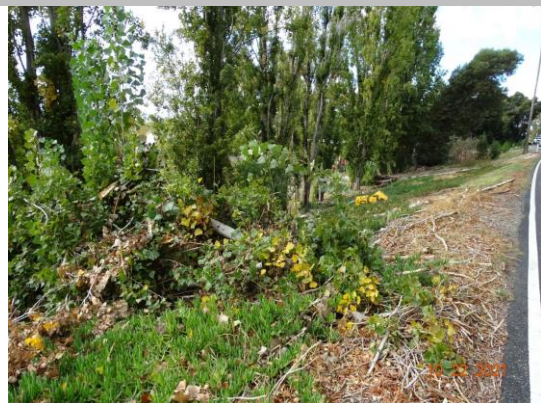
Photo 1 of 1 : SP_2024_NA0002_63_132_20240301_00060.jpg

View looking downstream at two downed trees on the landside slope (Fall 2021).

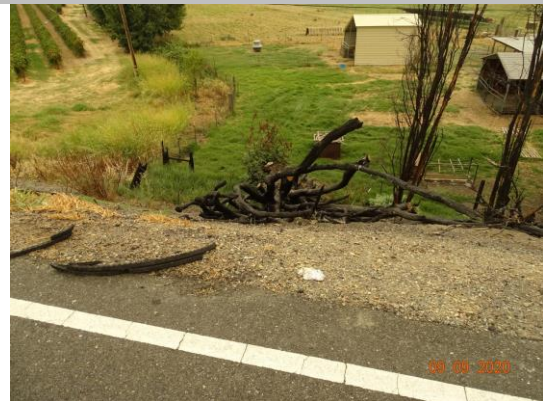
Photo 1 of 1 : SP_2024_NA0002_63_84_20240301_00040.jpg

View looking downslope at burned tree on the landside slope (Fall 2020).

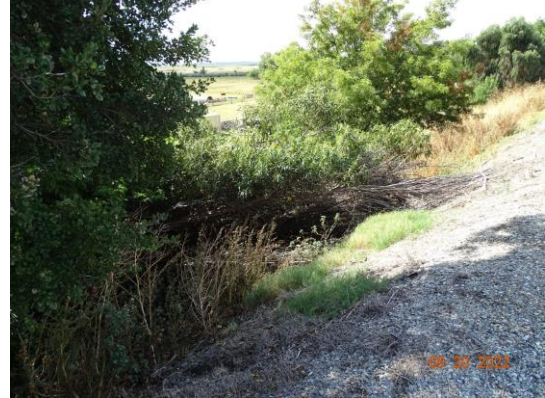
Photo 1 of 1 : SP_2024_NA0002_63_13_20240301_00004.jpg

View of the fallen tree on the LS slope (Fall 2022).

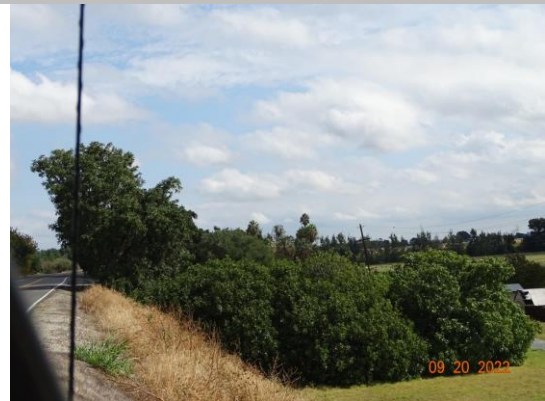
Photo 1 of 1 : SP_2024_NA0002_63_118_20240301_00055.jpg

View of the fig tree on the LS slope (Fall 2022).

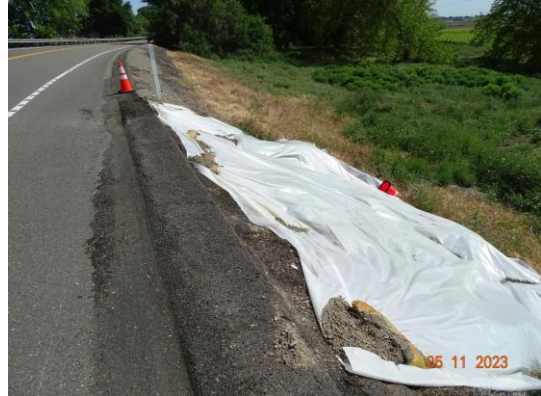
Photo 1 of 1 : SP_2024_NA0002_63_90_20240301_00044.jpg

View of the repaired shoulder and plastic cover on the LS slope (Spring 2023).

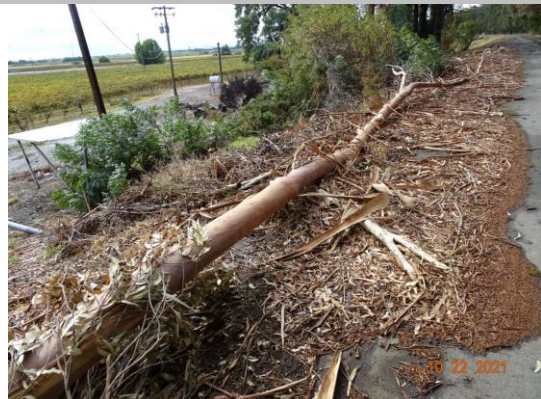
Photo 1 of 1 : SP_2024_NA0002_63_72_20240301_00034.jpg

View of large downed tree limb on the landside hinge (Fall 2021).

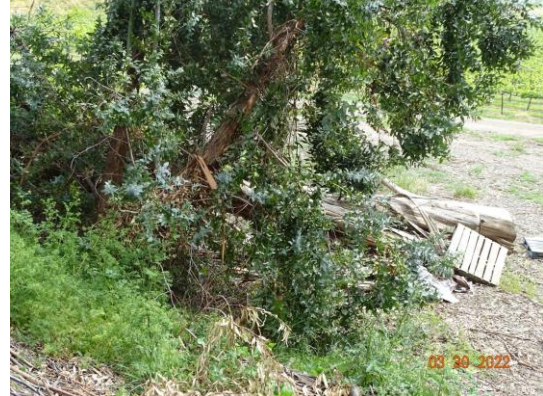
Photo 1 of 1 : SP_2024_NA0002_63_65_20240301_00022.jpg

View of large downed tree on the landside slope (Spring 2022).

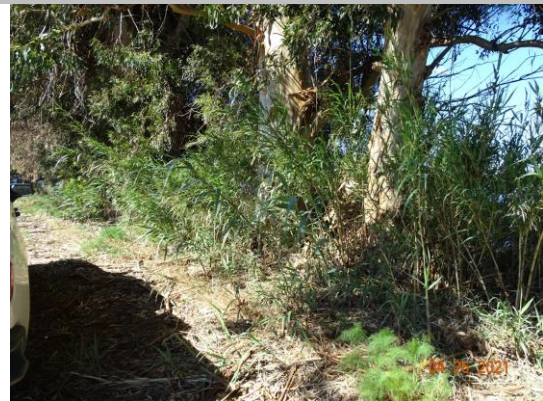
Photo 1 of 1 : SP_2024_NA0002_63_92_20240301_00045.jpg

View of arundo on the waterside slope (Spring 2021).

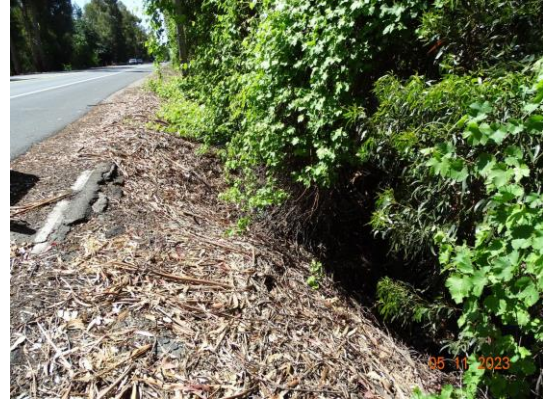
Photo 1 of 3 : SP_2024_NA0002_63_69_20240301_00029.jpg

View of the scour at LM 8.37 (Spring 2023).

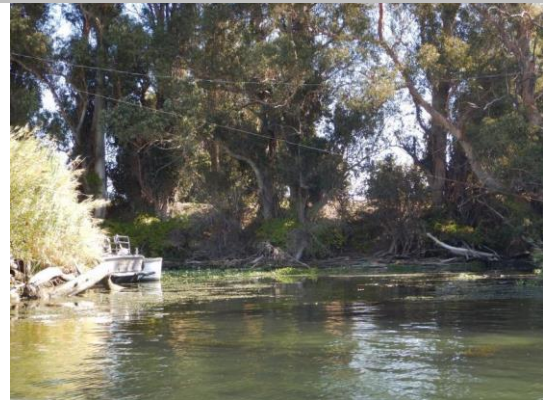
Photo 2 of 3 : SP_2024_NA0002_63_69_20240301_00030.jpg

USACE 2018 Erosion Photo #1

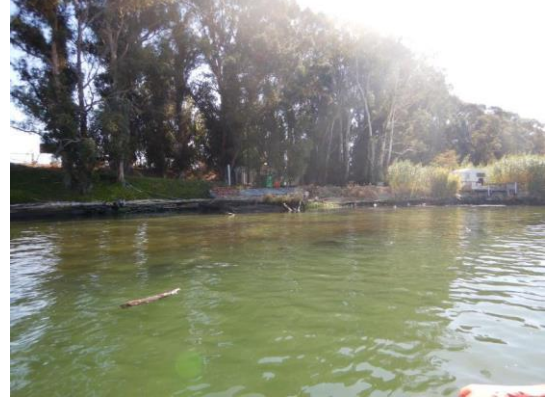
Photo 3 of 3 : SP_2024_NA0002_63_69_20240301_00031.jpg

USACE 2018 Erosion Photo #2

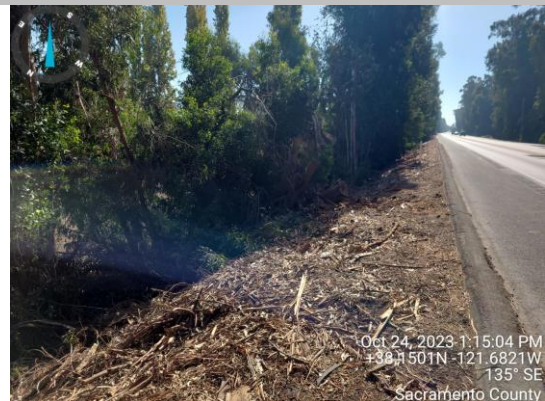
Photo 1 of 1 : SP_2024_NA0002_63_158_20240301_00064.jpg

View of downed trees on the landside slope. Fall 2023.

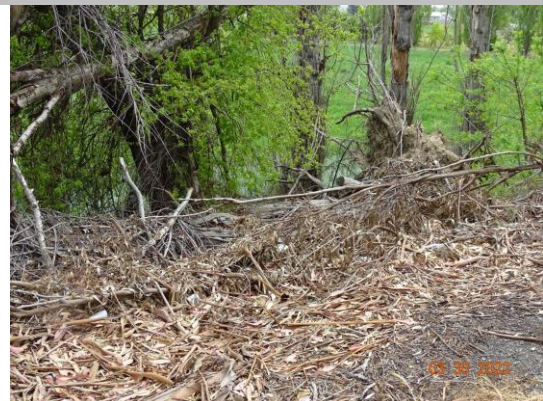
Photo 1 of 1 : SP_2024_NA0002_63_157_20240301_00063.jpg

View of downed tree on the landside slope (Spring 2022).

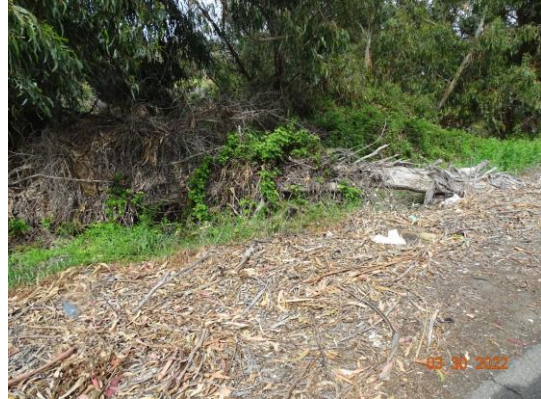
Photo 1 of 1 : SP_2024_NA0002_63_77_20240301_00035.jpg

View of downed trees needing removal on the waterside slope (Spring 2022).

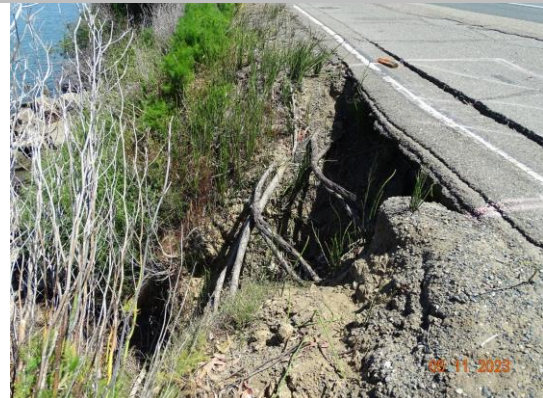
Photo 2 of 4 : SP_2024_NA0002_63_68_20240301_00026.jpg

Erosion at LM 9.10 by turnout (Spring 2023).

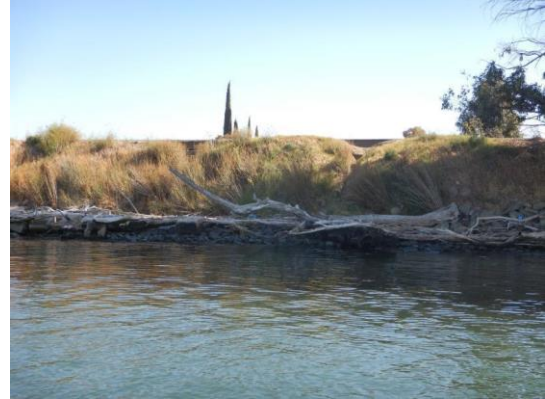
Photo 3 of 4 : SP_2024_NA0002_63_68_20240301_00027.jpg

USACE 2018 Erosion Photo #1

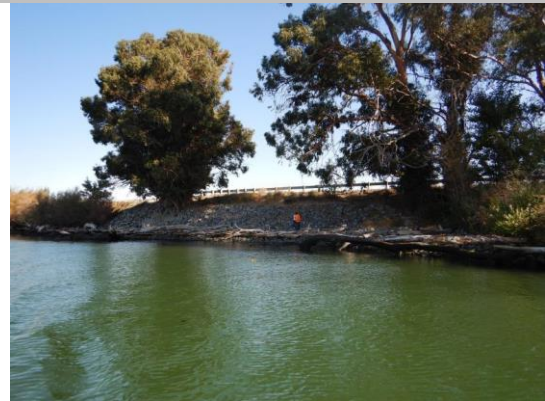
Photo 4 of 4 : SP_2024_NA0002_63_68_20240301_00028.jpg

USACE 2018 Erosion Photo #2

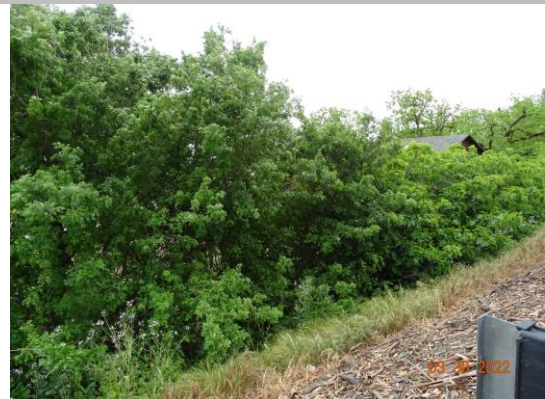
Photo 1 of 1 : SP_2024_NA0002_63_85_20240301_00041.jpg

View of thick trees on the landside slope (Spring 2022).

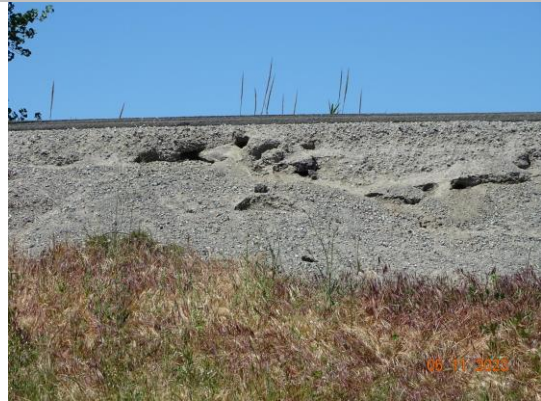
Photo 1 of 1 : SP_2024_NA0002_63_67_20240301_00024.jpg

View of rodent holes on the upper LS slope (Spring 2023).

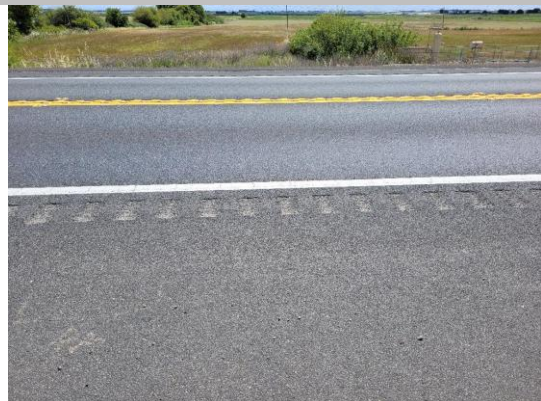
Photo 1 of 3 : UCIP_SP_2024_75626_113358.jpg

Top of Levee: View of levee crown looking from waterside

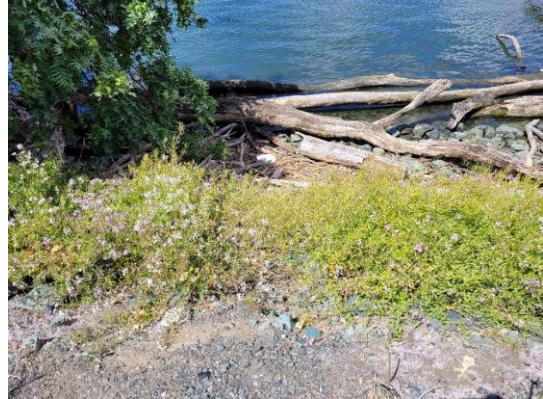
Photo 2 of 3 : UCIP_SP_2024_75626_113357.jpg

Water-Side: View of levee slope looking from crown

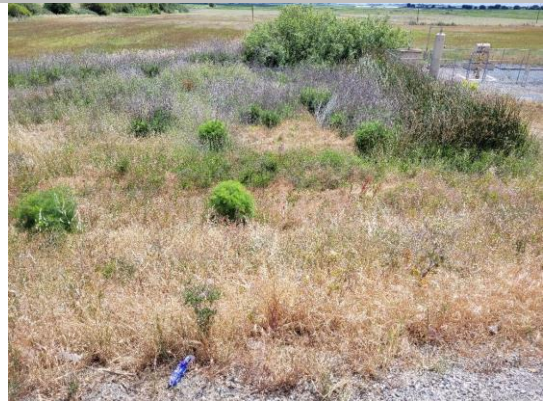
Photo 3 of 3 : UCIP_SP_2024_75626_113359.jpg

Land-Side: View of levee slope looking from crown

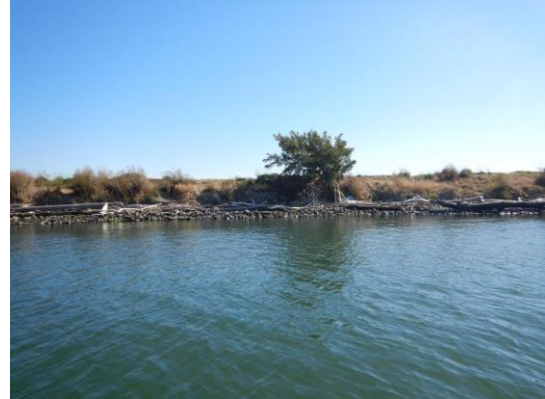
Photo 1 of 2 : SP_2024_NA0002_63_51_20240301_00016.jpg

USACE 2018 Erosion Photo #1

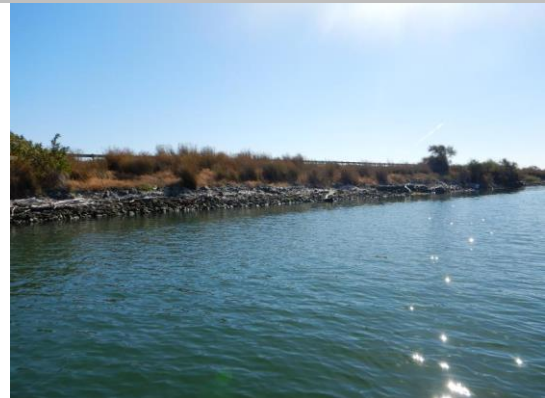
Photo 2 of 2 : SP_2024_NA0002_63_51_20240301_00017.jpg

USACE 2018 Erosion Photo #2

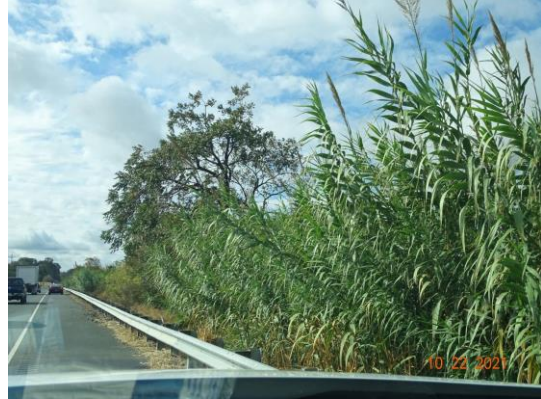
Photo 1 of 1 : SP_2024_NA0002_63_89_20240301_00043.jpg

View looking downstream at arundo on the waterside slope (Fall 2021).
