**Flood Control Project Maintenance  
Levee Inspections**

**Fall 2013 Levee Maintenance Deficiency Summary Report**

**Sacramento River Basin**

**Butte County Public Works Department**

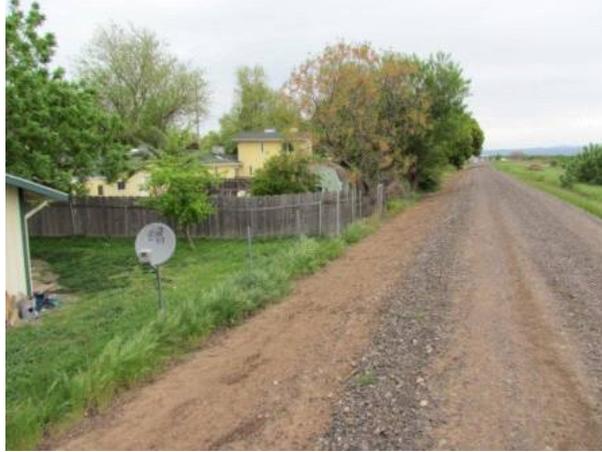
Levee Mile Report Line	4
Start Levee Mile	2.06
End Levee Mile	2.10
Location	Land Side
Category	Earthen Levee
Item	Encroachments
View of the fences along the L/S toe.	
rduffey_f_20130919_854.jpg

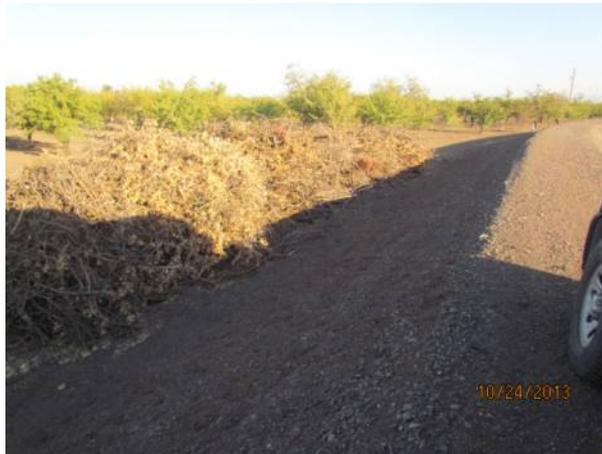
Levee Mile Report Line	7
Start Levee Mile	2.65
End Levee Mile	2.65
Location	Land Side
Category	Earthen Levee
Item	Encroachments
View of the prunings along landside toe.	
rduffey_f_20131104_121.JPG

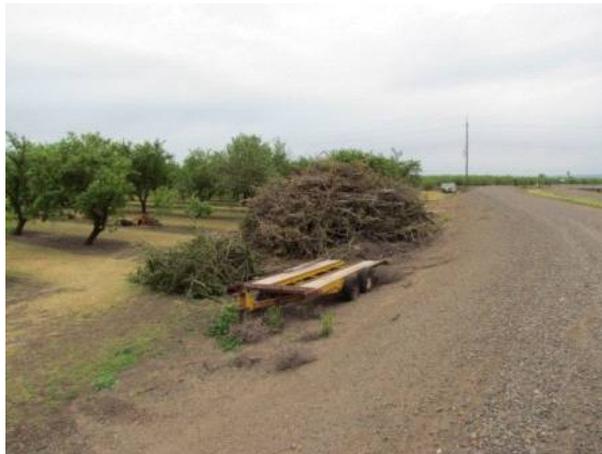
Levee Mile Report Line	8
Start Levee Mile	3.00
End Levee Mile	3.00
Location	Land Side
Category	Earthen Levee
Item	Encroachments
View of the pruning pile along the L/S toe.	
rduffey_f_20130919_853.jpg

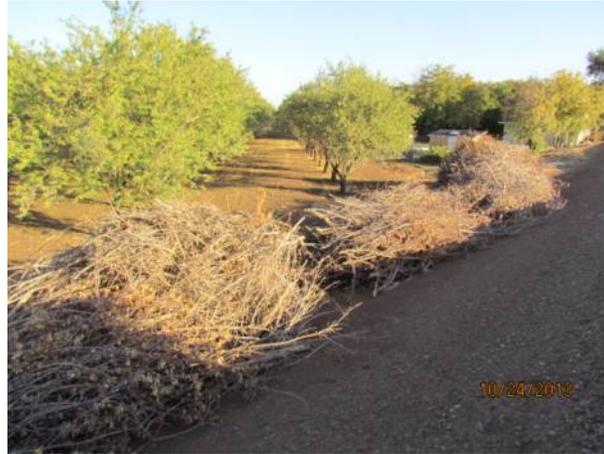
Levee Mile Report Line	11
Start Levee Mile	4.05
End Levee Mile	4.05
Location	Land Side
Category	Earthen Levee
Item	Encroachments

View of the prunings along the landside toe.

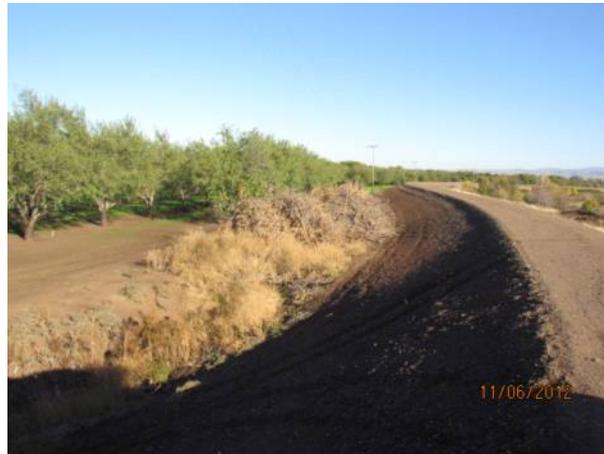
Levee Mile Report Line	13
Start Levee Mile	4.58
End Levee Mile	4.58
Location	Land Side
Category	Earthen Levee
Item	Encroachments

View of the brush pile along landside toe.

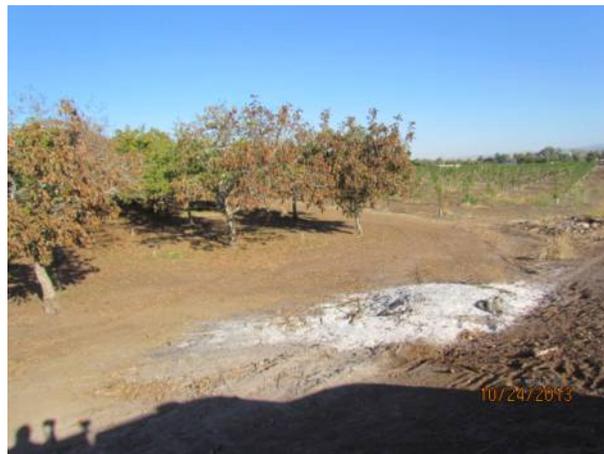
Levee Mile Report Line	15
Start Levee Mile	4.91
End Levee Mile	4.91
Location	Land Side
Category	Earthen Levee
Item	Encroachments

The landowner burned the pruning pile.

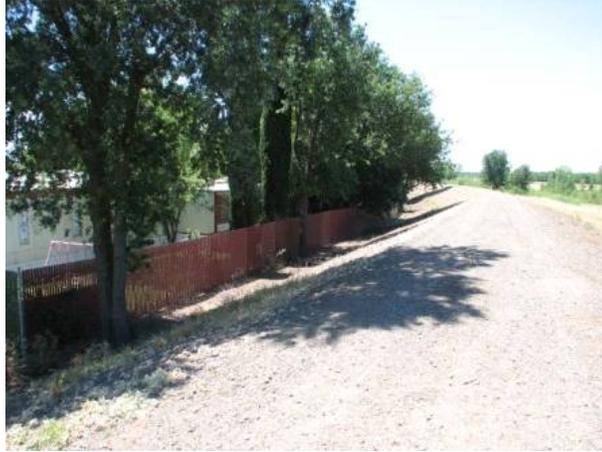
Levee Mile Report Line	1
Start Levee Mile	1.58
End Levee Mile	1.90
Location	Land Side
Category	Earthen Levee
Item	Encroachments
View of the fence along the landside toe of the levee.	
rduffey_f_20130919_858.jpg

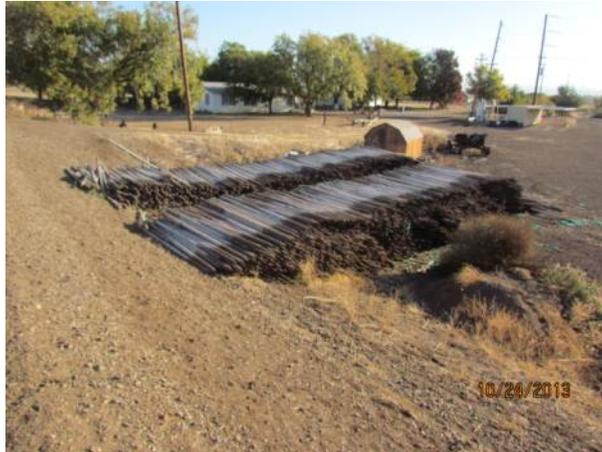
Levee Mile Report Line	2
Start Levee Mile	2.90
End Levee Mile	2.90
Location	Land Side
Category	Earthen Levee
Item	Encroachments
View of the tree stakes along the landside slope and toe.	
rduffey_f_20131104_123.JPG

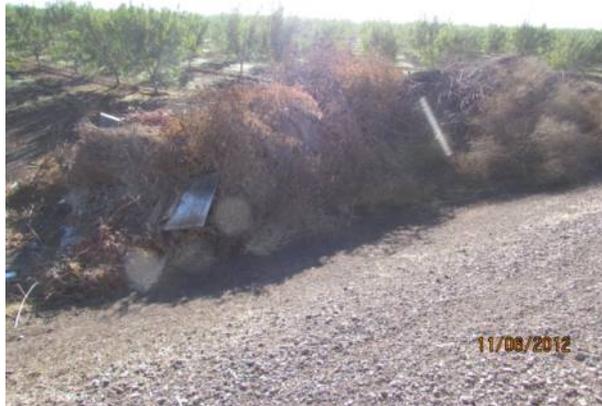
Levee Mile Report Line	3
Start Levee Mile	3.42
End Levee Mile	3.42
Location	Land Side
Category	Earthen Levee
Item	Encroachments
View of the brush pile along landside toe.	
rduffey_f_20130919_859.JPG

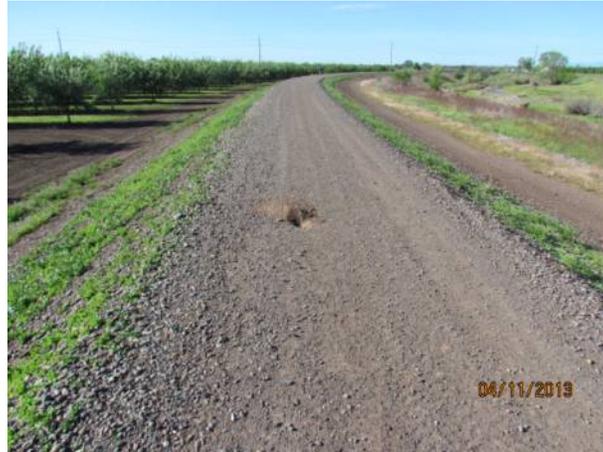
Levee Mile Report Line	4
Start Levee Mile	3.45
End Levee Mile	3.45
Location	Crown
Category	Earthen Levee
Item	Animal Control
View of the rodent hole in the crown roadway.	
rduffey_f_20130919_860.JPG

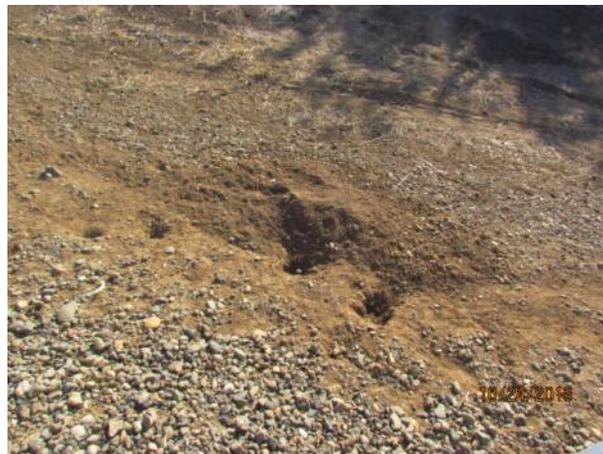
Levee Mile Report Line	5
Start Levee Mile	4.70
End Levee Mile	4.70
Location	Land Side
Category	Earthen Levee
Item	Animal Control
View of the rodent holes along the landside slope.	
rduffey_f_20131104_124.JPG

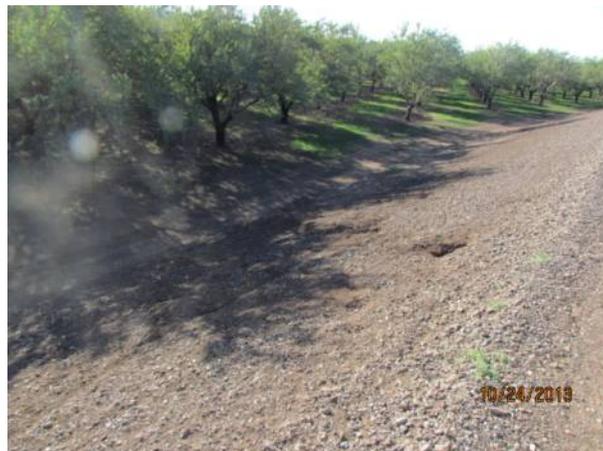
Levee Mile Report Line	6
Start Levee Mile	5.59
End Levee Mile	5.59
Location	Land Side
Category	Earthen Levee
Item	Animal Control
View of the rodent holes along the landside slope.	
rduffey_f_20131104_126.JPG

DWR ID: DWR_NA0003_02_f_2013_8										
6	5.59	5.59	Earthen Levee	Animal Control	LS	A/W	A3 : No rodents visible, but rodent burrows visible; need to backfill and compact or grout burrows.	39.740508 ° -121.926814 °	39.740508 ° -121.926814 °	9 Y
DWR ID: DWR_NA0003_02_f_2013_9										
7	6.02	6.02	Earthen Levee	Encroachments	LS	M	PR : Prunings	39.736652 ° -121.932053 °	39.736652 ° -121.932053 °	7 Y
DWR ID: DWR_NA0003_02_s_2013_7

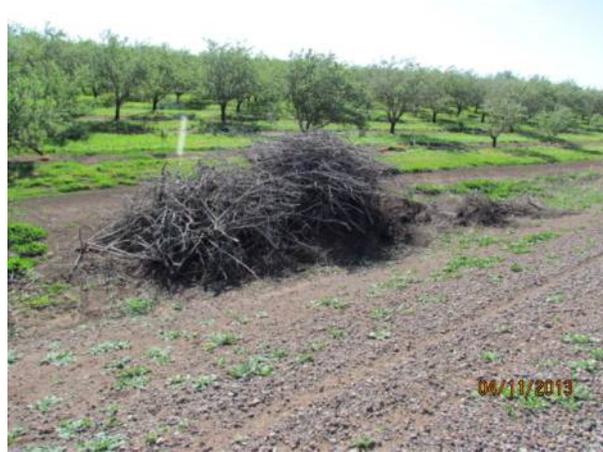
Levee Mile Report Line	7
Start Levee Mile	6.02
End Levee Mile	6.02
Location	Land Side
Category	Earthen Levee
Item	Encroachments
View of the prunings along the landside toe.	
rduffey_f_20130919_861.JPG

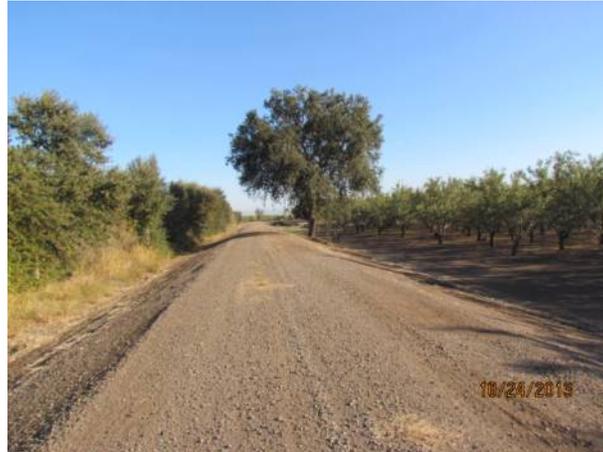
Levee Mile Report Line	1
Start Levee Mile	0.05
End Levee Mile	0.05
Location	Land Side
Category	Earthen Levee
Item	Vegetation
View of the levee where both slopes have been dragged.	
rduffey_f_20131104_125.JPG

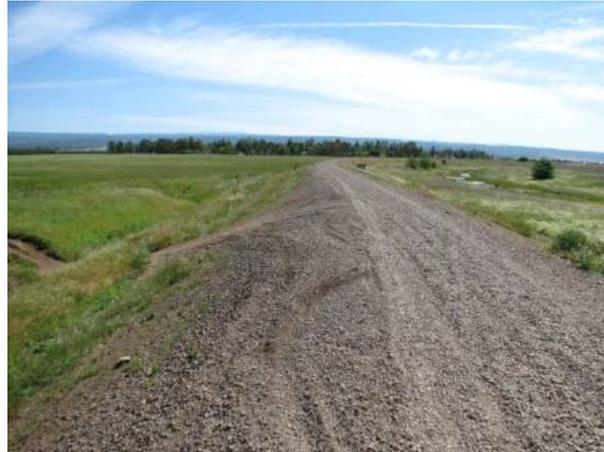
View of the motorcycle erosion on the landside slope of the levee.

LMIR No.	Levee Mile		Category	Item	Location	Rating	Action/Comment	GPS Latitude/Longitude		Issue No. Photo
	Start	End						Start	End	
1	0.06	0.06	Earthen Levee	Slope Stability	WS	M	S3 : Repair the levee slope damaged by vehicle traffic and prevent access where possible.	39.786068 ° -121.881828 °	39.786068 ° -121.881828 °	3 Y
DWR ID: DWR_NA0003_03_s_2012_3										
2	1.83	1.83	Earthen Levee	Vegetation	LS	A	V1 : Control annual grass and weeds on the levee slopes and easements.	39.780008 ° -121.852628 °	39.780008 ° -121.852628 °	4 Y
DWR ID: DWR_NA0003_03_f_2013_4

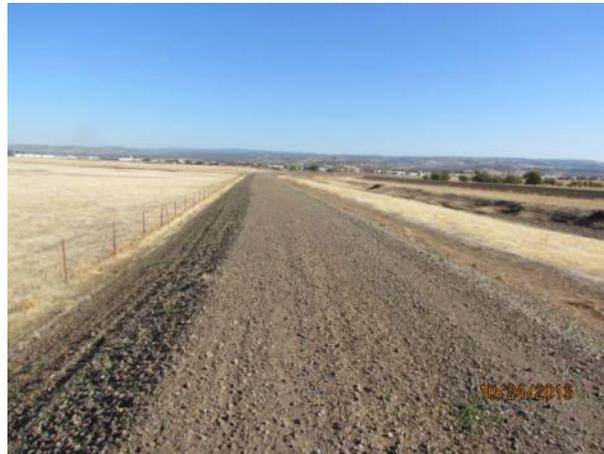
Levee Mile Report Line	2
Start Levee Mile	1.83
End Levee Mile	1.83
Location	Land Side
Category	Earthen Levee
Item	Vegetation

View of the levee where both slopes have been dragged.

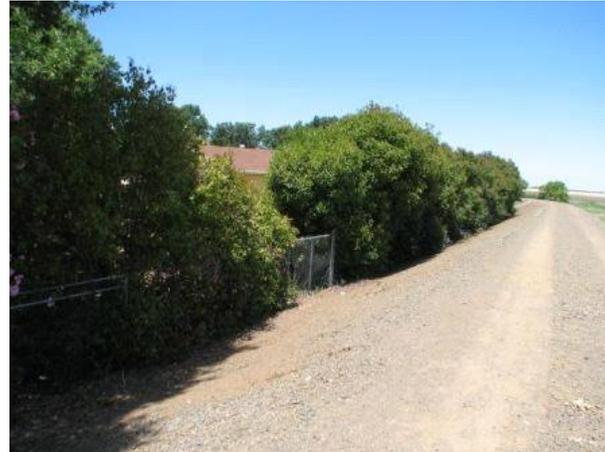
Levee Mile Report Line	1
Start Levee Mile	0.98
End Levee Mile	1.05
Location	Land Side
Category	Earthen Levee
Item	Encroachments
View of the fence and trees along the landside toe of the levee.	
rduffey_f_20130919_863.jpg

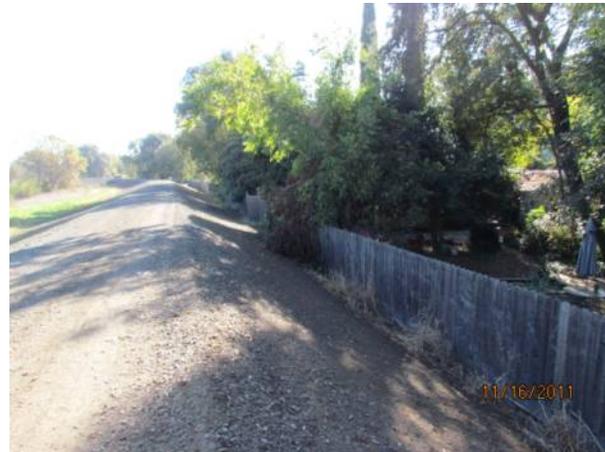
Levee Mile Report Line	2
Start Levee Mile	1.16
End Levee Mile	1.27
Location	Land Side
Category	Earthen Levee
Item	Encroachments
View of the fence along the L/S toe.	
rduffey_f_20130919_865.jpg

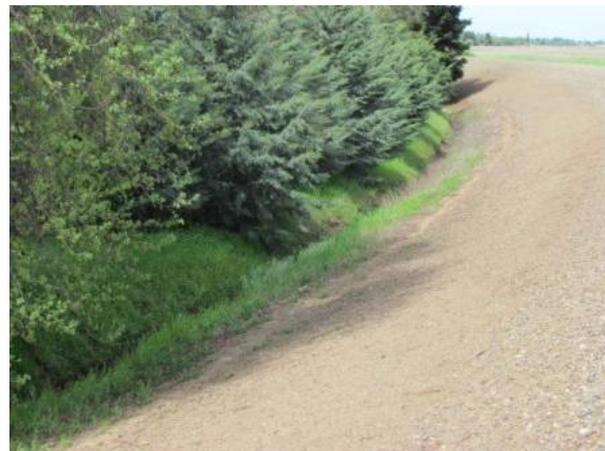
Levee Mile Report Line	3
Start Levee Mile	1.32
End Levee Mile	1.40
Location	Land Side
Category	Earthen Levee
Item	Encroachments
View of AG ditch at the L/S toe.	
rduffey_f_20130919_864.jpg

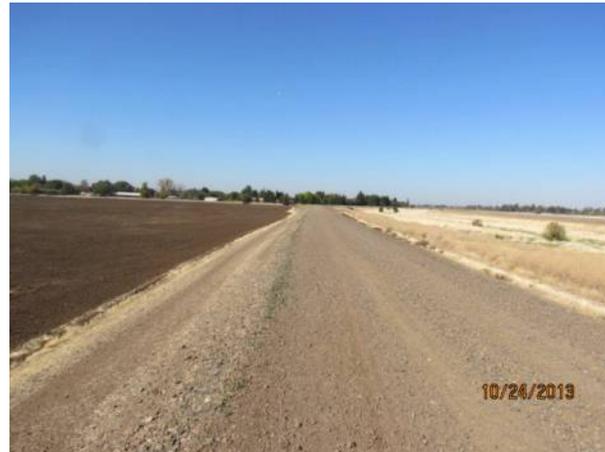
Levee Mile Report Line	4
Start Levee Mile	1.66
End Levee Mile	1.66
Location	Land Side
Category	Earthen Levee
Item	Vegetation
View of the levee where both slopes have been dragged.	
rduffey_f_20131104_130.JPG

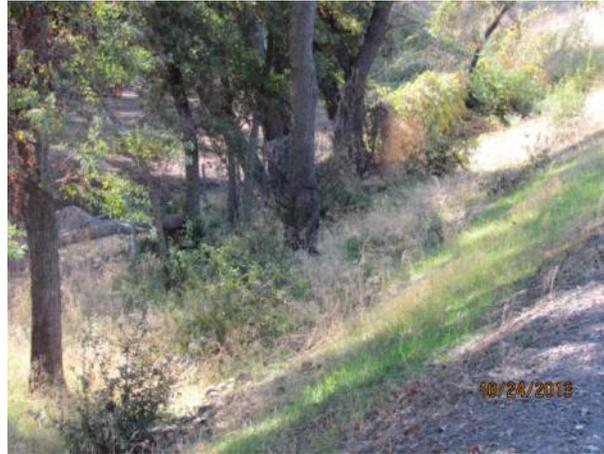
Levee Mile Report Line	1
Start Levee Mile	0.34
End Levee Mile	0.42
Location	Land Side
Category	Earthen Levee
Item	Vegetation
View of the vegetation along the landside slope and toe.	
rduffey_f_20131104_131.JPG
