**Flood Control Project Maintenance  
Levee Inspections**

**Fall 2015 Levee Maintenance Deficiency Summary Report**

**Sacramento River Basin**

**Butte County Department of Public Works**

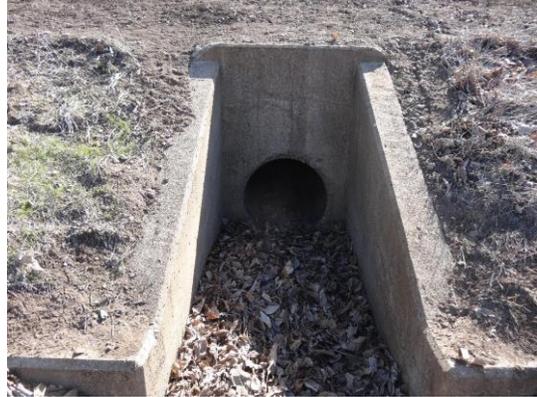
Photo 1 of 3 : UCIP\_FA\_2015\_3886.jpg

**Action/Comments**  
 Inspector Comments: FS\_ID:32044  
 DS\_ID:19211  
 EP\_NO: N/A  
 FS\_HLM: 1.021  
 Repair Type: Non-Urgent  
 Crossing Status: Found  
 UCIP Comments: Vegetation debris on waterside. Needs clearing and cleaning.  
 FIELD\_STRUCT\_DESC: 24-inch CM pipe through the levee, 12.0 feet below the crown. Flap gate on the waterward end. Concrete "U" headwalls on both ends. Grouted riprap apron on the landward end. Grouted riprap spillway on the waterward end. O&M Manual Sac 504, May 1965.  
 FS Date: 02/20/2014

LS view: U typed concrete headwall and CMP on levee slope.

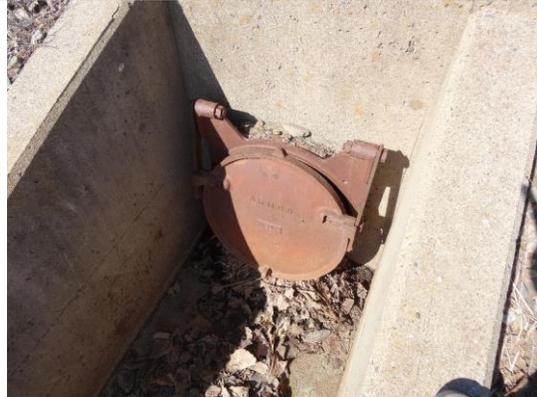
Photo 2 of 3 : UCIP\_FA\_2015\_3887.jpg

WS view: vegetation debris blocking outlet.

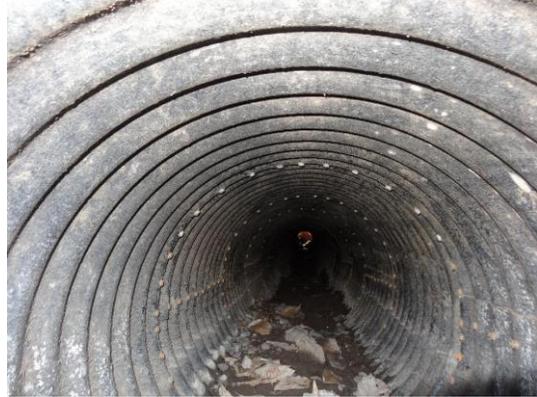
Photo 1 of 3 : UCIP\_FA\_2015\_4518.jpg

**Action/Comments**  
 Inspector Comments: FS\_ID:41767  
 DS\_ID:19212  
 EP\_NO: N/A  
 FS\_HLM: 1.944  
 Repair Type: Urgent  
 Crossing Status: Found  
 UCIP Comments: No riprap spillway on waterside. Needs cleaning and clearing of debris. Flap gate was not fully closed.  
 FIELD\_STRUCT\_DESC: 24-inch CM pipe through the levee, 13.0 feet below the crown. Flap gate on the waterward end. Concrete "U" headwalls on both ends. Grouted riprap apron on the landward end. Grouted riprap spillway on the waterward end. O&M Manual Sac 504, May 1965.  
 FS Date: 02/20/2014

LS view: inside view of CMP on levee slope. Needs cleaning and clearing.

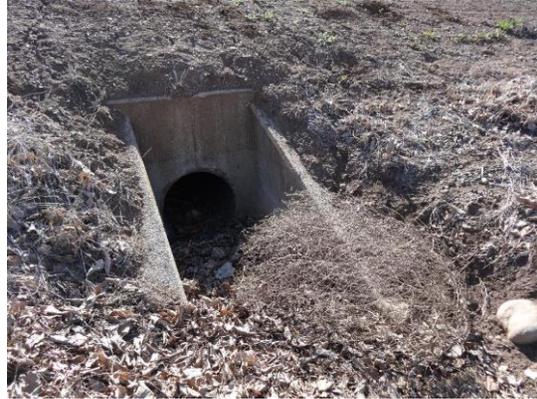
Photo 2 of 3 : UCIP\_FA\_2015\_4519.jpg

LS view: U type concrete headwall and CMP on levee slope. Vegetation debris blocking inlet.

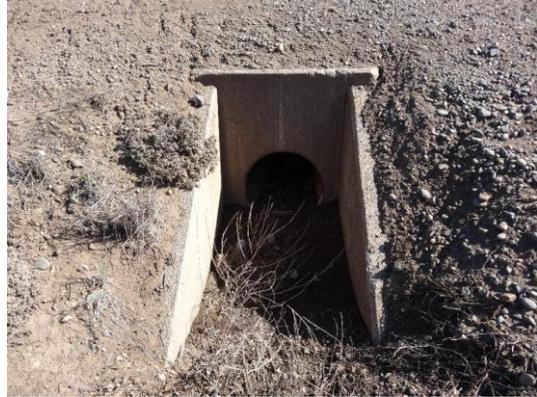
Photo 1 of 2 : UCIP\_FA\_2015\_4174.jpg

**Action/Comments**  
 Inspector Comments: FS\_ID:30294  
 DS\_ID:19216  
 EP\_NO: N/A  
 FS\_HLM: 3.106  
 Repair Type: Non-Urgent  
 Crossing Status: Found  
 UCIP Comments: Inlet and outlet needs cleaning and clearing of debris.  
 FIELD\_STRUCT\_DESC: 24-inch CM pipe through levee, 8.5 feet below the crown. Flap gate on the waterward end. Concrete "U" headwalls on both ends. Grouted riprap apron on the landward end. Grouted riprap spillway on the waterward end. O&M Manual Sac 504, May 1965.  
 FS Date: 02/20/2014

LS view: U type concrete headwall and CMP on levee slope. Debris blocking the inlet pipe.

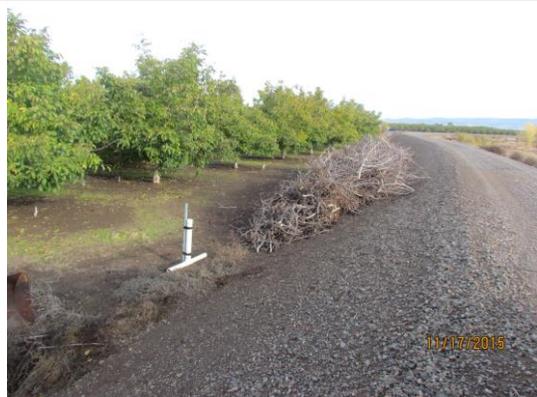
Photo 2 of 2 : FA\_2015\_NA0003\_64\_31\_20151118\_00015.jpg

View of the prunings and bait station along the landside slope.

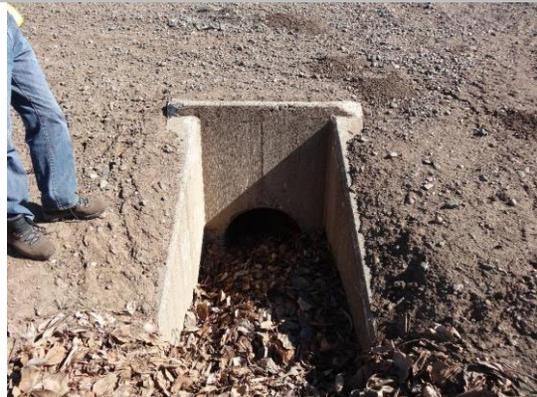
Photo 1 of 2 : UCIP\_FA\_2015\_4176.jpg

LS view: U type concrete headwall and CMP on levee slope. Vegetation debris blocking the inlet.

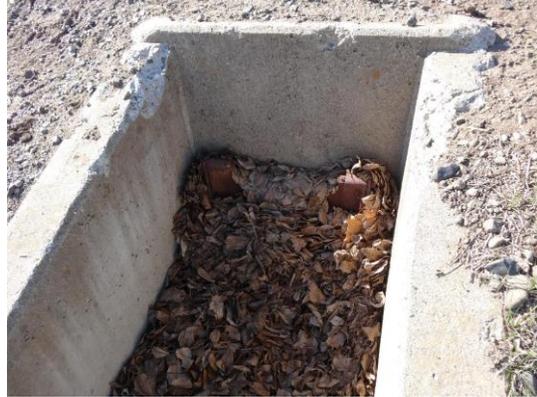
Photo 2 of 2 : UCIP\_FA\_2015\_4177.jpg

WS view: U type concrete headwall, flapgate on levee slope. Vegetation debris blocking the outlet.

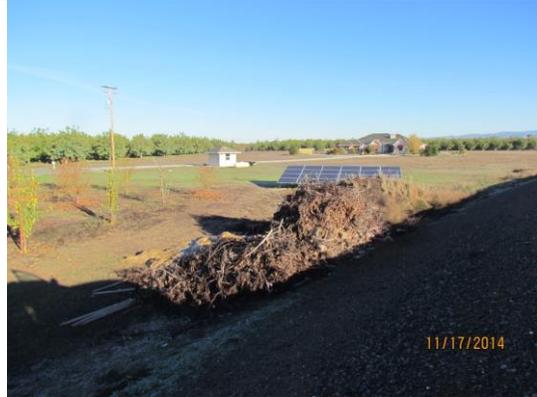
Photo 1 of 1 : FA\_2015\_NA0003\_64\_27\_20150910\_00009.jpg

View of the prunings along the landside toe.

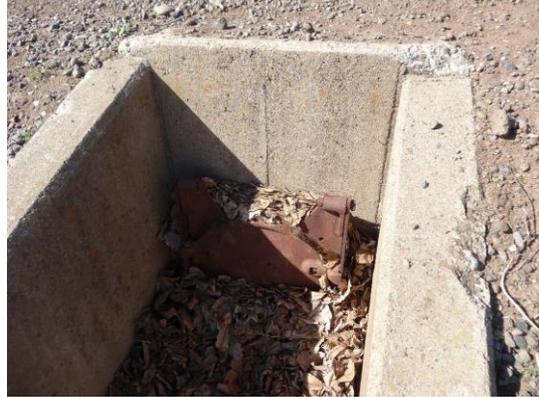
Photo 3 of 3 : UCIP\_FA\_2015\_4510.jpg

WS view: U type concrete headwall, pipe, and flapgate on levee slope. Vegetation debris blocking outlet.

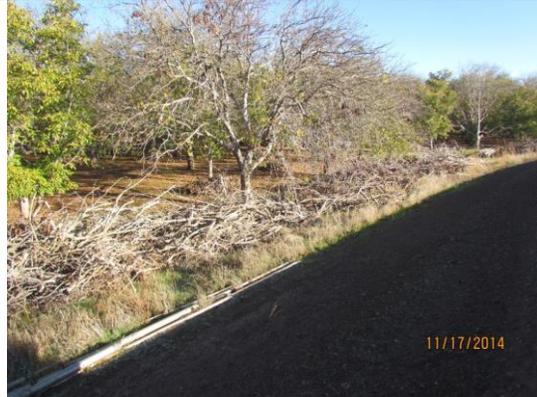
Photo 1 of 1 : FA\_2015\_NA0003\_64\_29\_20150910\_00010.jpg

View of the prunings along the landside toe.

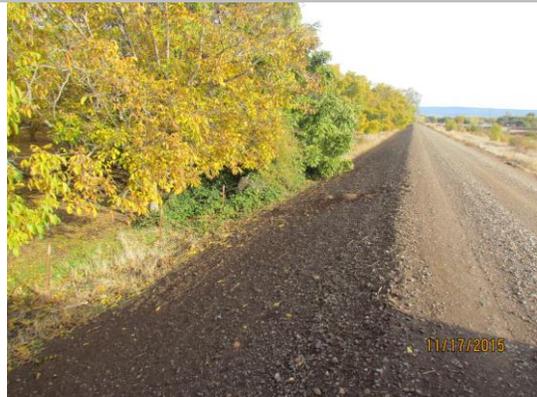
Photo 1 of 1 : FA\_2015\_NA0003\_64\_33\_20151118\_00018.jpg

LM Start	<b>4.27</b>	Rating **	M	Issue No.	<b>33</b>
LM End	<b>4.27</b>	Issue Type +	Ma	Location *	LS
Category	Earthen Levee		GPS Latitude/Longitude		
			Start	End	
Item	Animal Control		39.773398 °	39.773398 °	
			-121.895765 °	-121.895765 °	
DWR ID	DWR_NA0003_01_f_2015_33				
Action/Comments					
Exterminate rodents and backfill and compact or grout burrows. Inspector Comments: Repair the rodent holes along the landside slope.

View of the rodent holes along the landside slope.

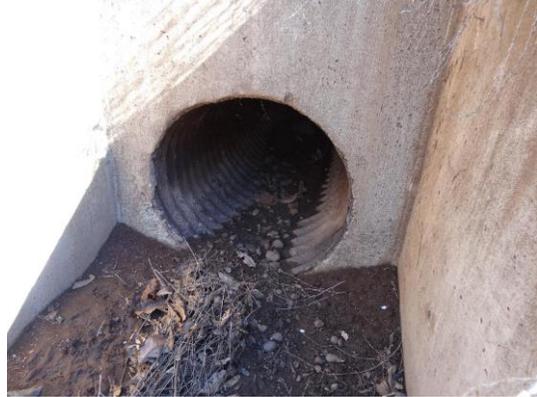
Photo 1 of 2 : UCIP\_FA\_2015\_4513.jpg

**Action/Comments**  
 Inspector Comments: FS\_ID:30312  
 DS\_ID:19220  
 EP\_NO: N/A  
 FS\_HLM: 4.574  
 Repair Type: Non-Urgent  
 Crossing Status: Found  
 UCIP Comments: Needs cleaning and clearing of debris.  
 FIELD\_STRUCT\_DESC: 24-inch CM pipe through the levee, 13.0 feet below the crown. Flap gate on the waterward end. Concrete "U" headwalls on both ends. Grouted riprap apron on the landward end. Grouted riprap spillway on the waterward end. O&M Manual Sac 504, May 1965.  
 FS Date: 02/20/2014

LS view: U type concrete headwall and CMP on levee slope. Needs cleaning and clearing of debris.

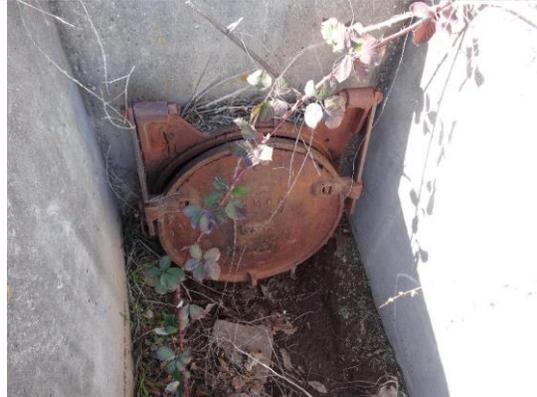
Photo 2 of 2 : UCIP\_FA\_2015\_4514.jpg

WS view: U type concrete headwall, pipe, and flapgate on levee slope. Vegetation debris blocking outlet.

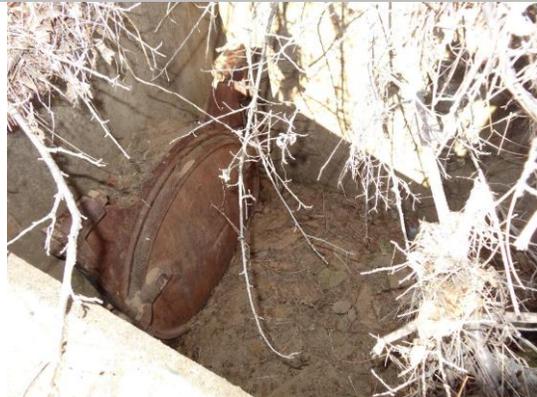
Photo 2 of 2 : UCIP\_FA\_2015\_4570.jpg

WS view: U type concrete headwall, pipe, and flapgate on levee slope. Vegetation/soil debris blocking outlet.

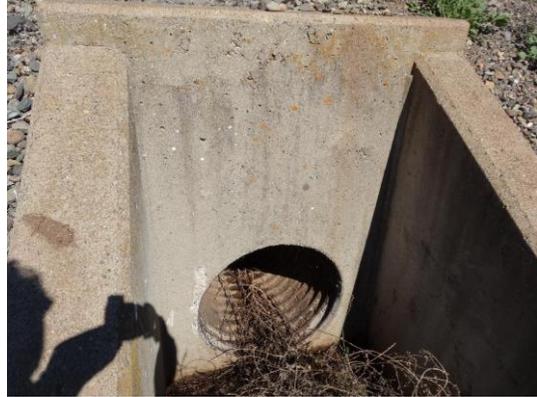
Photo 1 of 3 : UCIP\_FA\_2015\_3212.jpg

LS view: U type concrete headwall and CMP on levee slope. Vegetation debris on inlet box.

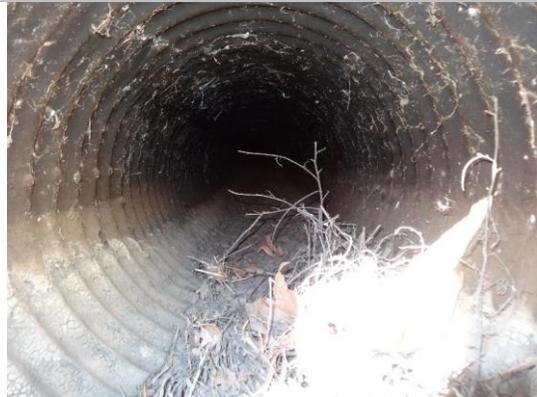
Photo 1 of 3 : UCIP\_FA\_2015\_4653.jpg

LS view: inside view of CMP on levee slope. Needs cleaning and clearing.

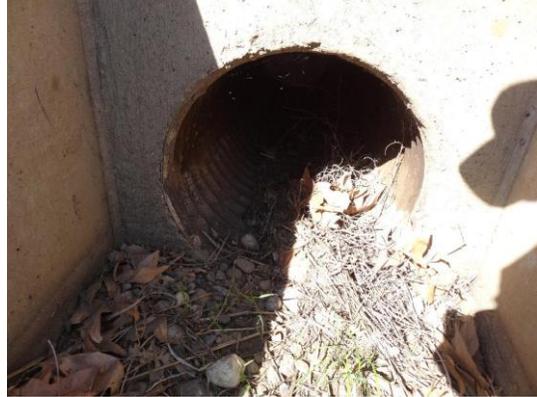
Photo 2 of 3 : UCIP\_FA\_2015\_4654.jpg

LS view: U type concrete headwall and CMP on levee slope. Vegetation debris in inlet pipe.

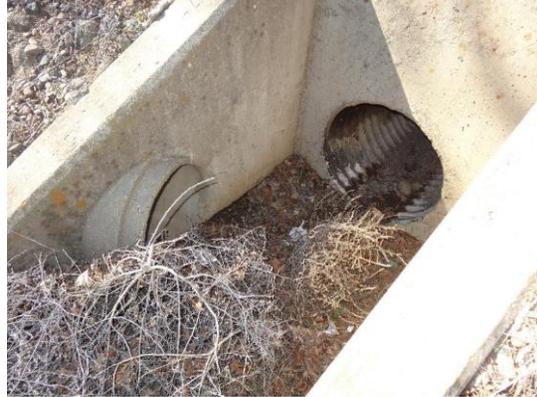
Photo 1 of 2 : UCIP\_FA\_2015\_4524.jpg

LS view: U type concrete headwall and CMP on levee slope. Vegetation debris and soil in inlet area.

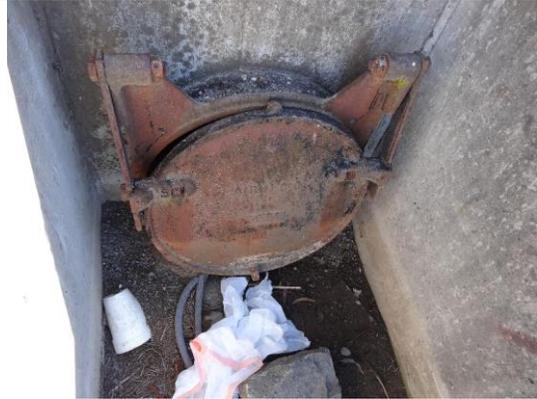
Photo 2 of 2 : UCIP\_FA\_2015\_4525.jpg

WS view: U type concrete headwall, pipe, and flapgate on levee slope. Debris in outlet box.

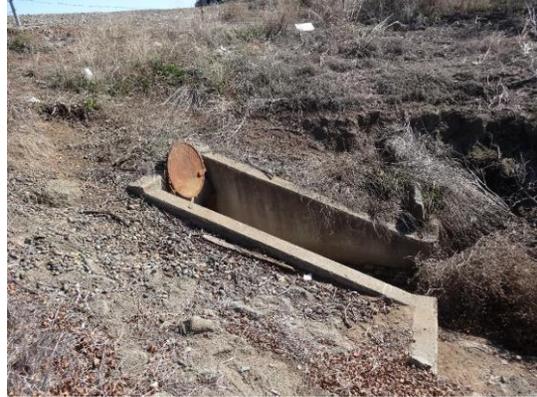
Photo 3 of 3 : UCIP\_FA\_2015\_4529.jpg

WS view: U type concrete headwall and flapgate on levee slope. Vegetation debris on spillway.

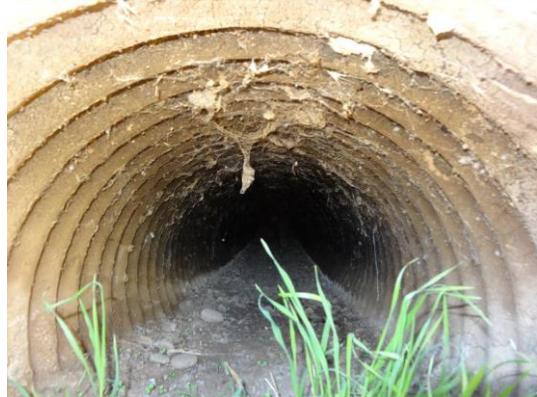
Photo 1 of 3 : UCIP\_FA\_2015\_4530.jpg

LS view: inside view of CMP on levee slope. Needs cleaning and clearing.

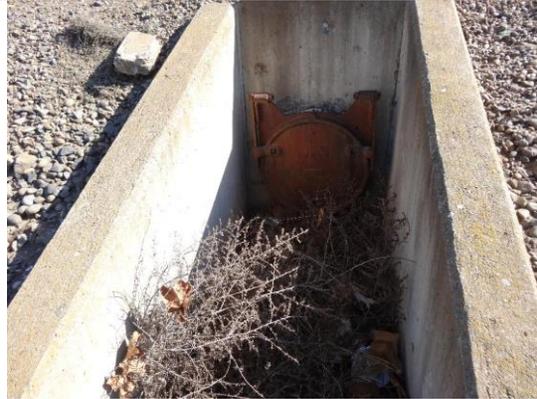
Photo 3 of 3 : UCIP\_FA\_2015\_4532.jpg

WS view: U type concrete headwall, pipe, and flapgate on levee slope. Vegetation debris blocking outlet.

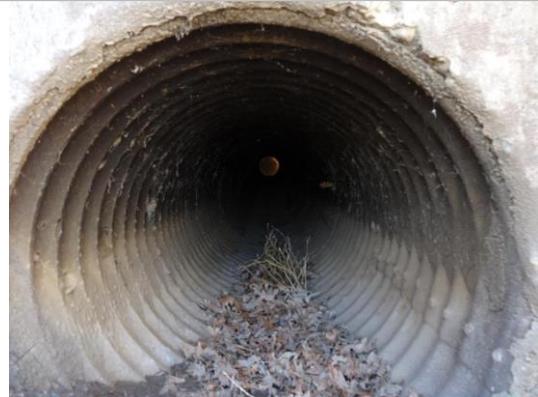
Photo 1 of 3 : UCIP\_FA\_2015\_4576.jpg

LS view: inside view of CMP on levee slope. Needs cleaning and clearing.

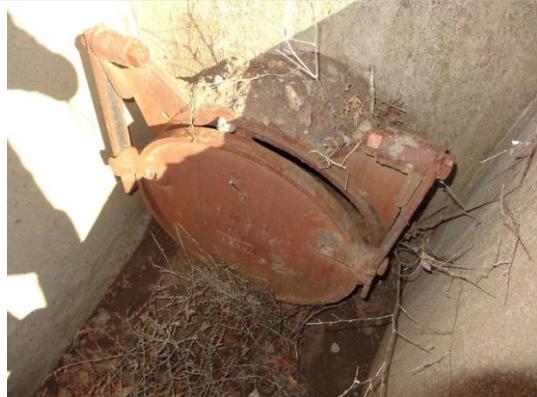
Photo 3 of 3 : UCIP\_FA\_2015\_4634.jpg

WS view: U type concrete headwall, pipe, and flapgate on levee slope. Gate not fully closed. Debris and soil in outlet box.

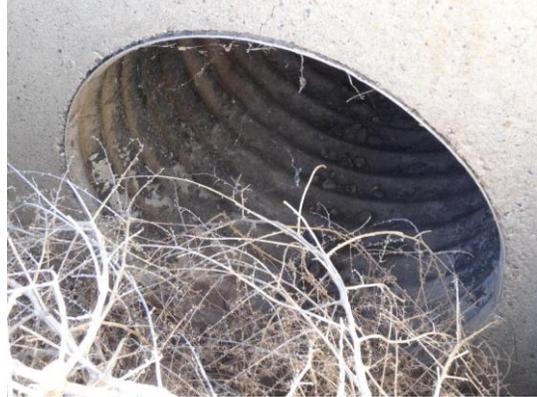
Photo 1 of 3 : UCIP\_FA\_2015\_4660.jpg

LS view: inside view of CMP on levee slope. Needs cleaning and clearing.

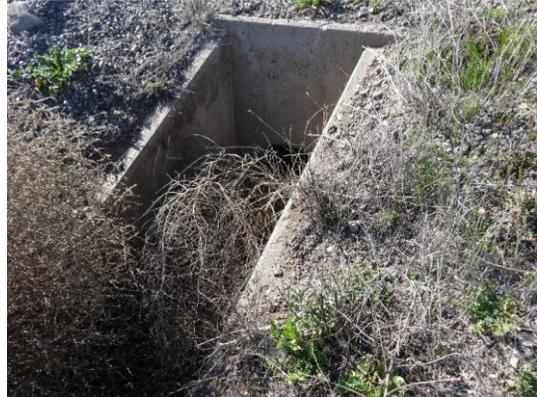
Photo 2 of 3 : UCIP\_FA\_2015\_4661.jpg

LS view: U type concrete headwall and CMP on levee slope. Vegetation debris and soil blocking inlet.

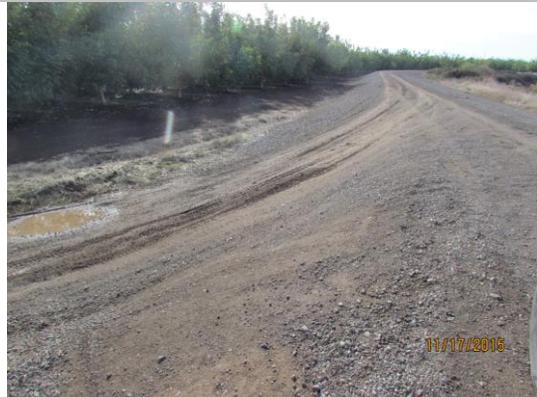
Photo 1 of 1 : FA\_2015\_NA0003\_65\_10\_20151118\_00007.jpg

View of the vehicle erosion along the landside slope.

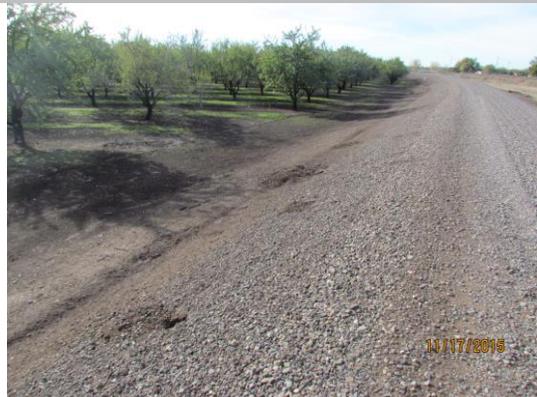
Photo 1 of 1 : FA\_2015\_NA0003\_65\_11\_20151118\_00008.jpg

View of the rodent holes along the landside slope.

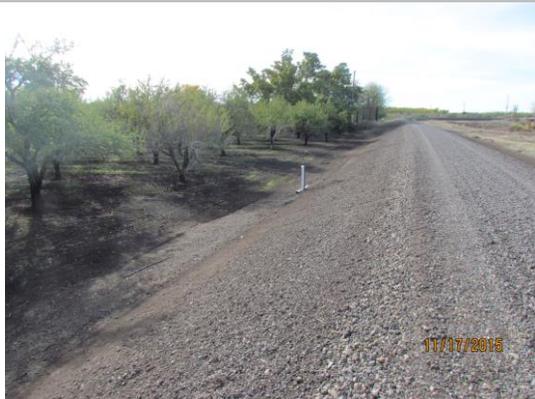
Photo 2 of 2 : FA\_2015\_NA0003\_65\_8\_20151118\_00009.jpg

View of the bait station by the rodent holes.

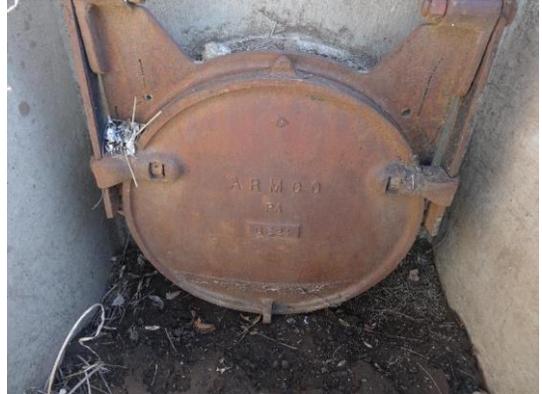
Photo 3 of 3 : UCIP\_FA\_2015\_4665.jpg

WS view: U type concrete headwall, pipe, and flapgate on levee slope. Soil/mud on outlet box.

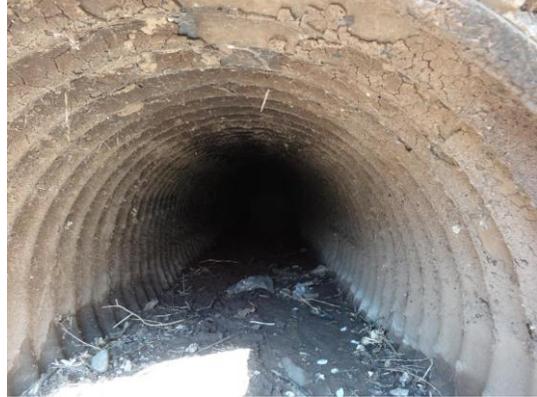
Photo 1 of 3 : UCIP\_FA\_2015\_4666.jpg

LS view: inside view of CMP on levee slope. Needs cleaning and clearing.

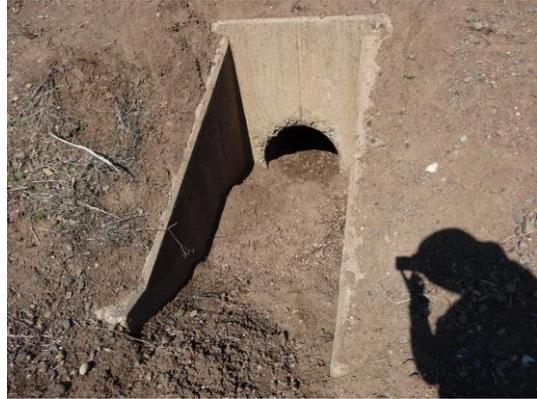
Photo 2 of 3 : UCIP\_FA\_2015\_4667.jpg

LS view: U type concrete headwall and CMP on levee slope. Soil/mud on inlet box.

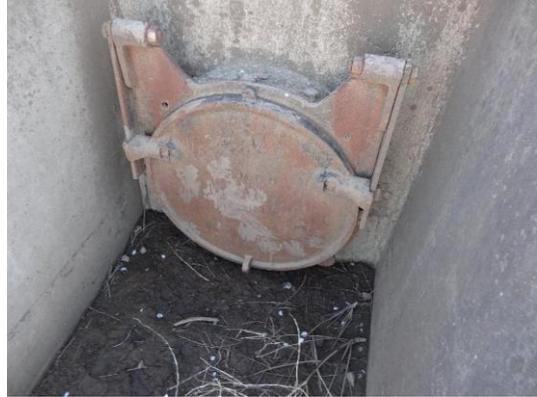
Photo 3 of 3 : UCIP\_FA\_2015\_4668.jpg

WS view: U type concrete headwall, pipe, and flapgate on levee slope. Soil/mud on outlet box.

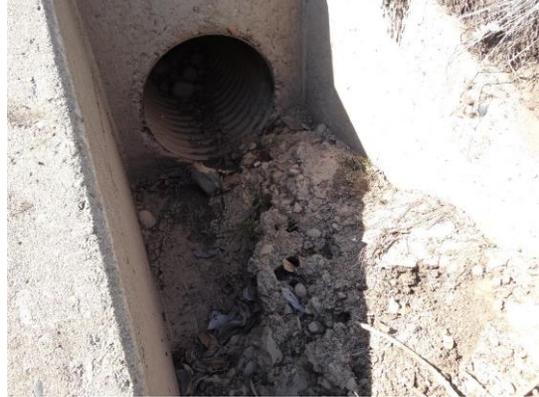
Photo 2 of 3 : UCIP\_FA\_2015\_3304.jpg

LS view: U type concrete headwall and CMP on levee slope. Soil/mud on inlet box.

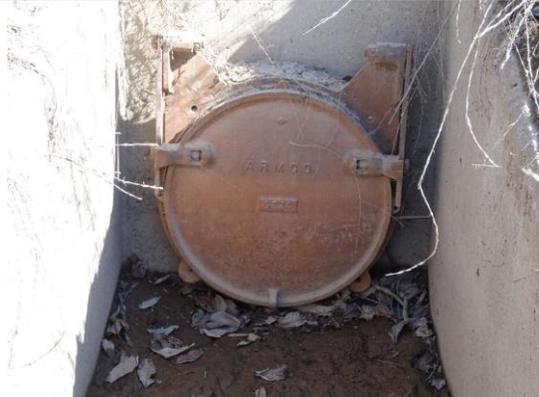
Photo 3 of 3 : UCIP\_FA\_2015\_3305.jpg

WS view: U type concrete headwall, pipe, and flapgate on levee slope. Soil/mud on outlet box.

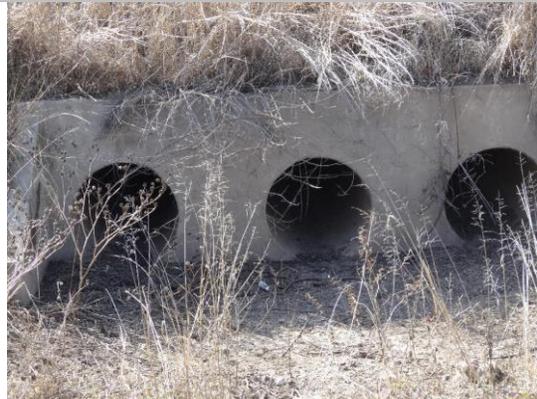
Photo 1 of 3 : UCIP\_FA\_2015\_3160.jpg

LS view: U type concrete headwall and CMPs on levee slope. Soil/mud on inlet box.

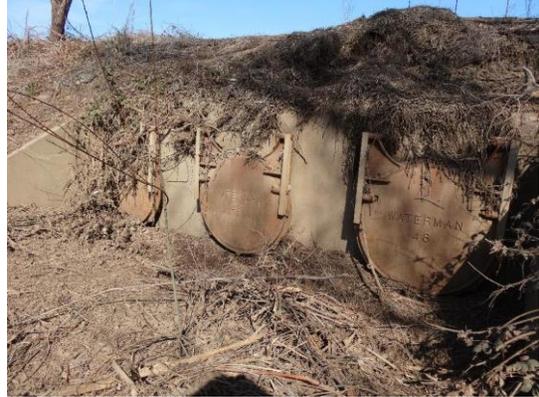
Photo 2 of 3 : UCIP\_FA\_2015\_3161.jpg

WS view: U type concrete headwall, pipes, and flapgates on levee slope. Soil/mud on outlet box. Vegetation debris on outlet box

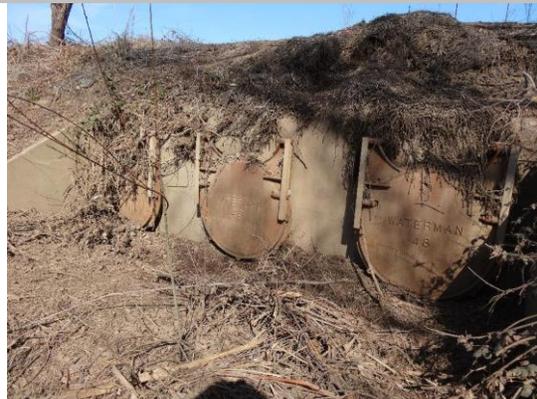
Photo 2 of 3 : UCIP\_FA\_2015\_3164.jpg

WS view: U type concrete headwall, pipes, and flapgates on levee slope. Soil/mud on outlet box. Vegetation debris on outlet box

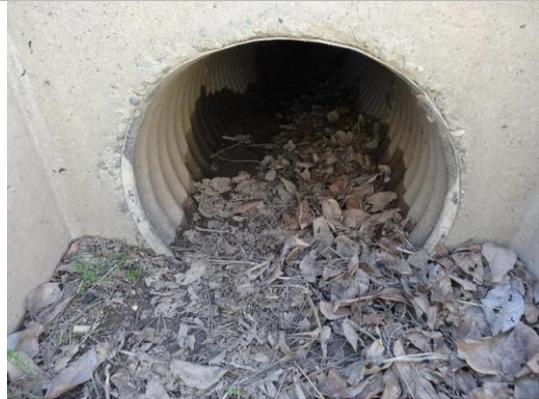
Photo 1 of 2 : UCIP\_FA\_2015\_3309.jpg

LS view: U type concrete headwall and CMP on levee slope. Soil/mud and vegetation on inlet box.

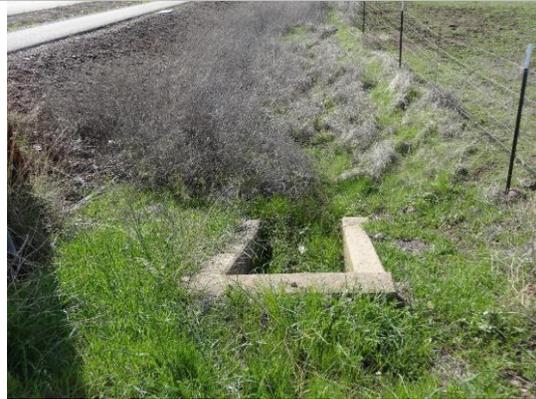
Photo 1 of 2 : UCIP\_FA\_2015\_3949.jpg

LS view: U type concrete headwall of CMP culvert on levee slope. Vegetation on inlet box.

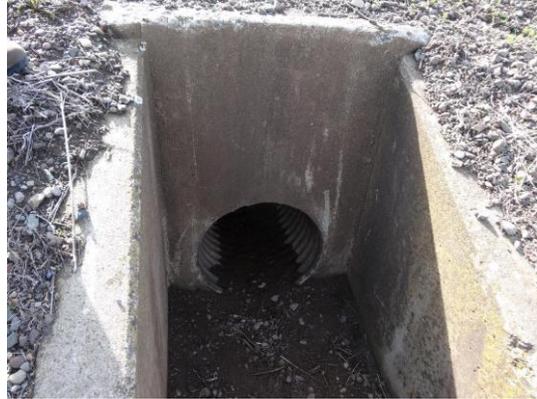
Photo 2 of 3 : UCIP\_FA\_2015\_3169.jpg

LS view: U type concrete headwall and CMP on levee slope. Soil/mud on inlet box.

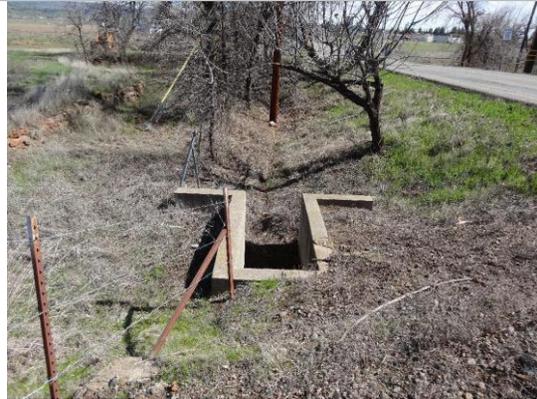
Photo 1 of 3 : UCIP\_FA\_2015\_3527.jpg

LS view: U type concrete headwall and CMP on levee slope. Vegetation debris and mud on inlet box.

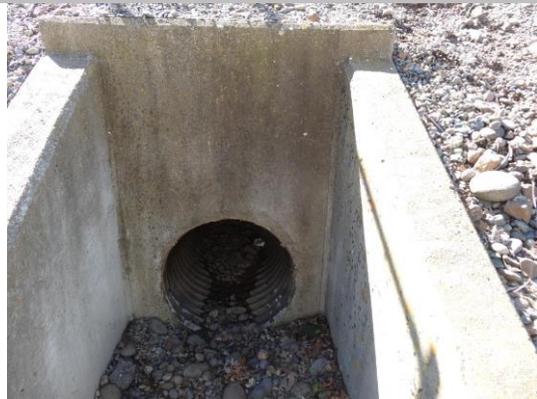
Photo 2 of 3 : UCIP\_FA\_2015\_3525.jpg

LS view: U type concrete headwall and CMP on levee slope. Pebbles and mud on inlet box.

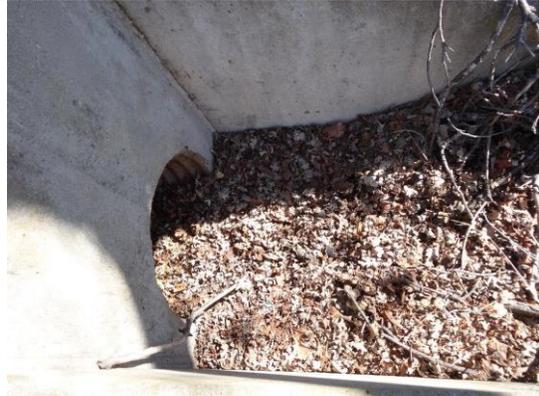
Photo 2 of 2 : UCIP\_FA\_2015\_3954.jpg

LS view: U type concrete headwall and CMP on levee slope. Vegetation and mud on inlet box.

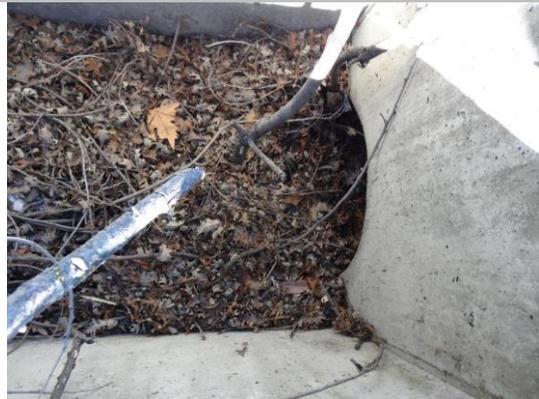
Photo 2 of 3 : UCIP\_FA\_2015\_4072.jpg

LS view: close view of vegetation debris and mud on inlet box.

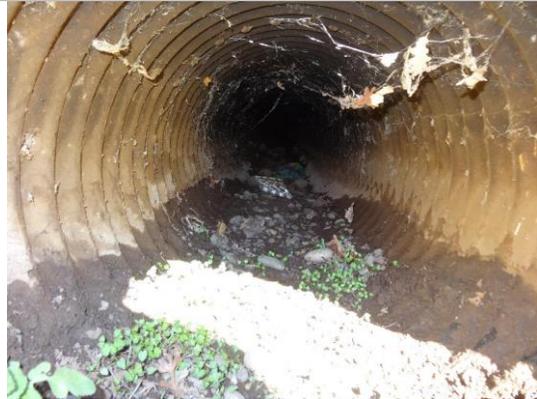
Photo 1 of 3 : UCIP\_FA\_2015\_4019.jpg

LS view: inside view of CMP on levee slope. Needs cleaning and clearing.

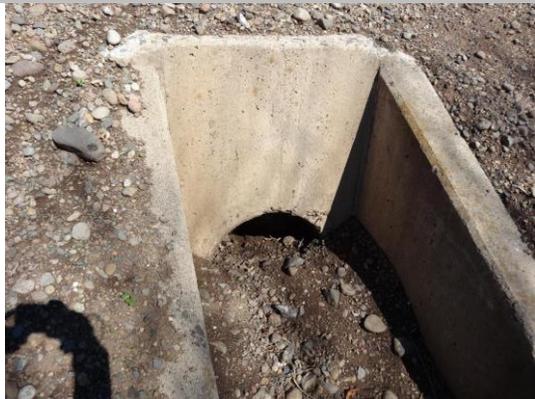
Photo 2 of 3 : UCIP\_FA\_2015\_4022.jpg

LS view: U type concrete headwall and CMP on levee slope. Vegetation debris and mud in pipe and inlet box.
