**Flood Control Project Maintenance
Levee Inspections**
LMA District Cover Sheet
Spring 2010 Levee Inspection Results
Butte County Public Works

Levee Inspection Report By Mile - Spring 2010

Butte County Public Works

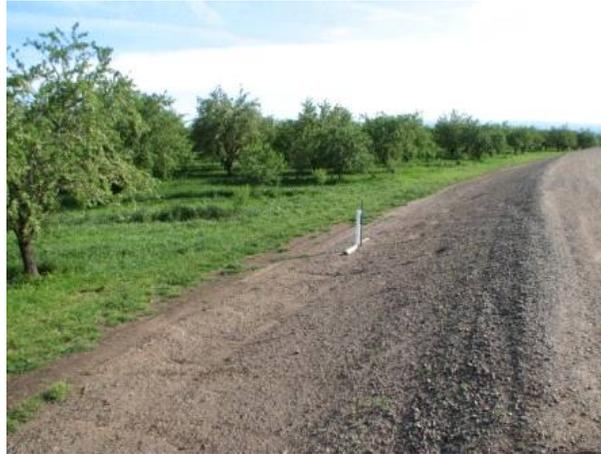
Levee Mile Report Line	3
Start Levee Mile	1.92
End Levee Mile	1.92
Location	Land Side
Category	Earthen Levee
Item	Animal Control
View of squirrel holes along the slope of land side levee and a bait station feeder.	
rduffey_s_20100607_022.jpg

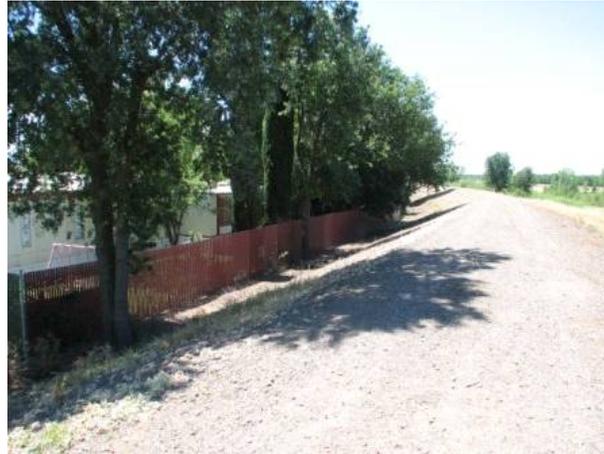
Levee Mile Report Line	1
Start Levee Mile	1.58
End Levee Mile	1.90
Location	Land Side
Category	Earthen Levee
Item	Encroachments
View of the fence along the landside toe of the levee.	
rduffey_s_20100628_093.jpg

LMIR No	Levee Mile		Category	Item	Location *	Rating **	Action/Comment	GPS Latitude/Longitude		Issue No. Photo
	Start	End						Start	End	
1	1.58	1.90	Earthen Levee	Encroachments	LS	CO	Fences	39.782773 ° -121.888178 °	39.778972 ° -121.891563 °	3 Y
2	2.90	2.90	Earthen Levee	Encroachments	LS	M	Firewood	39.767985 ° -121.901493 °	39.767985 ° -121.901493 °	11
3	4.69	4.69	Earthen Levee	Animal Control	LS	C	No rodents visible, but rodent burrows visible; need to backfill and compact or grout borrows.	39.749917 ° -121.917195 °	39.749917 ° -121.917195 °	16
4	5.10	5.10	Earthen Levee	Encroachments	LS	M	Prunings	39.745932 ° -121.921553 °	39.745932 ° -121.921553 °	15
5	6.63	6.63	Earthen Levee	Encroachments	LS	M	Prunings	39.728864 ° -121.932545 °	39.728864 ° -121.932545 °	1
6	7.38	7.38	Earthen Levee	Encroachments	LS	M	Prunings	39.719695 ° -121.938189 °	39.719695 ° -121.938189 °	2

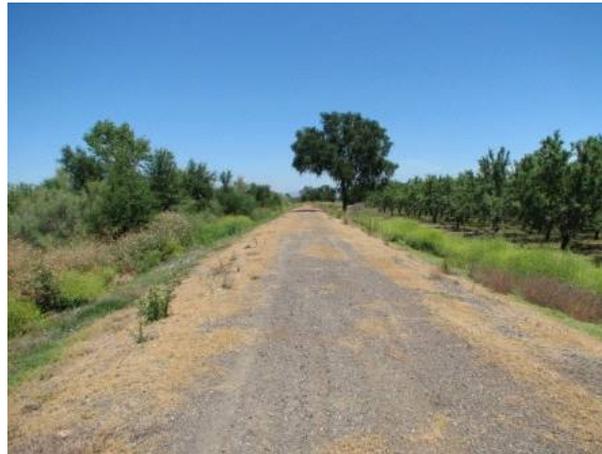
Levee Mile Report Line	1
Start Levee Mile	0.00
End Levee Mile	0.30
Location	Crown
Category	Earthen Levee
Item	Vegetation
View of the sprayed vegetation on both slopes of the levee.	
rduffey_s_20100628_094.jpg

LMIR No	Levee Mile		Category	Item	Location *	Rating **	Action/Comment	GPS Latitude/Longitude		Issue No. Photo
	Start	End						Start	End	
1	0.00	0.30	Earthen Levee	Vegetation	CR	W	Remove the wild growth other than native grasses from the levee slopes.	39.733565 ° -121.929807 °	39.733565 ° -121.929807 °	3 Y

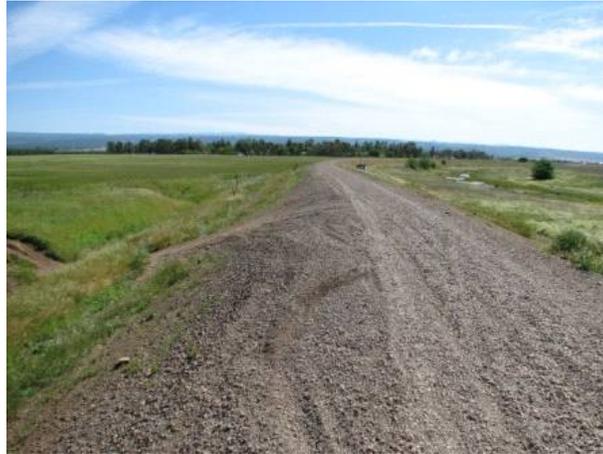
Levee Mile Report Line	1
Start Levee Mile	0.06
End Levee Mile	0.06
Location	Water Side
Category	Earthen Levee
Item	Slope Stability
View of the motorcycle erosion on the landside slope of the levee.	
rduffey_s_20100607_025.jpg

LMIR No	Levee Mile		Category	Item	Location *	Rating **	Action/Comment	GPS Latitude/Longitude		Issue No. Photo
	Start	End						Start	End	
1	0.06	0.06	Earthen Levee	Slope Stability	WS	M	Repair the levee slope damaged by vehicle traffic and prevent access where possible.	39.786068 ° -121.881828 °	39.786068 ° -121.881828 °	3 Y

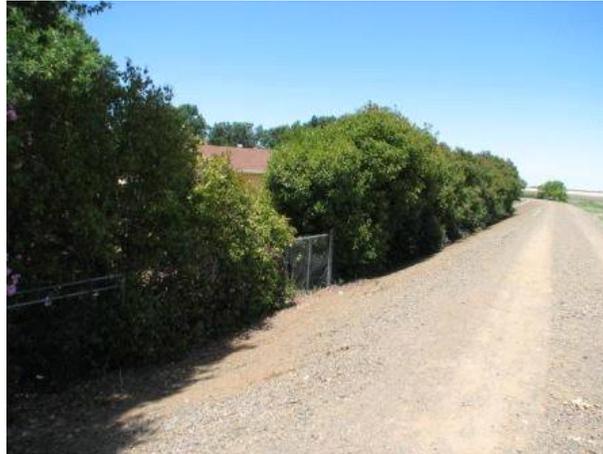
Levee Mile Report Line	1
Start Levee Mile	0.98
End Levee Mile	1.05
Location	Land Side
Category	Earthen Levee
Item	Encroachments

View of the fence and trees along the landside toe of the levee.

LMIR No	Levee Mile		Category	Item	Location *	Rating **	Action/Comment	GPS Latitude/Longitude		Issue No. Photo
	Start	End						Start	End	
1	0.98	1.05	Earthen Levee	Encroachments	LS	CO	Fences	39.776013 ° -121.851175 °	39.776595 ° -121.852005 °	1 Y
2	1.16	1.27	Earthen Levee	Encroachments	LS	CO	Fences	39.776760 ° -121.854022 °	39.777650 ° -121.855687 °	3
3	1.80	1.80	Earthen Levee	Vegetation	LS	A	Control annual grass and weeds on the levee slopes and easements.	° °	° °	2 Y

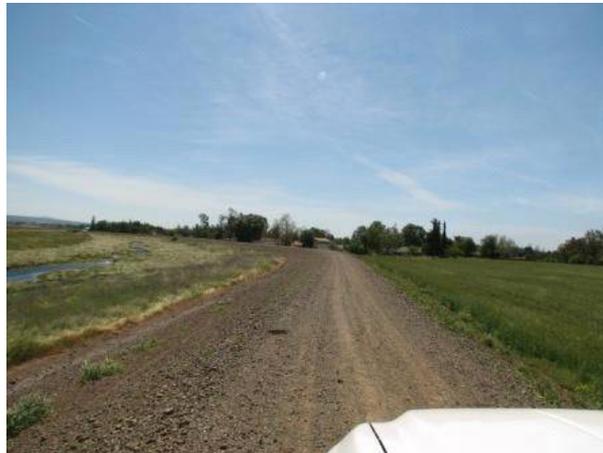
Levee Mile Report Line	3
Start Levee Mile	1.80
End Levee Mile	1.80
Location	Land Side
Category	Earthen Levee
Item	Vegetation

View of Levee without grass on it.

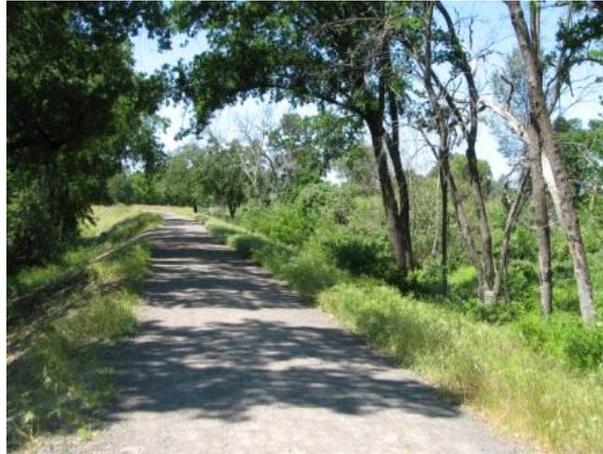
Levee Mile Report Line	1
Start Levee Mile	0.22
End Levee Mile	0.45
Location	Water Side
Category	Earthen Levee
Item	Vegetation
View of the noxious weeds on both slopes of the levee.	
rduffey_s_20100607_027.jpg

LMIR No	Levee Mile		Category	Item	Location *	Rating **	Action/Comment	GPS Latitude/Longitude		Issue No. Photo
	Start	End						Start	End	
1	0.22	0.45	Earthen Levee	Vegetation	WS	M	Remove the wild growth other than native grasses from the levee slopes.	39.761921 ° -121.792929 °	39.761110 ° -121.796950 °	2 Y
2	0.22	0.45	Earthen Levee	Vegetation	LS	M	Remove the wild growth other than native grasses from the levee slopes.	39.761920 ° -121.792930 °	39.761110 ° -121.796951 °	1
