**Flood Control Project Maintenance  
Levee Inspections**  
**LMA District Cover Sheet**  
**Spring 2015 Levee Inspection Results**

**Butte County Department of Public Works**

**Spring 2015 Levee Inspection Results**

Waterway		Bank	Unit Miles
Unit No. 01 Mud Creek		Right	6.80

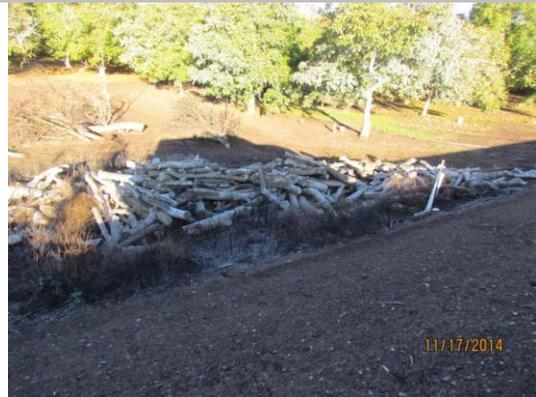
Photo 1 of 1 : SP\_2015\_NA0003\_64\_23\_20150310\_00006.jpg

LM Start	<b>1.29</b>	Rating **	M	Issue No.	<b>23</b>
LM End	<b>1.29</b>	Issue Type +	En	Location *	N/A
Category	Earthen Levee			GPS Latitude/Longitude	
				Start	End
Item	Encroachments			39.741277 °	39.741277 °
				-121.927485 °	-121.927485 °
DWR ID	DWR_NA0003_01_f_2014_23				
Action/Comments					
Firewood

View of the firewood along the landside toe.

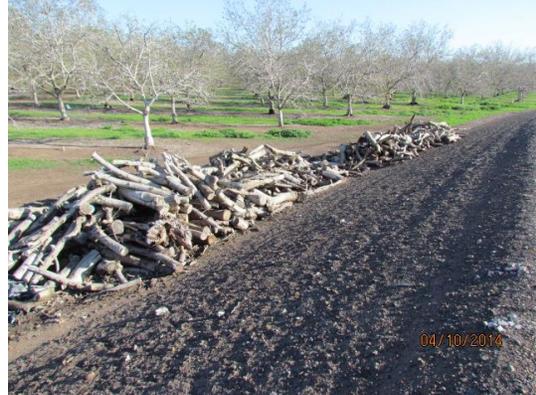
Photo 1 of 1 : SP\_2015\_NA0003\_64\_15\_20150310\_00004.jpg

LM Start	<b>1.69</b>	Rating **	M	Issue No.	<b>15</b>
LM End	<b>1.69</b>	Issue Type +	En	Location *	LS
Category	Earthen Levee		GPS Latitude/Longitude		
			Start	End	
Item	Encroachments		39.745718 °	39.745718 °	
			-121.923124 °	-121.923124 °	
DWR ID	DWR_NA0003_01_s_2014_15				
Action/Comments					
Firewood

View of the firewood along the landside toe.

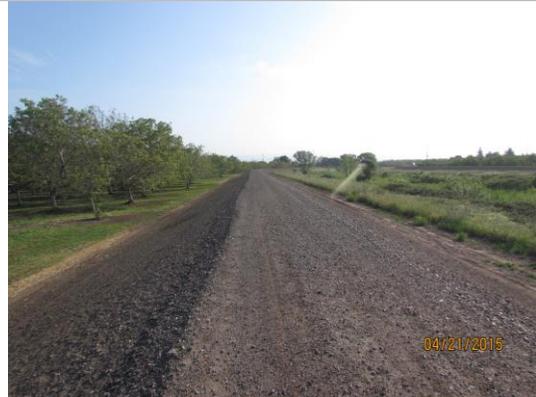
Photo 1 of 1 : SP\_2015\_NA0003\_64\_30\_20150428\_00012.jpg

LM Start	<b>1.72</b>	Rating **	A	Issue No.	<b>30</b>
LM End	<b>1.72</b>	Issue Type +	Ma	Location *	LS
Category	Earthen Levee		GPS Latitude/Longitude		
			Start	End	
Item	Vegetation		39.746040 °	39.746040 °	
			-121.922710 °	-121.922710 °	
DWR ID	DWR_NA0003_01_s_2015_30				
Action/Comments					
Control annual grass and weeds on the levee slopes and easements.

View of the levee with no grass on both slope.

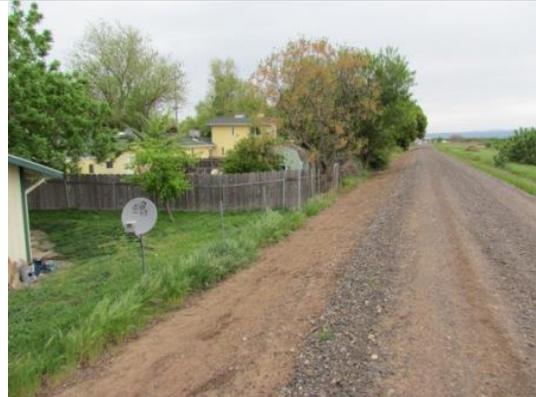
Photo 1 of 1 : SP\_2015\_NA0003\_64\_3\_20150310\_00002.jpg

LM Start	<b>2.00</b>	Rating **	U	Issue No.	<b>3</b>
LM End	<b>2.04</b>	Issue Type +	En	Location *	LS
Category	Earthen Levee			GPS Latitude/Longitude	
				Start	End
Item	Encroachments			39.748330 °	39.748867 °
				-121.918685 °	-121.918533 °
DWR ID	DWR_NA0003_01_s_2012_3				
Action/Comments					
Fence

View of the fences along the L/S toe.

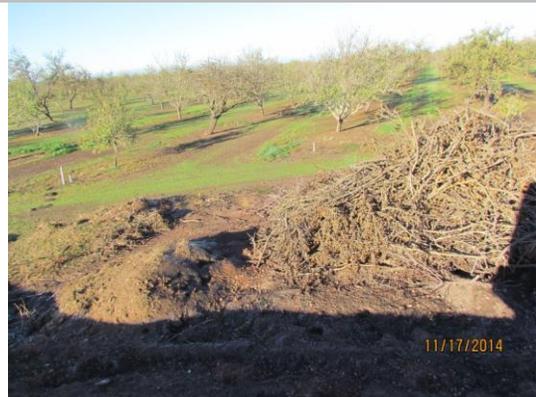
Photo 1 of 1 : SP\_2015\_NA0003\_64\_26\_20150310\_00008.jpg

LM Start	<b>2.60</b>	Rating **	M	Issue No.	<b>26</b>
LM End	<b>2.60</b>	Issue Type +	En	Location *	LS
Category	Earthen Levee		GPS Latitude/Longitude		
			Start	End	
Item	Encroachments		39.756022 °	39.756022 °	
			-121.914788 °	-121.914788 °	
DWR ID	DWR_NA0003_01_f_2014_26				
Action/Comments					
Prunings

View of the prunings along the landside toe.

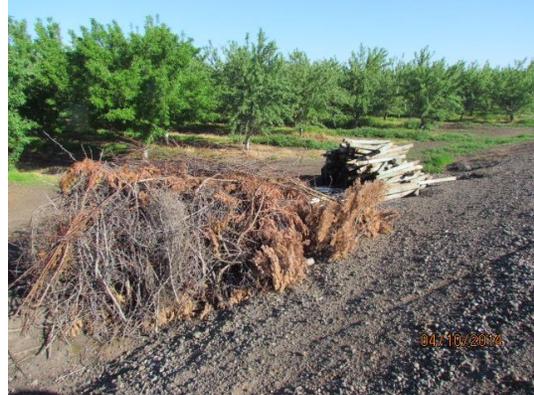
Photo 1 of 1 : SP\_2015\_NA0003\_64\_25\_20150310\_00007.jpg

LM Start	<b>3.02</b>	Rating **	M	Issue No.	<b>25</b>
LM End	<b>3.02</b>	Issue Type +	Ma	Location *	LS
Category	Earthen Levee			GPS Latitude/Longitude	
				Start	End
Item	Encroachments			39.761085 °	39.761085 °
				-121.911048 °	-121.911048 °
DWR ID	DWR_NA0003_01_s_2012_25				
Action/Comments					
Prunings

View of the prunings along the landside toe.

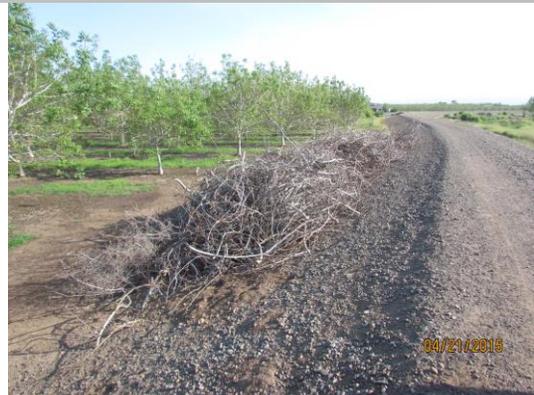
Photo 1 of 1 : SP\_2015\_NA0003\_64\_31\_20150428\_00013.jpg

LM Start	<b>3.15</b>	Rating **	M	Issue No.	<b>31</b>
LM End	<b>3.15</b>	Issue Type +	En	Location *	LS
Category	Earthen Levee			GPS Latitude/Longitude	
				Start	End
Item	Encroachments			39.762565 °	39.762565 °
				-121.909873 °	-121.909873 °
DWR ID	DWR_NA0003_01_s_2015_31				
Action/Comments					
Prunings Inspector Comments: Remove the prunings from the landside slope.

View of the prunings along the landside slope.

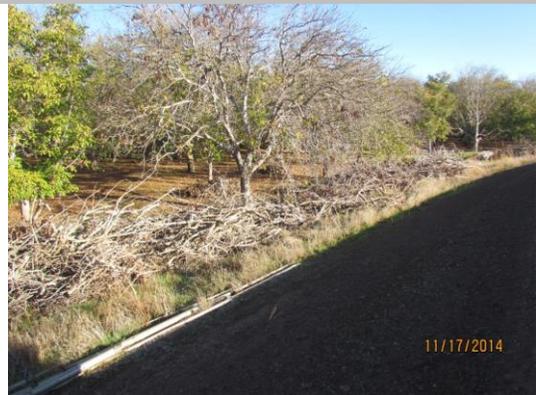
Photo 1 of 1 : SP\_2015\_NA0003\_64\_29\_20150310\_00011.jpg

LM Start	<b>4.03</b>	Rating **	M	Issue No.	<b>29</b>
LM End	<b>4.03</b>	Issue Type +	En	Location *	LS
Category	Earthen Levee			GPS Latitude/Longitude	
				Start	End
Item	Encroachments			39.771843 °	39.771843 °
				-121.899437 °	-121.899437 °
DWR ID	DWR_NA0003_01_f_2014_29				
Action/Comments					
Prunings

View of the prunings along the landside toe.

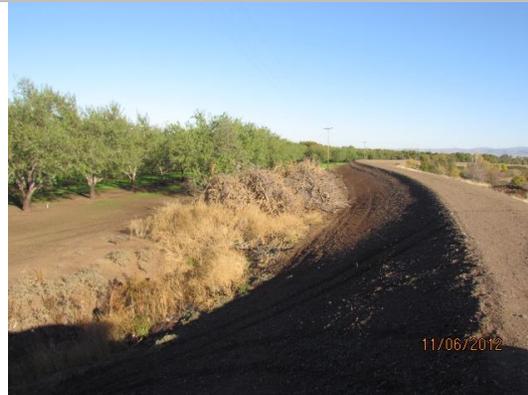
Photo 1 of 1 : SP\_2015\_NA0003\_64\_21\_20150310\_00005.jpg

LM Start	<b>4.46</b>	Rating **	M	Issue No.	<b>21</b>
LM End	<b>4.46</b>	Issue Type +	Ma	Location *	LS
Category	Earthen Levee		GPS Latitude/Longitude		
			Start	End	
Item	Encroachments		39.775908 °	39.775908 °	
			-121.893947 °	-121.893947 °	
DWR ID	DWR_NA0003_01_s_2012_21				
Action/Comments					
Prunings

View of the brush pile along landside toe.

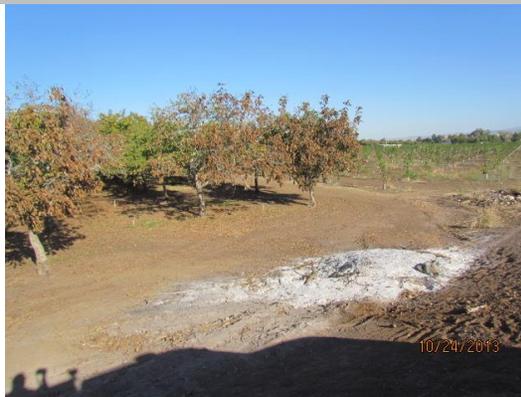
Photo 1 of 1 : SP\_2015\_NA0003\_64\_13\_20150310\_00003.jpg

LM Start	<b>4.79</b>	Rating **	A/W	Issue No.	<b>13</b>
LM End	<b>4.79</b>	Issue Type +	En	Location *	LS
Category	Earthen Levee			GPS Latitude/Longitude	
				Start	End
Item	Encroachments			39.780068 °	39.780068 °
				-121.891469 °	-121.891469 °
DWR ID	DWR_NA0003_01_s_2013_13				
Action/Comments					
Prunings

The landowner burned the pruning pile.

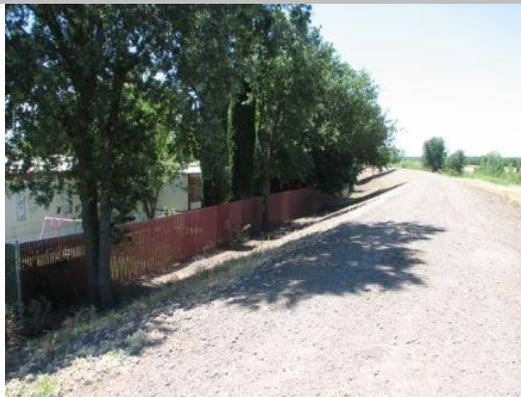
Photo 1 of 1 : SP\_2015\_NA0003\_65\_3\_20150310\_00002.jpg

LM Start	<b>1.49</b>	Rating **	U	Issue No.	<b>3</b>
LM End	<b>1.81</b>	Issue Type +	En	Location *	LS
Category	Earthen Levee			GPS Latitude/Longitude	
				Start	End
Item	Encroachments			39.782773 °	39.778972 °
				-121.888178 °	-121.891563 °
DWR ID	DWR_NA0003_02_s_2012_3				
Action/Comments					
Fence

View of the fence along the landside toe of the levee.

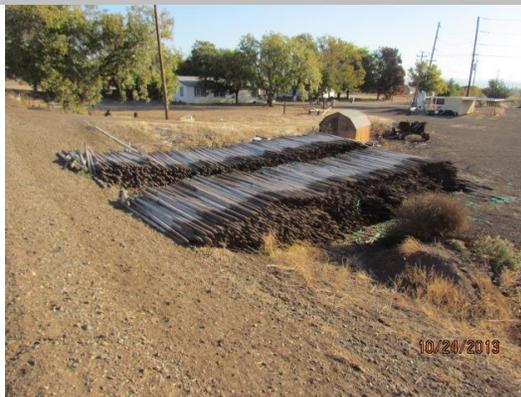
Photo 1 of 1 : SP\_2015\_NA0003\_65\_1\_20150310\_00001.jpg

LM Start	<b>2.80</b>	Rating **	M	Issue No.	<b>1</b>
LM End	<b>2.80</b>	Issue Type +	En	Location *	LS
Category	Earthen Levee			GPS Latitude/Longitude	
				Start	End
Item	Encroachments			39.767841 °	39.767841 °
				-121.901534 °	-121.901534 °
DWR ID	DWR_NA0003_02_f_2013_1				
Action/Comments					
Material

View of the tree stakes along the landside slope and toe.

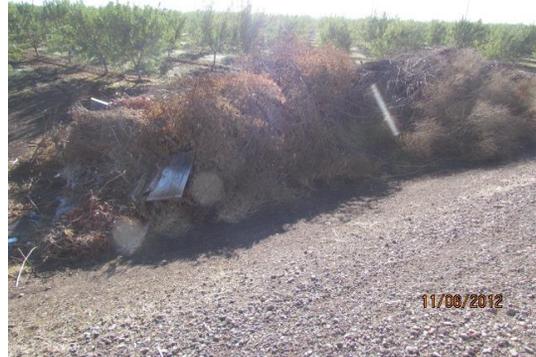
Photo 1 of 1 : SP\_2015\_NA0003\_65\_5\_20150310\_00003.jpg

LM Start	<b>3.31</b>	Rating **	M	Issue No.	<b>5</b>
LM End	<b>3.31</b>	Issue Type +	Ma	Location *	LS
Category	Earthen Levee		GPS Latitude/Longitude		
			Start	End	
Item	Encroachments		39.763208 °	39.763208 °	
			-121.908517 °	-121.908517 °	
DWR ID	DWR_NA0003_02_f_2012_5				
Action/Comments					
Prunings

View of the brush pile along landside toe.

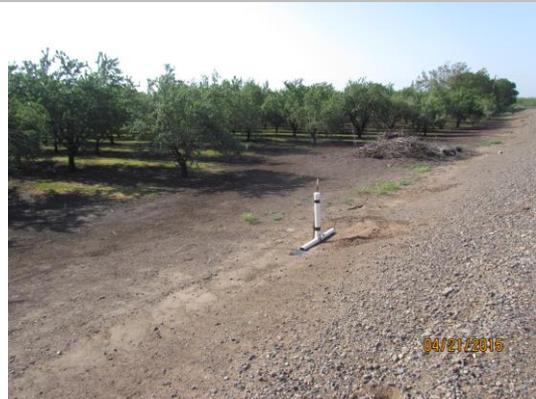
Photo 1 of 1 : SP\_2015\_NA0003\_65\_8\_20150428\_00010.jpg

LM Start	<b>4.55</b>	Rating **	A/W	Issue No.	<b>8</b>
LM End	<b>4.55</b>	Issue Type +	Ma	Location *	LS
Category	Earthen Levee		GPS Latitude/Longitude		
			Start	End	
Item	Animal Control		39.749639 °	39.749639 °	
			-121.917188 °	-121.917188 °	
DWR ID	DWR_NA0003_02_f_2013_8				
Action/Comments					
Exterminate rodents and backfill and compact or grout burrows.

View of the bait station placed by the rodent hole.

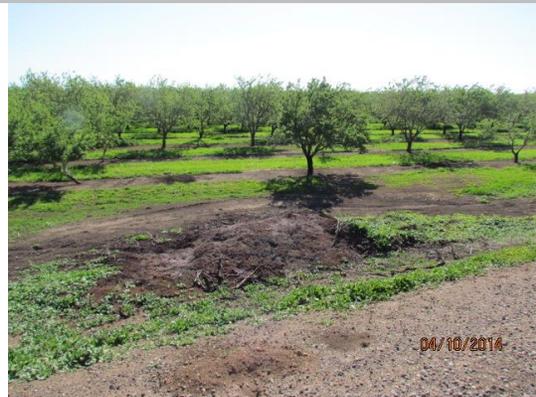
Photo 1 of 1 : SP\_2015\_NA0003\_65\_7\_20150310\_00004.jpg

LM Start	<b>5.85</b>	Rating **	A/W	Issue No.	<b>7</b>
LM End	<b>5.85</b>	Issue Type +	En	Location *	LS
Category	Earthen Levee		GPS Latitude/Longitude		
			Start	End	
Item	Encroachments		39.736652 °	39.736652 °	
			-121.932053 °	-121.932053 °	
DWR ID	DWR_NA0003_02_s_2013_7				
Action/Comments					
Prunings

View of the removed prunings from the landside toe.

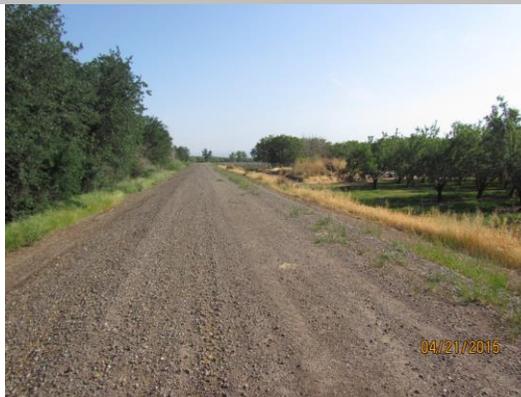
Photo 1 of 1 : SP\_2015\_NA0003\_66\_17\_20150428\_00001.jpg

View of the levee with no grass on both slopes.

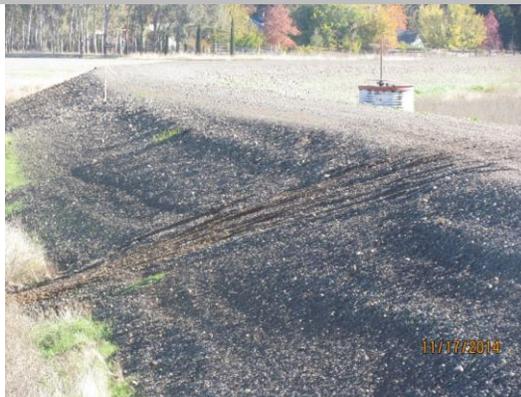
Photo 1 of 1 : SP\_2015\_NA0003\_67\_3\_20150310\_00001.jpg

View of the erosion caused by motorcycles on the land side slope.

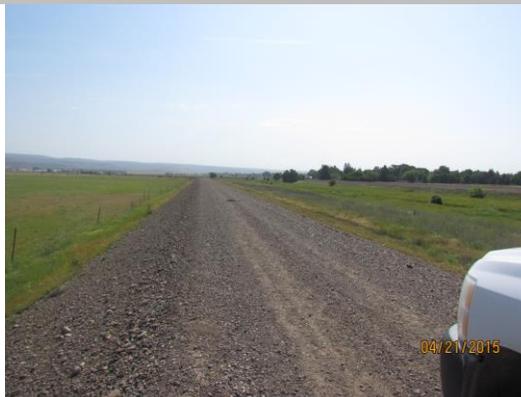
Photo 1 of 1 : SP\_2015\_NA0003\_67\_12\_20150428\_00002.jpg

View of the levee with no grass on both slopes.

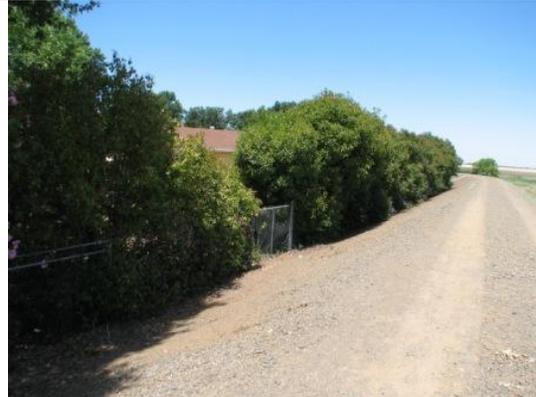
Photo 1 of 1 : SP\_2015\_NA0003\_68\_1\_20150310\_00001.jpg

View of the fence and trees along the landside toe of the levee.

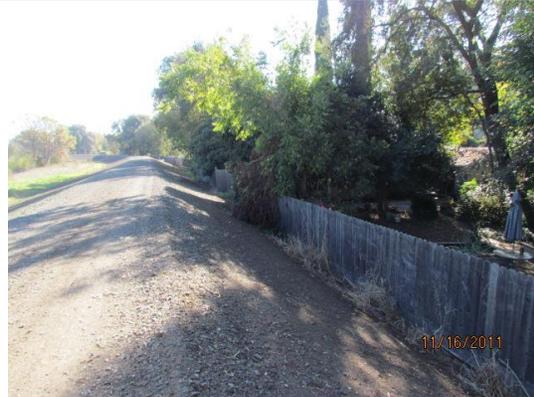
Photo 1 of 1 : SP\_2015\_NA0003\_68\_3\_20150310\_00003.jpg

View of the fence along the L/S toe.

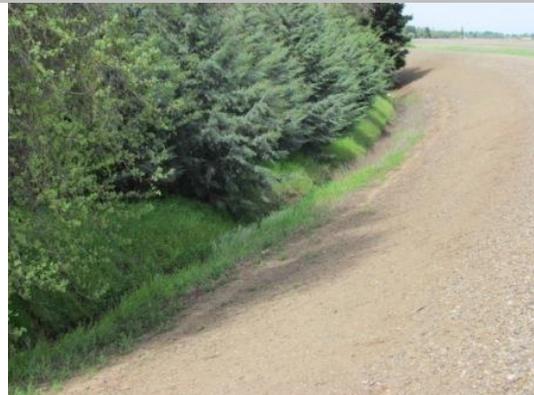
Photo 1 of 1 : SP\_2015\_NA0003\_68\_2\_20150310\_00002.jpg

View of AG ditch at the L/S toe.

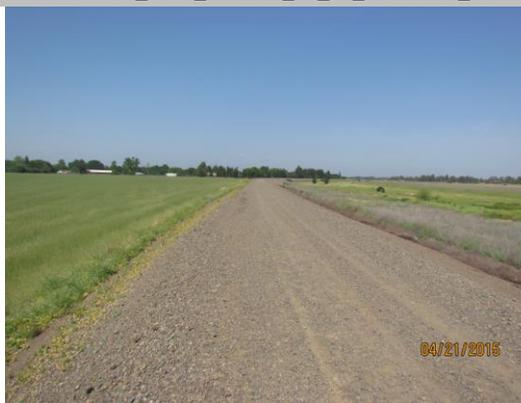
Photo 1 of 1 : SP\_2015\_NA0003\_68\_17\_20150428\_00004.jpg

View of the levee with no grass on both slopes.

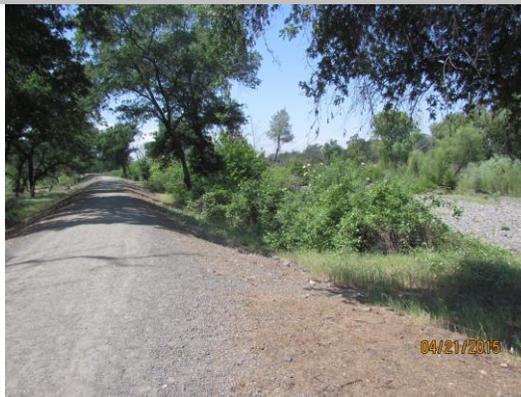
Photo 1 of 1 : SP\_2015\_NA0003\_69\_4\_20150428\_00004.jpg

View of the vegetation along the waterside slope.

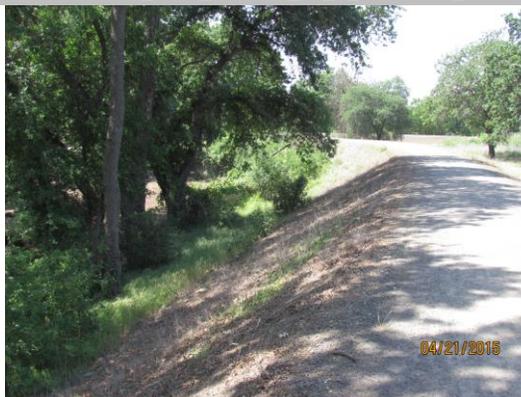
Photo 1 of 1 : SP\_2015\_NA0003\_69\_3\_20150428\_00005.jpg

LM Start	<b>0.34</b>	Rating **	M	Issue No.	<b>3</b>
LM End	<b>0.42</b>	Issue Type +	Ma	Location *	LS
Category	Earthen Levee		GPS Latitude/Longitude		
			Start	End	
Item	Vegetation		39.761633 °	39.761117 °	
			-121.795155 °	-121.796464 °	
DWR ID	DWR_NA0003_05_f_2013_3				
Action/Comments					
Remove the wild growth other than native grasses from the levee slopes. Inspector Comments: Remove the vegetation from the landside slope and toe.

View of the vegetation along the landside slope and toe

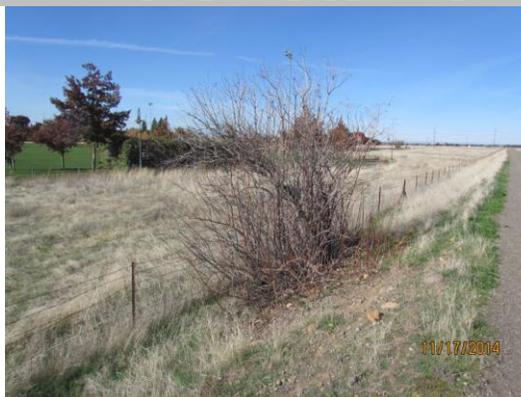
Photo 1 of 1 : SP\_2015\_NA0003\_69\_6\_20150310\_00003.jpg

LM Start	<b>0.89</b>	Rating **	A/W	Issue No.	<b>6</b>
LM End	<b>0.89</b>	Issue Type +	Ma	Location *	LS
Category	Earthen Levee		GPS Latitude/Longitude		
			Start	End	
Item	Vegetation		39.764397 °	39.764397 °	
			-121.803335 °	-121.803335 °	
DWR ID	DWR_NA0003_05_f_2014_6				
Action/Comments					
Elderberries are blocking visibility and flood fight capability.

View of the elderberry along the landside toe.
