**Flood Control Project Maintenance
Levee Inspections**
LMA District Cover Sheet
Spring 2016 Levee Inspection Results

Butte County Department of Public Works

Spring 2016 Levee Inspection Results

Waterway		Bank	Unit Miles
Unit No. 01 Mud Creek		Right	6.80

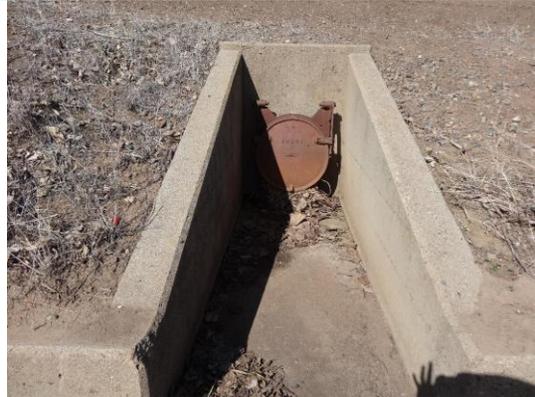
Photo 1 of 2 : UCIP_SP_2016_32044_58543.jpg

LM Start	1.00	Rating **	M	Issue No.	43
LM End	1.00	Issue Type +	En	Location *	N/A
Category	Supplemental			GPS Latitude/Longitude	
				Start	End
Item	DWR UCIP Field Study			39.739268 °	39.739268 °
				-121.931891 °	-121.931891 °
DWR ID					
Comment Code					
Inspector Comment					
FS_ID:32044 DS_ID:19211 EP_NO: N/A Repair Type: Non-Urgent Crossing Status: Found UCIP Comments: Vegetation debris on waterside. Needs clearing and cleaning. FIELD_STRUCT_DESC: 24-inch CM pipe through the levee, 12.0 feet below the crown. Flap gate on the waterward end. Concrete "U" headwalls on both ends. Grouted riprap apron on the landward end. Grouted riprap spillway on the waterward end. O&M Manual Sac 504, May 1965. FS Date: 2/20/2014

WS view: U typed concrete headwall, pipe, and flapgate on levee slope.

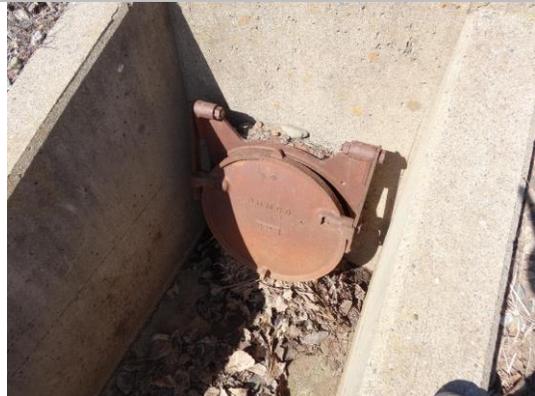
Photo 2 of 2 : UCIP_SP_2016_32044_58542.jpg

WS view: vegetation debris blocking outlet.

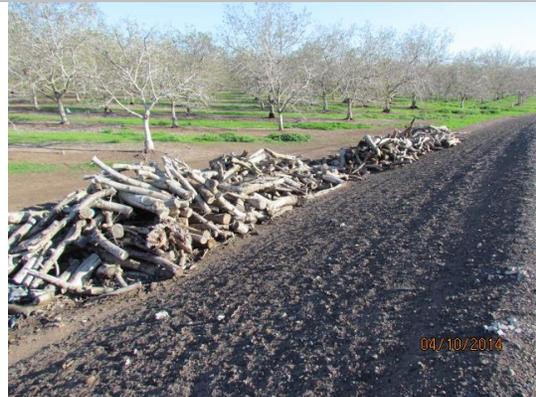
Photo 1 of 2 : SP_2016_NA0003_64_15_20160321_00003.jpg

View of the firewood along the landside toe.

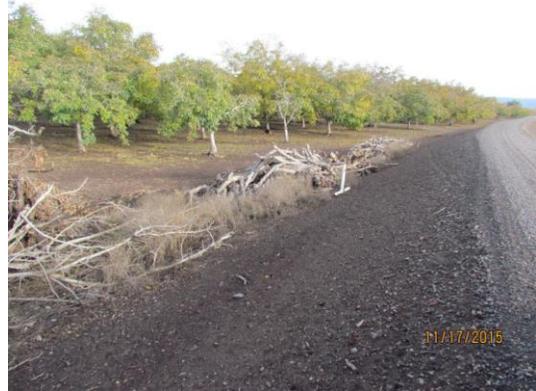
Photo 2 of 2 : SP_2016_NA0003_64_15_20160321_00004.jpg

View of the firewood along the landside toe.

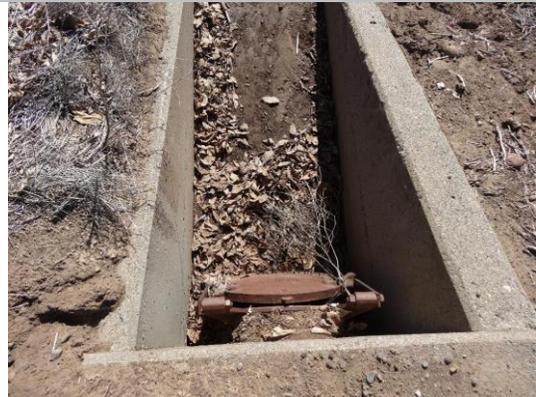
Photo 1 of 2 : UCIP_SP_2016_41767_55886.jpg

LM Start	1.90	Rating **	U	Issue No.	52
LM End	1.90	Issue Type +	En	Location *	LS
Category	Supplemental			GPS Latitude/Longitude	
				Start	End
Item	DWR UCIP Field Study			39.747563 °	39.747563 °
				-121.920170 °	-121.920170 °
DWR ID					
Comment Code					
Inspector Comment					
FS_ID:41767 DS_ID:19212 EP_NO: N/A Repair Type: Urgent Crossing Status: Found UCIP Comments: No riprap spillway on waterside.Needs cleaning and clearing of debris. Flap gate was not fully closed. FIELD_STRUCT_DESC: 24-inch CM pipe through the levee, 13.0 feet below the crown. Flap gate on the waterward end. Concrete "U" headwalls on both ends. Grouted riprap apron on the landward end. Grouted riprap spillway on the waterward end. O&M Manual Sac 504, May 1965. FS Date: 2/20/2014

WS view: U type concrete headwall, flapgate on levee slope. Gate was not fully closed.

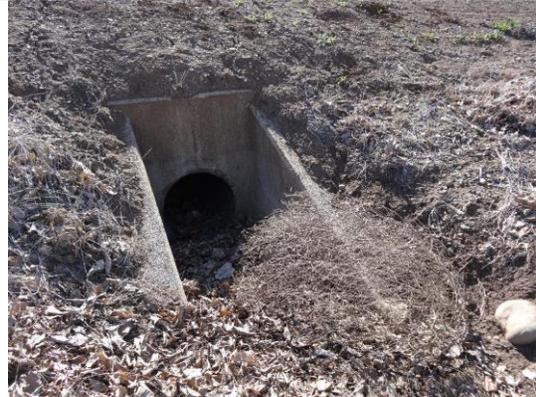
Photo 2 of 2 : UCIP_SP_2016_41767_55885.jpg

LS view: U type concrete headwall and CMP on levee slope. Vegetation debris blocking inlet.

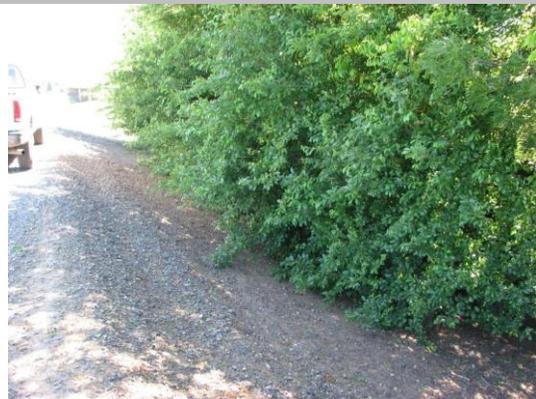
Photo 1 of 1 : SP_2016_NA0003_64_42_20160506_00054.jpg

LM Start	1.99	Rating **	U	Issue No.	42
LM End	1.99	Issue Type +	En	Location *	LS
Category	Earthen Levee			GPS Latitude/Longitude	
				Start	End
Item	Vegetation			39.748170 °	39.748170 °
				-121.918778 °	-121.918778 °
DWR ID	DWR_NA0003_01_s_2016_42				
Comment Code					
V6 : Landscaping					
Inspector Comment					
Landscaping vegetation completely obscuring landside toe.

04/25/2016: Trim vegetation on L/S slope.

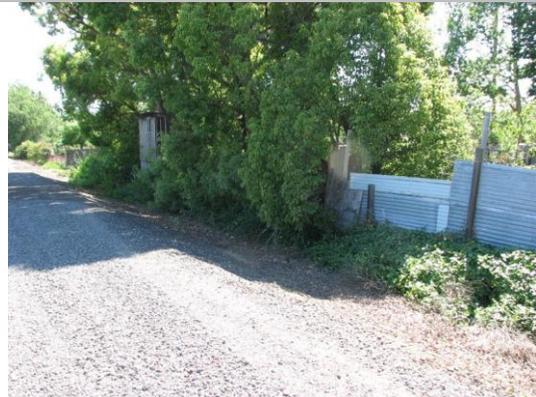
Photo 1 of 1 : SP_2016_NA0003_64_40_20160506_00050.jpg

04/25/2016: Metal fence and treehouse obstructing visibility and access. Should be removed.

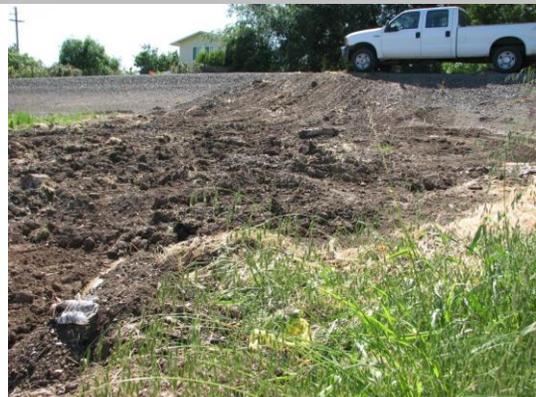
Photo 1 of 2 : SP_2016_NA0003_64_41_20160506_00051.jpg

LM Start	2.06	Rating **	M	Issue No.	41
LM End	2.06	Issue Type +	Ma	Location *	WS
Category	Earthen Levee		GPS Latitude/Longitude		
			Start	End	
Item	Slope Stability		39.749149 °	39.749149 °	
			-121.918510 °	-121.918510 °	
DWR ID	DWR_NA0003_01_s_2016_41				
Comment Code					
S3 : Repair the levee slope damaged by vehicle traffic and prevent access where possible.					
Inspector Comment					
Homeowner is dragging soil and debris across levee and dumping on waterside terrace.

04/25/2016: Soil and debris dragged across levee from L/S to W/S.

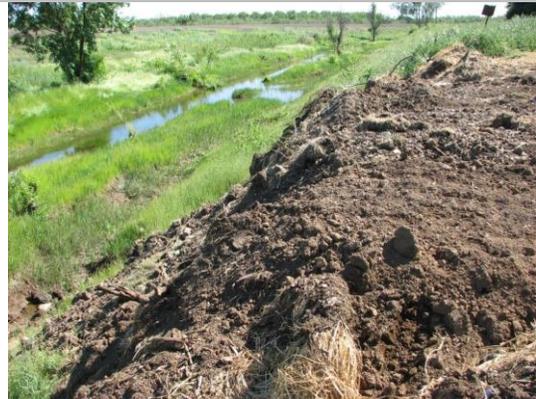
Photo 2 of 2 : SP_2016_NA0003_64_41_20160506_00053.jpg

LM Start	2.06	Rating **	M	Issue No.	41 (cont)
LM End	2.06	Issue Type +	Ma	Location *	WS
Category	Earthen Levee			GPS Latitude/Longitude	
				Start	End
Item	Slope Stability			39.749149 °	39.749149 °
				-121.918510 °	-121.918510 °
DWR ID	DWR_NA0003_01_s_2016_41				
Comment Code					
S3 : Repair the levee slope damaged by vehicle traffic and prevent access where possible.					
Inspector Comment					
Homeowner is dragging soil and debris across levee and dumping on waterside terrace.

04/25/2016: Soil and debris dragged across levee from L/S to W/S and pushed into channel.

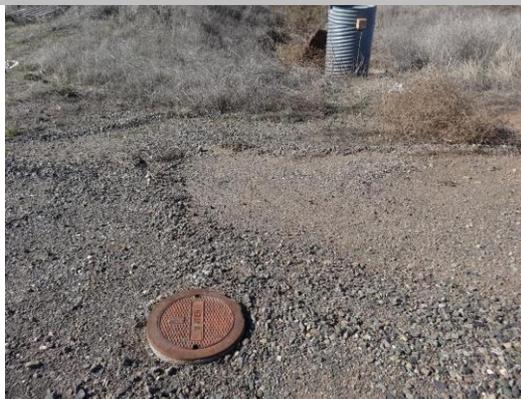
Photo 1 of 2 : UCIP_SP_2016_30291_55700.jpg

Comment Code					
Inspector Comment					
FS_ID:30291 DS_ID:19230 EP_NO: 16633 Repair Type: Non-Urgent Crossing Status: Indicator Found UCIP Comments: A concrete water control box on landside shoulder.It needs confirmation and more info from LMA and/or DWR Inspector. FIELD_STRUCT_DESC: A 2-inch diameter storm water discharge pipeline through the right bank and landward levee toe of Mud Creek. Used a 2-inch coated & wrapped steel pipe. Submerged pump in 36 inch dia CMP casing approx 10 ft from landside toe. Drainage ditch, up to 4 ft wide, runs perpendicular to levee alignment starting at CMP riser and running away from levee. (App. No. 16633) FS Date: 2/20/2014

LS view: CMP riser on levee toe (top) and control box on levee shoulder (bottom).

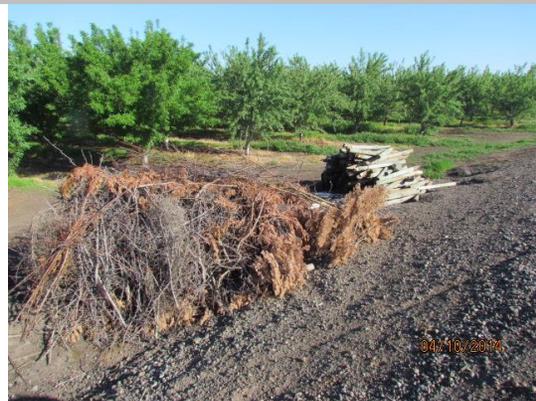
Photo 1 of 1 : SP_2016_NA0003_64_25_20160321_00008.jpg

View of the prunings along the landside toe.

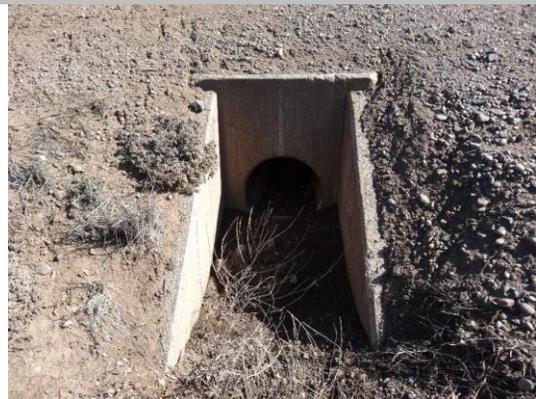
Photo 2 of 2 : UCIP_SP_2016_30294_55703.jpg

LS view: U type concrete headwall and CMP on levee slope. Debris blocking the inlet pipe.

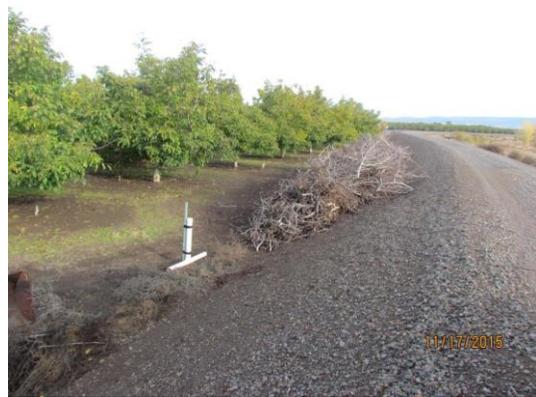
Photo 2 of 2 : SP_2016_NA0003_64_31_20160321_00013.jpg

View of the prunings and bait station along the landside slope.

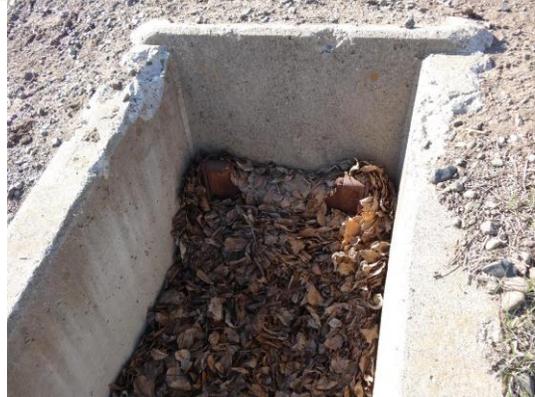
Photo 1 of 2 : UCIP_SP_2016_30295_55706.jpg

WS view: U type concrete headwall, flapgate on levee slope. Vegetation debris blocking the outlet.

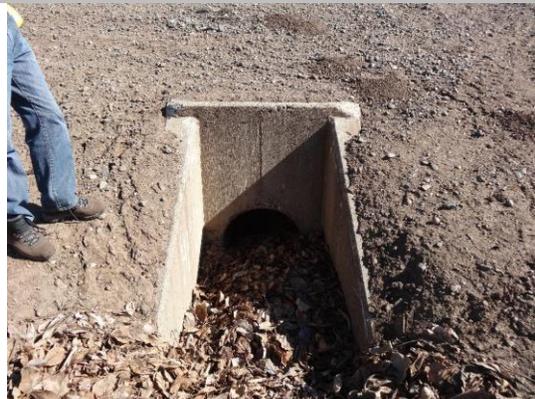
Photo 2 of 2 : UCIP_SP_2016_30295_55705.jpg

LS view: U type concrete headwall and CMP on levee slope. Vegetation debris blocking the inlet.

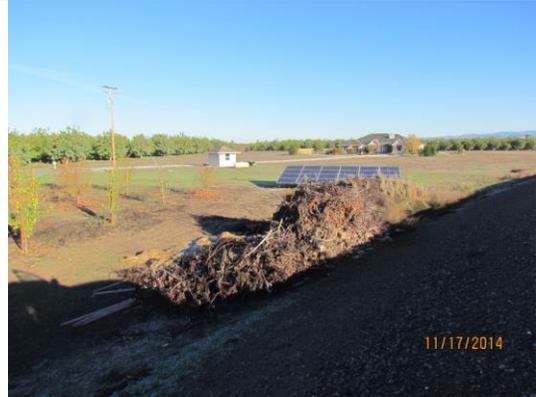
Photo 1 of 1 : SP_2016_NA0003_64_27_20160321_00010.jpg

View of the prunings along the landside toe.

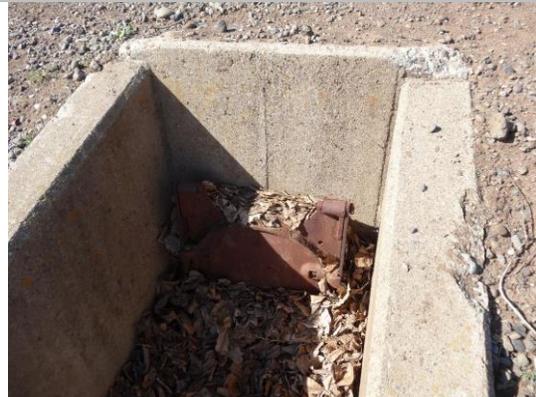
Photo 1 of 2 : UCIP_SP_2016_30310_55741.jpg

WS view: U type concrete headwall, pipe, and flapgate on levee slope. Vegetation debris blocking outlet.

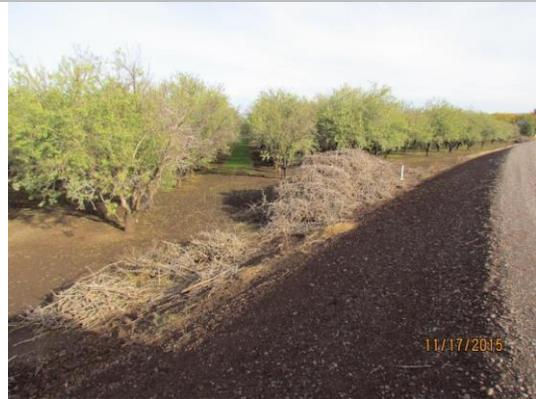
Photo 1 of 1 : SP_2016_NA0003_64_32_20160321_00014.jpg

View of the prunings along the landside toe.

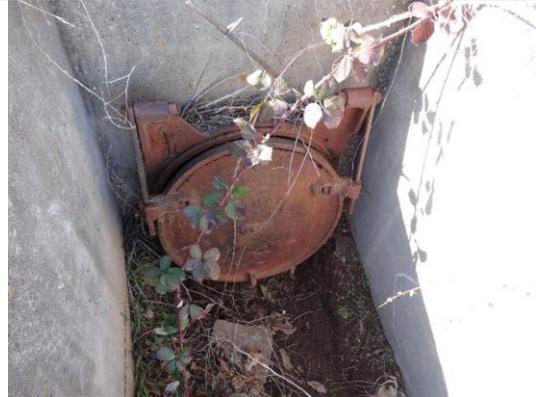
Photo 1 of 2 : UCIP_SP_2016_30312_55745.jpg

WS view: U type concrete headwall, pipe, and flapgate on levee slope. Vegetation debris blocking outlet.

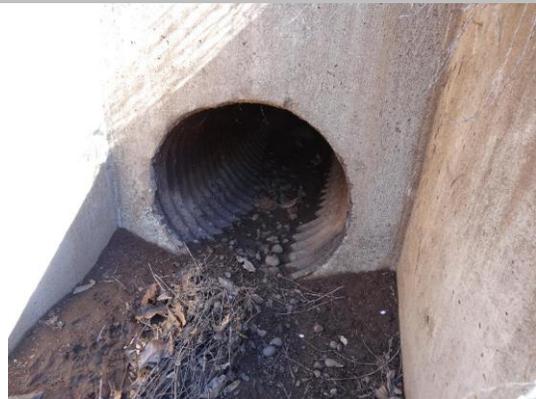
Photo 2 of 2 : UCIP_SP_2016_30312_55744.jpg

LS view: U type concrete headwall and CMP on levee slope. Needs cleaning and clearing of debris.

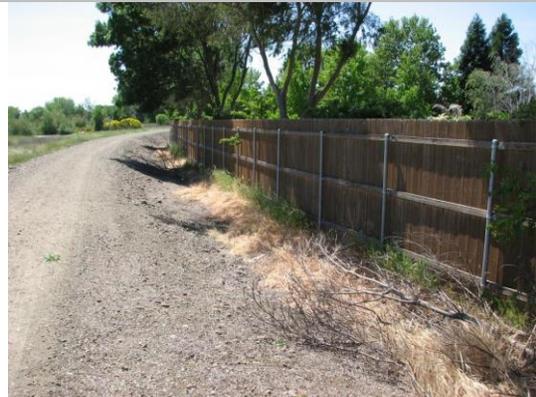
Photo 1 of 1 : SP_2016_NA0003_64_28_20160506_00041.jpg

04/25/2016: Fence blocking visibility and access at L/S toe.

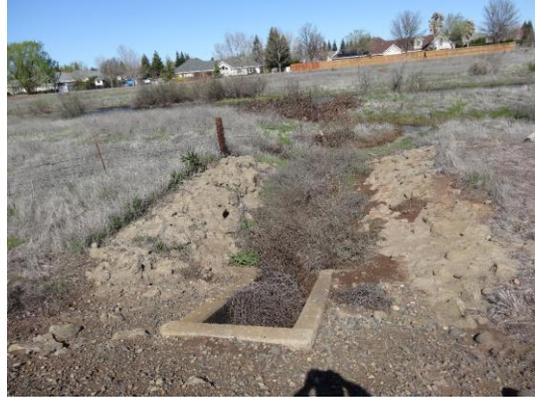
Photo 1 of 2 : UCIP_SP_2016_31667_57968.jpg

WS view: CMP culvert with U type concrete headwall. Vegetation debris blocking outlet box.

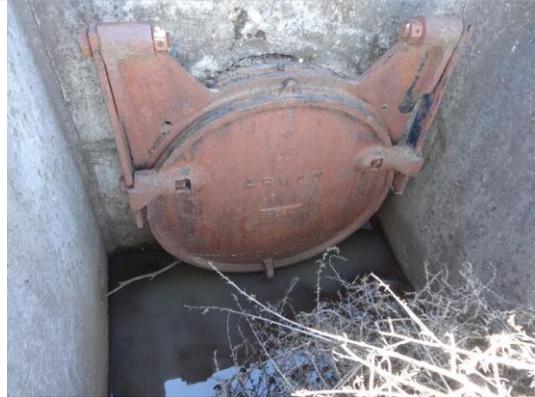
Photo 2 of 2 : UCIP_SP_2016_31667_57967.jpg

WS view: U type concrete headwall, pipe, and flapgate on levee slope. Vegetation debris on outlet box.

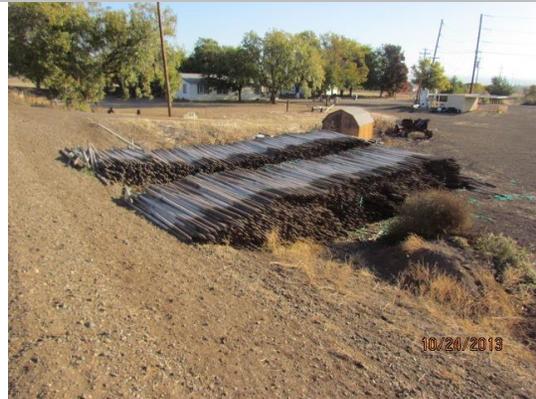
Photo 1 of 1 : SP_2016_NA0003_65_1_20160321_00001.jpg

View of the tree stakes along the landside slope and toe.

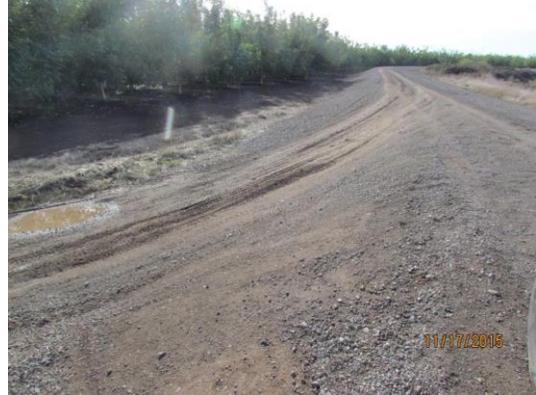
Photo 1 of 1 : SP_2016_NA0003_65_10_20160321_00006.jpg

View of the vehicle erosion along the landside slope.

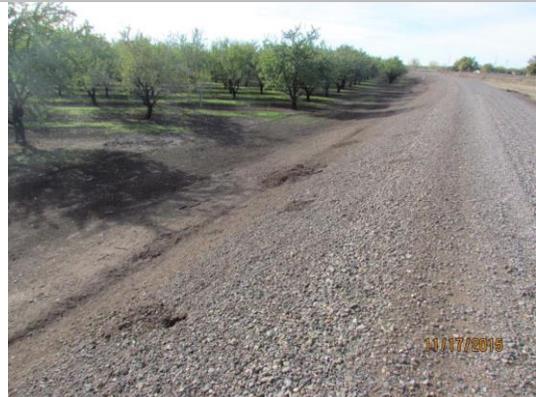
Photo 1 of 1 : SP_2016_NA0003_65_11_20160321_00007.jpg

View of the rodent holes along the landside slope.

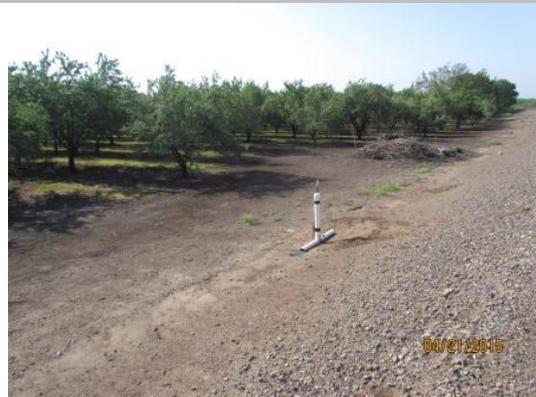
Photo 1 of 2 : SP_2016_NA0003_65_8_20160321_00004.jpg

View of the bait station placed by the rodent hole.

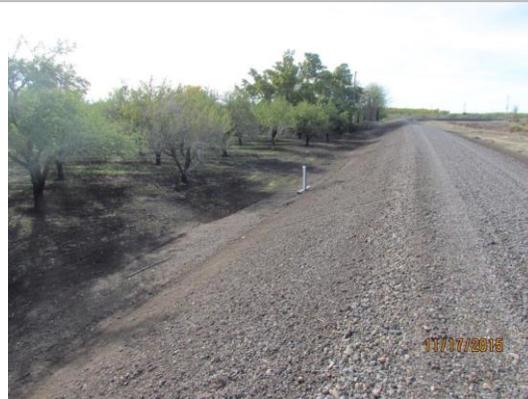
Photo 2 of 2 : SP_2016_NA0003_65_8_20160321_00005.jpg

View of the bait station by the rodent holes.

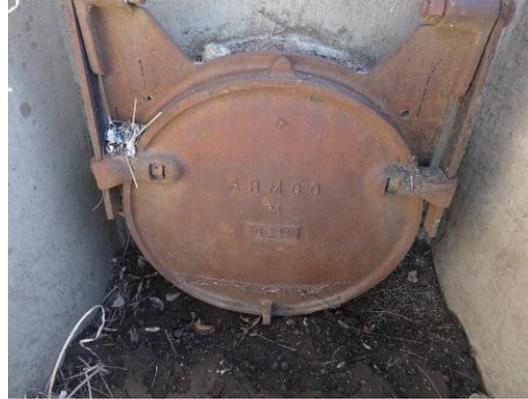
Photo 1 of 2 : UCIP_SP_2016_31028_56913.jpg

WS view: U type concrete headwall, pipe, and flapgate on levee slope. Soil/mud on outlet box.

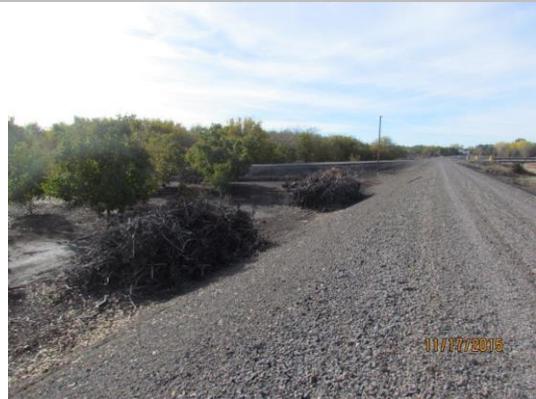
Photo 1 of 1 : SP_2016_NA0003_65_12_20160321_00008.jpg

View of the prunings along the landside toe.

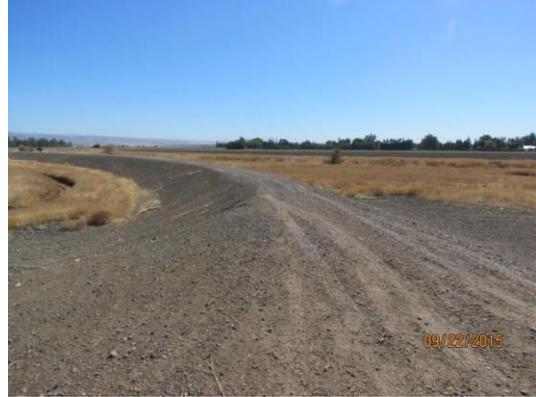
Photo 1 of 1 : SP_2016_NA0003_67_12_20160321_00002.jpg

View of the erosion on both slopes caused by motorcycle traffic.

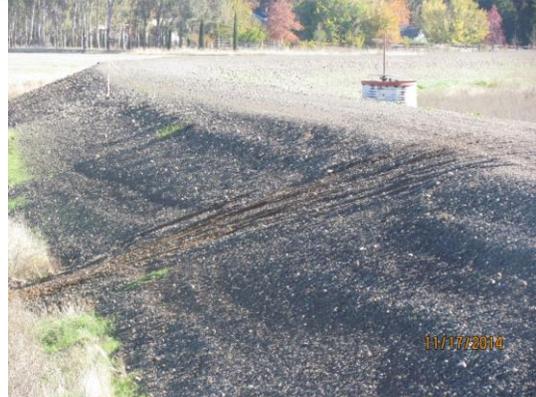
Photo 1 of 1 : SP_2016_NA0003_67_3_20160321_00001.jpg

View of the erosion caused by motorcycles on the land side slope.

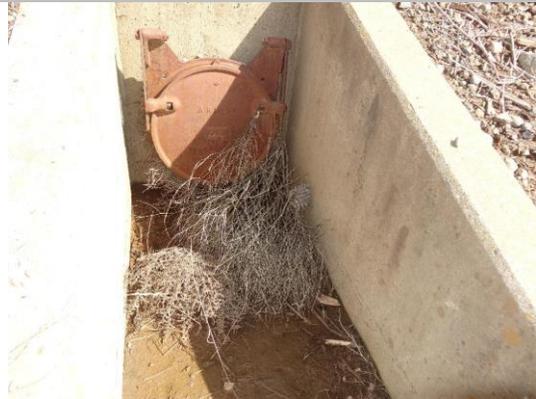
Photo 1 of 2 : UCIP_SP_2016_31901_58194.jpg

WS view: U type concrete headwall, flapgate, and CMP on levee slope. Needs cleaning and clearing.

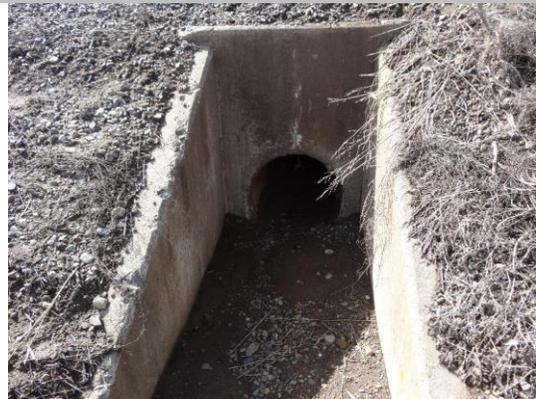
Photo 2 of 2 : UCIP_SP_2016_31901_58193.jpg

LS view: U type concrete headwall and CMP on levee slope. Soil/mud on inlet box.

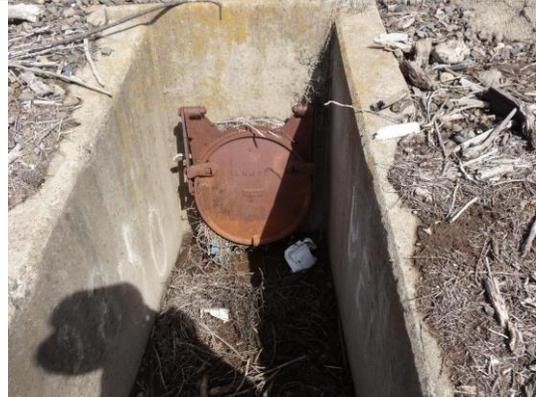
Photo 1 of 2 : UCIP_SP_2016_31864_58069.jpg

WS view: U type concrete headwall, pipe, and flapgate on levee slope. Soil/mud on outlet box. Vegetation debris blocking outlet box.

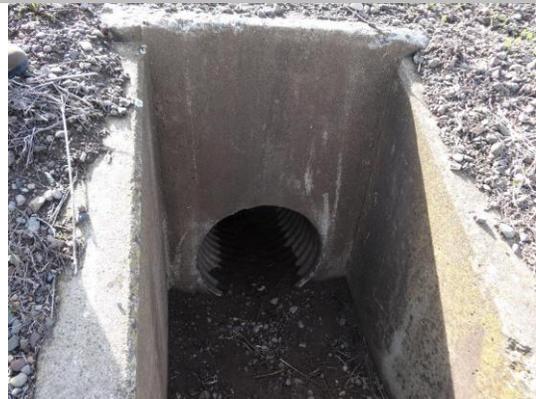
Photo 2 of 2 : UCIP_SP_2016_31864_58068.jpg

LS view: U type concrete headwall and CMP on levee slope. Soil/mud on inlet box.

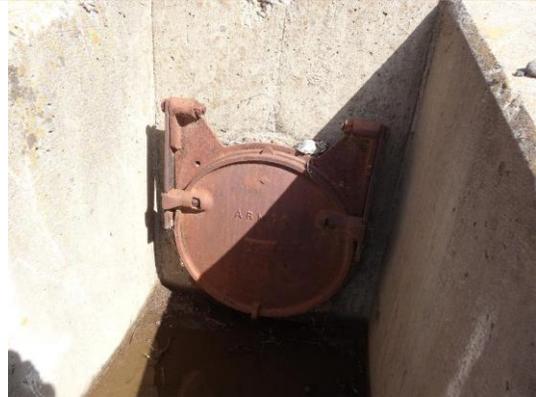
Photo 1 of 2 : UCIP_SP_2016_31856_58053.jpg

WS view: U type concrete headwall, pipe, and flapgate on levee slope. Soil/mud on outlet box.

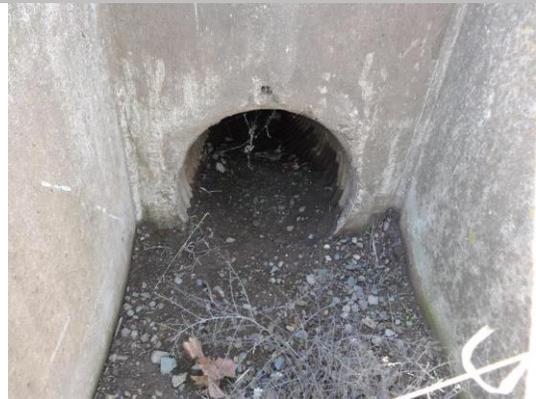
Photo 2 of 2 : UCIP_SP_2016_31856_58052.jpg

LS view: U type concrete headwall and CMP on levee slope. Soil/mud on inlet box.

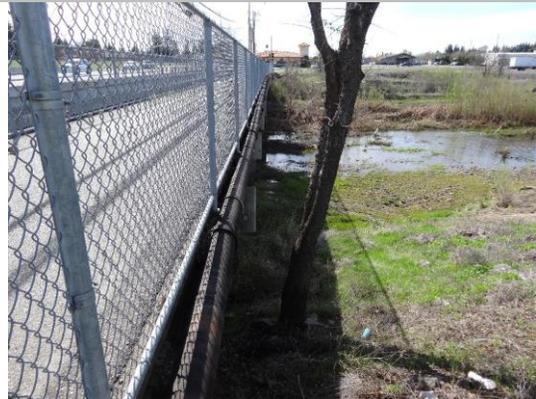
Photo 1 of 1 : UCIP_SP_2016_31851_58041.jpg

WS view: 6-inch steel pipe attached to Cohasset Road Bridge. Needs confirmation from LMA whether this is a gasoline.

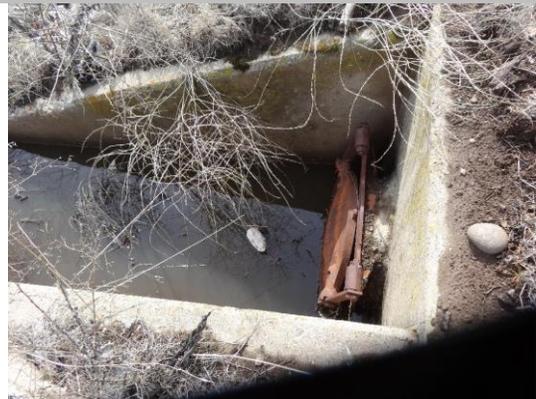
Photo 1 of 2 : UCIP_SP_2016_32125_58629.jpg

WS view: U type concrete headwall, pipe, and flapgate on levee slope. Soil/mud on outlet box. Vegetation debris blocking outlet box.

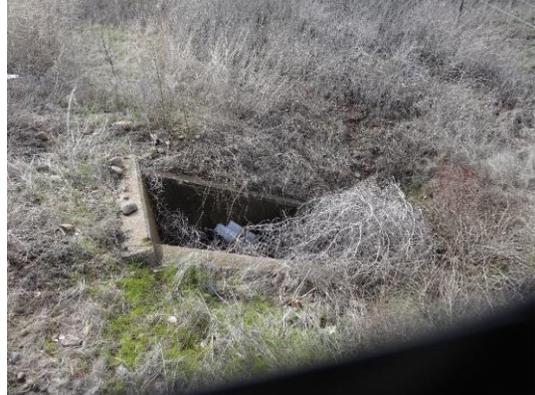
Photo 2 of 2 : UCIP_SP_2016_32125_58628.jpg

LS view: U type concrete headwall and pipe on levee slope. Soil/mud on inlet box. Vegetation debris blocking inlet box.

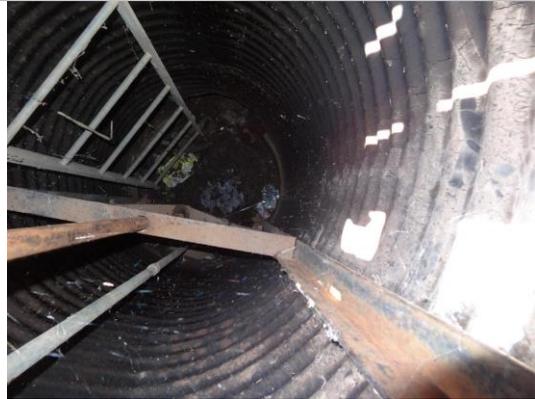
Photo 2 of 2 : UCIP_SP_2016_32025_58511.jpg

WS view: inside view of slide gate in CMP riser on waterside shoulder. Debris trapped in the riser.

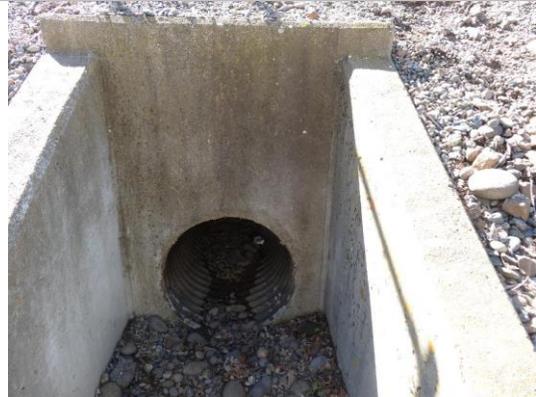
Photo 2 of 2 : UCIP_SP_2016_32023_58504.jpg

LS view: U type concrete headwall and CMP on levee slope. Pebbles and mud on inlet box.

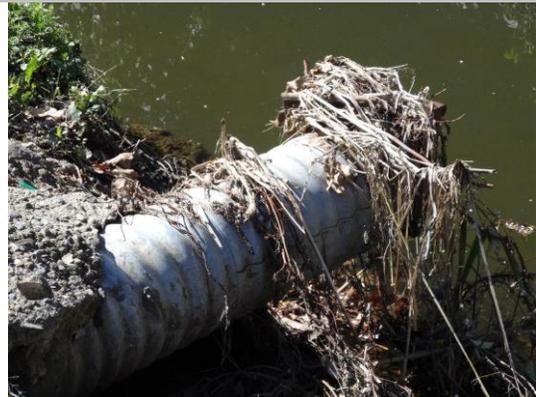
Photo 2 of 2 : UCIP_SP_2016_31968_58406.jpg

WS view: close view of CM outfall drain pipe with vegetation debris covered.

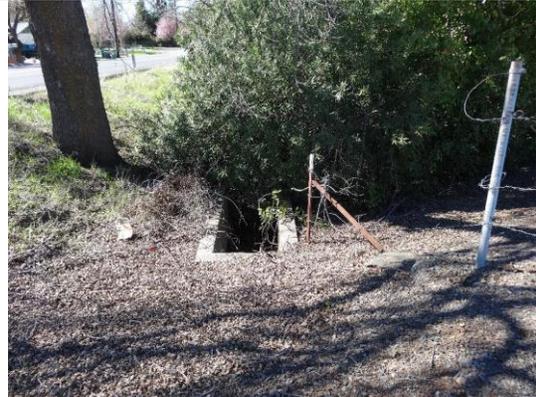
Photo 1 of 2 : UCIP_SP_2016_32144_58644.jpg

LS view: U type concrete headwall of CMP culvert on levee slope. Vegetation debris and mud on inlet box.

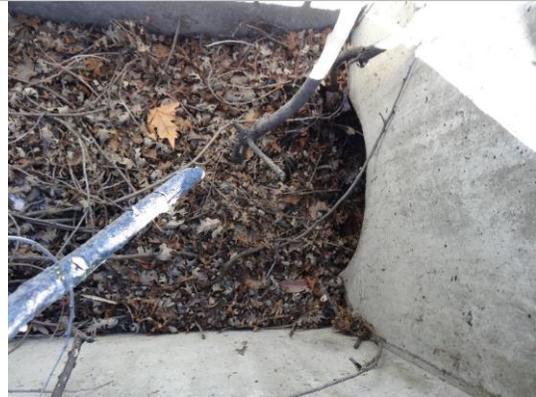
Photo 2 of 2 : UCIP_SP_2016_32144_58643.jpg

LS view: close view of vegetation debris and mud on inlet box.

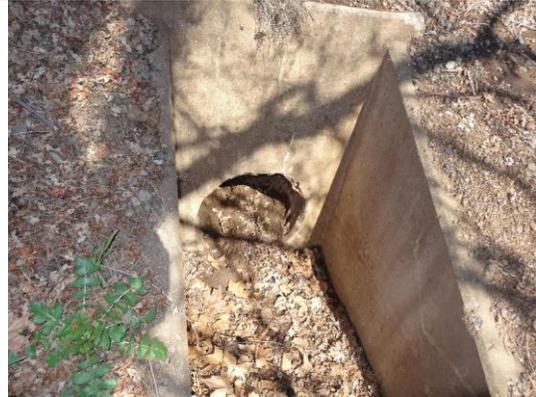
Photo 2 of 2 : UCIP_SP_2016_31963_58383.jpg

LS view: U type concrete headwall and CMP on levee slope. Vegetation debris and mud on inlet box.

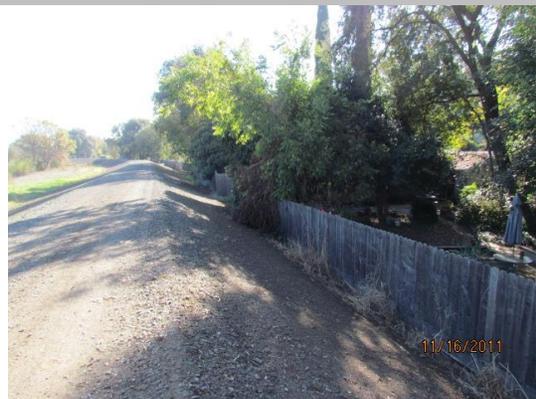
Photo 1 of 1 : SP_2016_NA0003_68_3_20160321_00003.jpg

View of the fence along the L/S toe.

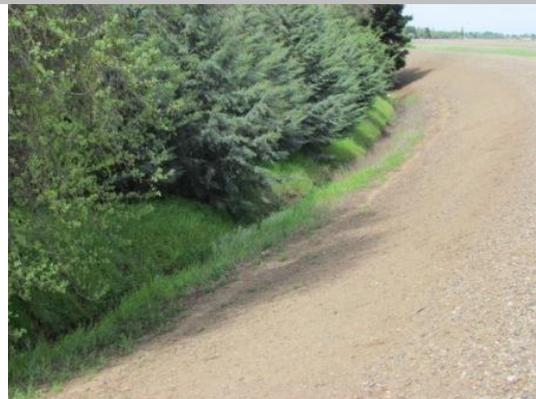
Photo 1 of 1 : SP_2016_NA0003_68_2_20160321_00002.jpg

View of ditch at the landside toe.

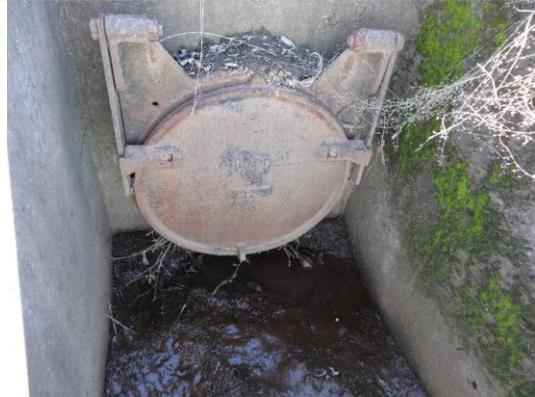
Photo 1 of 2 : UCIP_SP_2016_31964_58389.jpg

WS view: U type concrete headwall and CMP on levee slope. Vegetation debris and mud in outlet box. Needs cleaning and clearing.

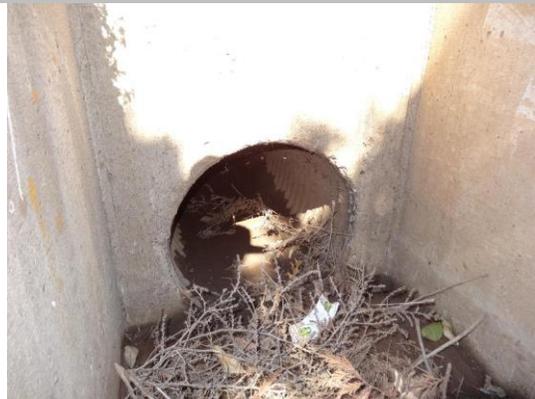
Photo 2 of 2 : UCIP_SP_2016_31964_58388.jpg

LS view: U type concrete headwall and CMP on levee slope. Vegetation debris and mud in inlet box.

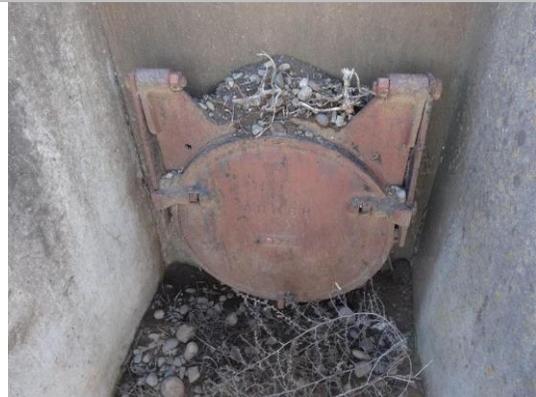
Photo 1 of 2 : UCIP_SP_2016_31965_58395.jpg

WS view: U type concrete headwall and CMP on levee slope. Vegetation debris and mud in outlet box. Needs cleaning and clearing.

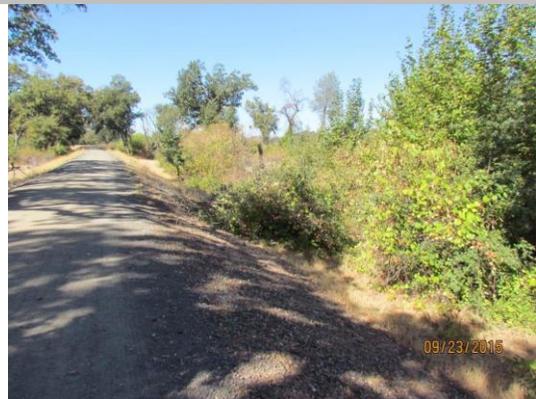
Photo 1 of 1 : SP_2016_NA0003_69_7_20160321_00006.jpg

View of the trees along the waterside slope.

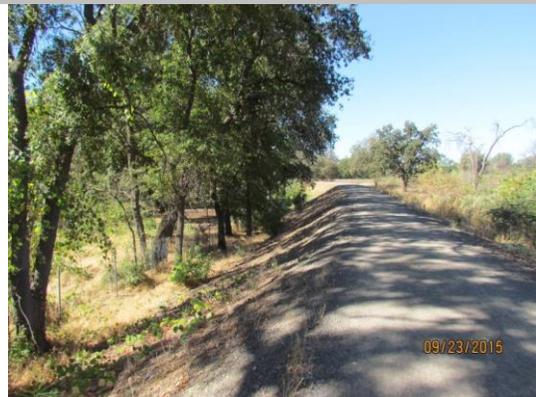
Photo 2 of 2 : SP_2016_NA0003_69_3_20160321_00002.jpg

View of the vegetation along the landside slope and toe.

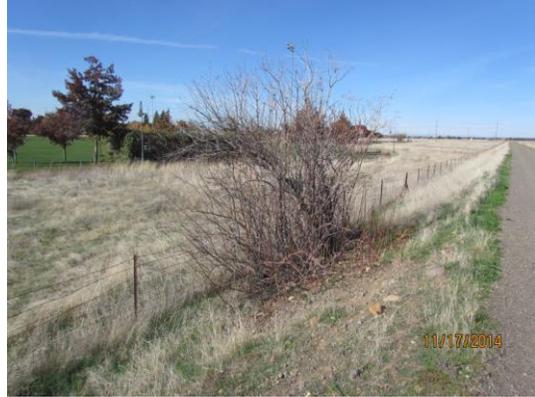
Photo 1 of 1 : SP_2016_NA0003_69_6_20160321_00005.jpg

View of the elderberry along the landside toe.

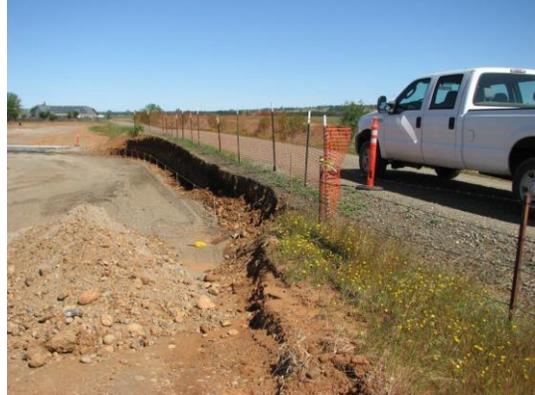
Photo 1 of 1 : SP_2016_NA0003_69_9_20160506_00008.jpg

04/25/2016: Construction cut into L/S slope.
