**Flood Control Project Maintenance
Levee Inspections**

Maintenance Issue Types Only, Levee Inspection Report By Mile - Fall 2014

Butte County Department of Public Works

Waterway	Bank	Unit Miles	Inspection Start/End	Inspector
Unit No. 01 Mud Creek	Right	6.80	11/17/2014 11/17/2014	Bob Duffey

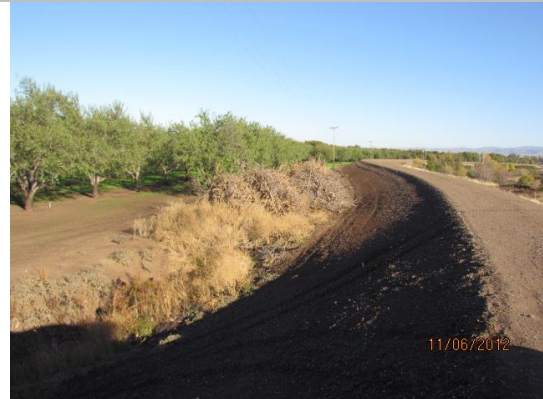
Photo 1 of 1 : FA_2014_NA0003_64_21_20141013_00005.jpg

LM Start	4.58	Rating **	M	Issue No.	21
LM End	4.58	Issue Type +	Ma	Location *	LS
Category	Earthen Levee			GPS Latitude/Longitude	
				Start	End
Item	Encroachments			39.775908 °	39.775908 °
				-121.893947 °	-121.893947 °
DWR ID	DWR_NA0003_01_s_2012_21				
Action/Comments					
Prunings

View of the brush pile along landside toe.

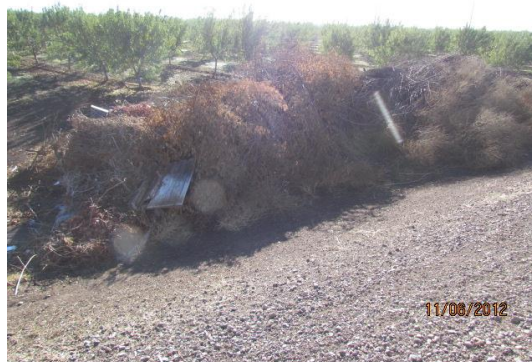
Photo 1 of 1 : FA_2014_NA0003_65_5_20141013_00003.jpg

LM Start	3.42	Rating **	M	Issue No.	5
LM End	3.42	Issue Type +	Ma	Location *	LS
Category	Earthen Levee			GPS Latitude/Longitude	
				Start	End
Item	Encroachments			39.763208 °	39.763208 °
				-121.908517 °	-121.908517 °
DWR ID	DWR_NA0003_02_f_2012_5				
Action/Comments					
Prunings

View of the brush pile along landside toe.

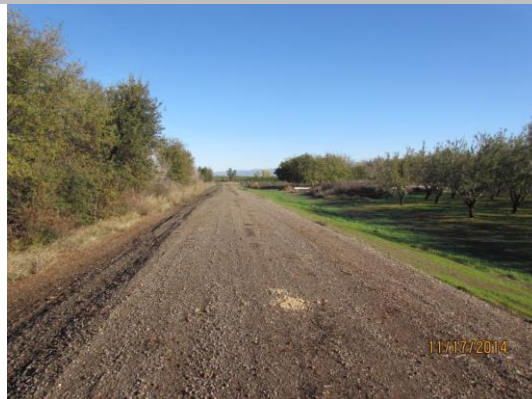
Photo 1 of 1 : FA_2014_NA0003_66_17_20141118_00001.jpg

LM Start	0.09	Rating **	A	Issue No.	17
LM End	0.09	Issue Type +	Ma	Location *	LS
Category	Earthen Levee			GPS Latitude/Longitude	
				Start	End
Item	Vegetation			39.734100 °	39.734100 °
				-121.929570 °	-121.929570 °
DWR ID	DWR_NA0003_02A_f_2014_17				
Action/Comments					
Control annual grass and weeds on the levee slopes and easements.

View of controlled vegetation on both slopes.

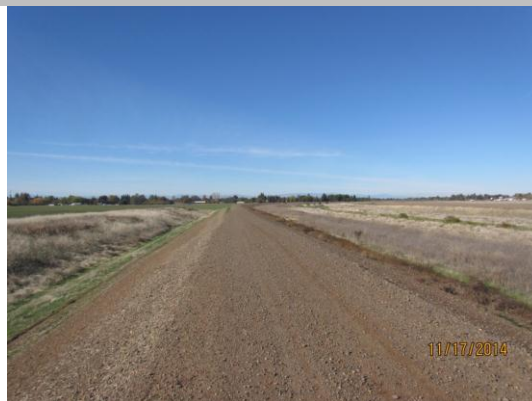
Photo 1 of 1 : FA_2014_NA0003_68_17_20141118_00004.jpg

LM Start	1.47	Rating **	A	Issue No.	17
LM End	1.47	Issue Type +	Ma	Location *	LS
Category	Earthen Levee			GPS Latitude/Longitude	
				Start	End
Item	Vegetation			39.778443 °	39.778443 °
				-121.859108 °	-121.859108 °
DWR ID	DWR_NA0003_04_f_2014_17				
Action/Comments					
Control annual grass and weeds on the levee slopes and easements.

View of controlled vegetation on both slopes.
