**Flood Control Project Maintenance  
Levee Inspections**

**Maintenance Issue Types Only, Levee Inspection Report By Mile - Fall 2015**

**Butte County Department of Public Works**

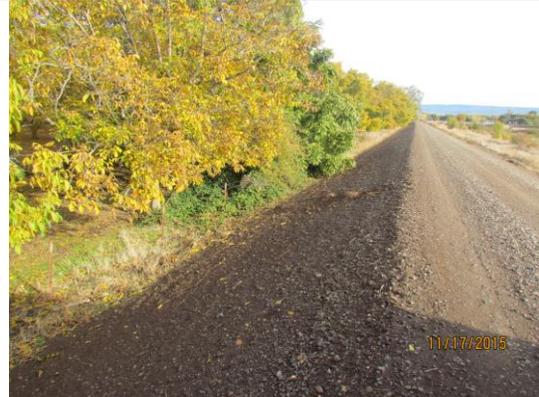
Photo 1 of 1 : FA\_2015\_NA0003\_64\_33\_20151118\_00018.jpg

LM Start	<b>4.27</b>	Rating **	M	Issue No.	<b>33</b>
LM End	<b>4.27</b>	Issue Type +	Ma	Location *	LS
Category	Earthen Levee		GPS Latitude/Longitude		
			Start	End	
Item	Animal Control		39.773398 °	39.773398 °	
			-121.895765 °	-121.895765 °	
DWR ID	DWR_NA0003_01_f_2015_33				
Action/Comments					
Exterminate rodents and backfill and compact or grout burrows. Inspector Comments: Repair the rodent holes along the landside slope.

View of the rodent holes along the landside slope.

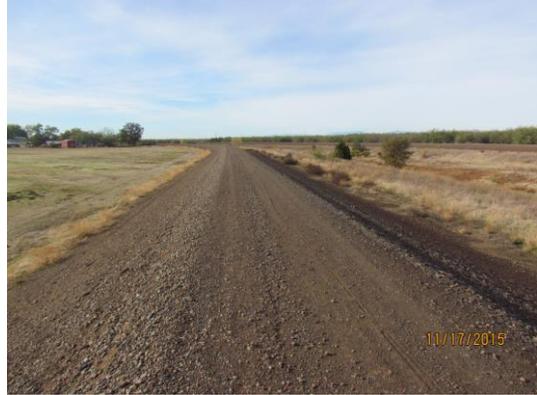
Photo 1 of 1 : FA\_2015\_NA0003\_65\_9\_20151118\_00006.jpg

LM Start	<b>2.57</b>	Rating **	A	Issue No.	<b>9</b>
LM End	<b>2.57</b>	Issue Type +	Ma	Location *	LS
Category	Earthen Levee		GPS Latitude/Longitude		
			Start	End	
Item	Vegetation		39.770788 °	39.770788 °	
			-121.899552 °	-121.899552 °	
DWR ID	DWR_NA0003_02_f_2015_9				
Action/Comments					
Control annual grass and weeds on the levee slopes and easements. Inspector Comments: Butte County sprayed and dragged both slope.

View of the no vegetation on both slopes.

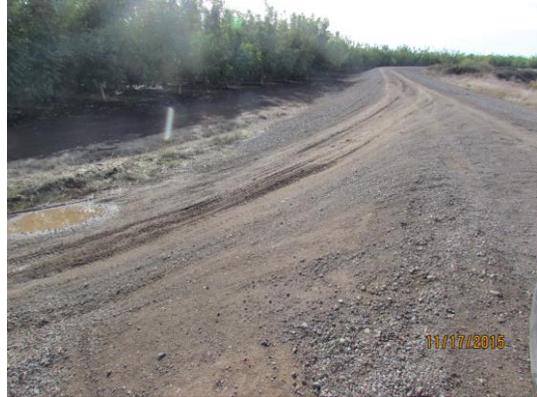
Photo 1 of 1 : FA\_2015\_NA0003\_65\_10\_20151118\_00007.jpg

LM Start	<b>3.52</b>	Rating **	M	Issue No.	<b>10</b>
LM End	<b>3.52</b>	Issue Type +	Ma	Location *	LS
Category	Earthen Levee		GPS Latitude/Longitude		
			Start	End	
Item	Slope Stability		39.760582 °	39.760582 °	
			-121.910303 °	-121.910303 °	
DWR ID	DWR_NA0003_02_f_2015_10				
Action/Comments					
Repair the levee slope damaged by vehicle traffic and prevent access where possible. Inspector Comments: Repair the vehicle erosion along the landside slope.

View of the vehicle erosion along the landside slope.

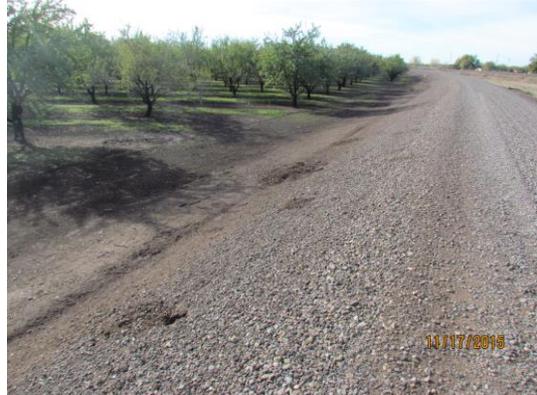
Photo 1 of 1 : FA\_2015\_NA0003\_65\_11\_20151118\_00008.jpg

LM Start	<b>4.42</b>	Rating **	M	Issue No.	<b>11</b>
LM End	<b>4.42</b>	Issue Type +	Ma	Location *	LS
Category	Earthen Levee		GPS Latitude/Longitude		
			Start	End	
Item	Animal Control		39.751120 °	39.751120 °	
			-121.915977 °	-121.915977 °	
DWR ID	DWR_NA0003_02_f_2015_11				
Action/Comments					
No rodents visible, but rodent burrows visible; need to backfill and compact or grout burrows. Inspector Comments: Repair the rodent holes along the landside slope.

View of the rodent holes along the landside slope.

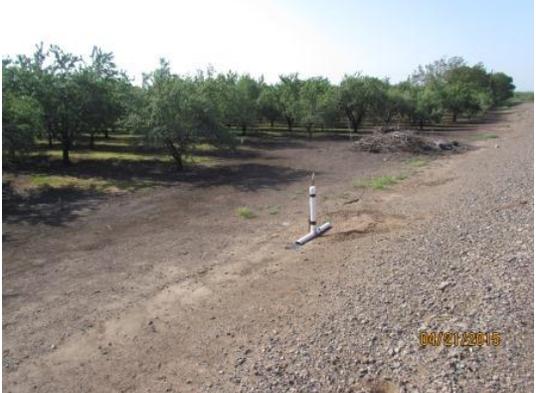
Photo 1 of 2 : FA\_2015\_NA0003\_65\_8\_20150910\_00005.jpg

LM Start	<b>4.55</b>	Rating **	A/W	Issue No.	<b>8</b>
LM End	<b>4.55</b>	Issue Type +	Ma	Location *	LS
Category	Earthen Levee		GPS Latitude/Longitude		
			Start	End	
Item	Animal Control		39.749639 °	39.749639 °	
			-121.917188 °	-121.917188 °	
DWR ID	DWR_NA0003_02_f_2013_8				
Action/Comments					
Exterminate rodents and backfill and compact or grout burrows. Inspector Comments: Butte County has been grouting the rodent holes.

View of the bait station placed by the rodent hole.

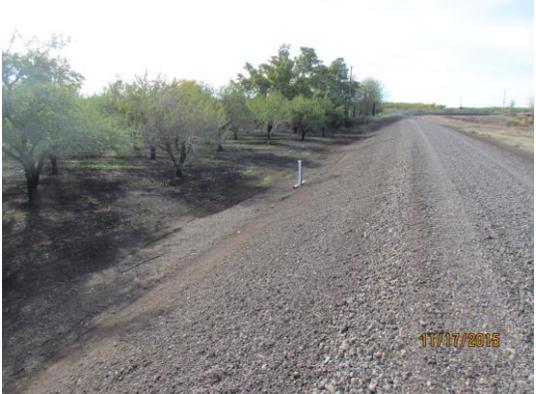
Photo 2 of 2 : FA\_2015\_NA0003\_65\_8\_20151118\_00009.jpg

View of the bait station by the rodent holes.

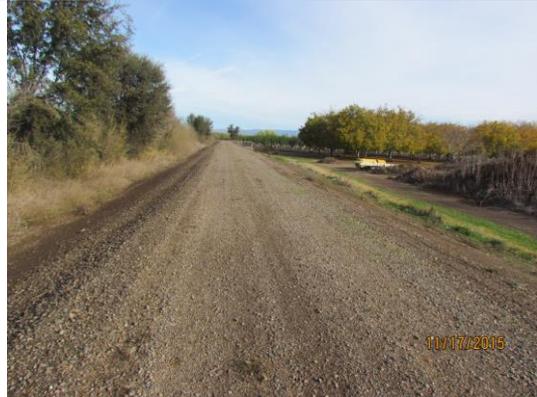
Photo 1 of 1 : FA\_2015\_NA0003\_66\_17\_20151118\_00001.jpg

LM Start	<b>0.11</b>	Rating **	A	Issue No.	<b>17</b>
LM End	<b>0.11</b>	Issue Type +	Ma	Location *	LS
Category	Earthen Levee		GPS Latitude/Longitude		
			Start	End	
Item	Vegetation		39.734465 °	39.734465 °	
			-121.929417 °	-121.929417 °	
DWR ID	DWR_NA0003_02A_f_2015_17				
Action/Comments					
Control annual grass and weeds on the levee slopes and easements. Inspector Comments: Butte County sprayed and dragged both slopes.

View of no vegetation on both slopes.

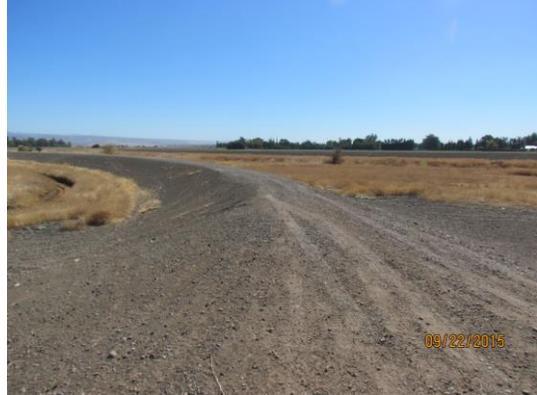
Photo 1 of 1 : FA\_2015\_NA0003\_67\_12\_20151013\_00002.jpg

LM Start	<b>0.02</b>	Rating **	M	Issue No.	<b>12</b>
LM End	<b>0.02</b>	Issue Type +	Ma	Location *	LS
Category	Earthen Levee		GPS Latitude/Longitude		
			Start	End	
Item	Slope Stability		39.785970 °	39.785970 °	
			-121.882797 °	-121.882797 °	
DWR ID	DWR_NA0003_03_f_2015_12				
Action/Comments					
Repair the levee slope damaged by vehicle traffic and prevent access where possible. Inspector Comments: Repair the erosion on both slopes caused by motorcycle traffic.

View of the erosion on both slopes caused by motorcycle traffic.

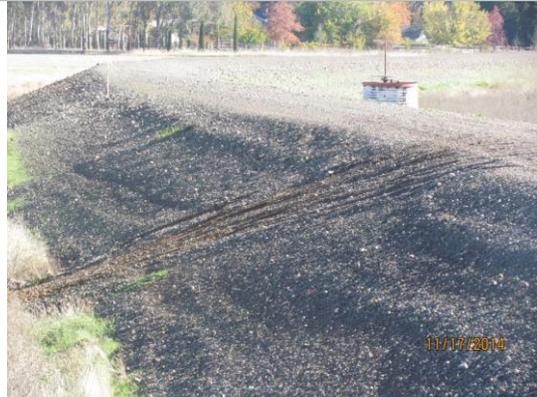
Photo 1 of 1 : FA\_2015\_NA0003\_67\_3\_20150910\_00001.jpg

LM Start	<b>0.07</b>	Rating **	M	Issue No.	<b>3</b>
LM End	<b>0.07</b>	Issue Type +	Ma	Location *	WS
Category	Earthen Levee		GPS Latitude/Longitude		
			Start	End	
Item	Slope Stability		39.786068 °	39.786068 °	
			-121.881828 °	-121.881828 °	
DWR ID	DWR_NA0003_03_s_2012_3				
Action/Comments					
Repair the levee slope damaged by vehicle traffic and prevent access where possible. Inspector Comments: Repair the erosion on landside slope caused by motorcycle traffic.

View of the erosion caused by motorcycles on the land side slope.

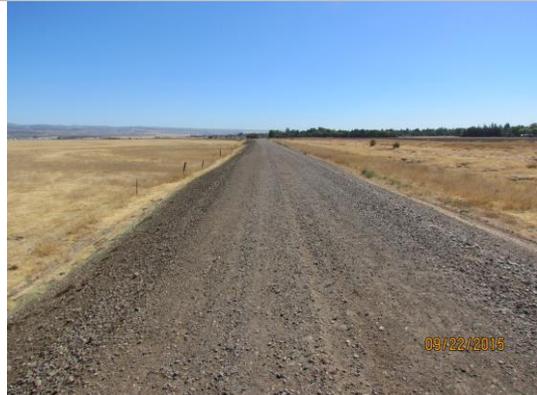
Photo 1 of 1 : FA\_2015\_NA0003\_67\_13\_20151013\_00004.jpg

LM Start	<b>1.11</b>	Rating **	A	Issue No.	<b>13</b>
LM End	<b>1.11</b>	Issue Type +	Ma	Location *	LS
Category	Earthen Levee		GPS Latitude/Longitude		
			Start	End	
Item	Vegetation		39.780317 °	39.780317 °	
			-121.865255 °	-121.865255 °	
DWR ID	DWR_NA0003_03_f_2015_13				
Action/Comments					
Control annual grass and weeds on the levee slopes and easements. Inspector Comments: Butte Co. sprayed and dragged both slopes.

View of both slopes with acceptable vegetation.

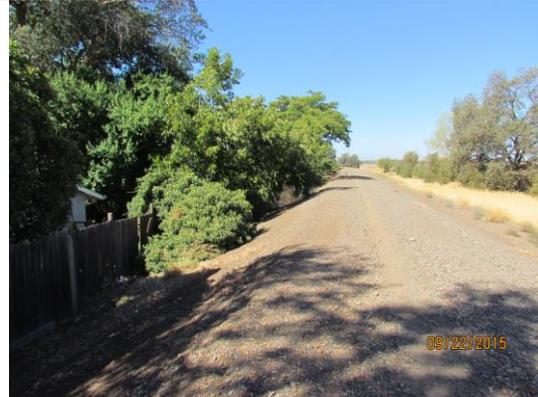
Photo 1 of 1 : FA\_2015\_NA0003\_68\_17\_20151013\_00004.jpg

LM Start	<b>1.16</b>	Rating **	M	Issue No.	<b>17</b>
LM End	<b>1.22</b>	Issue Type +	Ma	Location *	LS
Category	Earthen Levee		GPS Latitude/Longitude		
			Start	End	
Item	Trim / Thin Trees		39.777128 °	39.777580 °	
			-121.854763 °	-121.855612 °	
DWR ID	DWR_NA0003_04_f_2015_17				
Action/Comments					
Trim trees to at least five feet above ground level. Inspector Comments: Remove the trees that are overhanging the levee slope.

View of the trees overhanging the levee slope.

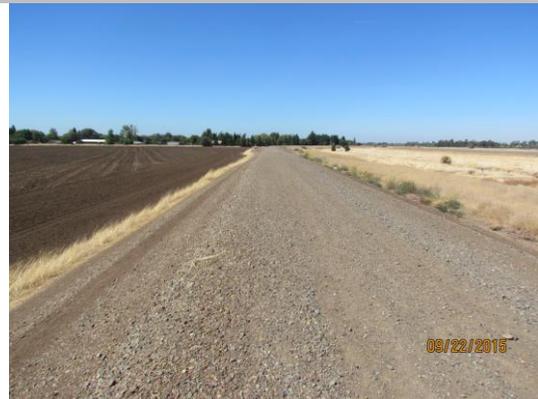
Photo 1 of 1 : FA\_2015\_NA0003\_68\_18\_20151013\_00005.jpg

LM Start	<b>1.62</b>	Rating **	A	Issue No.	<b>18</b>
LM End	<b>1.62</b>	Issue Type +	Ma	Location *	LS
Category	Earthen Levee		GPS Latitude/Longitude		
			Start	End	
Item	Vegetation		39.778842 °	39.778842 °	
			-121.862935 °	-121.862935 °	
DWR ID	DWR_NA0003_04_f_2015_18				
Action/Comments					
Control annual grass and weeds on the levee slopes and easements. Inspector Comments: Butte Co. sprayed and dragged oh slopes.

View of the slope with acceptable vegetation.

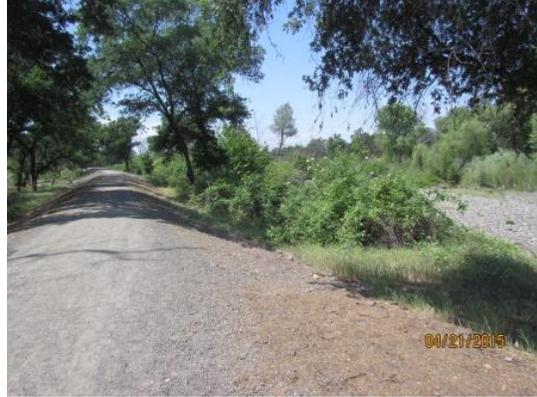
Photo 1 of 2 : FA\_2015\_NA0003\_69\_4\_20150910\_00002.jpg

LM Start	<b>0.21</b>	Rating **	M	Issue No.	<b>4</b>
LM End	<b>0.26</b>	Issue Type +	Ma	Location *	WS
Category	Earthen Levee		GPS Latitude/Longitude		
			Start	End	
Item	Vegetation		39.761957 °	39.761892 °	
			-121.792867 °	-121.793705 °	
DWR ID	DWR_NA0003_05_f_2014_4				
Action/Comments					
Remove the wild growth other than native grasses from the levee slopes. Inspector Comments: Remove the vegetation from the waterside slope.

View of the vegetation along the waterside slope.

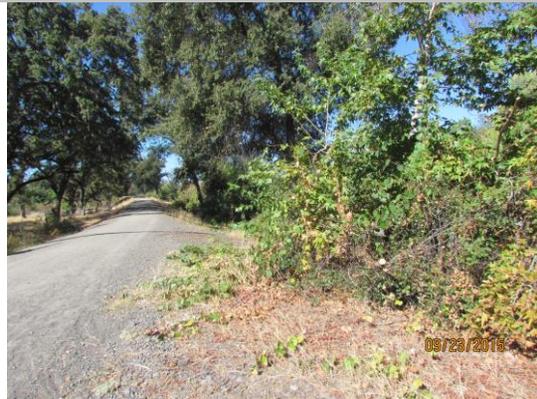
Photo 2 of 2 : FA\_2015\_NA0003\_69\_4\_20151013\_00004.jpg

View of the vegetation along the waterside slope.

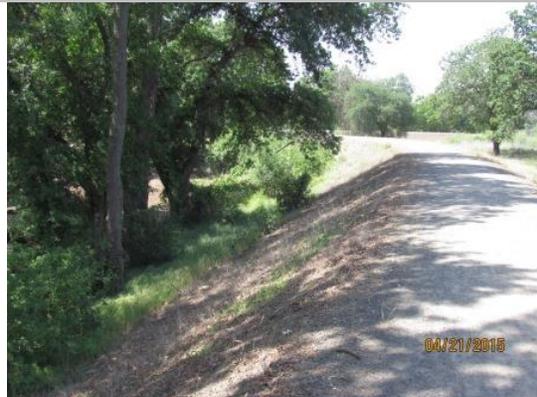
Photo 1 of 2 : FA\_2015\_NA0003\_69\_3\_20150910\_00001.jpg

LM Start	<b>0.34</b>	Rating **	M	Issue No.	<b>3</b>
LM End	<b>0.42</b>	Issue Type +	Ma	Location *	LS
Category	Earthen Levee		GPS Latitude/Longitude		
			Start	End	
Item	Vegetation		39.761633 °	39.761117 °	
			-121.795155 °	-121.796464 °	
DWR ID	DWR_NA0003_05_f_2013_3				
Action/Comments					
Remove the wild growth other than native grasses from the levee slopes. Inspector Comments: Remove the vegetation from the landside slope and toe.

View of the vegetation along the landside slope and toe

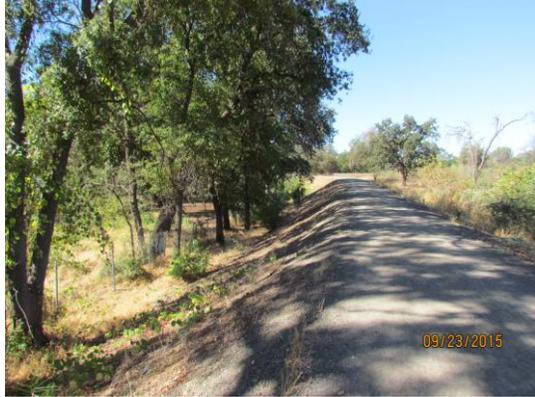
Photo 2 of 2 : FA\_2015\_NA0003\_69\_3\_20151013\_00008.jpg

LM Start	<b>0.34</b>	Rating **	M	Issue No.	<b>3 (cont)</b>
LM End	<b>0.42</b>	Issue Type +	Ma	Location *	LS
Category	Earthen Levee		GPS Latitude/Longitude		
			Start	End	
Item	Vegetation		39.761633 °	39.761117 °	
			-121.795155 °	-121.796464 °	
DWR ID	DWR_NA0003_05_f_2013_3				
Action/Comments					
Remove the wild growth other than native grasses from the levee slopes. Inspector Comments: Remove the vegetation from the landside slope and toe.

View of the vegetation along the landside slope and toe.

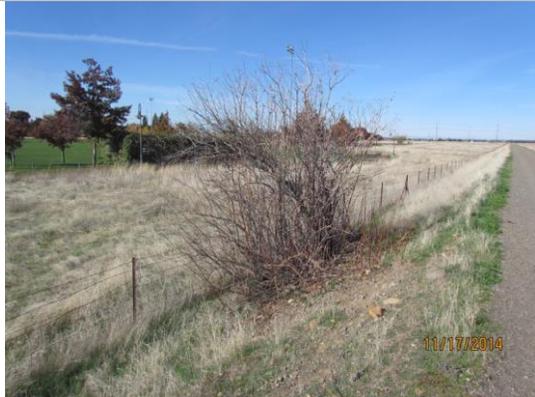
Photo 1 of 1 : FA\_2015\_NA0003\_69\_6\_20150910\_00003.jpg

LM Start	<b>0.89</b>	Rating **	A/W	Issue No.	<b>6</b>
LM End	<b>0.89</b>	Issue Type +	Ma	Location *	LS
Category	Earthen Levee		GPS Latitude/Longitude		
			Start	End	
Item	Vegetation		39.764397 °	39.764397 °	
			-121.803335 °	-121.803335 °	
DWR ID	DWR_NA0003_05_f_2014_6				
Action/Comments					
Elderberries are blocking visibility and flood fight capability. Inspector Comments: Elderberry is not completely blocking the visibility.

View of the elderberry along the landside toe.
