**Flood Control Project Maintenance
Levee Inspections**

Maintenance Issue Types Only, Levee Inspection Report By Mile - Fall 2016

Butte County Department of Public Works

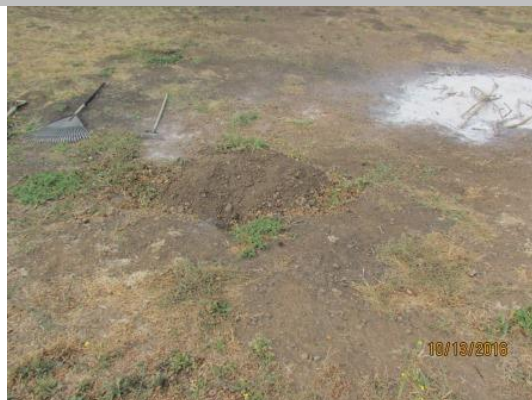
Photo 1 of 1 : FA_2016_NA0003_64_51_20161019_00059.jpg

LM Start	4.03	Rating **	M	Issue No.	51
LM End	4.03	Issue Type +	Ma	Location *	LS
Category	Earthen Levee		GPS Latitude/Longitude		
			Start	End	
Item	Animal Control		39.771877°	39.771877°	
			-121.899441°	-121.899441°	
DWR ID	DWR_NA0003_01_f_2016_51				
Comment Code					
A1 : Exterminate rodents and backfill and compact or grout burrows.					
Inspector Comment

View of the rodent holes along the landside slope.

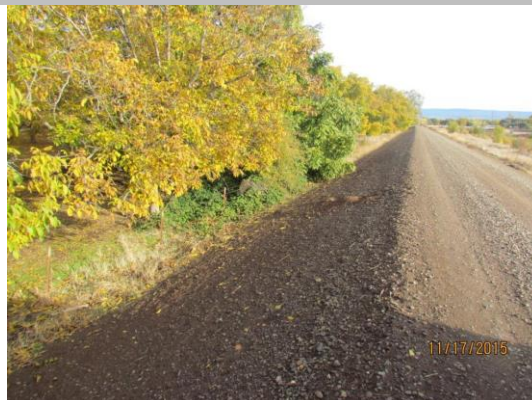
Photo 1 of 1 : FA_2016_NA0003_64_33_20160823_00018.jpg

LM Start	4.27	Rating **	A/W	Issue No.	33
LM End	4.27	Issue Type +	Ma	Location *	LS
Category	Earthen Levee			GPS Latitude/Longitude	
				Start	End
Item	Animal Control			39.773398 °	39.773398 °
				-121.895765 °	-121.895765 °
DWR ID	DWR_NA0003_01_f_2015_33				
Comment Code					
A1 : Exterminate rodents and backfill and compact or grout burrows.					
Inspector Comment					
Repair the rodent holes along the landside slope.

View of the rodent holes along the landside slope.

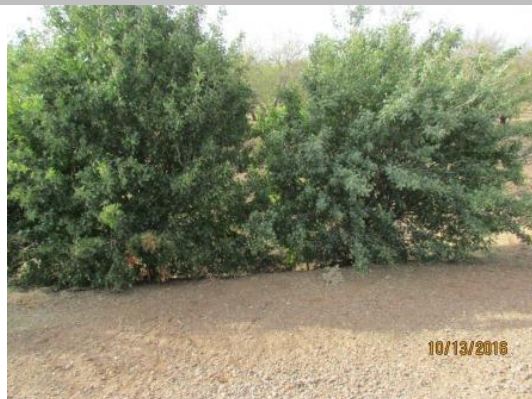
Photo 1 of 1 : FA_2016_NA0003_64_53_20161019_00061.jpg

LM Start	4.45	Rating **	M	Issue No.	53
LM End	4.45	Issue Type +	Ma	Location *	LS
Category	Earthen Levee			GPS Latitude/Longitude	
				Start	End
Item	Trim / Thin Trees			39.775789 °	39.775789 °
				-121.894048 °	-121.894048 °
DWR ID	DWR_NA0003_01_f_2016_53				
Comment Code					
T1 : Trim trees to at least five feet above ground level.					
Inspector Comment

View of the trees along the landside toe.

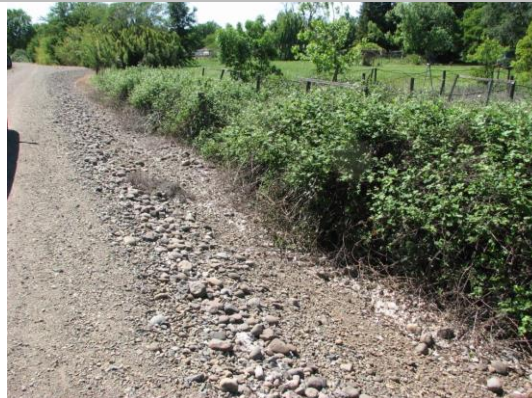
Photo 1 of 1 : FA_2016_NA0003_64_34_20160823_00019.jpg

LM Start	6.16	Rating **	M	Issue No.	34
LM End	6.16	Issue Type +	Ma	Location *	LS
Category	Earthen Levee			GPS Latitude/Longitude	
				Start	End
Item	Vegetation			39.795428 °	39.795428 °
				-121.885306 °	-121.885306 °
DWR ID	DWR_NA0003_01_s_2016_34				
Comment Code					
V2 : Remove the wild growth other than native grasses from the levee slopes.					
Inspector Comment					
Blackberry bramble on landside toe blocking visibility.

Trim vegetation at L/S toe.

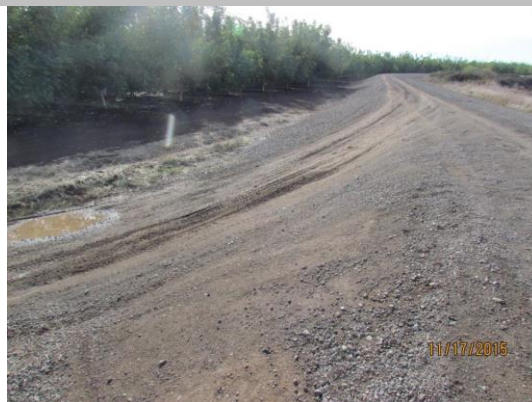
Photo 1 of 1 : FA_2016_NA0003_65_10_20160823_00006.jpg

LM Start	3.52	Rating **	M	Issue No.	10
LM End	3.52	Issue Type +	Ma	Location *	LS
Category	Earthen Levee			GPS Latitude/Longitude	
				Start	End
Item	Slope Stability			39.760582 °	39.760582 °
				-121.910303 °	-121.910303 °
DWR ID	DWR_NA0003_02_f_2015_10				
Comment Code					
S3 : Repair the levee slope damaged by vehicle traffic and prevent access where possible.					
Inspector Comment

View of the vehicle erosion along the landside slope.

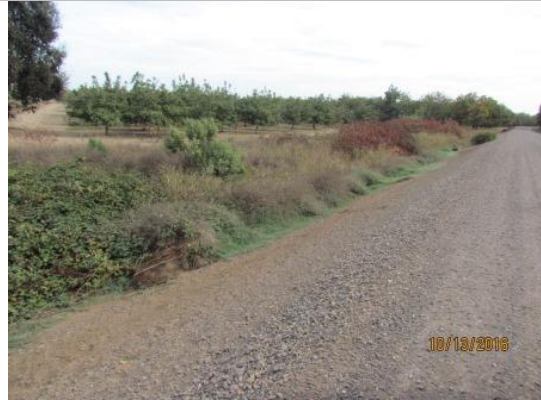
Photo 1 of 1 : FA_2016_NA0003_65_40_20161019_00027.jpg

LM Start	7.17	Rating **	M	Issue No.	40
LM End	7.22	Issue Type +	Ma	Location *	LS
Category	Earthen Levee			GPS Latitude/Longitude	
				Start	End
Item	Vegetation			39.719593 °	39.718933 °
				-121.938137 °	-121.937635 °
DWR ID	DWR_NA0003_02_f_2016_40				
Comment Code					
V2 : Remove the wild growth other than native grasses from the levee slopes.					
Inspector Comment

View of the dense vegetation along the landside toe blocking visibility and access.

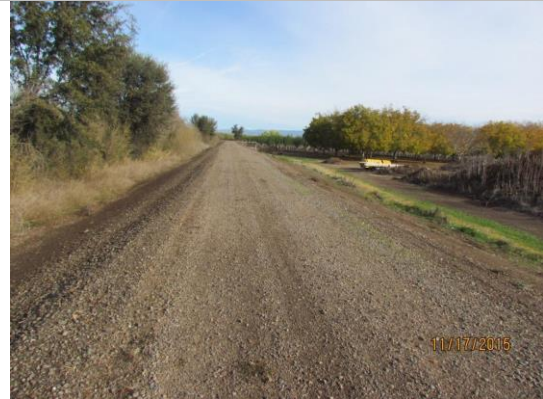
Photo 1 of 1 : FA_2016_NA0003_66_4_20161026_00001.jpg

LM Start	0.00	Rating **	A	Issue No.	4
LM End	0.00	Issue Type +	Ma	Location *	
Category	Earthen Levee			GPS Latitude/Longitude	
				Start	End
Item	Vegetation			39.733077°	39.733077°
				-121.930273°	-121.930273°
DWR ID	DWR_NA0003_02A_f_2016_4				
Comment Code					
Inspector Comment					
LMA is keeping grass and weeds off of levee slopes.

View of the levee crown.

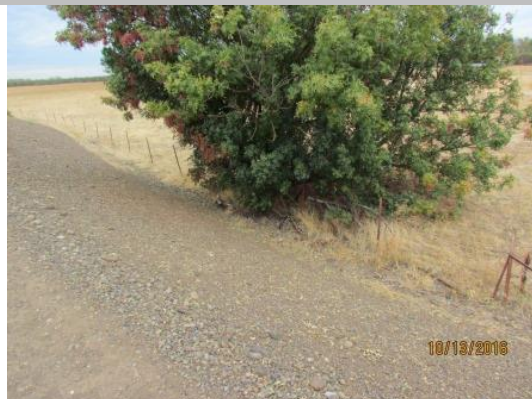
Photo 1 of 1 : FA_2016_NA0003_67_15_20161019_00022.jpg

LM Start	0.35	Rating **	M	Issue No.	15
LM End	0.35	Issue Type +	Ma	Location *	LS
Category	Earthen Levee			GPS Latitude/Longitude	
				Start	End
Item	Trim / Thin Trees			39.785704°	39.785704°
				-121.877004°	-121.877004°
DWR ID	DWR_NA0003_03_f_2016_15				
Comment Code					
T1 : Trim trees to at least five feet above ground level.					
Inspector Comment

View of the overgrown tree along the landside slope.

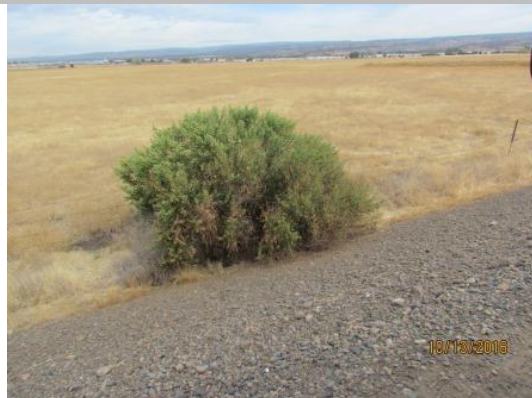
Photo 1 of 1 : FA_2016_NA0003_67_14_20161019_00023.jpg

LM Start	3.38	Rating **	M	Issue No.	14
LM End	3.38	Issue Type +	Ma	Location *	LS
Category	Earthen Levee			GPS Latitude/Longitude	
				Start	End
Item	Vegetation			39.777429 °	39.777429 °
				-121.848937 °	-121.848937 °
DWR ID	DWR_NA0003_03_f_2016_14				
Comment Code					
V2 : Remove the wild growth other than native grasses from the levee slopes.					
Inspector Comment

View of a bush along the landside toe.

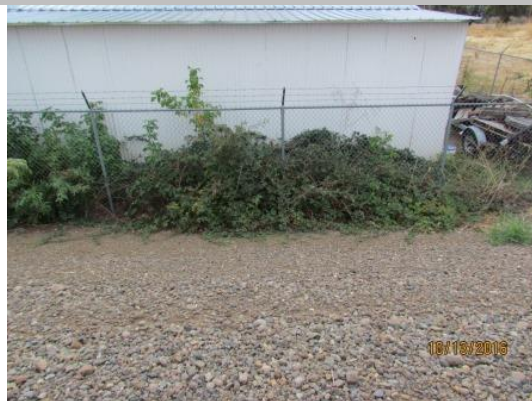
Photo 1 of 1 : FA_2016_NA0003_68_20_20161019_00036.jpg

LM Start	0.16	Rating **	M	Issue No.	20
LM End	0.16	Issue Type +	Ma	Location *	LS
Category	Earthen Levee			GPS Latitude/Longitude	
				Start	End
Item	Vegetation			39.776526 °	39.776526 °
				-121.848727 °	-121.848727 °
DWR ID	DWR_NA0003_04_f_2016_20				
Comment Code					
V2 : Remove the wild growth other than native grasses from the levee slopes.					
Inspector Comment

View of the vegetation along the landside toe blocking visibility.

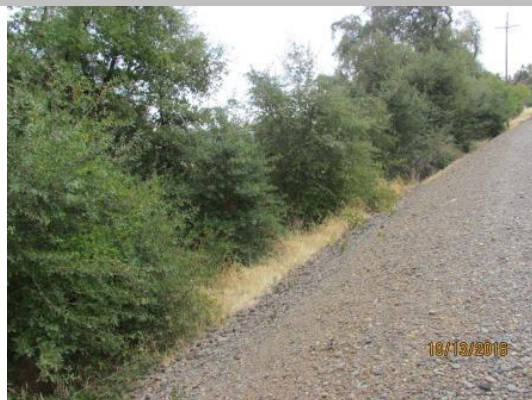
Photo 1 of 1 : FA_2016_NA0003_68_21_20161019_00037.jpg

LM Start	0.35	Rating **	M	Issue No.	21
LM End	0.39	Issue Type +	Ma	Location *	LS
Category	Earthen Levee			GPS Latitude/Longitude	
				Start	End
Item	Trim / Thin Trees			39.775672°	39.775220°
				-121.850301°	-121.849805°
DWR ID	DWR_NA0003_04_f_2016_21				
Comment Code					
T2 : Thin trees to allow visibility of the ground and room to flood fight.					
Inspector Comment

View of the overgrown trees along the landside toe.

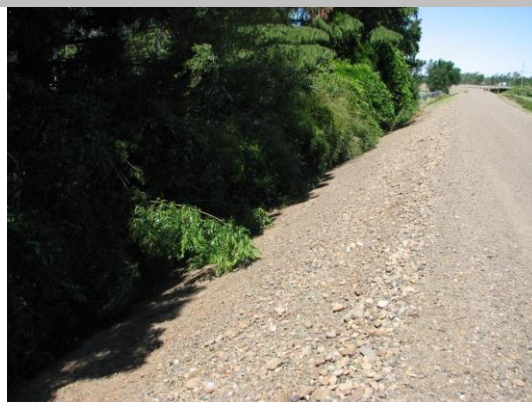
Photo 1 of 1 : FA_2016_NA0003_68_18_20160823_00005.jpg

LM Start	2.04	Rating **	U	Issue No.	18
LM End	2.08	Issue Type +	Ma	Location *	LS
Category	Earthen Levee			GPS Latitude/Longitude	
				Start	End
Item	Trim / Thin Trees			39.781669 °	39.782025 °
				-121.869804 °	-121.870252 °
DWR ID	DWR_NA0003_04_s_2016_18				
Comment Code					
T2 : Thin trees to allow visibility of the ground and room to flood fight.					
Inspector Comment					
Trees and shrubbery obscure visibility on landside toe hinge point.

View of the vegetation on fence at landside toe.

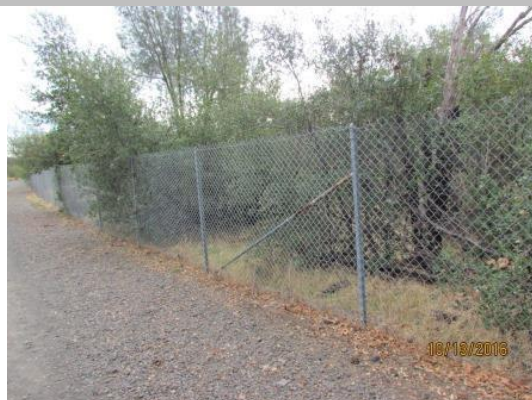
Photo 1 of 1 : FA_2016_NA0003_69_12_20161019_00013.jpg

LM Start	0.50	Rating **	M	Issue No.	12
LM End	0.82	Issue Type +	Ma	Location *	LS
Category	Earthen Levee			GPS Latitude/Longitude	
				Start	End
Item	Trim / Thin Trees			39.761836 °	39.763507 °
				-121.797316 °	-121.802545 °
DWR ID	DWR_NA0003_05_f_2016_12				
Comment Code					
T2 : Thin trees to allow visibility of the ground and room to flood fight.					
Inspector Comment

View of the trees along the landside slope.

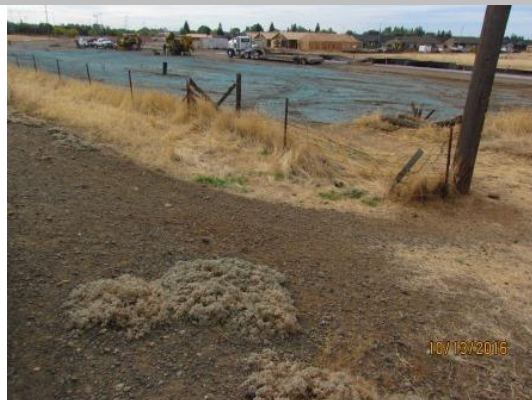
Photo 1 of 1 : FA_2016_NA0003_69_13_20161019_00014.jpg

LM Start	1.25	Rating **	M	Issue No.	13
LM End	1.25	Issue Type +	Ma	Location *	LS
Category	Earthen Levee			GPS Latitude/Longitude	
				Start	End
Item	Slope Stability			39.768621 °	39.768621 °
				-121.807052 °	-121.807052 °
DWR ID	DWR_NA0003_05_f_2016_13				
Comment Code					
S2 : Repair the levee slope damaged by foot traffic and prevent access where possible.					
Inspector Comment

View of the damaged slope by foot traffic.
