**Flood Control Project Maintenance  
Levee Inspections**

## Maintenance Issue Types Only, Levee Inspection Report By Mile - Fall 2017

### Butte County Department of Public Works

Waterway	Bank	Unit Miles	Inspection Start/End	Inspector
Unit No. 01 Mud Creek	Right	6.80	10/11/2017 10/11/2017	Bob Duffey

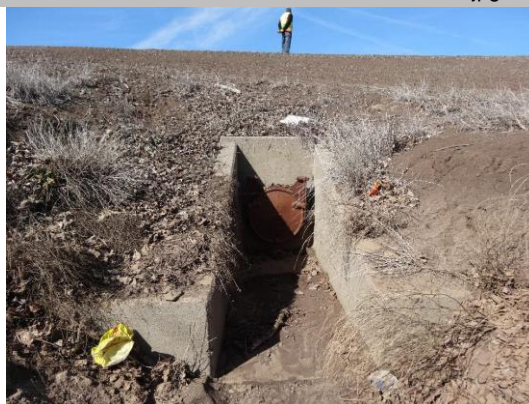
Photo 1 of 3 : UCIP\_FA\_2017\_29705\_54924.jpg

WS view: U typed concrete headwall, flapgate on levee slope.

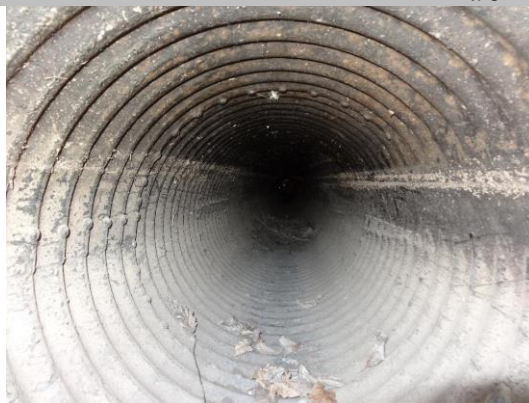
Photo 3 of 3 : UCIP\_FA\_2017\_29705\_54922.jpg

LS view: inside view of CMP on levee slope. Looks clean and clear.

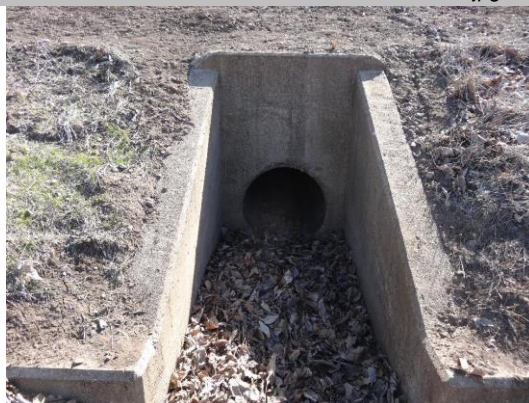
Photo 3 of 3 : UCIP\_FA\_2017\_32044\_58541.jpg

LS view: U typed concrete headwall and CMP on levee slope.

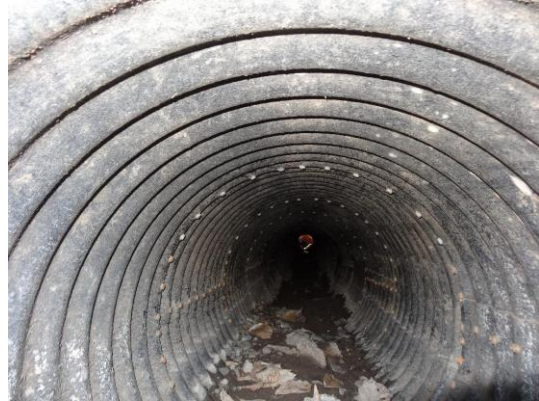
Photo 3 of 3 : UCIP\_FA\_2017\_50142\_55884.jpg

LS view: inside view of CMP on levee slope. Needs cleaning and clearing.

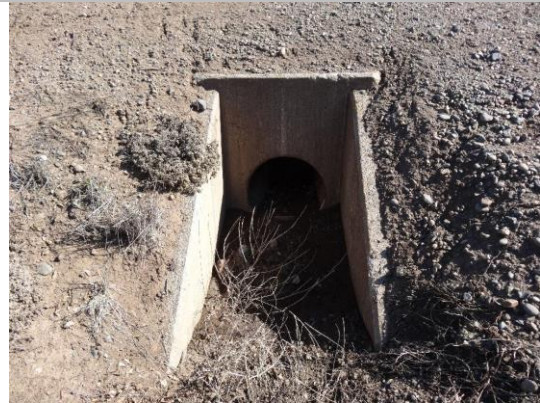
Photo 2 of 2 : UCIP\_FA\_2017\_30294\_55703.jpg

FS\_ID:30294  
DS\_ID:19216  
EP\_NO: N/A  
Repair Type: Non-Urgent  
Crossing Status: Found  
UCIP Comments: Inlet and outlet needs cleaning and clearing of debris.  
FIELD\_STRUCT\_DESC: 24-inch CM pipe through levee, 8.5 feet below the crown. Flap gate on the waterward end. Concrete "U" headwalls on both ends. Grouted riprap apron on the landward end. Grouted riprap spillway on the waterward end. O&M Manual Sac 504, May 1965.  
FS Date: 2/20/2014

LS view: U type concrete headwall and CMP on levee slope. Debris blocking the inlet pipe.

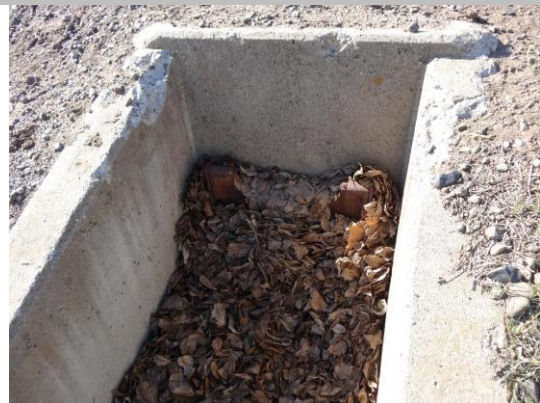
Photo 1 of 2 : UCIP\_FA\_2017\_30295\_55706.jpg

WS view: U type concrete headwall, flapgate on levee slope. Vegetation debris blocking the outlet.

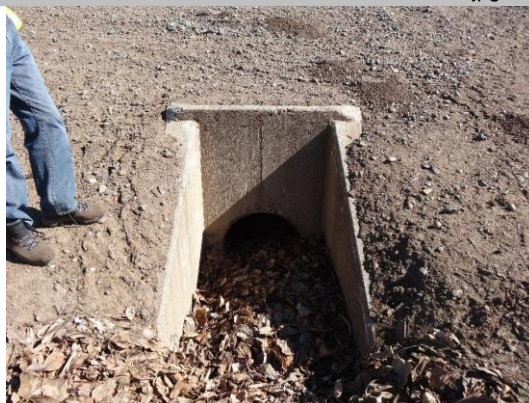
Photo 2 of 2 : UCIP\_FA\_2017\_30295\_55705.jpg

LS view: U type concrete headwall and CMP on levee slope. Vegetation debris blocking the inlet.

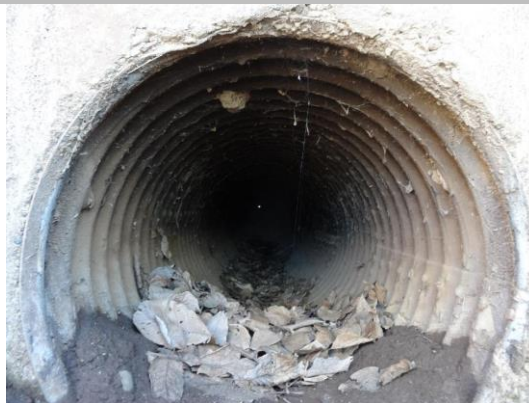
Photo 3 of 3 : UCIP\_FA\_2017\_30310\_55739.jpg

LS view: inside view of CMP on levee slope. Needs cleaning and clearing.

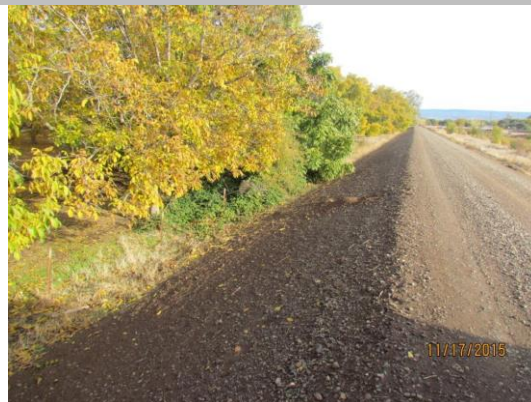
Photo 1 of 1 : FA\_2017\_NA0003\_64\_33\_20170911\_00016.jpg

LM Start	4.27	Rating **	M	Issue No.	33
LM End	4.27	Issue Type +	Ma	Location *	LS
Category	Earthen Levee			GPS Latitude/Longitude	
				Start	End
Item	Animal Control			39.773398 °	39.773398 °
				-121.895765 °	-121.895765 °
DWR ID	DWR_NA0003_01_f_2015_33				
Comment Code					
A1 : Exterminate rodents and backfill and compact or grout burrows.					
Inspector Comment					
Repair the rodent holes along the landside slope.

View of the rodent holes along the landside slope.

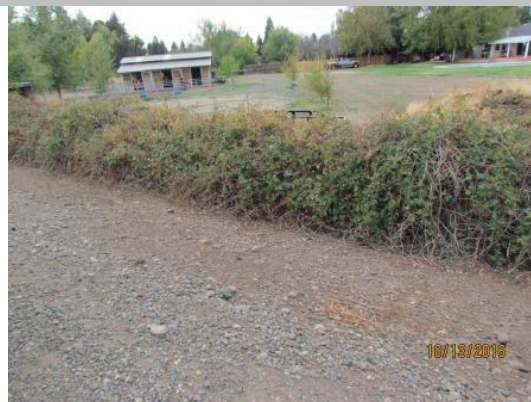
Photo 1 of 1 : FA\_2017\_NA0003\_64\_22\_20170911\_00005.jpg

View of the blackberries blocking visibility and access.

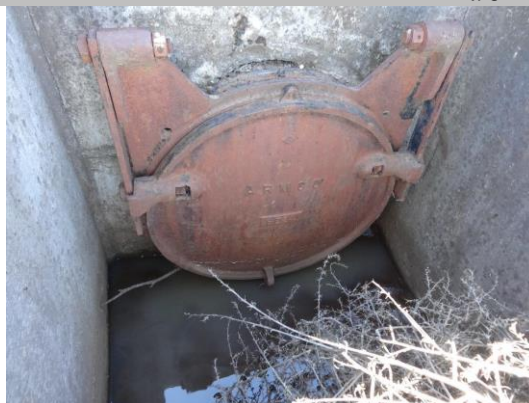
Photo 2 of 3 : UCIP\_FA\_2017\_31667\_57967.jpg

WS view: U type concrete headwall, pipe, and flapgate on levee slope. Vegetation debris on outlet box.

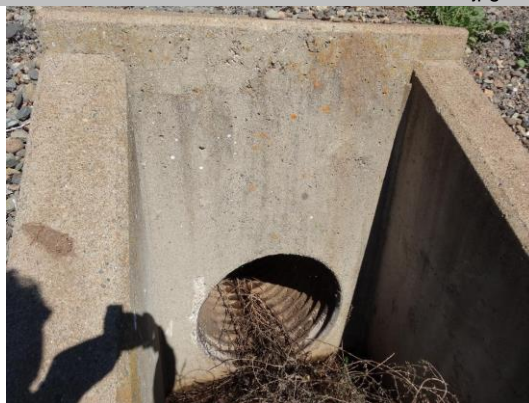
Photo 3 of 3 : UCIP\_FA\_2017\_31667\_57966.jpg

LS view: U type concrete headwall and CMP on levee slope. Vegetation debris on inlet box.

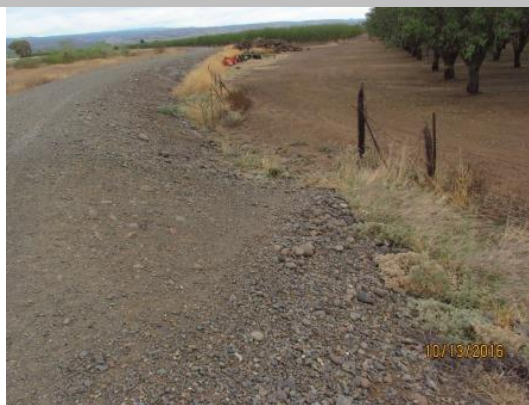
Photo 1 of 1 : FA\_2017\_NA0003\_65\_29\_20170911\_00008.jpg

View of the slope instability caused by vehicles along the landside slope.

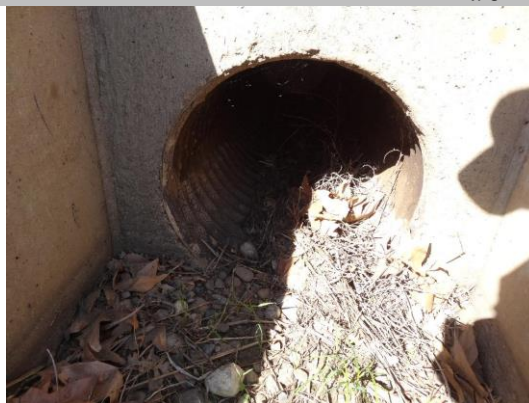
Photo 2 of 3 : UCIP\_FA\_2017\_30403\_55921.jpg

LS view: U type concrete headwall and CMP on levee slope. Vegetation debris in inlet pipe.

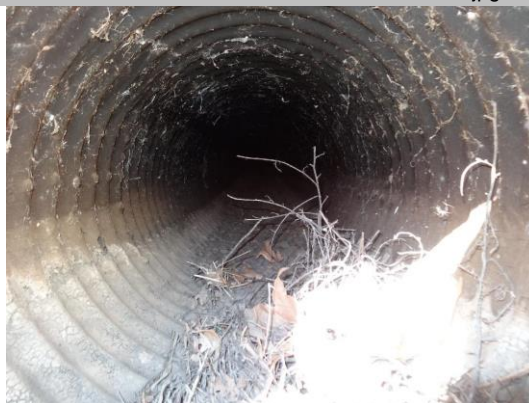
Photo 3 of 3 : UCIP\_FA\_2017\_30403\_55920.jpg

LS view: inside view of CMP on levee slope. Needs cleaning and clearing.

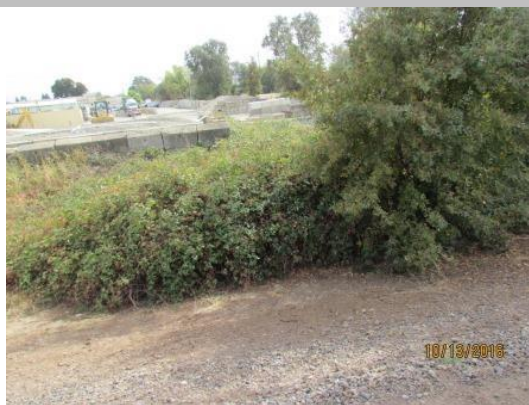
Photo 1 of 1 : FA\_2017\_NA0003\_65\_30\_20170911\_00009.jpg

View of the blackberries blocking visibility and access.

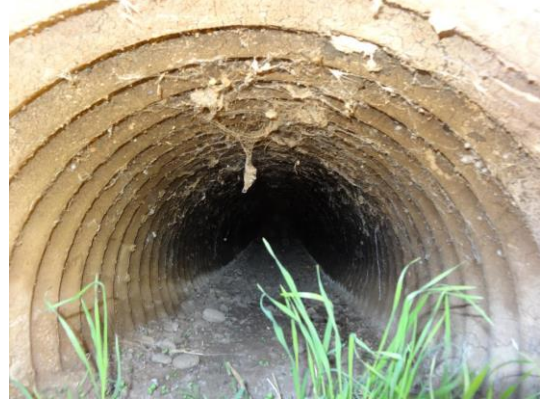
Photo 3 of 3 : UCIP\_FA\_2017\_30763\_56660.jpg

LS view: inside view of CMP on levee slope. Needs cleaning and clearing.

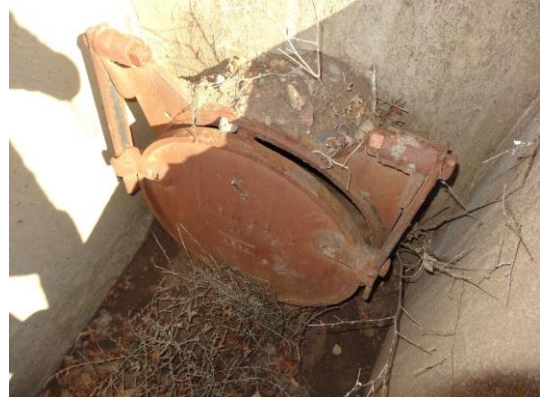
Photo 1 of 3 : UCIP\_FA\_2017\_30783\_56682.jpg

WS view: U type concrete headwall, pipe, and flapgate on levee slope. Gate not fully closed. Debris and soil in outlet box.

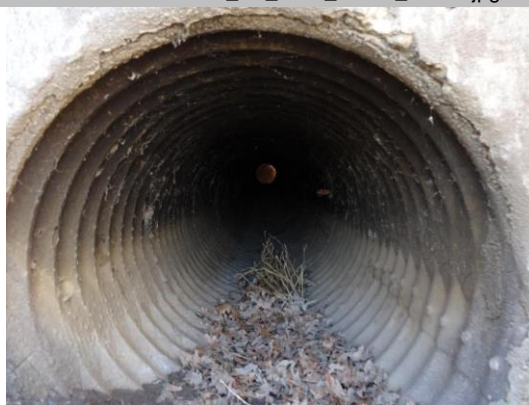
Photo 3 of 3 : UCIP\_FA\_2017\_30783\_56680.jpg

LS view: inside view of CMP on levee slope. Needs cleaning and clearing.

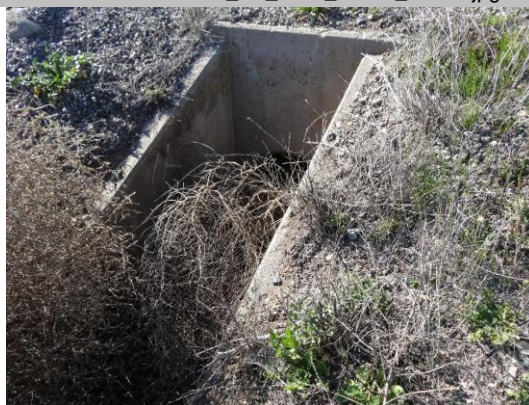
Photo 2 of 3 : UCIP\_FA\_2017\_30803\_56684.jpg

LS view: U type concrete headwall and CMP on levee slope. Vegetation debris and soil blocking inlet.

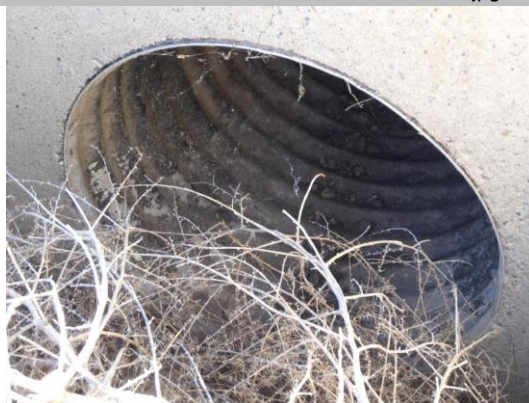
Photo 3 of 3 : UCIP\_FA\_2017\_30803\_56683.jpg

LS view: inside view of CMP on levee slope. Needs cleaning and clearing.

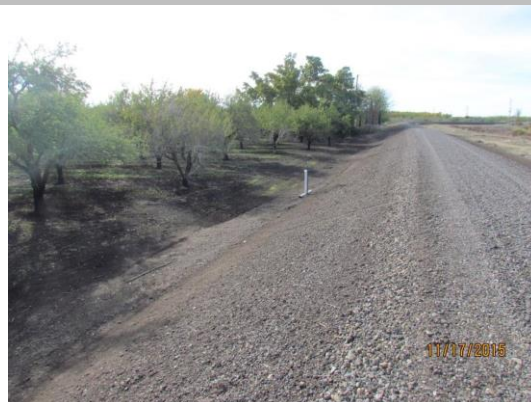
Photo 2 of 2 : FA\_2017\_NA0003\_65\_8\_20170911\_00006.jpg

View of the bait station by the rodent holes.

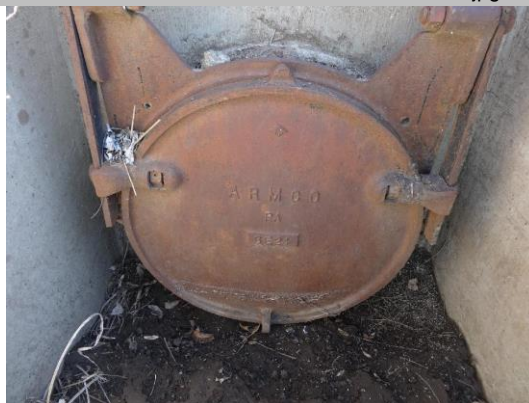
Photo 1 of 3 : UCIP\_FA\_2017\_31028\_56913.jpg

WS view: U type concrete headwall, pipe, and flapgate on levee slope. Soil/mud on outlet box.

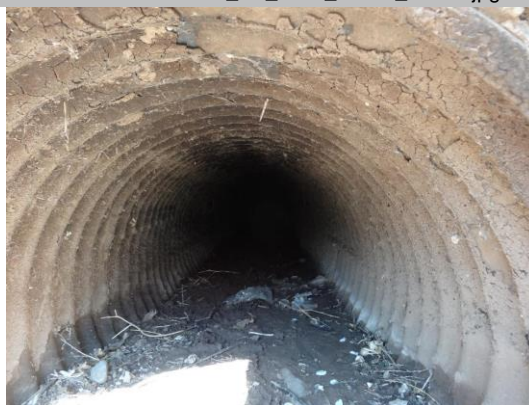
Photo 3 of 3 : UCIP\_FA\_2017\_31031\_56915.jpg

LS view: inside view of CMP on levee slope. Needs cleaning and clearing.

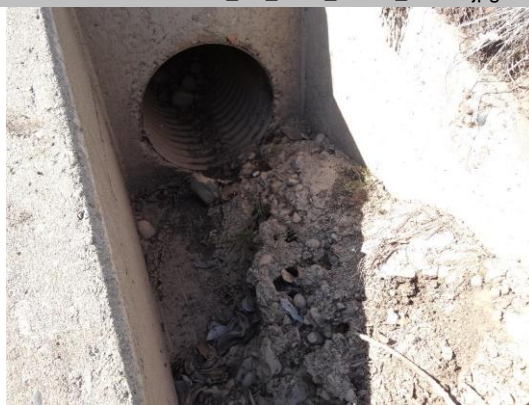
Photo 2 of 3 : UCIP\_FA\_2017\_31085\_56987.jpg

LS view: U type concrete headwall and CMP on levee slope. Soil/mud on inlet box.

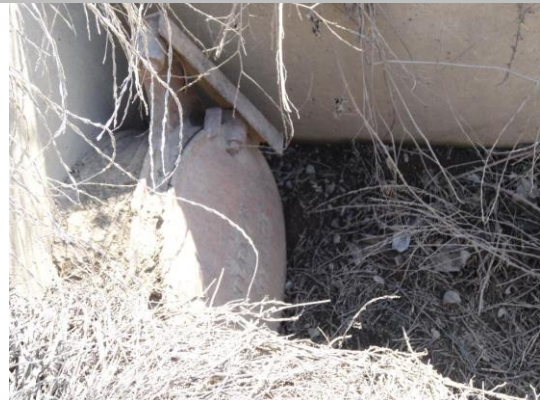
Photo 1 of 3 : UCIP\_FA\_2017\_31103\_57002.jpg

WS view: U type concrete headwall, pipe, and flapgate on levee slope.  
Soil/mud on outlet box. Vegetation debris blocking outlet box

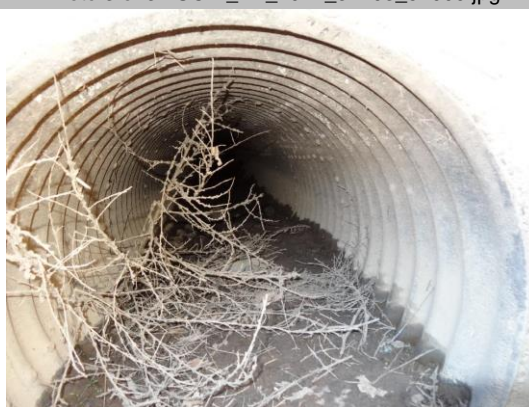
Photo 3 of 3 : UCIP\_FA\_2017\_31103\_57000.jpg

LS view: inside view of CMP on levee slope. Needs cleaning and clearing.

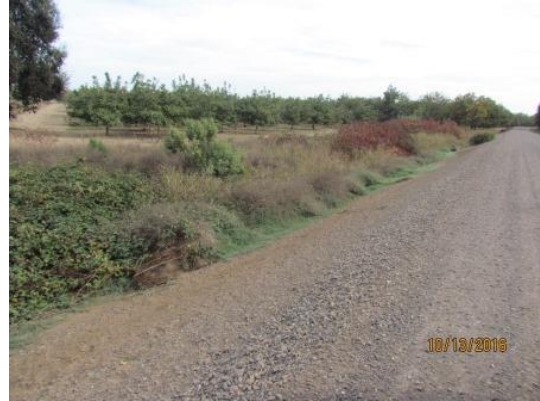
Photo 1 of 1 : FA\_2017\_NA0003\_65\_40\_20170911\_00017.jpg

View of the dense vegetation along the landside toe blocking visibility and access.

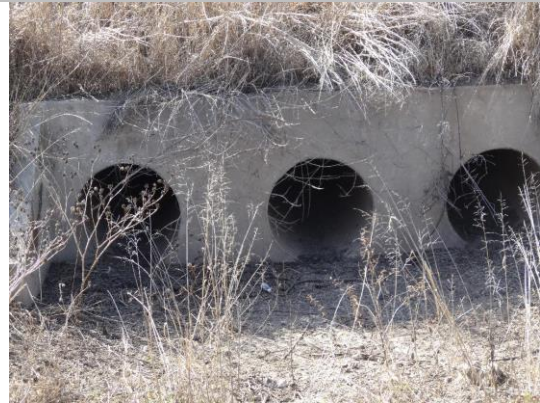
Photo 3 of 3 : UCIP\_FA\_2017\_32087\_58590.jpg

LS view: U type concrete headwall and CMPs on levee slope. Soil/mud on inlet box.

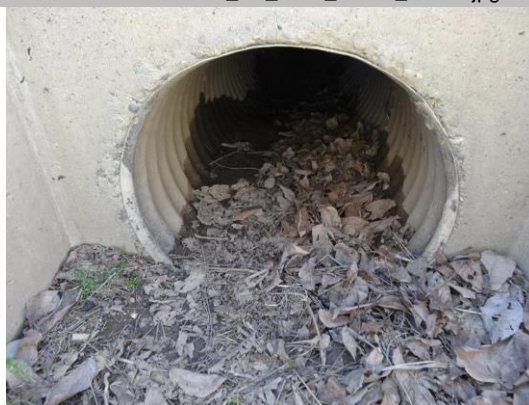
Photo 2 of 2 : UCIP\_FA\_2017\_31129\_57035.jpg

LS view: U type concrete headwall and CMP on levee slope. Soil/mud and vegetation on inlet box.

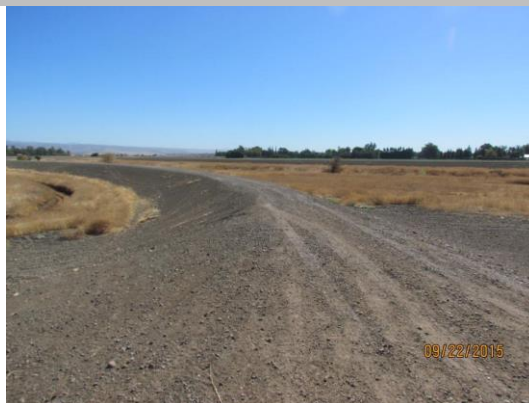
Photo 1 of 1 : FA\_2017\_NA0003\_67\_12\_20170911\_00002.jpg

View of the erosion on both slopes caused by motorcycle traffic.

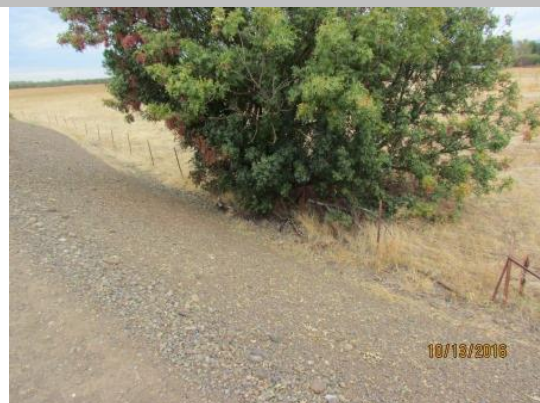
Photo 1 of 1 : FA\_2017\_NA0003\_67\_15\_20170911\_00004.jpg

View of the overgrown tree along the landside slope.

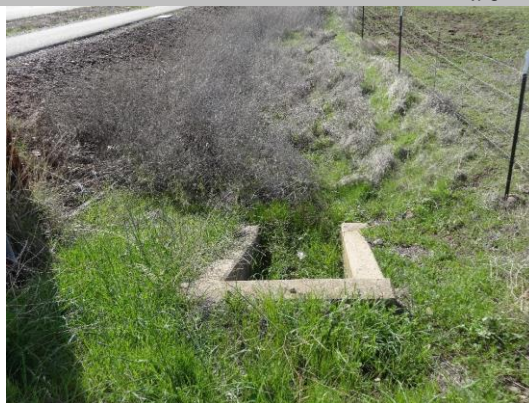
Photo 2 of 3 : UCIP\_FA\_2017\_32124\_58624.jpg

LS view: U type concrete headwall of CMP culvert on levee slope.  
Vegetation on inlet box.

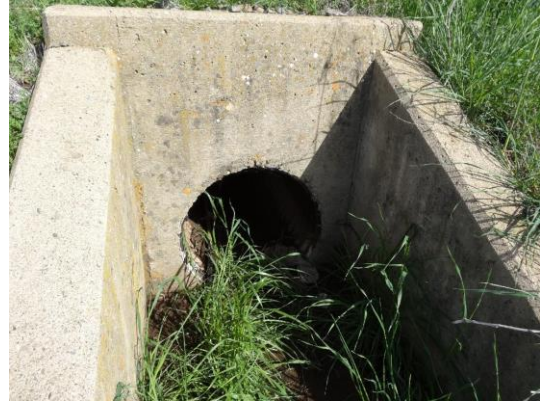
Photo 3 of 3 : UCIP\_FA\_2017\_32124\_58627.jpg

LS view: inside view of CMP on levee slope. Needs cleaning and clearing.

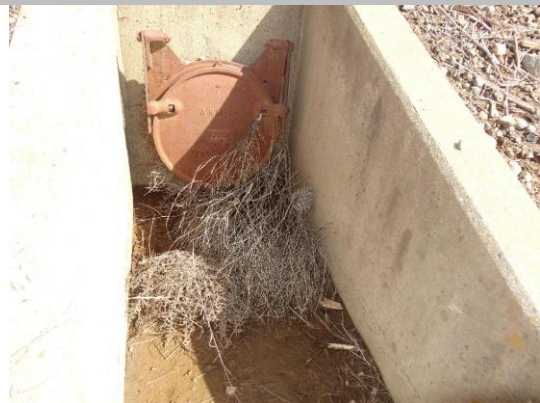
Photo 1 of 3 : UCIP\_FA\_2017\_31901\_58194.jpg

WS view: U type concrete headwall, flapgate, and CMP on levee slope. Needs cleaning and clearing.

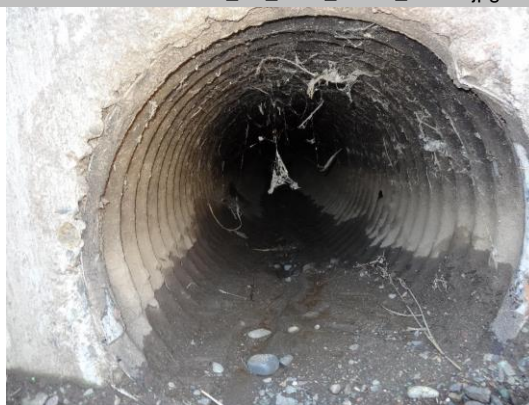
Photo 3 of 3 : UCIP\_FA\_2017\_31901\_58195.jpg

LS view: inside view of CMP on levee slope. Needs cleaning and clearing.

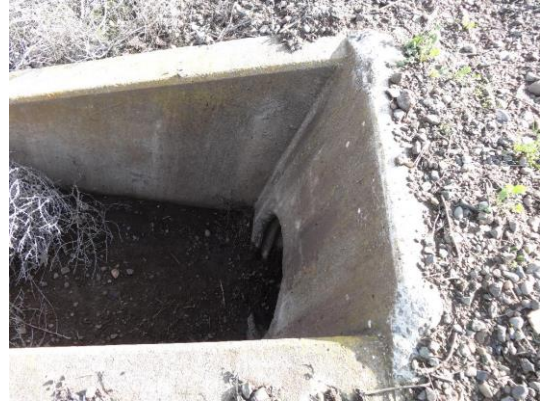
Photo 3 of 3 : UCIP\_FA\_2017\_31902\_58199.jpg

LS view: U type concrete headwall and CMP on levee slope. Soil/mud on inlet box.

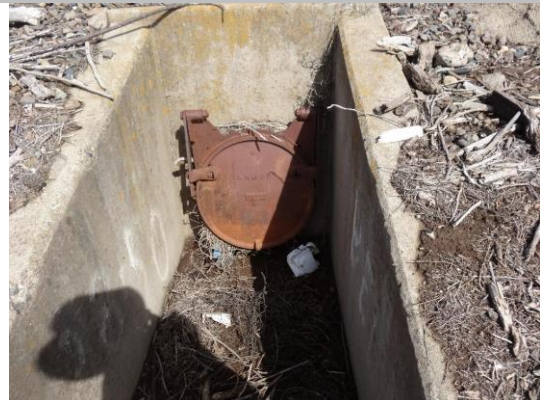
Photo 1 of 3 : UCIP\_FA\_2017\_31864\_58069.jpg

WS view: U type concrete headwall, pipe, and flapgate on levee slope. Soil/mud on outlet box. Vegetation debris blocking outlet box.

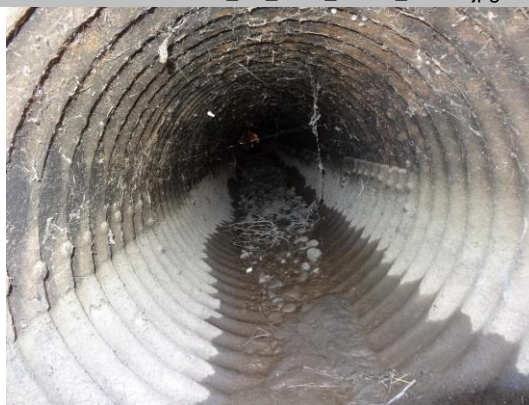
Photo 3 of 3 : UCIP\_FA\_2017\_31864\_58067.jpg

LS view: inside view of CMP on levee slope. Needs cleaning and clearing.

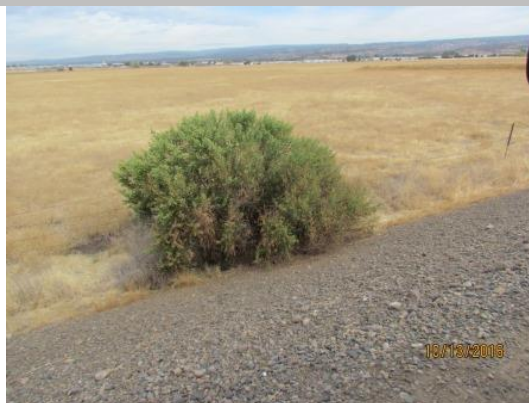
Photo 1 of 1 : FA\_2017\_NA0003\_67\_14\_20170911\_00003.jpg

View of a bush along the landside toe.

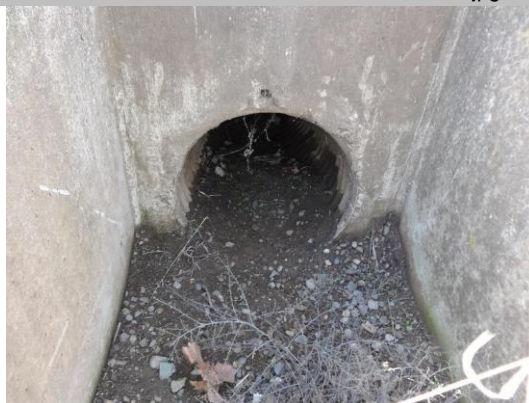
Photo 2 of 3 : UCIP\_FA\_2017\_31856\_58052.jpg

LS view: U type concrete headwall and CMP on levee slope. Soil/mud on inlet box.

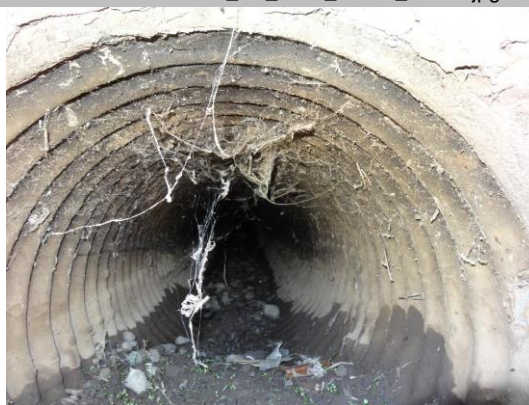
Photo 3 of 3 : UCIP\_FA\_2017\_31856\_58051.jpg

LS view: inside view of CMP on levee slope. Needs cleaning and clearing.

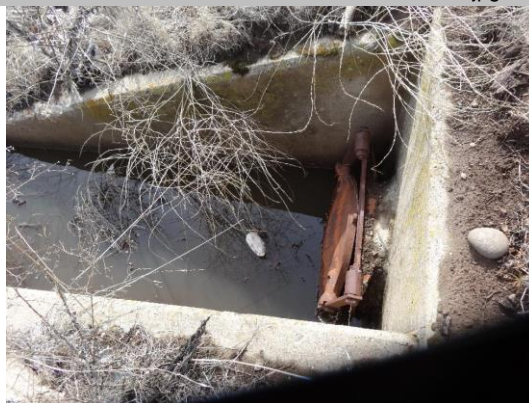
Photo 1 of 2 : UCIP\_FA\_2017\_32125\_58629.jpg

WS view: U type concrete headwall, pipe, and flapgate on levee slope. Soil/mud on outlet box. Vegetation debris blocking outlet box.

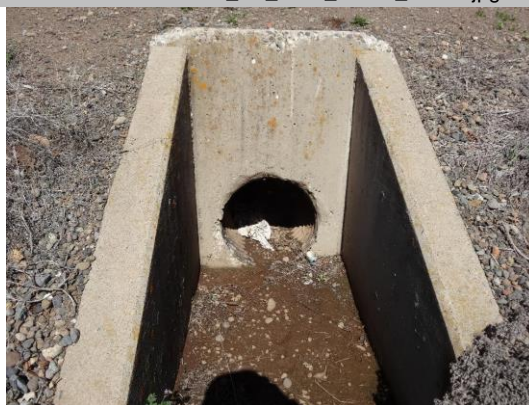
Photo 3 of 3 : UCIP\_FA\_2017\_32026\_58518.jpg

LS view: U type concrete headwall and CMP on levee slope. Mud and pebbles on inlet box.

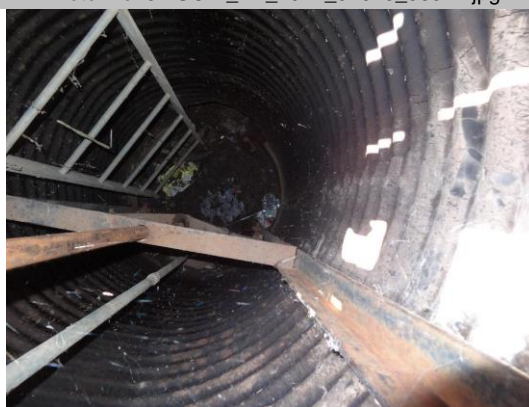
Photo 2 of 3 : UCIP\_FA\_2017\_32025\_58511.jpg

WS view: inside view of slide gate in CMP riser on waterside shoulder.  
Debris trapped in the riser.

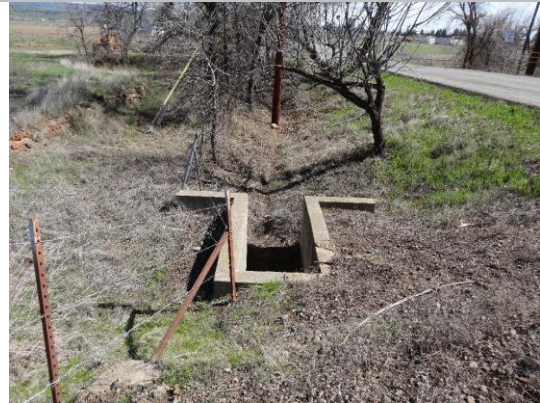
Photo 3 of 3 : UCIP\_FA\_2017\_32025\_58510.jpg

LS view: U type concrete headwall and CMP on levee slope. Vegetation debris and mud on inlet box.

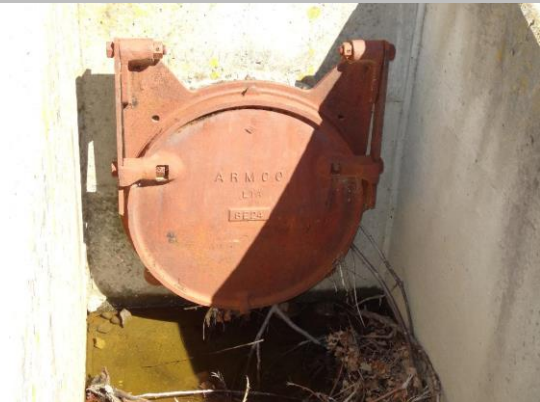
Photo 1 of 3 : UCIP\_FA\_2017\_32023\_58505.jpg

WS view: U type concrete headwall and CMP on levee slope. Vegetation debris and mud on outlet box. Needs cleaning and clearing.

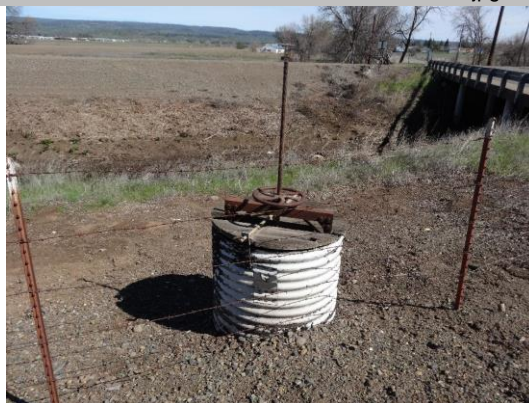
Photo 3 of 3 : UCIP\_FA\_2017\_32144\_58642.jpg

WS view: slide gate in CMP riser on waterside. No access to CMP riser.

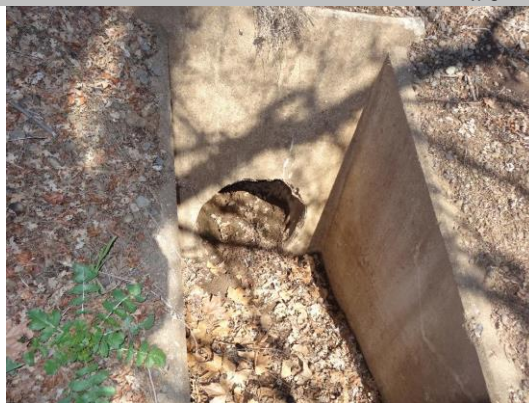
Photo 2 of 3 : UCIP\_FA\_2017\_31963\_58383.jpg

LS view: U type concrete headwall and CMP on levee slope. Vegetation debris and mud on inlet box.

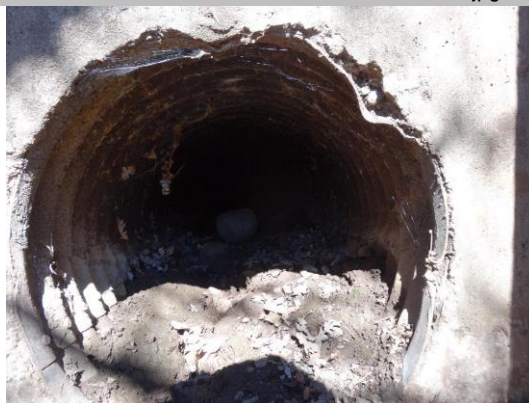
Photo 3 of 3 : UCIP\_FA\_2017\_31963\_58385.jpg

LS view: inside view of CMP on levee slope. Needs cleaning and clearing.

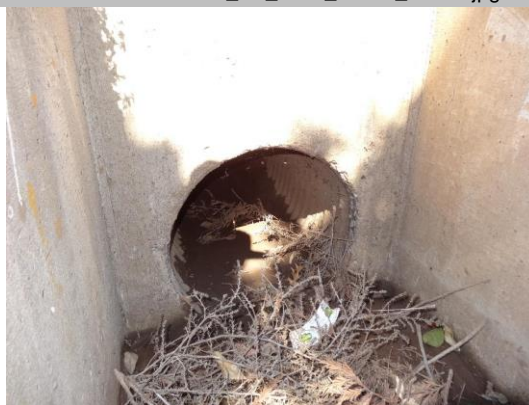
Photo 2 of 2 : UCIP\_FA\_2017\_31964\_58388.jpg

LS view: U type concrete headwall and CMP on levee slope. Vegetation debris and mud in inlet box.

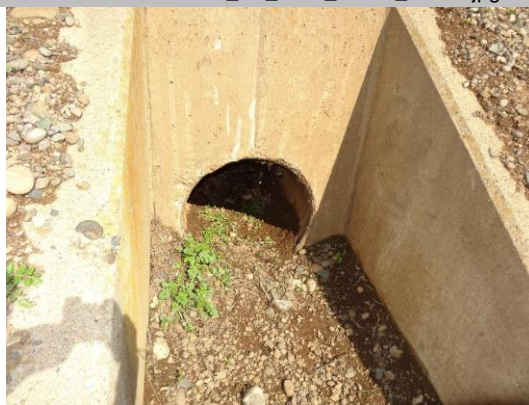
Photo 2 of 3 : UCIP\_FA\_2017\_31965\_58394.jpg

LS view: U type concrete headwall and CMP on levee slope. Vegetation debris and mud in inlet box.

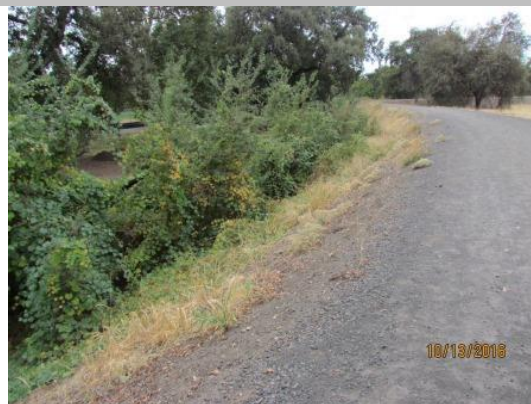
Photo 2 of 2 : FA\_2017\_NA0003\_69\_3\_20170911\_00002.jpg

View of the vegetation along the landside slope and toe.

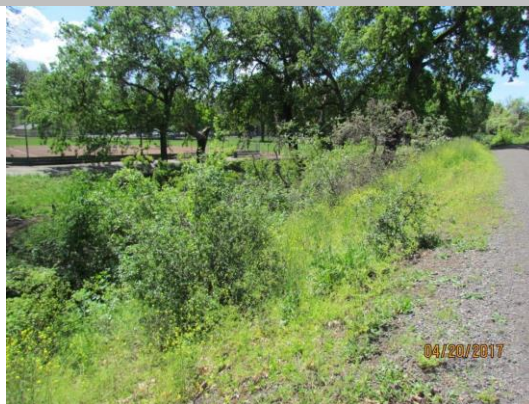
Photo 1 of 1 : FA\_2017\_NA0003\_69\_10\_20170911\_00008.jpg

View of the tree along the landside slope and toe.

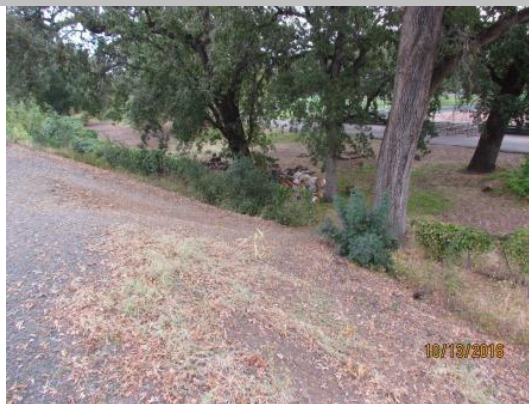
Photo 1 of 1 : FA\_2017\_NA0003\_69\_11\_20170911\_00009.jpg

View of the damaged slope by foot traffic.

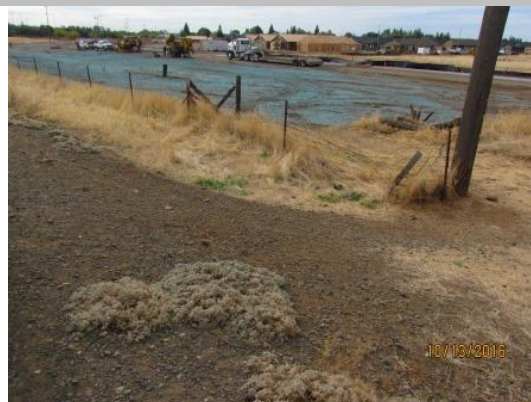
Photo 1 of 1 : FA\_2017\_NA0003\_69\_13\_20170911\_00011.jpg

View of the damaged slope by foot traffic.

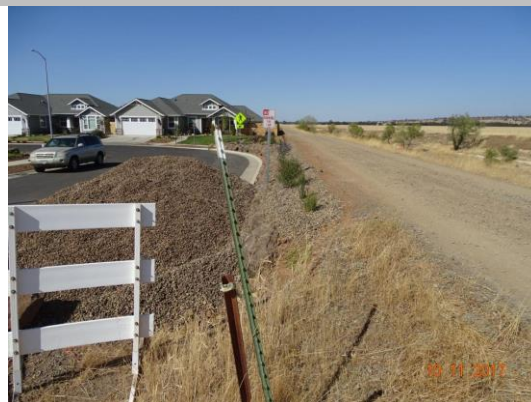
Photo 1 of 1 : FA\_2017\_NA0003\_69\_15\_20171019\_00013.jpg

View of the housing track road cutting into the levees slope and toe.
