**Flood Control Project Maintenance
Levee Inspections**

Maintenance Issue Types Only, Levee Inspection Report By Mile - Fall 2018

Butte County Department of Public Works

Waterway	Bank	Unit Miles	Inspection Start/End	Inspector
Unit No. 01 Mud Creek	Right	6.80	09/18/2018 09/18/2018	Bob Duffey

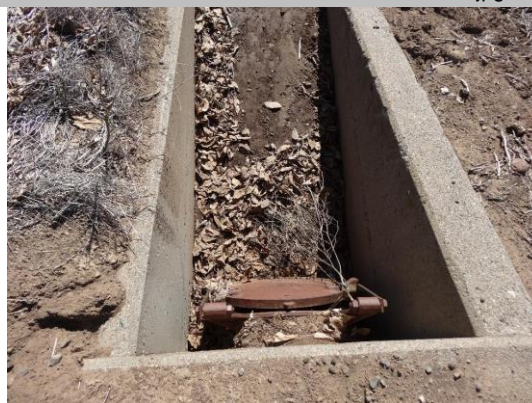
Photo 1 of 3 : UCIP_FA_2018_50142_55886.jpg

WS view: U type concrete headwall, flapgate on levee slope. Gate was not fully closed.

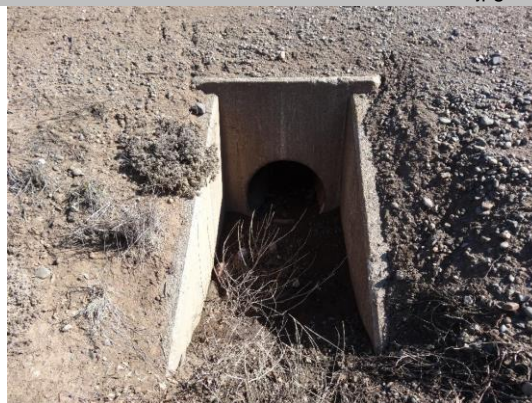
Photo 2 of 2 : UCIP_FA_2018_30294_55703.jpg

LS view: U type concrete headwall and CMP on levee slope. Debris blocking the inlet pipe.

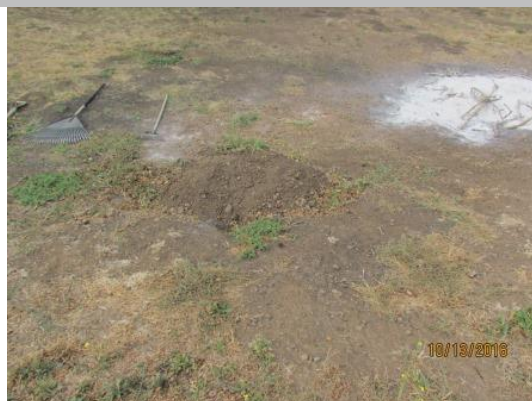
Photo 1 of 1 : FA_2018_NA0003_64_51_20180905_00028.jpg

View of the rodent holes along the landside slope.

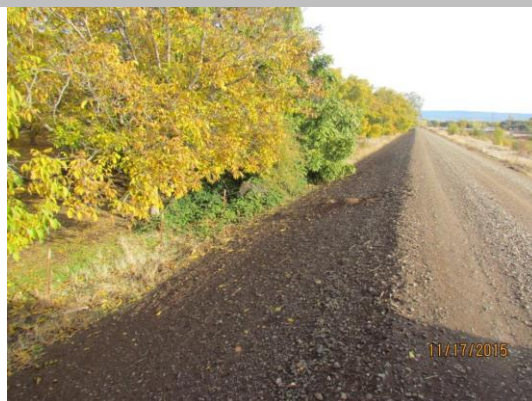
Photo 1 of 1 : FA_2018_NA0003_64_33_20180905_00015.jpg

LM Start	4.27	Rating **	M	Issue No.	33
LM End	4.27	Issue Type +	Ma	Location *	LS
Category	Earthen Levee			GPS Latitude/Longitude	
				Start	End
Item	Animal Control			39.773398 °	39.773398 °
				-121.895765 °	-121.895765 °
DWR ID	DWR_NA0003_01_f_2018_33				
Comment Code					
A1 : Exterminate rodents and backfill and compact or grout burrows.					
Inspector Comment					
Repair the rodent holes along the landside slope.

View of the rodent holes along the landside slope.

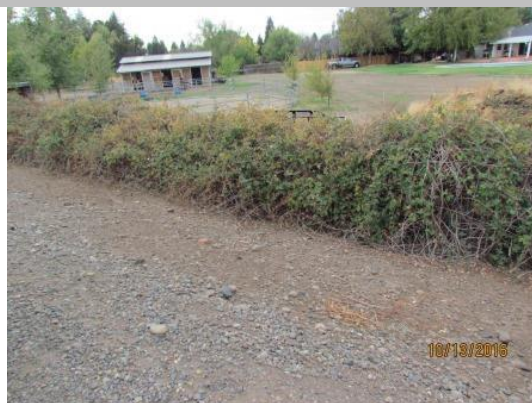
Photo 1 of 1 : FA_2018_NA0003_64_22_20180905_00005.jpg

View of the blackberries blocking visibility and access.

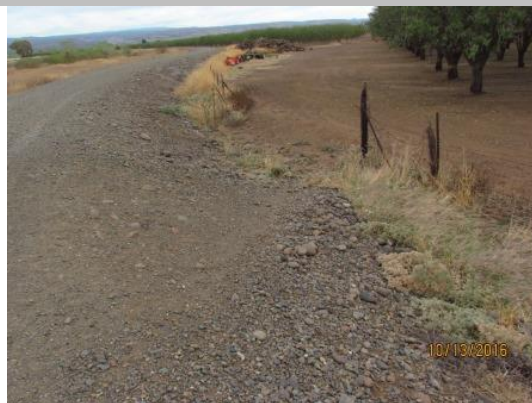
Photo 1 of 1 : FA_2018_NA0003_65_29_20180905_00006.jpg

View of the slope instability caused by vehicles along the landside slope.

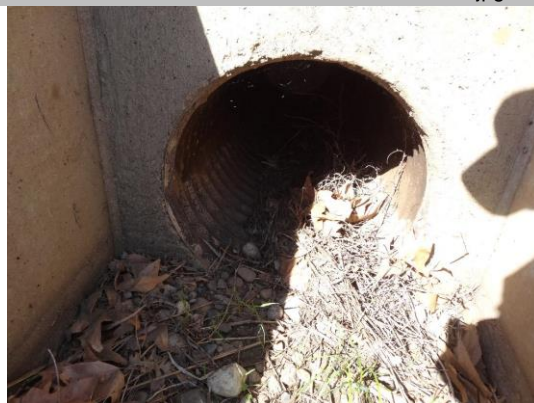
Photo 2 of 3 : UCIP_FA_2018_30403_55921.jpg

LS view: U type concrete headwall and CMP on levee slope. Vegetation debris in inlet pipe.

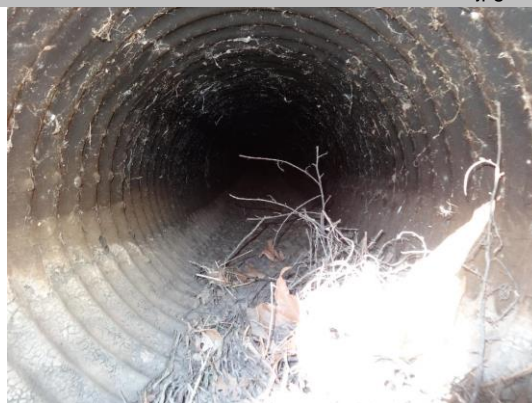
Photo 3 of 3 : UCIP_FA_2018_30403_55920.jpg

LS view: inside view of CMP on levee slope. Needs cleaning and clearing.

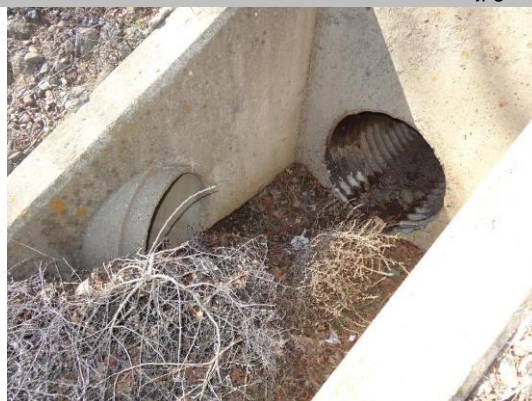
Photo 2 of 2 : UCIP_FA_2018_30743_56640.jpg

LS view: U type concrete headwall and CMP on levee slope. Vegetation debris and soil in inlet area.

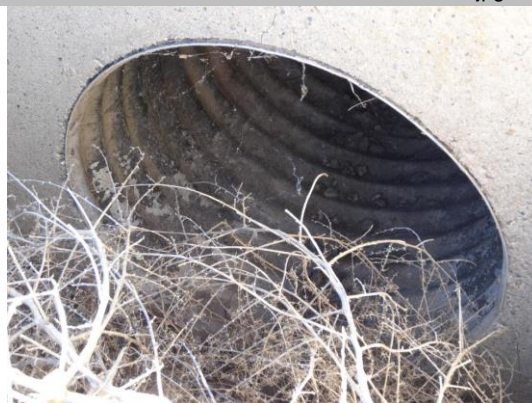
Photo 3 of 3 : UCIP_FA_2018_30803_56683.jpg

LS view: inside view of CMP on levee slope. Needs cleaning and clearing.

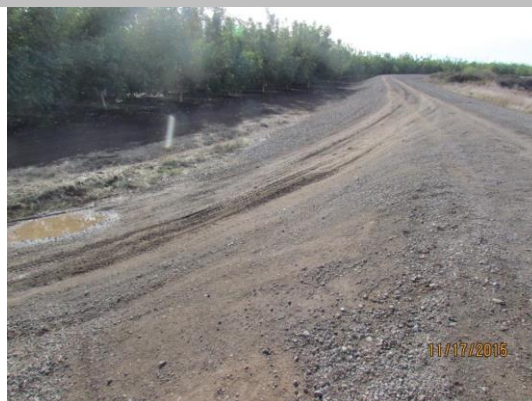
Photo 1 of 1 : FA_2018_NA0003_65_10_20180905_00005.jpg

View of the vehicle erosion along the landside slope.

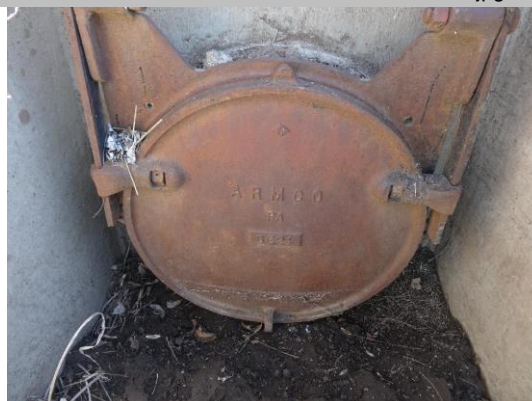
Photo 1 of 3 : UCIP_FA_2018_31028_56913.jpg

WS view: U type concrete headwall, pipe, and flapgate on levee slope. Soil/mud on outlet box.

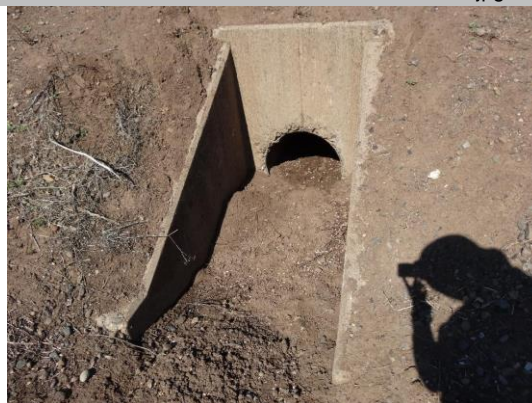
Photo 2 of 3 : UCIP_FA_2018_31031_56916.jpg

LS view: U type concrete headwall and CMP on levee slope. Soil/mud on inlet box.

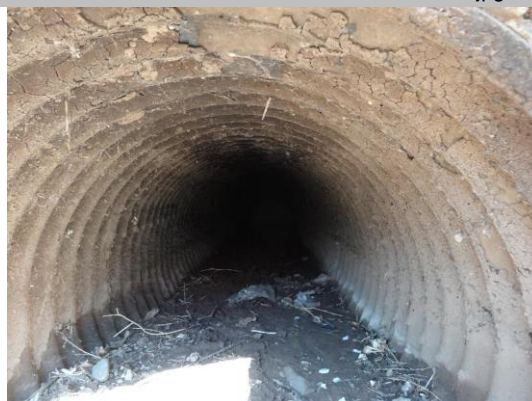
Photo 3 of 3 : UCIP_FA_2018_31031_56915.jpg

LS view: inside view of CMP on levee slope. Needs cleaning and clearing.

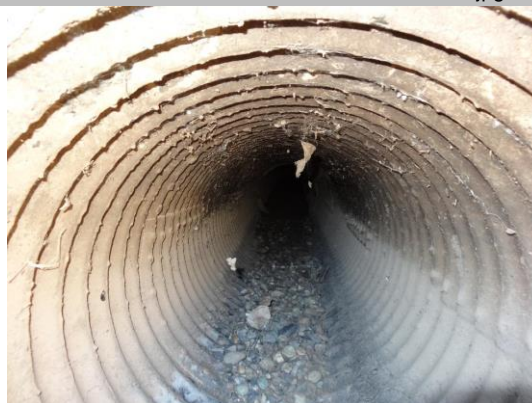
Photo 3 of 3 : UCIP_FA_2018_31034_56924.jpg

LS view: inside view of CMP on levee slope. Needs cleaning and clearing.

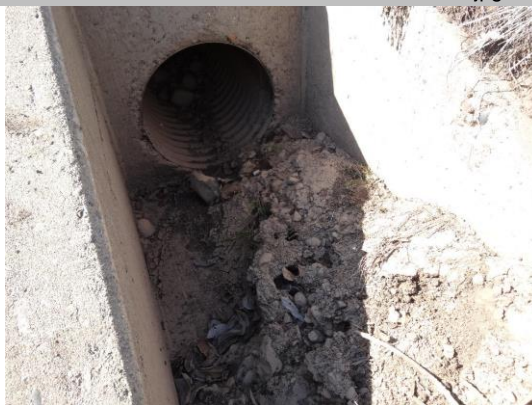
Photo 2 of 3 : UCIP_FA_2018_31085_56987.jpg

LS view: U type concrete headwall and CMP on levee slope. Soil/mud on inlet box.

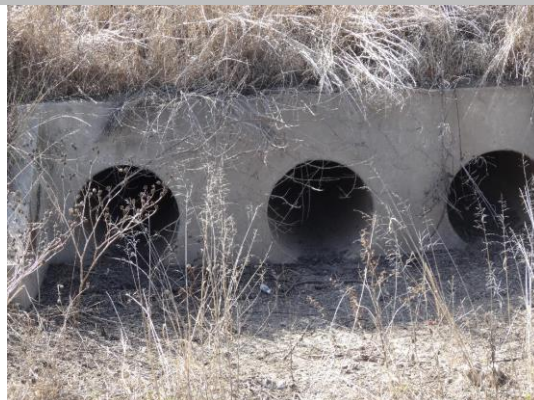
Photo 3 of 3 : UCIP_FA_2018_32086_58587.jpg

LS view: U type concrete headwall and CMPs on levee slope. Soil/mud on inlet box.

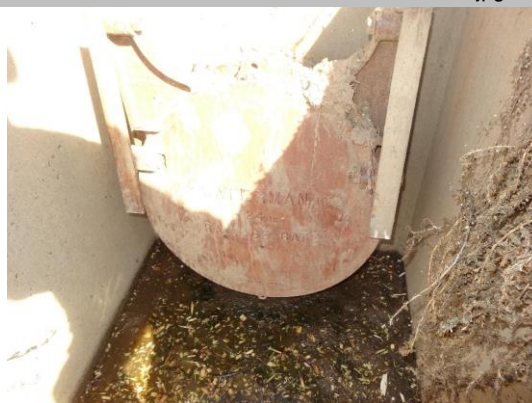
Photo 1 of 2 : UCIP_FA_2018_31129_57036.jpg

WS view: U type concrete headwall, pipe, and flapgate on levee slope.
Soil/mud on outlet box.

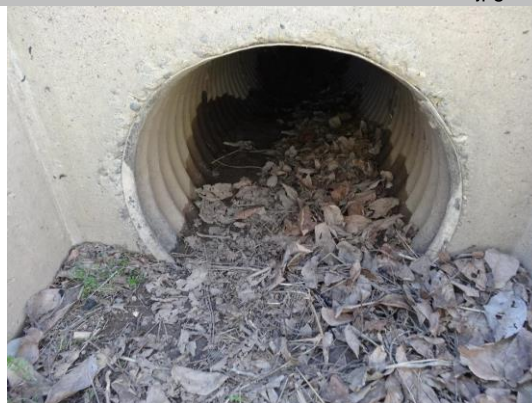
Photo 2 of 2 : UCIP_FA_2018_31129_57035.jpg

LS view: U type concrete headwall and CMP on levee slope. Soil/mud and vegetation on inlet box.

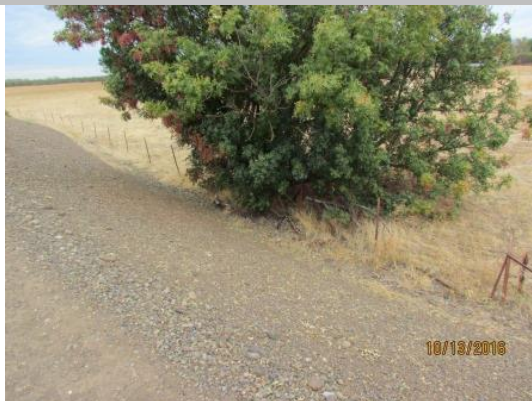
Photo 1 of 1 : FA_2018_NA0003_67_15_20180905_00004.jpg

View of the overgrown tree along the landside slope.

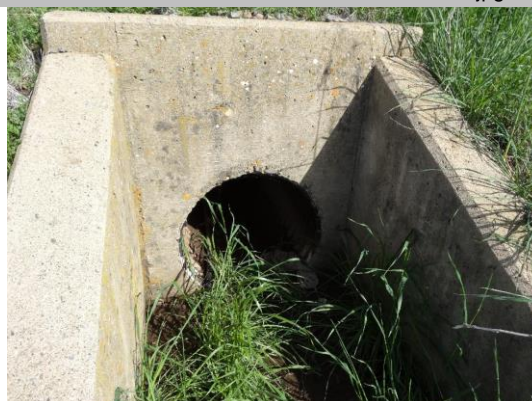
Photo 3 of 3 : UCIP_FA_2018_32124_58627.jpg

LS view: inside view of CMP on levee slope. Needs cleaning and clearing.

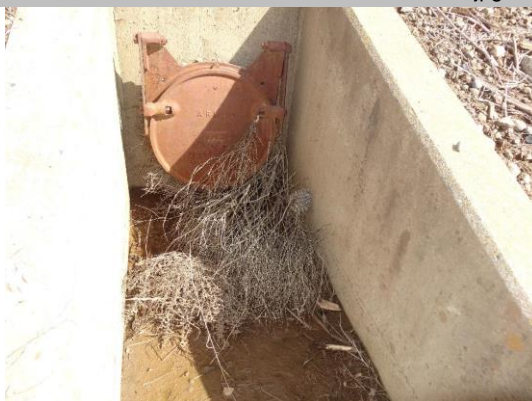
Photo 1 of 3 : UCIP_FA_2018_31901_58194.jpg

WS view: U type concrete headwall, flapgate, and CMP on levee slope.
Needs cleaning and clearing.

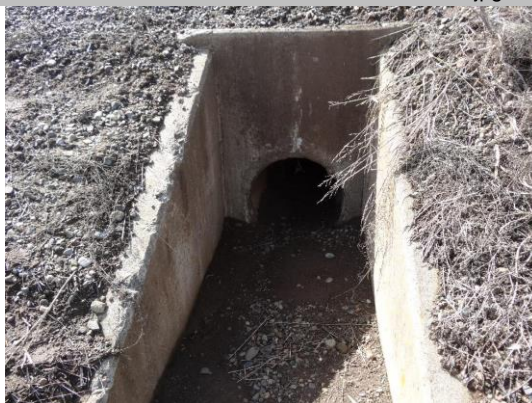
Photo 2 of 3 : UCIP_FA_2018_31901_58193.jpg

LS view: U type concrete headwall and CMP on levee slope. Soil/mud on inlet box.

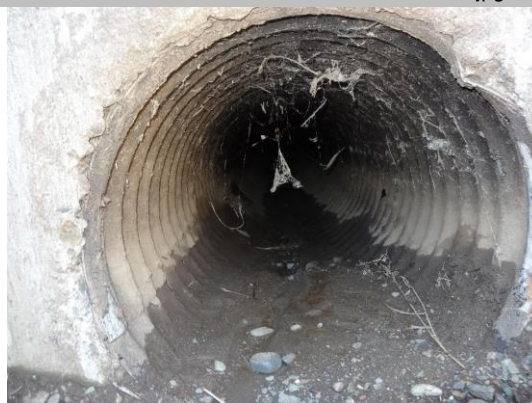
Photo 3 of 3 : UCIP_FA_2018_31901_58195.jpg

LS view: inside view of CMP on levee slope. Needs cleaning and clearing.

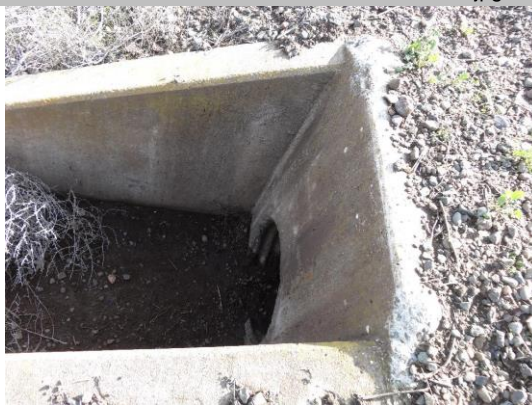
Photo 3 of 3 : UCIP_FA_2018_31902_58199.jpg

LS view: U type concrete headwall and CMP on levee slope. Soil/mud on inlet box.

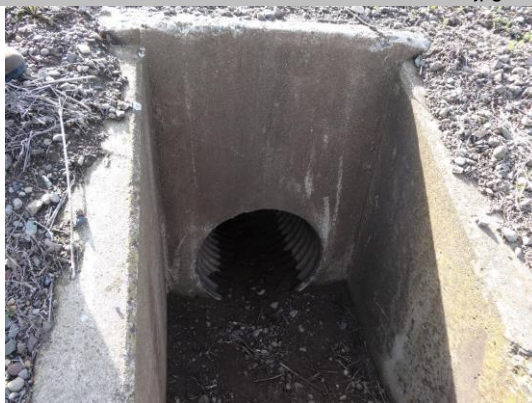
Photo 2 of 3 : UCIP_FA_2018_31864_58068.jpg

LS view: U type concrete headwall and CMP on levee slope. Soil/mud on inlet box.

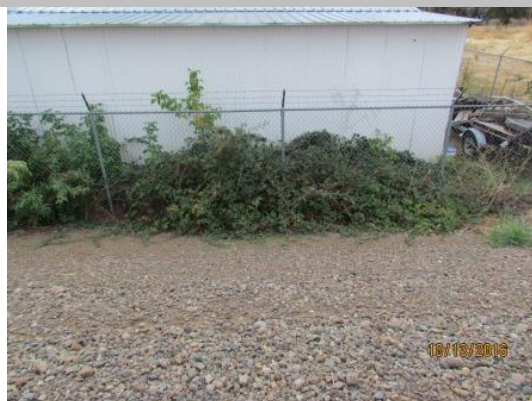
Photo 1 of 1 : FA_2018_NA0003_68_20_20180905_00006.jpg

View of the vegetation along the landside toe blocking visibility.

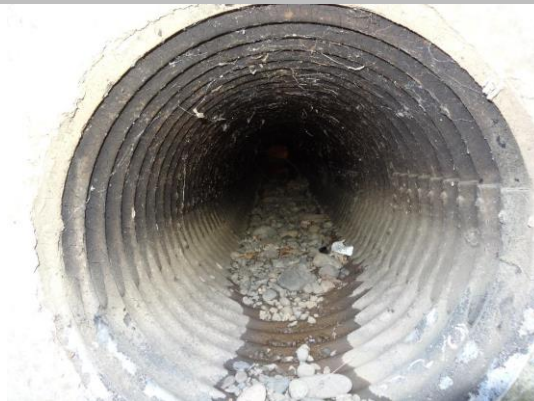
Photo 3 of 3 : UCIP_FA_2018_32023_58503.jpg

LS view: inside view of the CM pipe. Needs cleaning and clearing the pipe.

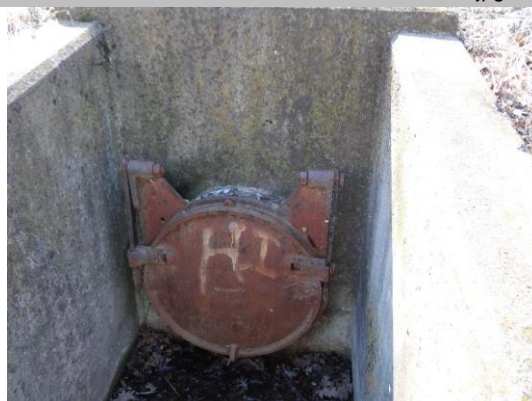
Photo 1 of 2 : UCIP_FA_2018_32143_58641.jpg

WS view: U type concrete headwall and CMP on levee slope. Soil/mud on outlet box. Needs cleaning and clearing.

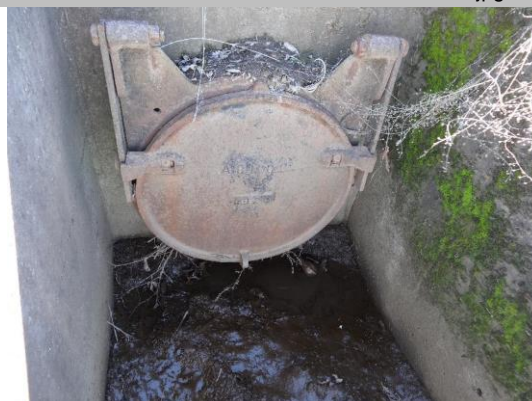
Photo 1 of 2 : UCIP_FA_2018_31964_58389.jpg

WS view: U type concrete headwall and CMP on levee slope. Vegetation debris and mud in outlet box. Needs cleaning and clearing.

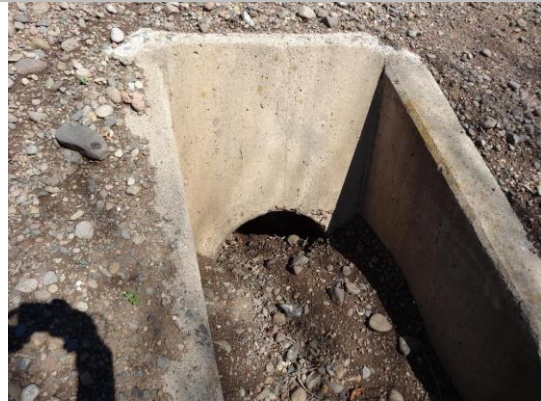
Photo 3 of 3 : UCIP_FA_2018_31966_58399.jpg

LS view: U type concrete headwall and CMP on levee slope. Vegetation debris and mud in pipe and inlet box.
