**Flood Control Project Maintenance
Levee Inspections**

Maintenance Issue Types Only, Levee Inspection Report By Mile - Fall 2019

Butte County Department of Public Works

Waterway	Bank	Unit Miles	Inspection Start/End	Inspector
Unit No. 01 Mud Creek	Right	6.80	10/22/2019 10/22/2019	Makar Sokol

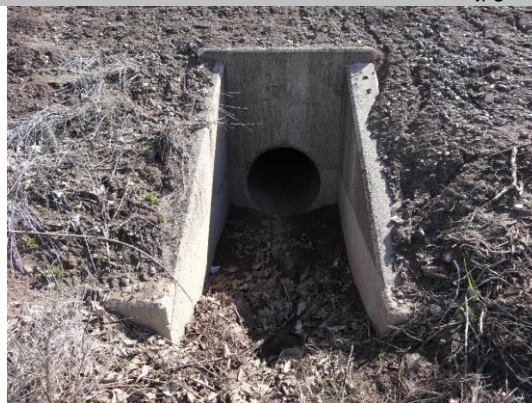
Photo 2 of 3 : UCIP_FA_2019_29705_54923.jpg

LS view: U typed concrete headwall, CMP on levee slope.

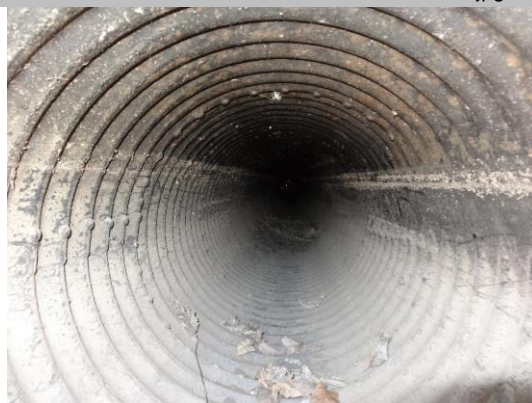
Photo 3 of 3 : UCIP_FA_2019_29705_54922.jpg

LS view: inside view of CMP on levee slope. Looks clean and clear.

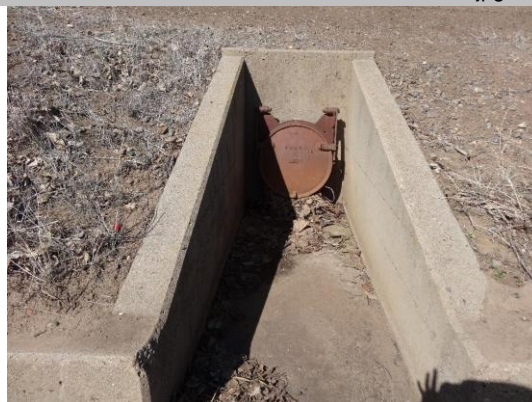
Photo 1 of 3 : UCIP_FA_2019_32044_58543.jpg

Comment Code						
Inspector Comment						
DS_ID:19211						
FS_ID:32044						
EP_NO: N/A						
Repair Type: Non-Urgent						
Crossing Status: Found						
UCIP Comments: Vegetation debris on waterside. Needs clearing and cleaning.						
FIELD_STRUCT_DESC: 24-inch corrugated metal gravity drainage pipe through the levee, 12 feet below the crown. Flap gate on the waterside (WS) end. Concrete U-shaped headwall on each end. Grouted riprap apron on the landside (LS) end. Grouted riprap spillway on the WS end. [Additional Reference(s): DWR Levee Log, 1992. USACE Sacramento O&M Manual 504, May 1965, (HLM 1.03)].						
FS Date: 2/20/2014

WS view: U typed concrete headwall, pipe, and flapgate on levee slope.

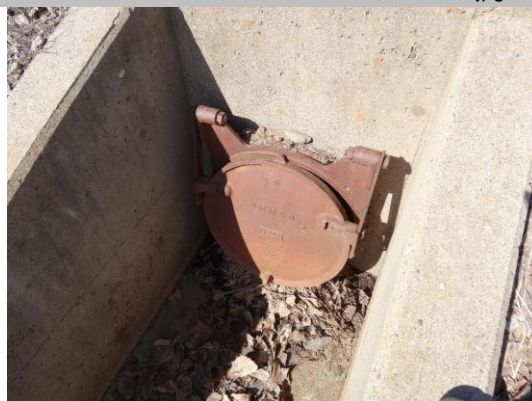
Photo 2 of 3 : UCIP_FA_2019_32044_58542.jpg

WS view: vegetation debris blocking outlet.

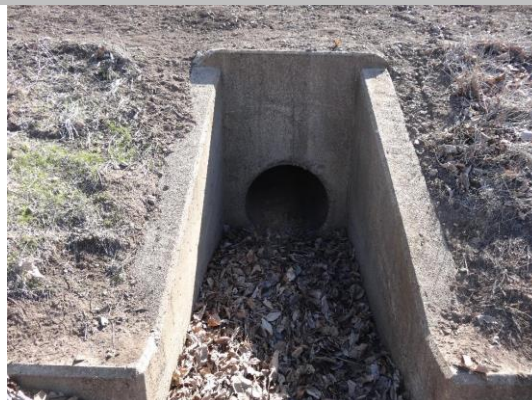
Photo 3 of 3 : UCIP_FA_2019_32044_58541.jpg

LS view: U typed concrete headwall and CMP on levee slope.

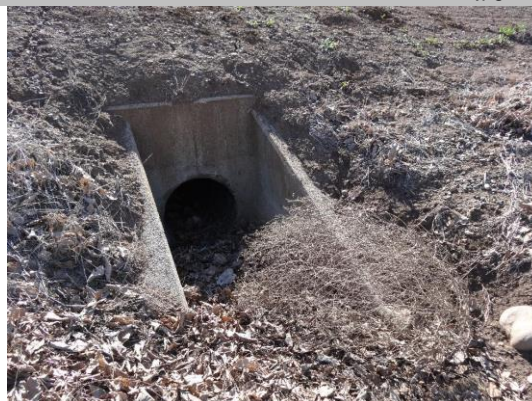
Photo 2 of 3 : UCIP_FA_2019_50142_55885.jpg

Comment Code						
Inspector Comment						
DS_ID:19212 FS_ID:50142 EP_NO: N/A Repair Type: No Action Needed Crossing Status: Found UCIP Comments: 08/29/2016: Shawn Bates of NA0003 has cleared the LS and WS of debris and blockage; WS gate functions properly now. Crossing has been downgraded from Urgent to No Action Needed. (K. Fazel - UCIP)08/11/2016: Same as last inspection. (K. Fazel - UCIP)02/20/2014:No riprap spillway on waterside. Needs cleaning and clearing of debris. Flap gate was not fully closed. (P. Amatya - UCIP) FIELD_STRUCT_DESC: 24-inch corrugated metal gravity drainage pipe through the levee, 13 feet below the crown. Flap gate on the waterside (WS) end. Concrete U-shaped headwall on each end. Grouted riprap apron on the landside (LS) end. Grouted riprap spillway on the WS end. [Additional Reference(s): DWR Levee Log, 2005. USACE Sacramento O&M Manual 504, May 1965, (HLM 1.95)]. FS Date: 8/11/2016

LS view: U type concrete headwall and CMP on levee slope. Vegetation debris blocking inlet.

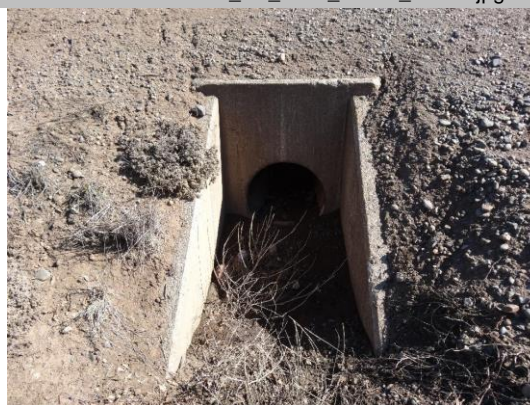
Photo 2 of 2 : UCIP_FA_2019_30294_55703.jpg

LS view: U type concrete headwall and CMP on levee slope. Debris blocking the inlet pipe.

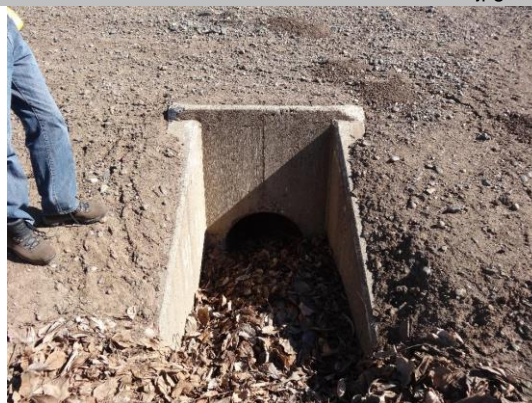
Photo 2 of 2 : UCIP_FA_2019_30295_55705.jpg

LS view: U type concrete headwall and CMP on levee slope. Vegetation debris blocking the inlet.

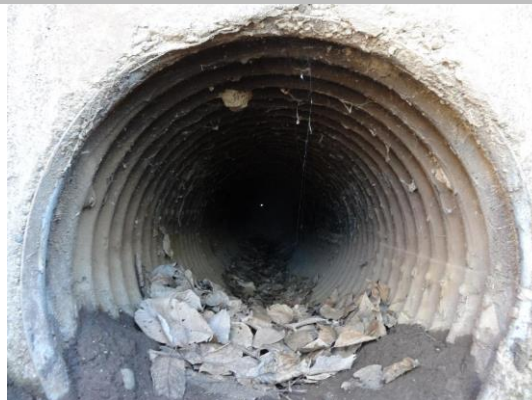
Photo 3 of 3 : UCIP_FA_2019_30310_55739.jpg

LS view: inside view of CMP on levee slope. Needs cleaning and clearing.

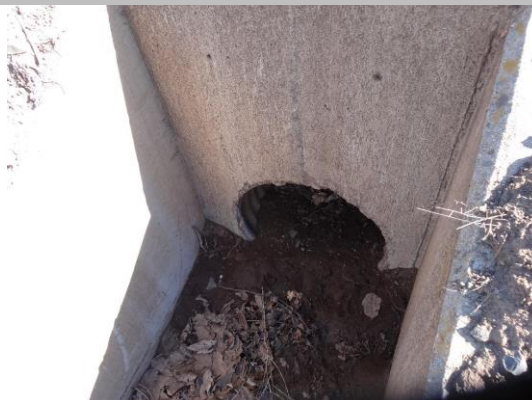
Photo 2 of 2 : UCIP_FA_2019_30311_55742.jpg

Comment Code						
Inspector Comment						
DS_ID:19219						
FS_ID:30311						
EP_NO: N/A						
Repair Type: Non-Urgent						
Crossing Status: Found						
UCIP Comments: Needs cleaning and clearing of debris in both ends of the pipe.						
FIELD_STRUCT_DESC: 24-inch corrugated metal gravity drainage pipe through the levee, 9 feet below the crown. Flap gate on the waterside (WS) end. Concrete U-shaped headwall on each end. Grouted riprap apron on the landside (LS) end. Grouted riprap spillway on the WS end. [Additional Reference(s): DWR Levee Log, 1992. USACE Sacramento O&M Manual 504, May 1965, (HLM 4.08)].						
FS Date: 2/20/2014

LS view: U type concrete headwall and CMP on levee slope.

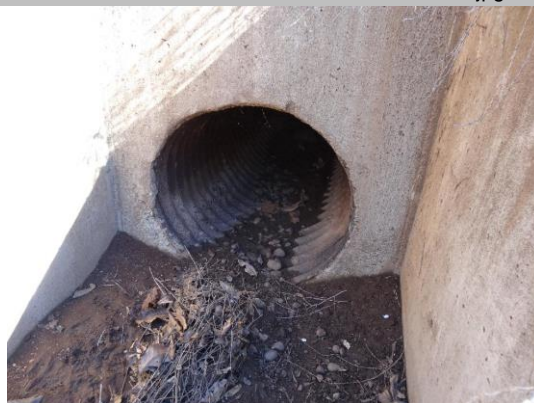
Photo 2 of 2 : UCIP_FA_2019_30312_55744.jpg

LS view: U type concrete headwall and CMP on levee slope. Needs cleaning and clearing of debris.

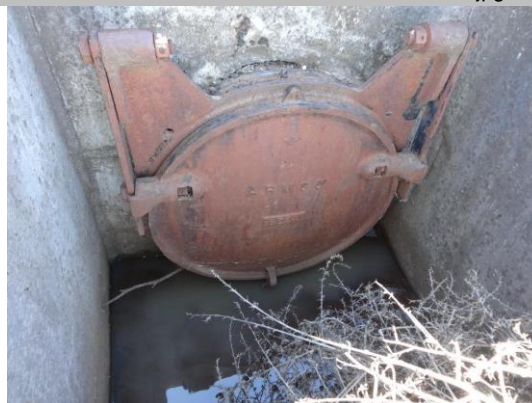
Photo 2 of 3 : UCIP_FA_2019_31667_57967.jpg

WS view: U type concrete headwall, pipe, and flapgate on levee slope. Vegetation debris on outlet box.

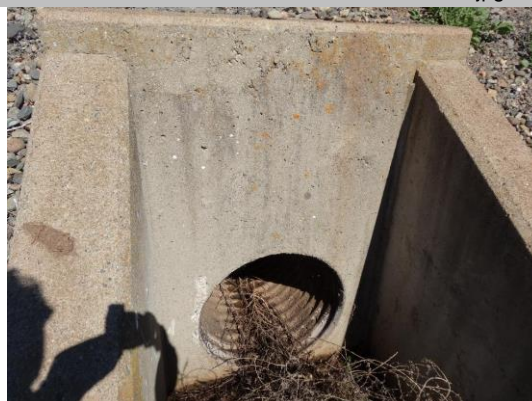
Photo 3 of 3 : UCIP_FA_2019_31667_57966.jpg

LS view: U type concrete headwall and CMP on levee slope. Vegetation debris on inlet box.

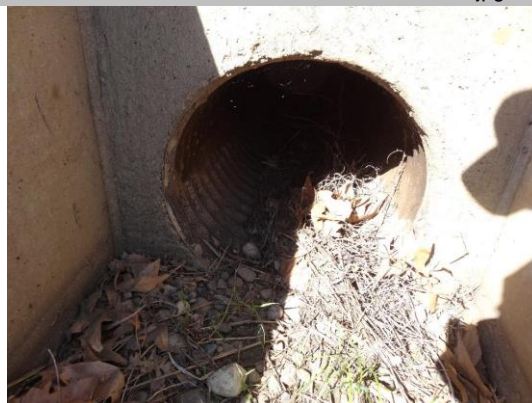
Photo 2 of 3 : UCIP_FA_2019_30403_55921.jpg

LS view: U type concrete headwall and CMP on levee slope. Vegetation debris in inlet pipe.

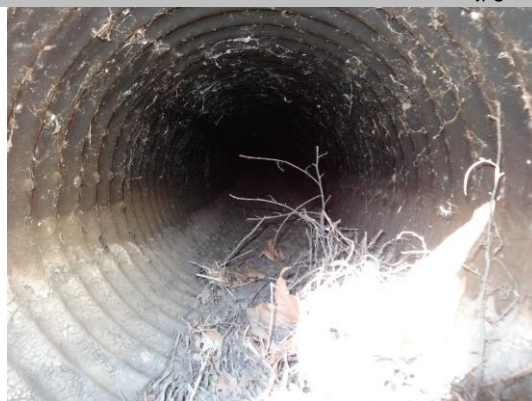
Photo 3 of 3 : UCIP_FA_2019_30403_55920.jpg

LS view: inside view of CMP on levee slope. Needs cleaning and clearing.

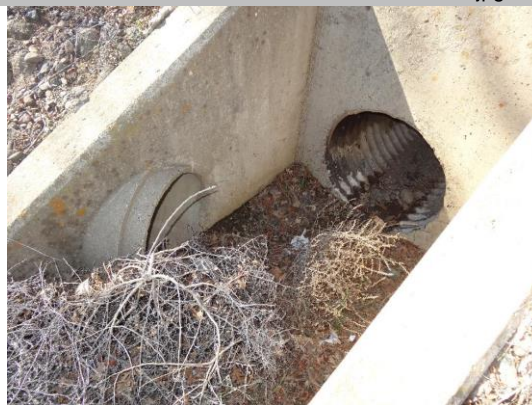
Photo 2 of 2 : UCIP_FA_2019_30743_56640.jpg

LS view: U type concrete headwall and CMP on levee slope. Vegetation debris and soil in inlet area.

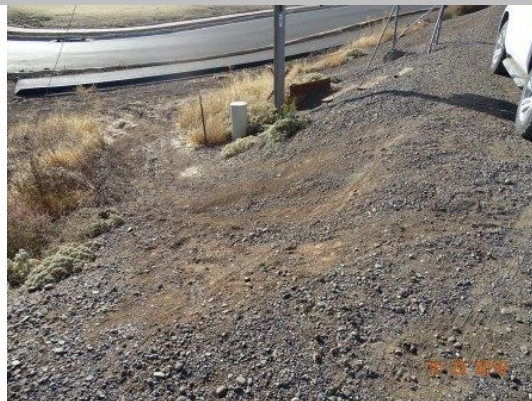
Photo 1 of 1 : FA_2019_NA0003_65_25_20191025_00064.jpg

View of the erosion on the landside slope due to vehicle traffic. Fall 2019.

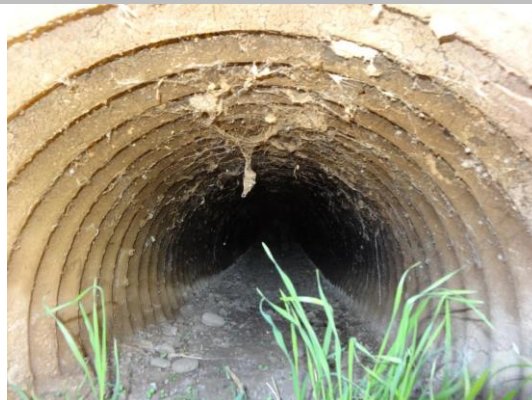
Photo 3 of 3 : UCIP_FA_2019_30763_56660.jpg

LS view: inside view of CMP on levee slope. Needs cleaning and clearing.

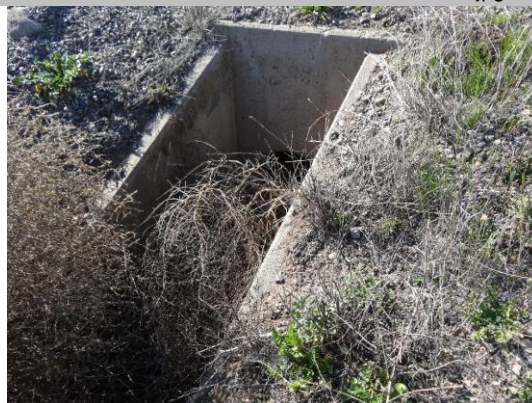
Photo 2 of 3 : UCIP_FA_2019_30803_56684.jpg

LS view: U type concrete headwall and CMP on levee slope. Vegetation debris and soil blocking inlet.

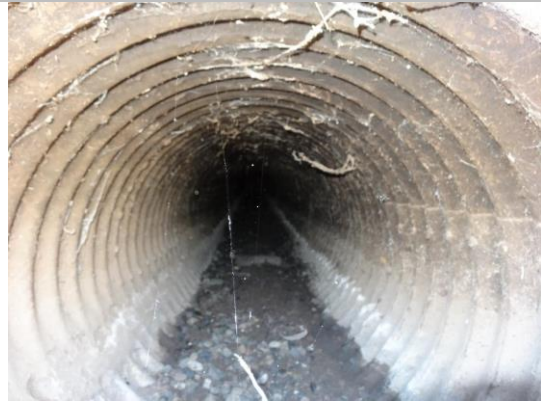
Photo 3 of 3 : UCIP_FA_2019_31028_56911.jpg

LS view: inside view of CMP on levee slope. Needs cleaning and clearing.

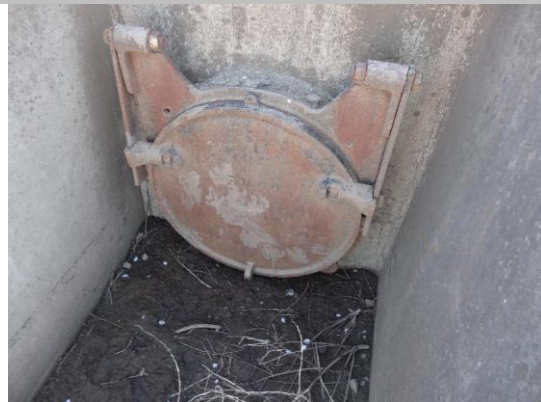
Photo 1 of 3 : UCIP_FA_2019_31031_56917.jpg

WS view: U type concrete headwall, pipe, and flapgate on levee slope. Soil/mud on outlet box.

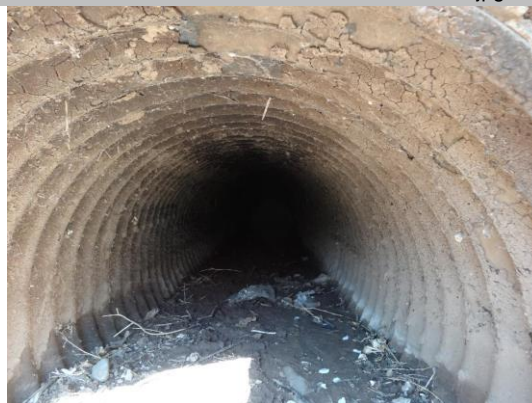
Photo 3 of 3 : UCIP_FA_2019_31031_56915.jpg

LS view: inside view of CMP on levee slope. Needs cleaning and clearing.

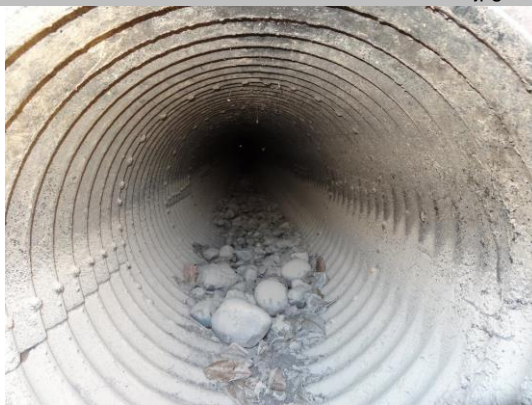
Photo 3 of 3 : UCIP_FA_2019_31085_56986.jpg

LS view: inside view of CMP on levee slope. Needs cleaning and clearing.

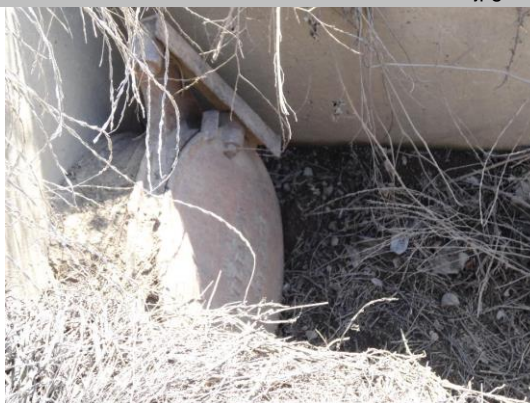
Photo 1 of 3 : UCIP_FA_2019_31103_57002.jpg

WS view: U type concrete headwall, pipe, and flapgate on levee slope.
Soil/mud on outlet box. Vegetation debris blocking outlet box

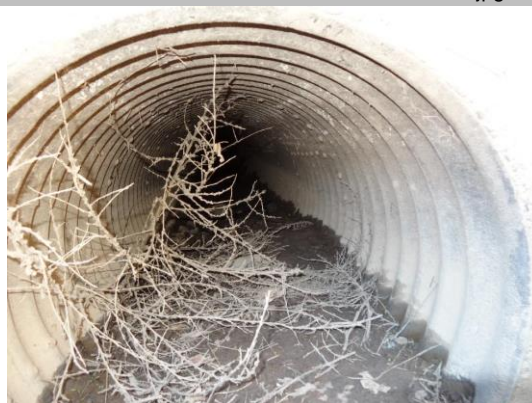
Photo 3 of 3 : UCIP_FA_2019_31103_57000.jpg

LS view: inside view of CMP on levee slope. Needs cleaning and clearing.

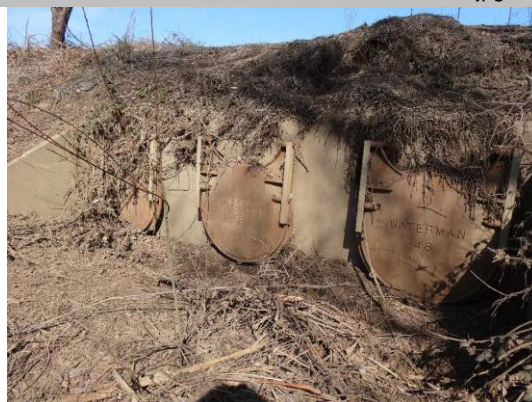
Photo 2 of 3 : UCIP_FA_2019_32085_58584.jpg

WS view: U type concrete headwall, pipes, and flapgates on levee slope. Soil/mud on outlet box. Vegetation debris blocking outlet box

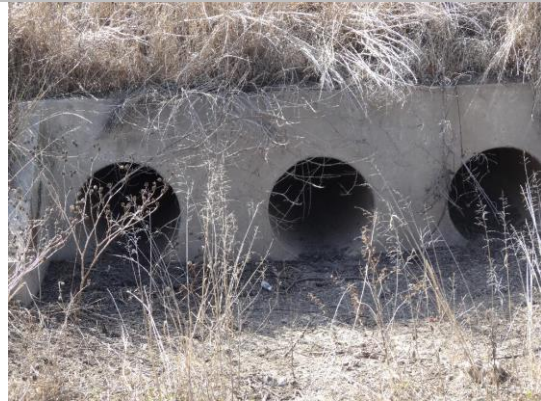
Photo 3 of 3 : UCIP_FA_2019_32085_58586.jpg

LS view: U type concrete headwall and CMPs on levee slope. Soil/mud on inlet box.

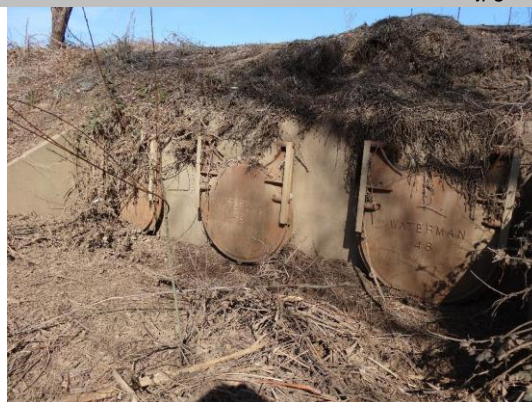
Photo 2 of 3 : UCIP_FA_2019_32086_58588.jpg

WS view: U type concrete headwall, pipes, and flapgates on levee slope.
Soil/mud on outlet box. Vegetation debris on outlet box

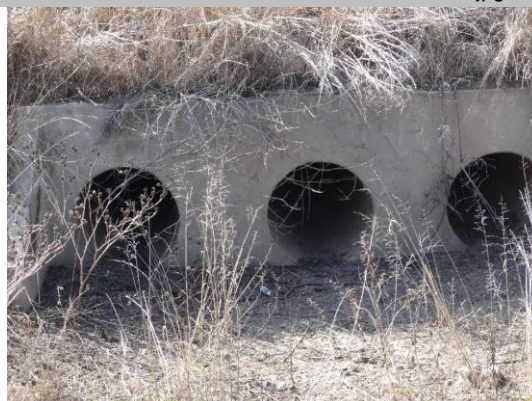
Photo 3 of 3 : UCIP_FA_2019_32086_58587.jpg

LS view: U type concrete headwall and CMPs on levee slope. Soil/mud on inlet box.

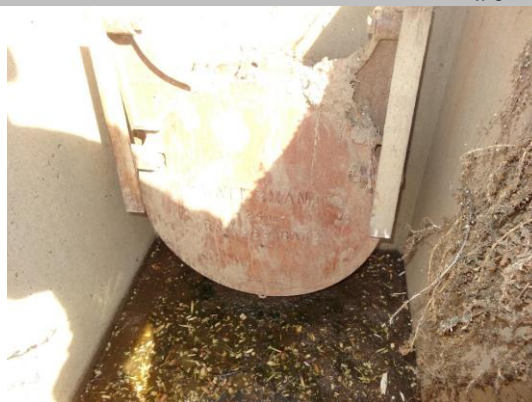
Photo 1 of 2 : UCIP_FA_2019_31129_57036.jpg

WS view: U type concrete headwall, pipe, and flapgate on levee slope. Soil/mud on outlet box.

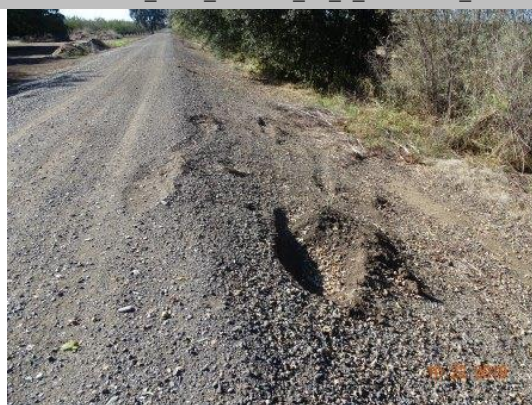
Photo 1 of 1 : FA_2019_NA0003_66_1_20191025_00001.jpg

View of depressions on the waterside slope. Fall 2019.

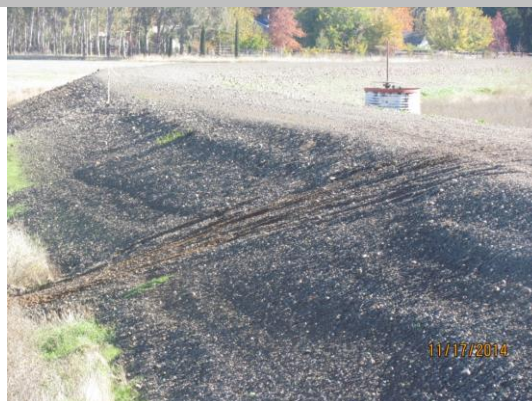
Photo 1 of 1 : FA_2019_NA0003_67_3_20190822_00001.jpg

View of the erosion caused by motorcycles on the landside slope.

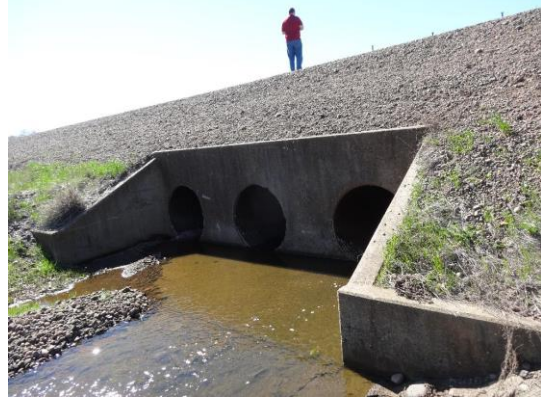
Photo 2 of 2 : UCIP_FA_2019_32106_58609.jpg

LS view: U type concrete headwall and three CMPs on levee slope. Soil/mud on inlet box.

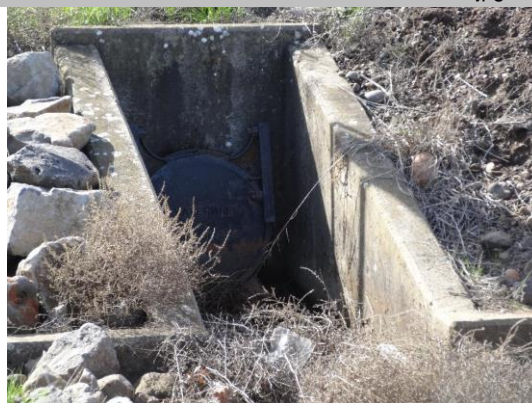
Photo 1 of 3 : UCIP_FA_2019_32124_58625.jpg

WS view: concrete headwall, pipe, and flapgate on levee slope.
Vegetation and mud on outlet box.

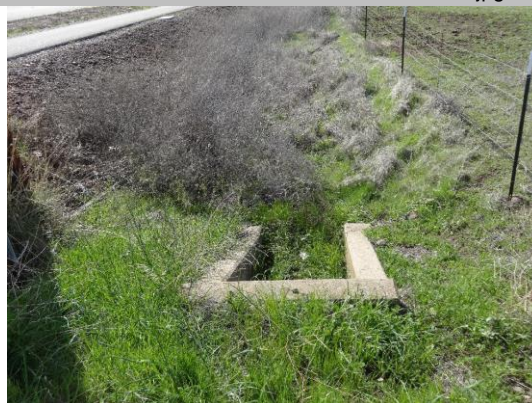
Photo 2 of 3 : UCIP_FA_2019_32124_58624.jpg

LS view: U type concrete headwall of CMP culvert on levee slope.
Vegetation on inlet box.

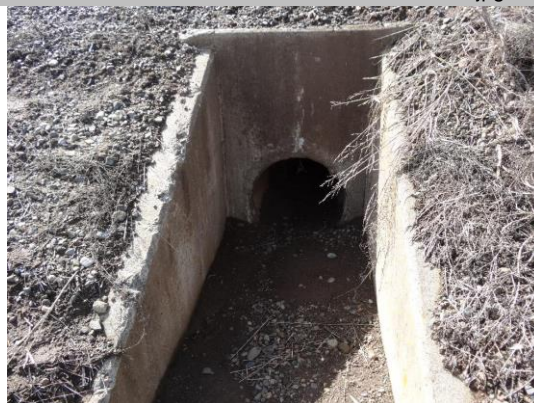
Photo 2 of 3 : UCIP_FA_2019_31901_58193.jpg

LS view: U type concrete headwall and CMP on levee slope. Soil/mud on inlet box.

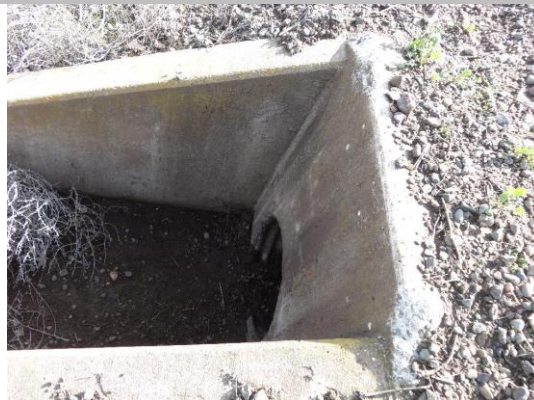
Photo 3 of 3 : UCIP_FA_2019_31902_58199.jpg

LS view: U type concrete headwall and CMP on levee slope. Soil/mud on inlet box.

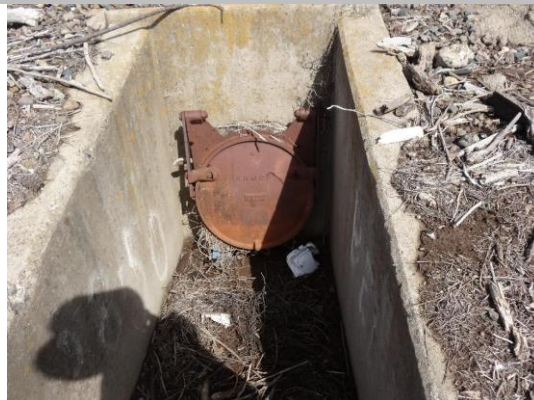
Photo 1 of 3 : UCIP_FA_2019_31864_58069.jpg

WS view: U type concrete headwall, pipe, and flapgate on levee slope. Soil/mud on outlet box. Vegetation debris blocking outlet box.

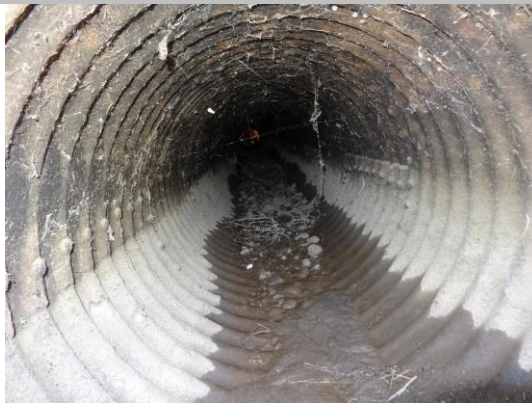
Photo 3 of 3 : UCIP_FA_2019_31864_58067.jpg

LS view: inside view of CMP on levee slope. Needs cleaning and clearing.

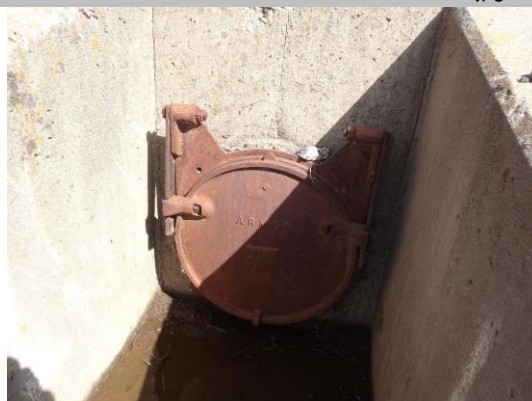
Photo 1 of 3 : UCIP_FA_2019_31856_58053.jpg

WS view: U type concrete headwall, pipe, and flapgate on levee slope.
Soil/mud on outlet box.

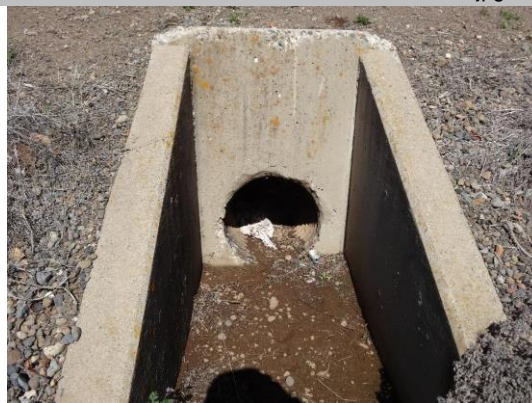
Photo 3 of 3 : UCIP_FA_2019_32026_58518.jpg

LS view: U type concrete headwall and CMP on levee slope. Mud and pebbles on inlet box.

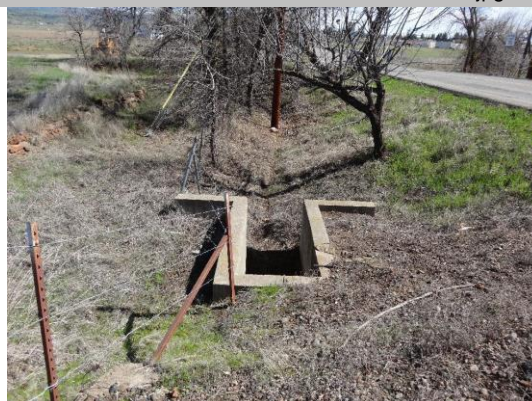
Photo 3 of 3 : UCIP_FA_2019_32025_58510.jpg

LS view: U type concrete headwall and CMP on levee slope. Vegetation debris and mud on inlet box.

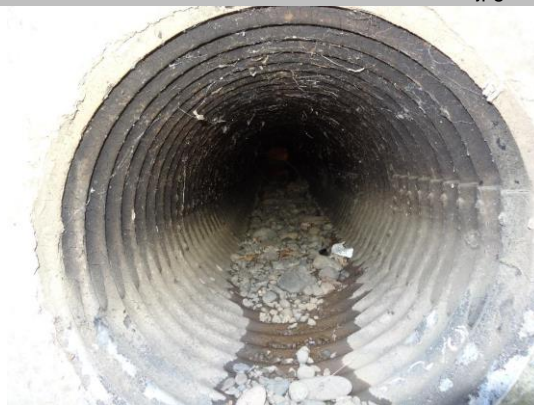
Photo 3 of 3 : UCIP_FA_2019_32023_58503.jpg

LS view: inside view of the CM pipe. Needs cleaning and clearing the pipe.

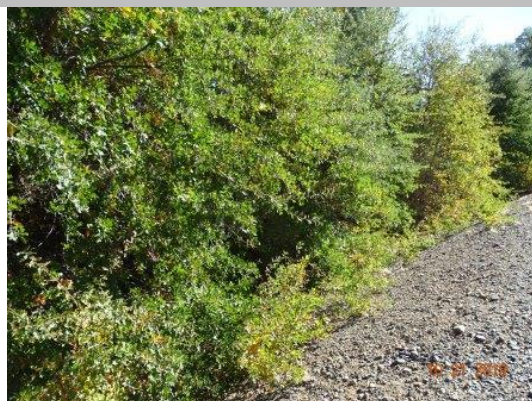
Photo 1 of 1 : FA_2019_NA0003_68_14_20191028_00035.jpg

View of trees and wild growth along the waterside slope and toe. Fall 2019.

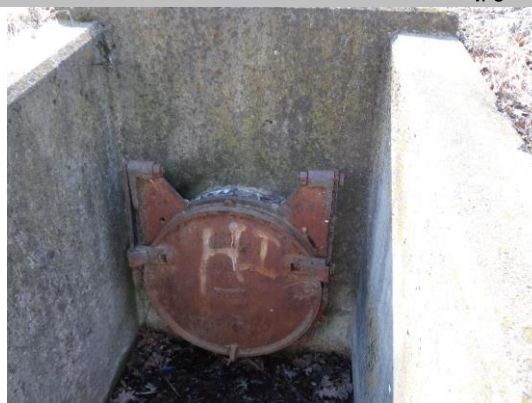
Photo 1 of 2 : UCIP_FA_2019_32143_58641.jpg

WS view: U type concrete headwall and CMP on levee slope. Soil/mud on outlet box. Needs cleaning and clearing.

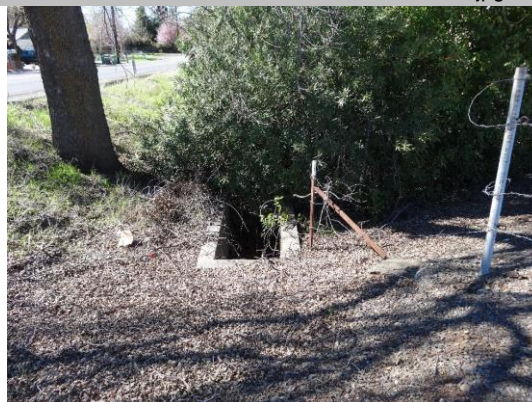
Photo 1 of 3 : UCIP_FA_2019_32144_58644.jpg

LS view: U type concrete headwall of CMP culvert on levee slope. Vegetation debris and mud on inlet box.

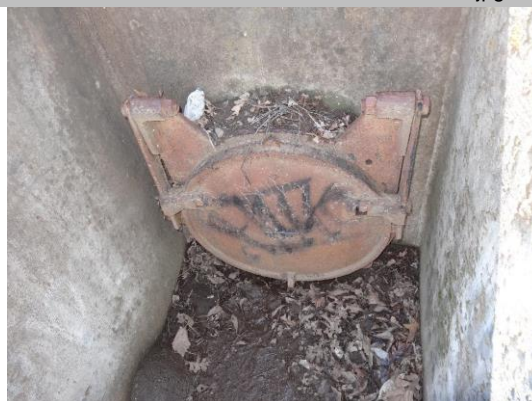
Photo 1 of 3 : UCIP_FA_2019_31963_58384.jpg

WS view: U type concrete headwall and CMP on levee slope. Vegetation debris and mud on outlet box. Needs cleaning and clearing.

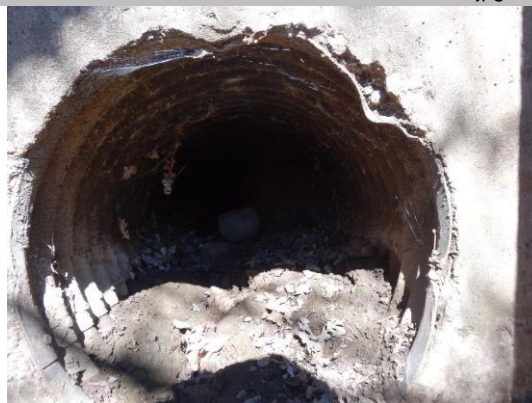
Photo 3 of 3 : UCIP_FA_2019_31963_58385.jpg

LS view: inside view of CMP on levee slope. Needs cleaning and clearing.

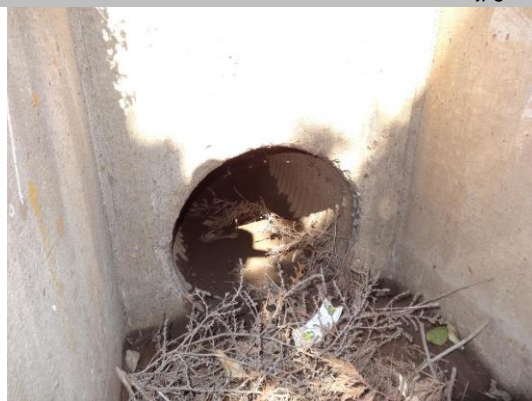
Photo 2 of 2 : UCIP_FA_2019_31964_58388.jpg

LS view: U type concrete headwall and CMP on levee slope. Vegetation debris and mud in inlet box.

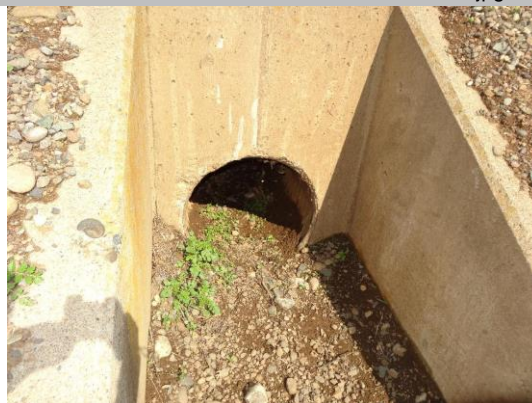
Photo 2 of 3 : UCIP_FA_2019_31965_58394.jpg

LS view: U type concrete headwall and CMP on levee slope. Vegetation debris and mud in inlet box.

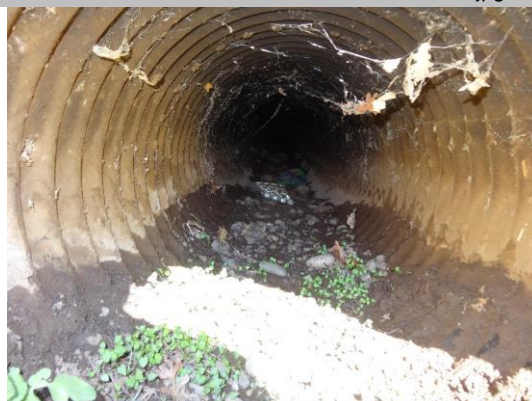
Photo 3 of 3 : UCIP_FA_2019_31965_58393.jpg

LS view: inside view of CMP on levee slope. Needs cleaning and clearing.

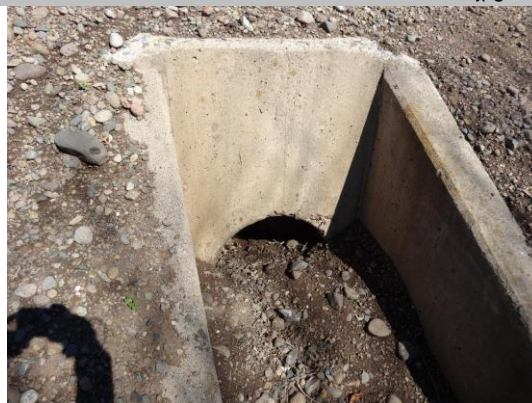
Photo 3 of 3 : UCIP_FA_2019_31966_58399.jpg

LS view: U type concrete headwall and CMP on levee slope. Vegetation debris and mud in pipe and inlet box.

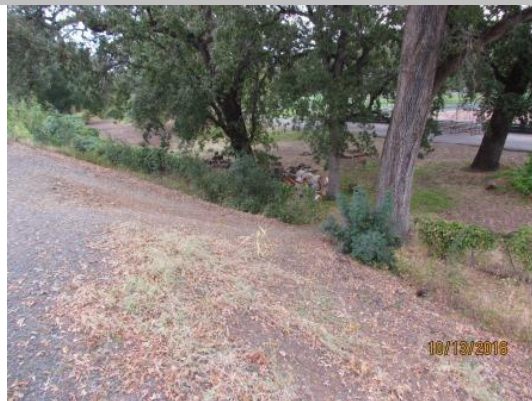
Photo 1 of 1 : FA_2019_NA0003_69_11_20190822_00002.jpg

View of the damaged slope by foot traffic.
