**Flood Control Project Maintenance
Levee Inspections**

Maintenance Issue Types Only, Levee Inspection Report By Mile - Fall 2020

Butte County Department of Public Works

Waterway	Bank	Unit Miles	Inspection Start/End	Inspector
Unit No. 01 Mud Creek	Right	6.80	10/27/2020 10/27/2020	Makar Sokol

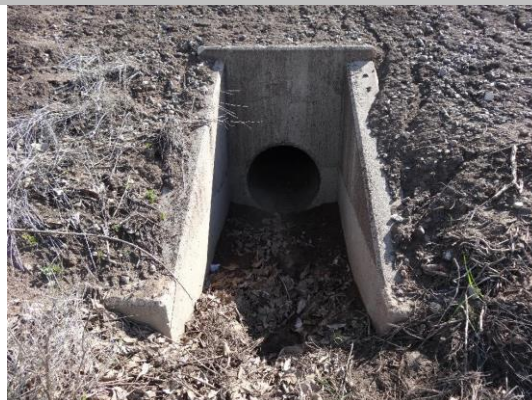
Photo 2 of 3 : UCIP_FA_2020_29705_54923.jpg

LS view: U typed concrete headwall, CMP on levee slope.

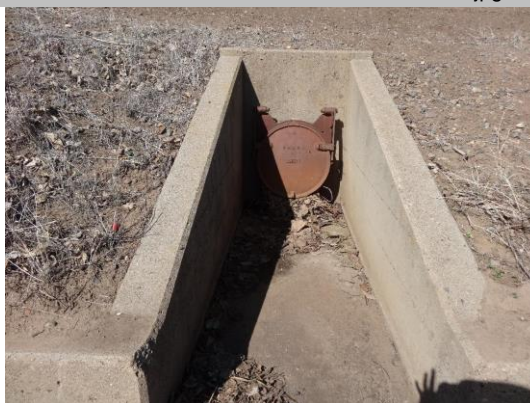
Photo 1 of 3 : UCIP_FA_2020_32044_58543.jpg

DS_ID:19211
 FS_ID:32044
 EP_NO: N/A
 Repair Type: Non-Urgent
 EVAL Issue:
 Crossing Status: Found
 UCIP Comments: Vegetation debris on waterside. Needs clearing and cleaning.
 FIELD_STRUCT_DESC: 24-inch corrugated metal gravity drainage pipe through the levee, 12 feet below the crown. Flap gate on the waterside (WS) end. Concrete U-shaped headwall on each end. Grouted riprap apron on the landside (LS) end. Grouted riprap spillway on the WS end. [Additional Reference(s): DWR Levee Log, 1992. USACE Sacramento O&M Manual 504, May 1965, (HLM 1.03)].
 FS Date: 2/20/2014

WS view: U typed concrete headwall, pipe, and flapgate on levee slope.

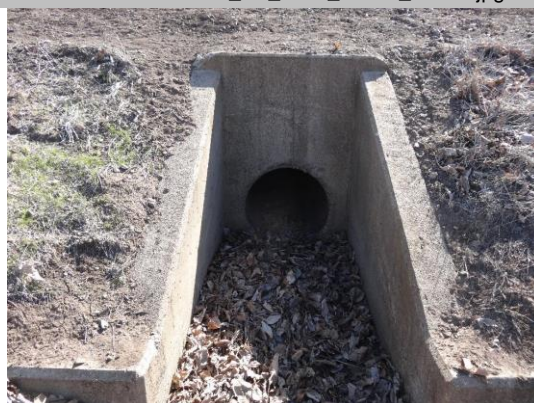
Photo 3 of 3 : UCIP_FA_2020_32044_58541.jpg

LS view: U typed concrete headwall and CMP on levee slope.

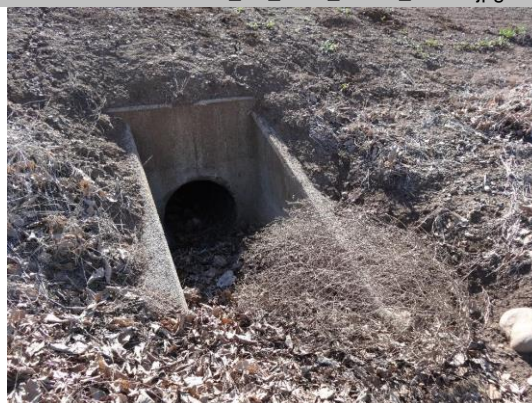
Photo 2 of 3 : UCIP_FA_2020_50142_55885.jpg

Comment Code					
Inspector Comment					
DS_ID:19212 FS_ID:50142 EP_NO: N/A Repair Type: No Action Needed EVAL Issue: Crossing Status: Found UCIP Comments: 08/29/2016: Shawn Bates of NA0003 has cleared the LS and WS of debris and blockage; WS gate functions properly now. Crossing has been downgraded from Urgent to No Action Needed. (K. Fazel - UCIP)08/11/2016: Same as last inspection. (K. Fazel - UCIP)02/20/2014:No riprap spillway on waterside. Needs cleaning and clearing of debris. Flap gate was not fully closed. (P. Amatya - UCIP) FIELD_STRUCT_DESC: 24-inch corrugated metal gravity drainage pipe through the levee, 13 feet below the crown. Flap gate on the waterside (WS) end. Concrete U-shaped headwall on each end. Grouted riprap apron on the landside (LS) end. Grouted riprap spillway on the WS end. [Additional Reference(s): DWR Levee Log, 2005. USACE Sacramento O&M Manual 504, May 1965, (HLM 1.95)]. FS Date: 8/11/2016

LS view: U type concrete headwall and CMP on levee slope. Vegetation debris blocking inlet.

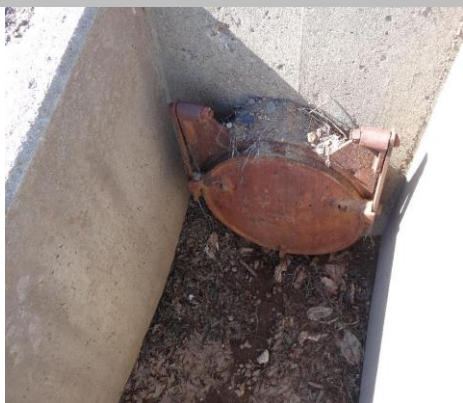
Photo 1 of 2 : UCIP_FA_2020_30294_55704.jpg

WS view: U type concrete headwall, flapgate on levee slope.

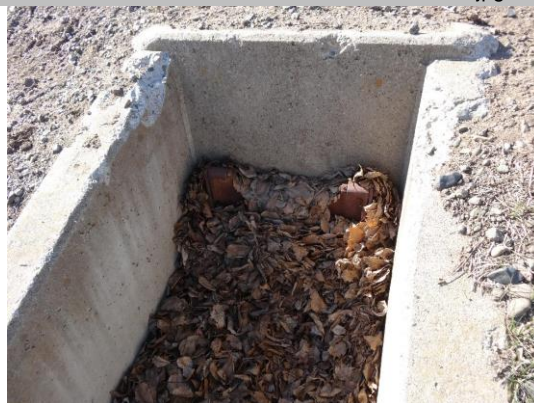
Photo 1 of 2 : UCIP_FA_2020_30295_55706.jpg

DS_ID:19217
FS_ID:30295
EP_NO: N/A
Repair Type: Non-Urgent
EVAL Issue:
Crossing Status: Found
UCIP Comments: It needs cleaning and clearing in inlet and outlet ends.
FIELD_STRUCT_DESC: 24-inch corrugated metal gravity drainage pipe through the levee, 9 feet below the crown. Flap gate on the waterside (WS) end. Concrete U-shaped headwall on each end. Grouted riprap apron on the landside (LS) end. Grouted riprap spillway on the WS end. [Additional Reference(s): DWR Levee Log, 1992. USACE Sacramento O&M Manual 504, May 1965, (HLM 3.27)].
FS Date: 2/20/2014

WS view: U type concrete headwall, flapgate on levee slope. Vegetation debris blocking the outlet.

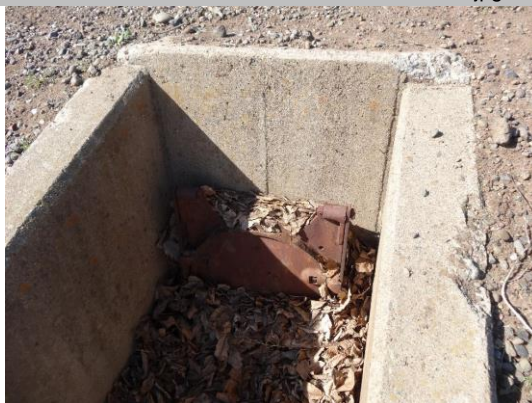
Photo 1 of 3 : UCIP_FA_2020_30310_55741.jpg

DS_ID:19218
 FS_ID:30310
 EP_NO: N/A
 Repair Type: Non-Urgent
 EVAL Issue:
 Crossing Status: Found
 UCIP Comments: Needs cleaning and clearing of debris.
 FIELD_STRUCT_DESC: 24-inch corrugated metal gravity drainage pipe through the levee, 10 feet below the crown. Flap gate on the waterside (WS) end. Concrete U-shaped headwall on each end. Grouted riprap apron on the landside (LS) end. Grouted riprap spillway on the WS end. [Additional Reference(s): DWR Levee Log, 1992. USACE Sacramento O&M Manual 504, May 1965, (HLM 3.48)].
 FS Date: 2/20/2014

WS view: U type concrete headwall, pipe, and flapgate on levee slope. Vegetation debris blocking outlet.

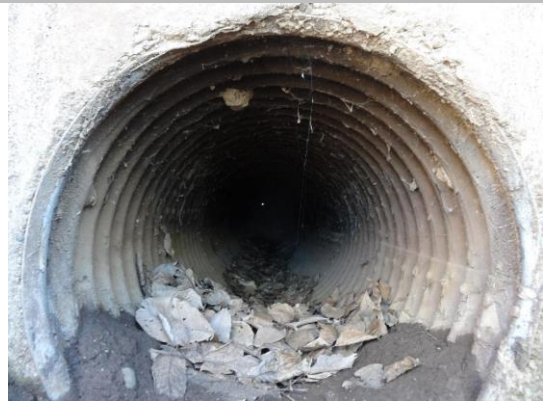
Photo 3 of 3 : UCIP_FA_2020_30310_55739.jpg

LS view: inside view of CMP on levee slope. Needs cleaning and clearing.

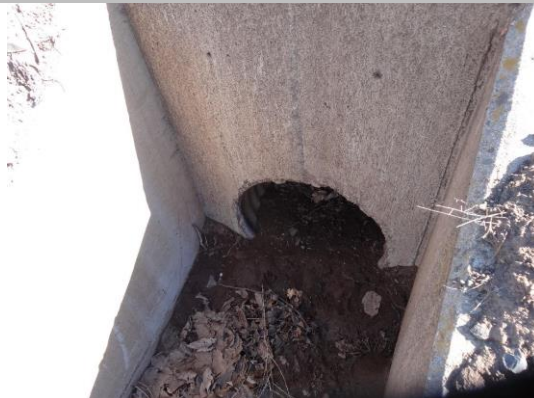
Photo 2 of 2 : UCIP_FA_2020_30311_55742.jpg

Comment Code						
Inspector Comment						
DS_ID:19219						
FS_ID:30311						
EP_NO: N/A						
Repair Type: Non-Urgent						
EVAL Issue:						
Crossing Status: Found						
UCIP Comments: Needs cleaning and clearing of debris in both ends of the pipe.						
FIELD_STRUCT_DESC: 24-inch corrugated metal gravity drainage pipe through the levee, 9 feet below the crown. Flap gate on the waterside (WS) end. Concrete U-shaped headwall on each end. Grouted riprap apron on the landside (LS) end. Grouted riprap spillway on the WS end. [Additional Reference(s): DWR Levee Log, 1992. USACE Sacramento O&M Manual 504, May 1965, (HLM 4.08)].						
FS Date: 2/20/2014

LS view: U type concrete headwall and CMP on levee slope.

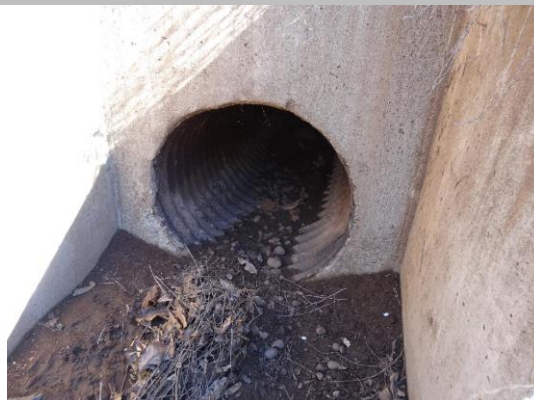
Photo 2 of 2 : UCIP_FA_2020_30312_55744.jpg

LS view: U type concrete headwall and CMP on levee slope. Needs cleaning and clearing of debris.

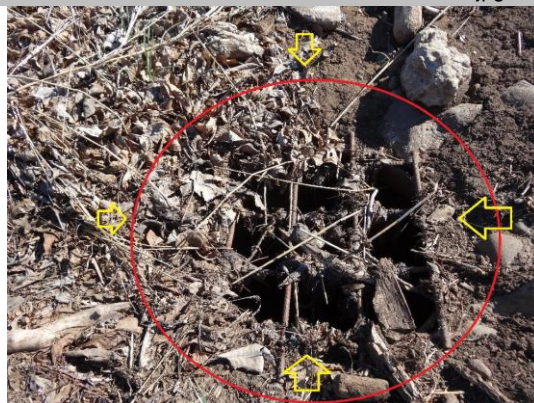
Photo 2 of 2 : UCIP_FA_2020_30388_55890.jpg

Comment Code					
Inspector Comment					
DS_ID:19221 FS_ID:30388 EP_NO: N/A Repair Type: Non-Urgent EVAL Issue: Crossing Status: Found UCIP Comments: CM Standpipe intake. Intake pipe with air vent. Steel rib-bar grit cover on the standpipe on landside levee toe.Needs cleaning and clearing on both ends of the pipe. FIELD_STRUCT_DESC: 24-inch corrugated metal gravity drainage pipe through the levee, 15 feet below the crown. Flap gate on the waterside (WS) end. Concrete U-shaped headwall on the WS end. Grouted riprap spillway on the WS end. Corrugated metal standpipe intake. Intake pipe with an air vent. Steel rib-bar grit cover on the standpipe on the landside (LS) toe. [Additional Reference(s): DWR Levee Log, 1992. USACE Sacramento O&M Manual 504, May 1965, (HLM 4.94)]. FS Date: 2/20/2014

LS view: Underground CM standpipe intake with steel grit on levee toe.

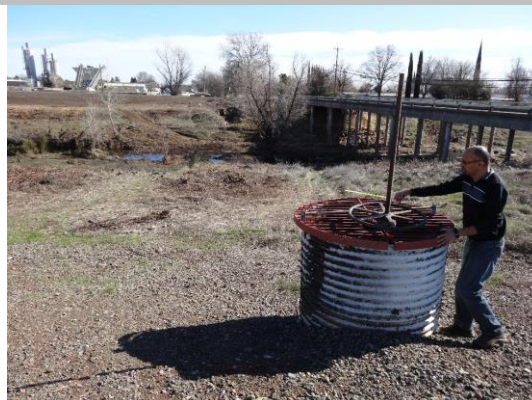
Photo 2 of 3 : UCIP_FA_2020_30327_55767.jpg

WS view: CM standpipe with slide gate on levee slope.

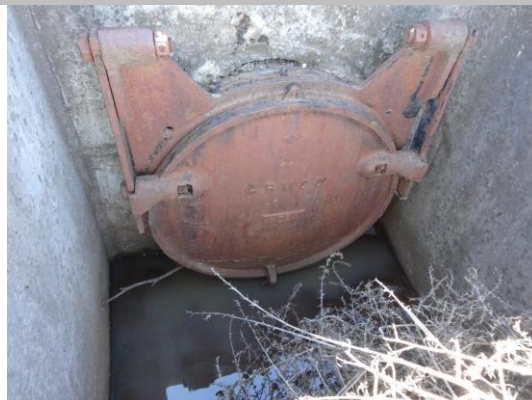
Photo 2 of 3 : UCIP_FA_2020_31667_57967.jpg

WS view: U type concrete headwall, pipe, and flapgate on levee slope. Vegetation debris on outlet box.

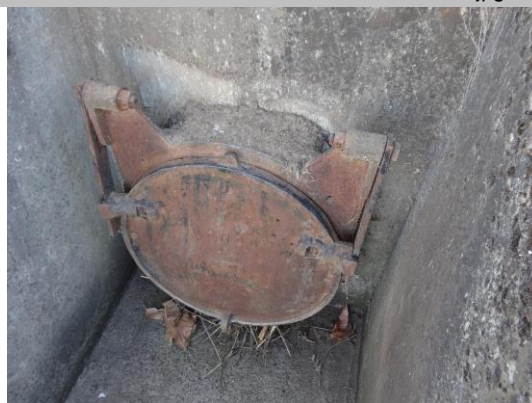
Photo 1 of 3 : UCIP_FA_2020_30403_55922.jpg

WS view: U type concrete headwall, pipe, and flapgate on levee slope.

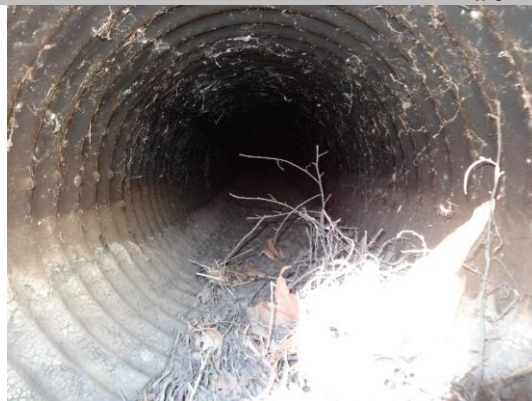
Photo 3 of 3 : UCIP_FA_2020_30403_55920.jpg

LS view: inside view of CMP on levee slope. Needs cleaning and clearing.

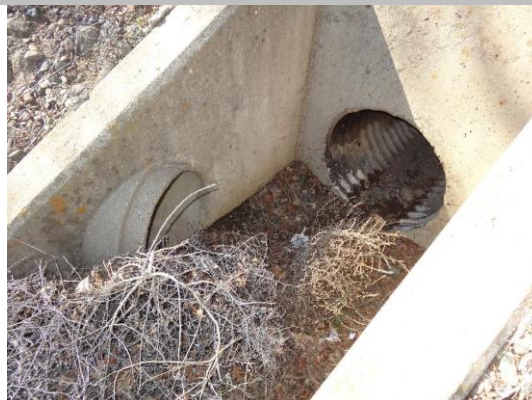
Photo 2 of 2 : UCIP_FA_2020_30743_56640.jpg

LS view: U type concrete headwall and CMP on levee slope. Vegetation debris and soil in inlet area.

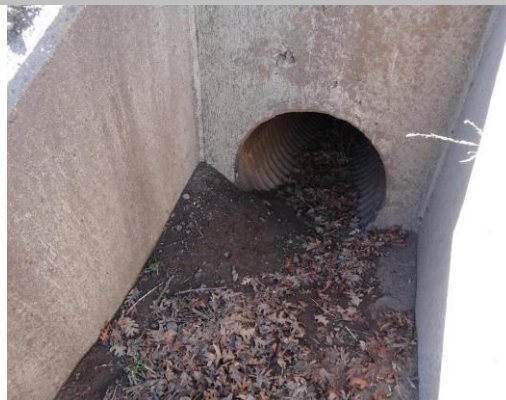
Photo 2 of 3 : UCIP_FA_2020_30783_56681.jpg

LS view: U type concrete headwall and CMP on levee slope. Debris and soil in inlet box.

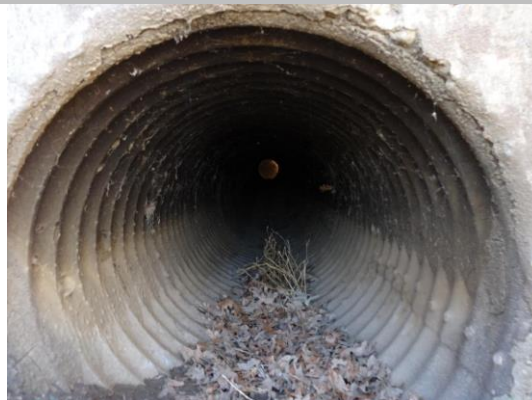
Photo 3 of 3 : UCIP_FA_2020_30783_56680.jpg

LS view: inside view of CMP on levee slope. Needs cleaning and clearing.

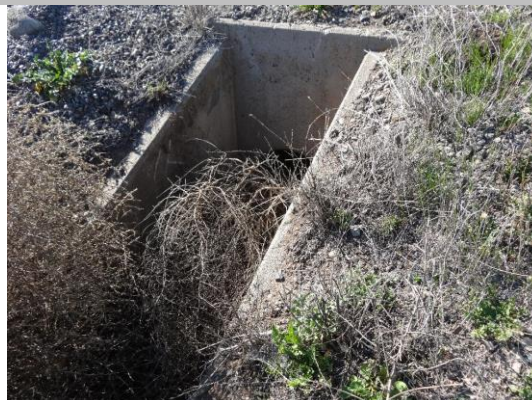
Photo 2 of 3 : UCIP_FA_2020_30803_56684.jpg

LS view: U type concrete headwall and CMP on levee slope. Vegetation debris and soil blocking inlet.

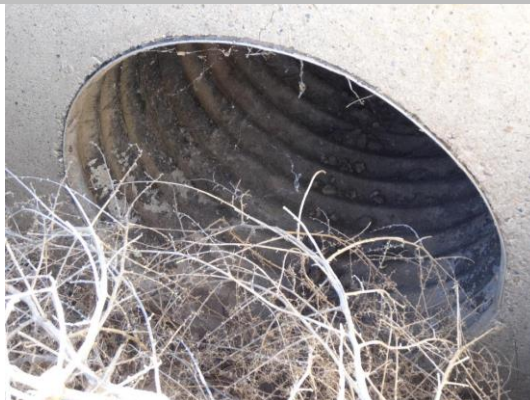
Photo 3 of 3 : UCIP_FA_2020_30803_56683.jpg

LS view: inside view of CMP on levee slope. Needs cleaning and clearing.

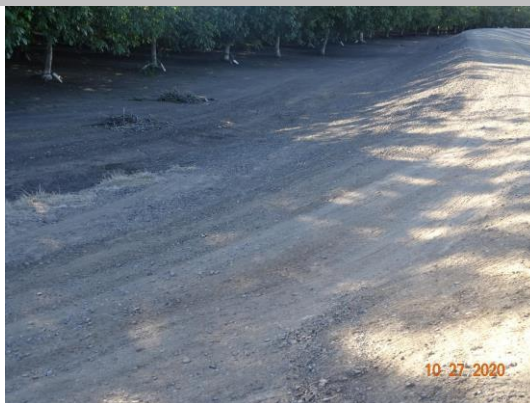
Photo 1 of 1 : FA_2020_NA0003_65_10_20201103_00059.jpg

View of the damaged landside slope due to vehicle traffic. Fall 2020.

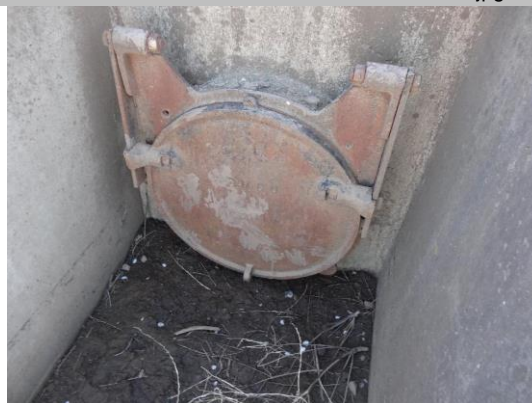
Photo 1 of 3 : UCIP_FA_2020_31031_56917.jpg

WS view: U type concrete headwall, pipe, and flapgate on levee slope. Soil/mud on outlet box.

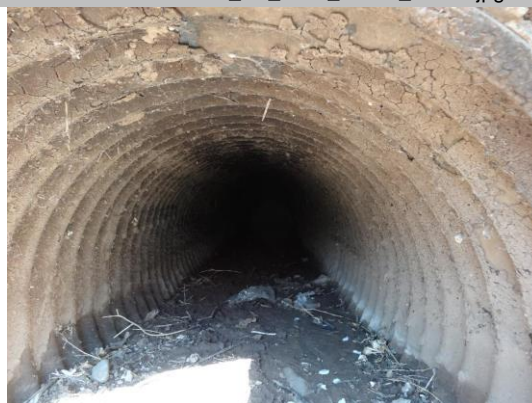
Photo 3 of 3 : UCIP_FA_2020_31031_56915.jpg

LS view: inside view of CMP on levee slope. Needs cleaning and clearing.

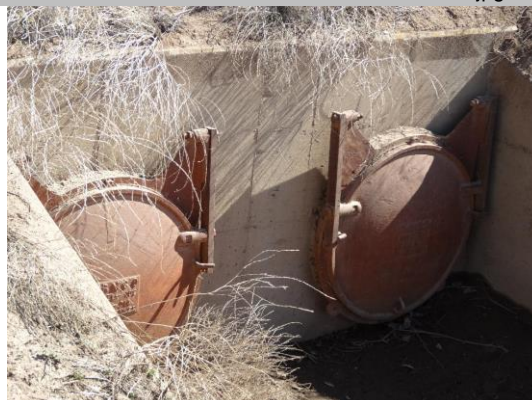
Photo 2 of 3 : UCIP_FA_2020_41376_56919.jpg

WS view: U type concrete headwall, pipes, and flapgates on levee slope. Vegetation debris on outlet box.

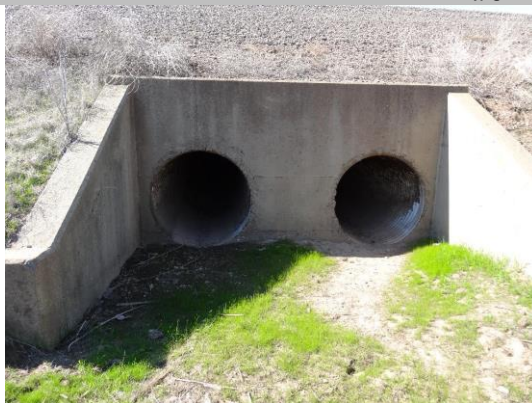
Photo 3 of 3 : UCIP_FA_2020_41377_56921.jpg

LS view: U type concrete headwall and CMPs on levee slope. Soil/mud on inlet box.

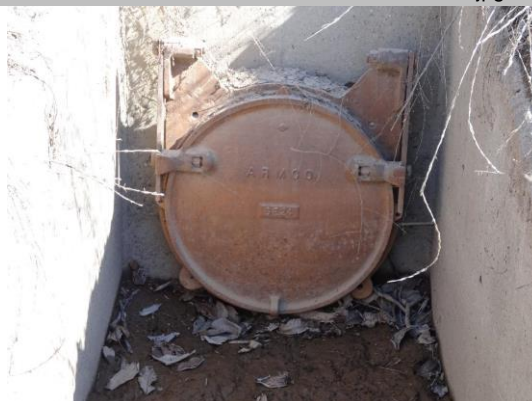
Photo 1 of 3 : UCIP_FA_2020_31085_56988.jpg

WS view: U type concrete headwall, pipe, and flapgate on levee slope. Soil/mud on outlet box.

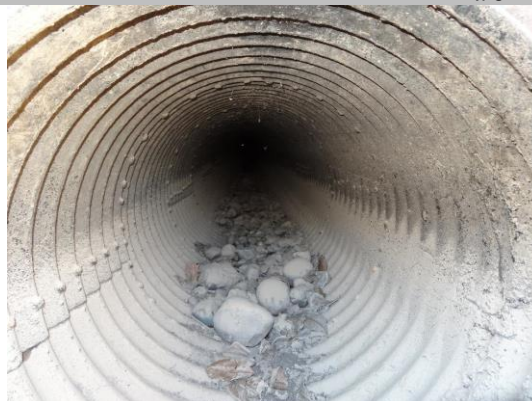
Photo 3 of 3 : UCIP_FA_2020_31085_56986.jpg

LS view: inside view of CMP on levee slope. Needs cleaning and clearing.

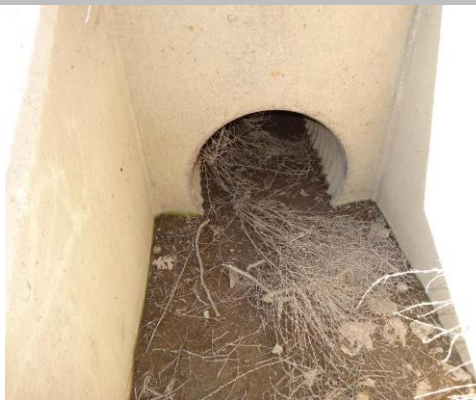
Photo 2 of 3 : UCIP_FA_2020_31103_57001.jpg

LS view: U type concrete headwall and CMP on levee slope. Soil/mud on inlet box.

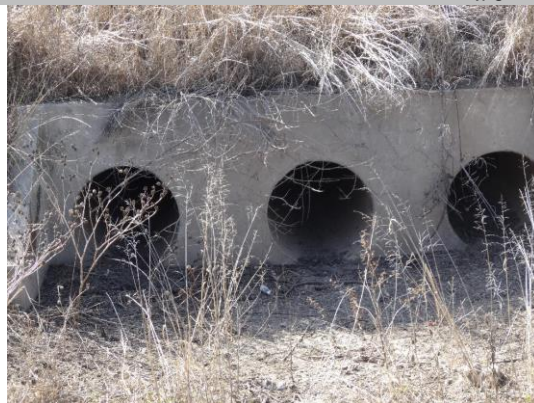
Photo 3 of 3 : UCIP_FA_2020_32085_58586.jpg

LS view: U type concrete headwall and CMPs on levee slope. Soil/mud on inlet box.

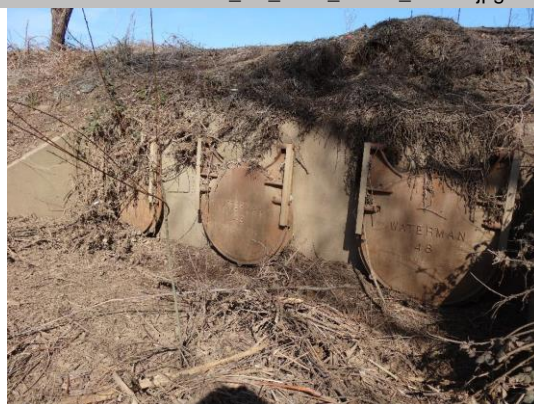
Photo 2 of 3 : UCIP_FA_2020_32087_58591.jpg

WS view: U type concrete headwall, pipes, and flapgates on levee slope. Soil/mud on outlet box. Vegetation debris on outlet box

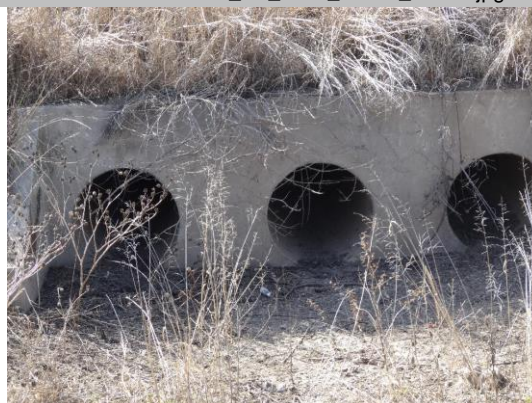
Photo 3 of 3 : UCIP_FA_2020_32086_58587.jpg

LS view: U type concrete headwall and CMPs on levee slope. Soil/mud on inlet box.

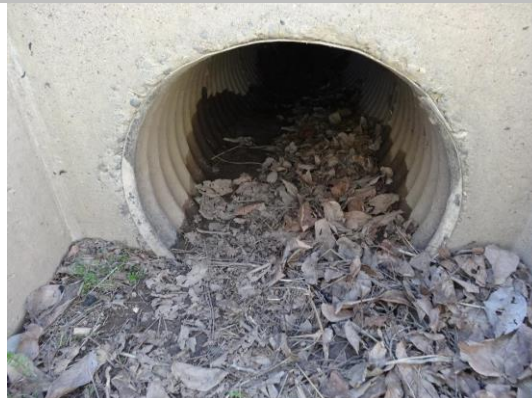
Photo 2 of 2 : UCIP_FA_2020_31129_57035.jpg

LS view: U type concrete headwall and CMP on levee slope. Soil/mud and vegetation on inlet box.

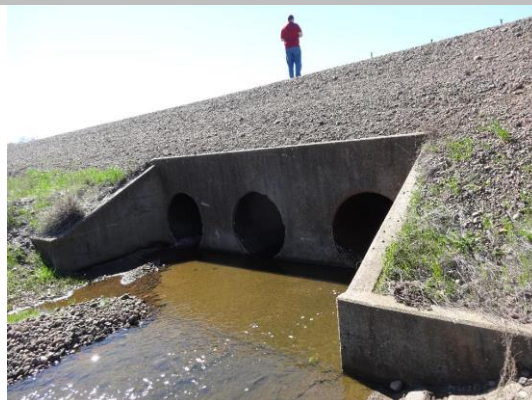
Photo 2 of 2 : UCIP_FA_2020_32104_58605.jpg

LS view: U type concrete headwall and three CMPs on levee slope. Soil/mud on inlet box.

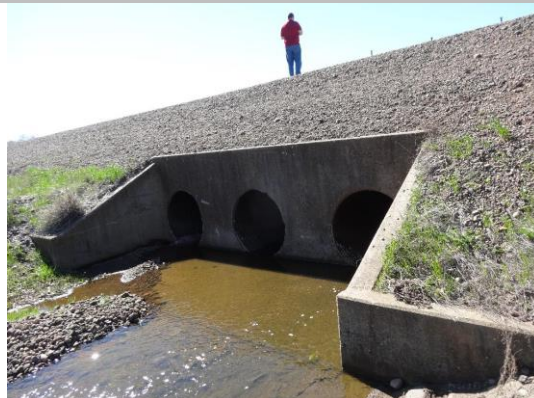
Photo 2 of 2 : UCIP_FA_2020_32105_58607.jpg

LS view: U type concrete headwall and three CMPs on levee slope. Soil/mud on inlet box.

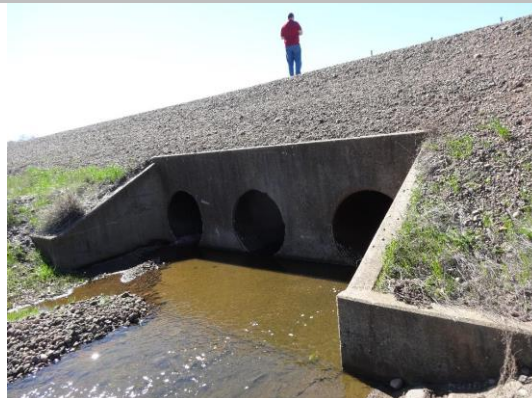
Photo 2 of 2 : UCIP_FA_2020_32106_58609.jpg

LS view: U type concrete headwall and three CMPs on levee slope. Soil/mud on inlet box.

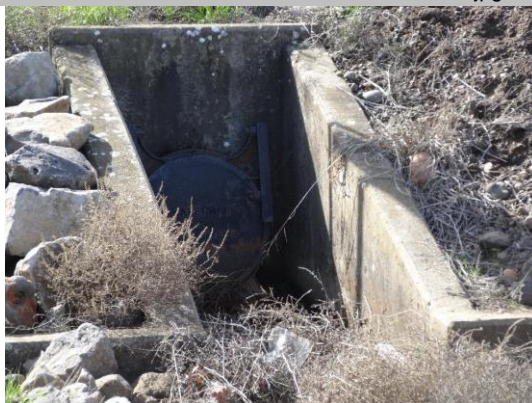
Photo 1 of 3 : UCIP_FA_2020_32124_58625.jpg

WS view: concrete headwall, pipe, and flapgate on levee slope. Vegetation and mud on outlet box.

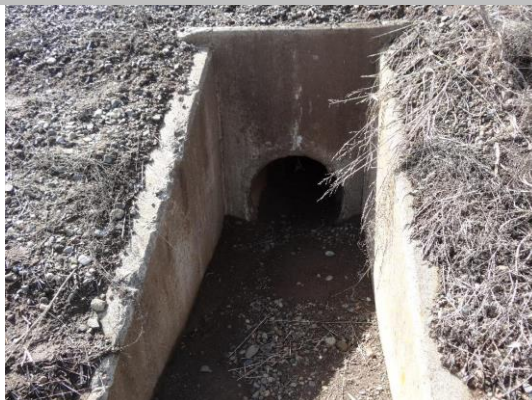
Photo 2 of 3 : UCIP_FA_2020_31901_58193.jpg

LS view: U type concrete headwall and CMP on levee slope. Soil/mud on inlet box.

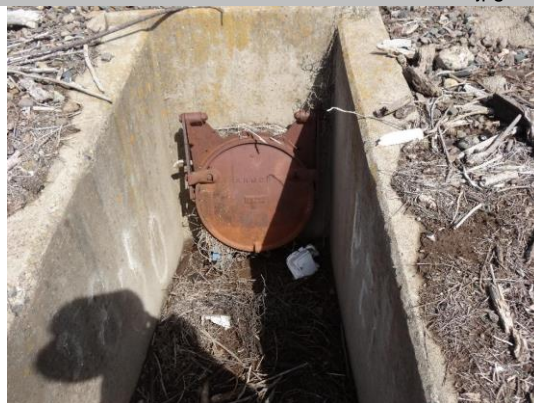
Photo 1 of 3 : UCIP_FA_2020_31864_58069.jpg

WS view: U type concrete headwall, pipe, and flapgate on levee slope. Soil/mud on outlet box. Vegetation debris blocking outlet box.

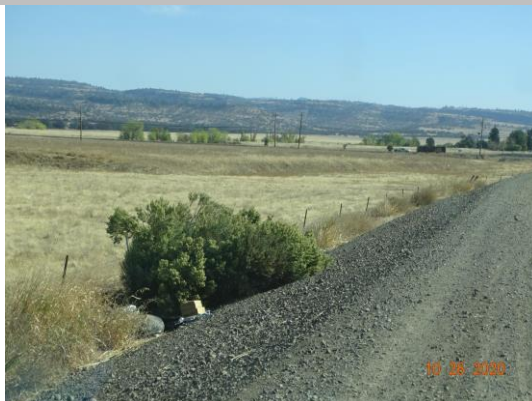
Photo 1 of 1 : FA_2020_NA0003_67_14_20201103_00039.jpg

View of a bush along the landside slope. Fall 2020.

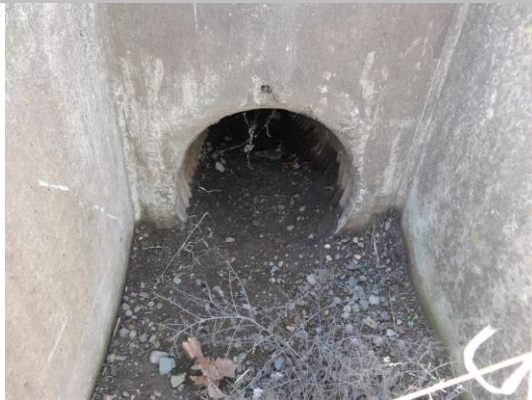
Photo 2 of 3 : UCIP_FA_2020_31856_58052.jpg

LS view: U type concrete headwall and CMP on levee slope. Soil/mud on inlet box.

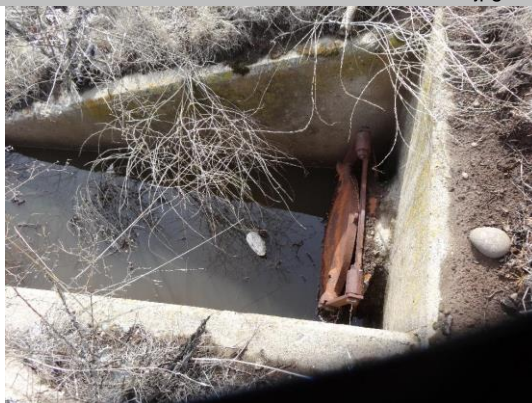
Photo 1 of 2 : UCIP_FA_2020_32125_58629.jpg

WS view: U type concrete headwall, pipe, and flapgate on levee slope. Soil/mud on outlet box. Vegetation debris blocking outlet box.

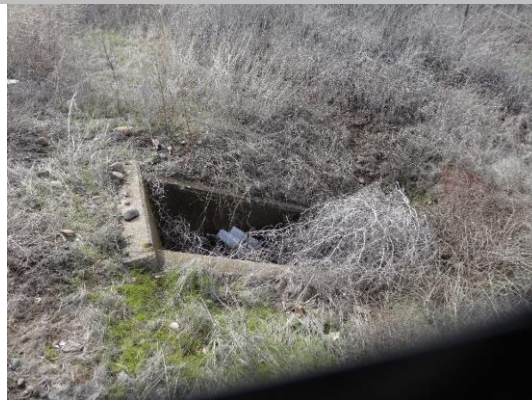
Photo 2 of 2 : UCIP_FA_2020_32125_58628.jpg

LS view: U type concrete headwall and pipe on levee slope. Soil/mud on inlet box. Vegetation debris blocking inlet box.

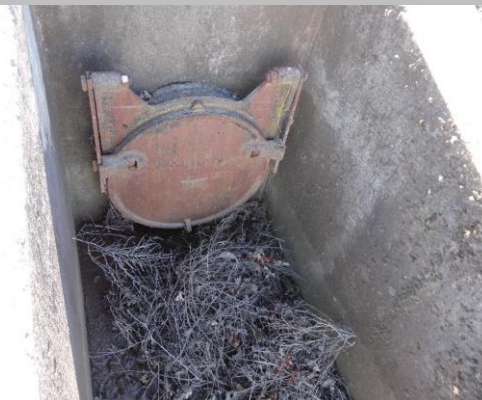
Photo 2 of 3 : UCIP_FA_2020_32026_58519.jpg

WS view: U type concrete headwall and CMP on levee slope. Mud and vegetation debris on outlet box.

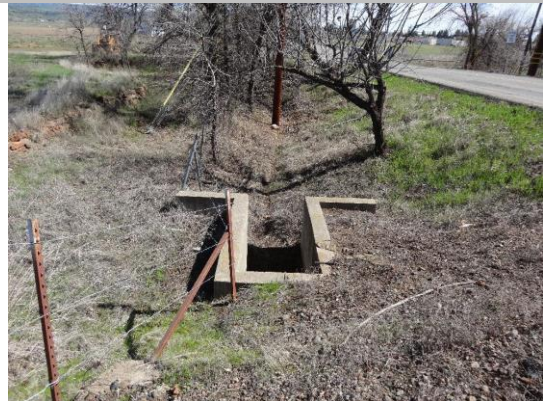
Photo 3 of 3 : UCIP_FA_2020_32025_58510.jpg

LS view: U type concrete headwall and CMP on levee slope. Vegetation debris and mud on inlet box.

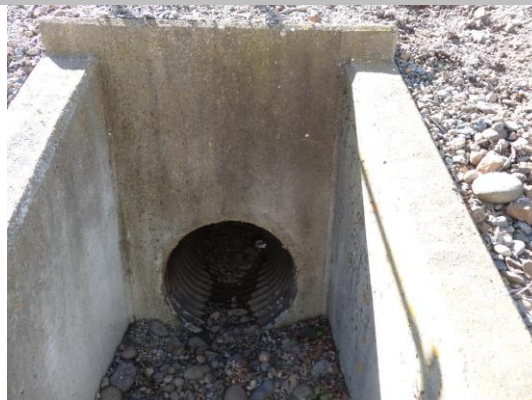
Photo 2 of 3 : UCIP_FA_2020_32023_58504.jpg

LS view: U type concrete headwall and CMP on levee slope. Pebbles and mud on inlet box.

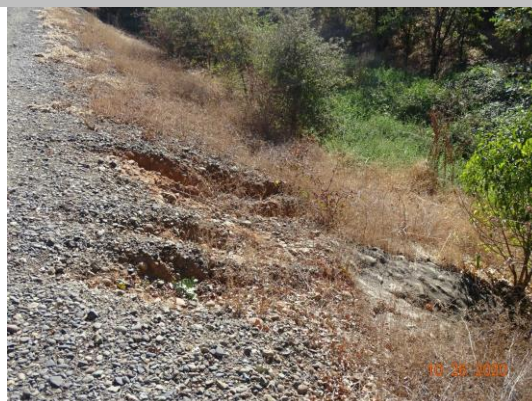
Photo 1 of 1 : FA_2020_NA0003_68_26_20201103_00034.jpg

View of the erosion on the waterside slope. Fall 2020.

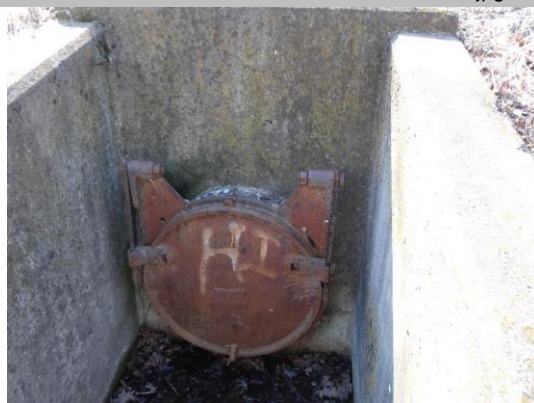
Photo 1 of 2 : UCIP_FA_2020_32143_58641.jpg

WS view: U type concrete headwall and CMP on levee slope. Soil/mud on outlet box. Needs cleaning and clearing.

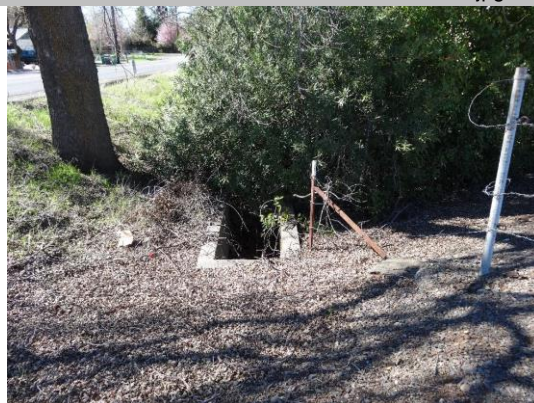
Photo 1 of 3 : UCIP_FA_2020_32144_58644.jpg

LS view: U type concrete headwall of CMP culvert on levee slope. Vegetation debris and mud on inlet box.

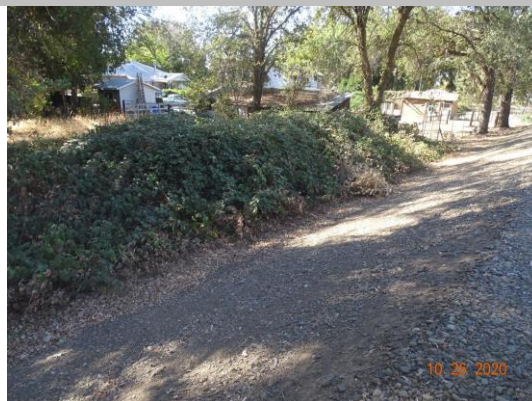
Photo 1 of 1 : FA_2020_NA0003_68_23_20201103_00036.jpg

View of the blackberry bushes along the landside toe. Fall 2020.

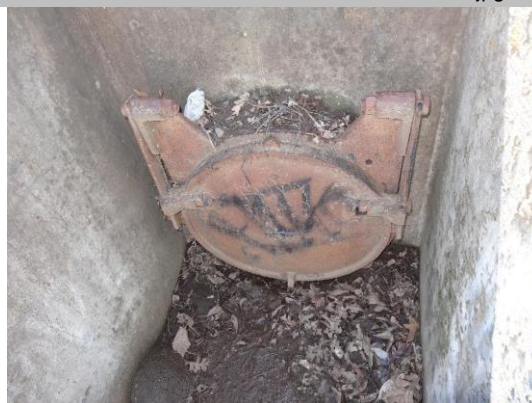
Photo 1 of 3 : UCIP_FA_2020_31963_58384.jpg

WS view: U type concrete headwall and CMP on levee slope. Vegetation debris and mud on outlet box. Needs cleaning and clearing.

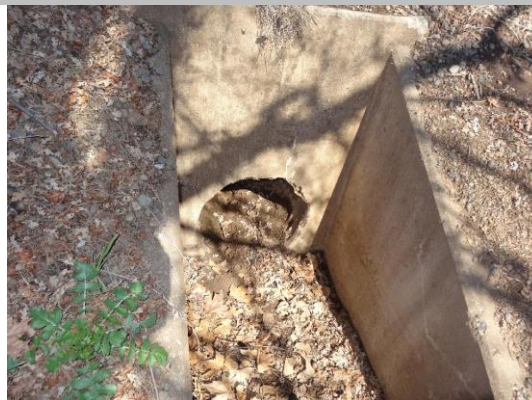
Photo 2 of 3 : UCIP_FA_2020_31963_58383.jpg

LS view: U type concrete headwall and CMP on levee slope. Vegetation debris and mud on inlet box.

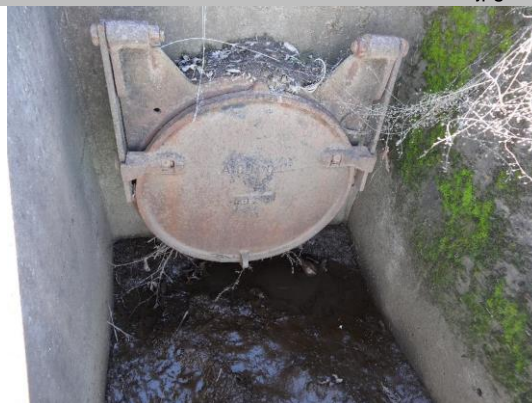
Photo 1 of 2 : UCIP_FA_2020_31964_58389.jpg

WS view: U type concrete headwall and CMP on levee slope. Vegetation debris and mud in outlet box. Needs cleaning and clearing.

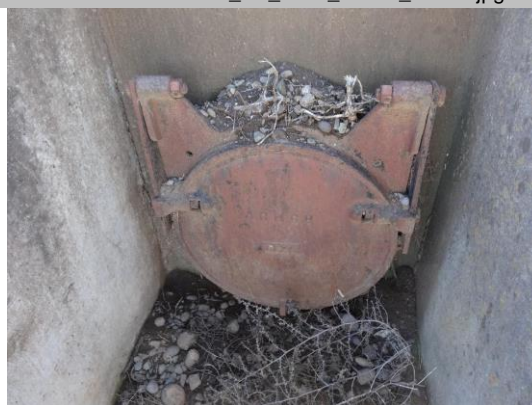
Photo 1 of 3 : UCIP_FA_2020_31965_58395.jpg

WS view: U type concrete headwall and CMP on levee slope. Vegetation debris and mud in outlet box. Needs cleaning and clearing.

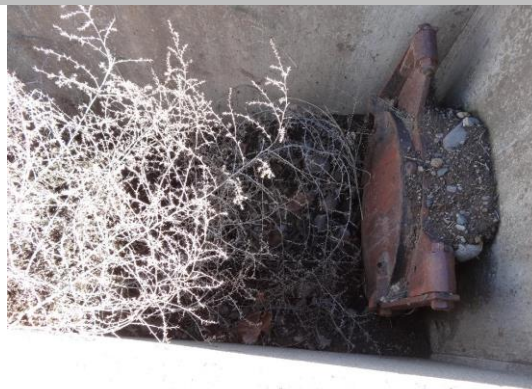
Photo 2 of 3 : UCIP_FA_2020_31966_58400.jpg

WS view: U type concrete headwall and CMP on levee slope. Vegetation debris and mud on outlet box. Needs cleaning and clearing.

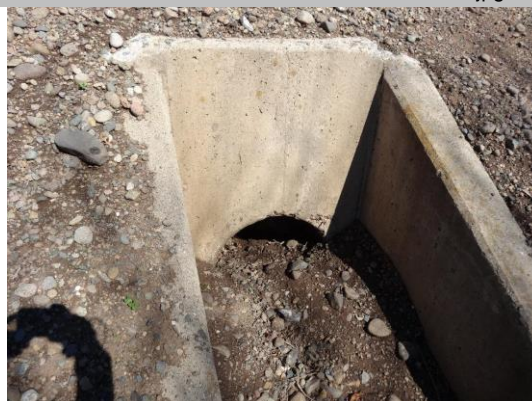
Photo 3 of 3 : UCIP_FA_2020_31966_58399.jpg

LS view: U type concrete headwall and CMP on levee slope. Vegetation debris and mud in pipe and inlet box.

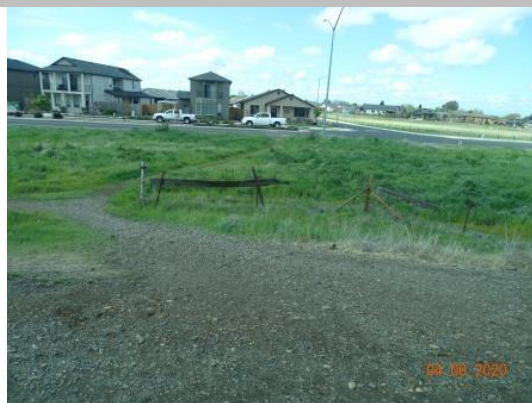
Photo 1 of 1 : FA_2020_NA0003_69_12_20200915_00002.jpg

View of the landside slope erosion caused by foot traffic. Spring 2020.

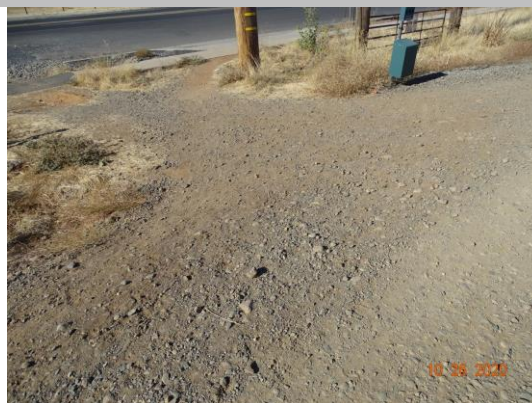
Photo 1 of 1 : FA_2020_NA0003_69_13_20201103_00006.jpg

View of the damaged landside slope due to foot traffic. Fall 2020.
