**Flood Control Project Maintenance
Levee Inspections**

Maintenance Issue Types Only, Levee Inspection Report By Mile - Fall 2021

Butte County Department of Public Works

Waterway	Bank	Unit Miles	Inspection Start/End	Inspector
Unit No. 01 Mud Creek	Right	6.80	10/18/2021 10/18/2021	Makar Sokol

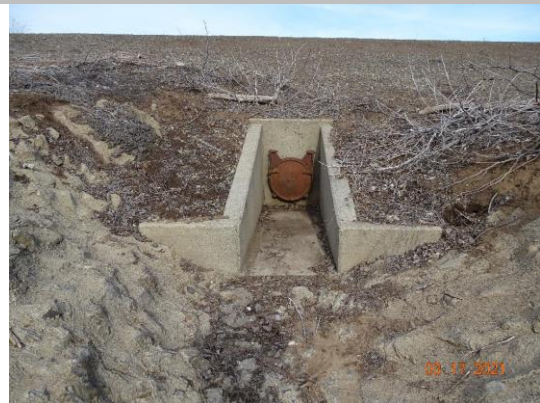
Photo 2 of 3 : UCIP_FA_2021_67236_99225.jpg

DS_ID:19209
FS_ID:67236
EP_NO: N/A
Repair Type: Urgent
EVAL Issue: Pipe Integrity
Crossing Status: Found
UCIP Comments: 03/17/2021 Record updated from No Action Needed to Urgent. DMP internal video inspection has found pipe integrity issues. LOF of crossing is between 5 and 6. Crossing will be monitored until funding becomes available to address the issues. No permit has been identified authorizing pipe. (O.Yakimov - DWR UCIP)
02/20/2014 Looks cleaned recently. (P. Amatya - DWR UCIP)
FIELD_STRUCT_DESC: 24-inch corrugated metal gravity drainage pipe through the levee, 12.5 feet below the crown. Flap gate on the waterside (WS) end. Concrete U-shaped headwall on each end. Grouted riprap apron on the landside (LS) end. Grouted riprap spillway on the WS end. [Additional Reference(s): DWR Levee Log, 1992. USACE Sacramento O&M Manual 504, May 1965, (HLM 0.26)].
FS Date: 3/17/2021 8:31:45 AM

Water-Side: Headwall and flap gate at levee toe

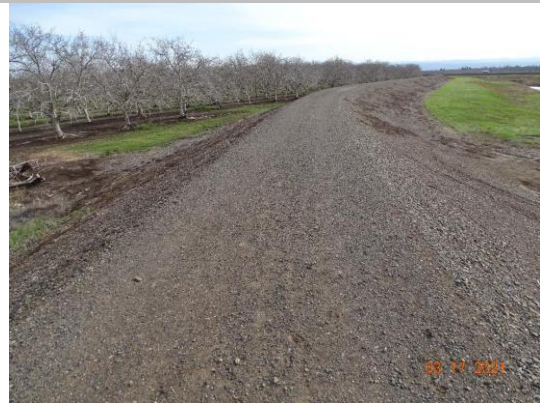
Photo 1 of 3 : UCIP_FA_2021_67238_99231.jpg

DS_ID:19211
 FS_ID:67238
 EP_NO: N/A
 Repair Type: Non-Urgent
 EVAL Issue: Pipe Damage
 Crossing Status: Found
 UCIP Comments: 03/17/2021 Record remains Non-Urgent. Vegetation on waterside has been cleared. No permit has been identified authorizing pipe. DMP internal video inspection has found pipe integrity issues. LOF of crossing is greater than or equal to 4.1 and less than 5. Crossing will be monitored until funding becomes available for rehabilitation. (O.Yakimov - DWR UCIP)
 02/20/2014 Vegetation debris on waterside. Needs clearing and cleaning. (P. Amatya - DWR UCIP)
 FIELD_STRUCT_DESC: 24-inch corrugated metal gravity drainage pipe through the levee, 12 feet below the crown. Flap gate on the waterside (WS) end. Concrete U-shaped headwall on each end. Grouted riprap apron on the landside (LS) end. Grouted riprap spillway on the WS end. [Additional Reference(s): DWR Levee Log, 1992. USACE Sacramento O&M Manual 504, May 1965, (HLM 1.03)].

Top of Levee: View of levee crown looking upstream

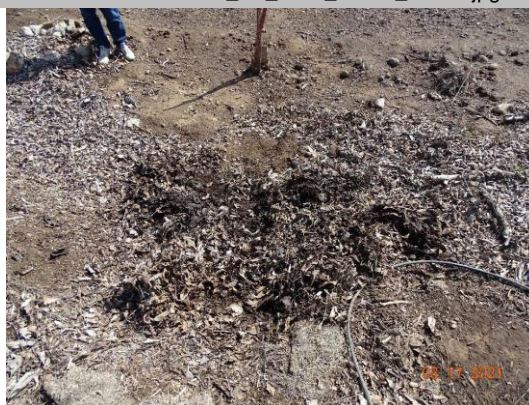
Photo 3 of 3 : UCIP_FA_2021_67251_99302.jpg

DS_ID:19221
FS_ID:67251
EP_NO: N/A
Repair Type: Urgent
EVAL Issue: Pipe Integrity
Crossing Status: Found
UCIP Comments: 03/17/2021 Record updated from Non-Urgent to Urgent. DMP internal video inspection has found pipe integrity issues. LOF of crossing is between 5 and 6. Crossing will be monitored until funding becomes available to address the issues. Flap gate on waterside pipe end is non-operating. Recommend lubricating hinges for easy opening. Drainage inlet at landside toe is buried in soil - unable to locate. Crossing appears abandoned. No permit has been identified authorizing pipe. (O.Yakimov - DWR UCIP)
02/20/2014 CM Standpipe intake. Intake pipe with air vent. Steel rib-bar grit cover on the standpipe on landside levee toe. Needs cleaning and clearing on both ends of the pip. (P. Amatya - DWR UCIP).
FIELD_STRUCT_DESC: 24-inch corrugated metal gravity drainage pipe through the levee, 15 feet below the crown. Flap gate on the waterside (WS) end. Concrete U-shaped headwall on the WS end. Grouted riprap spillway on the WS end. Corrugated metal standpipe intake. Intake pipe with an air vent. Steel rib-bar grit cover on the standpipe on the landside (LS) toe. [Additional Reference(s): DWR Levee Log, 1992. USACE Sacramento O&M Manual 504, May 1965, (HLM 4.94)].

Land-Side: Approximate location on pipe inlet at levee toe, although inlet was not found

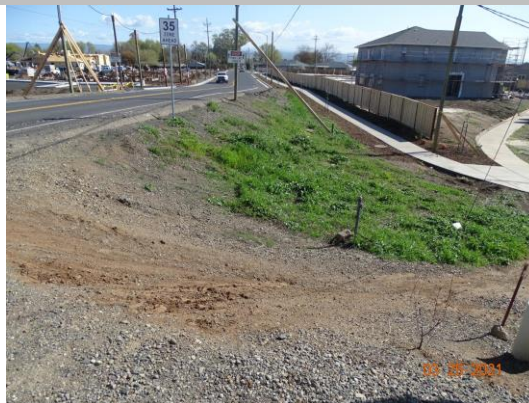
Photo 1 of 1 : FA_2021_NA0003_65_25_20211011_00003.jpg

LM Start	2.05	Rating **	M	Issue No.	25
LM End	2.05	Issue Type +	Ma	Location *	LS
Category	Earthen Levee			GPS Latitude/Longitude	
				Start	End
Item	Slope Stability			39.775748 °	39.775748 °
				-121.892958 °	-121.892958 °
DWR ID	DWR_NA0003_02_f_2019_25				
Comment Code					
S3 : Repair the levee slope damaged by vehicle traffic and prevent access where possible.					
Inspector Comment

View of the erosion on the landside slope due to vehicle traffic. Spring 2021.

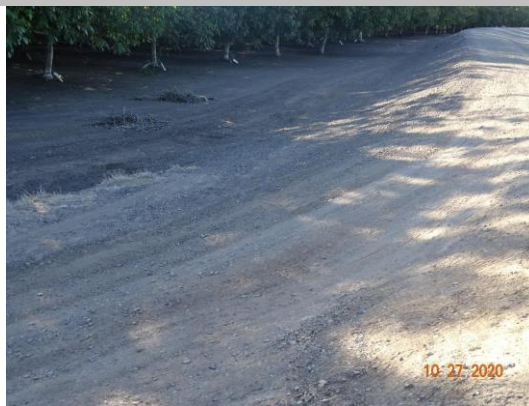
Photo 1 of 1 : FA_2021_NA0003_65_10_20211011_00002.jpg

View of the damaged landside slope due to vehicle traffic. Fall 2020.

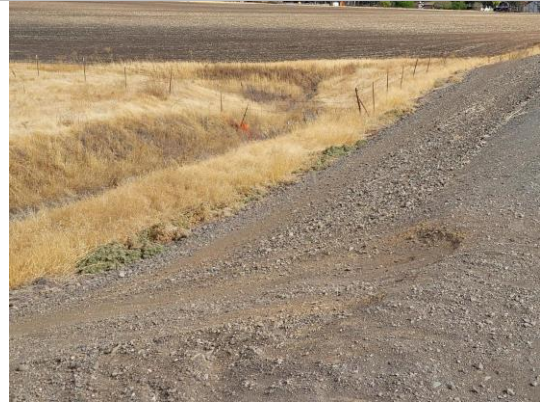
Photo 1 of 1 : FA_2021_NA0003_67_19_20211025_00054.jpg

View of the damaged landside slope due to vehicle traffic. Fall 2021.

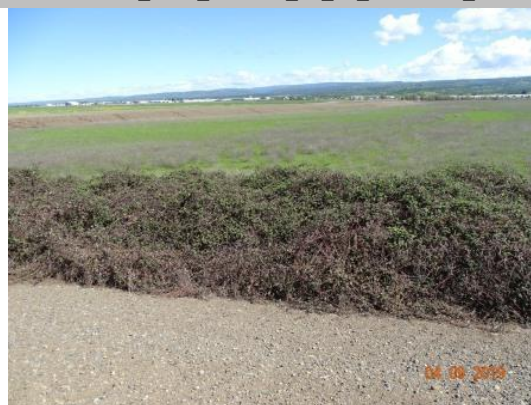
Photo 1 of 1 : FA_2021_NA0003_67_22_20211011_00002.jpg

View of the wild growth at the landside toe. Spring 2019.

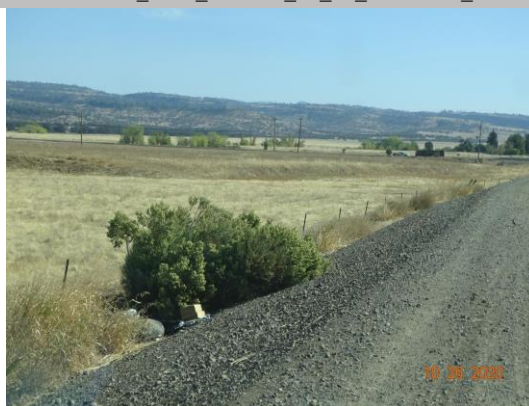
Photo 1 of 1 : FA_2021_NA0003_67_14_20211011_00001.jpg

View of a bush along the landside slope. Fall 2020.

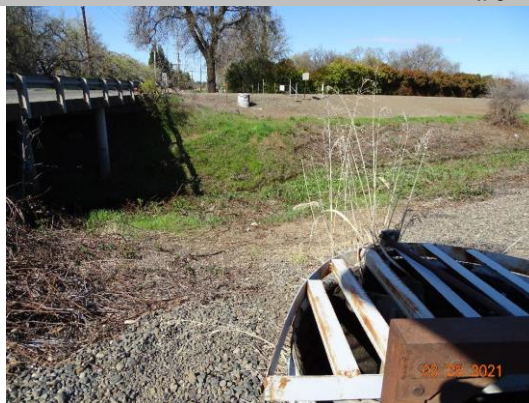
Photo 3 of 3 : UCIP_FA_2021_67693_100589.jpg

Water-Side: Detailed view of levee slope. Pipe outfall not visible on waterside. Crossing DSID 19288 on opposite side of levee

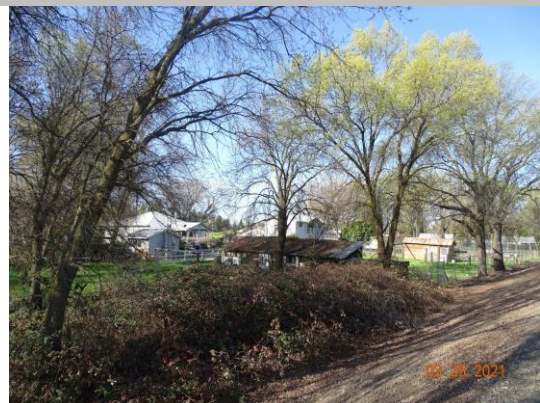
Photo 1 of 1 : FA_2021_NA0003_68_23_20211011_00004.jpg

View of the blackberry bushes along the landside toe. Spring 2021.

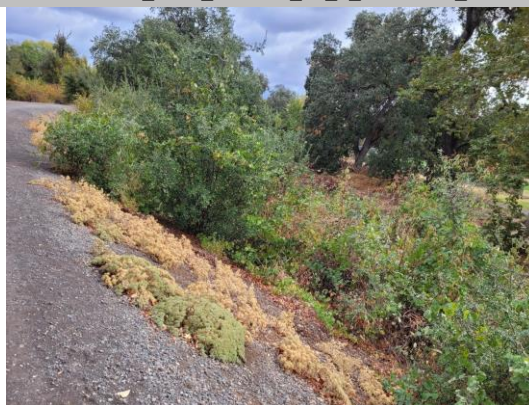
Photo 1 of 1 : FA_2021_NA0003_69_8_20211025_00045.jpg

View of the wild growth along the landside slope. Fall 2021.

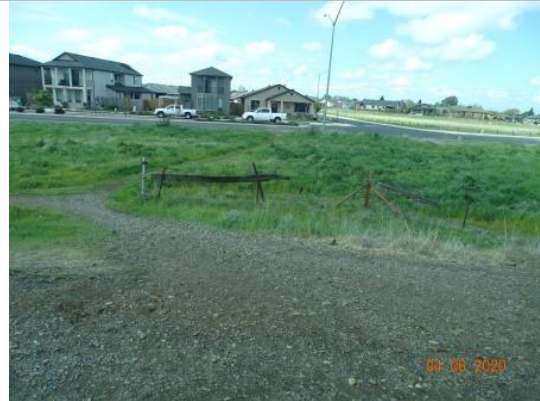
Photo 1 of 1 : FA_2021_NA0003_69_12_20211011_00003.jpg

View of the landside slope erosion caused by foot traffic. Spring 2020.

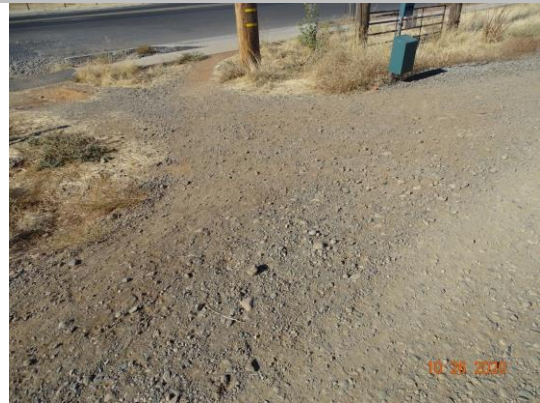
Photo 1 of 1 : FA_2021_NA0003_69_13_20211011_00004.jpg

View of the damaged landside slope due to foot traffic. Fall 2020.
