**Flood Control Project Maintenance
Levee Inspections**

Maintenance Issue Types Only, Levee Inspection Report By Mile - Fall 2022

Butte County Department of Public Works

Waterway	Bank	Unit Miles	Inspection Start/End	Inspector
Unit No. 01 Mud Creek	Right	6.80	10/04/2022 10/04/2022	Makar Sokol

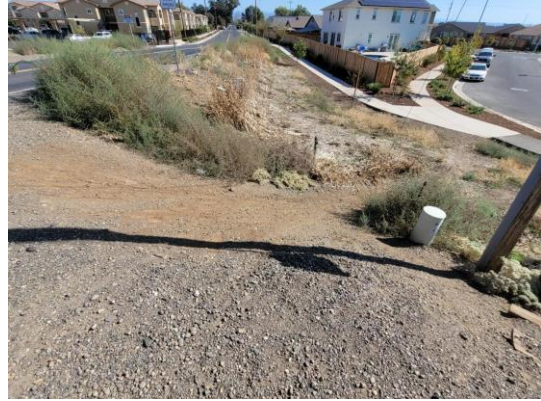
Photo 1 of 1 : FA_2022_NA0003_65_25_20221011_00082.jpg

LM Start	2.05	Rating **	M	Issue No.	25
LM End	2.05	Issue Type +	Ma	Location *	LS
Category	Earthen Levee			GPS Latitude/Longitude	
				Start	End
Item	Erosion / Vehicle Traffic			39.775748 °	39.775748 °
				-121.892958 °	-121.892958 °
DWR ID	DWR_NA0003_02_f_2019_25				
Comment Code					
E6 : Repair the levee slope damaged by vehicle traffic and prevent access where possible.					
Inspector Comment

View of the erosion on the landside slope due to vehicle traffic. Fall 2022.

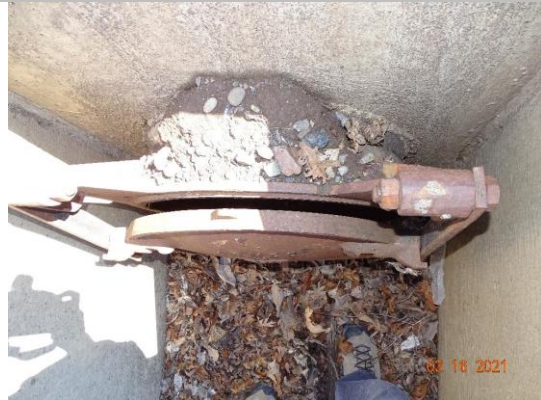
Photo 2 of 3 : UCIP_FA_2022_67341_99755.jpg

Water-Side: Gap visible between flap gate and pipe. Flap gate is unable to close tightly

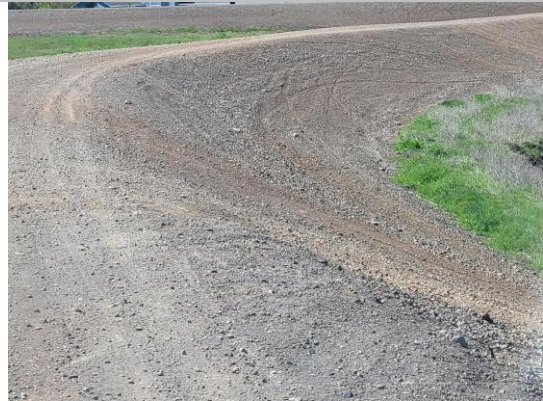
Photo 1 of 1 : FA_2022_NA0003_67_19_20220906_00002.jpg

View of the damaged landside slope due to vehicle traffic. Spring 2022.

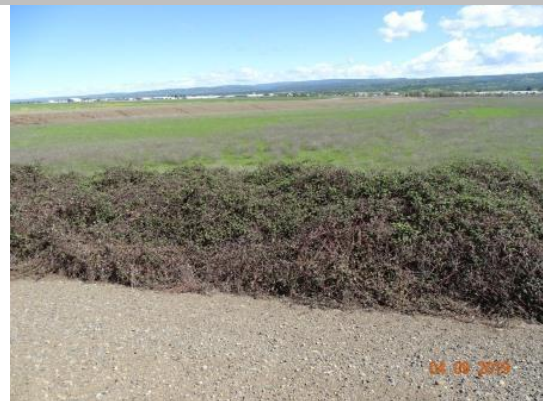
Photo 1 of 1 : FA_2022_NA0003_67_22_20220906_00003.jpg

View of the wild growth at the landside toe. Spring 2019.

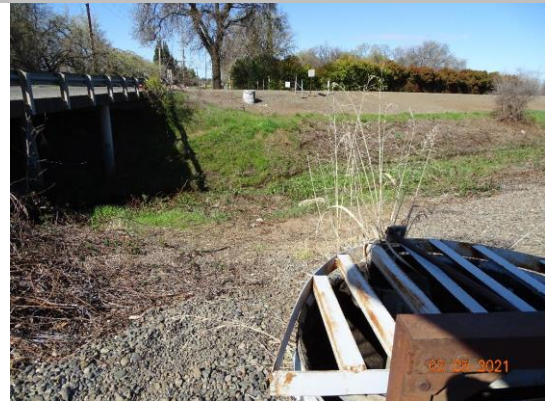
Photo 3 of 3 : UCIP_FA_2022_67693_100589.jpg

Water-Side: Detailed view of levee slope. Pipe outfall not visible on waterside. Crossing DSID 19288 on opposite side of levee

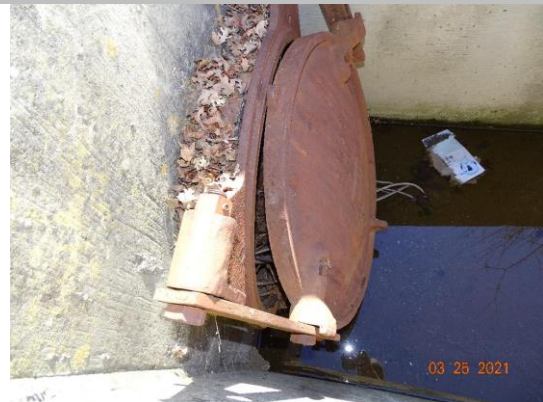
Photo 2 of 3 : UCIP_FA_2022_67694_100596.jpg

Water-Side: Debris inside of pipe blocks flap gate from complete closing

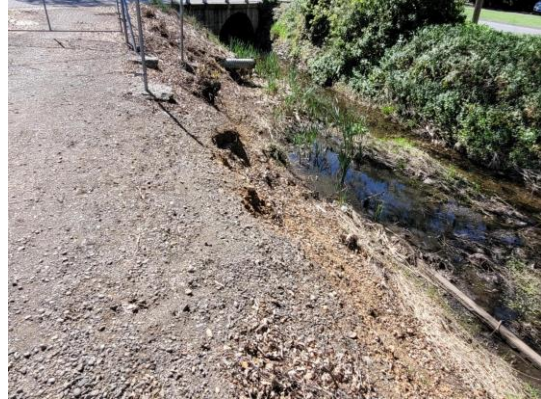
Photo 1 of 1 : FA_2022_NA0003_68_25_20220906_00005.jpg

View of the erosion along the waterside slope. Spring 2022.

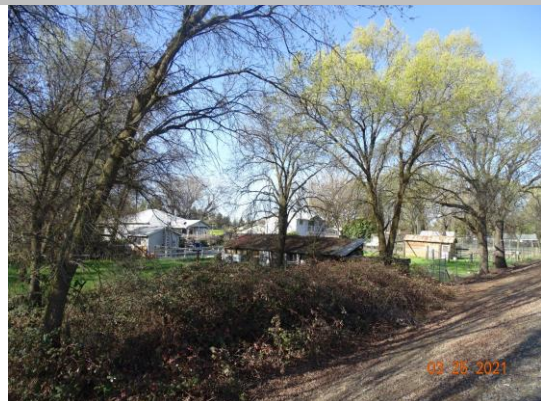
Photo 1 of 1 : FA_2022_NA0003_68_23_20220906_00004.jpg

View of the blackberry bushes along the landside toe. Spring 2021.

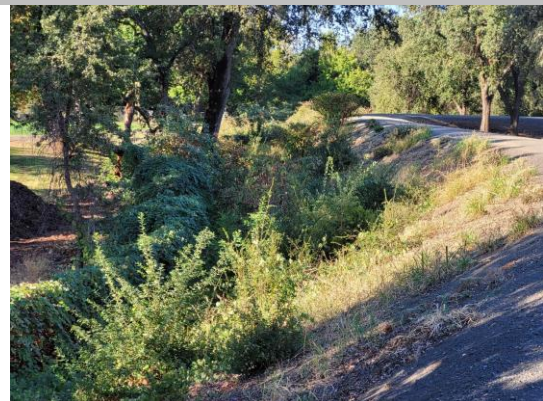
Photo 1 of 1 : FA_2022_NA0003_69_27_20221011_00051.jpg

View of the wild growth along the landside slope. Fall 2022.

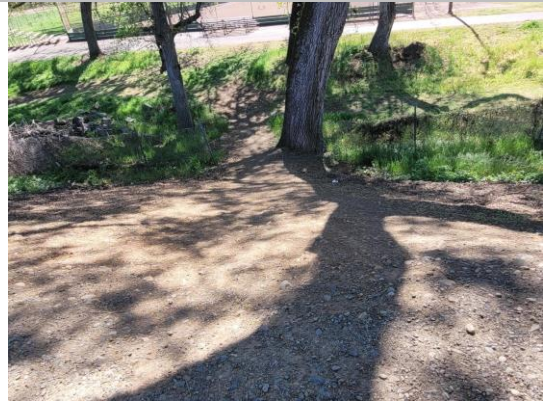
Photo 1 of 1 : FA_2022_NA0003_69_24_20220906_00005.jpg

View of the erosion on the landside slope due to foot traffic. Spring 2022.

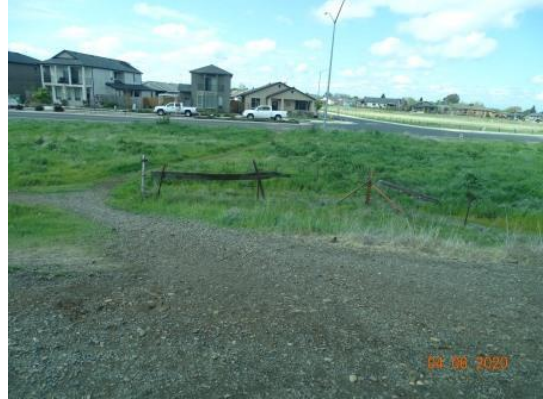
Photo 1 of 1 : FA_2022_NA0003_69_12_20220906_00002.jpg

View of the landside slope erosion caused by foot traffic. Spring 2020.

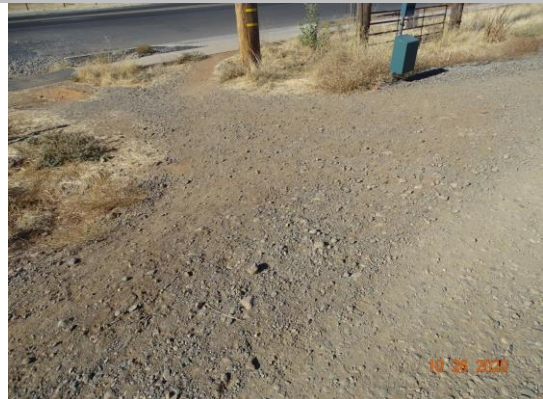
Photo 1 of 1 : FA_2022_NA0003_69_13_20220906_00003.jpg

View of the damaged landside slope due to foot traffic. Fall 2020.
