**Flood Control Project Maintenance
Levee Inspections**

Maintenance Issue Types Only, Levee Inspection Report By Mile - Fall 2023

Butte County Department of Public Works

Waterway	Bank	Unit Miles	Inspection Start/End	Inspector
Unit No. 01 Mud Creek	Right	6.80	10/11/2023 10/11/2023	Makar Sokol

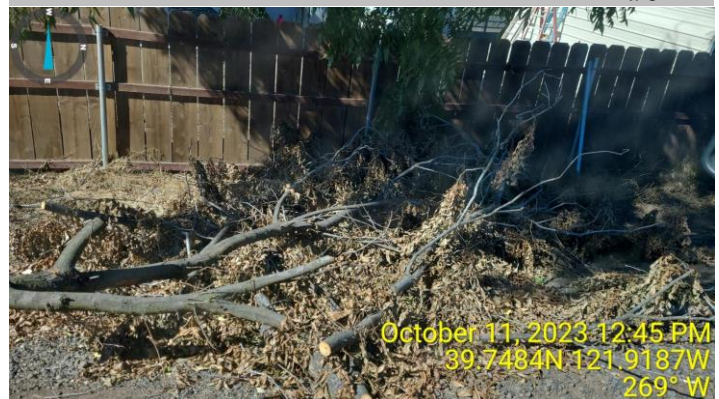
Photo 1 of 1 : FA_2023_NA0003_64_20_20231016_00049.jpg

View of tree limbs along the landside slope and toe. Fall 2023.

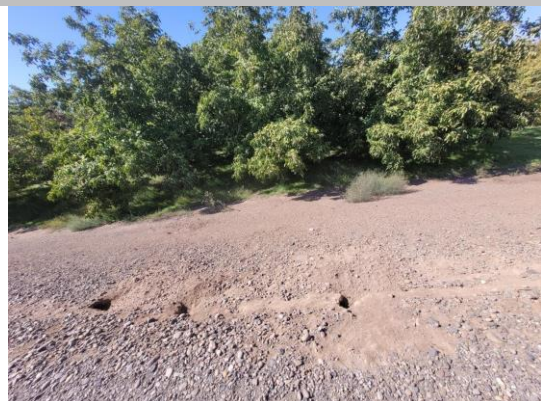
Photo 1 of 1 : FA_2023_NA0003_64_27_20231002_00004.jpg

View of animal burrows along the landside slope. Fall 2022.

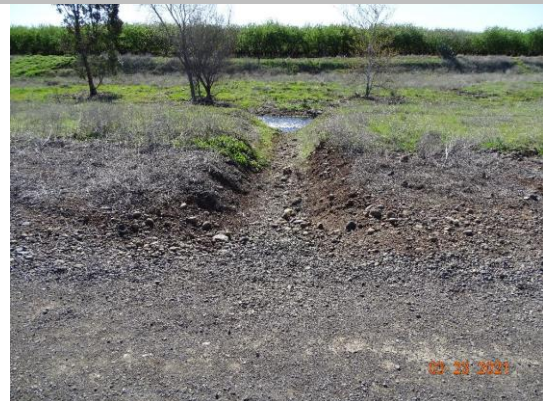
Photo 2 of 3 : UCIP_FA_2023_67292_99435.jpg

Comment Code						
Inspector Comment						
DS_ID:19226 FS_ID:67292 EP_NO: N/A Repair Type: Non-Urgent EVAL Issue: Crossing Status: Not Found UCIP Comments: 03/23/2021 Record is Non-Urgent. Crossing not found. A valley on waterside slope may indicate former pipe location. Need to confirm if pipe was removed. No permit has been identified authorizing pipe installation. (O.Yakimov - DWR UCIP) FIELD_STRUCT_DESC: 18-inch corrugated metal gravity drainage pipe through the levee, 2 feet below the crown. Pipe is open on both ends. Both ends appear to be covered with rock. [Additional Reference(s): DWR Levee Log, 1992 (HLM 7.00). USACE Sacramento O&M Manual, Unit 504, May 1965, Revised 2 February 2011, (HLM 7.01), listed as 18-inch pipe. USACE As-Built Drawing No. 50-04-3685, Sheet 8, STA 80+70, 19 May 1965]. FS Date: 3/23/2021 11:21:39 AM

Water-Side: View of levee slope looking from crown. Valley on the slope may indicate pipe location

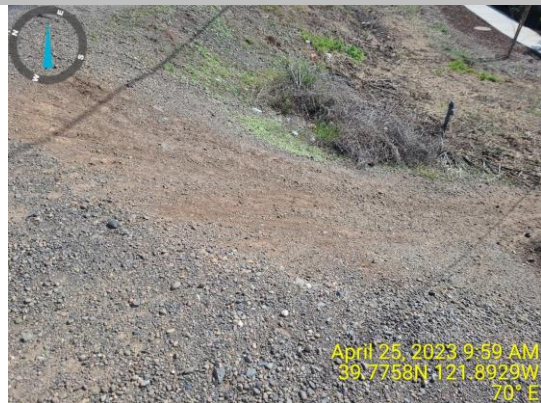
Photo 1 of 1 : FA_2023_NA0003_65_25_20231002_00003.jpg

View of the erosion on the landside slope due to vehicle traffic. Spring 2023.

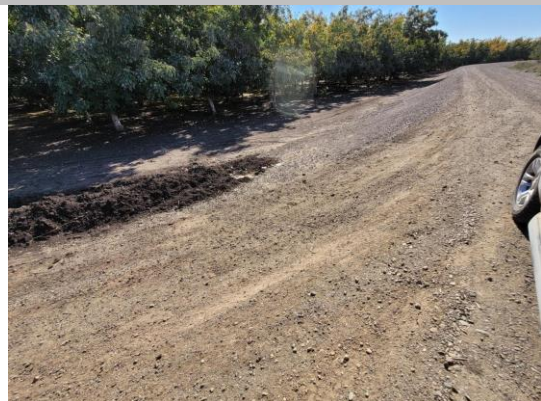
Photo 1 of 1 : FA_2023_NA0003_65_10_20231002_00002.jpg

View of the damaged landside slope due to vehicle traffic. Fall 2022.

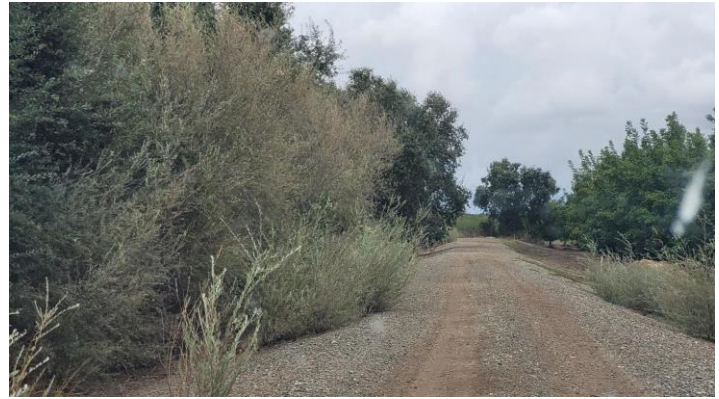
Photo 1 of 1 : FA_2023_NA0003_66_2_20231016_00003.jpg

View of wild growth along the waterside slope. Fall 2023.

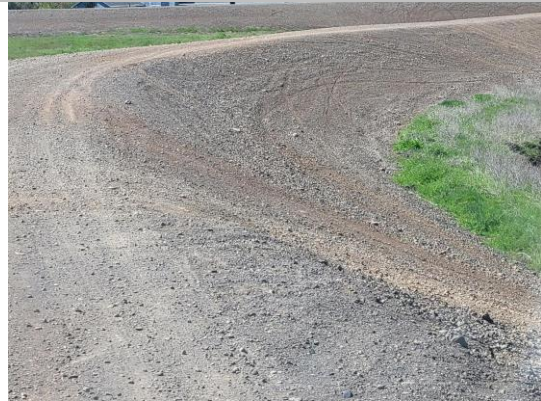
Photo 1 of 1 : FA_2023_NA0003_67_19_20231002_00002.jpg

View of the damaged landside slope due to vehicle traffic. Spring 2022.

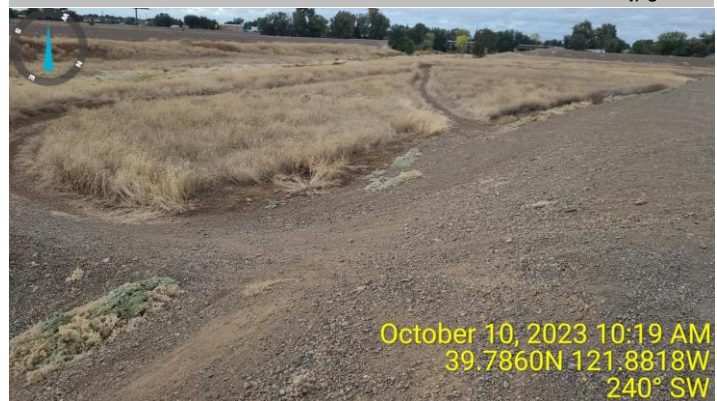
Photo 1 of 1 : FA_2023_NA0003_67_21_20231016_00047.jpg

View of erosion on the waterside slope due to vehicle traffic. Fall 2023.

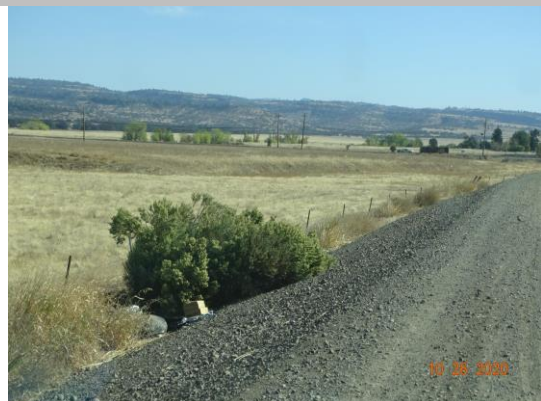
Photo 1 of 1 : FA_2023_NA0003_67_14_20231002_00001.jpg

View of a bush along the landside slope. Fall 2020.

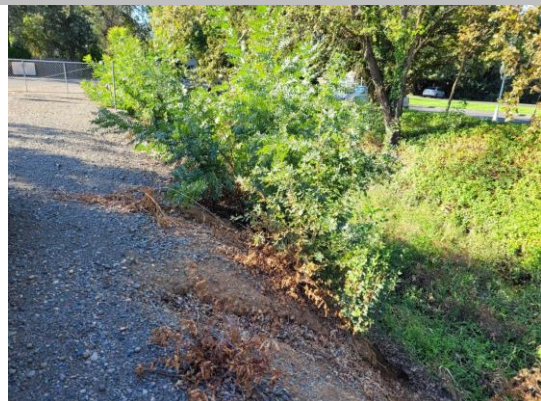
Photo 1 of 1 : FA_2023_NA0003_68_22_20231002_00004.jpg

View of wild growth along the waterside slope and toe. Fall 2022.

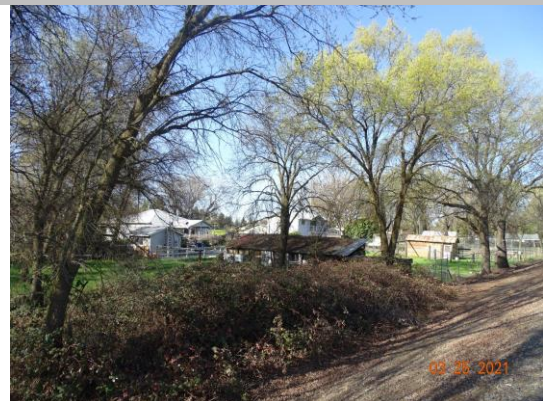
Photo 1 of 1 : FA_2023_NA0003_68_23_20231002_00005.jpg

View of the blackberry bushes along the landside toe. Spring 2021.

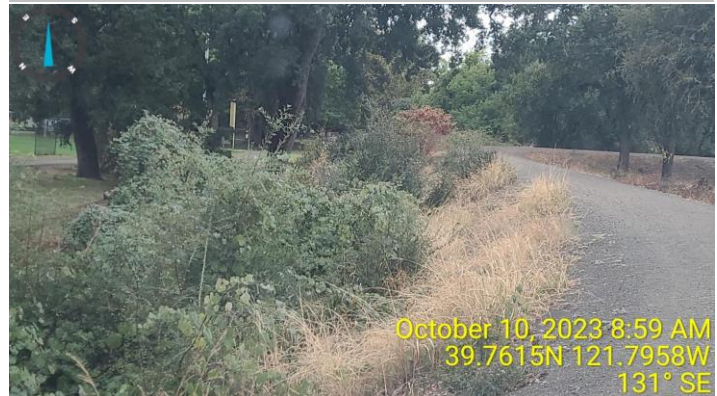
Photo 1 of 1 : FA_2023_NA0003_69_27_20231016_00006.jpg

View of the wild growth along the landside slope. Fall 2023.

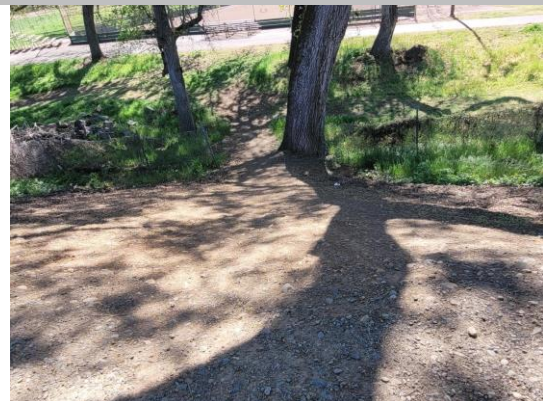
Photo 1 of 1 : FA_2023_NA0003_69_24_20231002_00004.jpg

View of the erosion on the landside slope due to foot traffic. Spring 2022.

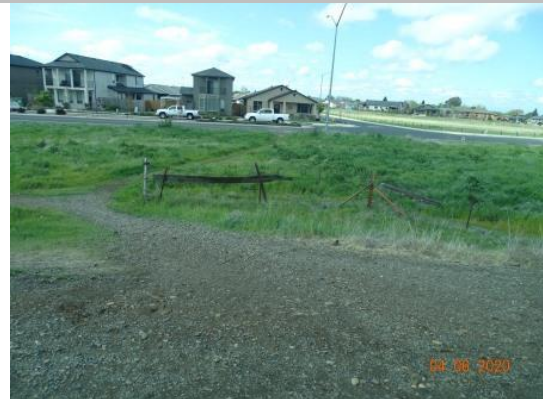
Photo 1 of 1 : FA_2023_NA0003_69_12_20231002_00002.jpg

View of the landside slope erosion caused by foot traffic. Spring 2020.

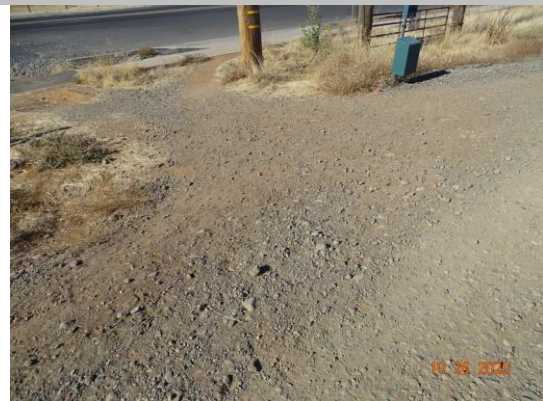
Photo 1 of 1 : FA_2023_NA0003_69_13_20231002_00003.jpg

View of the damaged landside slope due to foot traffic. Fall 2020.
