**Flood Control Project Maintenance  
Levee Inspections**

**Maintenance Issue Types Only, Levee Inspection Report By Mile - Fall 2024**

**Butte County Department of Public Works**

Waterway	Bank	Unit Miles	Inspection Start/End	Inspector
Unit No. 01 Mud Creek	Right	6.80	09/19/2024 09/19/2024	Makar Sokol

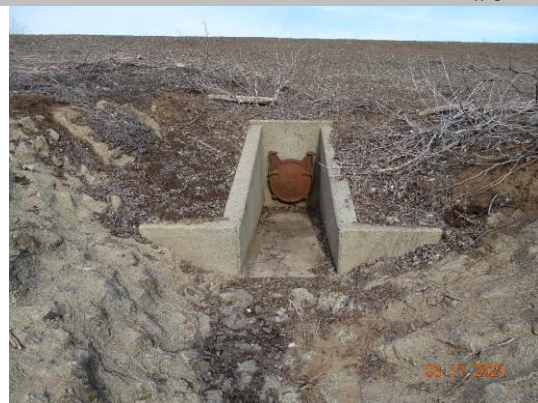
Photo 2 of 3 : UCIP\_FA\_2024\_77889\_99225.jpg

DS\_ID:19209  
FS\_ID:77889  
EP\_NO: N/A  
Repair Type: Non-Urgent  
EVAL Issue:  
Crossing Status: Found  
UCIP Comments: 12/19/2022 Record updated from Urgent to Non-Urgent. Pipe has been CIPP-lined. LOF of crossing is less or equal to 4. Recommend next video inspection in 5 years. (O.Yakimov - DWR UCIP).  
03/17/2021 Record updated from No Action Needed to Urgent. DMP internal video inspection has found pipe integrity issues. LOF of crossing is between 5 and 6. Crossing will be monitored until funding becomes available to address the issues. No permit has been identified authorizing pipe. (O.Yakimov - DWR UCIP)  
02/20/2014 Looks cleaned recently. (P. Amatya - DWR UCIP)  
FIELD\_STRUCT\_DESC: 24-inch CIPP-lined corrugated metal gravity drainage pipe through the levee, 12.5 feet below the crown. Flap gate on the waterside (WS) end. Concrete U-shaped headwall on each end. Grouted riprap apron on the landside (LS) end. Grouted riprap spillway on the WS end. [Additional Reference(s): DWR Levee Log, 1992 (HLM 0.26). USACE Sacramento O&M Manual, Unit 504, May 1965, Revised 2 February 2011, (HLM 0.26), listed as 24-inch pipe. USACE As-Built Drawing No. 50-04-3685, Sheet 41 table of drainage structures, STA 92+46, 19 May 1965].

Water-Side: Headwall and flap gate at levee toe

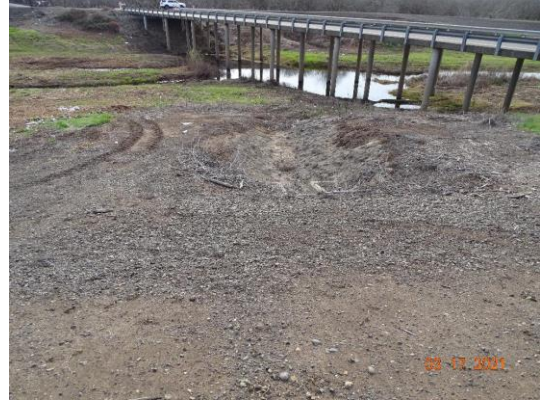
Photo 3 of 3 : UCIP\_FA\_2024\_77889\_99224.jpg

Water-Side: View of levee slope looking from crown

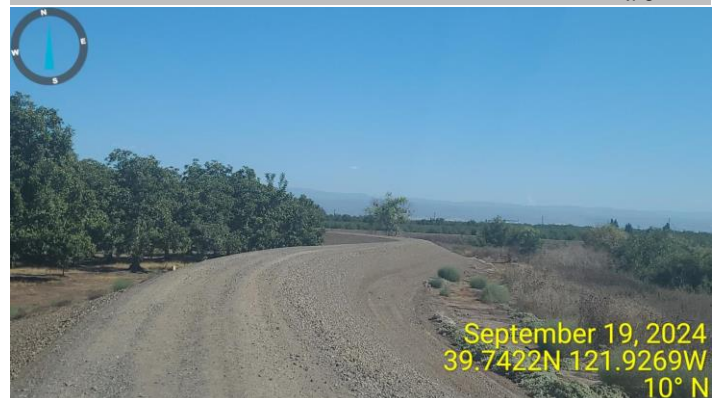
Photo 1 of 1 : FA\_2024\_NA0003\_64\_18\_20240924\_00047.jpg

View of good vegetation control along the levee slopes. Fall 2024.

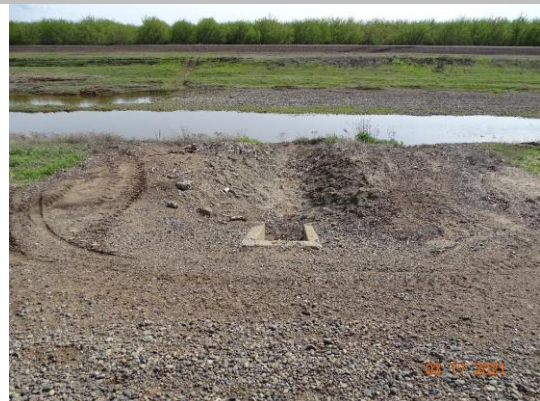
Photo 2 of 3 : UCIP\_FA\_2024\_67247\_99277.jpg

Comment Code						
Inspector Comment						
DS_ID:19217						
FS_ID:67247						
EP_NO: N/A						
Repair Type: Non-Urgent						
EVAL Issue:						
Crossing Status: Found						
UCIP Comments: 03/17/2021 Record remains Non-Urgent. No permit has been identified authorizing pipe. DMP internal video inspection has not found pipe integrity issues. LOF of crossing is less or equal to 4.0. Recommend next video inspection in 5 years. Debris has been cleared. (O.Yakimov - DWR UCIP)						
02/20/2014 It needs cleaning and clearing in inlet and outlet ends. (P. Amatya - DWR UCIP)						
FIELD_STRUCT_DESC: 24-inch corrugated metal gravity drainage pipe through the levee, 9 feet below the crown. Flap gate on the waterside (WS) end. Concrete U-shaped headwall on each end. Grouted riprap apron on the landside (LS) end. Grouted riprap spillway on the WS end. [Additional Reference(s): DWR Levee Log, 1992 (HLM 3.27). USACE Sacramento O&M Manual, Unit 504, May 1965, Revised 2 February 2011, (HLM 3.27), listed as 24-inch pipe. USACE As-Built Drawing No. 50-04-3685, Sheet 5, STA 247+60, 19 May 1965. USACE As-Built Drawing No. 50-04-3685, Sheet 41 table of drainage structures, STA 247+60, 19 May 1965].

Water-Side: View of levee slope looking from crown

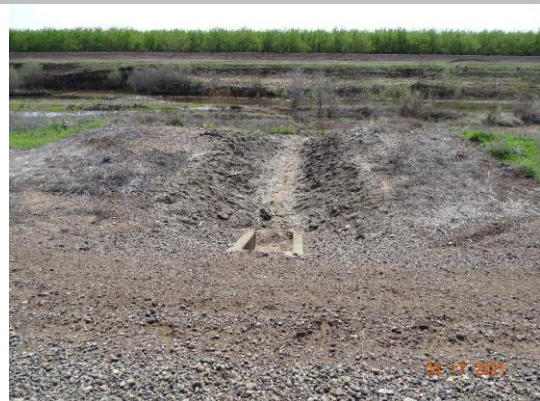
Photo 2 of 3 : UCIP\_FA\_2024\_67248\_99283.jpg

Comment Code					
Inspector Comment					
DS_ID:19218 FS_ID:67248 EP_NO: N/A Repair Type: Non-Urgent EVAL Issue: Crossing Status: Found UCIP Comments: 03/17/2021 Record remains Non-Urgent. No permit has been identified authorizing pipe. DMP internal video inspection has not found pipe integrity issues. LOF of crossing is less or equal to 4.0. Recommend next video inspection in 5 years. (O.Yakimov - DWR UCIP) 02/20/2014 Needs cleaning and clearing of debris. (P. Amatya - DWR UCIP) FIELD_STRUCT_DESC: 24-inch corrugated metal gravity drainage pipe through the levee, 10 feet below the crown. Flap gate on the waterside (WS) end. Concrete U-shaped headwall on each end. Grouted riprap apron on the landside (LS) end. Grouted riprap spillway on the WS end. [Additional Reference(s): DWR Levee Log, 1992 (HLM 3.48). USACE Sacramento O&M Manual, Unit 504, May 1965, Revised 2 February 2011, (HLM 3.48), listed as 24-inch pipe. USACE As-Built Drawing No. 50-04-3685, Sheet 5, STA 258+70, 19 May 1965. USACE As-Built Drawing No. 50-04-3685, Sheet 41 table of drainage structures, STA 258+70, 19 May 1965]. FS Date: 3/17/2021 10:18:14 AM

Water-Side: View of levee slope looking from crown

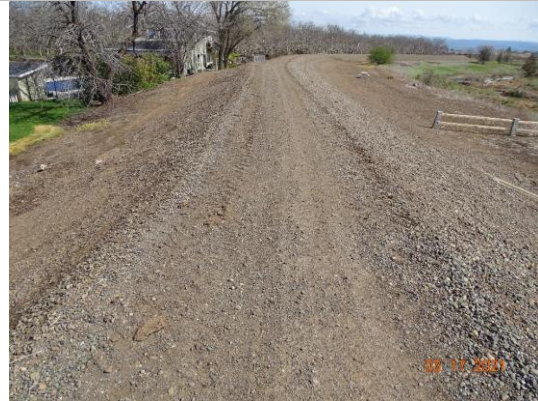
Photo 1 of 3 : UCIP\_FA\_2024\_67249\_99288.jpg

DS\_ID:19219  
FS\_ID:67249  
EP\_NO: N/A  
Repair Type: Non-Urgent  
EVAL Issue:  
Crossing Status: Found  
UCIP Comments: 03/17/2021 Record remains Non-Urgent. No permit has been identified authorizing pipe. DMP internal video inspection has not found pipe integrity issues. LOF of crossing is less or equal to 4.0. Recommend next video inspection in 5 years. (O.Yakimov - DWR UCIP)  
02/20/2014 Needs cleaning and clearing of debris in both ends of the pipe. (P. Amatya - DWR UCIP)  
FIELD\_STRUCT\_DESC: 24-inch corrugated metal gravity drainage pipe through the levee, 9 feet below the crown. Flap gate on the waterside (WS) end. Concrete U-shaped headwall on each end. Grouted riprap apron on the landside (LS) end. Grouted riprap spillway on the WS end. [Additional Reference(s): DWR Levee Log, 1992 (HLM 4.08). USACE Sacramento O&M Manual, Unit 504, May 1965, Revised 2 February 2011, (HLM 4.08), listed as 24-inch pipe. USACE As-Built Drawing No. 50-04-3685, Sheet 41 table of drainage structures, STA 289+20, 19 May 1965].

Top of Levee: View of levee crown looking upstream

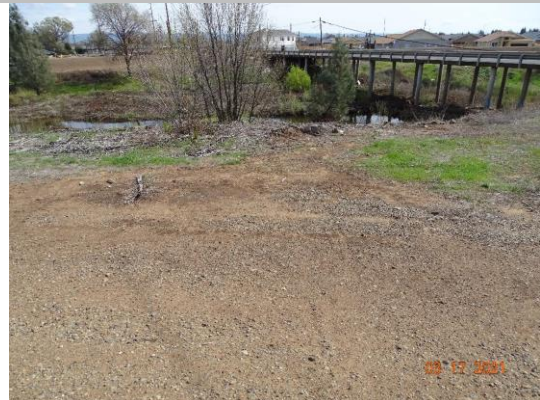
Photo 2 of 3 : UCIP\_FA\_2024\_67250\_99296.jpg

Comment Code					
Inspector Comment					
DS_ID:19220 FS_ID:67250 EP_NO: N/A Repair Type: Non-Urgent EVAL Issue: Crossing Status: Found UCIP Comments: 03/17/2021 Record remains Non-Urgent. Debris has been cleared. No permit has been identified authorizing pipe. DMP internal video inspection has not found pipe integrity issues. LOF of crossing is less or equal to 4.0. Recommend next video inspection in 5 years. (O.Yakimov - DWR UCIP) 02/20/2014 Needs cleaning and clearing of debris. (P. Amatya - DWR UCIP) FIELD_STRUCT_DESC: 24-inch corrugated metal gravity drainage pipe through the levee, 13 feet below the crown. Flap gate on the waterside (WS) end. Concrete U-shaped headwall on each end. Grouted riprap apron on the landside (LS) end. Grouted riprap spillway on the WS end. [Additional Reference(s): DWR Levee Log, 1992 (HLM 4.57). USACE Sacramento O&M Manual, Unit 504, May 1965, Revised 2 February 2011, (HLM 4.58), listed as 24-inch pipe. USACE As-Built Drawing No. 50-04-3685, Sheet 6, STA 315+18, 19 May 1965]. FS Date: 3/17/2021 10:24:31 AM

Water-Side: View of levee slope looking from crown

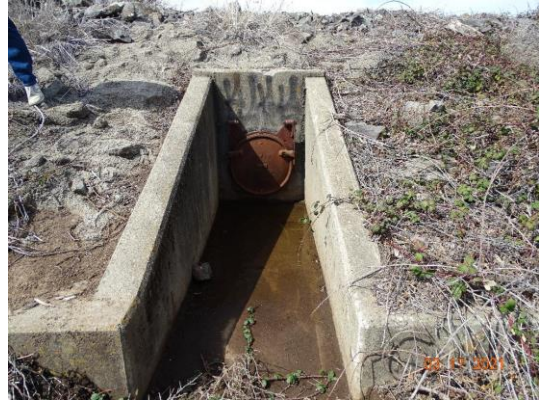
Photo 3 of 3 : UCIP\_FA\_2024\_67250\_99299.jpg

Water-Side: Headwall and flap gate on levee slope

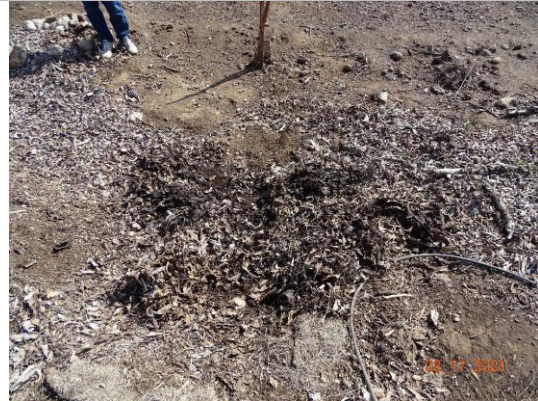
Photo 3 of 3 : UCIP\_FA\_2024\_67251\_99302.jpg

Land-Side: Approximate location on pipe inlet at levee toe, although inlet was not found

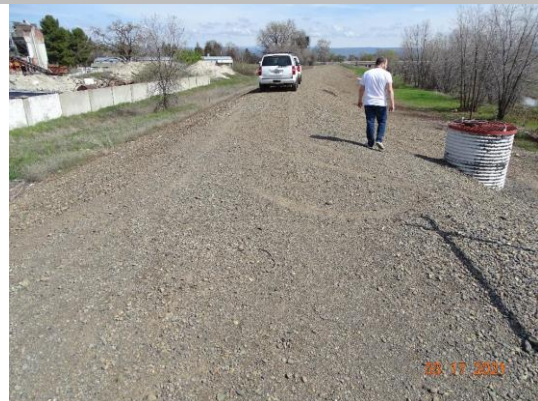
Photo 1 of 3 : UCIP\_FA\_2024\_67286\_99399.jpg

DS\_ID:19222  
FS\_ID:67286  
EP\_NO: N/A  
Repair Type: Non-Urgent  
EVAL Issue:  
Crossing Status: Found  
UCIP Comments: 03/17/2021 Record updated from No Action Needed to Non-Urgent. No permit has been identified authorizing pipe. DMP internal video inspection has not found pipe integrity issues. LOF of crossing is less or equal to 4.0. Recommend next video inspection in 5 years. (O.Yakimov - DWR UCIP)  
02/20/2014 Slide gate in CM standpipe on waterside levee slope. (P. Amatya - DWR UCIP)  
FIELD\_STRUCT\_DESC: 36-inch corrugated metal gravity drainage pipe through the levee, 17 feet below the crown. Slide gate in a corrugated metal standpipe on the waterside (WS) slope. Flap gate on the WS end. Concrete U-shaped headwall on each end. Grouted riprap apron on the landside (LS) end. Grouted riprap spillway on the WS end. [Additional Reference(s): DWR Levee Log, 1992 (HLM 5.22). USACE Sacramento O&M Manual, Unit 504, May 1965, Revised 2 February 2011, (HLM 5.22), listed as 36-inch pipe. USACE As-Built Drawing No. 50-04-3685, Sheet 7, from STA 348+25 to STA 352+50, 19 May 1965].

Top of Levee: View of levee crown looking upstream

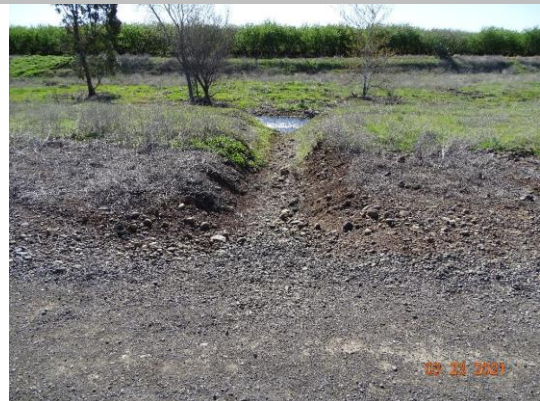
Photo 2 of 3 : UCIP\_FA\_2024\_67292\_99435.jpg

Comment Code						
Inspector Comment						
DS_ID:19226 FS_ID:67292 EP_NO: N/A Repair Type: Non-Urgent EVAL Issue: Crossing Status: Not Found UCIP Comments: 03/23/2021 Record is Non-Urgent. Crossing not found. A valley on waterside slope may indicate former pipe location. Need to confirm if pipe was removed. No permit has been identified authorizing pipe installation. (O.Yakimov - DWR UCIP) FIELD_STRUCT_DESC: 18-inch corrugated metal gravity drainage pipe through the levee, 2 feet below the crown. Pipe is open on both ends. Both ends appear to be covered with rock. [Additional Reference(s): DWR Levee Log, 1992 (HLM 7.00). USACE Sacramento O&M Manual, Unit 504, May 1965, Revised 2 February 2011, (HLM 7.01), listed as 18-inch pipe. USACE As-Built Drawing No. 50-04-3685, Sheet 8, STA 80+70, 19 May 1965]. FS Date: 3/23/2021 11:21:39 AM

Water-Side: View of levee slope looking from crown. Valley on the slope may indicate pipe location

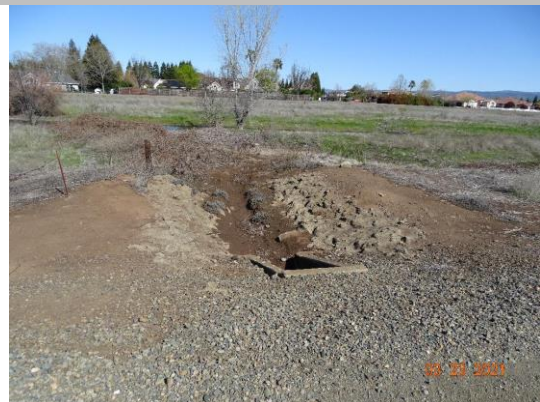
Photo 2 of 3 : UCIP\_FA\_2024\_67304\_99516.jpg

Comment Code						
Inspector Comment						
DS_ID:19234 FS_ID:67304 EP_NO: N/A Repair Type: No Action Needed EVAL Issue: Crossing Status: Found UCIP Comments: 09/15/2023 Record updated from Non-Urgent to No Action Needed. Pipe was CIPP lined. DMP internal video inspection has found none or minor pipe defects. Recommend next video inspection in 5 years. (O. Yakimov - DWR UCIP) 03/23/2021 Record remains Non-Urgent. No permit has been identified authorizing pipe. Debris noted in previous inspection has been cleared. DMP internal video inspection has found pipe integrity issues. LOF of crossing is greater than or equal to 4.1 and less than 5. Crossing will be monitored until funding becomes available for rehabilitation. (O.Yakimov - DWR UCIP) 03/11/2014 Needs cleaning and clearing the culvert. (P. Amatya - DWR UCIP) FIELD_STRUCT_DESC: 24-inch CIPP-lined corrugated metal gravity drainage pipe through the levee, 6.6 feet below the crown. Flap gate on the waterside (WS) end. Concrete U-shaped headwall on each end. Grouted riprap spillway on the WS end. [Additional Reference(s): DWR Levee Log, 1992 (HLM 0.25). USACE Sacramento O&M Manual, Unit 504, May 1965, Revised 2 February 2011, (HLM 0.25), listed as 24-inch pipe. USACE As-Built Drawing No. 50-04-3685, Sheet 8, STA 53+90, 19 May 1965]. FS Date: 3/23/2021 2:26:18 PM

Water-Side: View of levee slope looking from crown

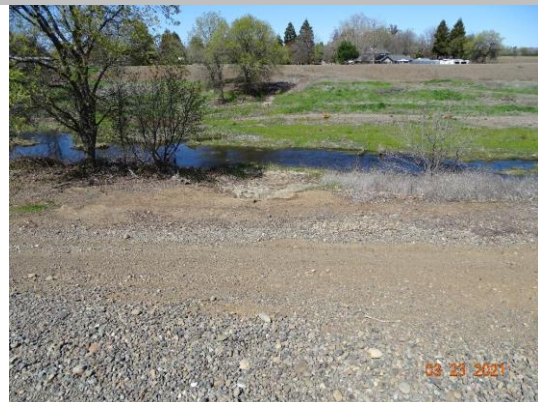
Photo 2 of 3 : UCIP\_FA\_2024\_77890\_99522.jpg

Comment Code						
Inspector Comment						
DS_ID:19235 FS_ID:77890 EP_NO: N/A Repair Type: Non-Urgent EVAL Issue: Crossing Status: Found UCIP Comments: 12/19/2022 Record updated from Urgent to Non-Urgent. Pipe has been CIPP-lined. LOF of crossing is less or equal to 4. Recommend next video inspection in 5 years. (O.Yakimov - DWR UCIP) 03/23/2021 Record updated from Non-Urgent to Urgent. DMP internal video inspection has found pipe integrity issues. LOF of crossing is between 5 and 6. Crossing will be monitored until funding becomes available to address the issues. No permit has been identified authorizing pipe. Recommend clearing debris from landside end of pipe. (O.Yakimov - DWR UCIP) 02/24/2014 Needs cleaning and clearing of debris. (P. Amatya - DWR UCIP) FIELD_STRUCT_DESC: 24-inch CIPP-lined corrugated metal gravity drainage pipe through the levee, 12.5 feet below the crown. Flap gate on the waterside (WS) end. Concrete U-shaped headwall on each end. Grouted riprap apron on the landside (LS) end. Grouted riprap spillway on the WS end. [Additional Reference(s): DWR Levee Log, 1992 (HLM 1.34). USACE Sacramento O&M Manual, Unit 504, May 1965, Revised 2 February 2011, (HLM 1.34), listed as 24-inch pipe. USACE As-Built Drawing No. 50-04-3685, Sheets 7 and 41, STA 358+10, 19 May 1965]. FS Date: 3/23/2021 3:56:40 PM

Water-Side: View of levee slope looking from crown

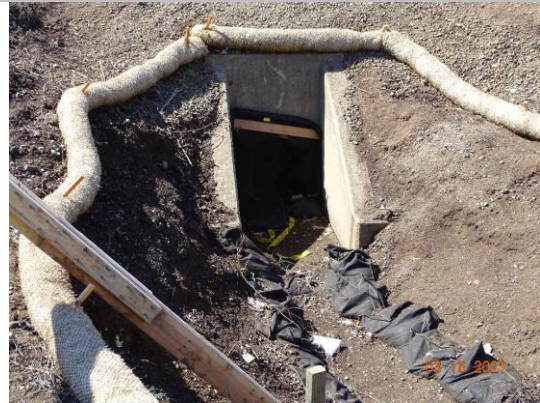
Photo 3 of 3 : UCIP\_FA\_2024\_67339\_99733.jpg

Land-Side: U-shaped headwall and covered pipe inlet at levee toe

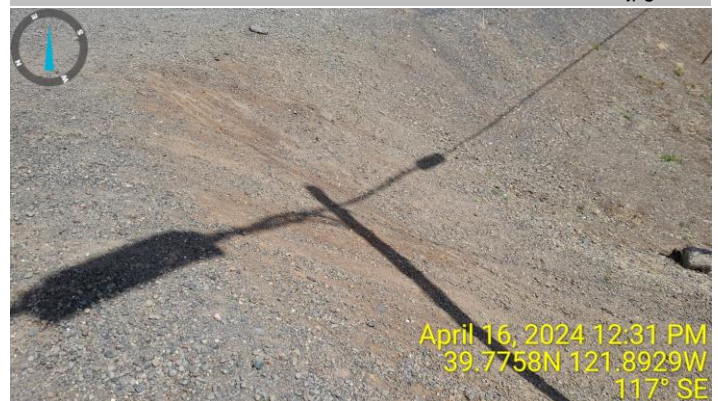
Photo 1 of 1 : FA\_2024\_NA0003\_65\_25\_20240924\_00003.jpg

View of the erosion on the landside slope due to vehicle traffic. Spring 2024.

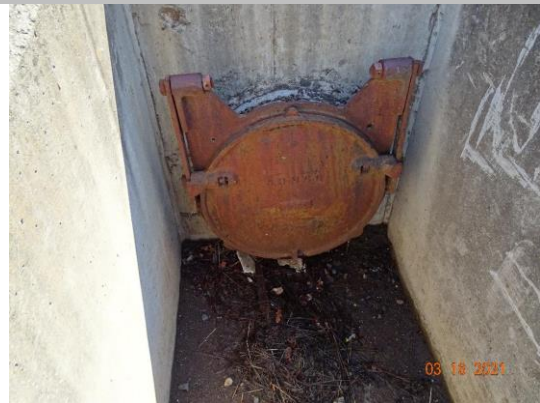
Photo 3 of 3 : UCIP\_FA\_2024\_67340\_99747.jpg

Water-Side: Headwall and flap gate at levee toe

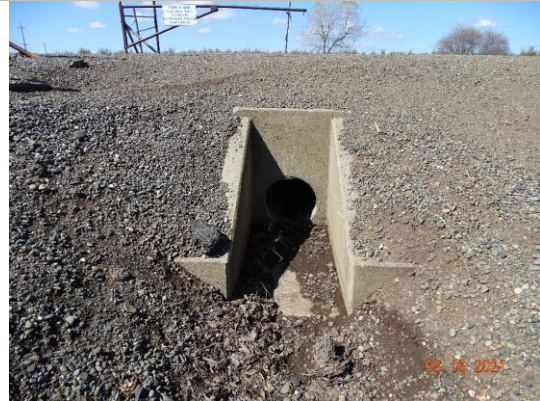
Photo 3 of 3 : UCIP\_FA\_2024\_67342\_99761.jpg

Land-Side: U-shaped headwall and pipe at levee toe

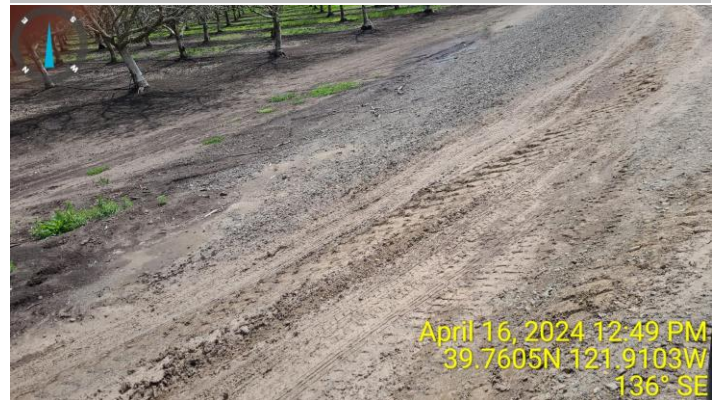
Photo 1 of 1 : FA\_2024\_NA0003\_65\_10\_20240924\_00002.jpg

View of the damaged landside slope due to vehicle traffic. Spring 2024.

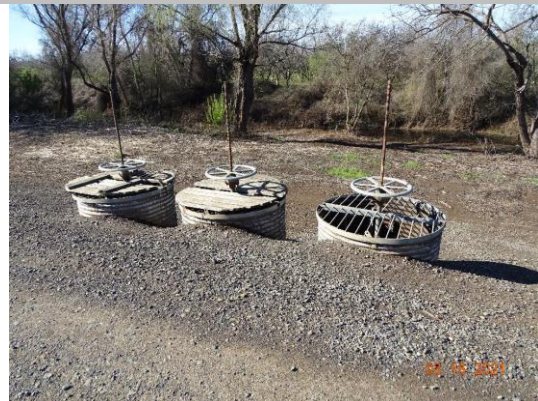
Photo 2 of 3 : UCIP\_FA\_2024\_67361\_99850.jpg

Water-Side: View of levee slope looking from crown. CMP riser with slide gate on levee shoulder

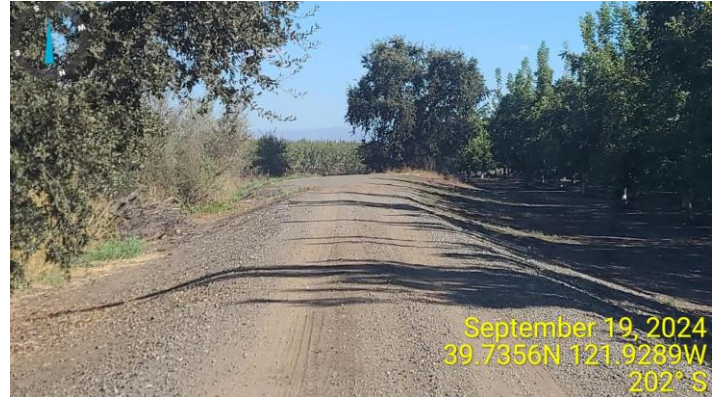
Photo 1 of 1 : FA\_2024\_NA0003\_66\_2\_20240924\_00002.jpg

View of good vegetation control along the levee slopes. Fall 2024.

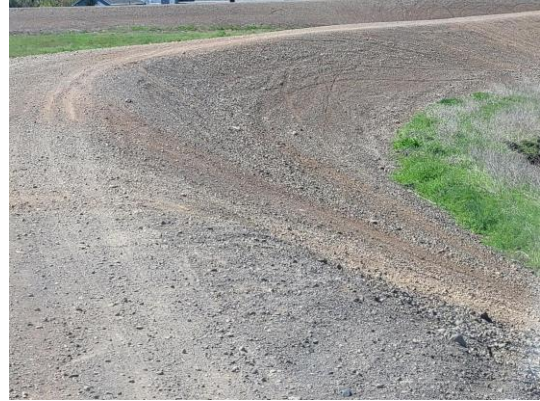
Photo 1 of 1 : FA\_2024\_NA0003\_67\_19\_20240924\_00003.jpg

View of the damaged landside slope due to vehicle traffic. Spring 2022.

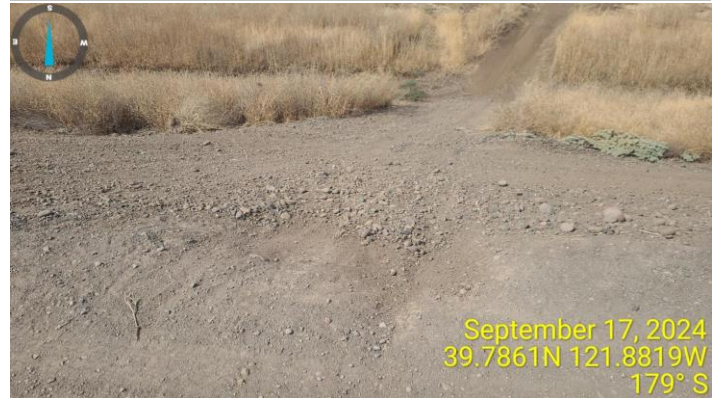
Photo 1 of 1 : FA\_2024\_NA0003\_67\_21\_20240924\_00049.jpg

View of erosion on the landside slope due to vehicle traffic. Fall 2024.

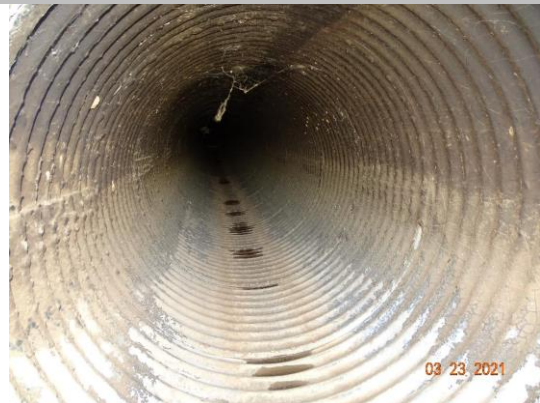
Photo 3 of 3 : UCIP\_FA\_2024\_77894\_100474.jpg

Land-Side: View inside of pipe looking from landside end

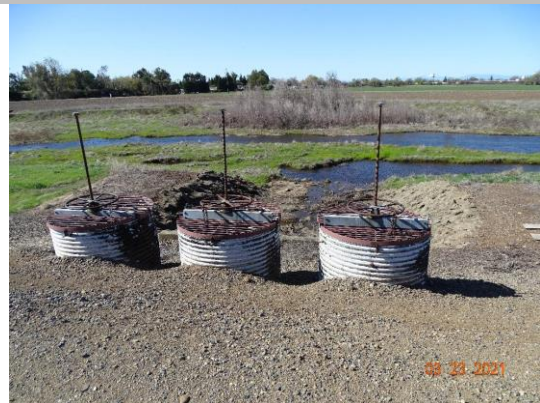
Photo 3 of 3 : UCIP\_FA\_2024\_67670\_100488.jpg

Water-Side: View of levee slope looking from crown. CMP riser with slide gate on levee shoulder

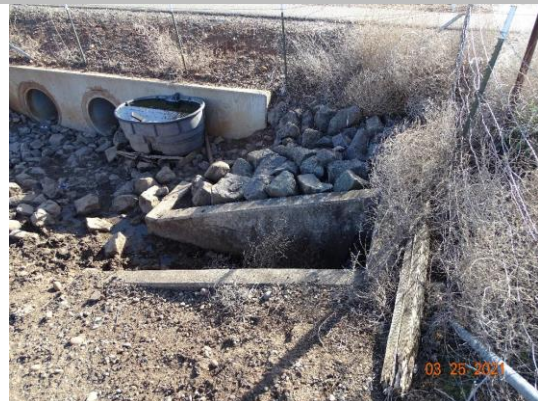
Photo 2 of 3 : UCIP\_FA\_2024\_84808\_100528.jpg

Water-Side: U-shaped Headwall and revetment on levee slope

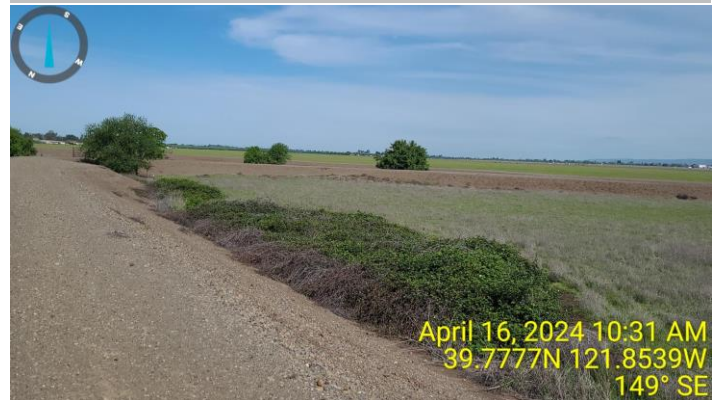
Photo 1 of 1 : FA\_2024\_NA0003\_67\_22\_20240924\_00005.jpg

View of the wild growth at the landside toe. Spring 2024.

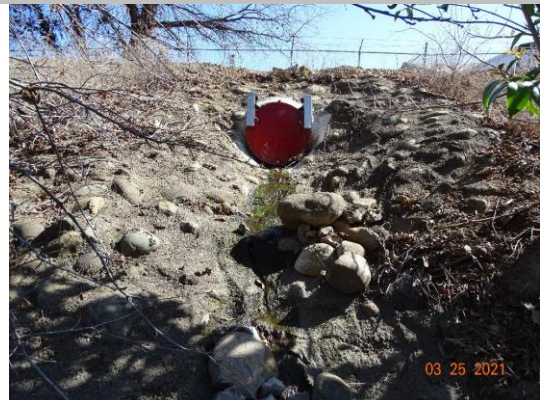
Photo 2 of 3 : UCIP\_FA\_2024\_67757\_100820.jpg

Water-Side: View of levee slope looking from toe. Flap gate installed on pipe end

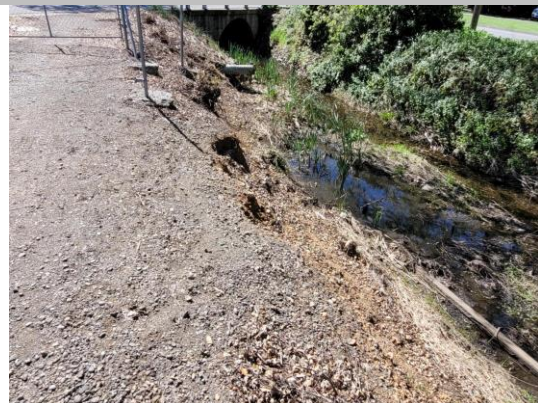
Photo 1 of 1 : FA\_2024\_NA0003\_68\_25\_20240924\_00008.jpg

View of the erosion along the waterside slope. Spring 2022.

E2 : Schedule repair of erosion site prior to the next inspection.

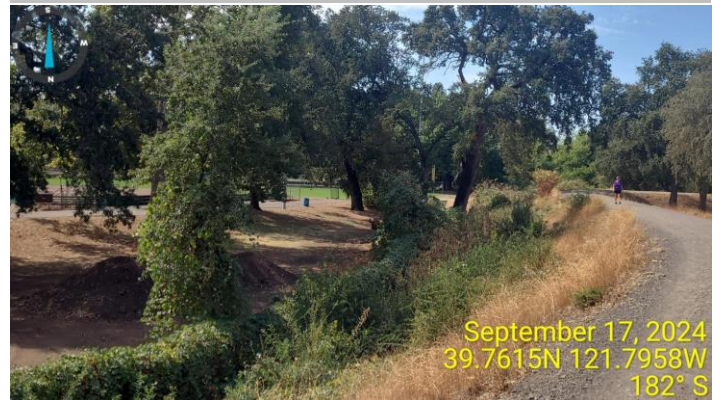
Photo 1 of 1 : FA\_2024\_NA0003\_69\_1\_20240924\_00004.jpg

View of the wild growth along the landside slope and toe. Fall 2024.

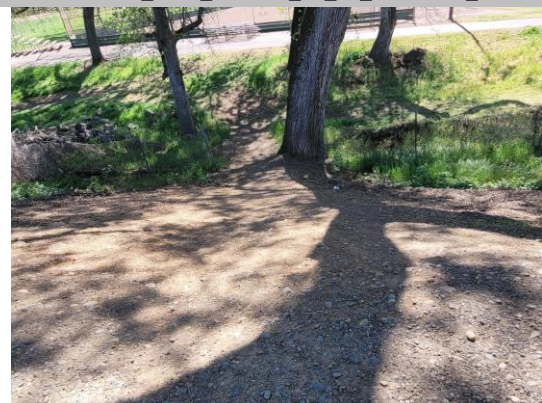
Photo 1 of 1 : FA\_2024\_NA0003\_69\_24\_20240924\_00003.jpg

View of the erosion on the landside slope due to foot traffic. Spring 2022.

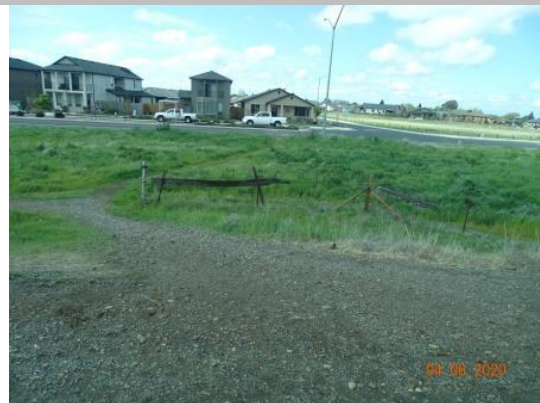
Photo 1 of 1 : FA\_2024\_NA0003\_69\_12\_20240924\_00001.jpg

View of the landside slope erosion caused by foot traffic. Spring 2020.

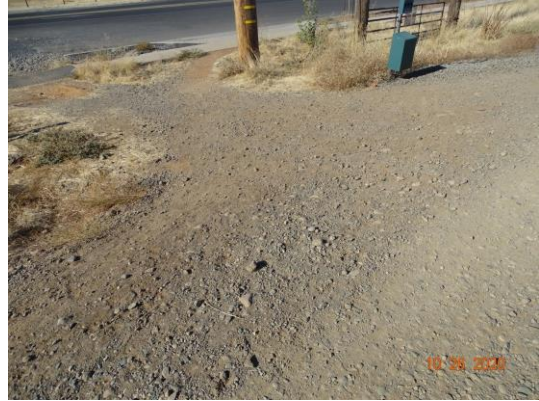
Photo 1 of 1 : FA\_2024\_NA0003\_69\_13\_20240924\_00002.jpg

View of the damaged landside slope due to foot traffic. Fall 2020.
