**Flood Control Project Maintenance
Levee Inspections**

Maintenance Issue Types Only, Levee Inspection Report By Mile - Spring 2015

Butte County Department of Public Works

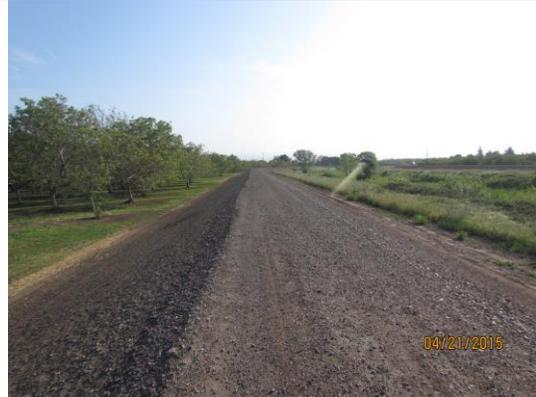
Photo 1 of 1 : SP_2015_NA0003_64_30_20150428_00012.jpg

LM Start	1.72	Rating **	A	Issue No.	30
LM End	1.72	Issue Type +	Ma	Location *	LS
Category	Earthen Levee		GPS Latitude/Longitude		
			Start	End	
Item	Vegetation		39.746040 °	39.746040 °	
			-121.922710 °	-121.922710 °	
DWR ID	DWR_NA0003_01_s_2015_30				
Action/Comments					
Control annual grass and weeds on the levee slopes and easements.

View of the levee with no grass on both slope.

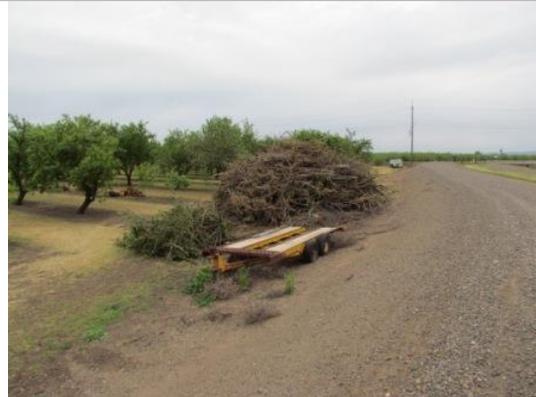
Photo 1 of 1 : SP_2015_NA0003_64_1_20150310_00001.jpg

LM Start	2.93	Rating **	M	Issue No.	1
LM End	2.93	Issue Type +	Ma	Location *	LS
Category	Earthen Levee		GPS Latitude/Longitude		
			Start	End	
Item	Encroachments		39.759755 °	39.759755 °	
			-121.911160 °	-121.911160 °	
DWR ID	DWR_NA0003_01_s_2012_1				
Action/Comments					
Prunings

View of the pruning pile along the L/S toe.

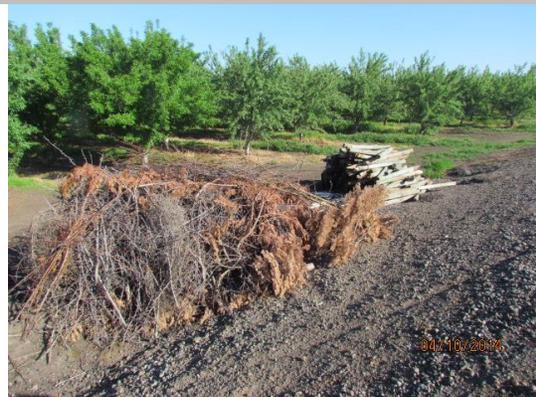
Photo 1 of 1 : SP_2015_NA0003_64_25_20150310_00007.jpg

LM Start	3.02	Rating **	M	Issue No.	25
LM End	3.02	Issue Type +	Ma	Location *	LS
Category	Earthen Levee		GPS Latitude/Longitude		
			Start	End	
Item	Encroachments		39.761085 °	39.761085 °	
			-121.911048 °	-121.911048 °	
DWR ID	DWR_NA0003_01_s_2012_25				
Action/Comments					
Prunings

View of the prunings along the landside toe.

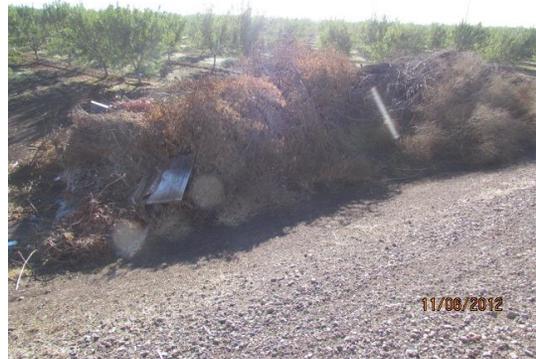
Photo 1 of 1 : SP_2015_NA0003_65_5_20150310_00003.jpg

LM Start	3.31	Rating **	M	Issue No.	5
LM End	3.31	Issue Type +	Ma	Location *	LS
Category	Earthen Levee		GPS Latitude/Longitude		
			Start	End	
Item	Encroachments		39.763208 °	39.763208 °	
			-121.908517 °	-121.908517 °	
DWR ID	DWR_NA0003_02_f_2012_5				
Action/Comments					
Prunings

View of the brush pile along landside toe.

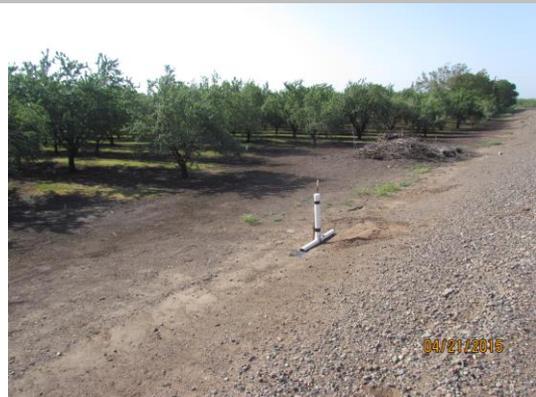
Photo 1 of 1 : SP_2015_NA0003_65_8_20150428_00010.jpg

LM Start	4.55	Rating **	A/W	Issue No.	8
LM End	4.55	Issue Type +	Ma	Location *	LS
Category	Earthen Levee		GPS Latitude/Longitude		
			Start	End	
Item	Animal Control		39.749639 °	39.749639 °	
			-121.917188 °	-121.917188 °	
DWR ID	DWR_NA0003_02_f_2013_8				
Action/Comments					
Exterminate rodents and backfill and compact or grout burrows.

View of the bait station placed by the rodent hole.

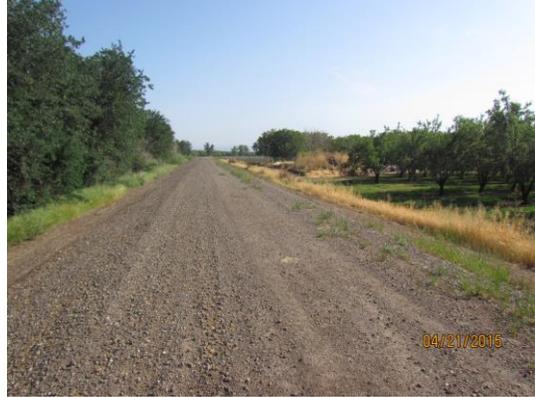
Photo 1 of 1 : SP_2015_NA0003_66_17_20150428_00001.jpg

LM Start	0.09	Rating **	A	Issue No.	17
LM End	0.09	Issue Type +	Ma	Location *	LS
Category	Earthen Levee			GPS Latitude/Longitude	
				Start	End
Item	Vegetation			39.734145 °	39.734145 °
				-121.929565 °	-121.929565 °
DWR ID	DWR_NA0003_02A_s_2015_17				
Action/Comments					
Control annual grass and weeds on the levee slopes and easements.

View of the levee with no grass on both slopes.

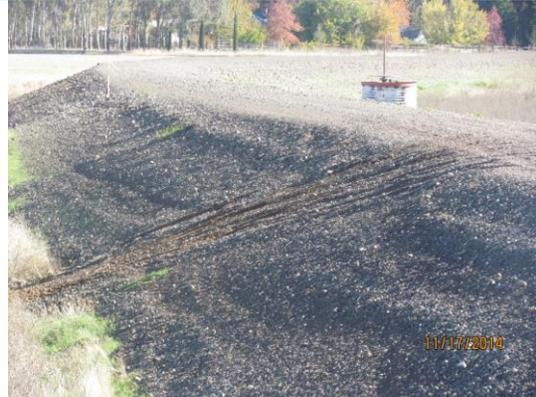
Photo 1 of 1 : SP_2015_NA0003_67_3_20150310_00001.jpg

LM Start	0.07	Rating **	M	Issue No.	3
LM End	0.07	Issue Type +	Ma	Location *	WS
Category	Earthen Levee		GPS Latitude/Longitude		
			Start	End	
Item	Slope Stability		39.786068 °	39.786068 °	
			-121.881828 °	-121.881828 °	
DWR ID	DWR_NA0003_03_s_2012_3				
Action/Comments					
Repair the levee slope damaged by vehicle traffic and prevent access where possible.

View of the erosion caused by motorcycles on the land side slope.

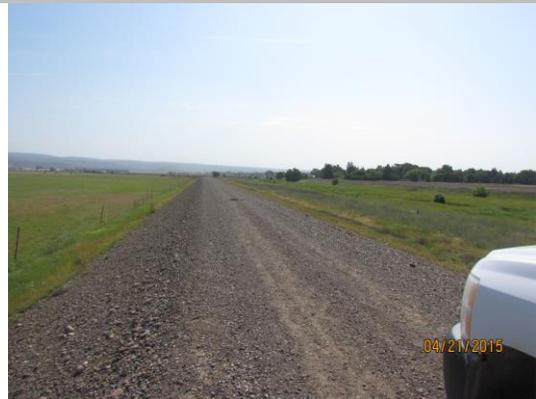
Photo 1 of 1 : SP_2015_NA0003_67_12_20150428_00002.jpg

LM Start	1.34	Rating **	A	Issue No.	12
LM End	1.34	Issue Type +	Ma	Location *	LS
Category	Earthen Levee		GPS Latitude/Longitude		
			Start	End	
Item	Vegetation		39.779442 °	39.779442 °	
			-121.861035 °	-121.861035 °	
DWR ID	DWR_NA0003_03_s_2015_12				
Action/Comments					
Control annual grass and weeds on the levee slopes and easements.

View of the levee with no grass on both slopes.

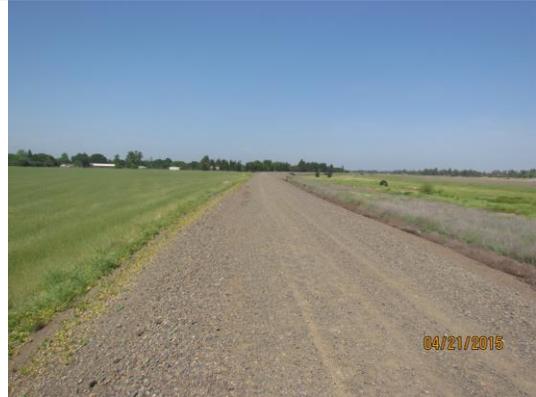
Photo 1 of 1 : SP_2015_NA0003_68_17_20150428_00004.jpg

LM Start	1.60	Rating **	A	Issue No.	17
LM End	1.60	Issue Type +	Ma	Location *	LS
Category	Earthen Levee			GPS Latitude/Longitude	
				Start	End
Item	Vegetation			39.778717 °	39.778717 °
				-121.862483 °	-121.862483 °
DWR ID	DWR_NA0003_04_s_2015_17				
Action/Comments					
Control annual grass and weeds on the levee slopes and easements.

View of the levee with no grass on both slopes.

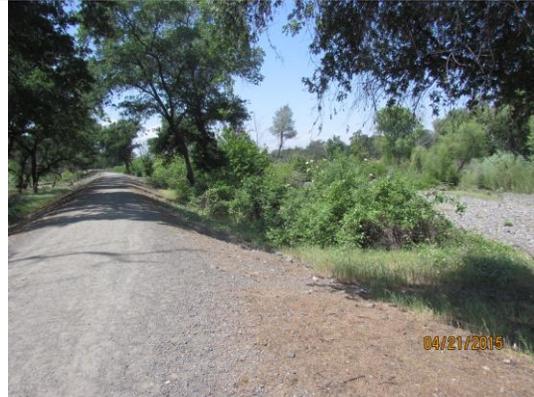
Photo 1 of 1 : SP_2015_NA0003_69_4_20150428_00004.jpg

LM Start	0.21	Rating **	M	Issue No.	4
LM End	0.26	Issue Type +	Ma	Location *	WS
Category	Earthen Levee		GPS Latitude/Longitude		
			Start	End	
Item	Vegetation		39.761957 °	39.761892 °	
			-121.792867 °	-121.793705 °	
DWR ID	DWR_NA0003_05_f_2014_4				
Action/Comments					
Remove the wild growth other than native grasses from the levee slopes. Inspector Comments: Remove the vegetation from the waterside slope.

View of the vegetation along the waterside slope.

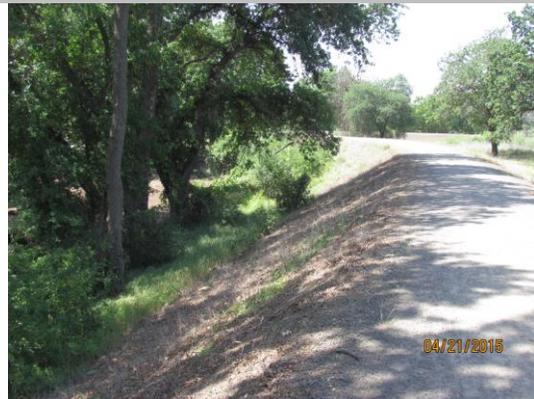
Photo 1 of 1 : SP_2015_NA0003_69_3_20150428_00005.jpg

LM Start	0.34	Rating **	M	Issue No.	3
LM End	0.42	Issue Type +	Ma	Location *	LS
Category	Earthen Levee		GPS Latitude/Longitude		
			Start	End	
Item	Vegetation		39.761633 °	39.761117 °	
			-121.795155 °	-121.796464 °	
DWR ID	DWR_NA0003_05_f_2013_3				
Action/Comments					
Remove the wild growth other than native grasses from the levee slopes. Inspector Comments: Remove the vegetation from the landside slope and toe.

View of the vegetation along the landside slope and toe

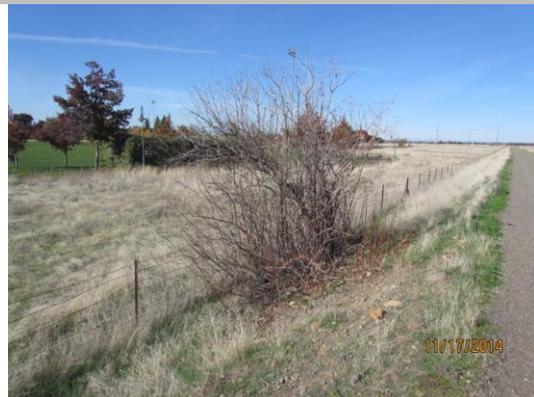
Photo 1 of 1 : SP_2015_NA0003_69_6_20150310_00003.jpg

LM Start	0.89	Rating **	A/W	Issue No.	6
LM End	0.89	Issue Type +	Ma	Location *	LS
Category	Earthen Levee		GPS Latitude/Longitude		
			Start	End	
Item	Vegetation		39.764397 °	39.764397 °	
			-121.803335 °	-121.803335 °	
DWR ID	DWR_NA0003_05_f_2014_6				
Action/Comments					
Elderberries are blocking visibility and flood fight capability.

View of the elderberry along the landside toe.
