Flood Control Project Maintenance
2008 Structure Summary Report
Overall Unit and Item Ratings

Butte County Public Works

2008 Structure Inspection Results

**Flood Control Project Maintenance
Inspection Report - Structure 2008**

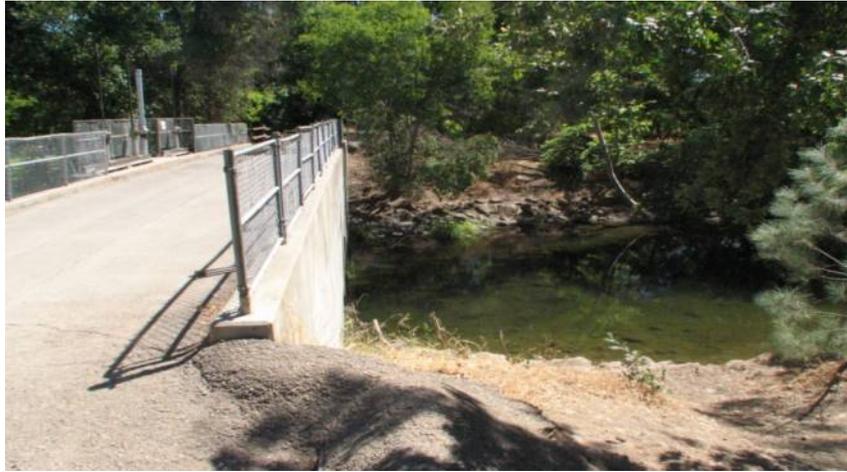
Report Line	1
Location	
Category	Structures & Concrete Lined Channels
Item	Vegetation & Obstructions
Downstream at discharge end of the structure from the right bank.

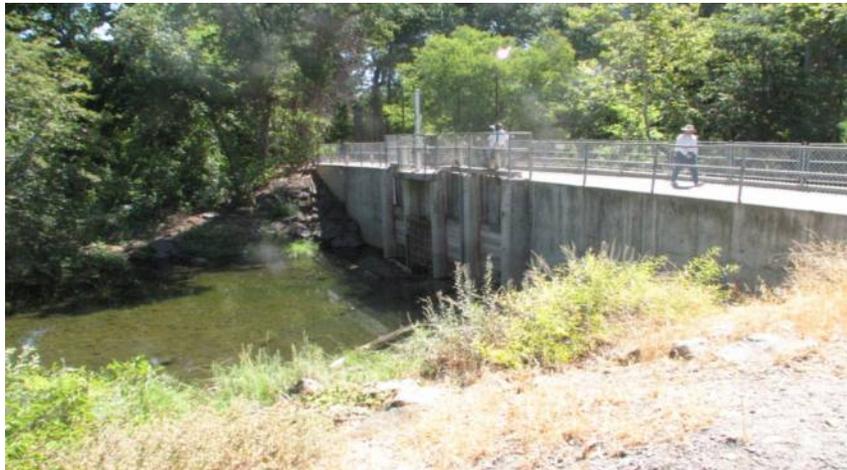
Report Line	2
Location	
Category	Structures & Concrete Lined Channels
Item	Vegetation & Obstructions
View of the upstream side of the structure.

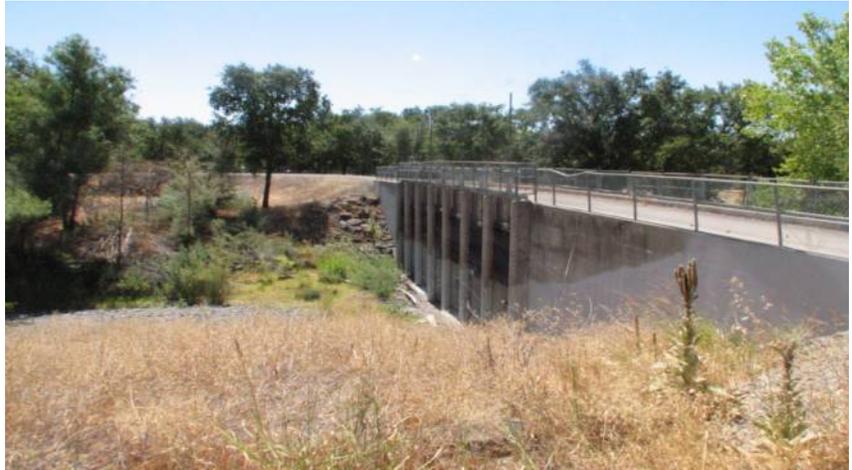
Report Line	1
Location	
Category	Structures & Concrete Lined Channels
Item	Concrete Foundations

View of the upstream side of structure.

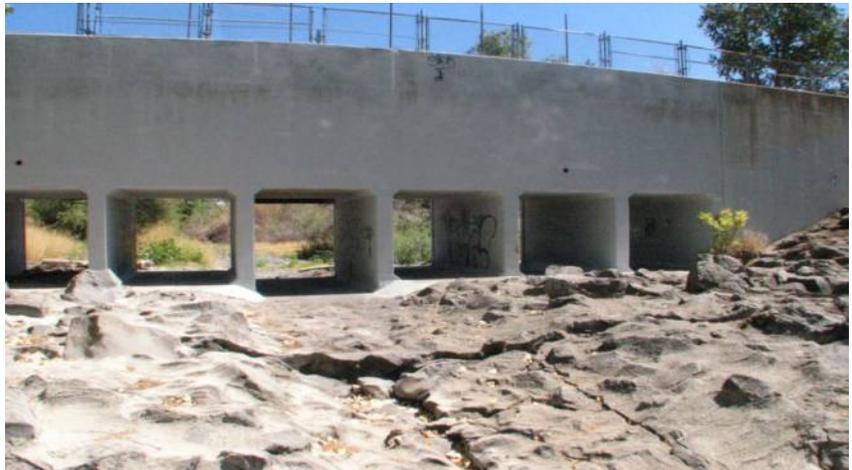
Report Line	2
Location	
Category	Structures & Concrete Lined Channels
Item	Concrete Foundations

View of the downstream side of structure.

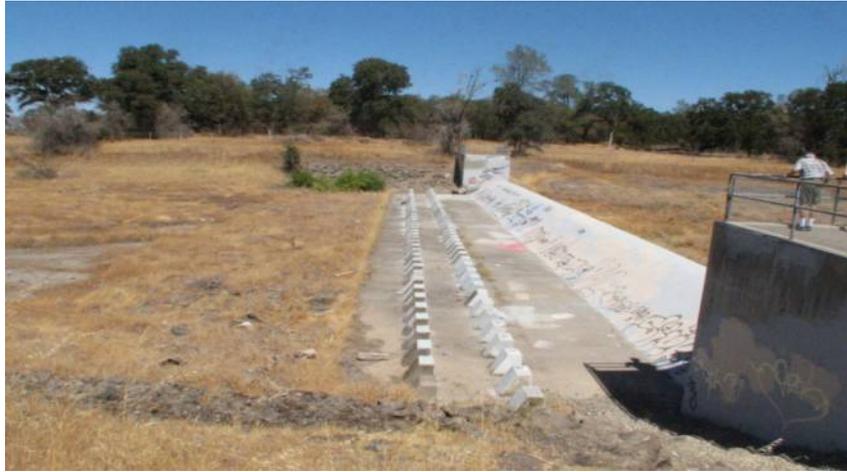
Report Line	1
Location	
Category	Structures & Concrete Lined Channels
Item	Concrete Foundations

The velocity dissipaters on the downstream side of structure from the left bank.

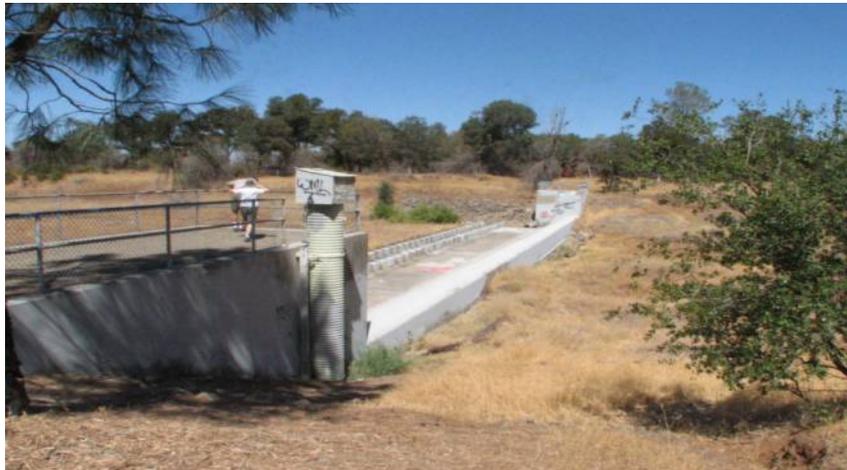
Report Line	2
Location	
Category	Structures & Concrete Lined Channels
Item	Concrete Foundations

Upstream side of the structure from the left bank.
