Flood Control Project Maintenance
2011 Structure Summary Report
Overall Unit and Item Ratings

Butte County Public Works

2011 Structure Inspection Results

Structure
Big Chico Creek Diversion Structure

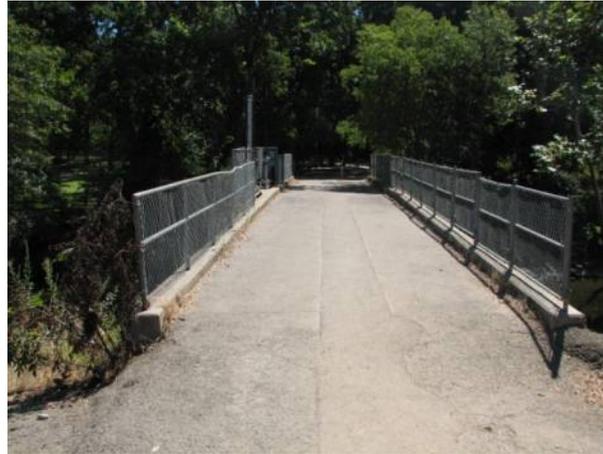
cathom_t_20110906_019.jpg

View of the structure.

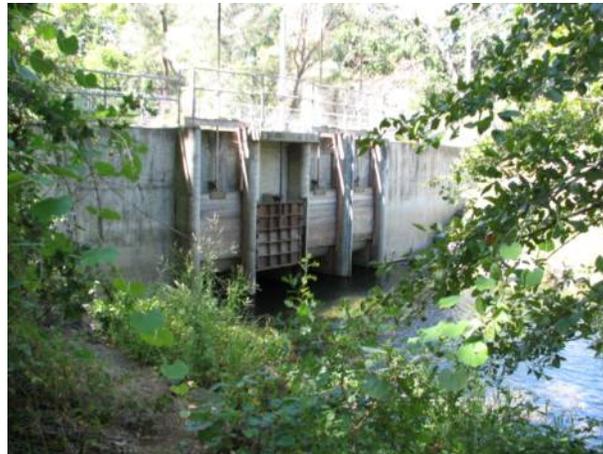
cathom_t_20110906_020.jpg

LNI# No.	Levee Mile		Category	Item	Location *	Rating **	Action/Comment	GPS Latitude/Longitude		Issue No.
	Start	End						Start	End	Photo
1	0.00	0.00	Structures	Photo Documentation				°	°	1 Y
2	0.00	0.00	Structures	Vegetation & Obstructions		A	Inspector Comments: Minimal vegetation, the flow does not appear impeded.	°	°	2 Y
3	0.00	0.00	Structures	Shoaling / Sedimentation		A	Inspector Comments: There is some sedimentation, it does not appear to impeded the flow.	°	°	3
4	0.00	0.00	Structures	Erosion / Bank Caving		A	Inspector Comments: No erosion observed.	°	°	4
5	0.00	0.00	Structures	Revetments		A	Inspector Comments: Riprap is visible and appears properly maintained.	°	°	5
6	0.00	0.00	Structures	Encroachments		A	Inspector Comments: No encroachment present.	°	°	6
7	0.00	0.00	Structures	Culverts: Inlets / Outlets		A	Inspector Comments: Minimal sedimentation, the flow does not appear impeded.	°	°	7
8	0.00	0.00	Structures	Culverts: Breaks / Holes / Cracks		A	Inspector Comments: The culverts appear in good condition.	°	°	8

View of the upstream side of the structure.

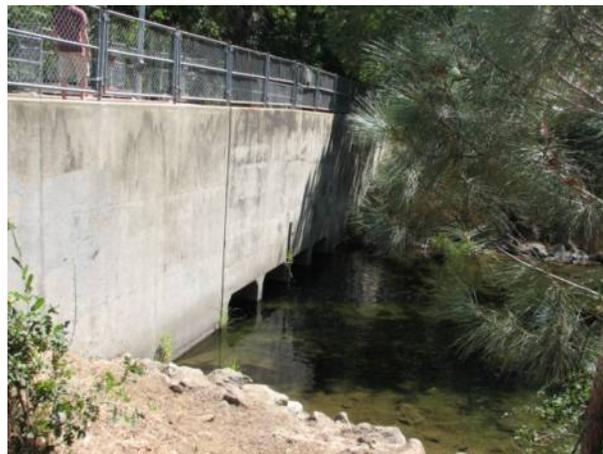
cathom_t_20110906_021.jpg

View of the discharge side of the structure.

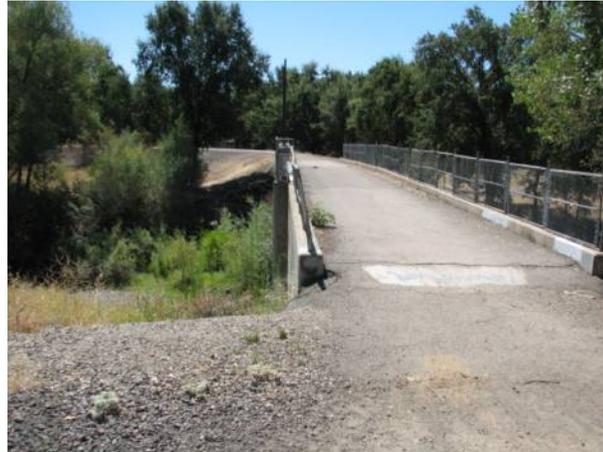
Levee Mile Report Line	1
Start Levee Mile	0.00
End Levee Mile	0.00
Location	
Category	Structures
Item	Photo Documentation
View of the structure.	
cathom_t_20110906_022.jpg

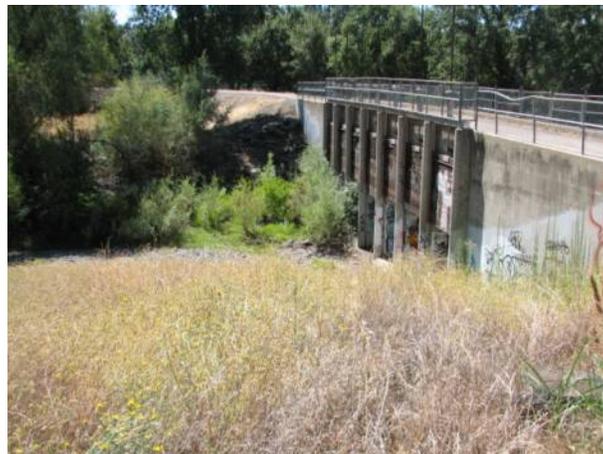
LMR No.	Levee Mile		Category	Item	Location	Rating	Action/Comment	GPS Latitude/Longitude		Issue No.
	Start	End						Start	End	Photo
1	0.00	0.00	Structures	Photo Documentation				°	°	1 Y
2	0.00	0.00	Structures	Vegetation & Obstructions		A	Inspector Comments: Minimal vegetation, the flow does not appear impeded.	°	°	2 Y
3	0.00	0.00	Structures	Shoaling / Sedimentation		A	Inspector Comments: Minimal shoaling observed.	°	°	3
4	0.00	0.00	Structures	Erosion / Bank Caving		A	Inspector Comments: No erosion observed.	°	°	4
5	0.00	0.00	Structures	Revetments		A	Inspector Comments: Riprap is visible and appears properly maintained.	°	°	5
6	0.00	0.00	Structures	Encroachments		A	Inspector Comments: No encroachments observed.	°	°	6
7	0.00	0.00	Structures	Culverts: Inlets / Outlets		A	Inspector Comments: The culverts appear in good condition, the flow does not appear impeded.	°	°	7
8	0.00	0.00	Structures	Culverts: Breaks / Holes / Cracks		A	Inspector Comments: The culverts appear in good condition.	°	°	8

Levee Mile Report Line	2
Start Levee Mile	0.00
End Levee Mile	0.00
Location	
Category	Structures
Item	Vegetation & Obstructions
View of the upstream side of the structure.	
cathom_t_20110906_023.jpg

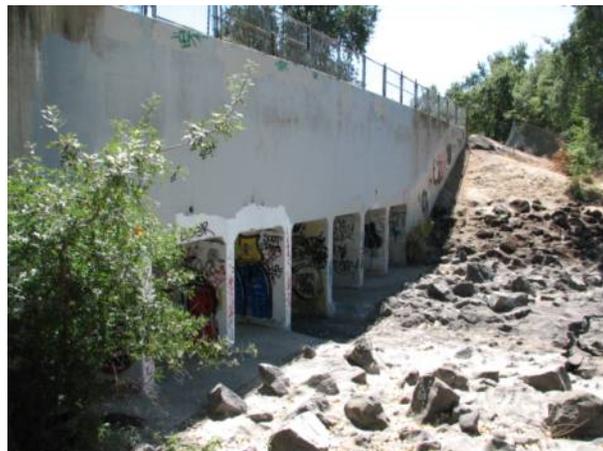
Levee Mile Report Line	2
Start Levee Mile	0.00
End Levee Mile	0.00
Location	
Category	Structures
Item	Vegetation & Obstructions
View of the downstream side of the structure.	
cathom_t_20110906_024.jpg

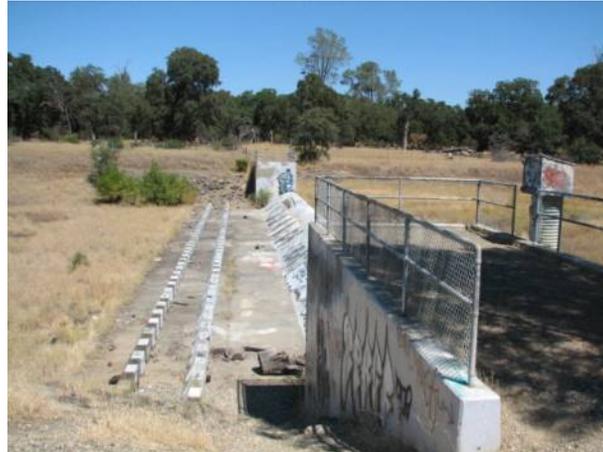
Levee Mile Report Line	1
Start Levee Mile	0.00
End Levee Mile	0.00
Location	
Category	Structures
Item	Photo Documentation
This is a view of the weir.	
cathom_t_20110906_025.jpg

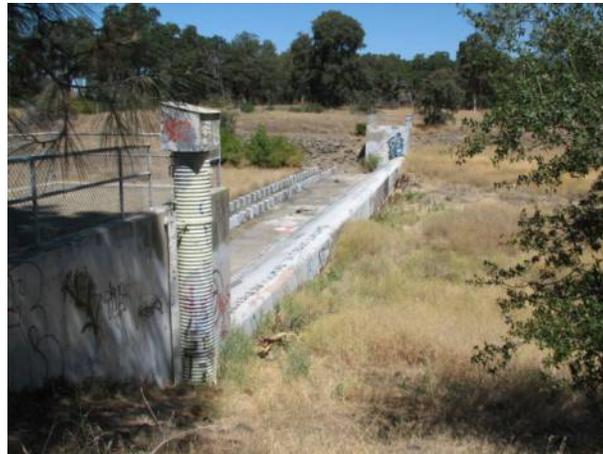
LMR No.	Levee Mile		Category	Item	Location	Rating	Action/Comment	GPS Latitude/Longitude		Issue No.
	Start	End						Start	End	Photo
1	0.00	0.00	Structures	Photo Documentation				°	°	1 Y
2	0.00	0.00	Structures	Vegetation & Obstructions		A	Inspector Comments: There is vegetation, the flow does not appear impeded.	°	°	2 Y
3	0.00	0.00	Structures	Shoaling / Sedimentation		A	Inspector Comments: No shoaling or sedimentation observed.	°	°	3
4	0.00	0.00	Structures	Erosion / Bank Caving		A	Inspector Comments: No erosion observed.	°	°	4
5	0.00	0.00	Structures	Revetments		A	Inspector Comments: Riprap is visible and appears properly maintained.	°	°	5
6	0.00	0.00	Structures	Encroachments		A	Inspector Comments: No encroachments observed.	°	°	6
7	0.00	0.00	Structures	Culverts: Inlets / Outlets		N	Inspector Comments: This item does not apply to this inspection.	°	°	7
8	0.00	0.00	Structures	Culverts: Breaks / Holes / Cracks		N	Inspector Comments: This item does not apply to this inspection.	°	°	8

Levee Mile Report Line	2
Start Levee Mile	0.00
End Levee Mile	0.00
Location	
Category	Structures
Item	Vegetation & Obstructions
This is a view of the upstream side of the weir.	
cathom_t_20110906_026.jpg

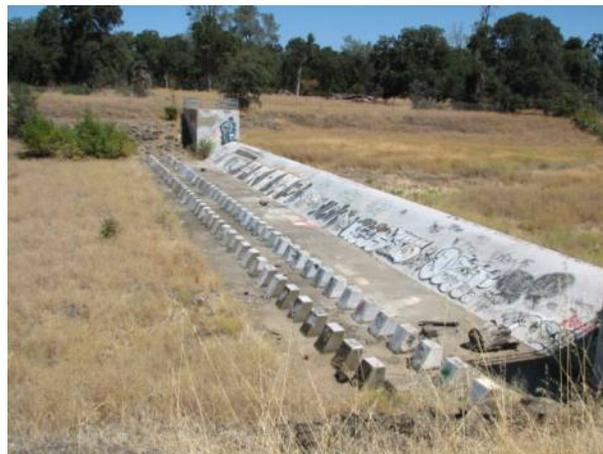
Levee Mile Report Line	2
Start Levee Mile	0.00
End Levee Mile	0.00
Location	
Category	Structures
Item	Vegetation & Obstructions
This is a view of the downstream side of the weir.	
cathom_t_20110906_027.jpg
