**Flood Control Project Maintenance
Levee Inspections**

Fall 2014 Levee Maintenance Deficiency Summary Report

Levee Inspection Report By Mile - Fall 2014

Marysville Levee Commission

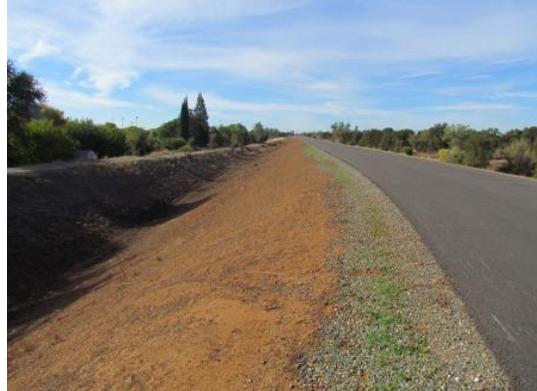
Photo 1 of 1 : FA_2014_NA0004_104_10_20141103_00002.jpg

LM Start	1.85	Rating **	A	Issue No.	10
LM End	1.85	Issue Type +	Ma	Location *	LS
Category	Earthen Levee		GPS Latitude/Longitude		
			Start	End	
Item	Vegetation		39.164735 °	39.164735 °	
			-121.583859 °	-121.583859 °	
DWR ID	DWR_NA0004_01_f_2014_10				
Action/Comments					
Control annual grass and weeds on the levee slopes and easements.

This photo was taken from the levee crown facing west looking down the landward slope at acceptable vegetation maintenance. Fall 2014.

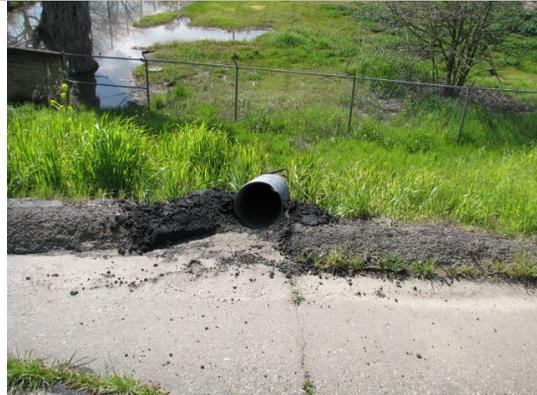
Photo 1 of 1 : FA_2014_NA0004_104_1_20141023_00001.jpg

LM Start	3.21	Rating **	A/W	Issue No.	1
LM End	3.21	Issue Type +	Ma	Location *	LS
Category	Earthen Levee			GPS Latitude/Longitude	
				Start	End
Item	Slope Stability			39.163590 °	39.163590 °
				-121.559495 °	-121.559495 °
DWR ID	DWR_NA0004_01_s_2012_1				
Action/Comments					
Repair slope instability. Inspector Comments: This drain pipe has been added to the site on the Corps PI.

This site is on the Corps PI.

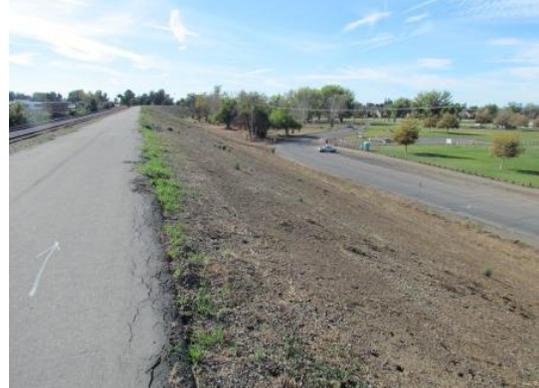
Photo 1 of 1 : FA_2014_NA0004_105_5_20141103_00002.jpg

LM Start	0.43	Rating **	A	Issue No.	5
LM End	0.43	Issue Type +	Ma	Location *	WS
Category	Earthen Levee			GPS Latitude/Longitude	
				Start	End
Item	Vegetation			39.143573 °	39.143573 °
				-121.600375 °	-121.600375 °
DWR ID	DWR_NA0004_02_f_2014_5				
Action/Comments					
Control annual grass and weeds on the levee slopes and easements.

This photo was taken from the levee crown facing south looking down the waterward slope at acceptable vegetation maintenance. Fall 2014.

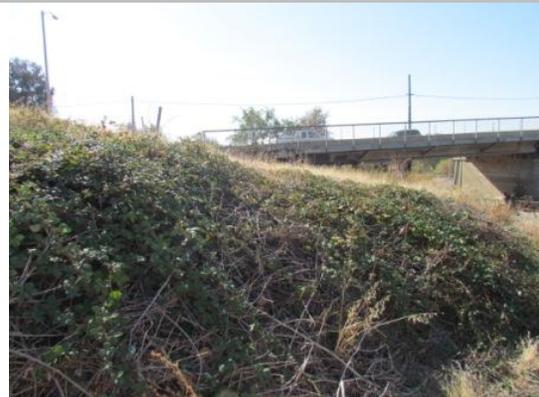
Photo 1 of 1 : FA_2014_NA0004_105_9_20141023_00001.jpg

LM Start	0.72	Rating **	M	Issue No.	9
LM End	0.72	Issue Type +	Ma	Location *	WS
Category	Earthen Levee		GPS Latitude/Longitude		
			Start	End	
Item	Vegetation		39.139752 °	39.139752 °	
			-121.600637 °	-121.600637 °	
DWR ID	DWR_NA0004_02_f_2013_9				
Action/Comments					
Remove the wild growth other than native grasses from the levee slopes. Inspector Comments: Blackberries on waterward levee slope.

This photo was taken from the access road going under the 5th street bridge of blackberries growing on the waterward levee slope. Fall 2013.

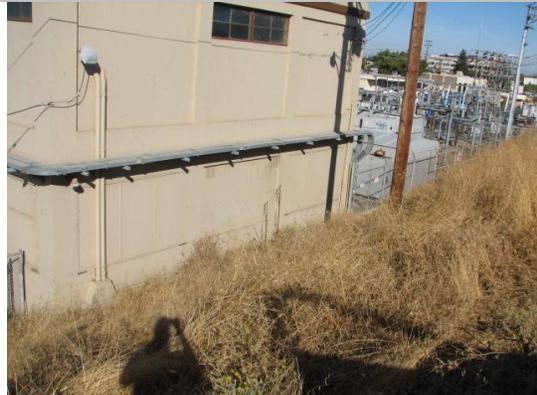
Photo 1 of 1 : FA_2014_NA0004_106_4_20141023_00002.jpg

LM Start	0.86	Rating **	M	Issue No.	4
LM End	0.86	Issue Type +	En	Location *	LS
Category	Earthen Levee			GPS Latitude/Longitude	
				Start	End
Item	Encroachments			39.139843 °	39.139843 °
				-121.583033 °	-121.583033 °
DWR ID	DWR_NA0004_03_s_2012_4				
Action/Comments					
Building Inspector Comments: This building is at least 30 years old and is part of the PG&E site.

Building encroaching at landside levee toe.

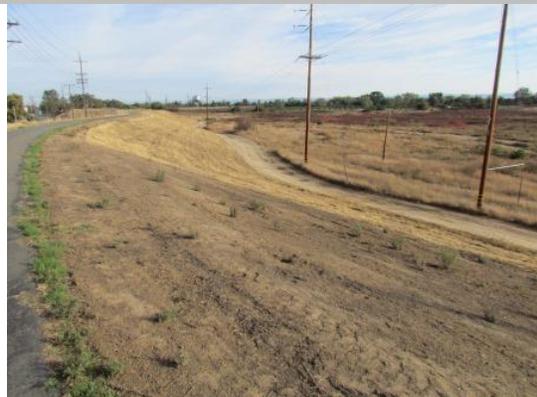
Photo 1 of 1 : FA_2014_NA0004_106_25_20141103_00007.jpg

LM Start	0.87	Rating **	A	Issue No.	25
LM End	0.87	Issue Type +	Ma	Location *	WS
Category	Earthen Levee			GPS Latitude/Longitude	
				Start	End
Item	Vegetation			39.139990 °	39.139990 °
				-121.583184 °	-121.583184 °
DWR ID	DWR_NA0004_03_f_2014_25				
Action/Comments					
Control annual grass and weeds on the levee slopes and easements.

This photo was taken from the levee crown facing east looking down the waterward slope at acceptable vegetation maintenance. Fall 2014.

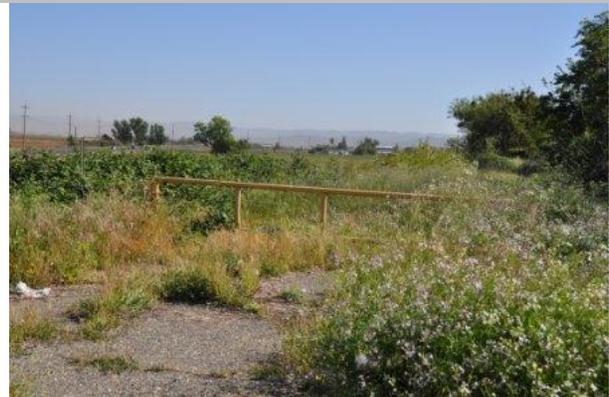
Photo 1 of 1 : FA_2014_NA0004_106_1_20141023_00001.jpg

LM Start	4.88	Rating **	U	Issue No.	1
LM End	6.79	Issue Type +	En	Location *	CR
Category	Earthen Levee			GPS Latitude/Longitude	
				Start	End
Item	Encroachments			°	°
				°	°
DWR ID	DWR_NA0004_03_s_2012_1				
Action/Comments					
Fence Inspector Comments: Levee miles 4.88-6.79 not inspected due to limited access from livestock fencing. Levee crown has been mowed.

Marysville, Unit 3 - Spring 2013 - Patrol road vegetation.
