**Flood Control Project Maintenance
Levee Inspections**
LMA District Cover Sheet
Spring 2014 Levee Inspection Results

Marysville Levee Commission

Spring 2014 Levee Inspection Results

Waterway	Bank	Unit Miles
Unit No. 01 Simmerly Slough	Left	3.25

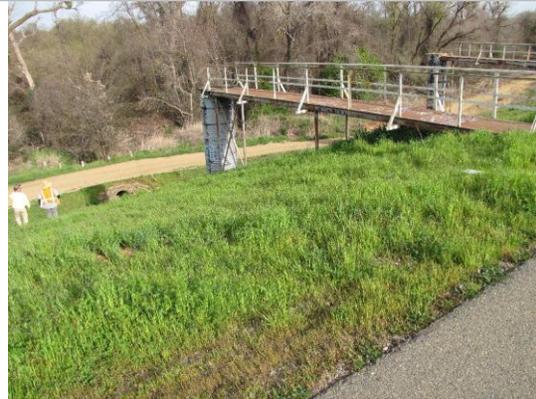
Photo 1 of 1 : UCIP_1274.jpg

LM Start	0.42	Rating **	M	Issue No.	2
LM End	0.42	Issue Type +	En	Location *	LS
Category	Supplemental			GPS Latitude/Longitude	
				Start	End
Item	DWR UCIP Field Study			39.152962 °	39.152962 °
				-121.594934 °	-121.594934 °
DWR ID	DWR_NA0004_01_s_2014_2				
Action/Comments					
Inspector Comments: FS_ID:15302 EP_NO: N/A Repair Type: Crossing Status: UCIP Comments: FIELD_STRUCT_DESC: 36-inch steel pipe through levee, 27.0 feet below crown. Flap gate and concrete "U" headwall on waterward end. Slide gate in 48-inch corrugated metal riser on waterward slope of pipe. Steel walkway to control gate. Concrete base under riser units. Pipe delivers water to Ellis Lake (USACE-1955). This entry matches the Drainage or Irrigation Structure referenced in O&M manual (Station 7+91). Steel riser unit & slide gate added under Permit No. 4041. FS Date: 3/14/2013 10:04:00 AM

View of waterward side.

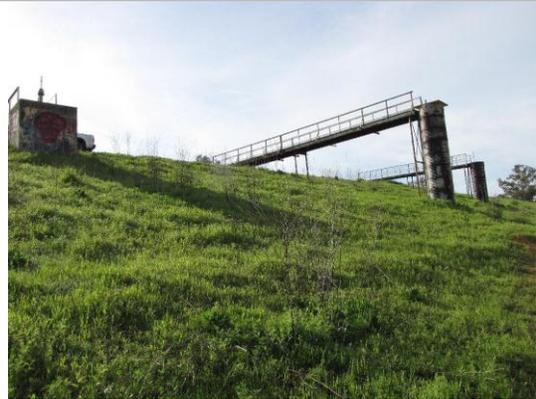
Photo 1 of 1 : UCIP_1260.jpg

LM Start	0.43	Rating **	M	Issue No.	3
LM End	0.43	Issue Type +	En	Location *	LS
Category	Supplemental			GPS Latitude/Longitude	
				Start	End
Item	DWR UCIP Field Study			39.153109 °	39.153109 °
				-121.594816 °	-121.594816 °
DWR ID	DWR_NA0004_01_s_2014_3

Action/Comments
 Inspector Comments: FS_ID:15291
 EP_NO: N/A
 Repair Type:
 Crossing Status:
 UCIP Comments:
 FIELD_STRUCT_DESC: 36-inch CM pipe through levee, 27.0 feet below crown. Flap gate and concrete "U" headwall on waterward end. Slide gate in 48-inch Corrugated metal riser on waterward slope of pipe. Steel walkway to control gate. Outfall drains from Ellis Lake. Concrete headwall at both toes. Concrete base under riser units. (USACE-1955). This entry matches the Drainage or Irrigation Structure referenced in O&M manual (Station 8+48). Steel riser unit & slide gate added under Permit No. 4041.
 FS Date: 3/14/2013

Overview of waterward side with multiple crossings. This crossing is the middle crossing.

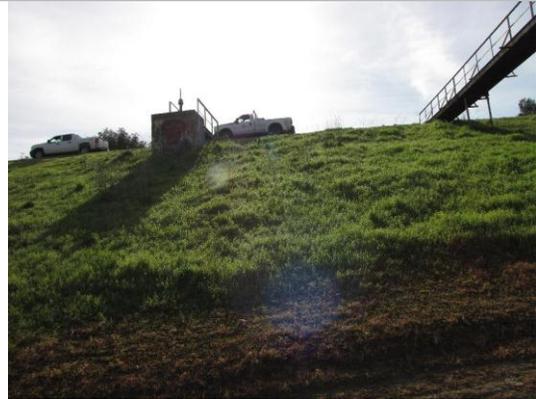
Photo 1 of 1 : UCIP_1265.jpg

LM Start	0.44	Rating **	M	Issue No.	7
LM End	0.44	Issue Type +	En	Location *	LS
Category	Supplemental			GPS Latitude/Longitude	
				Start	End
Item	DWR UCIP Field Study			39.153207 °	39.153207 °
				-121.594713 °	-121.594713 °
DWR ID	DWR_NA0004_01_s_2014_7				
Action/Comments					
Inspector Comments: FS_ID:15292 EP_NO: 12676 Repair Type: Crossing Status: UCIP Comments: FIELD_STRUCT_DESC: 42-inch concrete pipe is sleeved through 60-inch pipe, annular space grouted, 41 feet below crown. The pipe drains into a settling basin (65x245-foot). Steel walkway to platform on the waterward slope. Reinforced concrete collars around pipe within levee section. Concrete headwall and flap gate installed at discharge end of pipe. (Permit No. 12676-1980). Design of basin authorized under Permit No. 12795. FS Date: 3/14/2013

View of waterward side. Concrete box with gate stem through top.

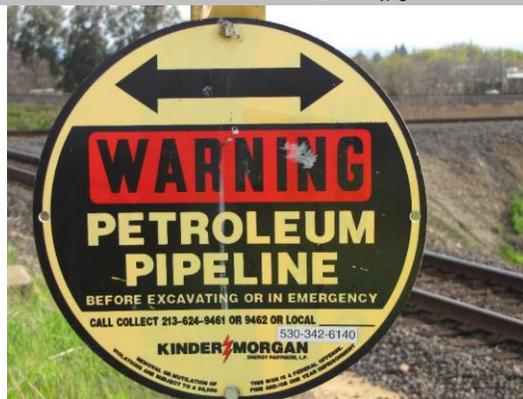
Photo 1 of 1 : UCIP_4354.jpg

LM Start	0.77	Rating **	M	Issue No.	8
LM End	0.77	Issue Type +	En	Location *	LS
Category	Supplemental			GPS Latitude/Longitude	
				Start	End
Item	DWR UCIP Field Study			39.157045 °	39.157045 °
				-121.591102 °	-121.591102 °
DWR ID	DWR_NA0004_01_s_2014_8				
Action/Comments					
Inspector Comments: FS_ID:24896 EP_NO: 3823 Repair Type: Crossing Status: UCIP Comments: Need to contact owner to determine if crossing is still active and to determine last inspection date. Will need copy of letter showing crossings passed inspection 12/3/13 Spoke to Frank Villalobos (supervisor-530-624-4048) and Doug Hubbard (maps-916-416-2972) was told to contact Brian Gamble (916-869-7148) to find out additional information about crossing and the status. Additional information can be requested through Kinder Morgan's Engineering Department by sending email to pipelineinquiries@kindermorgan.com ATTN: Engineering Department Line Section 64. FIELD_STRUCT_DESC: 8 5/8-inch steel gas line sleeved through 12 inch, then 30 inch line, annular gaps grouted, 3 feet below crown. Standard metal cutoff wall around pipe, in line with shoulder. Metal plate welded to end of pipe. Extends beyond levee on both waterward and landward sides. (Permit No. 3823-1962). Marker indicates Kinder Morgan is owner contact phone number is 1-530-342-6140. FS Date: 3/14/2013

Marker visible on landward side.

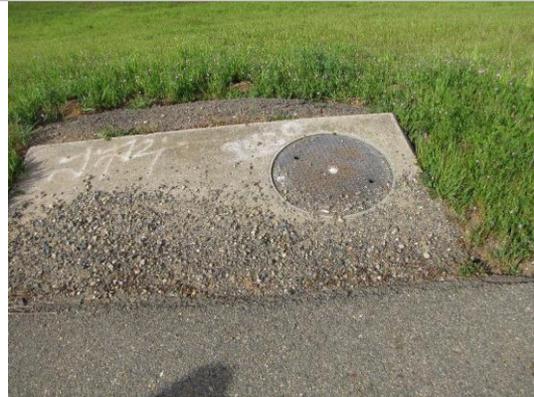
Photo 1 of 1 : UCIP_202.jpg

LM Start	0.92	Rating **	M	Issue No.	9
LM End	0.92	Issue Type +	En	Location *	WS
Category	Supplemental			GPS Latitude/Longitude	
				Start	End
Item	DWR UCIP Field Study			39.158920 °	39.158920 °
				-121.589913 °	-121.589913 °
DWR ID	DWR_NA0004_01_s_2014_9				
Action/Comments					
Inspector Comments: FS_ID:9828 EP_NO: 14518 Repair Type: Crossing Status: UCIP Comments: FIELD_STRUCT_DESC: 1 of 2: 10-inch steel pipe through levee, 4.0 feet below crown. Flap gate on waterward end. Concrete vault on waterward shoulder. Metal meter box on the landward shoulder. Pump placed on concrete footings at toe of landward slope. Drainage for underpass. Pipes approx. 2.5-feet apart. (Permit No. 14518-1987). FS Date: 3/14/2013

Concrete vault on waterward shoulder with manhole.

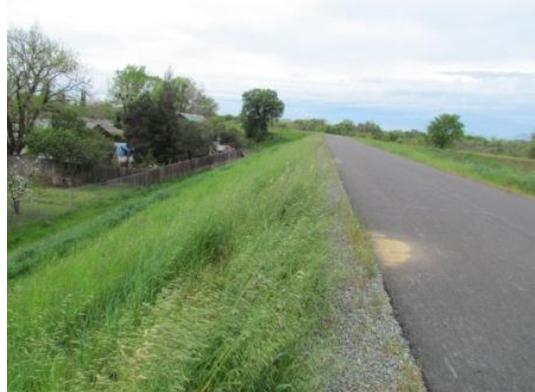
Photo 1 of 1 : mhoffman_s_20140326_274.jpg

LM Start	1.96	Rating **	M	Issue No.	14
LM End	1.96	Issue Type +	Ma	Location *	LS
Category	Earthen Levee		GPS Latitude/Longitude		
			Start	End	
Item	Vegetation		39.164926 °	39.164926 °	
			-121.581996 °	-121.581996 °	
DWR ID	DWR_NA0004_01_s_2014_14				
Action/Comments					
Control annual grass and weeds on the levee slopes and easements.

This photo was taken from the levee crown facing west looking down the landward slope at vegetation prior to annual maintenance. Spring 2014.

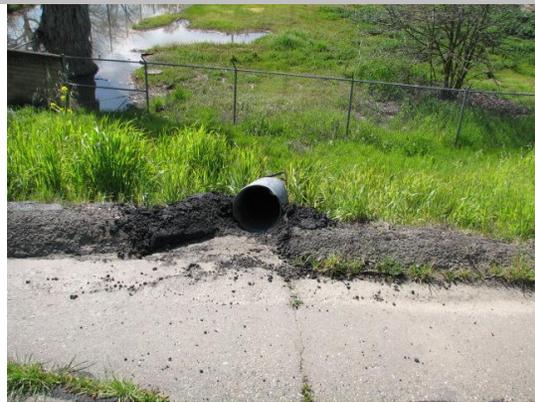
Photo 1 of 1 : mhoffman_s_20140306_102.jpg

LM Start	3.21	Rating **	A/W	Issue No.	1
LM End	3.21	Issue Type +	Ma	Location *	LS
Category	Earthen Levee		GPS Latitude/Longitude		
			Start	End	
Item	Slope Stability		39.163590 °	39.163590 °	
			-121.559495 °	-121.559495 °	
DWR ID	DWR_NA0004_01_s_2012_1				
Action/Comments					
Repair slope instability. Inspector Comments: This drain pipe has been added to the site on the Corps PI.

This site is on the Corps PI.

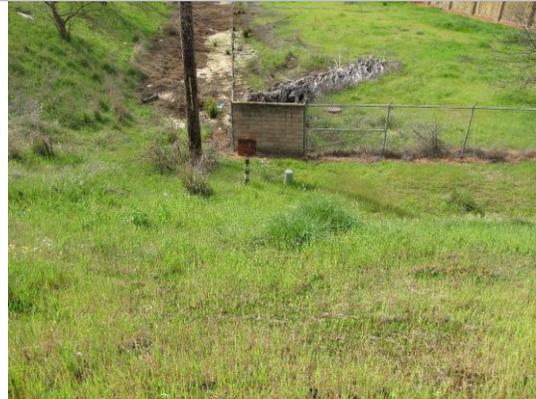
Photo 1 of 1 : UCIP_210.jpg

LM Start	3.23	Rating **	M	Issue No.	13
LM End	3.23	Issue Type +	En	Location *	LS
Category	Supplemental			GPS Latitude/Longitude	
				Start	End
Item	DWR UCIP Field Study			39.163829 °	39.163829 °
				-121.559769 °	-121.559769 °
DWR ID	DWR_NA0004_01_s_2014_13				
Action/Comments					
Inspector Comments: FS_ID:9830 EP_NO: 12878 Repair Type: Crossing Status: UCIP Comments: FIELD_STRUCT_DESC: 24-inch steel pipe encasing 4-inch PVC communications extension through the levee, annular gap grouted, 8 feet below levee crown. Cutoff wall (12x12x20-inch) around extension from levee slopes. (Permit No. 12878-1980). FS Date: 3/14/2013

View of landward side.

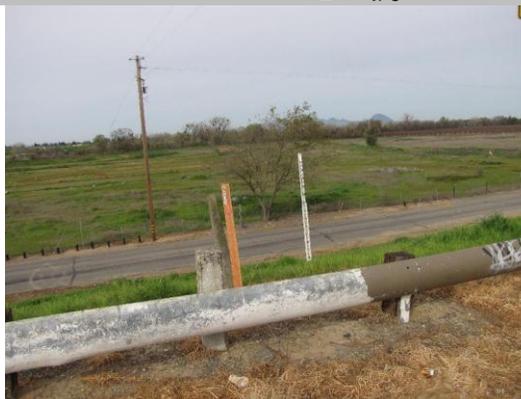
Photo 1 of 1 : UCIP_215.jpg

LM Start	0.00	Rating **	M	Issue No.	1
LM End	0.00	Issue Type +	En	Location *	WS
Category	Supplemental			GPS Latitude/Longitude	
				Start	End
Item	DWR UCIP Field Study			39.149688 °	39.149688 °
				-121.601058 °	-121.601058 °
DWR ID	DWR_NA0004_02_s_2014_1				
Action/Comments					
Inspector Comments: FS_ID:9831 EP_NO: 3684 Repair Type: Crossing Status: UCIP Comments: FIELD_STRUCT_DESC: 8-inch gas line through the levee, 4.0 feet below the crown. Concrete cutoff wall around pipe, near center of levee (8x56x56-inch). Gas main cut off 110-feet landward of waterward toe. Permit covers replacement of portion of pre-existing gas main and cutoff wall (Permit No. 3684-1961). FS Date: 3/15/2013

View of waterward side, marker located on waterward shoulder.

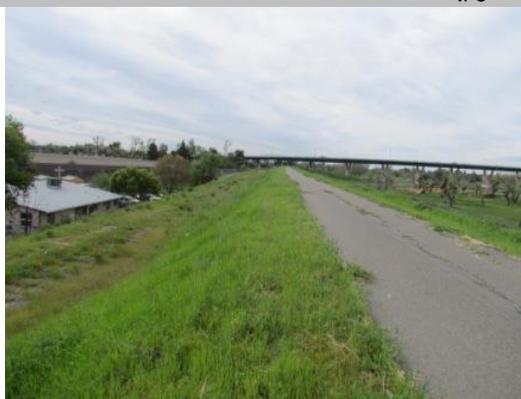
Photo 1 of 1 : mhoffman_s_20140326_275.jpg

LM Start	0.12	Rating **	M	Issue No.	6
LM End	0.12	Issue Type +	Ma	Location *	LS
Category	Earthen Levee			GPS Latitude/Longitude	
				Start	End
Item	Vegetation			39.147943 °	39.147943 °
				-121.600919 °	-121.600919 °
DWR ID	DWR_NA0004_02_s_2014_6				
Action/Comments					
Control annual grass and weeds on the levee slopes and easements.

This photo was taken from the levee crown facing south looking down the landward slope at annual vegetation prior to maintenance. Spring 2014.

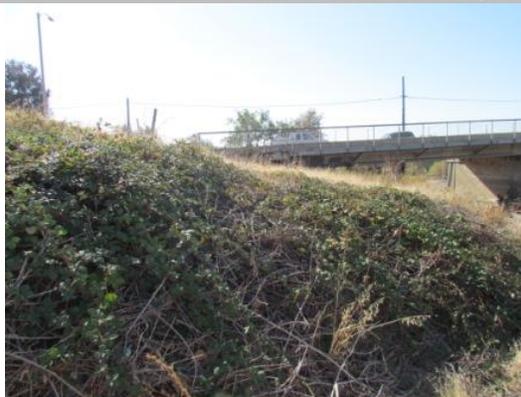
Photo 1 of 1 : mhoffman_s_20140306_109.jpg

LM Start	0.72	Rating **	M	Issue No.	9
LM End	0.72	Issue Type +	Ma	Location *	WS
Category	Earthen Levee		GPS Latitude/Longitude		
			Start	End	
Item	Vegetation		39.139752 °	39.139752 °	
			-121.600637 °	-121.600637 °	
DWR ID	DWR_NA0004_02_f_2013_9				
Action/Comments					
Remove the wild growth other than native grasses from the levee slopes. Inspector Comments: Blackberries on waterward levee slope.

This photo was taken from the access road going under the 5th street bridge of blackberries growing on the waterward levee slope. Fall 2013.

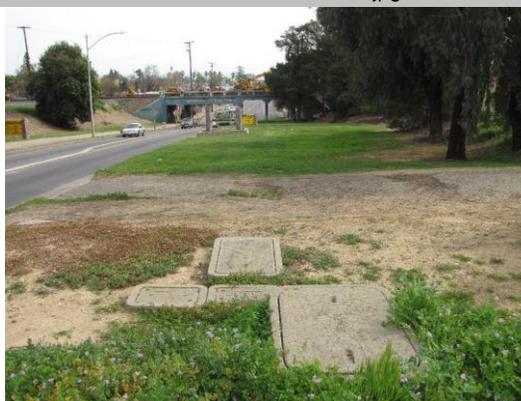
Photo 1 of 1 : UCIP_221.jpg

LM Start	0.74	Rating **	M	Issue No.	2
LM End	0.74	Issue Type +	En	Location *	WS
Category	Supplemental		GPS Latitude/Longitude		
			Start	End	
Item	DWR UCIP Field Study		39.139563 °	39.139563 °	
			-121.600873 °	-121.600873 °	
DWR ID	DWR_NA0004_02_s_2014_2				
Action/Comments					
Inspector Comments: FS_ID:9832 EP_NO: 11632 Repair Type: Crossing Status: UCIP Comments: manhole FIELD_STRUCT_DESC: 1 of 3: 4-inch PVC sewer line through the levee. In reinforced vertical concrete encasement (1x3.16x1.33-feet) with 3 other utility lines, separated by 6-inches. Encased from waterward toe to 30-feet landward of levee centerline. Air release valves on landward shoulder of levee. (Permit No. 11632-1976). FS Date: 3/15/2013

Concrete service boxes for sewer, water, and electrical lines.

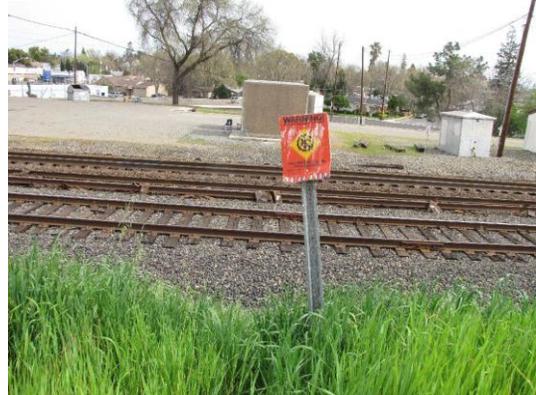
Photo 1 of 1 : UCIP_223.jpg

LM Start	0.88	Rating **	M	Issue No.	3
LM End	0.88	Issue Type +	En	Location *	WS
Category	Supplemental		GPS Latitude/Longitude		
			Start	End	
Item	DWR UCIP Field Study		39.138463 °	39.138463 °	
			-121.599139 °	-121.599139 °	
DWR ID	DWR_NA0004_02_s_2014_3				
Action/Comments					
Inspector Comments: FS_ID:9835 EP_NO: N/A Repair Type: Crossing Status: UCIP Comments: unable to tell if crossing goes through levee; according to Frank Miller crossing does not cross levee FIELD_STRUCT_DESC: Fiber optics communication line through levee. Marker on waterward shoulder. FS Date: 3/15/2013

View of landward side with bldg that could be associated with cable line.

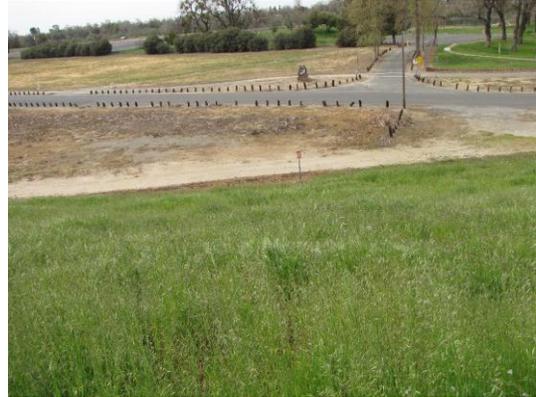
Photo 1 of 1 : UCIP_1267.jpg

LM Start	0.93	Rating **	M	Issue No.	4
LM End	0.93	Issue Type +	En	Location *	WS
Category	Supplemental			GPS Latitude/Longitude	
				Start	End
Item	DWR UCIP Field Study			39.137749 °	39.137749 °
				-121.598560 °	-121.598560 °
DWR ID	DWR_NA0004_02_s_2014_4				
Action/Comments					
Inspector Comments: FS_ID:9792 EP_NO: N/A Repair Type: Crossing Status: UCIP Comments: unable to tell if crossing goes through levee. FIELD_STRUCT_DESC: 12-inch HDPE conduit, with electrical lines, through the levee. Extends to controller cabinet within the overflow area. FS Date: 3/15/2013

View of markers located on waterward toe.

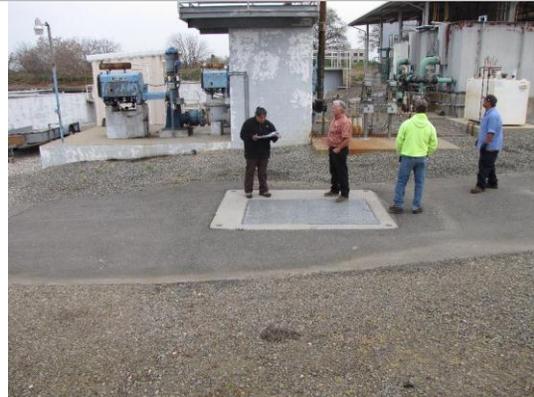
Photo 1 of 1 : UCIP_227.jpg

LM Start	0.03	Rating **	M	Issue No.	2
LM End	0.03	Issue Type +	En	Location *	CR
Category	Supplemental			GPS Latitude/Longitude	
				Start	End
Item	DWR UCIP Field Study			39.134965 °	39.134965 °
				-121.593366 °	-121.593366 °
DWR ID	DWR_NA0004_03_s_2014_2				
Action/Comments					
Inspector Comments: FS_ID:9836 EP_NO: 4174 Repair Type: Crossing Status: UCIP Comments: FIELD_STRUCT_DESC: 30-inch steel sewer pipe through levee, 13.4 feet below crown. Encased in reinforced concrete, with two concrete cutoff walls around pipe in-line with each levee shoulder. Slide gate in 4 foot by 4-foot concrete riser on waterward shoulder. Extends from pump on landward side, to percolation beds on waterward side (Permit No. 4174-1963). FS Date: 3/15/2013

View of vault located inside Marysville Wastewater Treatment Facility.

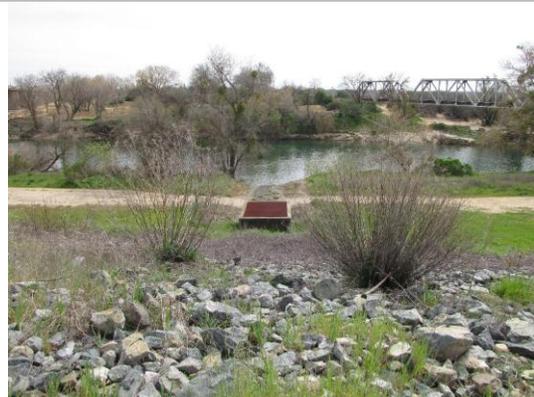
Photo 1 of 1 : UCIP_229.jpg

LM Start	0.13	Rating **	M	Issue No.	3
LM End	0.13	Issue Type +	En	Location *	CR
Category	Supplemental			GPS Latitude/Longitude	
				Start	End
Item	DWR UCIP Field Study			39.135177 °	39.135177 °
				-121.591612 °	-121.591612 °
DWR ID	DWR_NA0004_03_s_2014_3				
Action/Comments					
Inspector Comments: FS_ID:9838 EP_NO: 4063 Repair Type: Crossing Status: UCIP Comments: FIELD_STRUCT_DESC: 30-inch steel pipe through levee, 9.0 feet below crown. Flap gate on waterward end. Discharges into concrete distribution box (14x10.5x9 feet) at the waterward toe. Concrete lined discharge (grouted cobble) ditch across the waterward berm. 30-inch CM riser and siphon breaker on the landward shoulder. (Permit No. 4063-1965). Detention basin and storm water pumping station, on waterward side, included under permit. FS Date: 3/15/2013

Distribution box located on waterward slope.

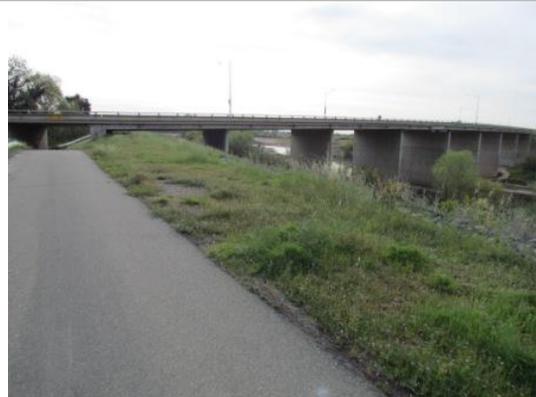
Photo 1 of 1 : mhoffman_s_20140326_273.jpg

LM Start	0.18	Rating **	M	Issue No.	18
LM End	4.87	Issue Type +	Ma	Location *	WS
Category	Earthen Levee			GPS Latitude/Longitude	
				Start	End
Item	Vegetation			39.135189 °	39.185058 °
				-121.590706 °	-121.540451 °
DWR ID	DWR_NA0004_03_s_2014_18				
Action/Comments					
Control annual grass and weeds on the levee slopes and easements.

This photo was taken from the levee crown facing east looking down the waterward levee slope annual vegetation prior to maintenance. Spring 2014.

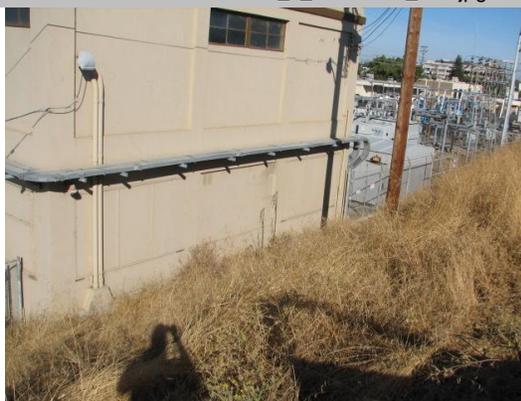
Photo 1 of 1 : mhoffman_s_20140306_115.jpg

LM Start	0.86	Rating **	M	Issue No.	4
LM End	0.86	Issue Type +	En	Location *	LS
Category	Earthen Levee		GPS Latitude/Longitude		
			Start	End	
Item	Encroachments		39.139843 °	39.139843 °	
			-121.583033 °	-121.583033 °	
DWR ID	DWR_NA0004_03_s_2012_4				
Action/Comments					
Building Inspector Comments: This building is at least 30 years old and is part of the PG&E site.

Building encroaching at landside levee toe.

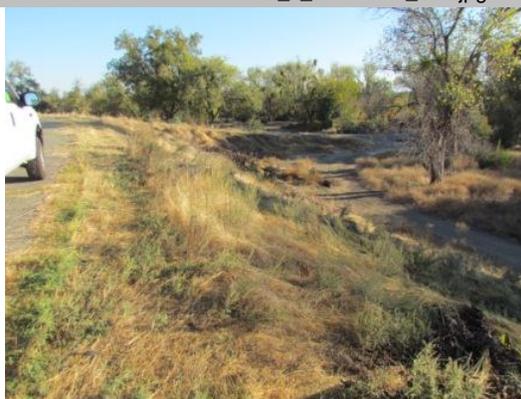
Photo 1 of 1 : mhoffman_s_20140306_119.jpg

LM Start	0.87	Rating **	M	Issue No.	30
LM End	0.87	Issue Type +	Ma	Location *	LS
Category	Earthen Levee		GPS Latitude/Longitude		
			Start	End	
Item	Vegetation		39.140038 °	39.140038 °	
			-121.583234 °	-121.583234 °	
DWR ID	DWR_NA0004_03_f_2013_30				
Action/Comments					
Control annual grass and weeds on the levee slopes and easements.

This photo was taken from the crown facing east looking down the waterward levee slope at vegetation. Fall 2013.

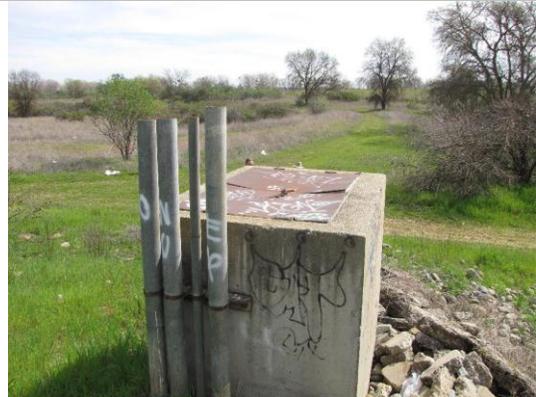
Photo 1 of 1 : UCIP_240.jpg

LM Start	2.23	Rating **	M	Issue No.	16
LM End	2.23	Issue Type +	En	Location *	LS
Category	Supplemental		GPS Latitude/Longitude		
			Start	End	
Item	DWR UCIP Field Study		39.154700 °	39.154700 °	
			-121.569367 °	-121.569367 °	
DWR ID	DWR_NA0004_03_s_2014_16				
Action/Comments					
Inspector Comments: FS_ID:9840 EP_NO: 2149 Repair Type: Crossing Status: UCIP Comments: FIELD_STRUCT_DESC: 3 of 4: 17th & Howell Pump Station. 24-inch steel drain pipe, buried 15-feet below the crown. Runs parallel to other drainpipes, encased in concrete approx. 1-foot spacing. Pipe extends from storm water pump house to manhole (259 feet) north of landward toe. Flap gates and vent pipes at waterward toe. Discharges into concrete distribution box (3x4 foot). (Permit No. 2149-1956). FS Date: 3/14/2013

View of concrete distribution box and metal gates.

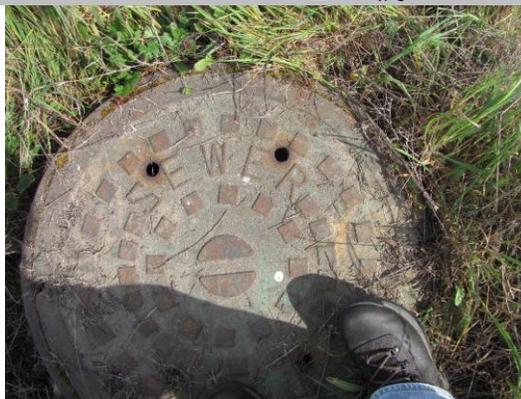
Photo 1 of 1 : UCIP_1271.jpg

LM Start	3.25	Rating **	M	Issue No.	17
LM End	3.25	Issue Type +	En	Location *	LS
Category	Supplemental			GPS Latitude/Longitude	
				Start	End
Item	DWR UCIP Field Study			39.166213 °	39.166213 °
				-121.557802 °	-121.557802 °
DWR ID	DWR_NA0004_03_s_2014_17				
Action/Comments					
Inspector Comments: FS_ID:15300 EP_NO: 15010 Repair Type: Crossing Status: UCIP Comments: FIELD_STRUCT_DESC: 8-inch fusion welded polyethylene gravity sewer pipe through levee, 8-feet below the levee crown. Shut-off valve within manhole located 46-feet waterward of levee shoulder. Encased in reinforced concrete through levee section. Extends parallel to levee, 10-feet from toe. (Permit No. 15010-1989). FS Date: 3/14/2013

Manhole located on landward toe.

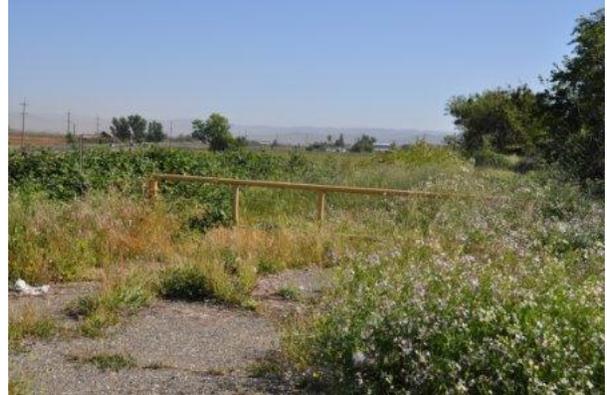
Photo 1 of 1 : mhoffman_s_20140306_114.jpg

Marysville, Unit 3 - Spring 2013 - Patrol road vegetation.

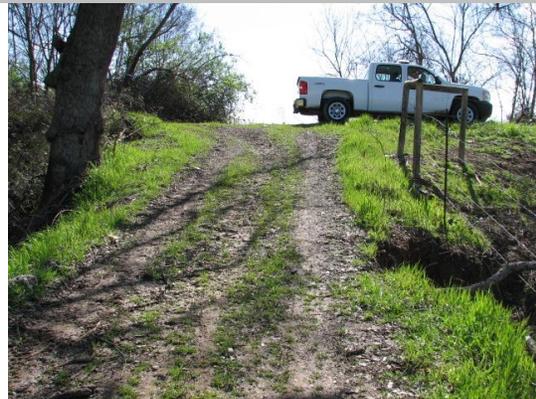
Photo 1 of 1 : mhoffman_s_20140306_118.jpg

LM Start	5.54	Rating **	M	Issue No.	10
LM End	5.54	Issue Type +	En	Location *	CR
Category	Earthen Levee		GPS Latitude/Longitude		
			Start	End	
Item	Encroachments		39.190993 °	39.190993 °	
			-121.530650 °	-121.530650 °	
DWR ID	DWR_NA0004_03_s_2012_10				
Action/Comments					
Ramp Inspector Comments: This is on the patrol road.

This ramp is on the patrol road, no known permit.
