**Flood Control Project Maintenance
Levee Inspections**
LMA District Cover Sheet
Spring 2015 Levee Inspection Results

Marysville Levee Commission

Levee Inspection Report By Mile - Spring 2015

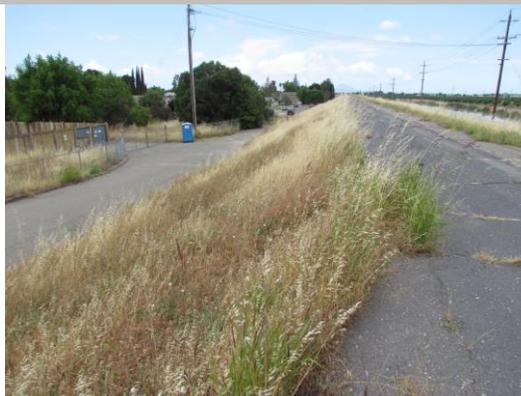
Photo 1 of 1 : SP_2015_NA0004_104_10_20150520_00002.jpg

LM Start	0.02	Rating **	M	Issue No.	10
LM End	3.15	Issue Type +	Ma	Location *	LS
Category	Earthen Levee		GPS Latitude/Longitude		
			Start	End	
Item	Vegetation		39.149856 °	39.164086 °	
			-121.600998 °	-121.560836 °	
DWR ID	DWR_NA0004_01_s_2015_10				
Action/Comments					
Control annual grass and weeds on the levee slopes and easements.

View of the vegetation on the landside of the levee facing downstream.

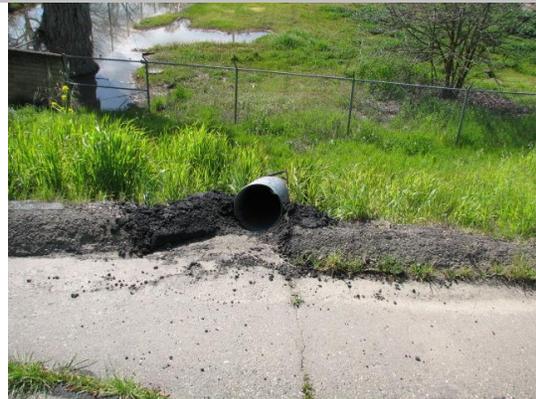
Photo 1 of 1 : SP_2015_NA0004_104_1_20150401_00001.jpg

LM Start	3.23	Rating **	A/W	Issue No.	1
LM End	3.23	Issue Type +	Ma	Location *	LS
Category	Earthen Levee			GPS Latitude/Longitude	
				Start	End
Item	Slope Stability			39.163590 °	39.163590 °
				-121.559495 °	-121.559495 °
DWR ID	DWR_NA0004_01_s_2012_1				
Action/Comments					
Repair slope instability. Inspector Comments: This drain pipe has been added to the site on the Corps PI.

This site is on the Corps PI.

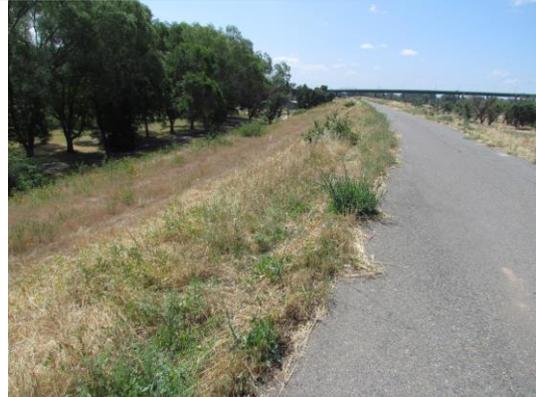
Photo 1 of 1 : SP_2015_NA0004_105_5_20150520_00002.jpg

LM Start	0.01	Rating **	A/W	Issue No.	5
LM End	1.23	Issue Type +	Ma	Location *	LS
Category	Earthen Levee			GPS Latitude/Longitude	
				Start	End
Item	Vegetation			39.149439 °	39.134764 °
				-121.601109 °	-121.594121 °
DWR ID	DWR_NA0004_02_s_2015_5				
Action/Comments					
Control annual grass and weeds on the levee slopes and easements.

View of the vegetation on the landside of the levee facing downstream.

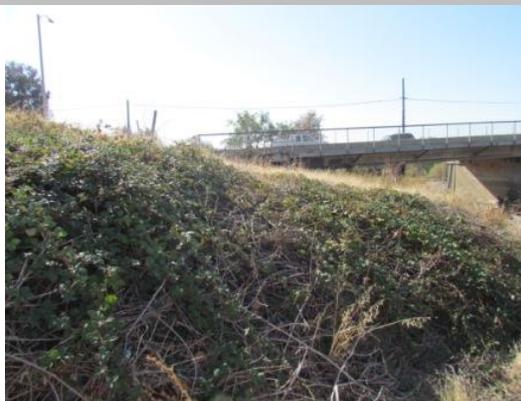
Photo 1 of 1 : SP_2015_NA0004_105_9_20150401_00001.jpg

LM Start	0.70	Rating **	M	Issue No.	9
LM End	0.70	Issue Type +	Ma	Location *	WS
Category	Earthen Levee			GPS Latitude/Longitude	
				Start	End
Item	Vegetation			39.139752 °	39.139752 °
				-121.600637 °	-121.600637 °
DWR ID	DWR_NA0004_02_f_2013_9				
Action/Comments					
Remove the wild growth other than native grasses from the levee slopes. Inspector Comments: Blackberries on waterward levee slope.

This photo was taken from the access road going under the 5th street bridge of blackberries growing on the waterward levee slope. Fall 2013.

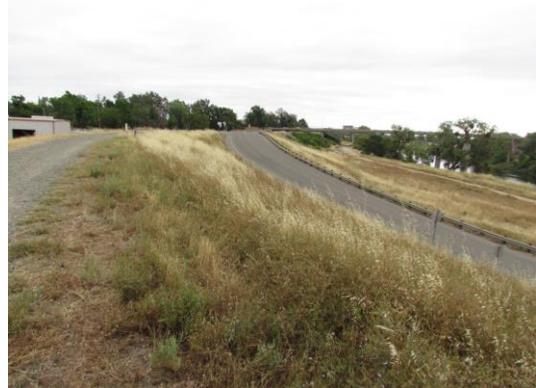
Photo 1 of 1 : SP_2015_NA0004_106_26_20150520_00007.jpg

LM Start	0.01	Rating **	M	Issue No.	26
LM End	3.70	Issue Type +	Ma	Location *	WS
Category	Earthen Levee			GPS Latitude/Longitude	
				Start	End
Item	Vegetation			39.134858 °	39.172095 °
				-121.593641 °	-121.552278 °
DWR ID	DWR_NA0004_03_s_2015_26				
Action/Comments					
Control annual grass and weeds on the levee slopes and easements.

View of the vegetation on the waterside of the levee facing downstream.

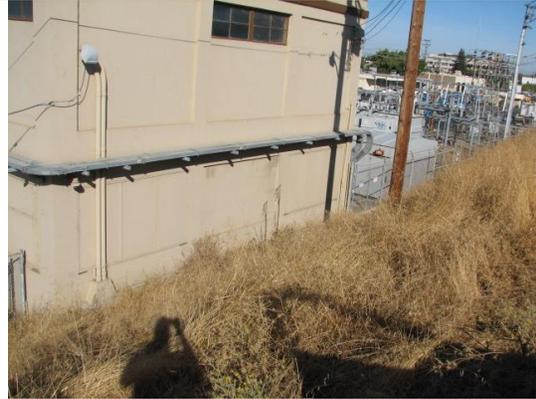
Photo 1 of 1 : SP_2015_NA0004_106_4_20150401_00002.jpg

LM Start	0.83	Rating **	M	Issue No.	4
LM End	0.83	Issue Type +	En	Location *	LS
Category	Earthen Levee			GPS Latitude/Longitude	
				Start	End
Item	Encroachments			39.139843 °	39.139843 °
				-121.583033 °	-121.583033 °
DWR ID	DWR_NA0004_03_s_2012_4				
Action/Comments					
Building Inspector Comments: This building is at least 30 years old and is part of the PG&E site.

Building encroaching at landside levee toe.

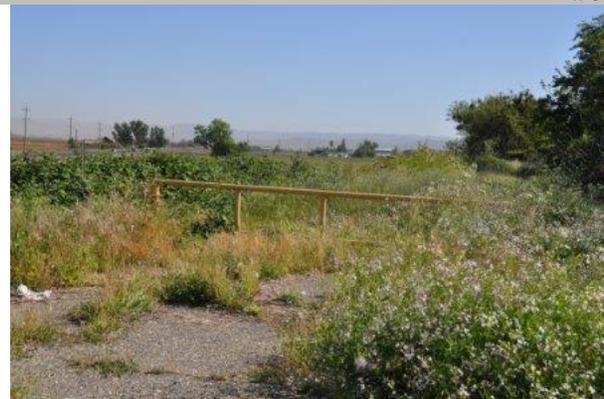
Photo 1 of 1 : SP_2015_NA0004_106_1_20150401_00001.jpg

LM Start	4.88	Rating **	U	Issue No.	1
LM End	6.79	Issue Type +	En	Location *	CR
Category	Earthen Levee			GPS Latitude/Longitude	
				Start	End
Item	Encroachments			°	°
				°	°
DWR ID	DWR_NA0004_03_s_2012_1				
Action/Comments					
Fence Inspector Comments: Levee miles 4.88-6.79 not inspected due to limited access from livestock fencing. Levee crown has been mowed.

Marysville, Unit 3 - Spring 2013 - Patrol road vegetation.

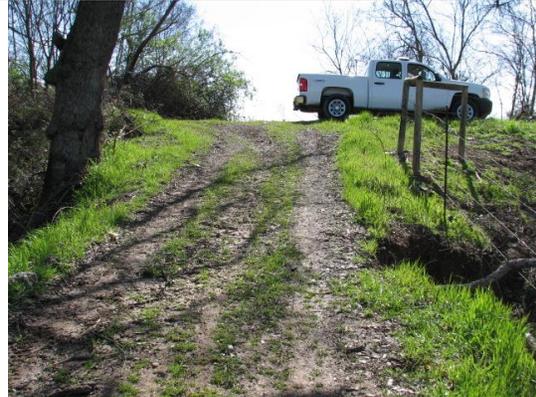
Photo 1 of 1 : SP_2015_NA0004_106_10_20150401_00005.jpg

LM Start	5.47	Rating **	M	Issue No.	10
LM End	5.47	Issue Type +	En	Location *	CR
Category	Earthen Levee			GPS Latitude/Longitude	
				Start	End
Item	Encroachments			39.190993 °	39.190993 °
				-121.530650 °	-121.530650 °
DWR ID	DWR_NA0004_03_s_2012_10				
Action/Comments					
Ramp Inspector Comments: This is on the patrol road.

This ramp is on the patrol road, no known permit.
