**Flood Control Project Maintenance  
Levee Inspections**

**Maintenance Issue Types Only, Levee Inspection Report By Mile - Fall 2014**

**Marysville Levee Commission**

Waterway	Bank	Unit Miles	Inspection Start/End	Inspector
Unit No. 01 Simmerly Slough	Left	3.23	10/27/2014 10/27/2014	Matthew Hoffman

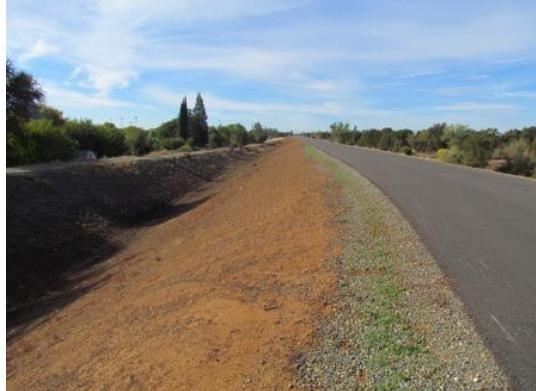
Photo 1 of 1 : FA\_2014\_NA0004\_104\_10\_20141103\_00002.jpg

LM Start	<b>1.85</b>	Rating **	A	Issue No.	<b>10</b>
LM End	<b>1.85</b>	Issue Type +	Ma	Location *	LS
Category	Earthen Levee		GPS Latitude/Longitude		
			Start	End	
Item	Vegetation		39.164735 °	39.164735 °	
			-121.583859 °	-121.583859 °	
DWR ID	DWR_NA0004_01_f_2014_10				
Action/Comments					
Control annual grass and weeds on the levee slopes and easements.

This photo was taken from the levee crown facing west looking down the landward slope at acceptable vegetation maintenance. Fall 2014.

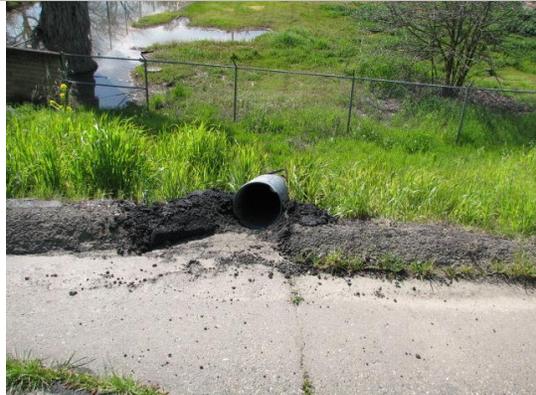
Photo 1 of 1 : FA\_2014\_NA0004\_104\_1\_20141023\_00001.jpg

LM Start	<b>3.21</b>	Rating **	A/W	Issue No.	<b>1</b>
LM End	<b>3.21</b>	Issue Type +	Ma	Location *	LS
Category	Earthen Levee		GPS Latitude/Longitude		
			Start	End	
Item	Slope Stability		39.163590 °	39.163590 °	
			-121.559495 °	-121.559495 °	
DWR ID	DWR_NA0004_01_s_2012_1				
Action/Comments					
Repair slope instability. Inspector Comments: This drain pipe has been added to the site on the Corps PI.

This site is on the Corps PI.

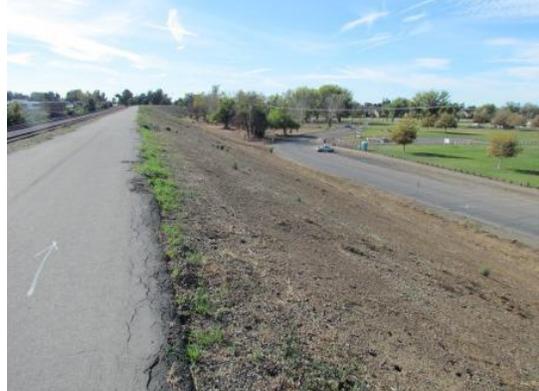
Photo 1 of 1 : FA\_2014\_NA0004\_105\_5\_20141103\_00002.jpg

LM Start	<b>0.43</b>	Rating **	A	Issue No.	<b>5</b>
LM End	<b>0.43</b>	Issue Type +	Ma	Location *	WS
Category	Earthen Levee		GPS Latitude/Longitude		
			Start	End	
Item	Vegetation		39.143573 °	39.143573 °	
			-121.600375 °	-121.600375 °	
DWR ID	DWR_NA0004_02_f_2014_5				
Action/Comments					
Control annual grass and weeds on the levee slopes and easements.

This photo was taken from the levee crown facing south looking down the waterward slope at acceptable vegetation maintenance. Fall 2014.

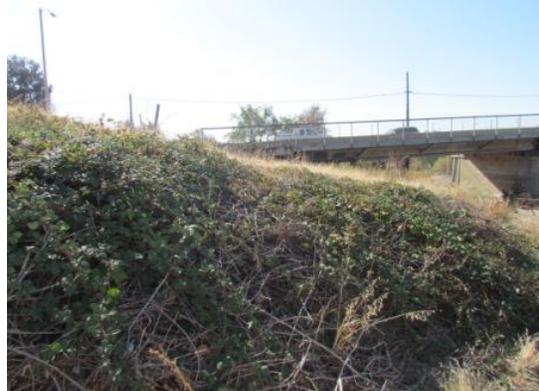
Photo 1 of 1 : FA\_2014\_NA0004\_105\_9\_20141023\_00001.jpg

LM Start	<b>0.72</b>	Rating **	M	Issue No.	<b>9</b>
LM End	<b>0.72</b>	Issue Type +	Ma	Location *	WS
Category	Earthen Levee		GPS Latitude/Longitude		
			Start	End	
Item	Vegetation		39.139752 °	39.139752 °	
			-121.600637 °	-121.600637 °	
DWR ID	DWR_NA0004_02_f_2013_9				
Action/Comments					
Remove the wild growth other than native grasses from the levee slopes. Inspector Comments: Blackberries on waterward levee slope.

This photo was taken from the access road going under the 5th street bridge of blackberries growing on the waterward levee slope. Fall 2013.

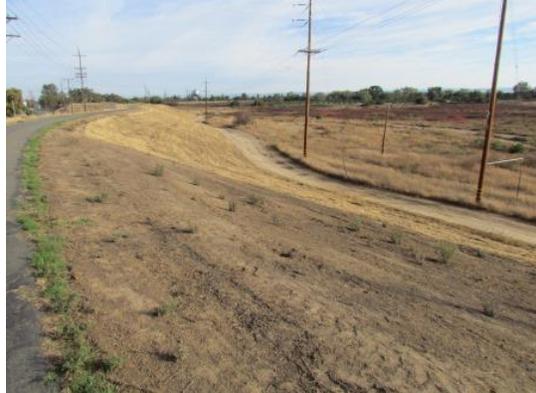
Photo 1 of 1 : FA\_2014\_NA0004\_106\_25\_20141103\_00007.jpg

LM Start	<b>0.87</b>	Rating **	A	Issue No.	<b>25</b>
LM End	<b>0.87</b>	Issue Type +	Ma	Location *	WS
Category	Earthen Levee		GPS Latitude/Longitude		
			Start	End	
Item	Vegetation		39.139990 °	39.139990 °	
			-121.583184 °	-121.583184 °	
DWR ID	DWR_NA0004_03_f_2014_25				
Action/Comments					
Control annual grass and weeds on the levee slopes and easements.

This photo was taken from the levee crown facing east looking down the waterward slope at acceptable vegetation maintenance. Fall 2014.
