**Flood Control Project Maintenance  
Levee Inspections**

**Maintenance Issue Types Only, Levee Inspection Report By Mile - Fall 2015**

**Marysville Levee Commission**

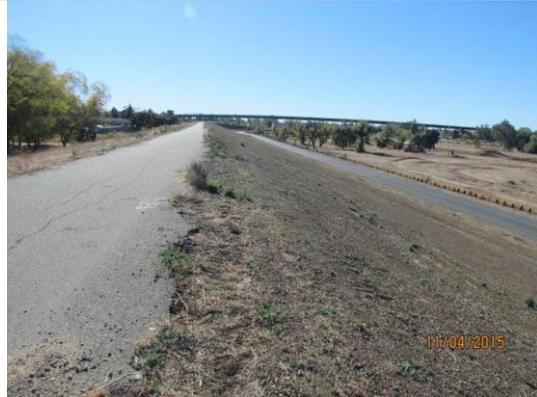
Photo 1 of 1 : FA\_2015\_NA0004\_105\_5\_20151112\_00002.jpg

LM Start	<b>0.01</b>	Rating **	A	Issue No.	<b>5</b>
LM End	<b>1.23</b>	Issue Type +	Ma	Location *	WS
Category	Earthen Levee			GPS Latitude/Longitude	
				Start	End
Item	Vegetation			39.149387 °	39.134750 °
				-121.601125 °	-121.594045 °
DWR ID	DWR_NA0004_02_f_2015_5				
Action/Comments					
Control annual grass and weeds on the levee slopes and easements. Inspector Comments: Levee slope has been burned and dragged.

View of the vegetation on the waterward side of the levee looking downstream. Fall 2015.

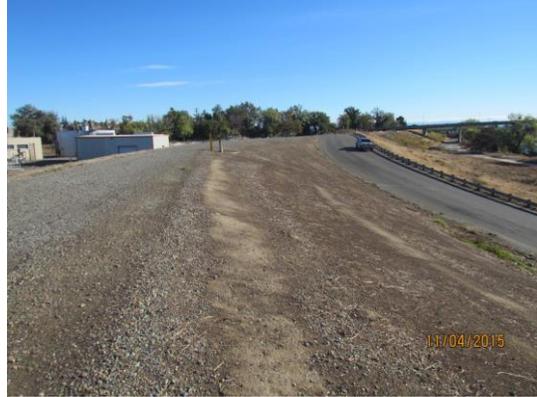
Photo 1 of 1 : FA\_2015\_NA0004\_106\_25\_20151112\_00007.jpg

LM Start	<b>0.01</b>	Rating **	A	Issue No.	<b>25</b>
LM End	<b>0.27</b>	Issue Type +	Ma	Location *	WS
Category	Earthen Levee			GPS Latitude/Longitude	
				Start	End
Item	Vegetation			39.134850 °	39.135147 °
				-121.593650 °	-121.588987 °
DWR ID	DWR_NA0004_03_f_2015_25				
Action/Comments					
Control annual grass and weeds on the levee slopes and easements. Inspector Comments: LMA has burned and dragged the levee.

View of the vegetation on the waterward side of the levee looking upstream. Fall 2015.
