**Flood Control Project Maintenance
Levee Inspections**
LMA District Cover Sheet
Spring 2010 Levee Inspection Results

Marysville Levee Commission

Levee Inspection Report By Mile - Spring 2010

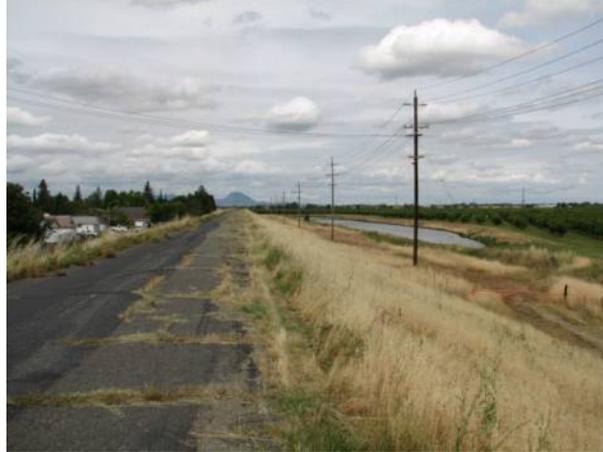
Levee Mile Report Line	1
Start Levee Mile	0.01
End Levee Mile	3.17
Location	Water Side
Category	Earthen Levee
Item	Vegetation
Water side vegetation levee mile 3.20.	
cathom_s_20100609_109.jpg

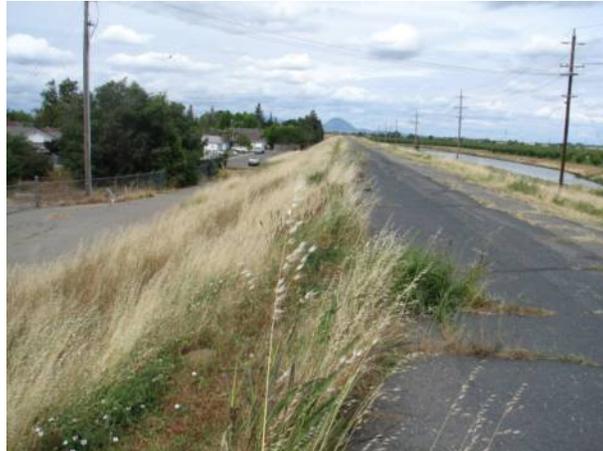
Levee Mile Report Line	2
Start Levee Mile	0.01
End Levee Mile	3.17
Location	Land Side
Category	Earthen Levee
Item	Vegetation
Land side vegetation levee mile 3.20.	
cathom_s_20100609_108.jpg

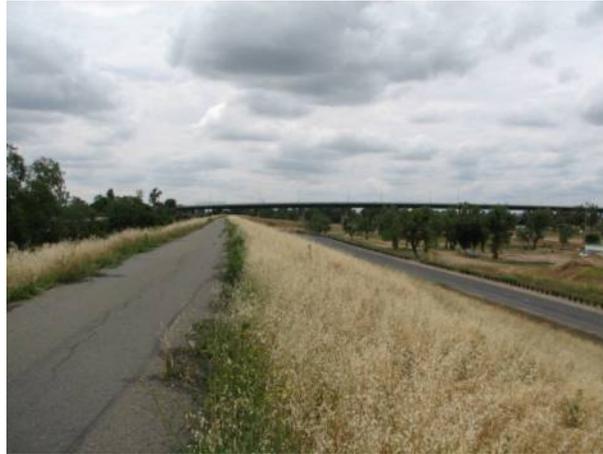
Levee Mile Report Line	1
Start Levee Mile	0.02
End Levee Mile	1.25
Location	Water Side
Category	Earthen Levee
Item	Vegetation
Water side vegetation levee mile 0.00.	
cathom_s_20100603_093.jpg

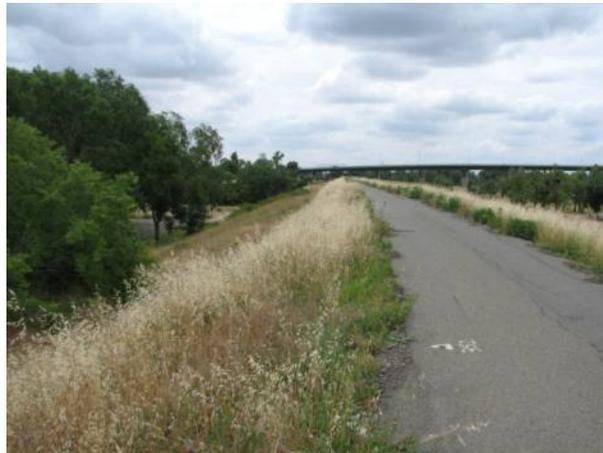
Levee Mile Report Line	2
Start Levee Mile	0.02
End Levee Mile	1.25
Location	Land Side
Category	Earthen Levee
Item	Vegetation
Land side vegetation levee mile 0.00.	
cathom_s_20100603_092.jpg

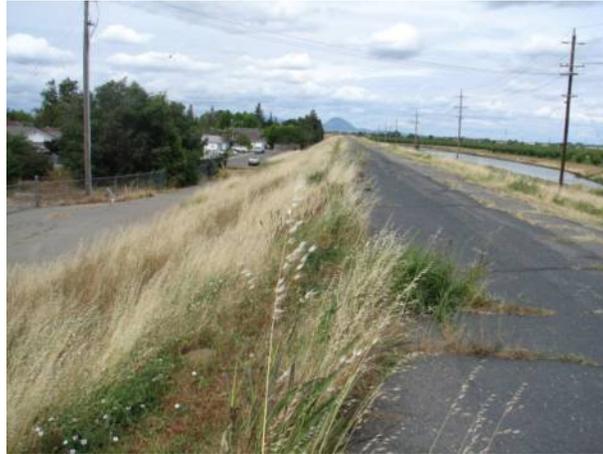
Levee Mile Report Line	1
Start Levee Mile	0.00
End Levee Mile	6.86
Location	Land Side
Category	Earthen Levee
Item	Vegetation
Land side vegetation levee mile 3.20.	
cathom_s_20100603_091.jpg

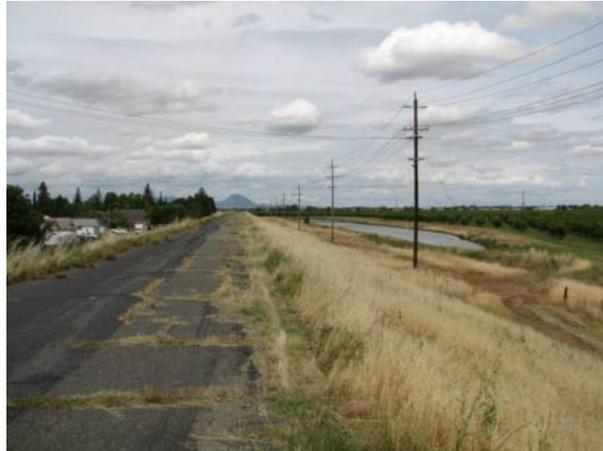
Levee Mile Report Line	2
Start Levee Mile	0.00
End Levee Mile	6.86
Location	Water Side
Category	Earthen Levee
Item	Vegetation
Water side vegetation levee mile 3.20.	
cathom_s_20100603_090.jpg
