**Flood Control Project Maintenance
Levee Inspections**
LMA District Cover Sheet
Spring 2011 Levee Inspection Results

Marysville Levee Commission

Levee Inspection Report By Mile - Spring 2011

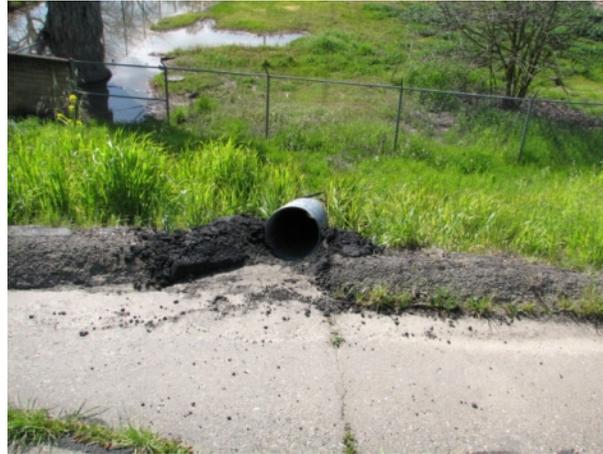
LMR No.	Levee Mile		Category	Item	* Location	** Rating	Action/Comment	GPS Latitude/Longitude		Issue No. Photo
	Start	End						Start	End	
1	3.21	3.21	Earthen Levee	Slope Stability	LS	M	Repair slope instability. Inspector Comments: This drain pipe has been added to the site on the Corps PI.	39.163590 ° -121.559495 °	39.163590 ° -121.559495 °	1 Y

Levee Mile Report Line	1
Start Levee Mile	3.21
End Levee Mile	3.21
Location	Land Side
Category	Earthen Levee
Item	Slope Stability
This site is on the Corps PI.	
cathom_s_20110325_107.jpg

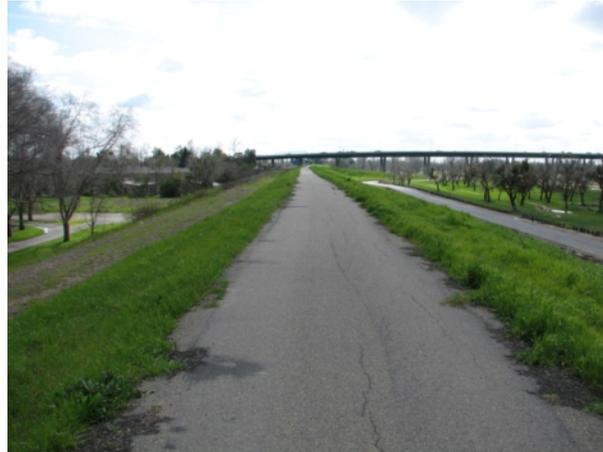
Levee Mile Report Line	1
Start Levee Mile	0.02
End Levee Mile	0.02
Location	Crown
Category	Earthen Levee
Item	Vegetation
Levee mile 0.02, vegetation on the levee.	
cathom_s_20110404_109.jpg

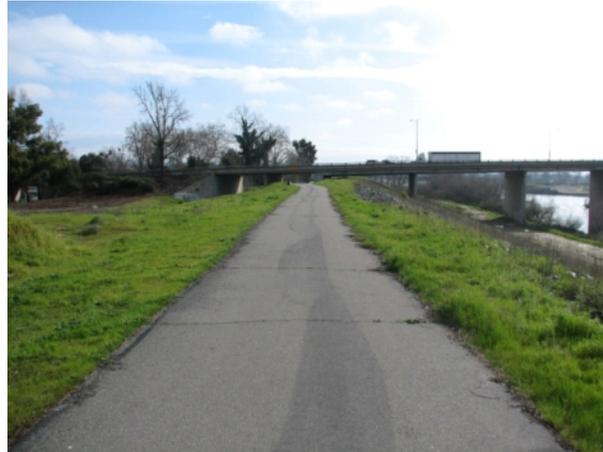
Levee Mile Report Line	1
Start Levee Mile	0.13
End Levee Mile	0.13
Location	Crown
Category	Earthen Levee
Item	Vegetation
Levee mile 0.13, looking upstream at the vegetation on the levee.	
cathom_s_20110314_099.jpg

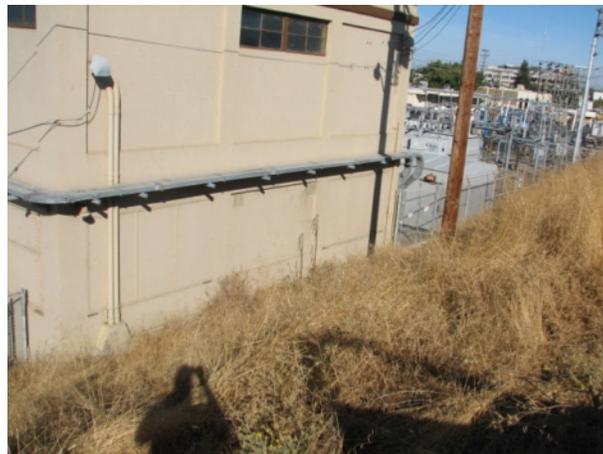
Levee Mile Report Line	5
Start Levee Mile	0.86
End Levee Mile	0.86
Location	Land Side
Category	Earthen Levee
Item	Encroachments
Building encroaching at land side levee toe.	
cathom_s_20110228_007.jpg

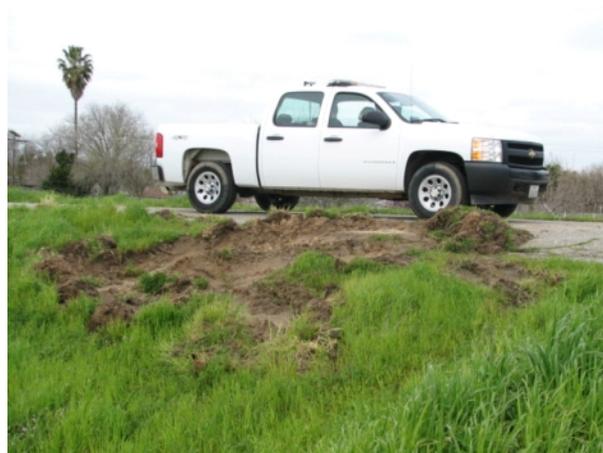
Levee Mile Report Line	6
Start Levee Mile	2.17
End Levee Mile	2.17
Location	Water Side
Category	Earthen Levee
Item	Slope Stability
Levee mile 2.17, this photo was taken from the waterside slope of the shoulder and the slope.	
cathom_s_20110314_100.jpg

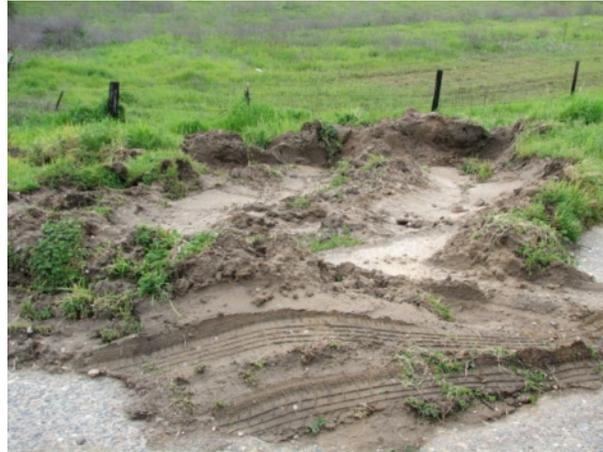
Levee Mile Report Line	6
Start Levee Mile	2.17
End Levee Mile	2.17
Location	Water Side
Category	Earthen Levee
Item	Slope Stability
Levee mile 2.17, this photo was taken from the shoulder looking down the waterside slope.	
cathom_s_20110314_101.jpg

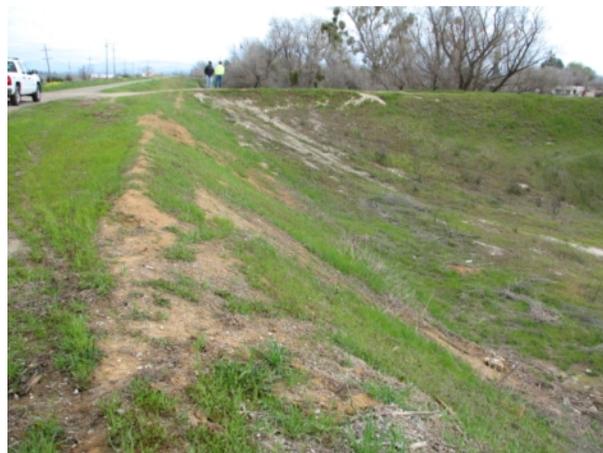
Levee Mile Report Line	8
Start Levee Mile	4.37
End Levee Mile	4.37
Location	Water Side
Category	Earthen Levee
Item	Vegetation
This site is on the Corps PI.	
cathom_s_20110325_104.jpg

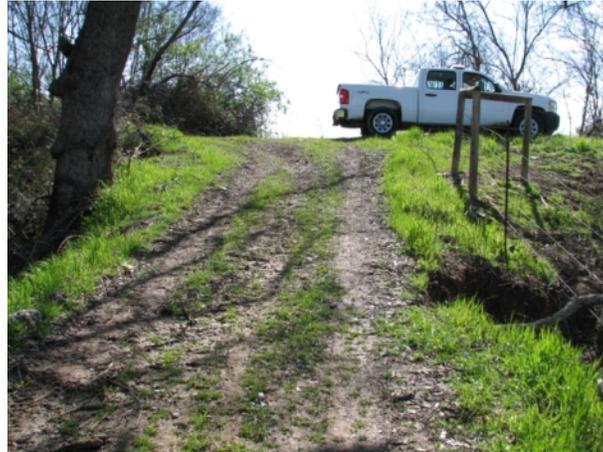
Levee Mile Report Line	10
Start Levee Mile	5.54
End Levee Mile	5.54
Location	Crown
Category	Earthen Levee
Item	Encroachments
This ramp is on the patrol road, no known permit.	
cathom_s_20110325_106.jpg
